THE MORANDI BRIDGE DISASTER COULD HAVE BEEN PREVENTED

The collapse of the Morandi Bridge in Genoa, Italy, on August 14, 2018, was a result of a combination of **flawed original design, long-term corrosion and material degradation, and insufficient maintenance and monitoring**. The failure of a single stay cable on pylon 9 triggered a chain reaction that brought down a section of the bridge, killing 43 people.

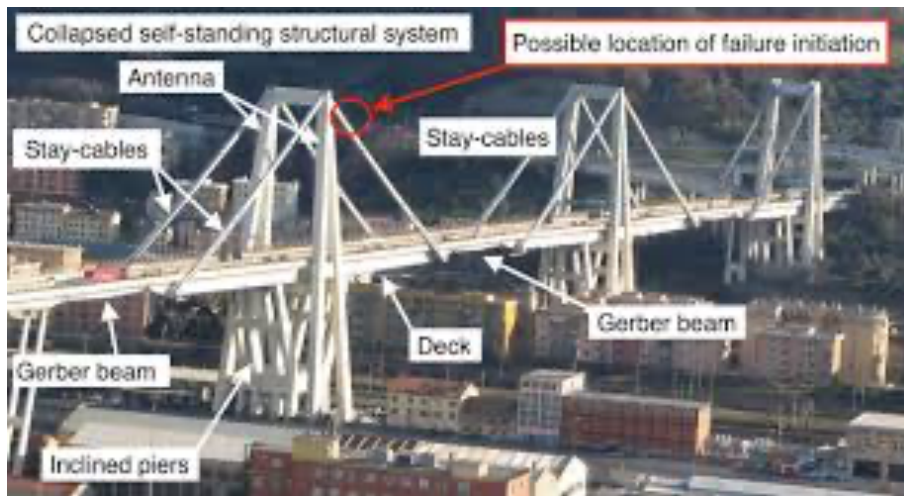
- **Design Deficiencies:** The bridge, designed by Riccardo Morandi and opened in 1967, had a unique cable-stayed design that used relatively few stays made of prestressed concrete.
 - **Inaccurate Calculations:** Some experts believe the original calculations for how the concrete and prestressing tendons would age and perform over time were inaccurate.
 - **Lack of Redundancy:** The design's reliance on only a few stay cables per pylon meant there was little structural redundancy; the failure of one stay could lead to a catastrophic collapse.
 - **Concealed Tendons:** The critical prestressing tendons were encased in concrete, making them vulnerable to corrosion that was difficult to detect through standard inspections.

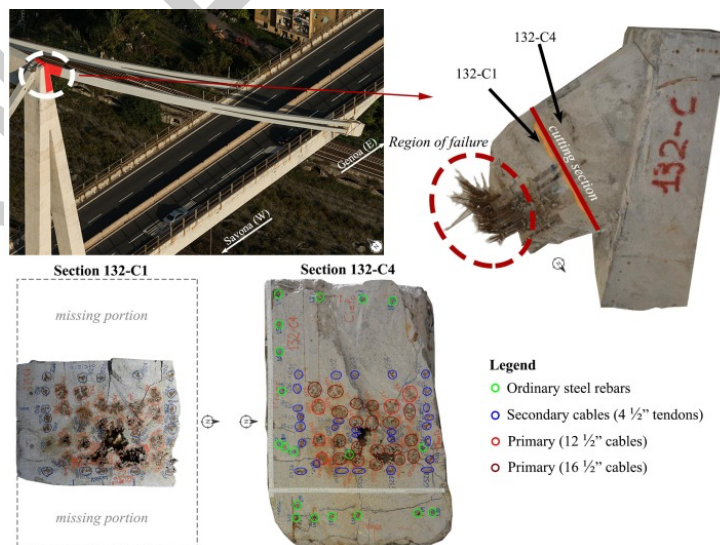
- **Corrosion and Material Degradation:** The bridge experienced persistent problems and required constant, costly maintenance throughout its 50-year lifespan.
 - **Vulnerability to Water Damage:** The concrete was prone to cracking, which allowed water ingress, leading to the corrosion of the internal steel tendons.
 - **Advanced Deterioration:** Years before the collapse, reports noted severe degradation of the stays, with one report in early 2018 indicating a 10 to 20% reduction in the cross-section of the tendons in the area that eventually failed.

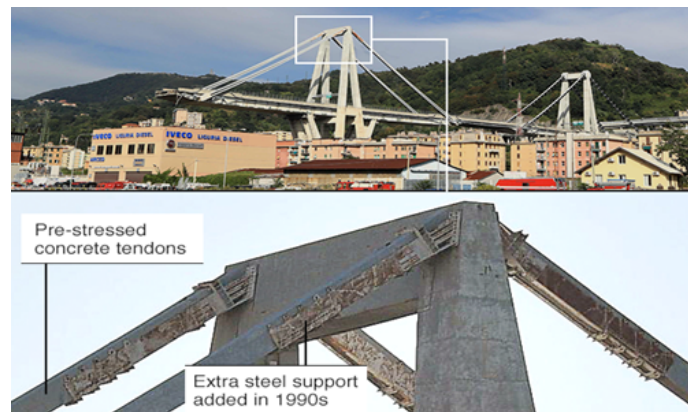
- **Insufficient Maintenance and Oversight:** The company responsible for the bridge's management and safety, Autostrade per l'Italia (ASPI), was found responsible for a "reactive" rather than "predict and prevent" approach to asset management.
 - **Ignored Warning Signs:** Cracks and other signs of damage were monitored for years, but no suggestion was made to reduce the load on the bridge or close it to traffic.
 - **Flawed Inspection Practices:** The inspection and repair processes failed to address the underlying degradation effectively.
