**HDX HOME  
INSPECTIONS**

## Home Inspection Report

**861 Test Street**

Inspected on Tue, Jan 18 2022 at 12:40 AM

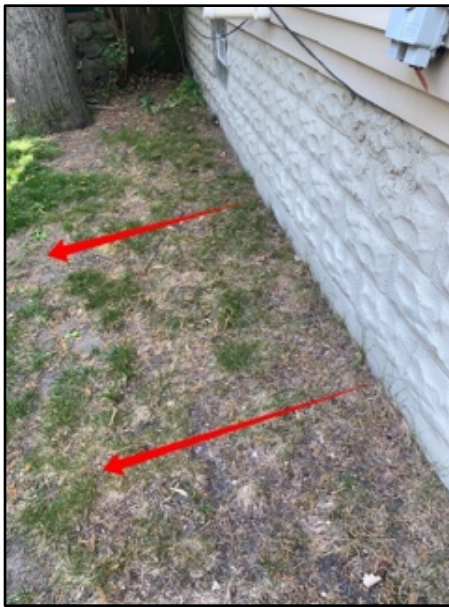
Figure 12-1

Regrade to pitch slope away from home to direct surface water away from foundation. This may assist in moisture entry to lower levels or structure of home. A positive slope directed away from the foundation is suggested.

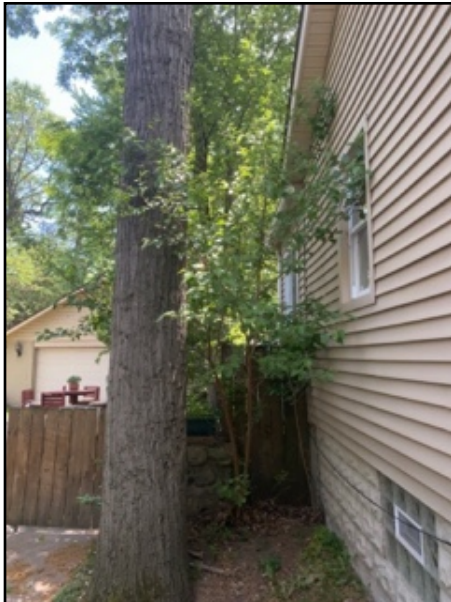
Figure 13-1

Trim trees and vegetation away from Structure and roof to prevent damages to home, siding or roofing materials.

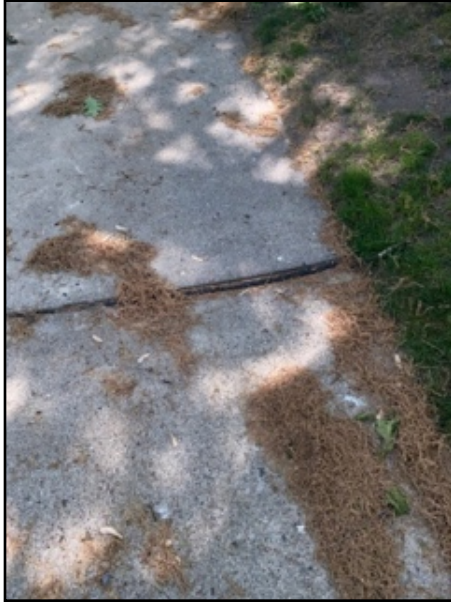
Figure 14-1

Driveway is unlevel from settlement. Have driveway leveled or mud jacked to prevent trip hazards.

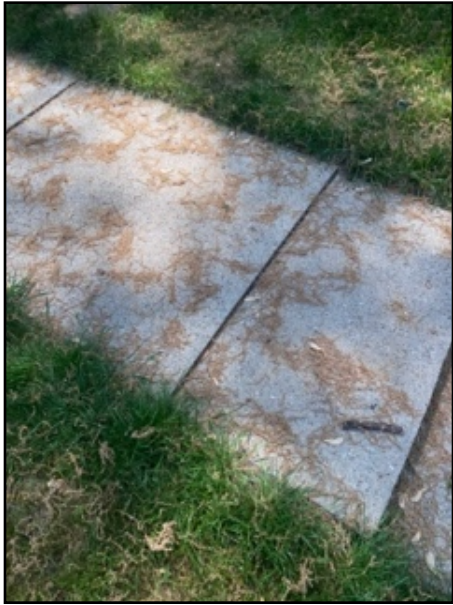
Figure 15-1

Walkway has settled. This may cause trip hazards. Have areas mud jacked or leveled to prevent safety issues or trip hazards. Walkways should be directed away from structure to assist in water dispersion away from home.

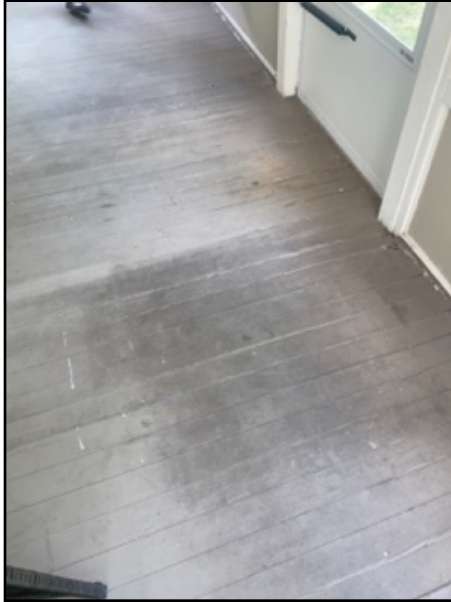
Figure 17-1

Repaint any areas where paint has faded or peeled. Repaint to prevent rot or deterioration at wood porch.

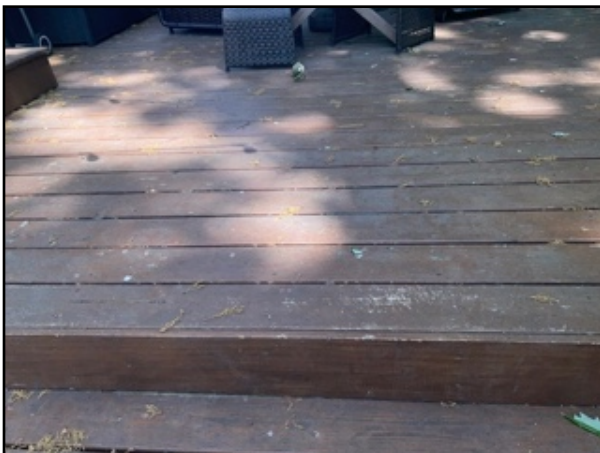
Figure 19-1

Repaint wood deck to prevent rot and deterioration. Deck shows signs of wear at wood members.

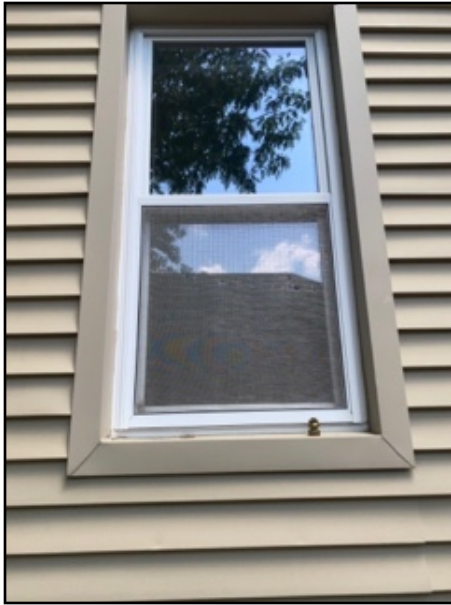
Figure 22-1

Replace any missing or damaged screens surrounding the home.

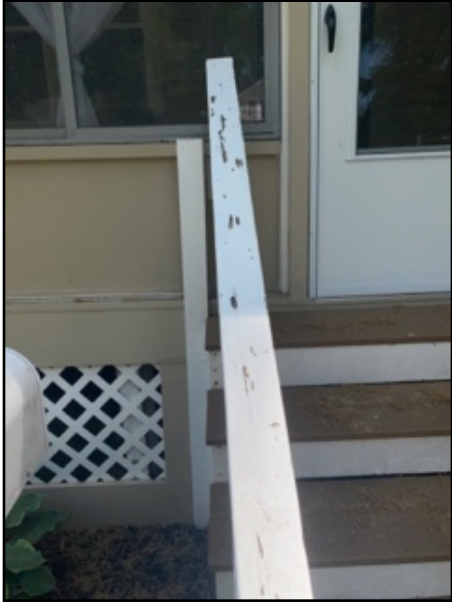
Figure 23-1

Some railings show signs of paint peel. Repaint to prevent further rot or damages. Replace any damaged sections.

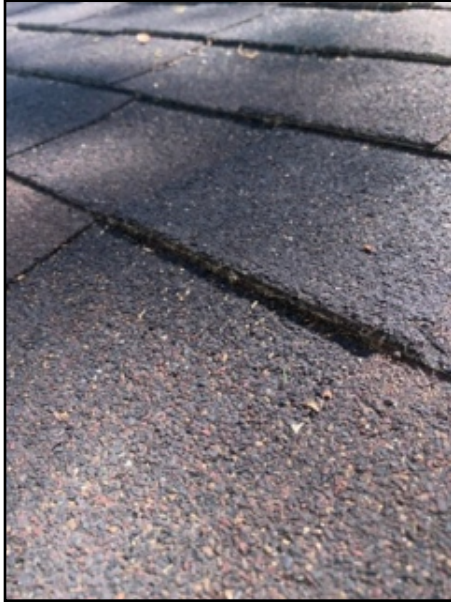
Figure 26-1

Clean any mold or moss at shingles to prevent further damages or deterioration at surfaces.

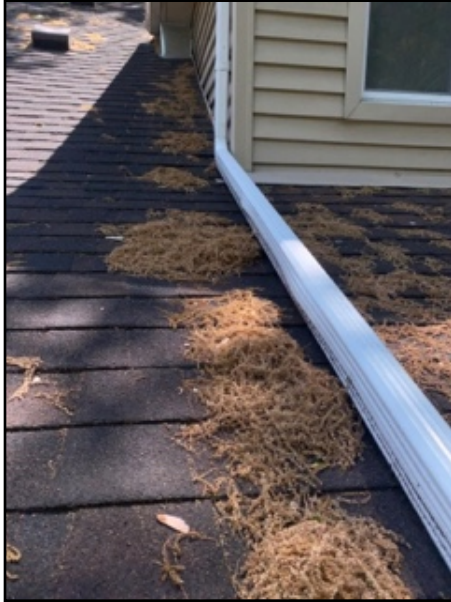
Figure 27-1

Recommended clearing any debris at roof surface to prevent damages or further organic growth at the shingles.

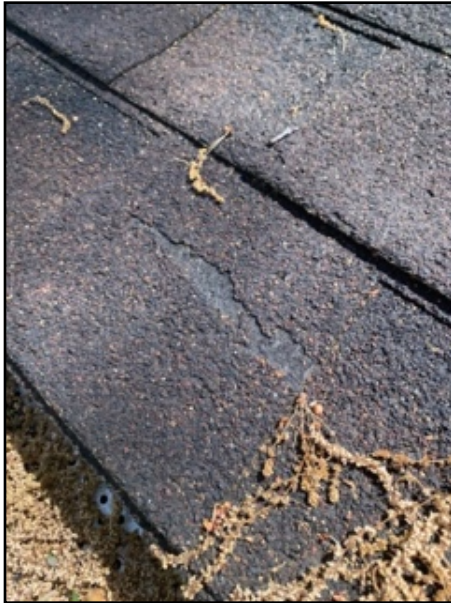
Figure 28-1

There is noticeable surface wear and aggregate loss at some areas of shingles. Continue to monitor. Repair may be necessary. Consult a licensed roofer to review damages, chipping and wear to shingles.

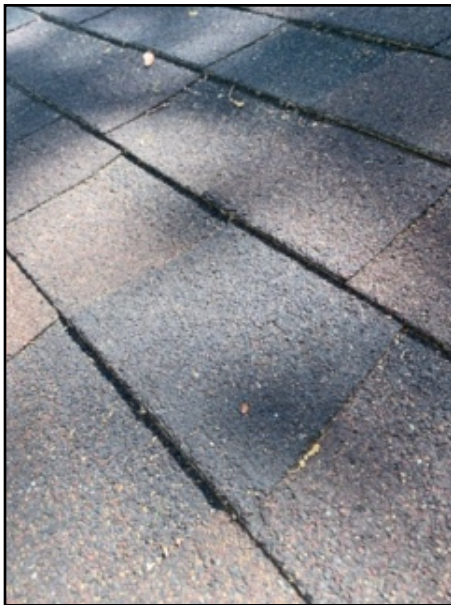
Figure 29-1

There is significant wear at some shingles. Consult a licensed roofer for full review.

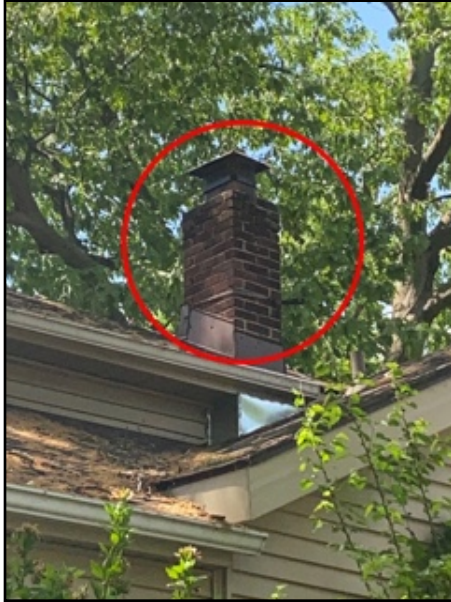
Figure 31-1

Chimney shows some signs of wear. Some tuckpointing is necessary. Consult a licensed brick mason for repair

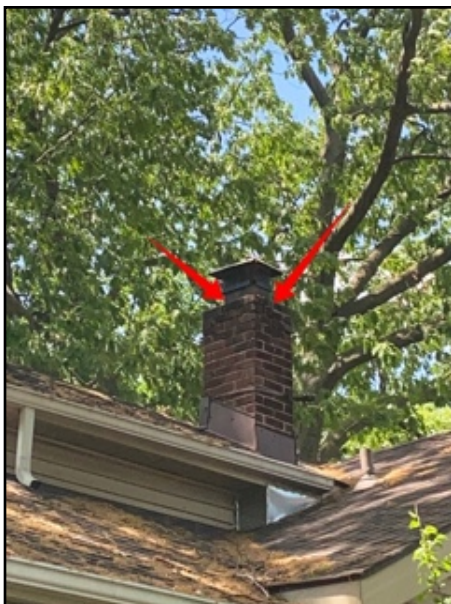
Figure 32-1

Chimney crown may require patching or repairs. Consult a licensed brick mason for estimate.

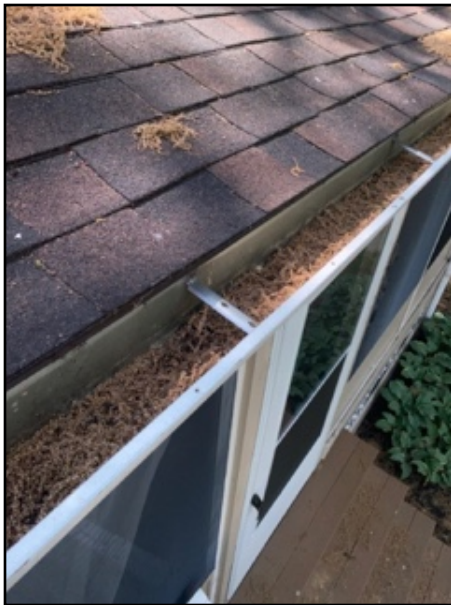
Figure 33-1

Recommended cleaning gutters as they are full of debris. This will not provide proper water runoff away from the roof and structure.

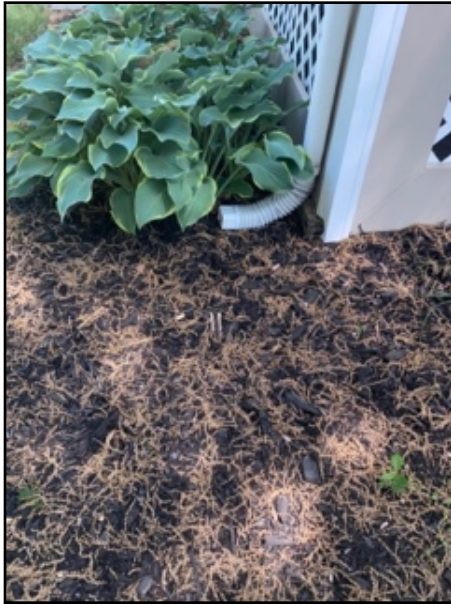
Figure 34-1

Extend downspouts away from home to direct water away from foundation. Extend 6-8 feet away from home

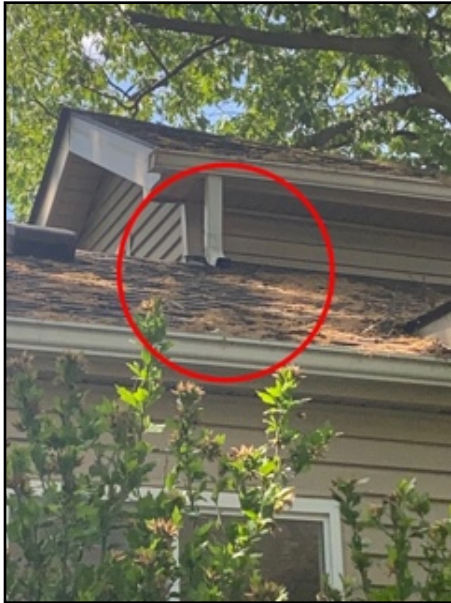
Figure 35-1

Extend leaders to lower gutter systems to direct water away from roof and to prevent wear to shingles. Any upper leaders should be directed to lower gutter system

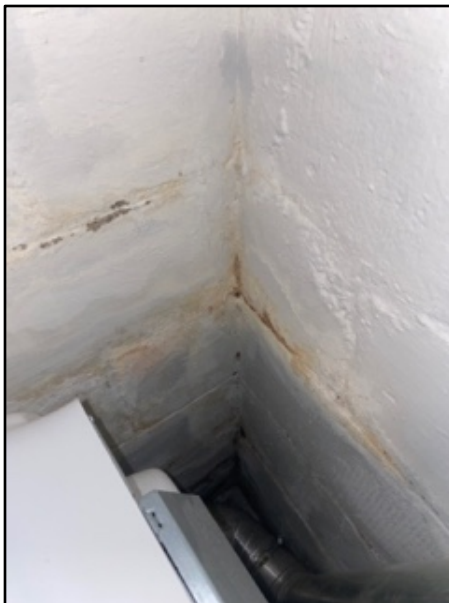
Figure 38-1

Some signs of water penetration and staining exists at basement walls or other areas. Continue to monitor. Regrade to pitch water away from home and direct downspouts further away from foundation to reduce risks for moisture intrusion.

Efflorescence exists at some areas of foundation block.

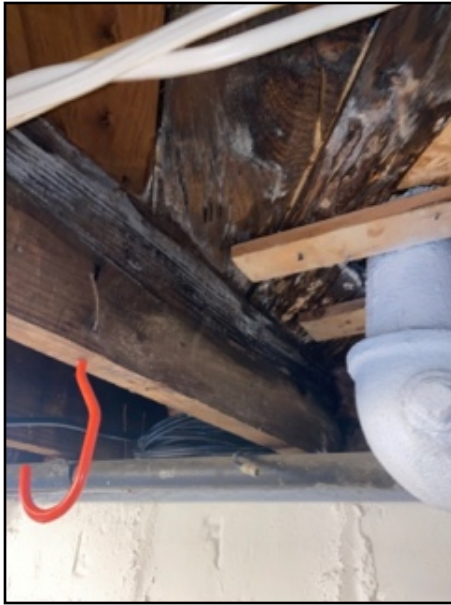
Figure 39-1

There is a mold like substance at some areas of floor joists and subflooring. Recommended remediation at any areas that show signs of organic growth

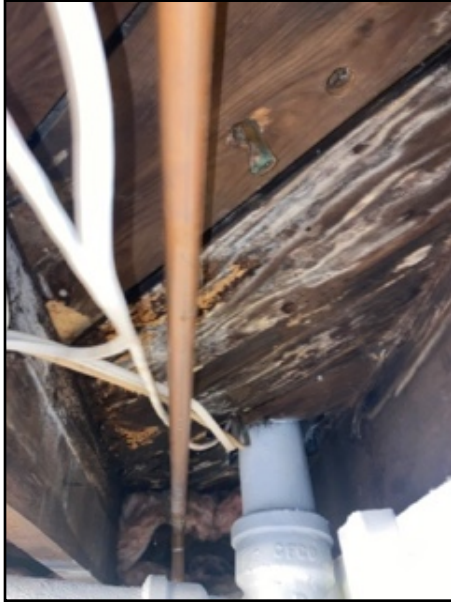
Figure 40-1

Monitor any areas of previous staining. Floor is currently dry. Continue to monitor.

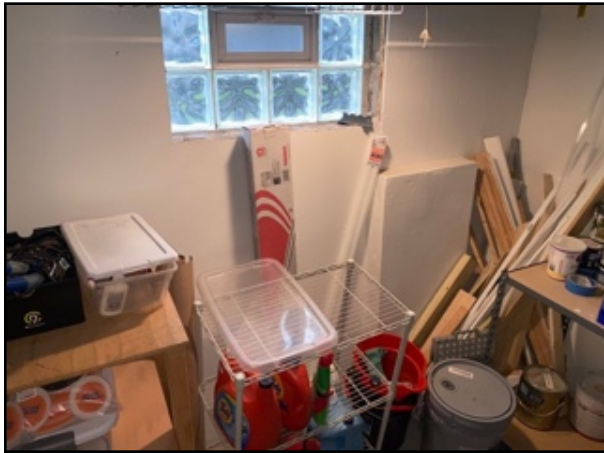
Figure 43-1

Finished walls conceal foundation in some parts of basement. This is a limitation to the inspection process

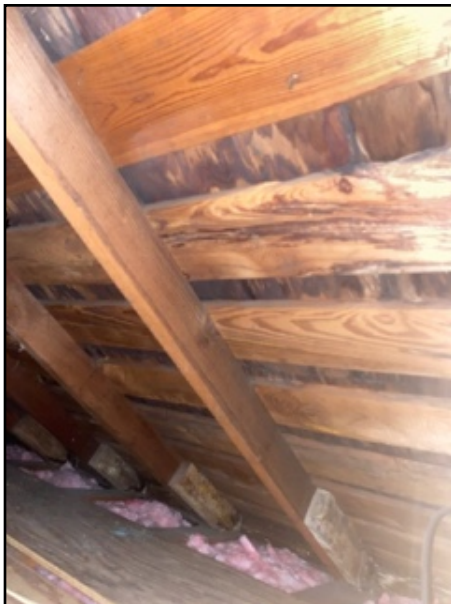
Figure 49-1

There is a mold like substance at areas of sheathing . A licensed environmental contractor should estimate these areas for remediation. Corrective measures may be required to add additional ventilation to reduce condensation damages

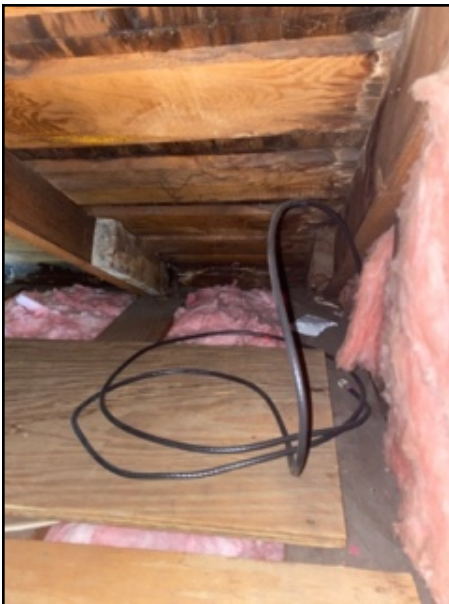
Figure 50-1

Wood shows visible signs of staining. Areas tested as dry. Continue to monitor.

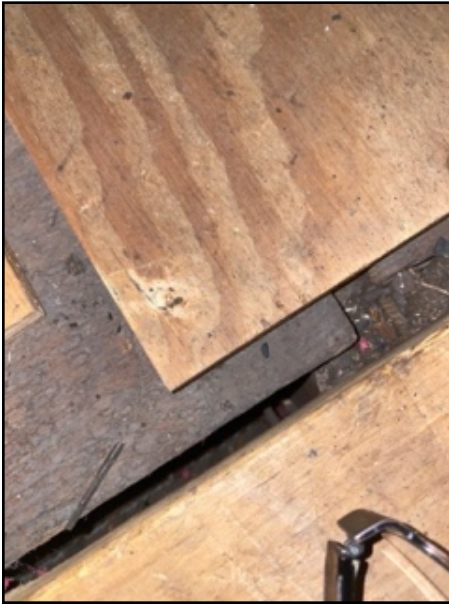
Figure 51-1

There are pest droppings in the attic. Consult a licensed exterminator for estimation of removal.

Noted pest baits in attic.

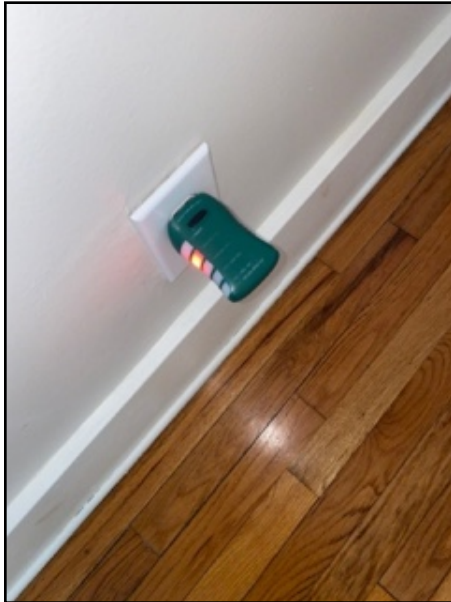
Figure 57-1

3 prong outlets are ungrounded in some areas. It is recommended to ground outlets to meet current safety standards

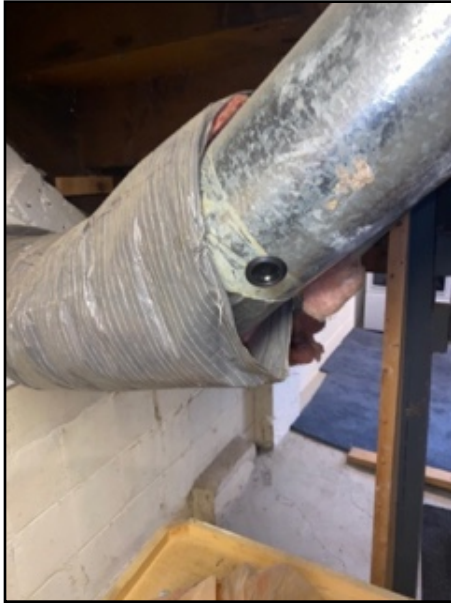
Figure 60-1

Comment 60:  
Recommended taping transitions to flexible ducting.

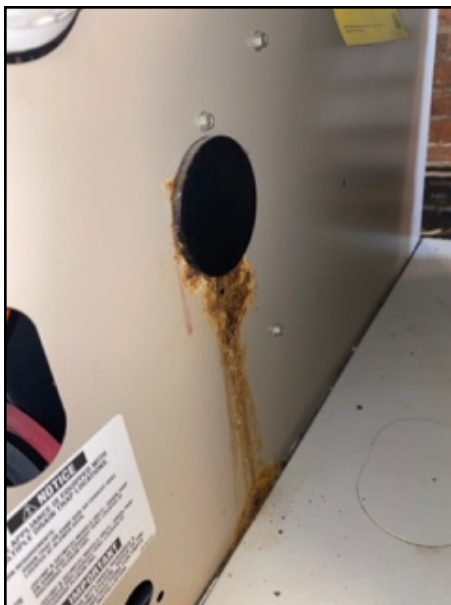
Figure 63-1

Housing shows some signs of corrosion. Repair may be needed in time.

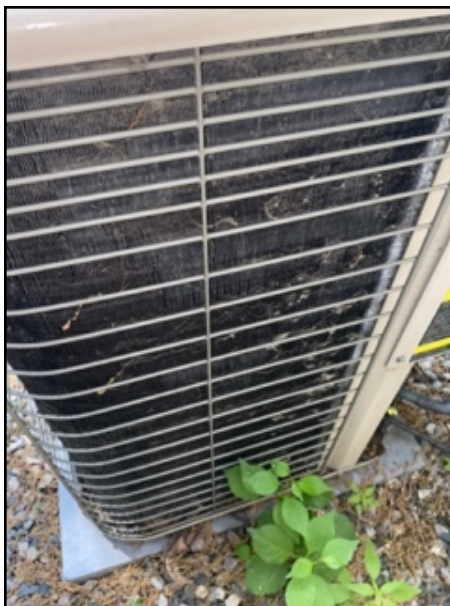
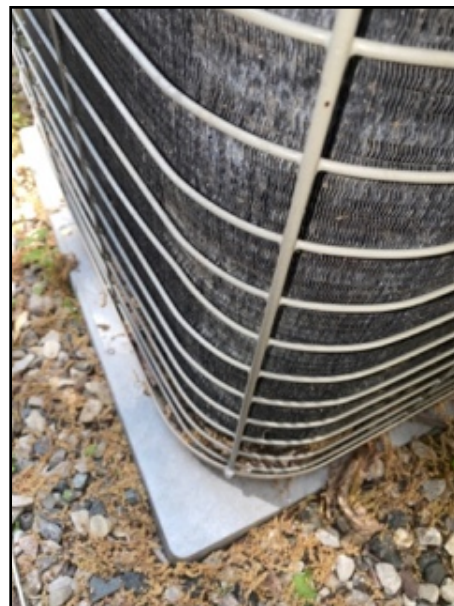
AC coils show some signs of damage related to age and wear. Some coils are corroded. Budget to repair and maintain

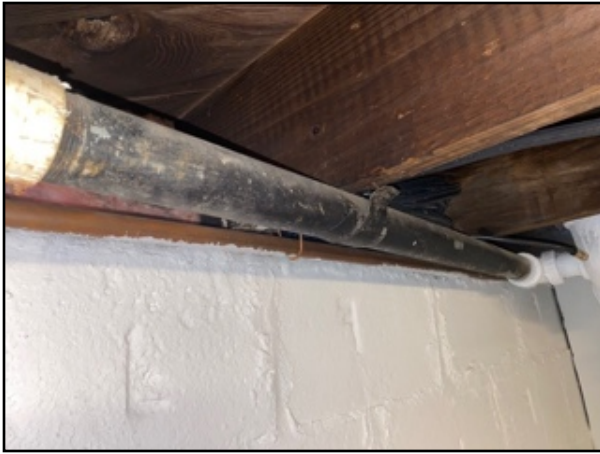
Figure 69-1

Replace any galvanized waste to prevent low water flow or poor drainage.

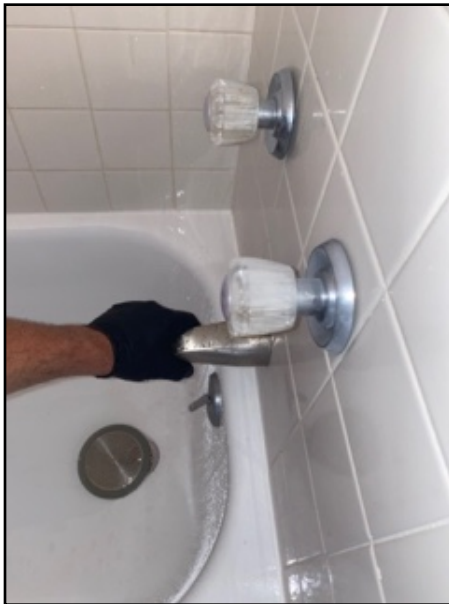
Figure 75-1

Secure loose shower hardware to reduce stress on plumbing and leakage.

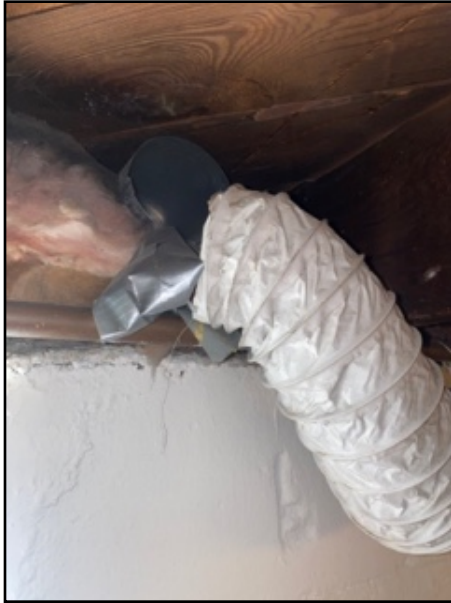
Figure 76-1

Comment 76:  
Reattach bathroom vent to exterior. System is loose.

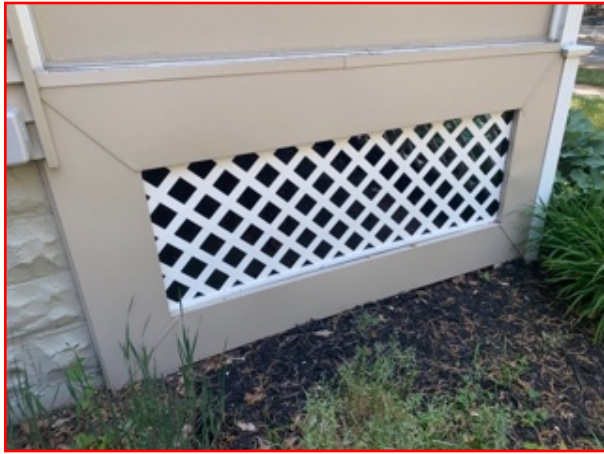
Figure 16-1

5) Cannot view porch structure due to skirting.

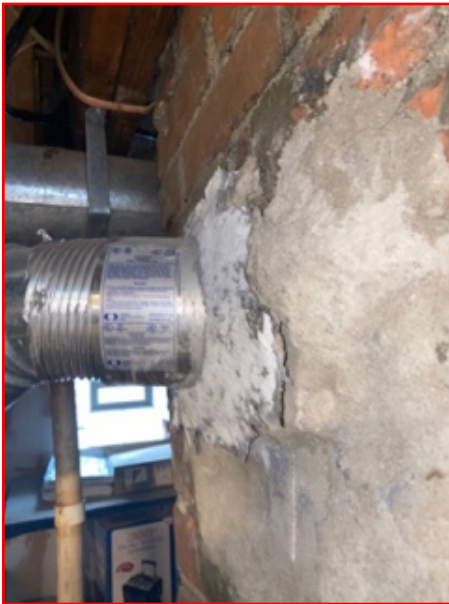
Figure 73-1

40) Recommended sealing any gaps at chimney where hot water heater vent meets system. This will prevent back drafting of gases into home.
