# Visual Inspection Report

## Mays Swiss Lake Dam

State ID#:154-027-02309

November 2023 Inspection

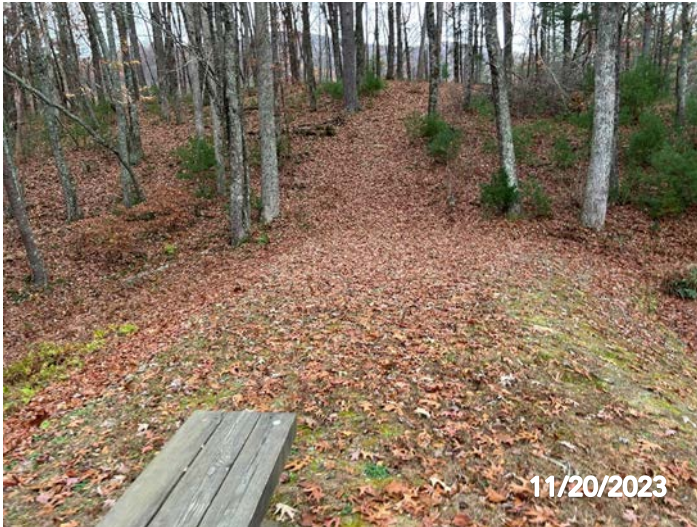
Picture 1

| DEFICIENCY NUMBER | DEFICIENCY DESCRIPTION |
|---|---|
| 1 | The crest exhibited minor unevenness and minor areas of sparse vegetation. The minor areas of sparse vegetation was noted near the right abutment. |

- Picture 1:** Dam Crest (Some areas of sparse vegetation observed)
- Picture 2:** Downstream Slope (Inappropriate vegetation)
- Picture 3:** Downstream Slope (Inappropriate vegetation)
- Picture 4:** Dam Crest (Some areas of sparse vegetation observed)

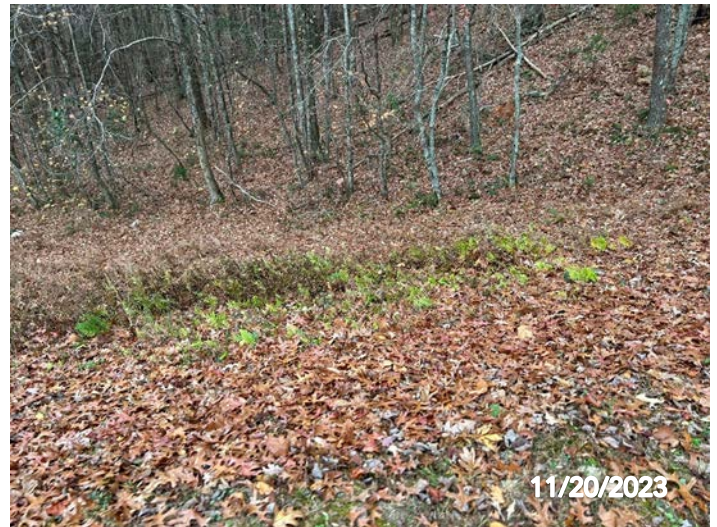
Picture 2

| DEFICIENCY NUMBER | DEFICIENCY DESCRIPTION |
|---|---|
| 4 | Inappropriate vegetation was observed on the slope. Woody vegetation in the form of brush and weeds were noted. Thorough inspection of the downstream slope was limited due to the presence of inappropriate vegetation and leaf litter groundcover. |

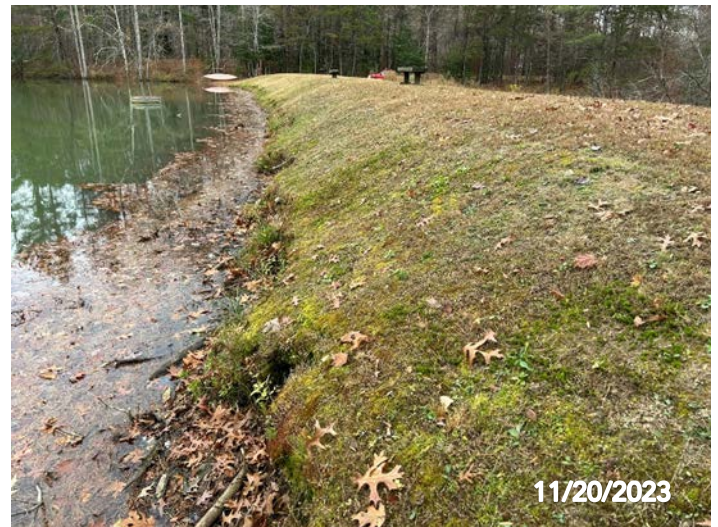
Picture 8

| DEFICIENCY NUMBER | DEFICIENCY DESCRIPTION |
|---|---|
| 3 | Wave action erosion was noted and extends, in varying degree, along the waterline of the entire upstream slope. Some erosion has resulted in sloughs areas with shear drops ranging from 24-36" in height. |

**Picture 8:** Upstream Slope (Wave Action Erosion)

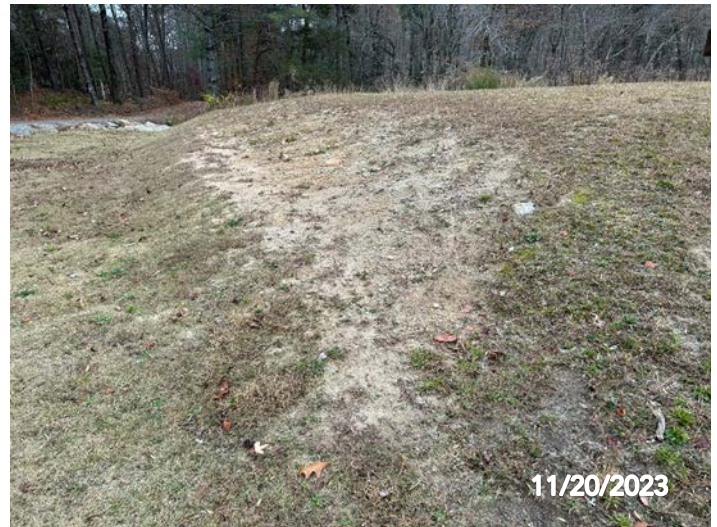
Picture 14

- Picture 13:** Auxiliary Spillway Approach Section
- Picture 14:** Auxiliary Spillway right slope (Sparse Vegetation)
- Picture 15:** Auxiliary Spillway (Note limited capacity on left side)
- Picture 16:** Auxiliary Spillway Approach Section

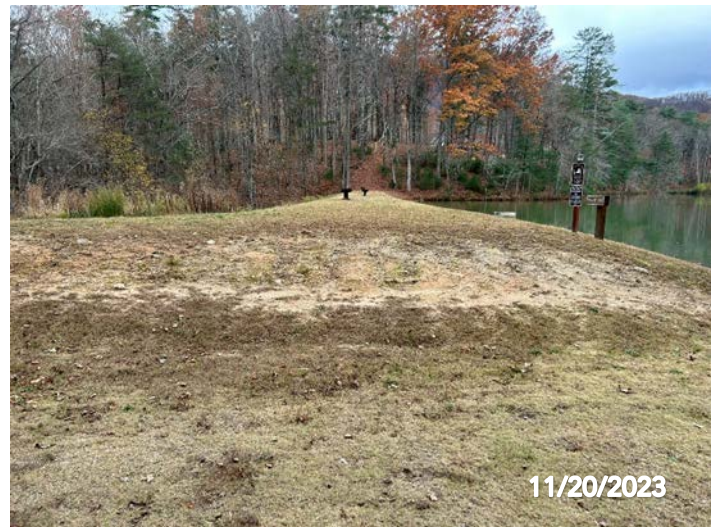
Picture 20

**Picture 20:** Auxiliary Spillway right slope (Sparse Vegetation)

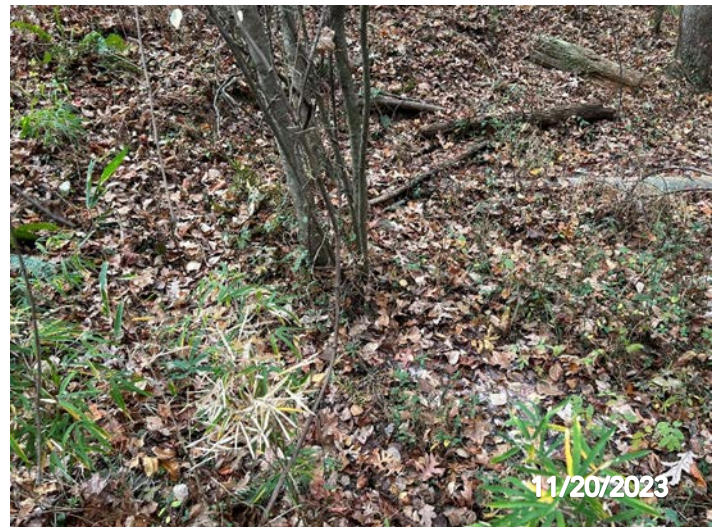
Picture 28

| DEFICIENCY NUMBER | DEFICIENCY DESCRIPTION |
|---|---|
| 6 | A fairly large area of standing water observed at the toe of the downstream slope. The water was "rust" colored, resulting from iron oxide, and is typical from seepage through an earthen embankment dam. A CMP outlet pipe was observed and could be from an internal drainage system. The pipe outlet was completely filled with silt and buildup. The standing water at the toe of the dam indicates the dam is experiencing a moderate seepage rate that is, at minimum, surfacing at the toe of slope. |

**Picture 28:** Downstream toe of slope (Seepage)

| DEFICIENCY NUMBER | DEFICIENCY | PRIORITY | CORRECTIVE ACTION |
|---|---|---|---|
| 6 | <b>Downstream Slope</b><br>Seepage | Moderate | The seepage observed was mainly concentrated at the toe and just downstream of the toe. Any future work on the dam should include investigation and cleaning of the existing CMP drain outlet. It is likely that the installation of a new internal drainage system to collect and monitor seepage is required. Prior to the installation of a drainage system, the owner should monitor the seepage and notify an engineer if seepage discharge (flowing water) is detected, a significant increase in wet areas are observed or if settlement, slough areas, or sink holes begin to form. |

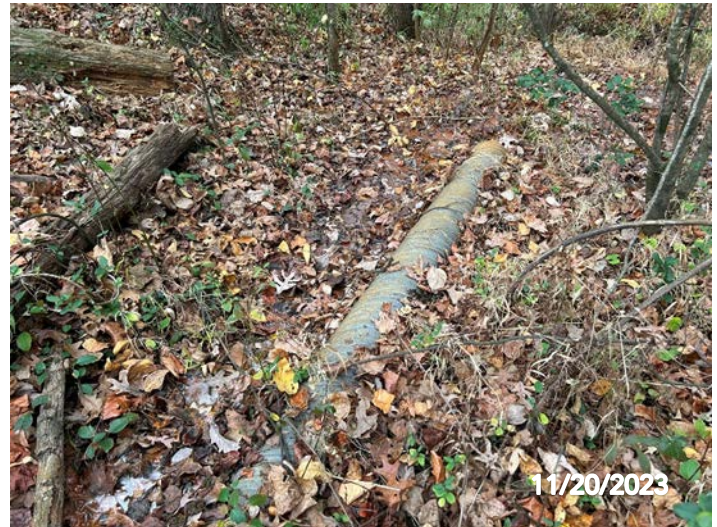
Picture 32

**Picture 32:** Downstream toe of slope (Possible internal drain outlet. Note seepage)

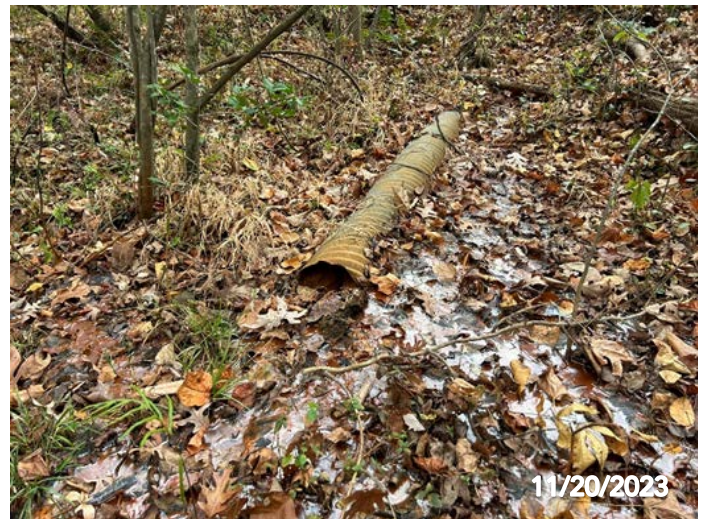
Picture 36

**Picture 36:** Downstream toe of slope (Possible internal drain outlet. Note seepage)

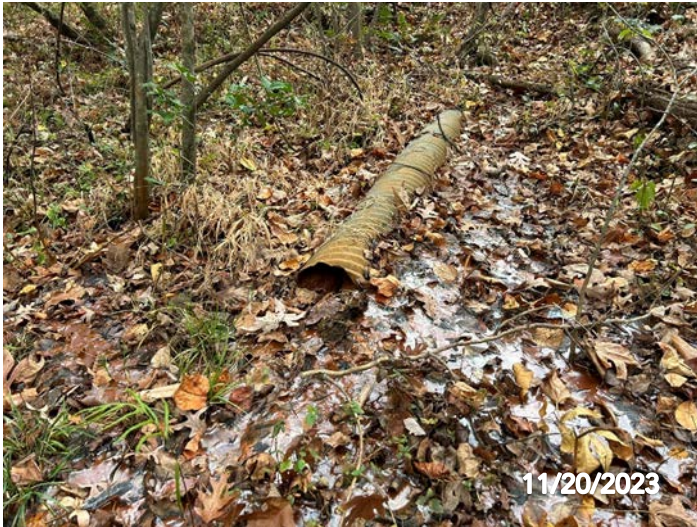
Picture 37

- Picture 37:** Downstream toe of slope (Possible internal drain outlet. Note seepage)
- Picture 38:** Drawdown Siphon
- Picture 39:** Drawdown Siphon
- Picture 40:** Principal Spillway Conduit Outlet (Rust & deterioration)

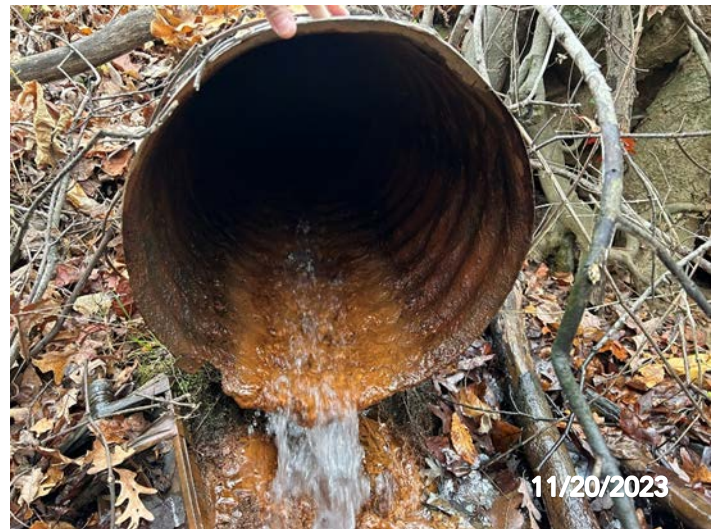
Picture 40

| DEFICIENCY NUMBER | DEFICIENCY DESCRIPTION |
|---|---|
| 8 | The principal spillway conduit was inspected at the outlet. The CMP conduit exhibited significant rust from the invert of the pipe to the springline of the pipe. The rust appeared to be consistent along the pipe for the sections visually inspected. |

| 8 | <b>Principal Spillway</b><br>Deterioration | Moderate | The spillway conduit shows significant signs of rust and deterioration. Repair of the system may be possible. However, it is highly likely that replacement of this system will be necessary with a similar system or siphon system. |

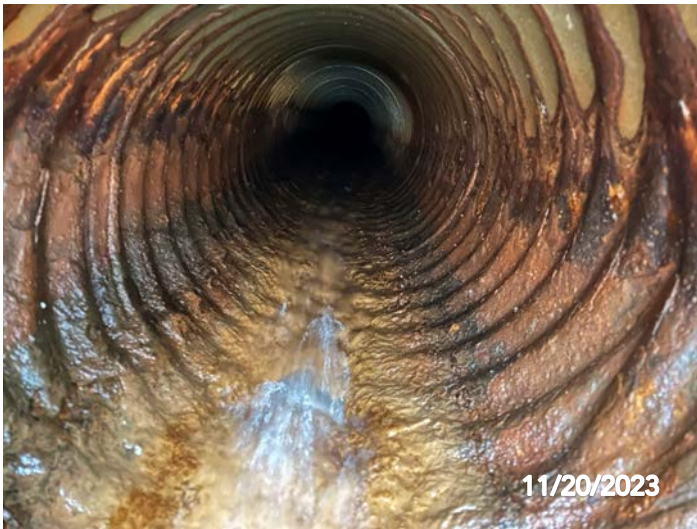
Picture 41

**Picture 41:** Principal Spillway Conduit Outlet (Rust & deterioration)

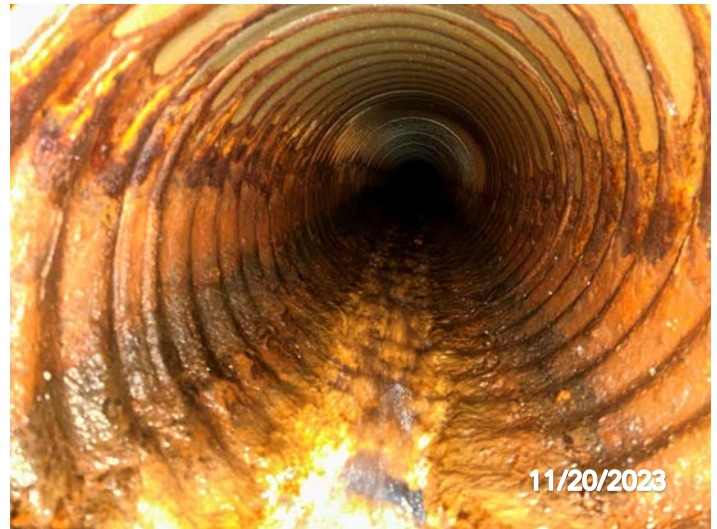
Picture 42

**Picture 42:** Principal Spillway Conduit Outlet (Rust & deterioration)

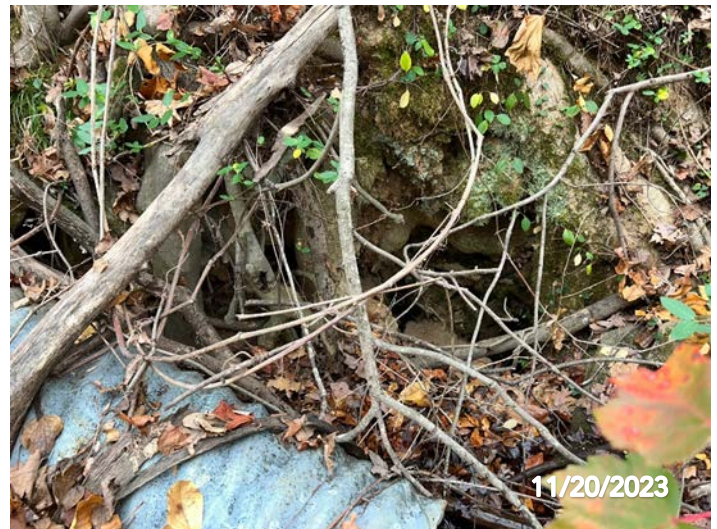
Picture 44

| DEFICIENCY NUMBER | DEFICIENCY DESCRIPTION |
|---|---|
| 9 | There are two (2) trees 12"-24" in diameter on the left side of the principal spillway conduit outlet. The root system of these trees is exposed next to the pipe cause voids around the pipe outlet. In general, the area around the conduit outlet is overgrown and shows signs of erosion, headcutting and undermining of the pipe outlet and channel. |

**Picture 44:** 2 trees next to spillway outlet with exposed roots and voids around pipe

| 9 | <b>Principal Spillway</b><br>Inappropriate Vegetation | High | The two (2) trees at the spillway conduit outlet should be removed. It recommended this deficiency be corrected in two (2) phases. Phase one (1) should be completed as soon as possible and include cutting and removing the trees while leaving the stump in place to prevent damage to the existing conduit. The voids at the tree rootball. Backfill all voids under rootball and around pipe to strengthen integrity of pipe outlet until phase two can commence. Phase two (2) should remove the entirety of the tree rootball(s) as part of a new principal spillway repair or replacement plan. |

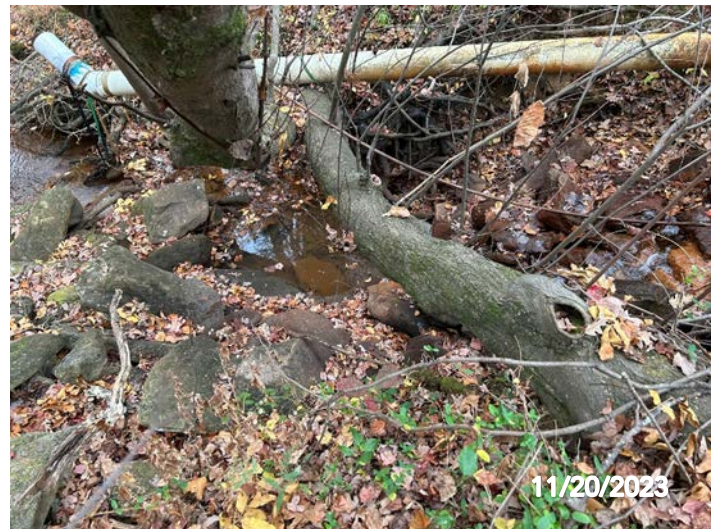
Picture 48

| DEFICIENCY NUMBER | DEFICIENCY DESCRIPTION |
|---|---|
| 7 | Currently there is not a plunge pool at the principal spillway outlet for energy dissipation and downstream channel protection. The existing channel shows signs of damage, likely from the erosive forces of discharging water from the spillway conduit. |

**Picture 48:** Principal Spillway outlet conduit & siphon outlet (Note lack of plunge pool)

| DEFICIENCY NUMBER | DEFICIENCY | PRIORITY | CORRECTIVE ACTION |
|---|---|---|---|
| 7 | <b>Plunge Pool</b><br>Inadequate | Moderate | A plunge pool should be designed and installed at the principal spillway conduit outlet. The plunge pool should be designed to sufficiently dissipate energy from discharging water to prevent erosion at the outlet and downstream channel. All inappropriate vegetation should be removed from the plunge pool area. |

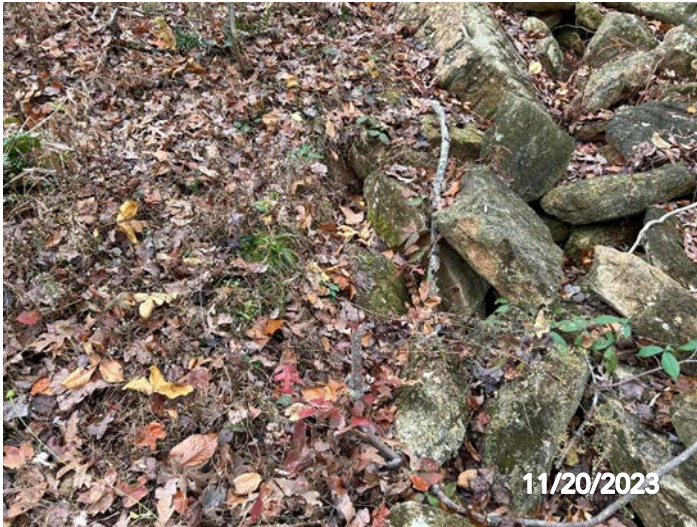
Picture 53

| DEFICIENCY NUMBER | DEFICIENCY DESCRIPTION |
|---|---|
| 11 | The rock armament appears to be adequate in size to resist movement from discharging water. However, water appears to be flowing beneath the rock and eroded the foundation due to the lack of geotextile or other means of soil stability and erosion prevention. Erosion was also noted along the edges of the exit channel. |

**Picture 53:** Auxiliary Spillway exit channel (erosion around and beneath rock observed)

| 11 | <b>Auxiliary Spillway</b><br>Channel Erosion | Low | Erosion in the spillway exit channel under and around the rock armament will continue. The spillway exit channel should be monitored for worsening conditions. It is likely periodic maintenance will be required. An engineer should be notified if conditions worsen for a corrective action or remedial plan. |

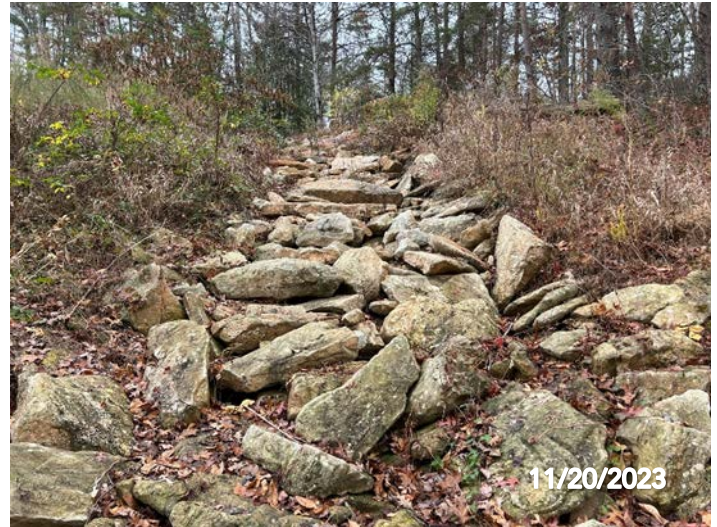
Picture 54

**Picture 54:** Auxiliary Spillway exit channel (erosion around and beneath rock observed)

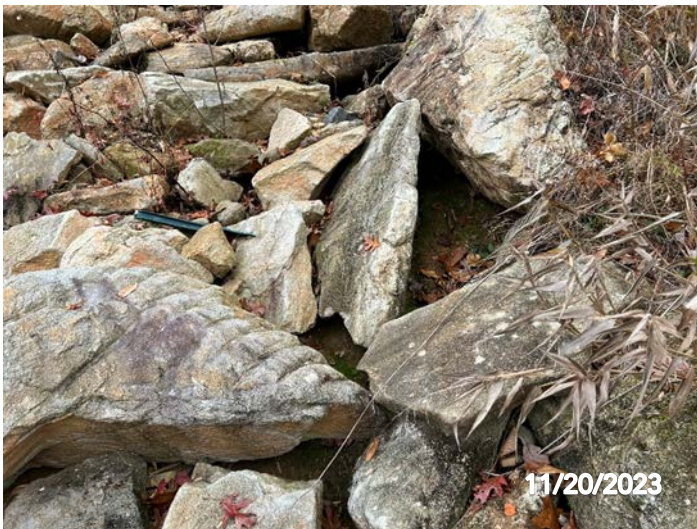
Picture 55

**Picture 55:** Auxiliary Spillway exit channel (erosion around and beneath rock observed)

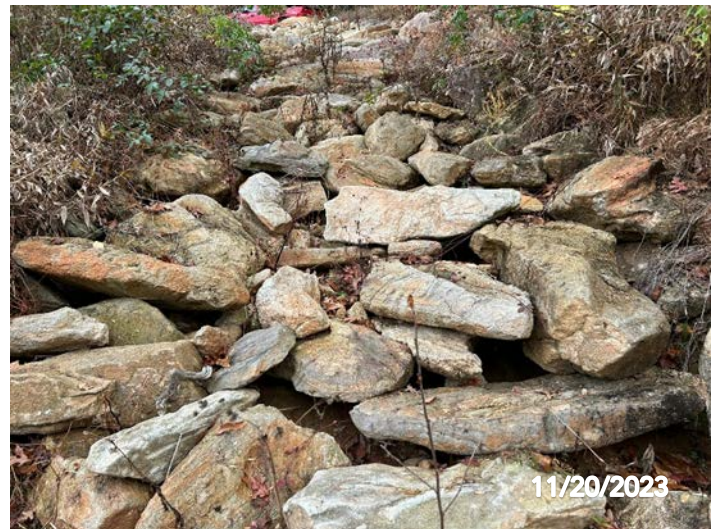
Picture 56

**Picture 56:** Auxiliary Spillway exit channel (erosion around and beneath rock observed)

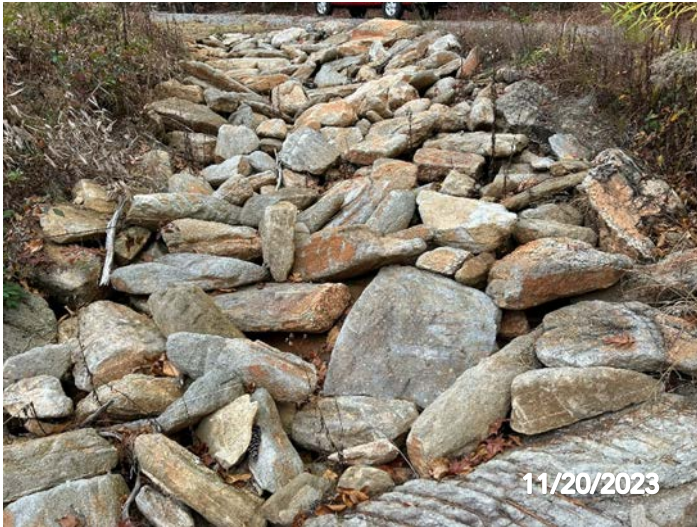
Picture 57

**Picture 57:** Auxiliary Spillway exit channel (erosion around and beneath rock observed)

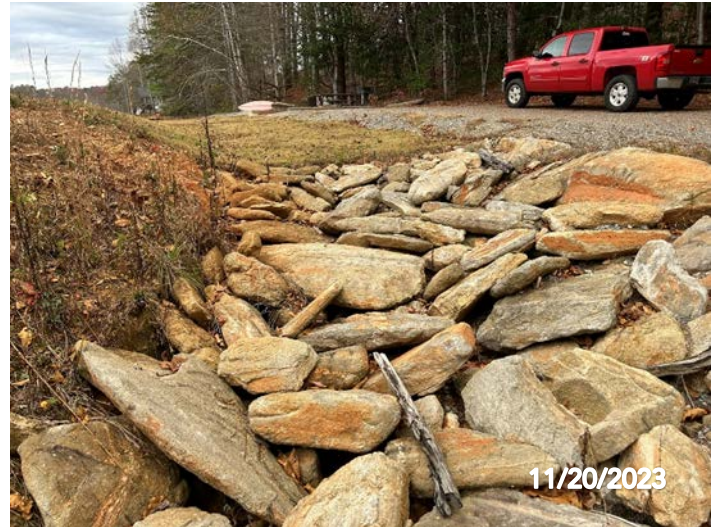
Picture 58

**Picture 58:** Auxiliary Spillway exit channel (erosion around and beneath rock observed)
