# FULL RESERVE STUDY

## Canyon Gate at Cinco Ranch Owners Association, Inc.

**Katy, Texas**

**December 8, 2015**

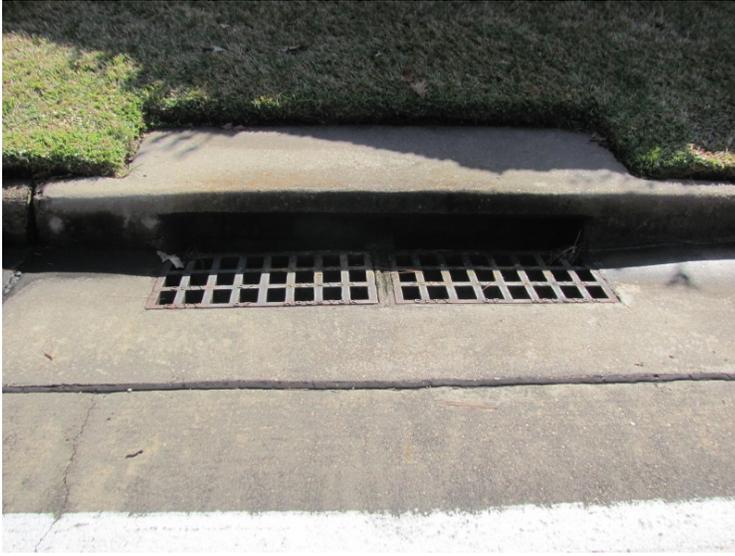
**Catch Basins** - The 158 concrete catch basins collect storm water from the concrete streets and conduct it into the storm water system. The overall condition of the catch basins is good without significant settlement visually apparent. The useful life of catch basins is up to 60 years. However, achieving this useful life usually requires interim capital repairs or partial replacements every 15- to 20-years.

Catch basin

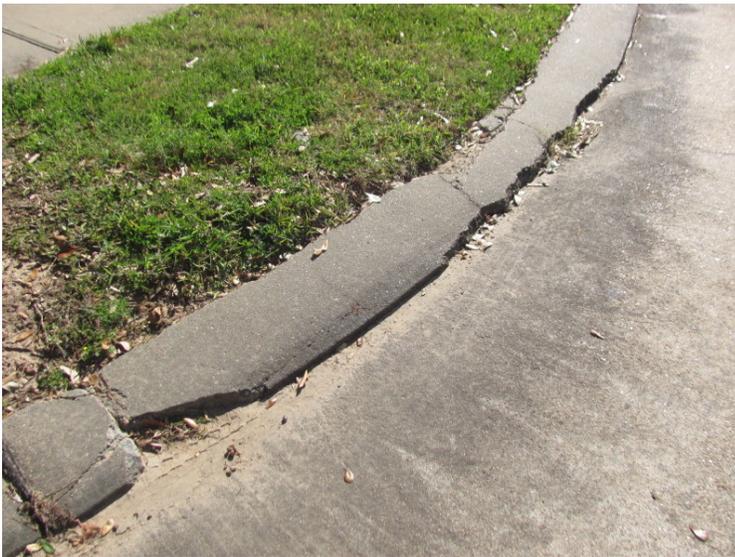
**Concrete Curbs** - Concrete curbs line the pavement of Canyon Gate at Cinco Ranch. These curbs comprise 72,000 linear feet and are in good condition overall. We note limited cracks, spalled concrete and damage. Page 5.2 of *Photographs* depicts these conditions. We estimate that up to 10,800 linear feet of curbs, or fifteen percent (15%) of the total, will require replacement during the next 30 years. We estimate that up to 1,080 linear feet of curbs, or less than two percent (1.5%) of the total, will require replacement in conjunction with partial concrete street replacement beginning by 2026 and every two years thereafter. We depict this information on Line Item 4.110 of *Reserve Expenditures*. We assume the use of 3,500 pounds per square inch (PSI) concrete.

Damaged and spalled concrete curb

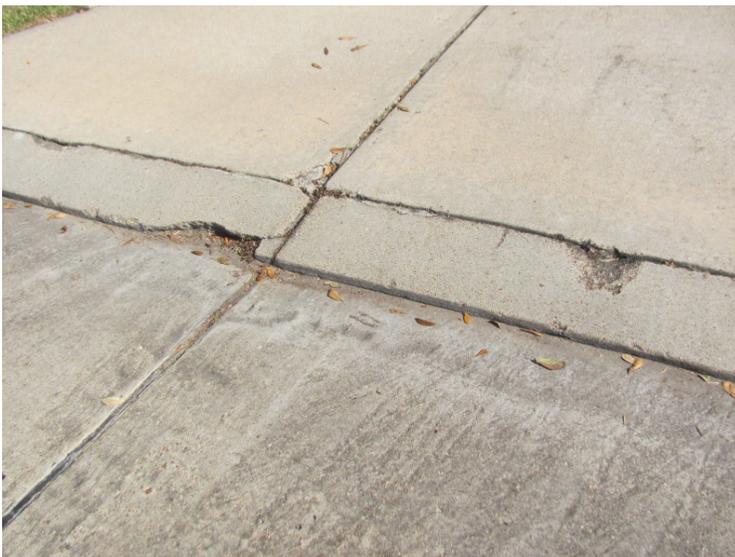
Damaged and spalled concrete curb

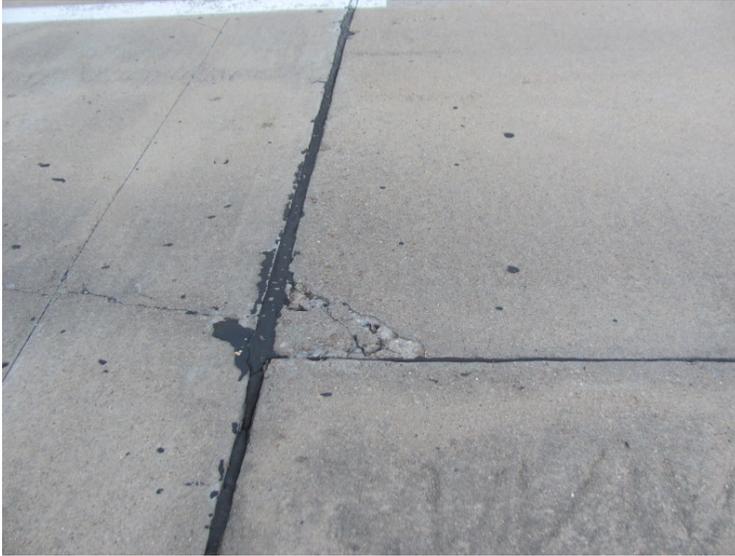
**Concrete Streets** - The Association maintains approximately 1,019,000 square feet of concrete at the private streets. The streets are original and in good overall condition. We note limited areas of cracks, spalls and deterioration. Pages 5.4 through

Concrete cracks near joint

We estimate that up to 152,850 square feet of concrete streets, or fifteen percent (15%) of the total, will require replacement during the next 30 years. We advise the Association budget for the replacement of 15,285 square feet of the streets every two years beginning by 2026. Line Item 4.180 of Reserve Expenditures notes our estimate of future costs and anticipated times of replacements.

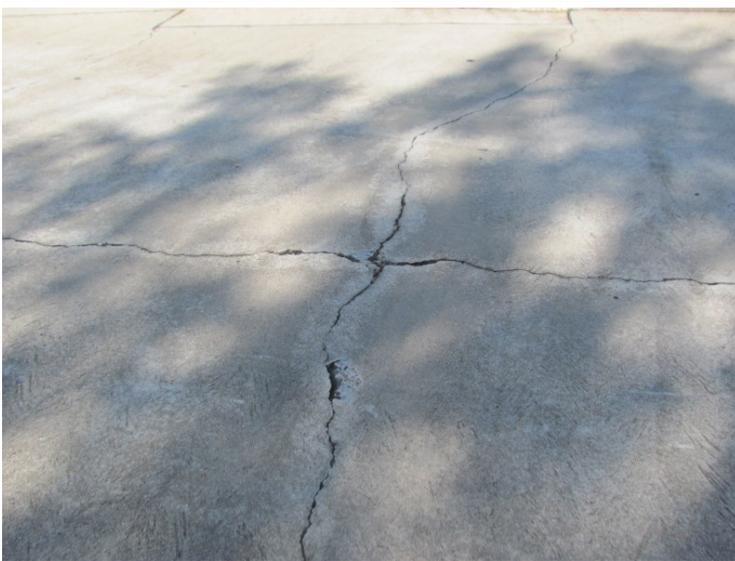
Concrete cracks at Canyon Gate Boulevard

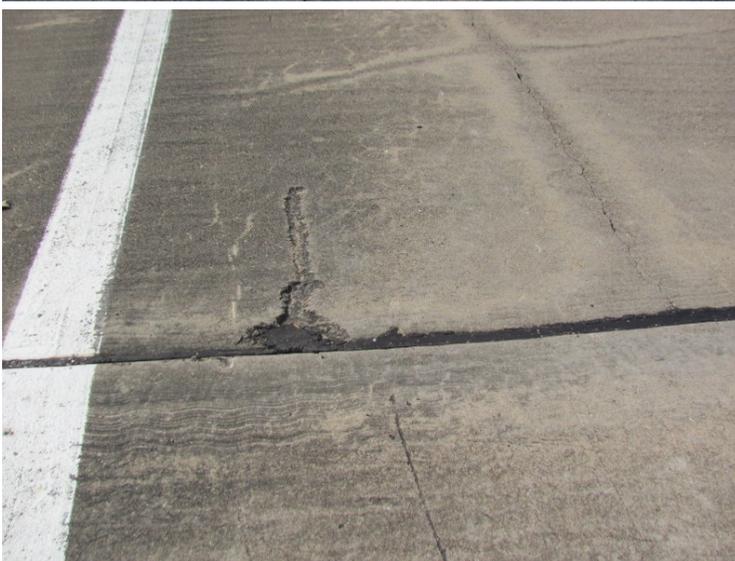
Concrete damage at Canyon Gate Boulevard

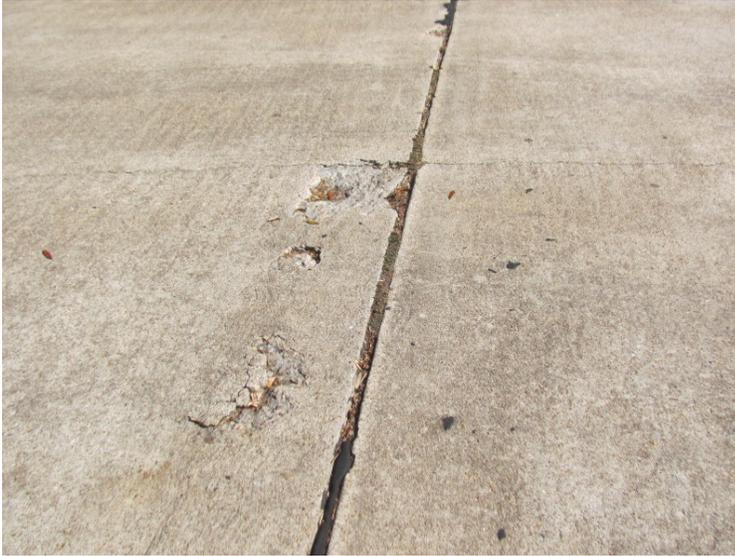
Concrete deterioration at Tall Canyon Drive

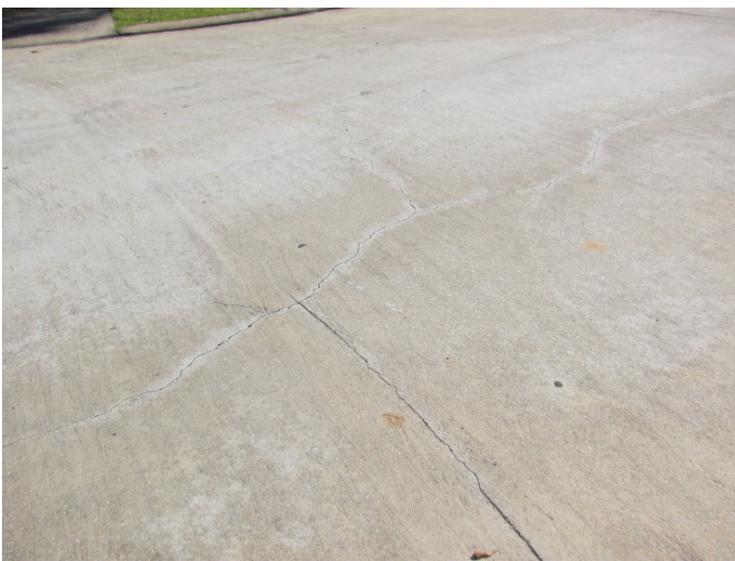
Concrete cracks at Canyon Park Drive

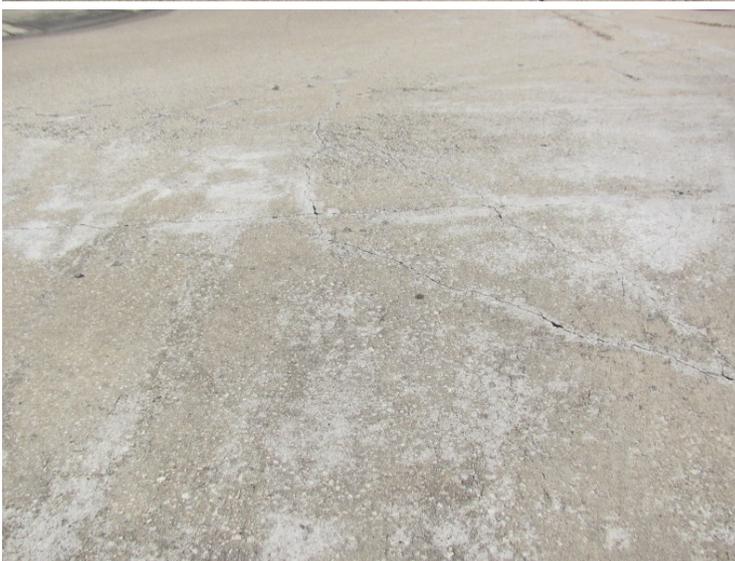
During warm weather, the pavement expands and the joints narrow. Accumulated incompressible debris in the joints produces high compressive stresses at the adjoining faces of the joints. These compressive stresses can cause spalling of the concrete along the joints. The disintegration and spalling associated with these stresses typically occurs at open, unsealed pavement joints due to moisture and debris accumulation in the joints. For these reasons, we recommend the Association seal all concrete street joints to maximize the useful life of the concrete. The Association should fund these expenses through the operating budget.

Concrete cracks and spalls at Canyon Park Drive

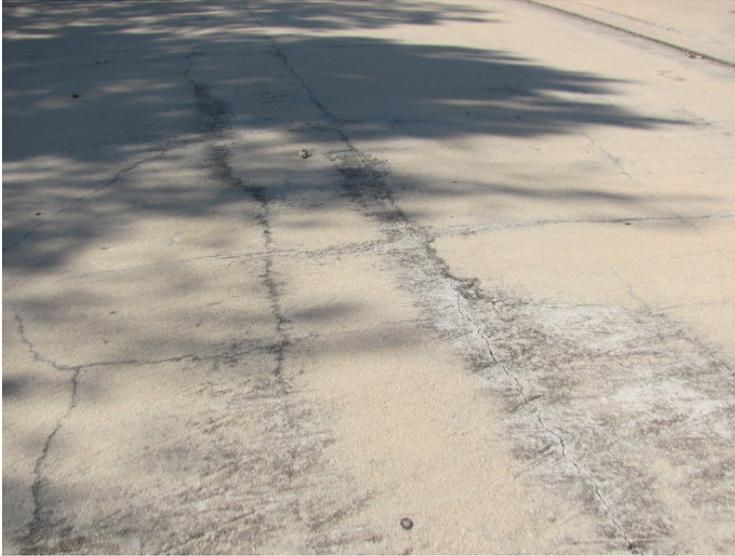
Concrete cracks at Wind Canyon Drive

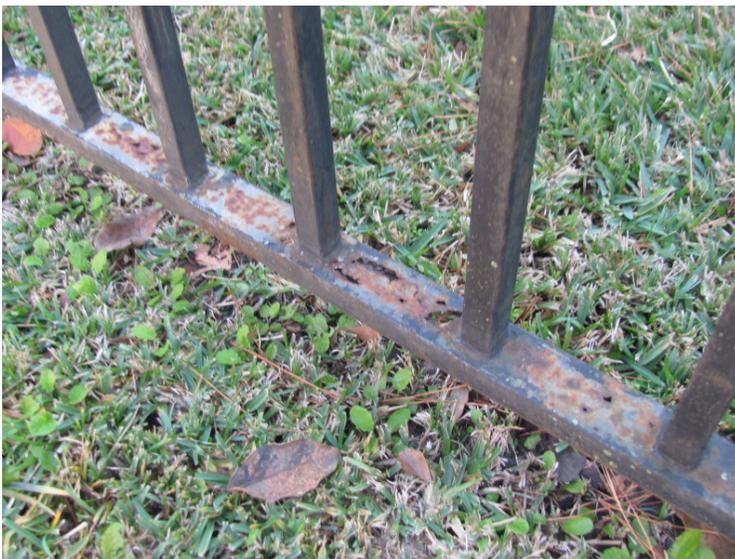
**Fences, Steel** - Approximately 2,150 linear feet of steel fences are found at the main entrance, a portion of the north perimeter of the property and at cul-de-sacs. This quantity excludes the steel fences atop panelized concrete walls, as we include replacement on a separate line item. The fences are original and in good to fair condition. The protective finishes are in fair condition at an unknown age. We note rust and corrosion. Page 5.7 of *Photographs* depicts this condition. Fences of this type have a long useful life but are not maintenance free. Periodic maintenance should include periodic applications of protective paint finish to the steel surfaces and partial replacement of deteriorated sections as needed. Steel components at grade and key structural connections are especially prone to failure if not thoroughly maintained. Secure and rust free fasteners and connections will prevent premature deterioration. We recommend paint applications funded through the operating budget and we anticipate a useful life of up to 35 years for the fences. We anticipate a phased replacement beginning by 2033 and concluding by 2034. We depict this information on Line Item 4.245 of *Reserve Expenditures*.

Corrosion at steel fence

*Note - maintain paint finishes through the operating budget*

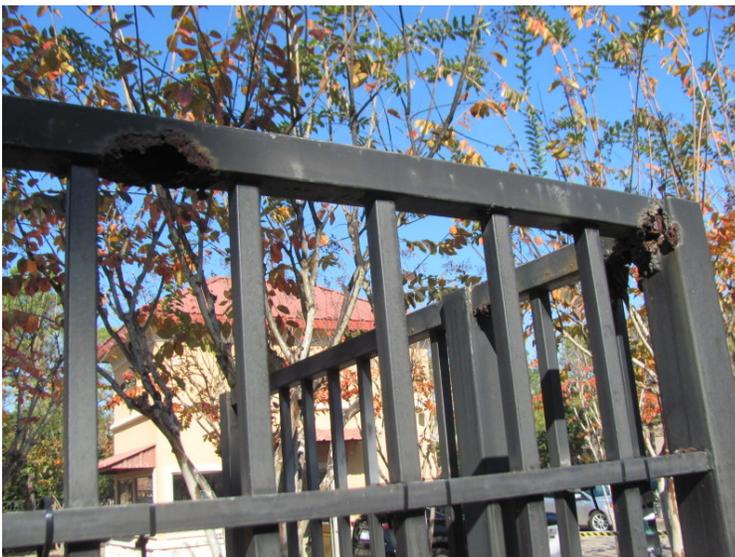
Corrosion at steel fence

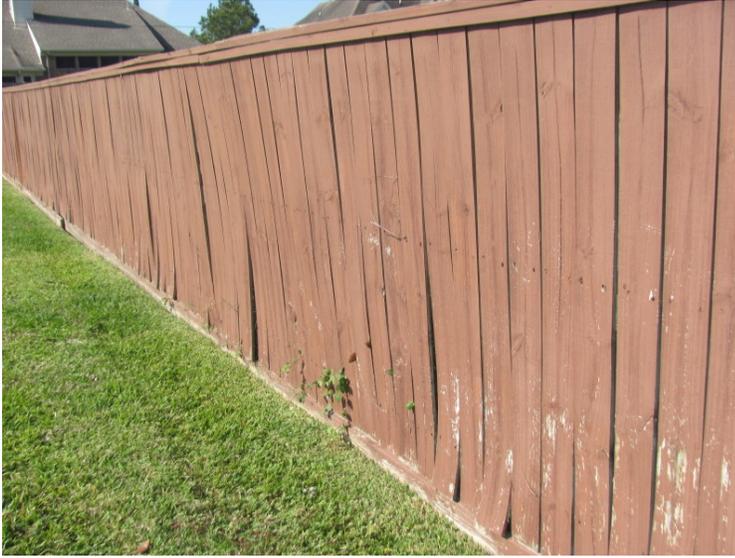
**Fences, Wood** - Approximately 350 linear feet of wood fences are found along Canyon Gate Boulevard between Marina Canyon Way and Deep Canyon Drive. The fences are original and in fair to poor condition. We note damage, warped boards and leaning sections. Page 5.8 of *Photographs* depicts this condition. Wood fences of this type have useful lives of 15- to 20-

Warped boards at wood fence along Canyon Gate Boulevard near Marina Canyon Way

years. The Association should anticipate periodic partial replacements due to the non-uniform nature of wood deterioration. Along with these partial replacements, the Association should apply periodic paint applications as needed and fund these activities through the operating budget. We suggest the Association plan for replacement by 2018 and again by 2038. We depict this information on Line Item 4.285 of *Reserve Expenditures*.

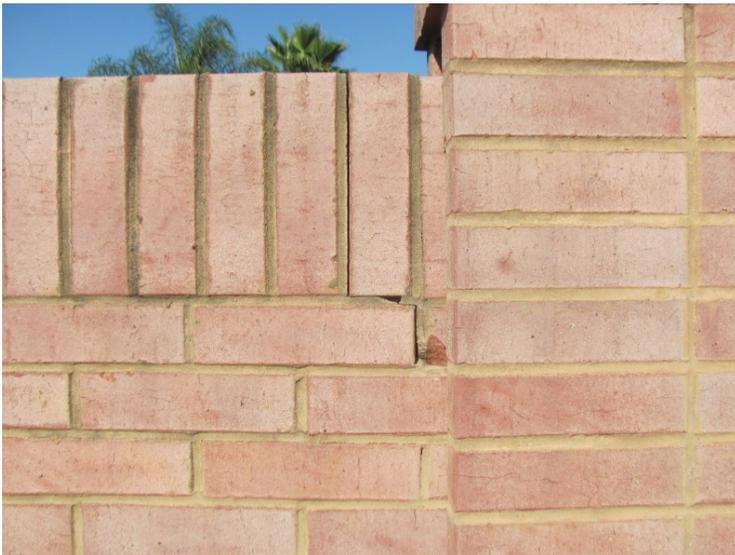
**Perimeter Walls, Panelized Brick** - The Association maintains approximately 1,250 linear feet of panelized brick masonry perimeter walls, also referred to as panel fences. The walls are primarily located at the west perimeter and along a portion of Canyon Gate Boulevard near the main entrance. The walls are original and in good overall condition. We note limited areas of efflorescence, mortar deterioration and settlement. Pages 5.9 and 5.10 of *Photographs* depict these conditions.

Mortar deterioration

*Note - fund for interim repairs and partial replacements through the operating budget*

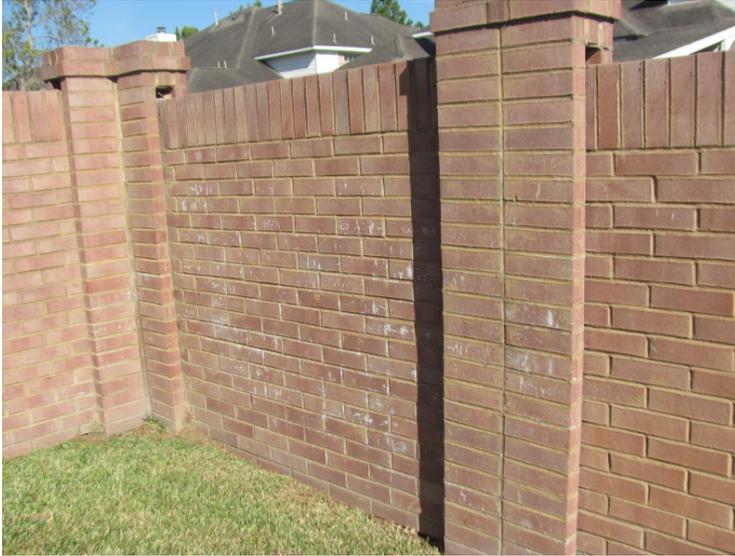
Efflorescence

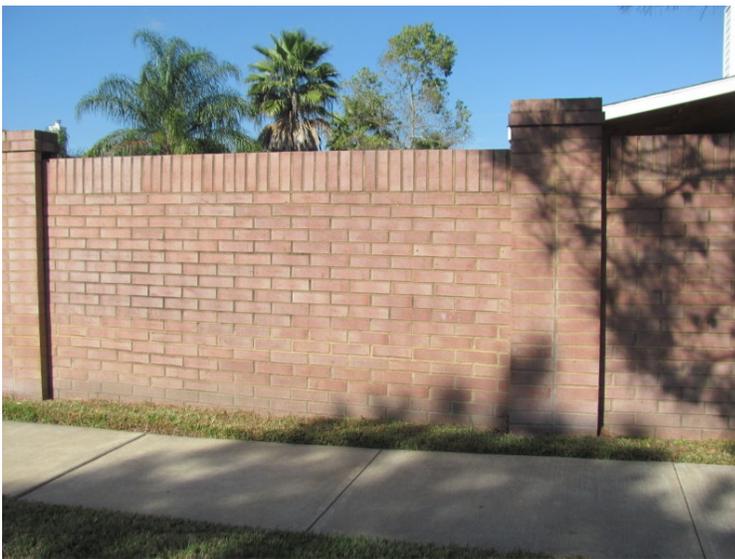
These walls comprise brick masonry panels with a thickness of one brick and do not utilize a foundation for support. Rather, the panels are supported internally with ladder wire and externally by traditional masonry columns. These types of walls are prone to damage primarily as a result of water infiltration due to precipitation or errant spray from irrigation systems. Water infiltration within the panels or columns results in deterioration of the internal metal support wire. Sag, cracks, spalls and mortar deterioration are evidence of water infiltration and the likely need to replace the panels. Therefore, we anticipate a significantly shorter useful life when compared to typical brick masonry walls. Based on the type of walls and history of replacement, we anticipate a useful life of 40- to 50-years. We suggest the Association budget for a phased replacement of the walls beginning by 2042 and concluding by 2043. We depict this information

Settled/sagging panel

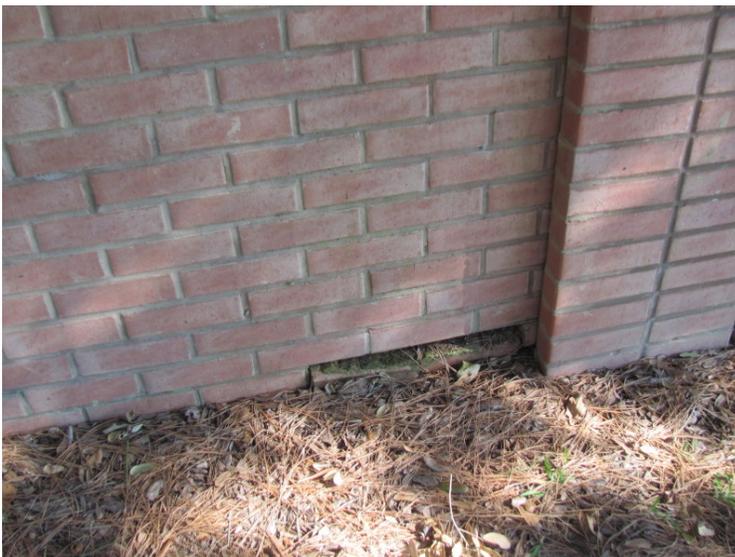
Loose bricks

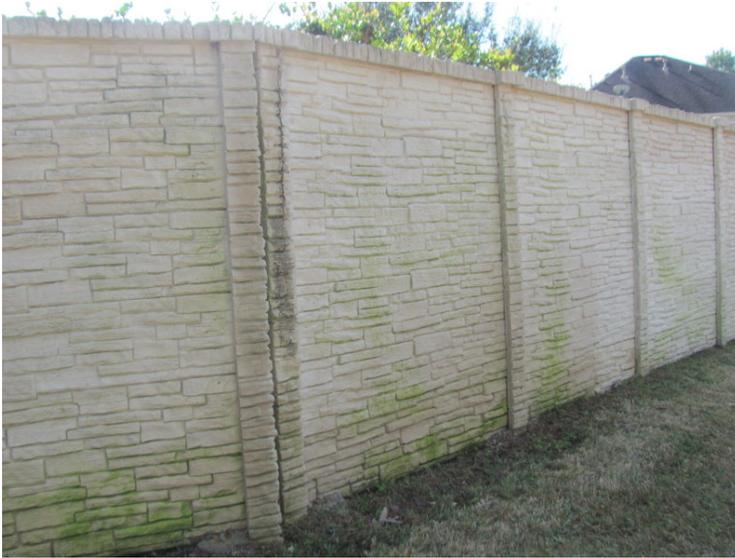
Stains at panelized concrete wall

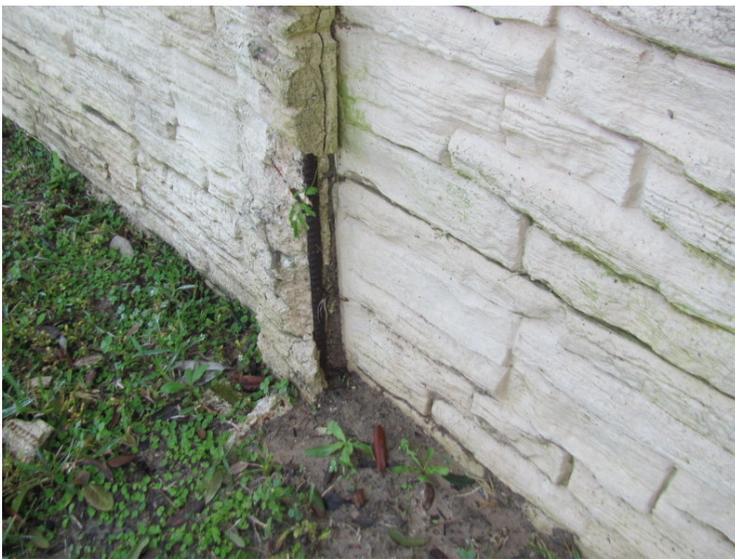
As mentioned previously, these types of walls do not utilize a foundation for support. Rather, the panels are supported internally with ladder wire and externally by traditional masonry columns. These types of walls are prone to damage primarily as a result of water infiltration due to precipitation or errant spray from irrigation systems. Water infiltration within the panels or columns results in deterioration of the internal metal support wire. Sag, cracks, spalls and mortar deterioration are evidence of water infiltration and the likely need to replace the panels. Therefore, we anticipate a useful life of 40- to 50-years. We suggest the Association budget for a phased replacement of the tall walls without steel fences beginning by 2026 and concluding by

Concrete post deterioration and exposed reinforcement

2034. We recommend the Association budget for a phased replacement of the combination concrete and steel fence walls beginning by 2033 and concluding by 2034. We depict this information on Line Items 4.643 and 4.644 of *Reserve Expenditures*.

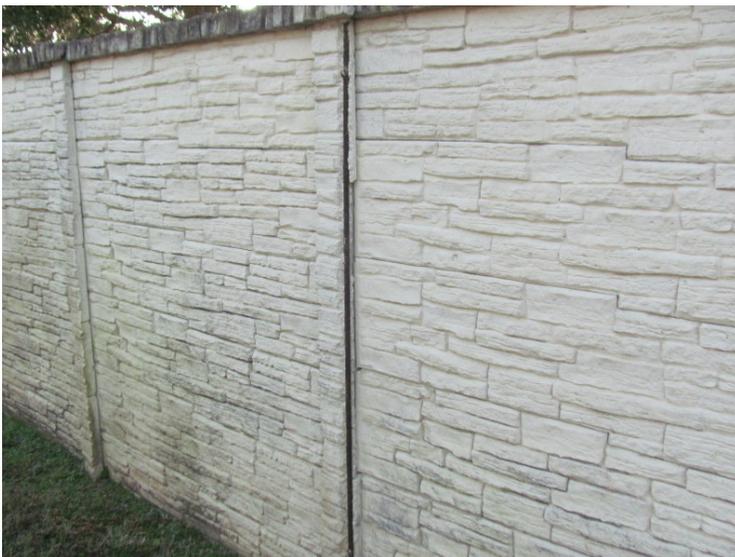
Concrete post deterioration and exposed reinforcement

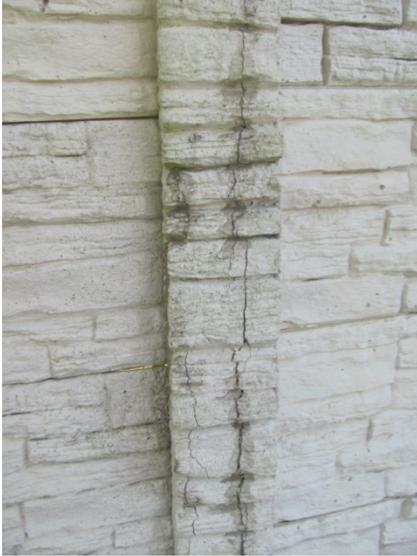
Concrete crack

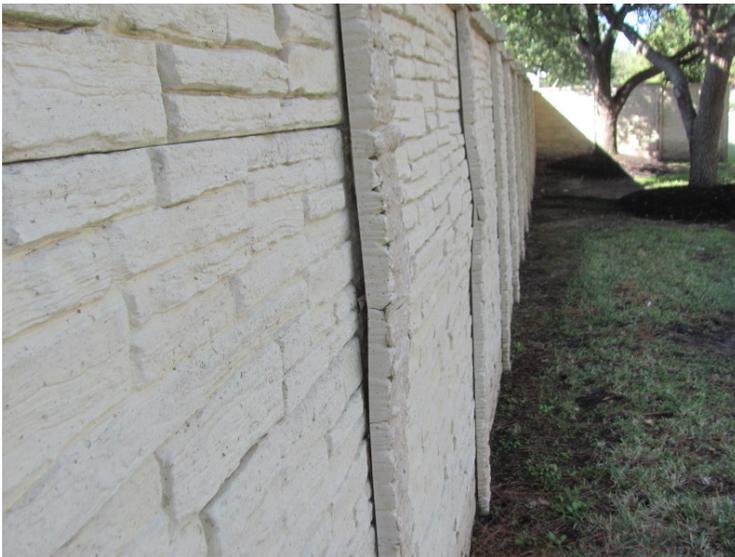
Movement evident at wall

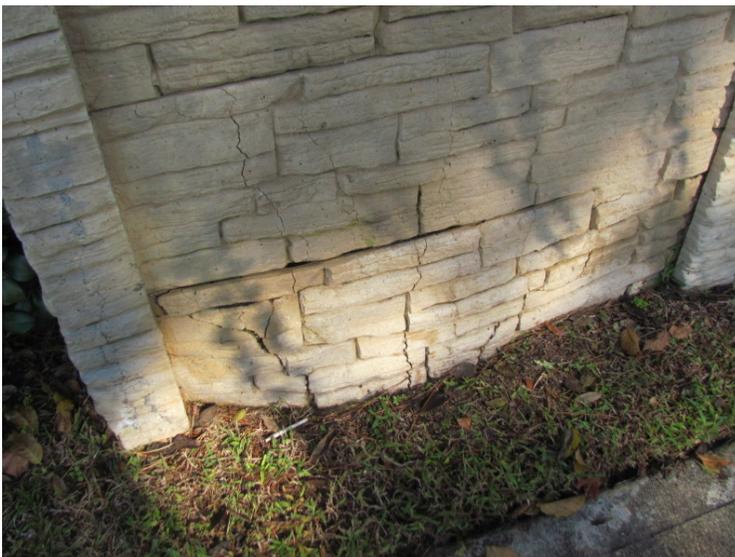
Shifted and cracked concrete panel

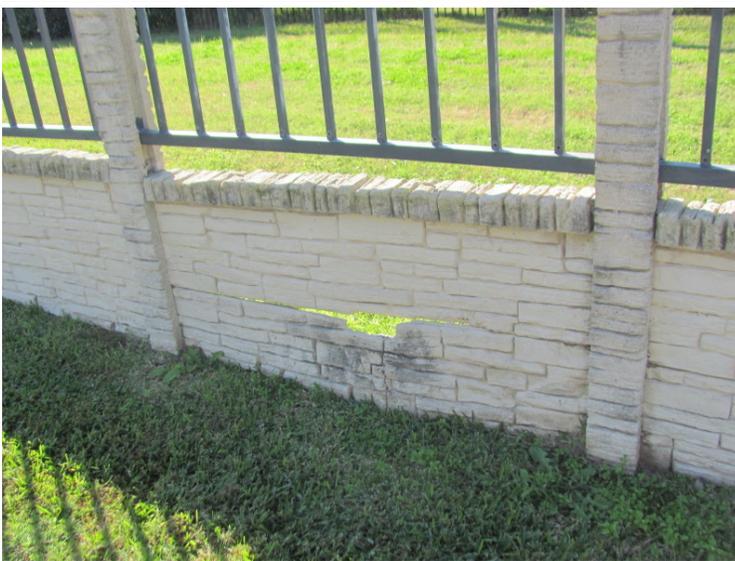
Damaged concrete panel

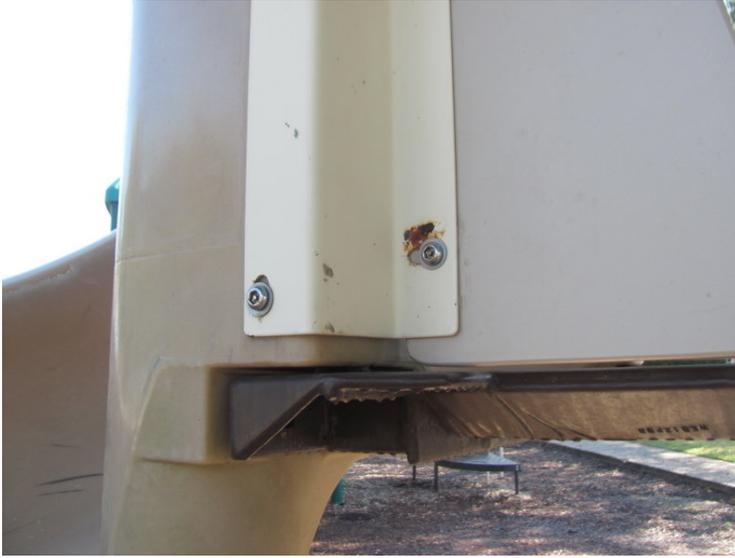
The playground equipment at the clubhouse is original and in fair condition. The playground equipment at the south park was installed in 2006 and is in good overall condition. Safety is the major purpose for maintaining playground equipment. We recommend an annual inspection of the playground equipment to identify and repair as normal maintenance loose connections and fasteners or damaged elements. We suggest the Association learn more about the specific requirements of playground equipment at [PlaygroundSafety.org](http://PlaygroundSafety.org). We recommend the use of a specialist for the design or replacement of the playground equipment environment. Playground equipment of this type has a useful life of 15- to 20- years. We recommend replacement of the playground equipment at the clubhouse by 2018 and again by 2037. We recommend the Association anticipate replacement at the south park by 2026. We include this information on Line Items 4.660 and 4.661 of *Reserve Expenditures*.

Rust at playset at clubhouse

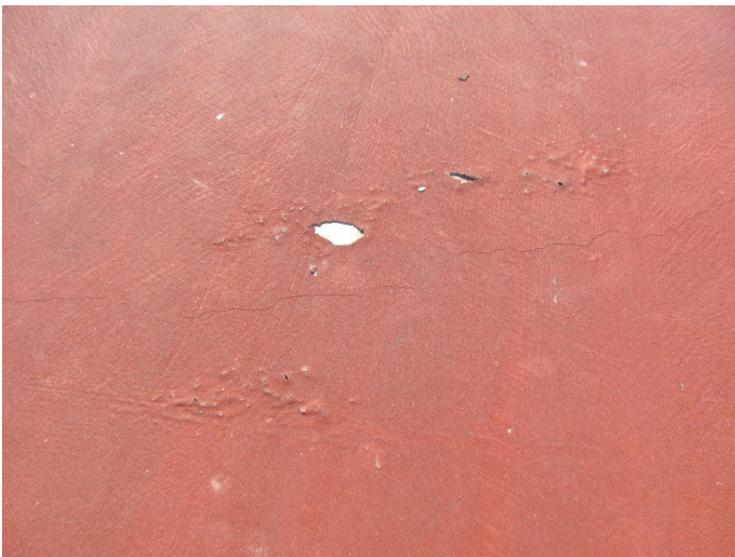
**Color Coat** - The court color coat surfaces at the tennis courts are in fair overall condition at an unknown age. We recommend the Association apply a new color coat every four- to six-years to maximize the useful life. Prior to the application of the color coat, the Association should require the contractor to rout and fill all cracks with hot emulsion. This deters water infiltration and further deterioration of the concrete playing surface. We advise the Association to perform crack repairs and apply a new color coat application by 2017 and every five years thereafter except when replacement occurs. We include this information on Line Item 4.830 of *Reserve Expenditures*. The Association

Blistered and chipped color coat at tennis court

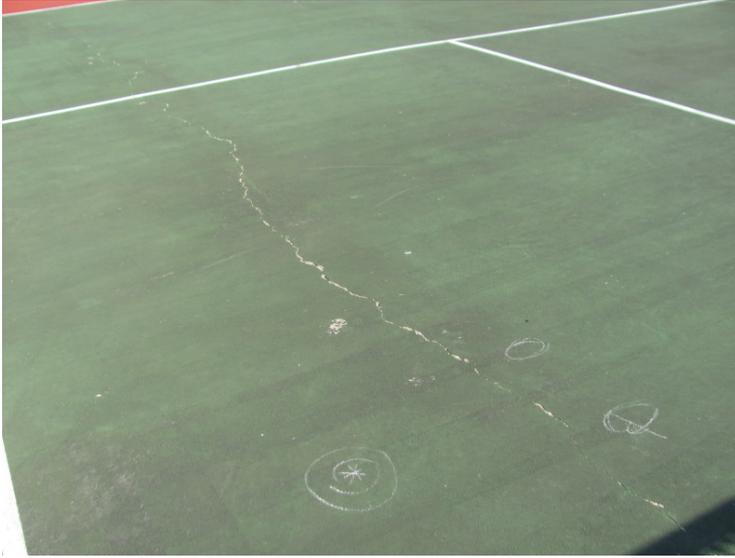
Crack at tennis court

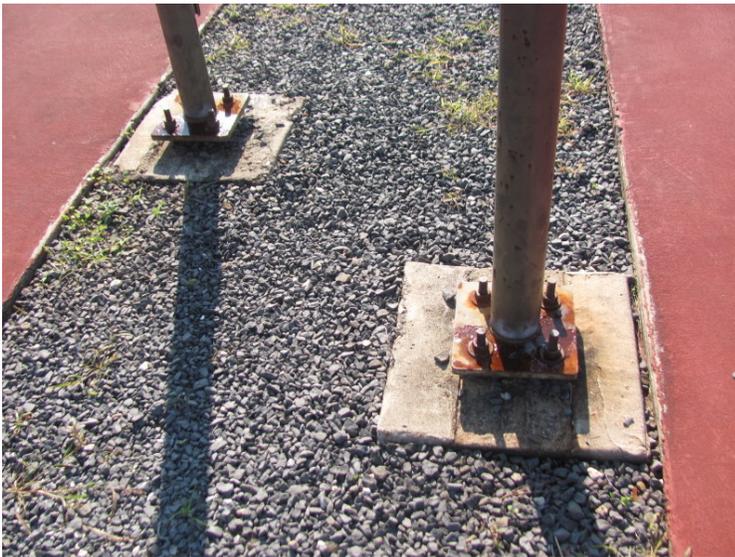
*Light Poles and Fixtures* - The Association maintains eight light poles and fixtures to illuminate the tennis courts. The metal poles and fixtures are original and in good to fair condition with rust evident. Page 5.16 of *Photographs* depicts this condition. Light poles and fixtures of this type have a useful life of up to 35 years. We recommend the Association anticipate replacement by 2022, concurrent with fence replacement. We include this information on Line Item 4.850 of *Reserve Expenditures*.

Rust at tennis court light poles

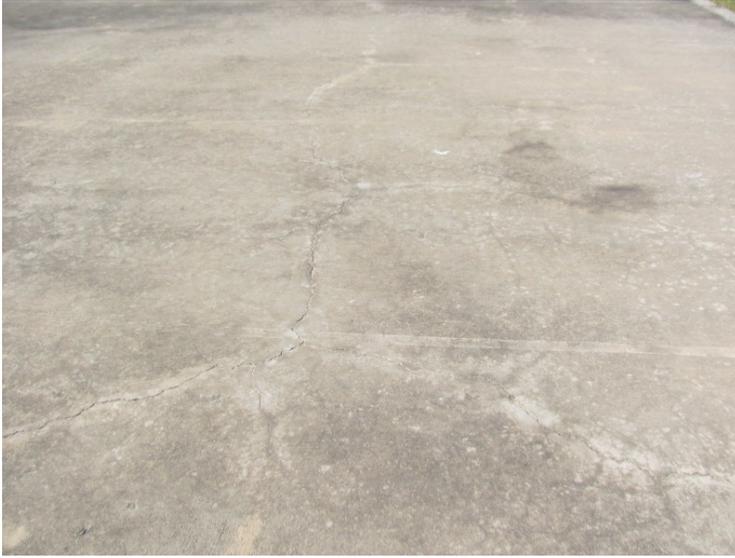
Concrete cracks at open basketball court near skate park

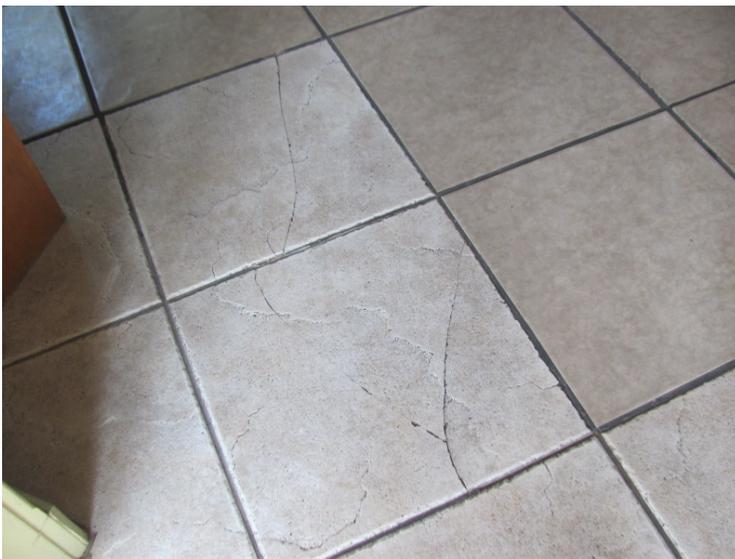
Cracked tiles at clubhouse

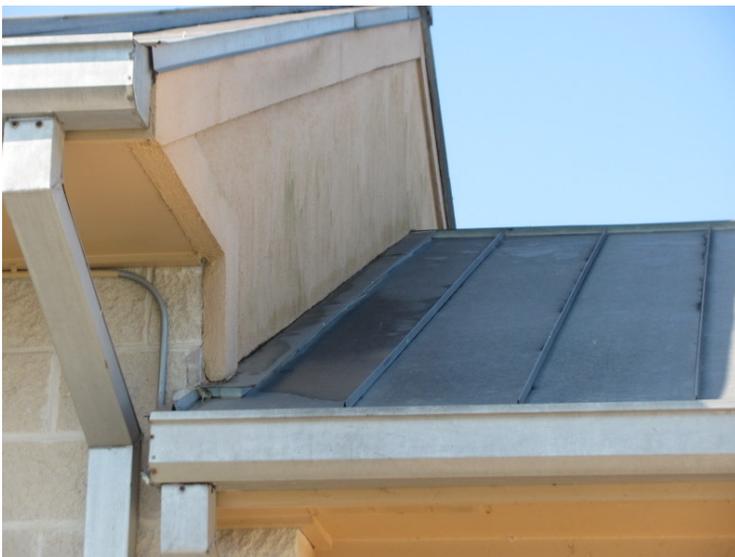
Stains and finish deterioration at clubhouse

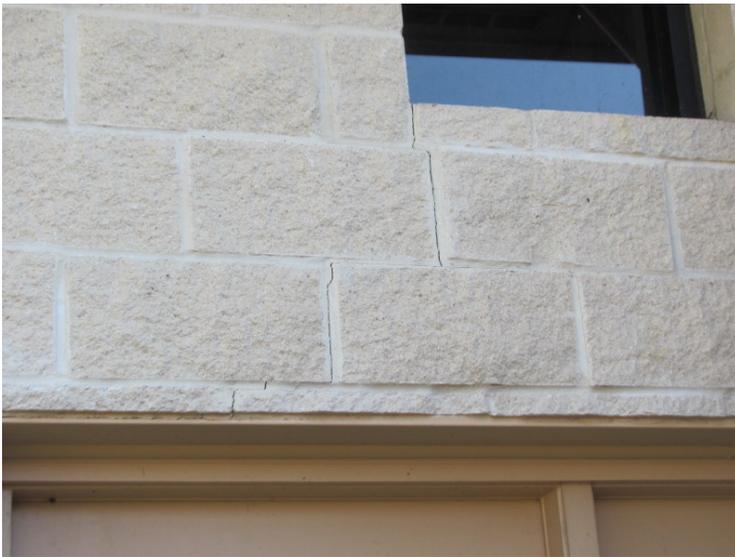
Masonry step crack at clubhouse

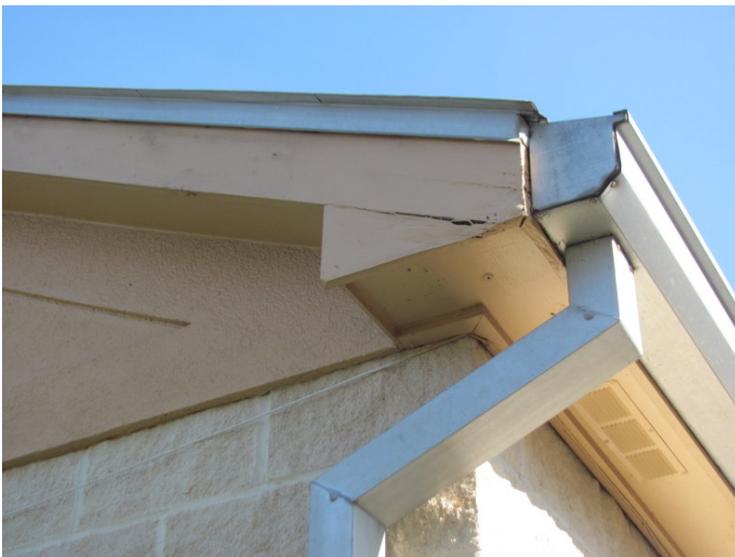
Minor wood deterioration at clubhouse

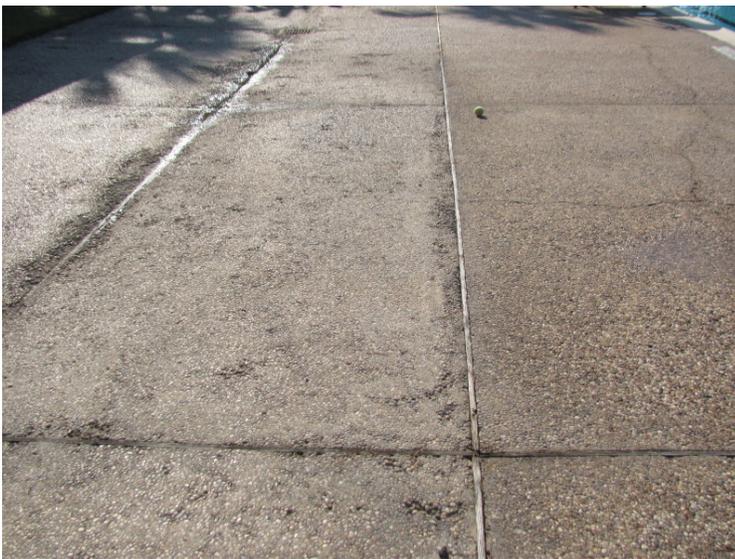
Concrete cracks and spalls at pool deck

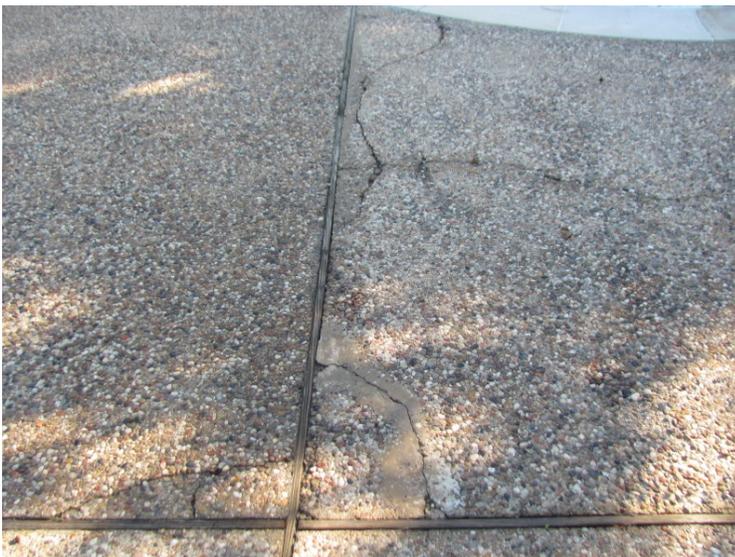
Concrete cracks at pool deck

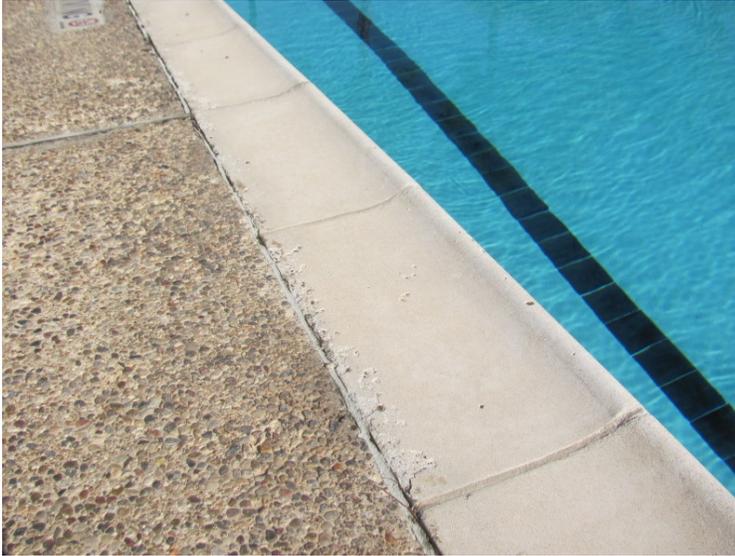
Spalls along coping
