NORTHERN TERRACE HOA
Association #: 01.01.1741

Level 1 -- Full Reserve Study with Site Visit

Date of Site Inspection: **07/31/2024**

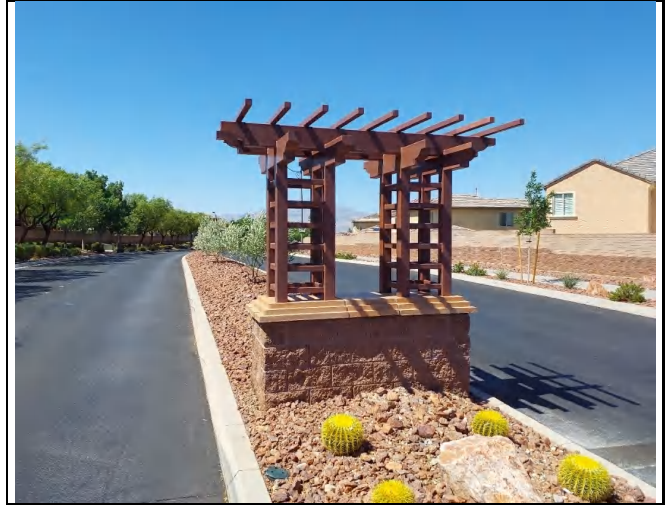
Comp #: 1.102 Entrance Pergolas - Refurbish

Quantity:	9 Monument	Original Service Date:	2009
Unit Cost:	\$10,000.00	Useful Life:	40
% of Unit Cost:	100.0%	Rem. Useful Life Adjustment:	0
Total Cost:	\$90,000.00	Remaining Useful Life:	24
Cost Source:	GeoReserves Database	Next Scheduled Year:	2049
Description:	This component funds to refurbish the monuments. This includes replacing the signage as well as updating the walls and monument area to give a modern appearance. This work should be done every 25 to 30 years or when necessary to maintain safety and appearance standards.		
Evaluation:	No problems noted		
General Notes:

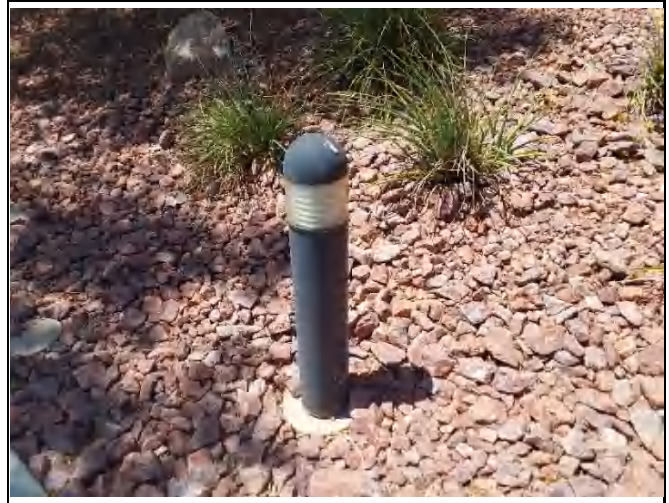
Quantity:	8 Bollard Lights	Original Service Date:	2009
Unit Cost:	\$1,000.00	Useful Life:	24
% of Unit Cost:	100.0%	Rem. Useful Life Adjustment:	0
Total Cost:	\$8,000.00	Remaining Useful Life:	8
Cost Source:	GeoReserves Database	Next Scheduled Year:	2033
Description:	This component includes replacing the bollard light fixtures located throughout the community. These bollard lights should be replaced every 20 to 25 years to maintain appearance and functionality standards.		
Evaluation:	One of these bollard lights appear to be broken. Otherwise, no problems noted.		
General Notes:

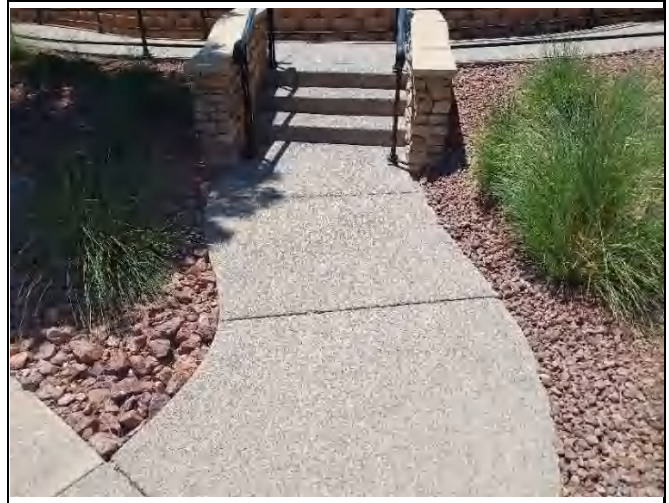
Comp #: 1.402 Concrete - Repair

Quantity:	1 Allowance	Original Service Date:	2022
Unit Cost:	\$36,000.00	Useful Life:	5
% of Unit Cost:	100.0%	Rem. Useful Life Adjustment:	0
Total Cost:	\$36,000.00	Remaining Useful Life:	2
Cost Source:	GeoReserves Database	Next Scheduled Year:	2027
Description:	This component funds for repairs to the association maintained sidewalks, walkways, curbs, and other concrete areas. These repairs should be made every five to ten years depending on the quantity and age of community. Any tripping hazards should be addressed when they arise. This cost schedule can be adjusted as necessary.		
Evaluation:	No major spalling or delamination noted. We recommend inspecting and repairing any minor cracks or issues annually.		
General Notes:

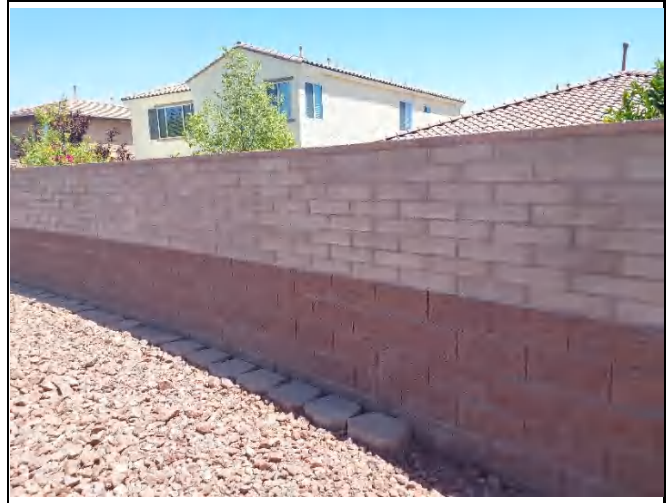
Quantity:	18,750 Linear ft.	Original Service Date:	2019
Unit Cost:	\$100.00	Useful Life:	10
% of Unit Cost:	10.0%	Rem. Useful Life Adjustment:	5
Total Cost:	\$187,500.00	Remaining Useful Life:	9
Cost Source:	GeoReserves Database	Next Scheduled Year:	2034
Description:	This component includes the portions of the block wall that the association is obligated to maintain. These walls are designed to last a very long time and funding for a complete replacement is not necessary. However, repairs are usually necessary due to water damage, tree roots and other ground movement, and vandalism or other damages. A feasible reserve study plan is to make repairs every 10 to 20 years. However, this schedule and cost estimate may be adjusted as the community ages and a cost history is developed.		
Evaluation:	Per client, there are no major problems noted.		
General Notes:

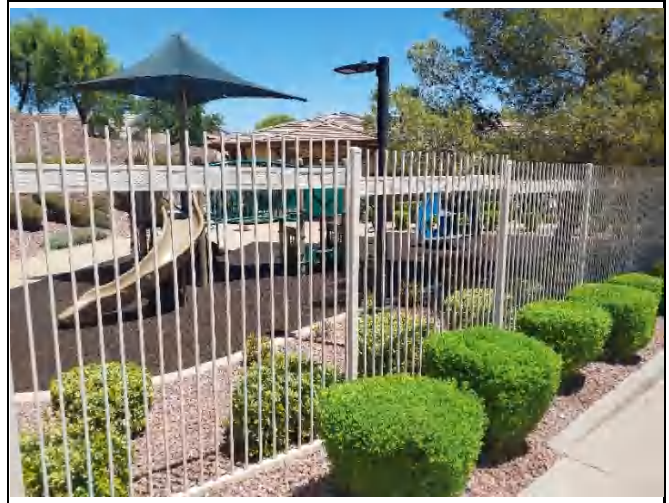
Quantity:	1,300 Linear ft.	Original Service Date:	2009
Unit Cost:	\$65.00	Useful Life:	36
% of Unit Cost:	100.0%	Rem. Useful Life Adjustment:	0
Total Cost:	\$84,500.00	Remaining Useful Life:	20
Cost Source:	GeoReserves Database	Next Scheduled Year:	2045
Description:	Although this fencing is referred to as wrought iron, it is typically hollow metal that has been rolled and made to give a classic wrought iron look. With regular painting and maintenance, this fencing should last approximately 30 to 40 years.		
Evaluation:	No major rusting, bent areas or other damage noted.		
General Notes:

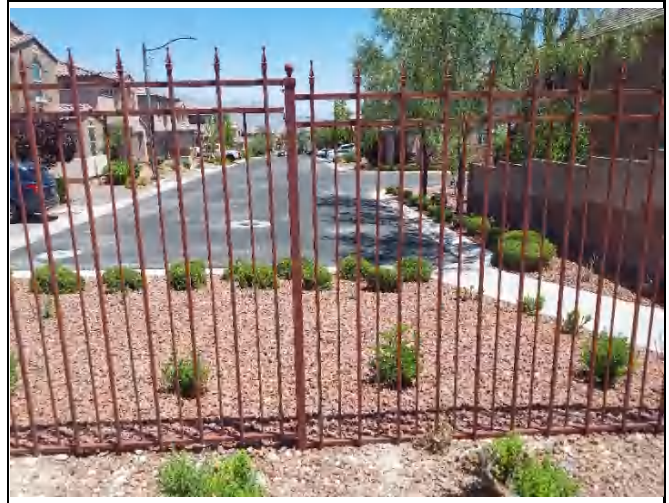
Quantity:	1,300 Linear ft.	Original Service Date:	2021
Unit Cost:	\$15.00	Useful Life:	6
% of Unit Cost:	100.0%	Rem. Useful Life Adjustment:	0
Total Cost:	\$19,500.00	Remaining Useful Life:	2
Cost Source:	GeoReserves Database	Next Scheduled Year:	2027
Description:	This component includes painting the metal fencing, along with making any repairs to bent or rusted areas. This project should be performed every 6 years or when necessary to maintain appearance and ensure the fence realizes a full useful life. Different paint materials and techniques will determine the actual useful life and may result in adjusting this schedule.		
Evaluation:	No significant rusting or faded paint noted.		
General Notes:

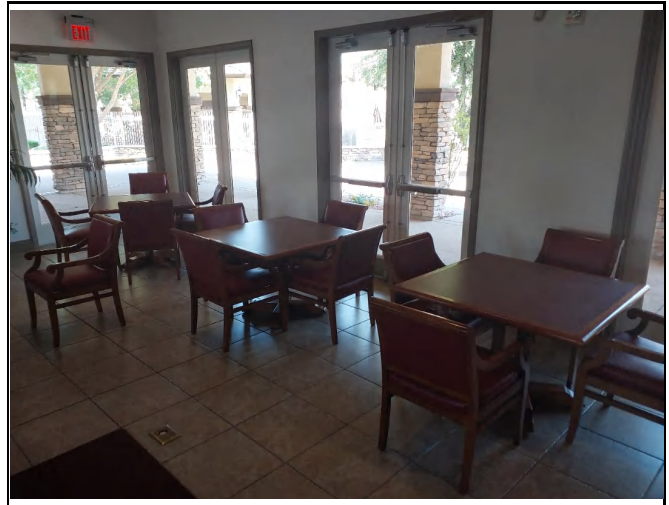
Quantity:	1 Allowance	Original Service Date:	2009
Unit Cost:	\$100,000.00	Useful Life:	25
% of Unit Cost:	100.0%	Rem. Useful Life Adjustment:	1
Total Cost:	\$100,000.00	Remaining Useful Life:	10
Cost Source:	GeoReserves Database	Next Scheduled Year:	2035
Description:	This component includes a general update and remodel to the clubhouse interior. This includes painting, replacing the floor, replacing any furniture and appliances, and any other related work. Not all of this work needs to be done at one time. This component funds for a general allowance for projects to occur every 20 to 25 years or when necessary.		
Evaluation:	No major problems or appearance concerns noted.		
General Notes:

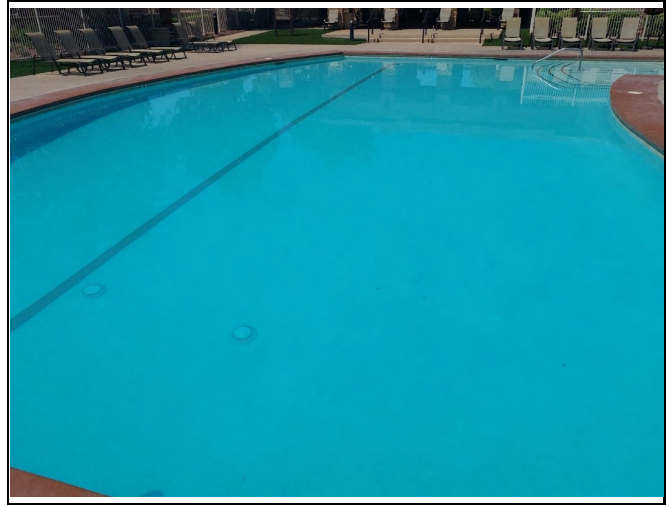
Quantity:	1 Pool	Original Service Date:	2021
Unit Cost:	\$5,000.00	Useful Life:	6
% of Unit Cost:	100.0%	Rem. Useful Life Adjustment:	-2
Total Cost:	\$5,000.00	Remaining Useful Life:	0
Cost Source:	GeoReserves Database	Next Scheduled Year:	2025
Description:	This component funds for a general allowance to make any repairs to the pool above the normal pool maintenance. This work is scheduled to be done every five to six years but can occur whenever necessary.		
Evaluation:	Some minor repairs may be necessary.		
General Notes:
