# NOXON RAPIDS & CABINET GORGE RESERVOIRS SANDERS COUNTY, MONTANA

### 2019 Aquatic Invasive Species (AIS) Aquatic Pesticide Application Report (APAR)

Prepared For: Sanders County 1111 Main Street Thompson Falls, MT 59873

October 2019

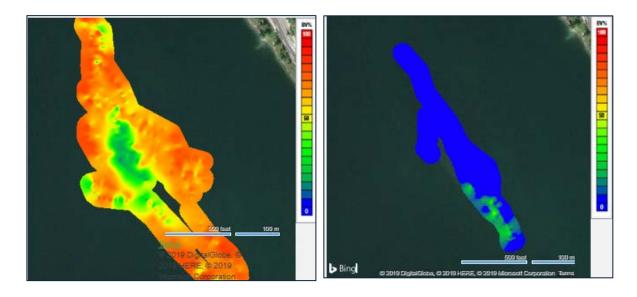
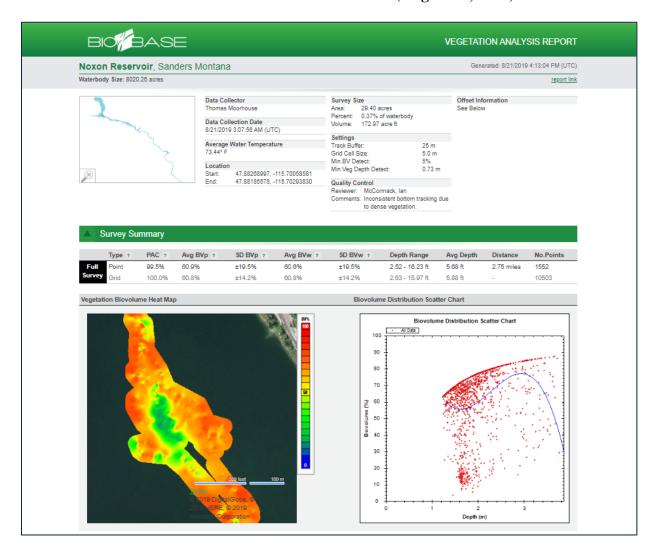
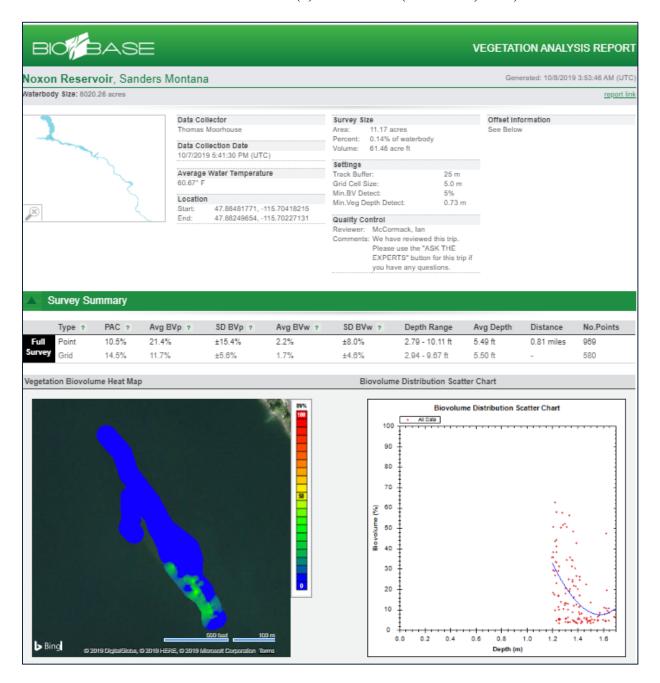
Plot NOX-02: At Time of Treatment (August 19, 2019 Left), ~ Seven (7) Weeks Post (October 7, 2019 Right)

**Observations/Notes NOX-02:** Treated with combination of endothall and diquat, control visually estimated at +/- 95%. Some Coontail and Elodea present post treatment.

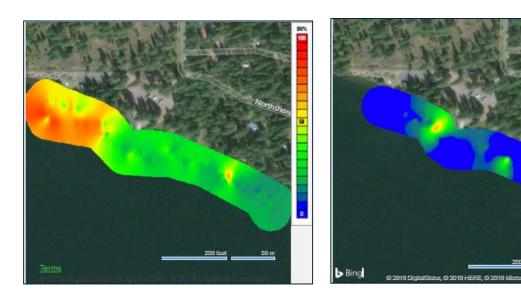
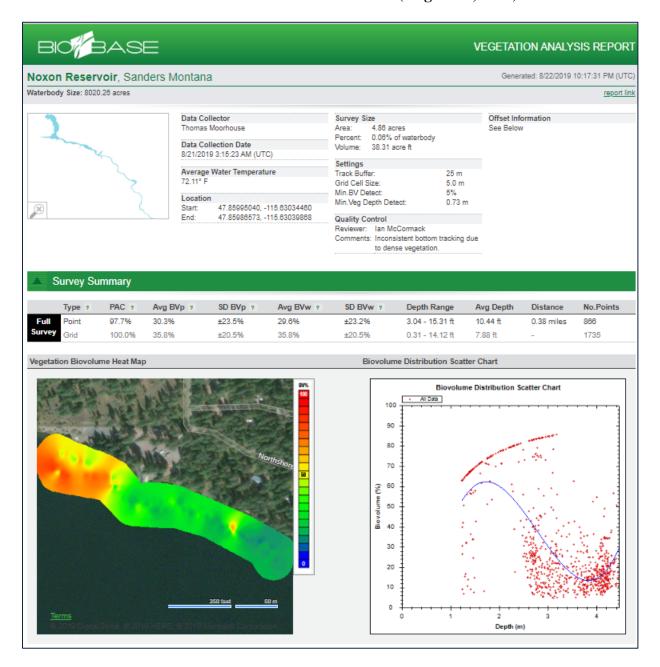
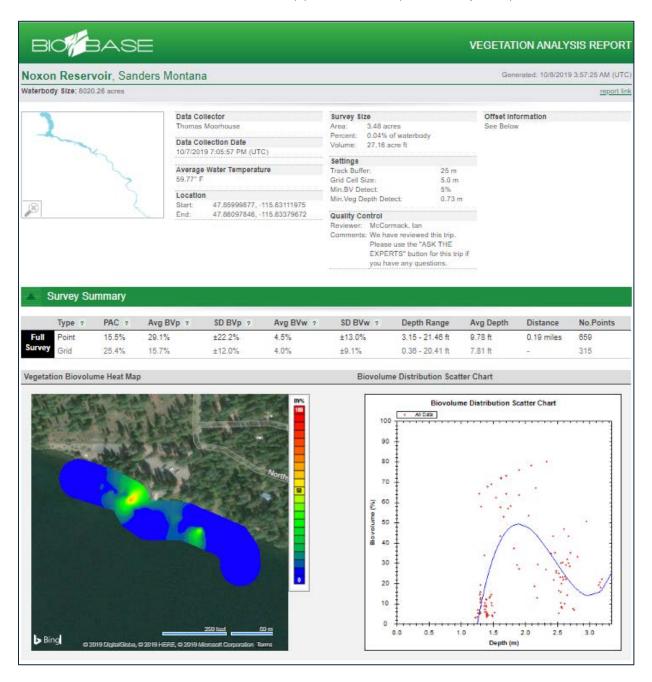
Plot NOX-03: At Time of Treatment (August 20, 2019 Left), ~ Seven (7) Weeks Post (October 7, 2019 Right)

**Observations/Notes NOX-03:** Treated with combination of endothall and diquat, control visually estimated at +/- 85%. Some Elodea present post treatment.

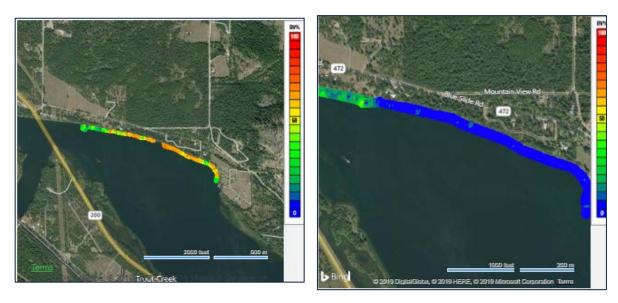
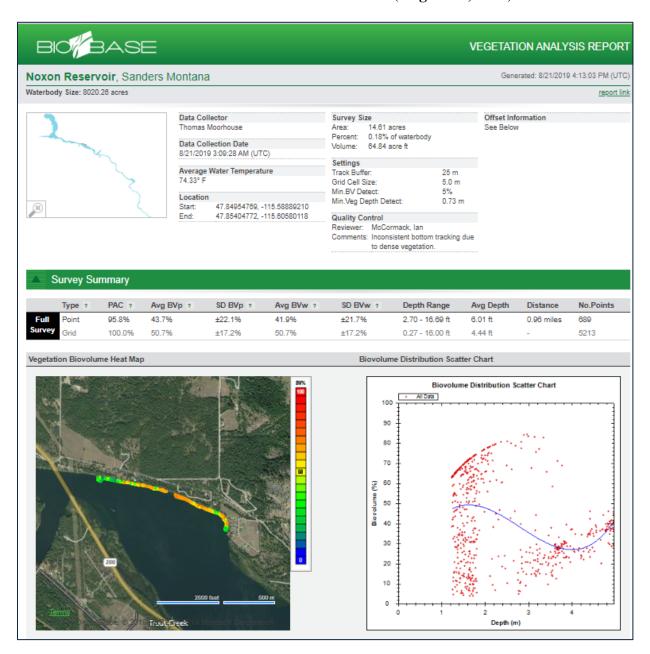
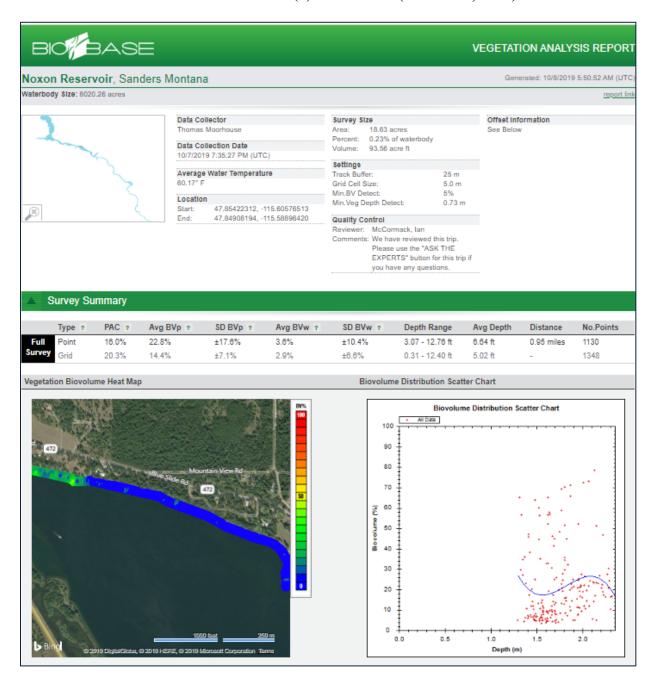
Plot NOX-04: At Time of Treatment (August 19, 2019 Left), ~ Seven (7) Weeks Post (October 7, 2019 Right)

**Observations/Notes NOX-04:** Treated with combination of endothall and diquat, control visually estimated at +/- 75 to 85%. Better control in upper 3/4s of plot 85% +/-. Downstream part of plot variable control, all EWM injured, some entirely while other plants less so. Potential increased water velocity downstream and more exposed.

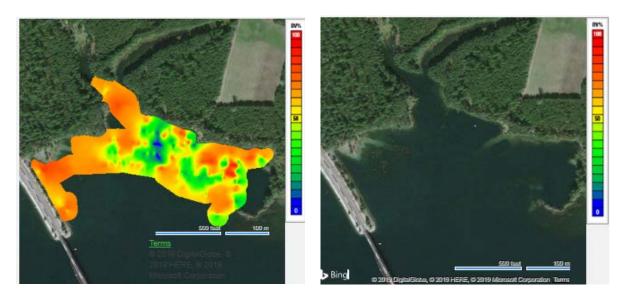
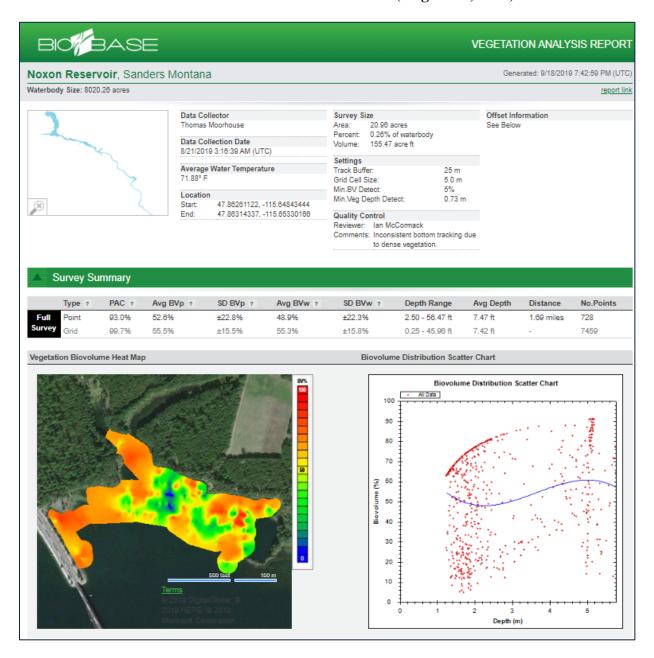
Plot NOX-11: At Time of Treatment (August 20, 2019 Left), ~ Seven (7) Weeks Post (October 7, 2019 Right)

**Observations/Notes NOX-11:** Treated with combination of endothall and diquat, control visually estimated at +/- 98%. Some Elodea present post treatment. Post October 7, 2019 image not available due to a technical issue related to the cloud-based processing site (BioBase).

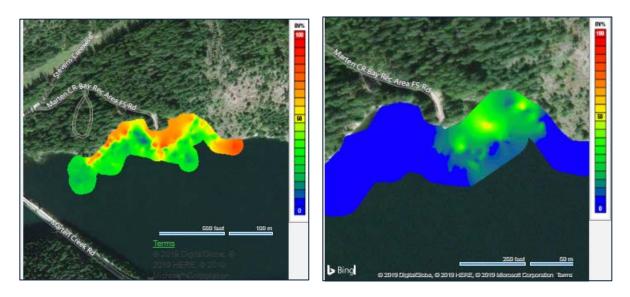
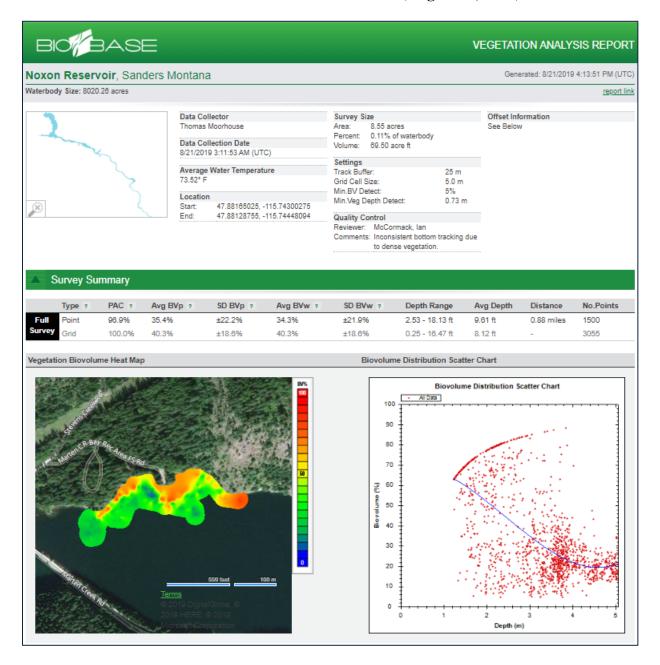
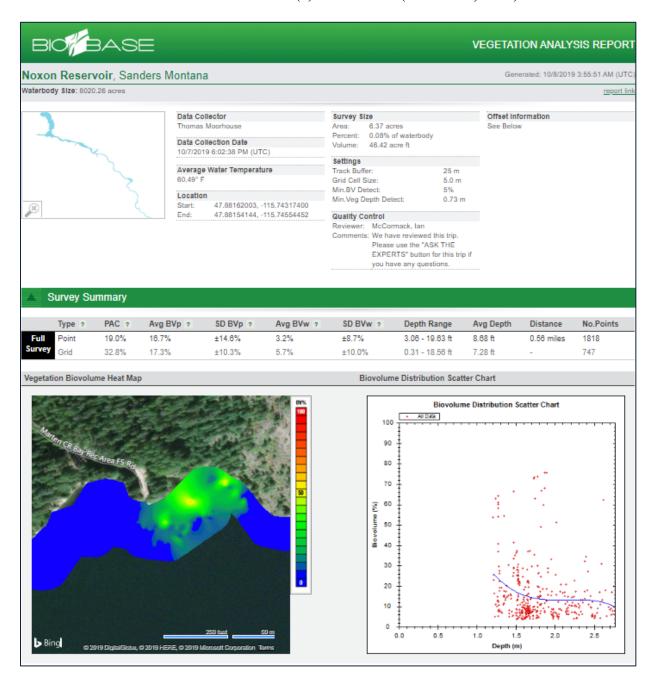
Plot NOX-31: At Time of Treatment (August 19, 2019 Left), ~ Seven (7) Weeks Post (October 7, 2019 Right)

**Observations/Notes NOX-31:** Treated with combination of endothall and diquat, control visually estimated at +/- 80%. Control looks better deep, and at eastern and western ends. Suspect a potential spring or subsurface water flows from small drainage immediately adjacent to the site could be impacting contact exposure times in this particular area of lower level control.

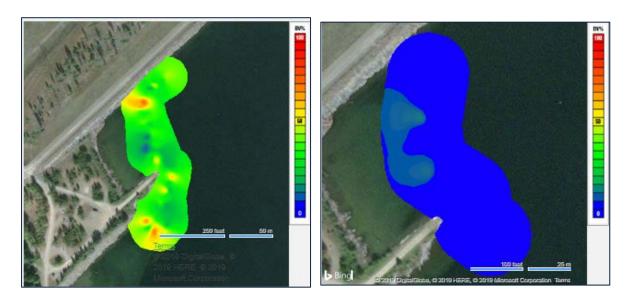
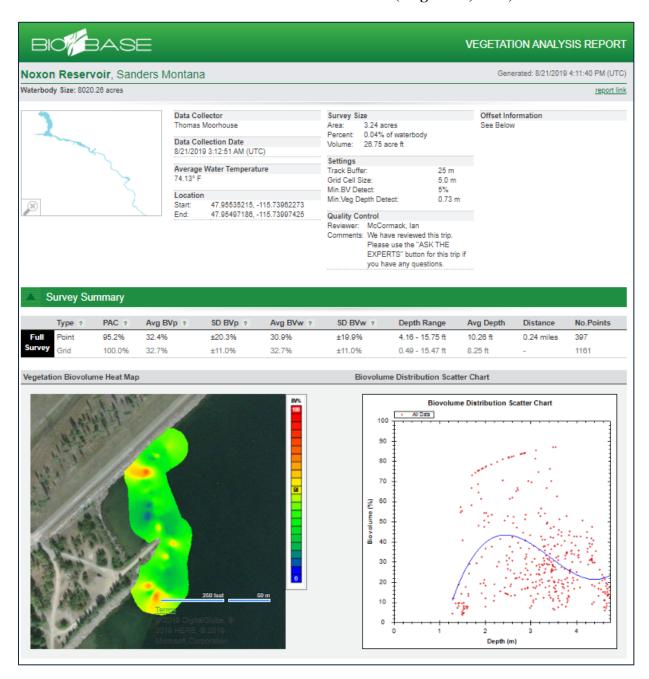
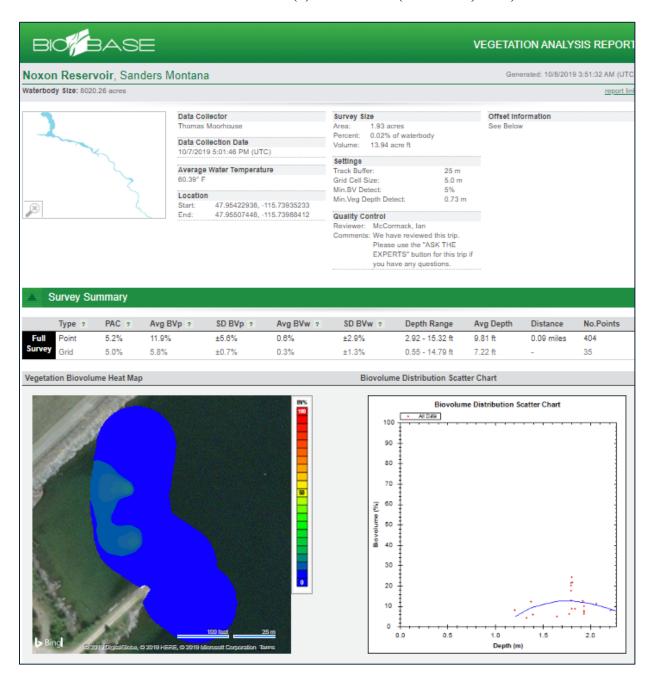
Plot NOX-52: At Time of Treatment (August 19, 2019 Left), ~ Seven (7) Weeks Post (October 7, 2019 Right)

**Observations/Notes NOX-52:** Treated with combination of endothall and diquat, control visually estimated at +/- 98%. Coontail and Nitella present post treatment.

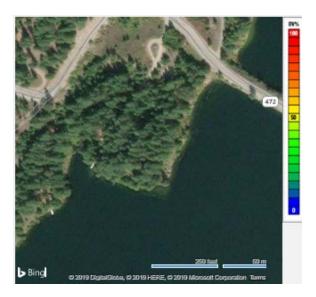
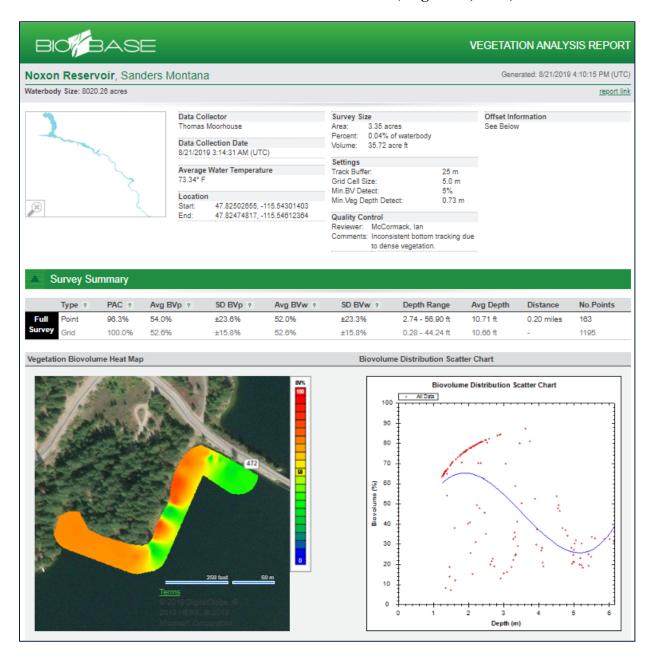
Plot NOX-73: At Time of Treatment (August 19, 2019 Left), ~ Seven (7) Weeks Post (October 7, 2019 Right)

**Observations/Notes NOX-73:** Treated with combination of endothall and diquat, control visually estimated at +/- 95%. Some EWM present to west of dock. Difficult to see in water due to blue-green algae bloom (BGA). Evidence of severe BGA bloom visible as scum lines on the shoreline. Post October 7, 2019 image above not available due to a technical issue related to the cloud-based processing site (BioBase).

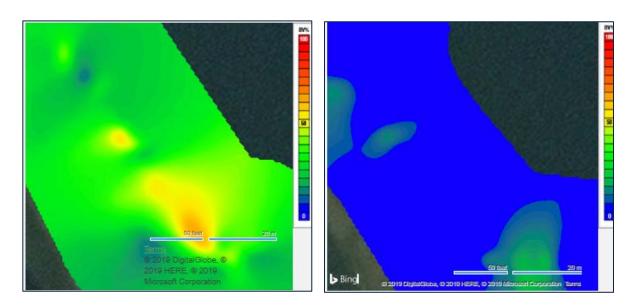
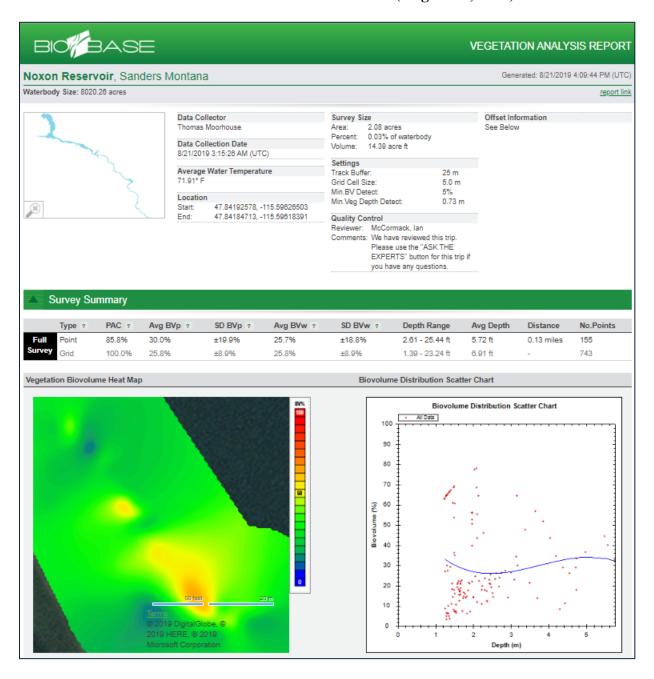
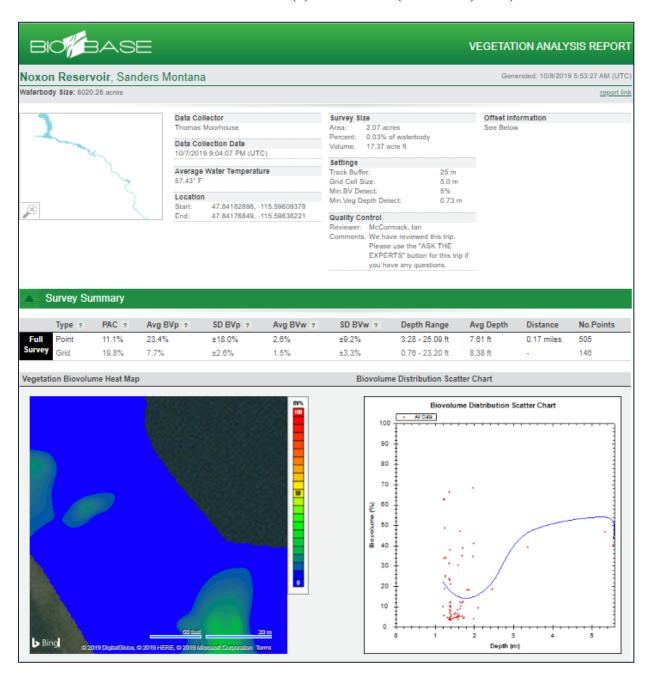
Plot NOX-77: At Time of Treatment (August 20, 2019 Left), ~ Seven (7) Weeks Post (October 7, 2019 Right)

**Observations/Notes NOX-77:** Treated with combination of endothall and diquat, control visually estimated at +/- 90%. Patch of EWM present along southern edge of swim beach buoy line.

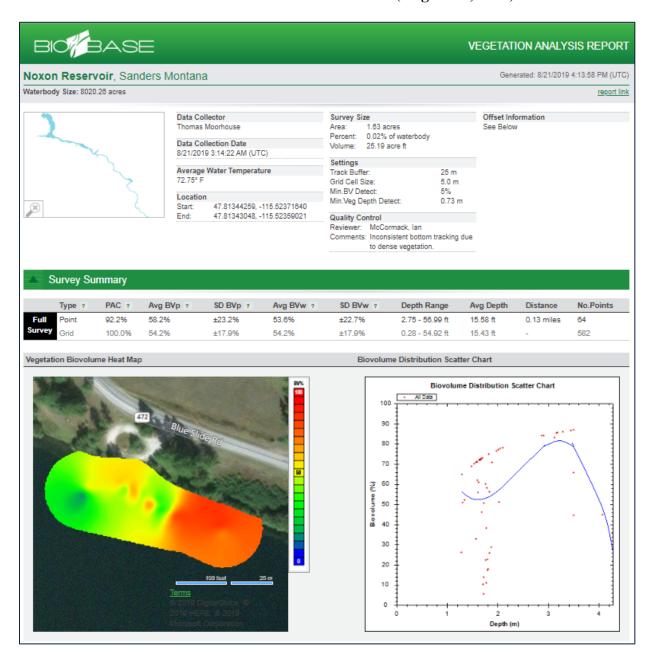
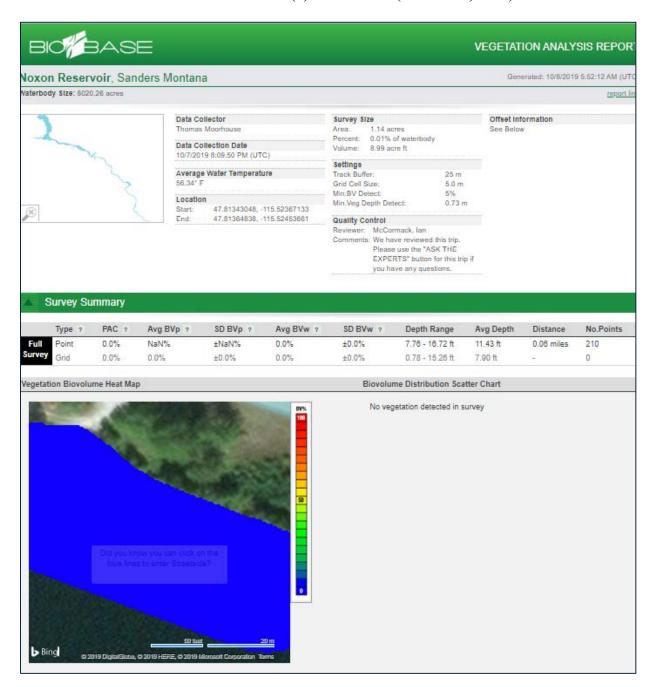
Plot NOX-78: At Time of Treatment (August 19, 2019 Left), ~ Seven (7) Weeks Post (October 7, 2019 Right)

**Observations/Notes NOX-78:** Treated with combination of endothall and diquat, control visually estimated at +/- 98%. Clarity impacted by Blue Green Algae bloom.

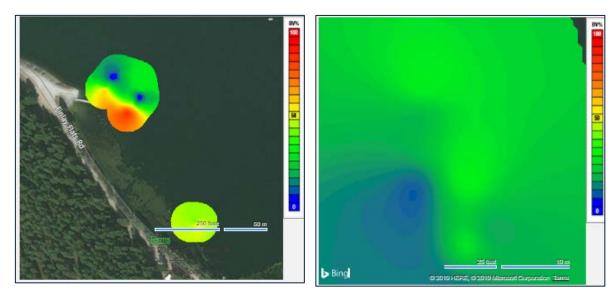
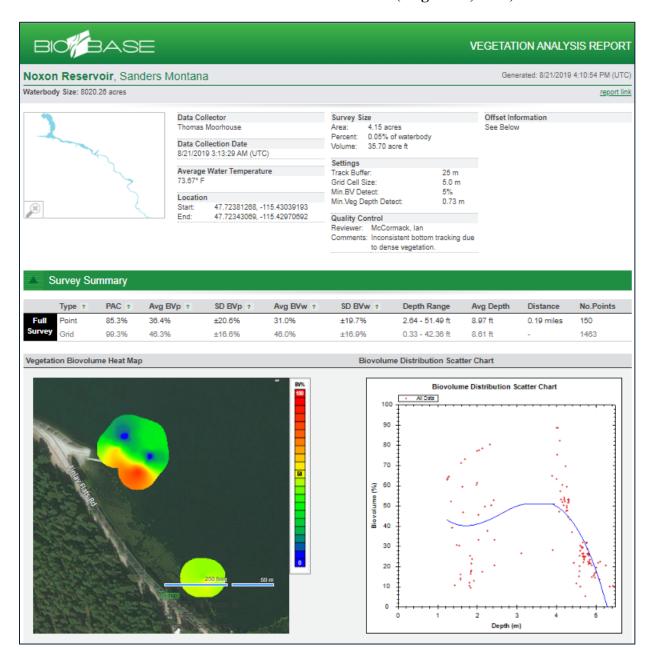
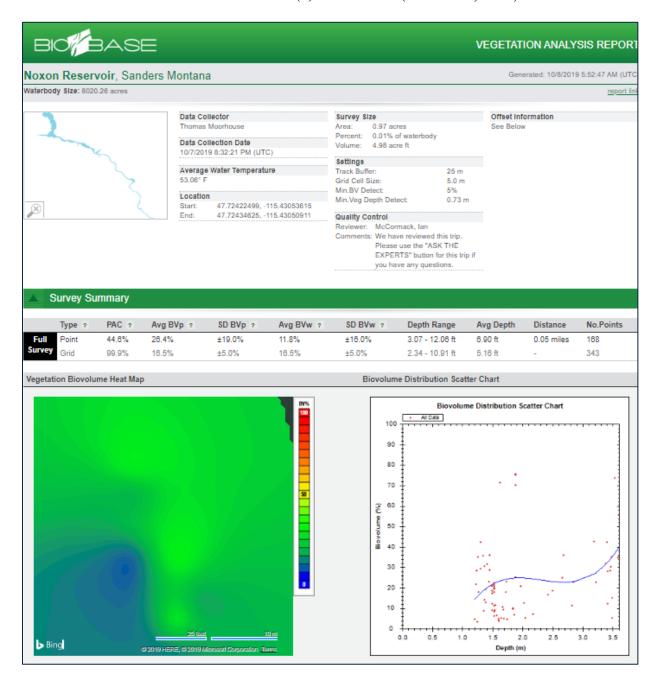
Plot NOX-79: At Time of Treatment (August 19, 2019 Left), ~ Seven (7) Weeks Post (October 7, 2019 Right)

**Observations/Notes NOX-79:** Treated with combination of endothall and diquat, control visually estimated at +/- 100%. Elodea present post treatment. Part of plot was exposed or to shallow to approach, however no EWM visible. Abundant filamentous algae.

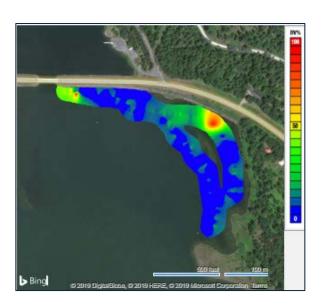
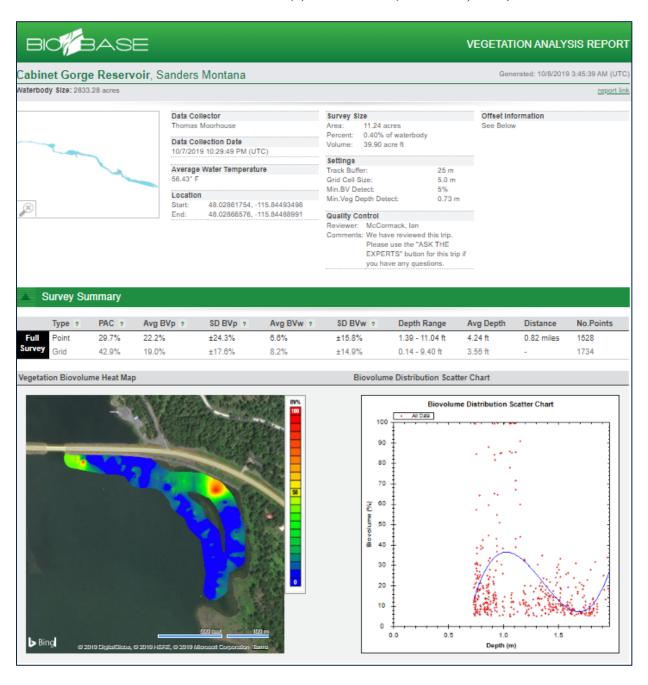
Plot CAB-05: At Time of Treatment (August 20, 2019 Left), ~ Seven (7) Weeks Post (October 7, 2019 Right)

**Observations/Notes CAB-05:** Treated with combination of endothall and diquat, control visually estimated at +/- 90%. Coontail and Elodea present post treatment. Some EWM on plot edges.

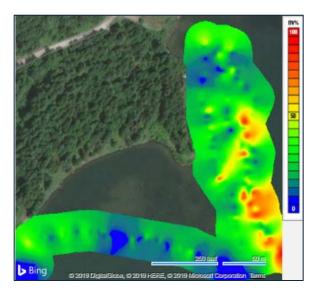
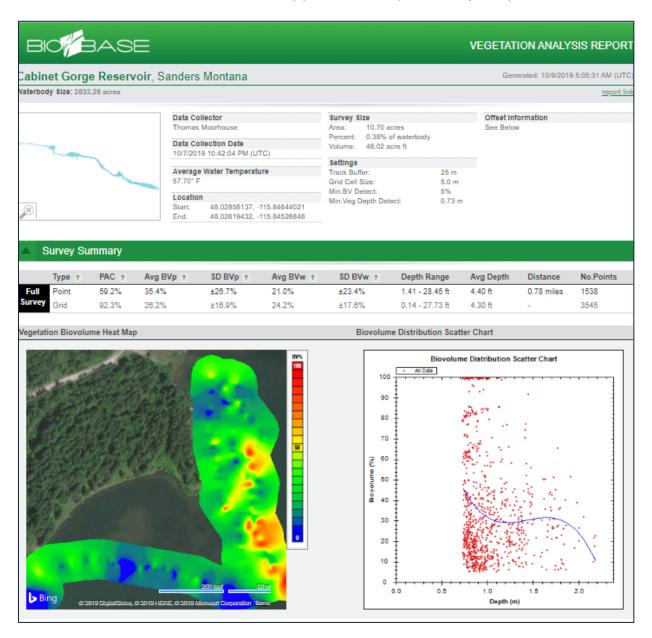
# Plot CAB-06: At Time of Treatment (August 20, 2019 Left), ~ Seven (7) Weeks Post (October 7, 2019 Right)

**Observations/Notes CAB-06:** Treated with combination of endothall and diquat, control visually estimated at +/- 95%. Elodea and Coontail present post treatment. Some EWM present along edge of plot on south an east sides.

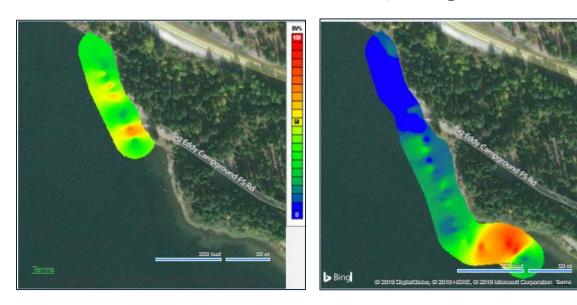
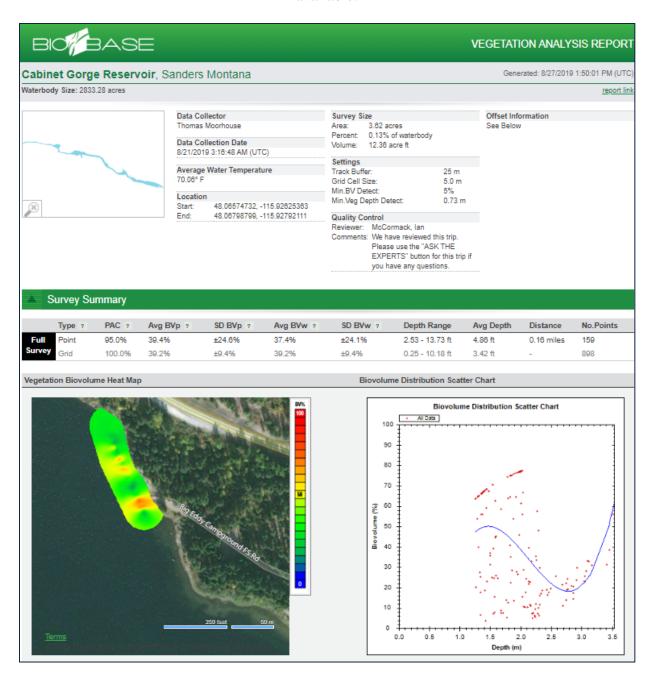
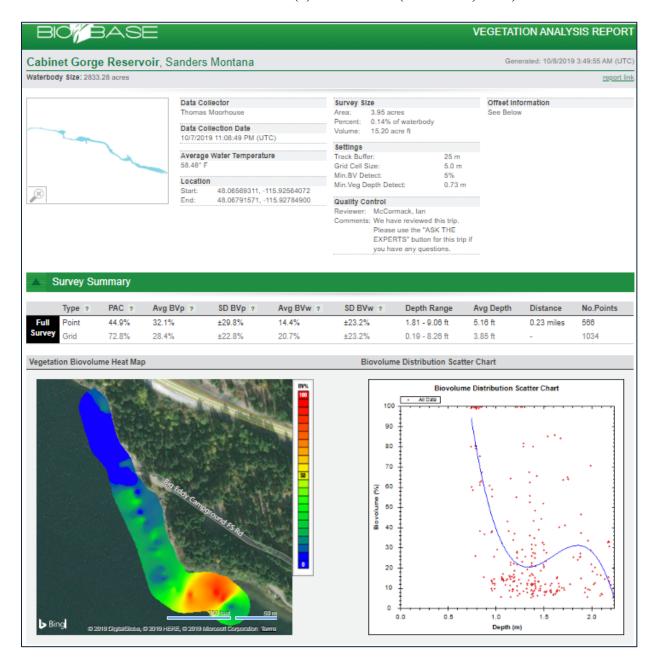
Plot CAB-12: At Time of Treatment (August 20, 2019 Left), ~ Seven (7) Weeks Post (October 7, 2019 Right)

**Observations/Notes CAB-12:** Treated with combination of endothall and diquat, control visually estimated at +/- 90% to 95%. Some injured EWM visible, mostly dead. Elodea and Coontail present post treatment. Due to a technical difficulty less than the whole plot data is available at time of treatment.

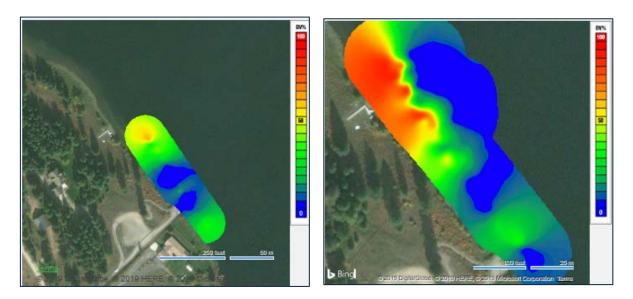
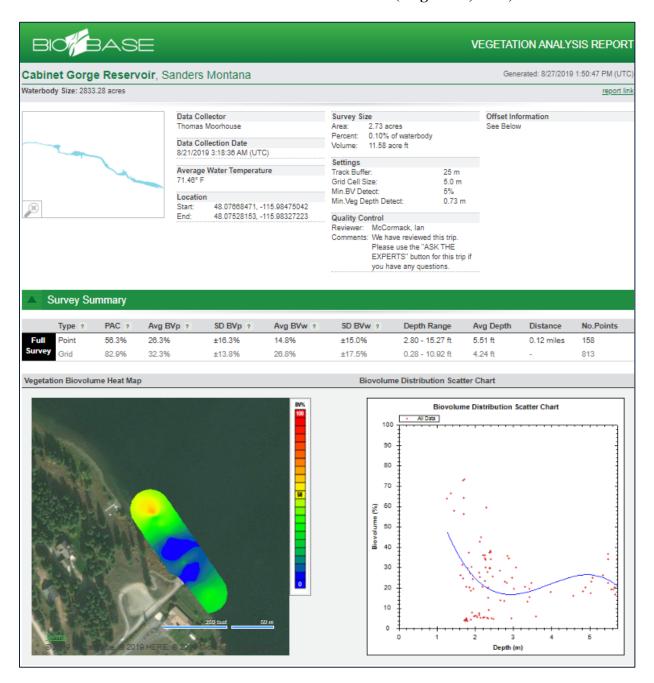
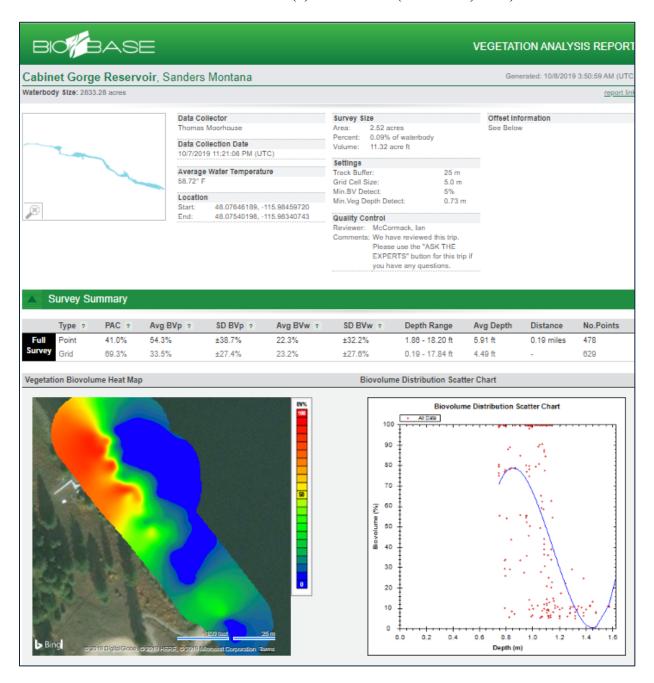
Plot CAB-29: At Time of Treatment (August 20, 2019 Left), ~ Seven (7) Weeks Post (October 7, 2019 Right)

**Observations/Notes CAB-29:** Treated with combination of endothall and diquat, control visually estimated at +/- 75%. North end of plot had weaker control. Elodea and Coontail present post treatment.
