# HOME INSPECTION REPORT

*123 Main Street, Anytown , GA 30506*

*Inspection prepared for: Your Buyer*

*Date of Inspection: 1/1/2022 Time: 9:00*

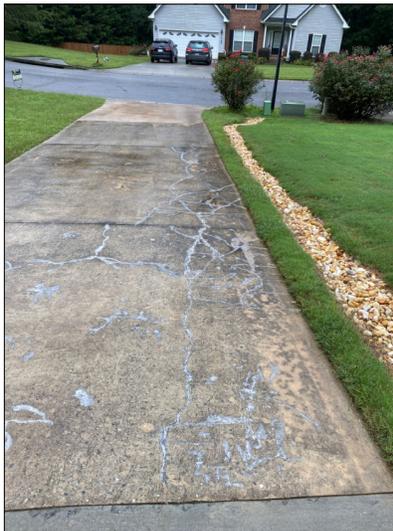
MINOR CRACKS were observed on driveway surface, this is a typical condition and maintenance includes sealing the cracks.

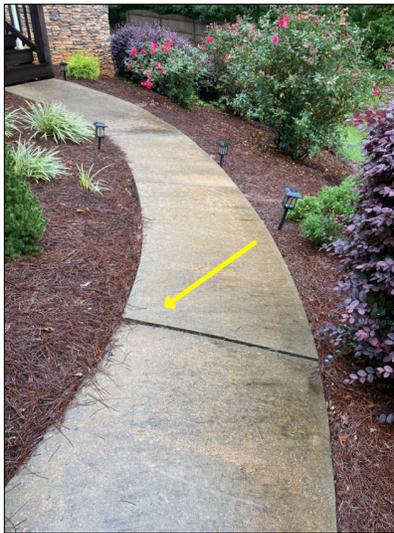
**SETTLEMENT** was observed of walkway and could be caused by settlement of fill dirt below surface. Recommend further review and repair by a qualified licensed contractor.

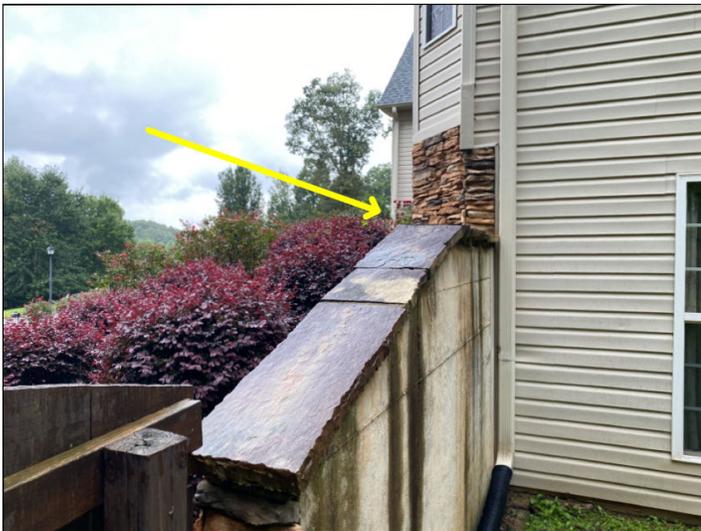
Page 8 Item: 6	Retaining Wall Inspection	<ul style="list-style-type: none"> <li>• <b>MISSING GUARDRAIL</b> along retaining wall at the left side of house was observed and is a safety issue. Guardrails may not be desirable but should be installed for safety on any wall over 30" tall. Recommend review and repair by a licensed contractor.</li> </ul>
----------------	---------------------------	---

**MISSING GUARDRAIL** along retaining wall at the left side of house was observed and is a safety issue. Guardrails may not be desirable but should be installed for safety on any wall over 30" tall. Recommend review and repair by a licensed contractor.

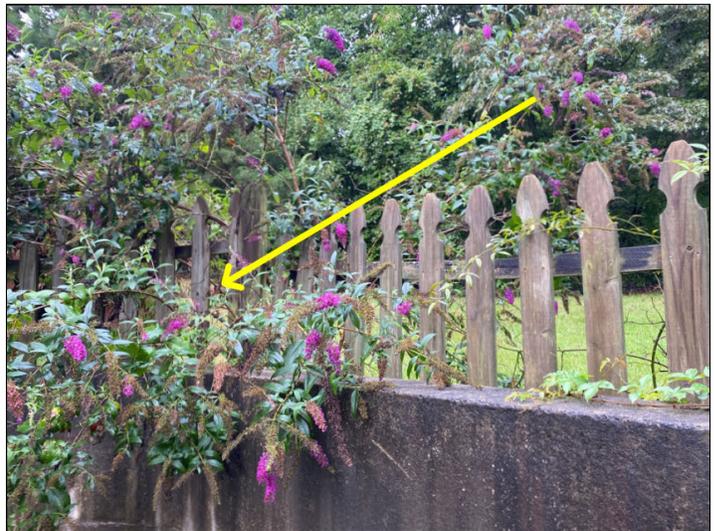
Page 8 Item: 6	Retaining Wall Inspection	<ul style="list-style-type: none"> <li>• <b>DAMAGED GUARDRAIL</b> along retaining wall at the left side of house was observed and is a safety hazard. Recommend review and repair by a licensed contractor.</li> </ul>
----------------	---------------------------	--

**DAMAGED GUARDRAIL** along retaining wall at the left side of house was observed and is a safety hazard. Recommend review and repair by a licensed contractor.

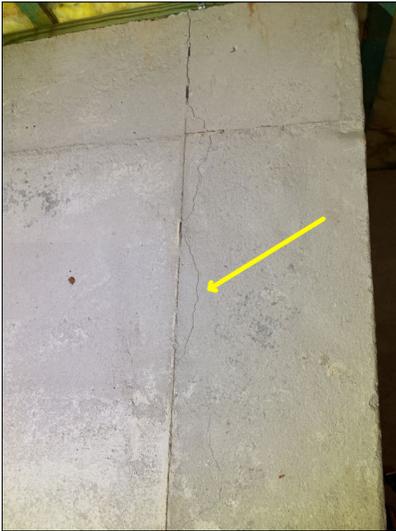
*MINOR WALL CRACKS* were observed in the foundation walls and are typical for most homes in this area. Maintenance should include sealing against moisture and monitoring. Cracks could be access points for moisture and insect intrusion into the home.

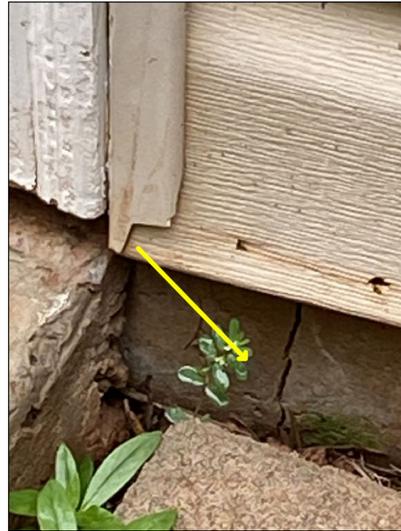
*MINOR SLAB CRACKS* were observed in the concrete slab and are typical for most homes in this area. Maintenance should include sealing against moisture and monitoring. Cracks could be access points for moisture and insect intrusion into the home.

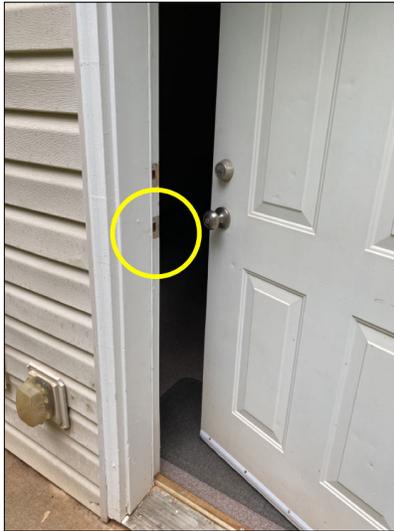
**DOOR DOESN'T LATCH** - Door does not securely close or latch at the basement entry, recommend repair by a qualified handyman.

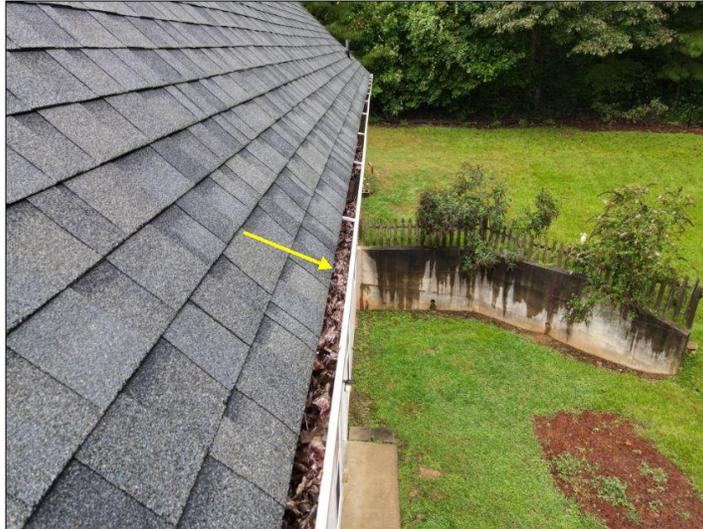
**VISIBLE DEBRIS in gutters was observed and could cause water damage if gutters are not regularly cleaned and maintained.**

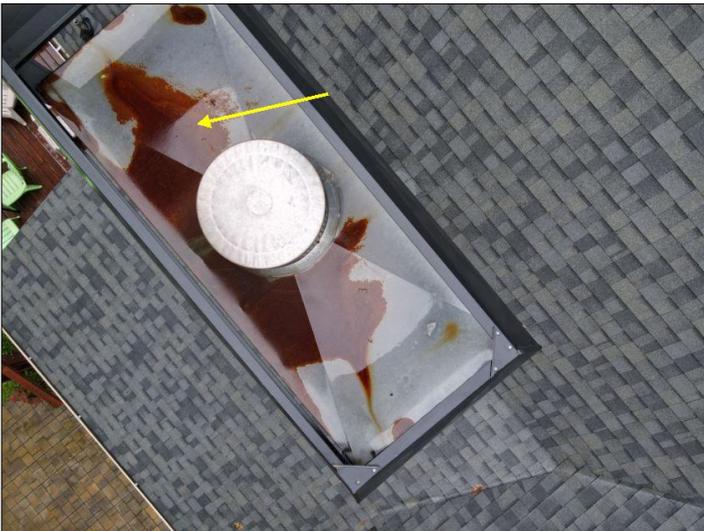
Page 15 Item: 5	Chimney Inspections	<ul style="list-style-type: none"> <li>• <b>WATER POOLING</b> on the chimney cap was observed. Standing water is an indicator of poor drainage on the chimney cap which could damage the cap and be a point of moisture intrusion. Recommend review and repair by a licensed contractor.</li> </ul>
-----------------	---------------------	---

**WATER POOLING** on the chimney cap was observed. Standing water is an indicator of poor drainage on the chimney cap which could damage the cap and be a point of moisture intrusion. Recommend review and repair by a licensed contractor.

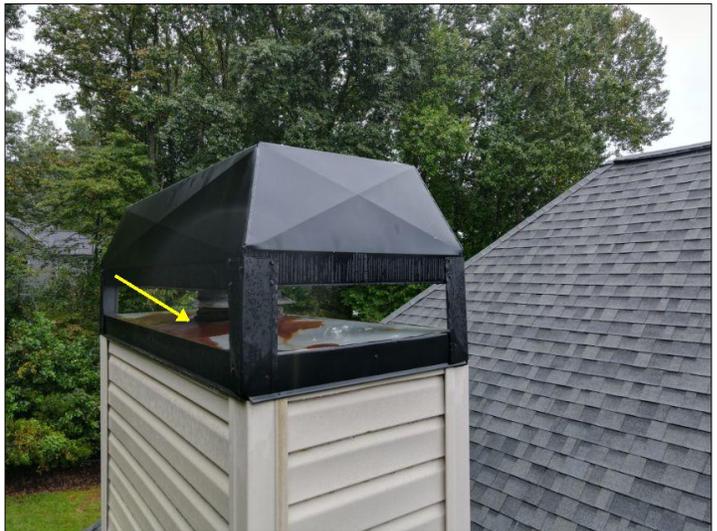
<b>Maintenance Items</b>		
<b>Roof</b>		
Page 15 Item: 5	Chimney Inspections	<ul style="list-style-type: none"> <li>• <b>RUSTED COMPONENTS</b> were observed on chimney top and should be evaluated and refinished to maintain water tight integrity from rust damage.</li> </ul>
<b>Electrical</b>		
Page 21 Item: 4	Sensors Inspection	<ul style="list-style-type: none"> <li>• <b>MISSING SMOKE DETECTOR</b>- Smoke detectors were not installed and should be properly located according to the manufacturers instructions. Typical installation includes bedrooms, hallways and basements.</li> </ul>
<b>HVAC 1</b>		
Page 27 Item: 4	Air Conditioner 1 Inspection	<ul style="list-style-type: none"> <li>• <b>R22 REFRIGERANT</b> in use and is costlier to service than the R410a refrigerant being used in current <b>HVAC</b> systems. R22 refrigerant is currently being phased out of service.</li> </ul>
<b>Garage</b>		
Page 35 Item: 4	Floor Inspection	<ul style="list-style-type: none"> <li>• <b>MINOR CONCRETE CRACKING</b> was observed and is typical for a concrete slab. Cracks should be monitored for further movement or damage, recommend review by a licensed contractor if needed.</li> </ul>

**RUSTED COMPONENTS** were observed on chimney top and should be evaluated and refinished to maintain water tight integrity from rust damage.

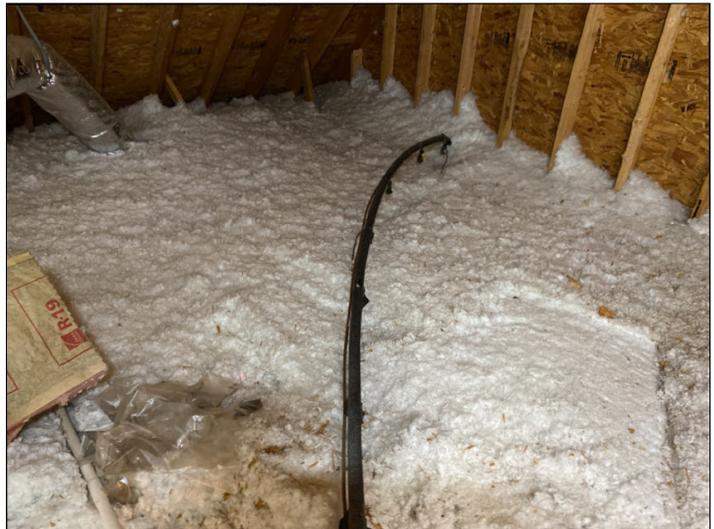
LIMITED VIEW of attic structure because of installed insulation. Inspection was limited to readily accessible or visual areas of the attic space.

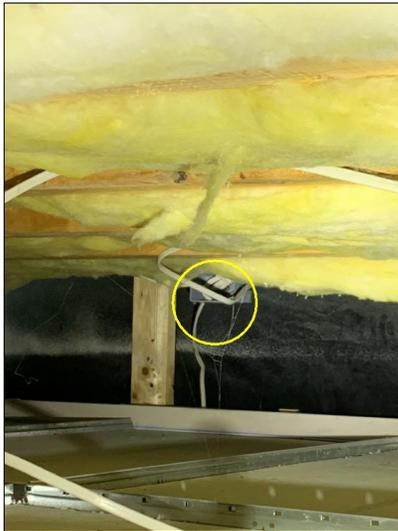
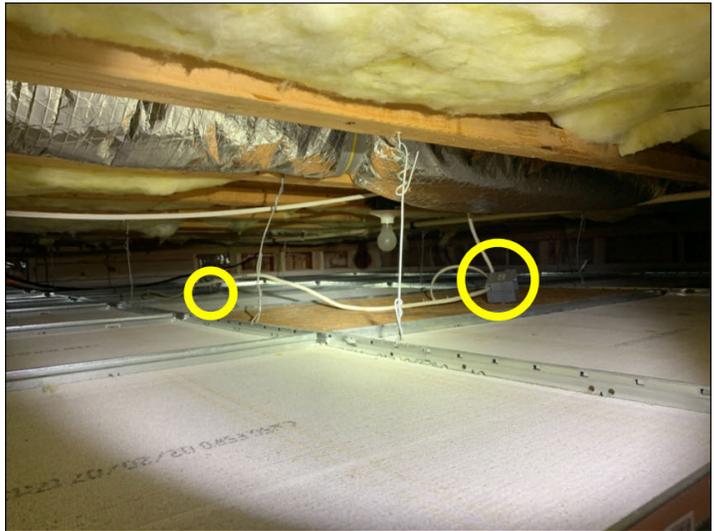
MISSING BOX COVERS - Missing covers on electrical junction boxes were observed in the basement, all junction boxes should have a cover. Recommend appropriate covers be properly installed.

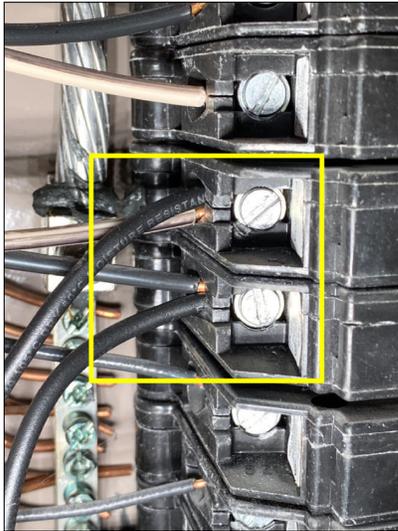
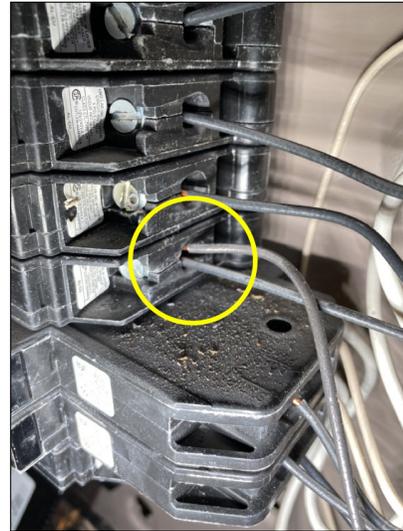
Page 22 Item: 2	Main Panel Inspection	<ul style="list-style-type: none"> <li>• <b>DOUBLE TAP(S)</b> on BREAKER - More than one branch circuit wire was connected on a single lug of the circuit breaker. Improperly secured wires can cause heat or arcing at the connection, a safety hazard. Recommend repair by a licensed electrician.</li> </ul>
-----------------	-----------------------	---

**DOUBLE TAP(S) on BREAKER** - More than one branch circuit wire was connected on a single lug of the circuit breaker. Improperly secured wires can cause heat or arcing at the connection, a safety hazard. Recommend repair by a licensed electrician.

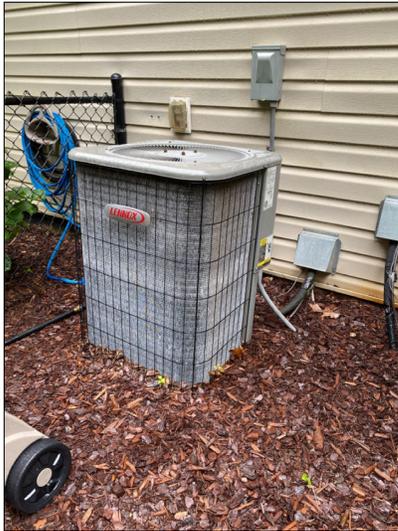
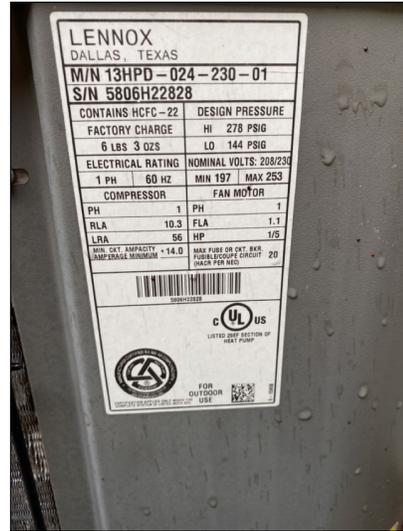
**OLDER A/C CONDENSER** - An older A/C condenser was installed and should be recognized as "Nearing the end of service life" and will likely need replacement in the near future. The average lifespan for an A/C condenser is considered to be about 15 years although there are many factors that contribute to the actual working life.

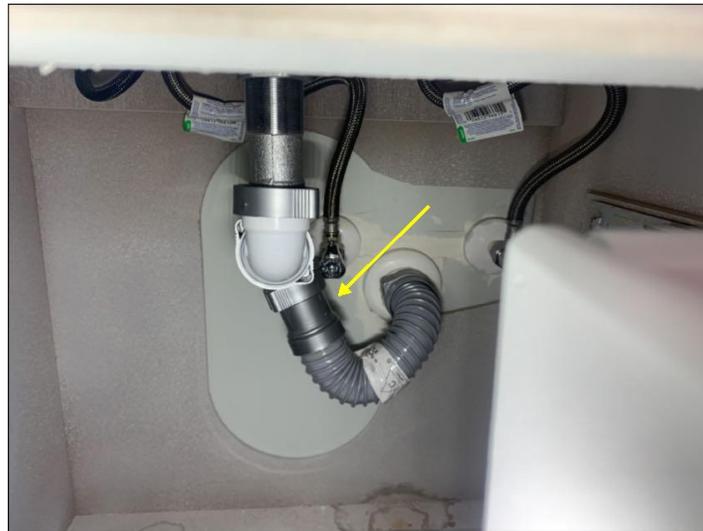
**IMPROPER TRAP-** An improperly installed or designed waste trap was observed in the master bathroom. A standard P-trap should be installed to maintain correct separation of waste gasses from the interior air. Recommend repair by a licensed plumber.

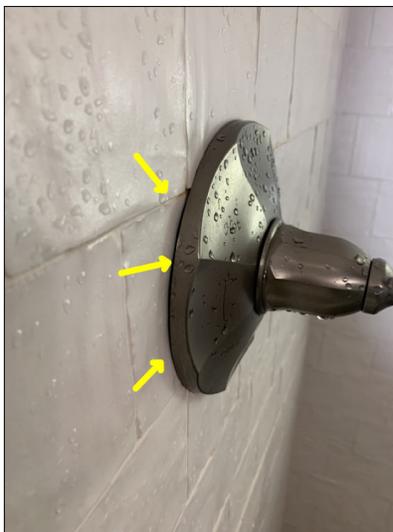
**CAULKING DAMAGE** - Areas of missing or damaged sealant was observed in the master bathroom and should be properly caulked. Recommend correctly sealing to maintain water tight integrity around tub/shower enclosure.

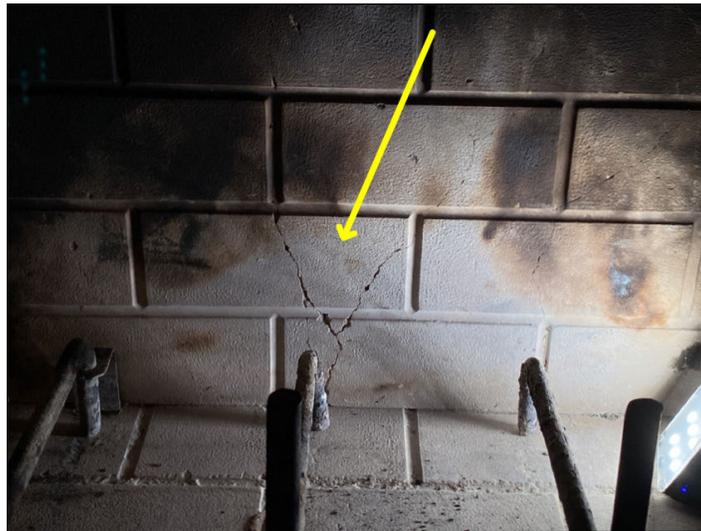
**MINOR FIREBOX CRACKING** was observed in living room fireplace and should be monitored for further damage. Hairline cracks are generally considered safe and serviceable, recommend consulting fireplace contractor if damage increases.

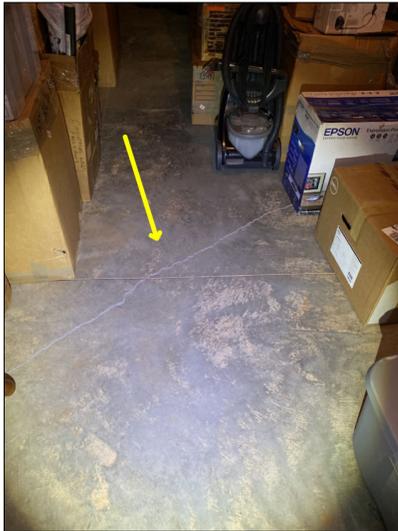
**MINOR SLAB CRACKS** were observed in the concrete slab and are typical for most homes in this area. Maintenance should include sealing against moisture and monitoring. Cracks could be access points for moisture and insect intrusion into the home.

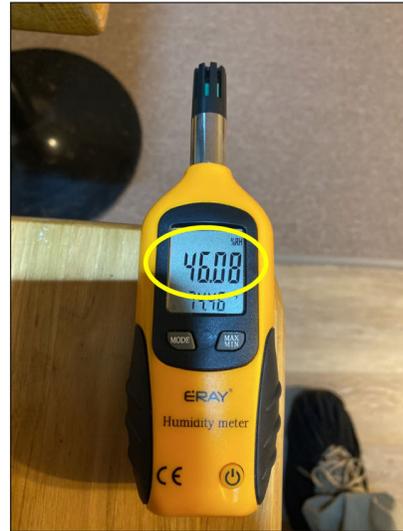
**PORTABLE DEHUMIDIFIER** recommended be used to maintain proper humidity levels, 46%, in the unfinished basement that does not have an air conditioning source. High humidity can result in organic growth, mildew.

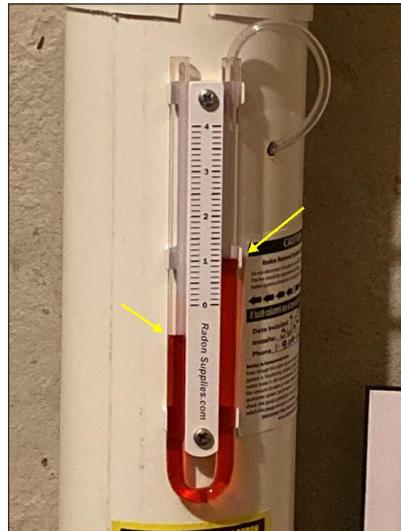
RADON MITIGATION - A properly working Radon removal system will show a correct vacuum with a "J" shaped indicator. The meter was indicating the system was currently in operation, recommend further information from homeowner.
