First Sergeant Inspection Services, LLC

Property Inspection Report

Property address: **123 Steele LN**
Lacey, WA 98501

Inspection date: **Saturday, February 24, 2018**

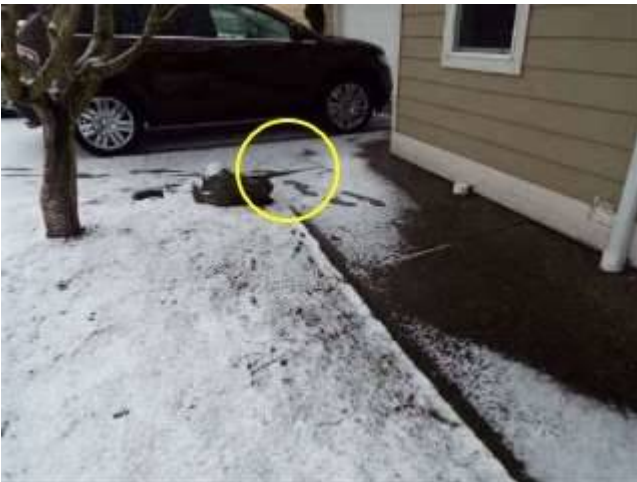
Photo 2-1

- 2) 🛠️ Cracks, holes, settlement, heaving and/or deterioration resulting in trip hazards were found in the front sidewalks. For safety reasons, I recommend that a qualified contractor repair as necessary to eliminate trip hazards.

Front walk way

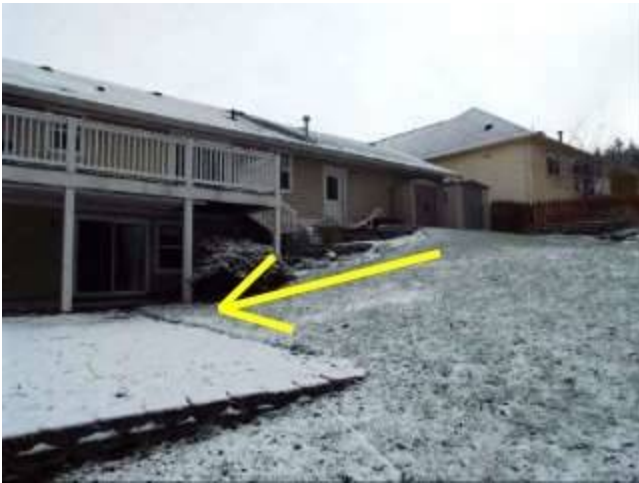
around building foundations or underneath buildings. At a minimum, monitor this area in the future for accumulated water. If water does accumulate, I recommend grading soil so it slopes down and away from buildings with a slope of at least 1 inch per horizontal foot for a minimum 6 feet out from buildings.

Photo 3-1
Backyard in front of sliding glass door

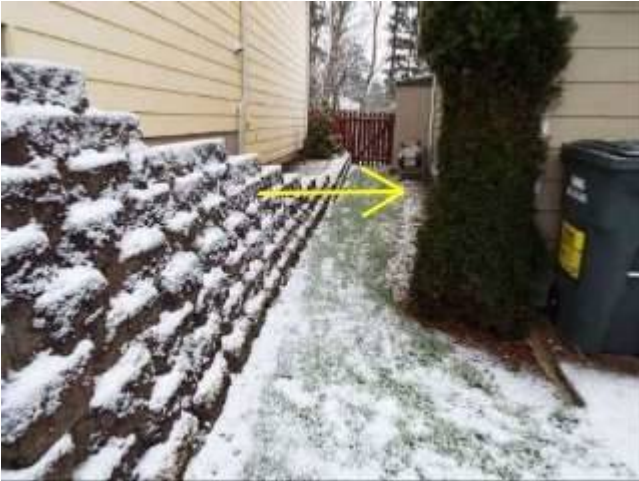
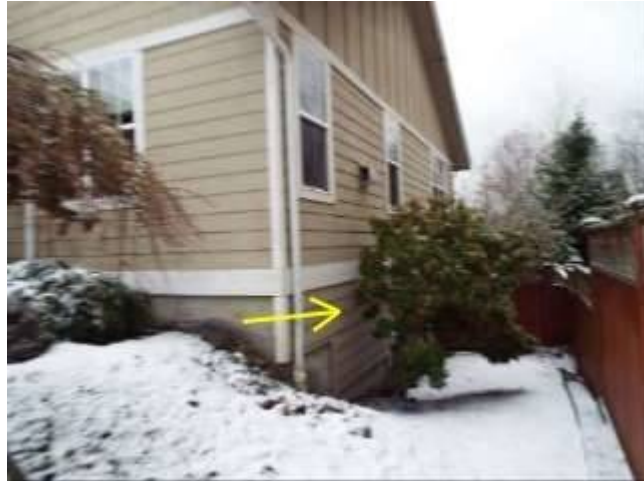
Vegetation such as trees and shrubs were in contact with the building exterior. Vegetation can serve as a pathway for wood-destroying insects and can retain moisture against the exterior after it rains. This is a condition conducive to attracting wood-destroying organisms. I recommend pruning, moving or removing vegetation as necessary to maintain at least 6 inches of space between it and the building exterior. A 1-foot clearance is better.

Photo 4-1
East North corner of house

Photo 4-2
West side of house

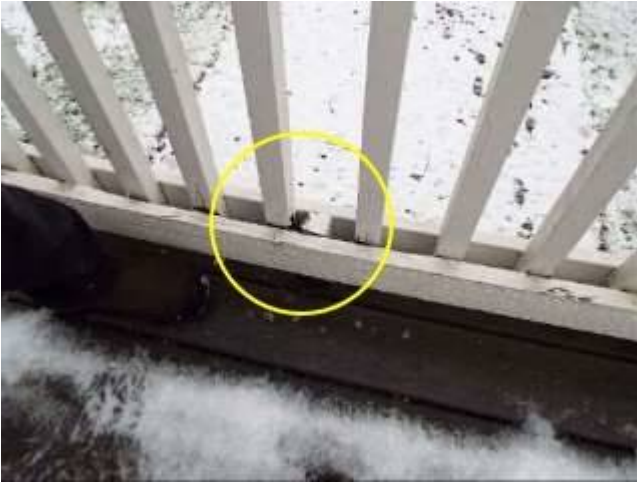
Photo 5-1

Fungal rot was found in support guards at backyard deck. Will not hold weight of average person and can cause safety risk of breaking and falling. I recommend that a qualified contractor evaluate and repair as necessary. All rotten wood should be replaced.

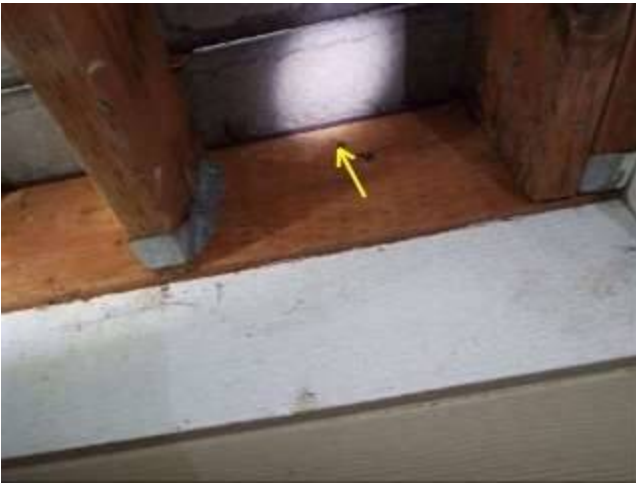
Flashing was bent over to prevent water from following the flashing behind the board from above deck ledger boards. Flashing at this location can cause moisture to accumulate between the ledger boards and the building. Fungal rot may occur in this area and cause the ledger board fasteners to fail. The deck may separate from the building in this event. This is a potential safety hazard. I recommend that a qualified contractor install flashing above ledger boards per standard building practices.

Photo 6-1
Underneath backyard deck

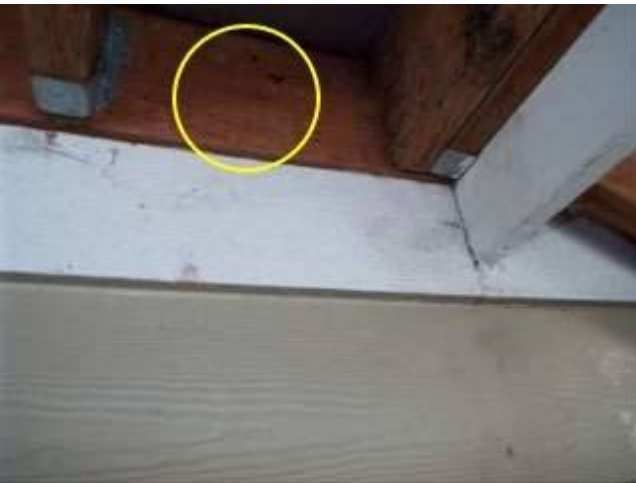
Ledger boards at deck appeared to be attached with nails only. This method of attachment is substandard and may result in such structures separating from the main building. This is a potential safety hazard. Modern standards call for ledger boards to be installed with 1/2 inch lag screws or bolts into solid backing, and brackets such as [Simpson Strong Tie DTT2 brackets and threaded rod](#), connecting interior and exterior joists. I recommend that a qualified contractor repair per standard building practices.

Photo 7-1
Underneath backyard deck

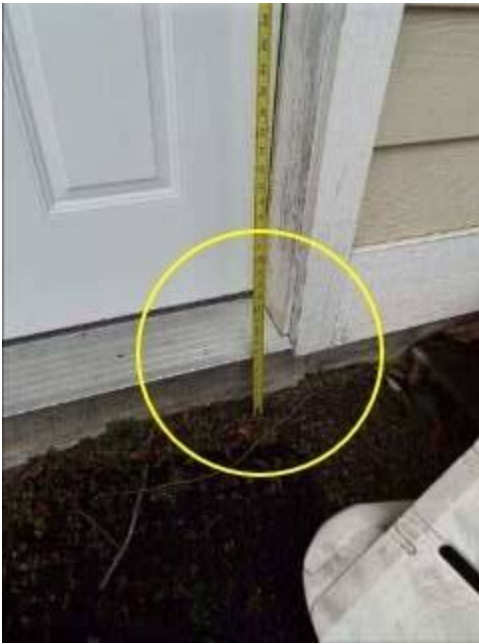
Risers for stairs at rear garage door were higher than 7 3/4 inches and posed a fall or trip hazard. Risers should be 7 3/4 inches or shorter. At a minimum, be aware of this hazard, especially when guests who are not familiar with the stairs are present. I recommend that a qualified contractor repair per standard building practices.

Photo 8-1
Rear garage door that goes into backyard

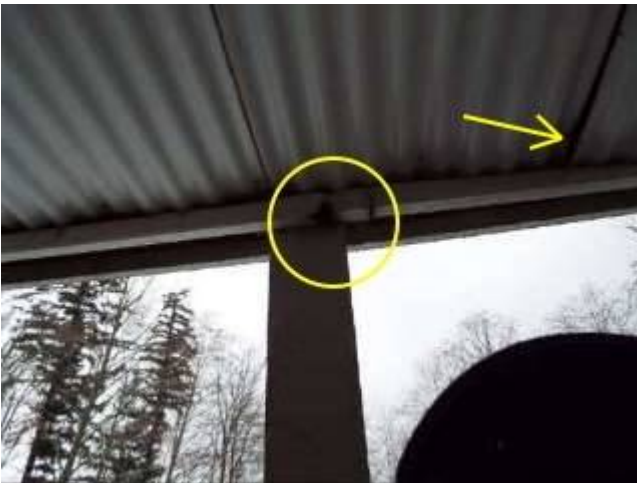
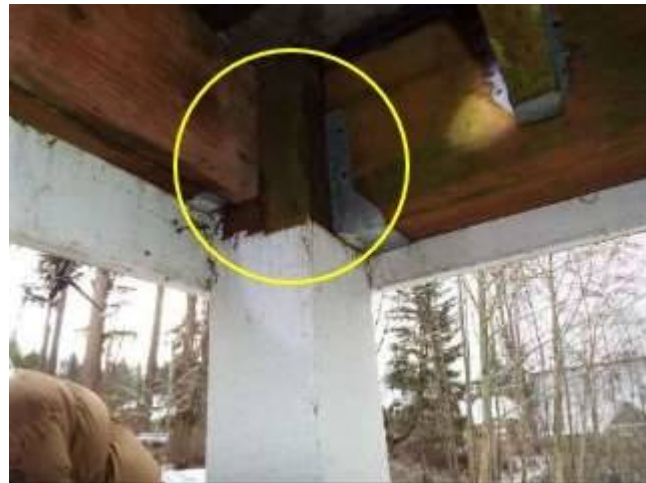
The roofing material under deck shows signs of less than professional construction that is at its service life. Roofing material is showing signs of mildew, bowing, and is possibly assisting the rotting process of the posts holding up the south side of the deck. This is reducing the strength of the deck and can result in the collapse of the deck. This is a safety risk. Also, Deck is unstable due to substandard bracing (picture on right) and lack of diagonal bracing. This is a safety hazard since severe movement may cause the cover to collapse. I recommend that a qualified contractor remove all material.

Photo 9-1
Underneath backyard deck

Photo 9-2
Post holding south west corner of deck in backyard

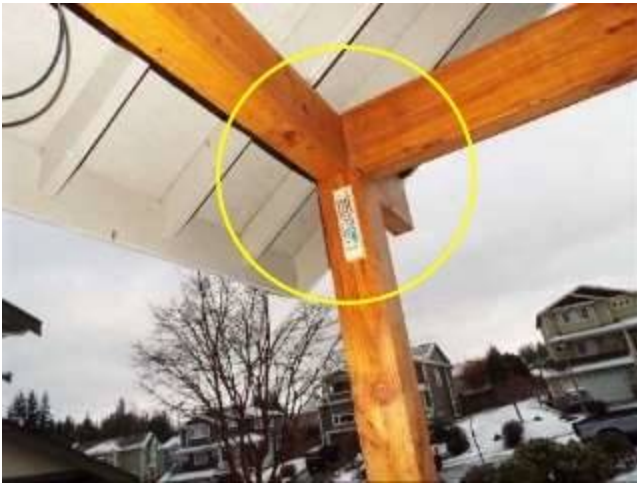
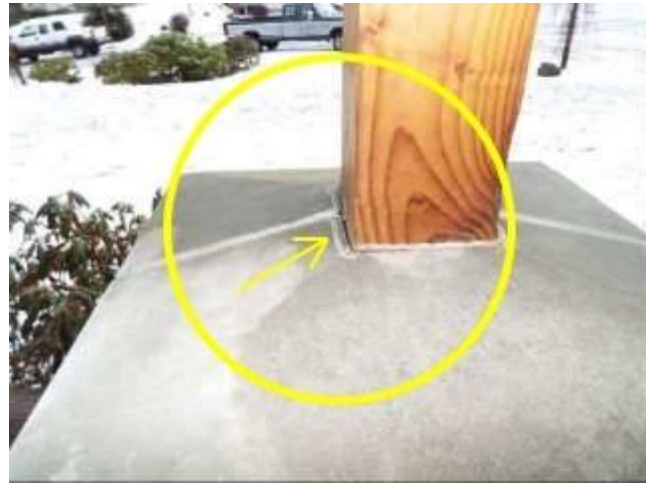
Front porch cover beams missing support brackets that reduce the stability of the cover and promotes a safety risk. I recommend that a qualified person repair or replace as necessary, and per standard building practices.

Photo 10-1
Front porch, missing brackets

Photo 10-2
Front porch, pooling water at base

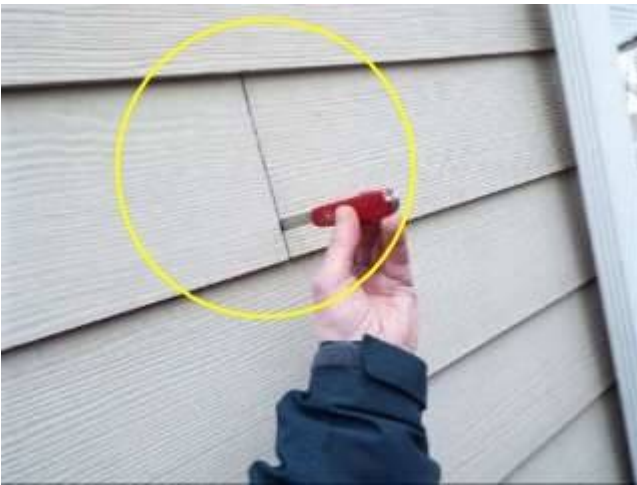
No flashing installed behind the exterior siding at the butt joints allowing water to enter into the house. I recommend that a qualified person reassess and repair.

Photo 11-1
The whole house exterior

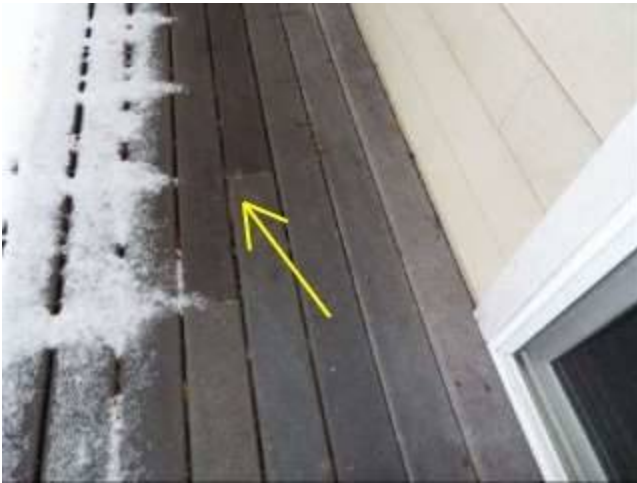
Photo 12-1

Plastic composite decking boards were delaminated or deteriorated. Typically, this material is designed to last longer than wood. Softwoods such as cedar normally last 15 to 20 years, and hardwoods longer. Based on the short period during which this composite decking has been installed, it appears to have failed prematurely and is likely defective. Numerous actions have been filed against composite decking manufacturers. The inspector cannot determine the manufacturer of this particular decking material. Consult with the property owner to determine the manufacturer, the installation date, if receipts for documentation purposes are available, and what options there are for reimbursement by the manufacturer. I recommend that a qualified contractor repair as necessary. Deteriorated composite decking must be replaced.

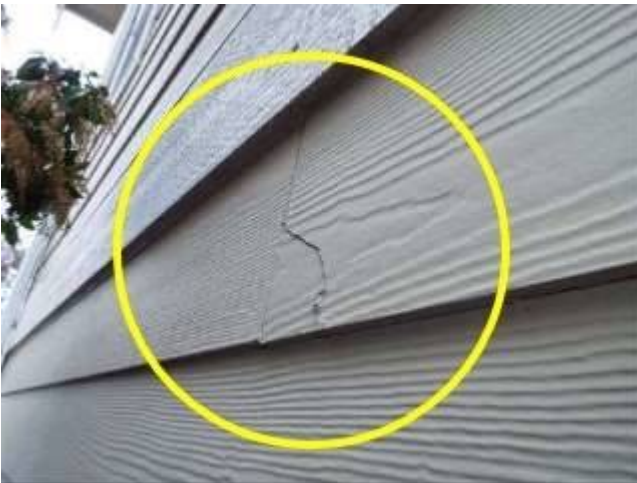
Photo 13-1

Siding was cracked and can be an entrance for water into the interior that can cause rot. I recommend that a qualified person replace siding.

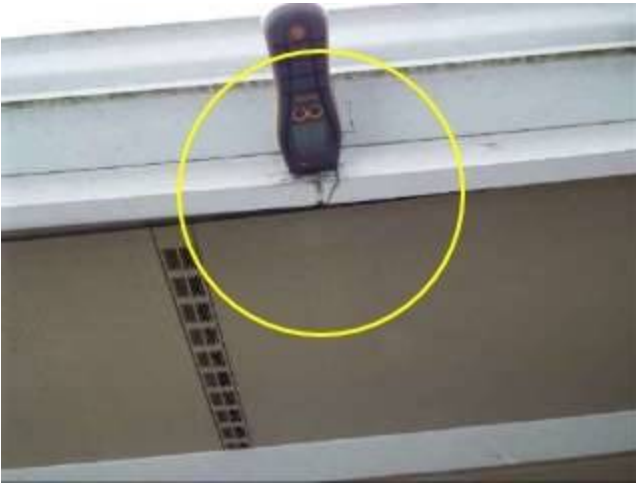
Elevated moisture levels consistent with water from roof finding its way behind the gutter was found at fascia. Conductive conditions for rot should be corrected (e.g. wood-soil contact, reverse perimeter slope). I recommend that a qualified contractor repair as necessary. All rotten wood should be replaced.

Photo 14-1
On south side of house

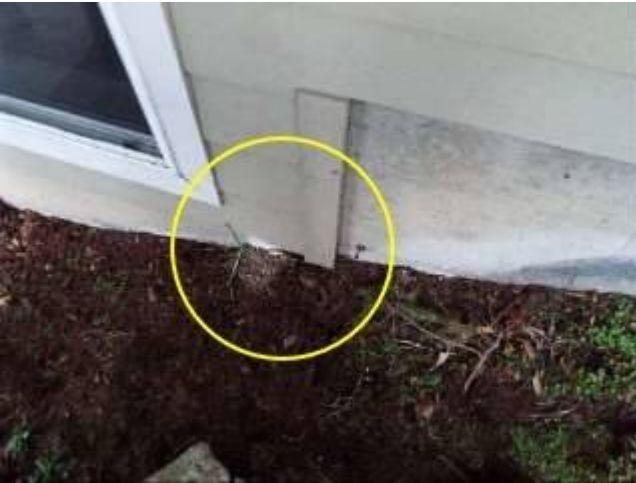
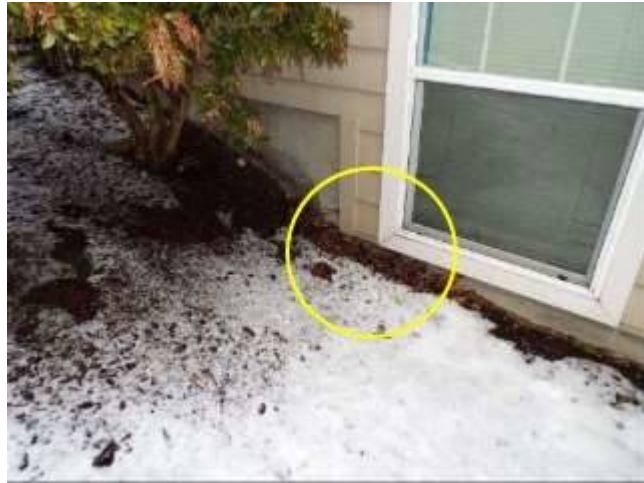
Soil was in contact with or less than 6 inches from siding. This condition is conducive to attracting wood-destroying organisms. I recommend grading or removing soil as necessary to maintain a 6-inch clearance. If that's not possible, have a qualified person replace untreated wood with rot resistant pressure-treated lumber. Since even pressure-treated materials can eventually decay, plan to periodically check the condition of any wood that is in contact with earth. Note that damage from fungal rot and/or insects may be discovered when soil is removed, and further repairs and wood replacement may be necessary.

Photo 15-1
South side of house

Photo 15-2
West side of house

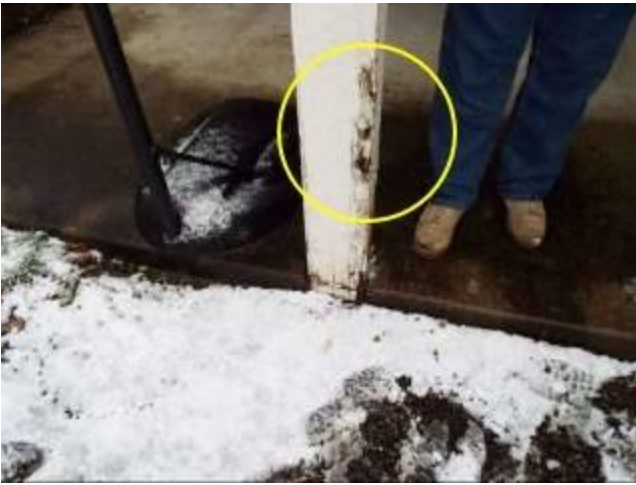
Fungal rot was found in support posts under backyard deck on south side of house. Can create unstable support and safety concern. I recommend that a qualified person repair as necessary. All rotten wood should be replaced.

Photo 16-1
Under backyard deck

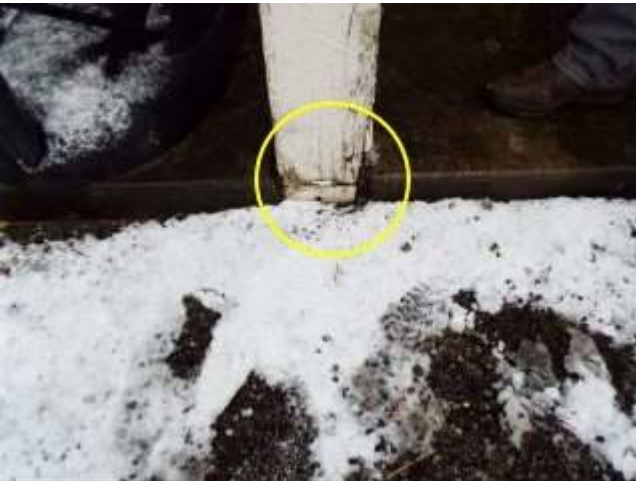
Soil was in contact with wooden deck support posts. This is a condition conducive to attracting wood-destroying organisms. Even if posts are made of treated wood, the cut ends below soil may not have been field treated. I recommend grading soil or repairing as necessary to prevent wood-soil contact.

Photo 17-1
South side post under deck

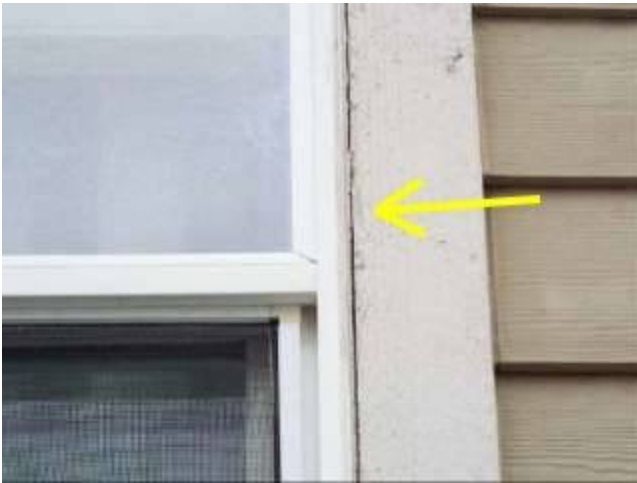
Photo 18-1

Caulk was deteriorated around numerous windows. This can be an avenue for water into the house causing rot. I recommend that a qualified person renew or install caulk as necessary. Where gaps are wider than 1/4 inch, an appropriate material other than caulk should be used. For more information, visit: <http://www.reporthost.com/?CAULK>

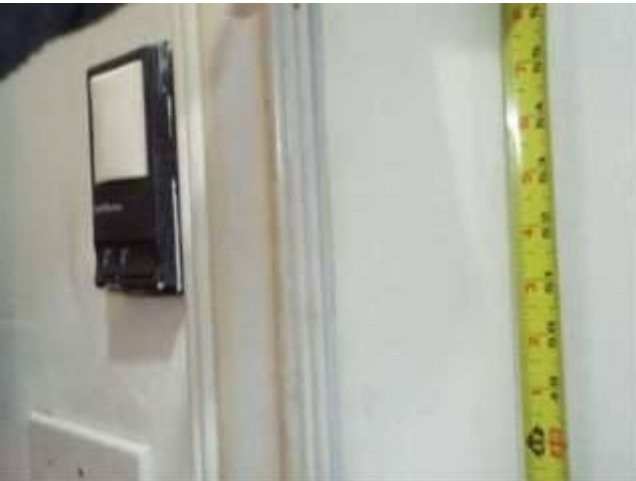
Photo 20-1

The wall-mounted control for the automatic garage vehicle door opener was less than 5 feet off the floor. This is a safety hazard -- children should not be able to operate automatic garage vehicle doors. A qualified person should relocate controls for door openers so they are at least 5 feet above floors and/or out of reach of children.

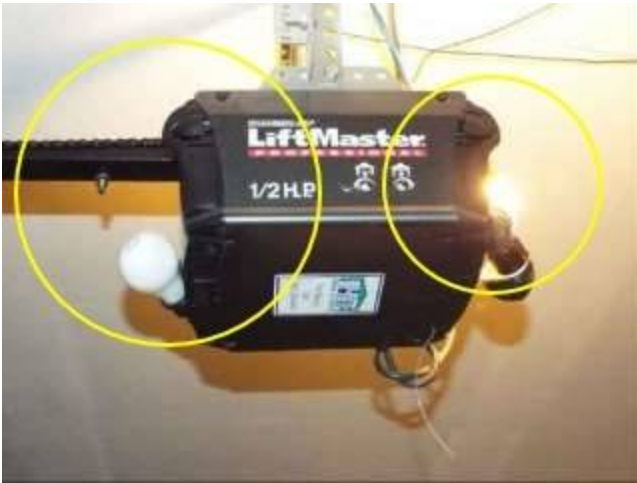
An automatic vehicle door opener was missing covers over light fixtures. Covers are located in the attic space above garage. They may interfere with the location beams for when the car is in the garage far enough. I recommend that a qualified contractor evaluate and repair or replace opener(s) as necessary.

Photo 21-1
Missing covers

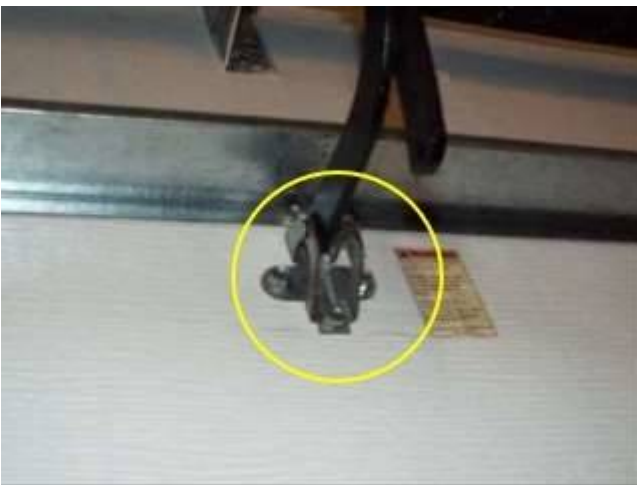
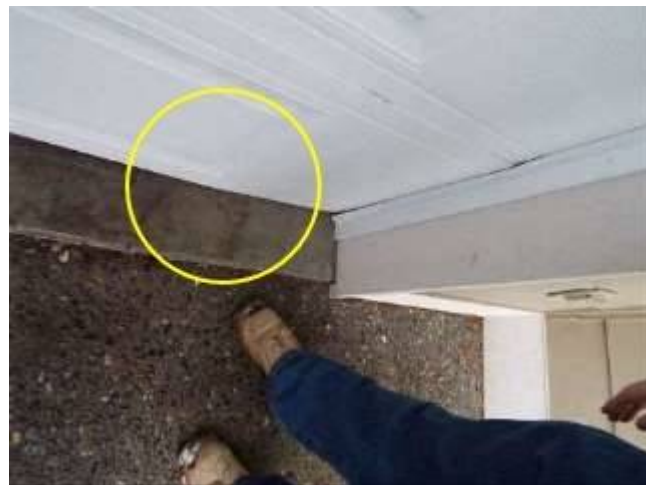
A garage vehicle door cracking and bent. Can cause a safety concern if bracket breaks. I recommend that a qualified contractor door(s) as necessary.

Photo 22-1
Bracket pulling and cracking garage door

Photo 22-2
Garage door bent

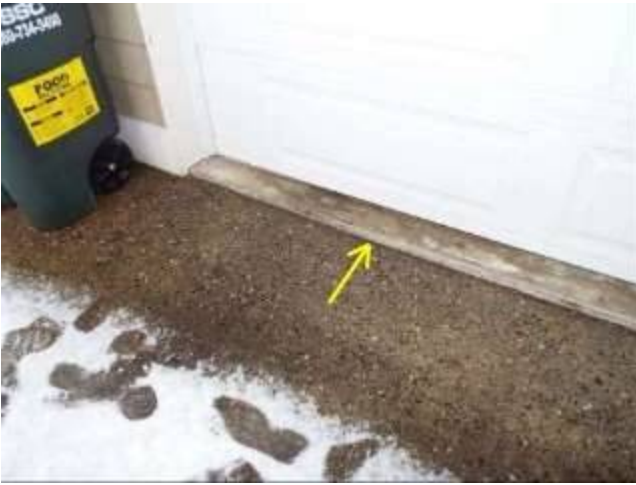
23) Uneven concrete between driveway and garage poses a possible trip hazard. Recommend licensed contractor to assess for possible remedies.

Photo 23-1
Lip in front of garage

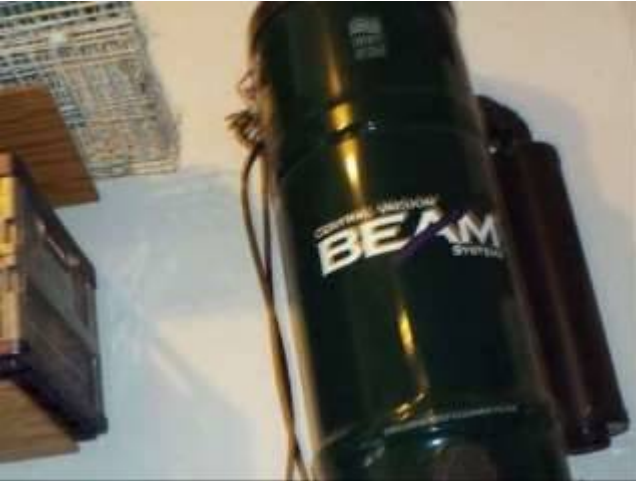
24) Home built-in vacuum system inoperable per owners of home. Did not inspect.

Photo 24-1
Main unit located in garage

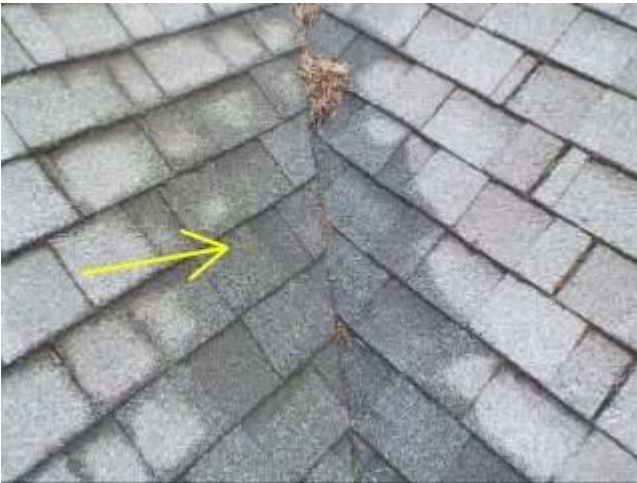
Photo 25-1

The roof appears to be near the end of its service life and it will likely require replacement in the near future. Several shingles are missing their granules that can make water assessable to penetration into the attic causing rot. I recommend discussing repair/replacement options with a qualified contractor.

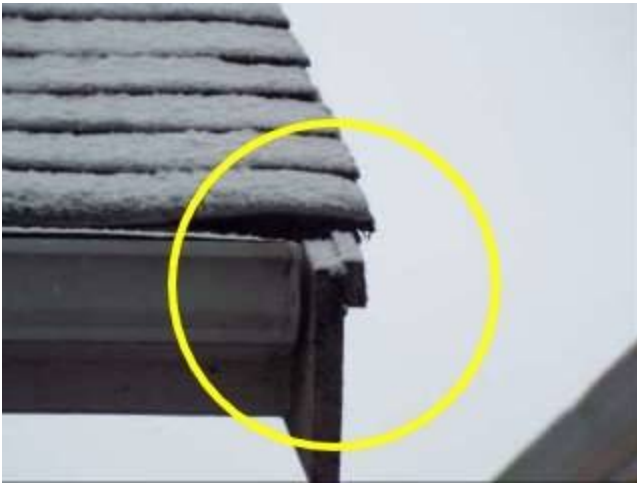
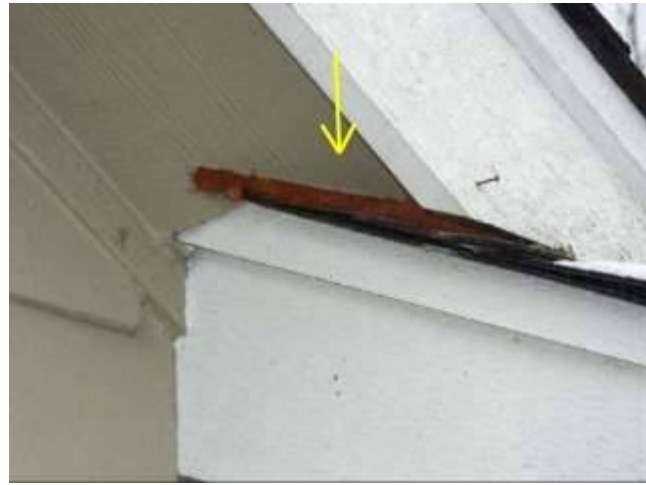
Gaps between shingles and joists were found in the flat or low-slope roof surface at seams. Leaks can occur as a result. This is a condition conducive to attracting wood-destroying organisms. I recommend that a qualified contractor repair as necessary.

Photo 27-1
South east corner of roof

Photo 27-2
Front of house

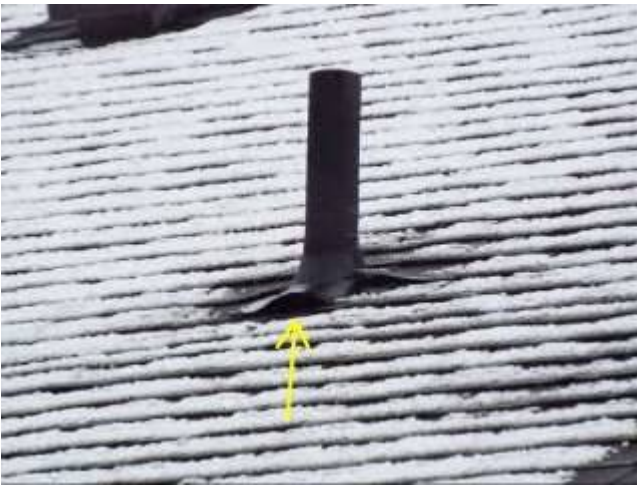
Roof flashings around vent was lifting. Leaks can occur as a result. This is a condition conducive to attracting wood-destroying organisms. I recommend that a qualified person repair as necessary.

Photo 28-1
South side of roof

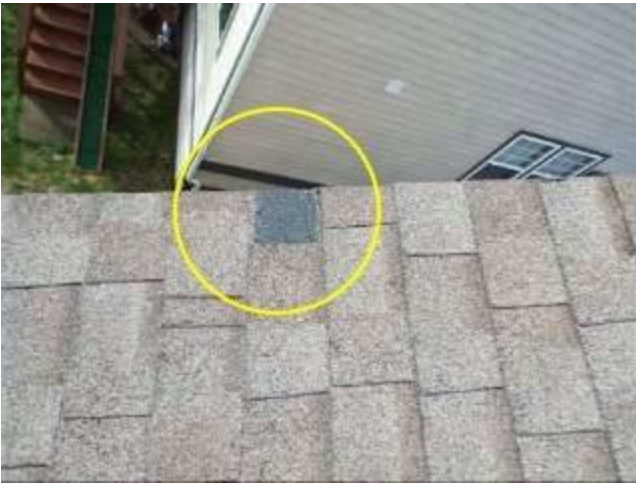
**Photo 29-1**

Missing shingle that can cause leaks into attic. This is a condition conducive to attracting wood-destroying organisms. I recommend that a qualified contractor repair as necessary.

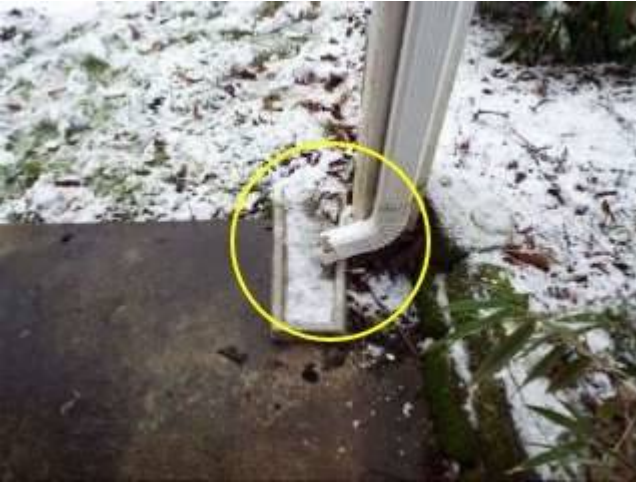
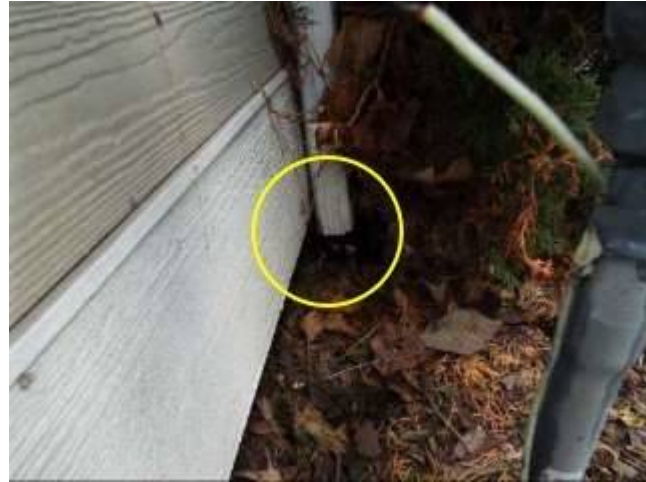
Downspout extensions such as splash blocks or drain pipes were missing and damaged. Water can accumulate around the building foundation or inside crawl spaces or basements as a result. I recommend that a qualified person install, replace or repair extensions as necessary so rainwater drains away from the structure.

**Photo 30-1**

South west corner under deck

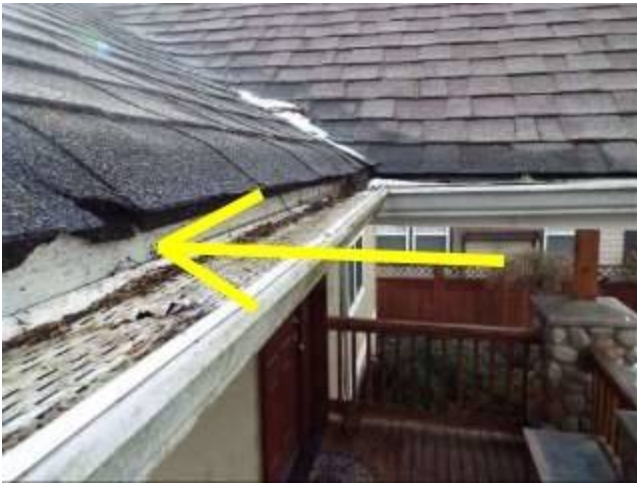
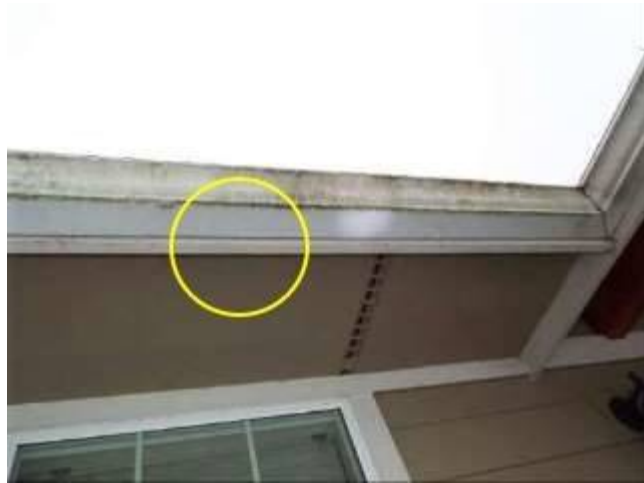
Flashings between shingles and the roof was missing. Leaks can occur as a result. This is a condition conducive to attracting wood-destroying organisms. I recommend that a qualified person repair as necessary.

Photo 31-1
Lack of flashing from roof to gutter

Photo 31-2
Water leaking behind gutter

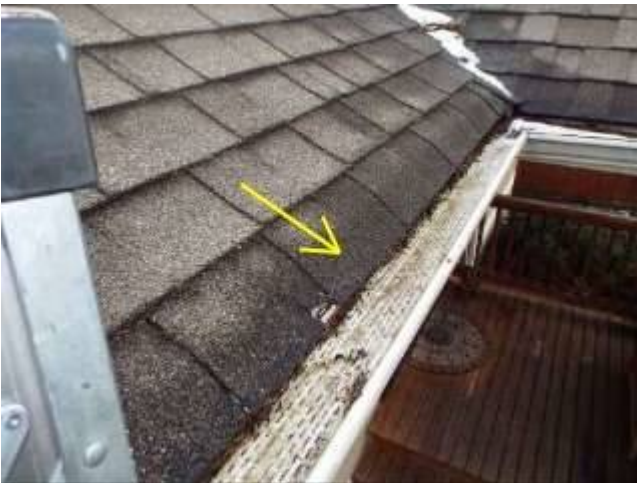
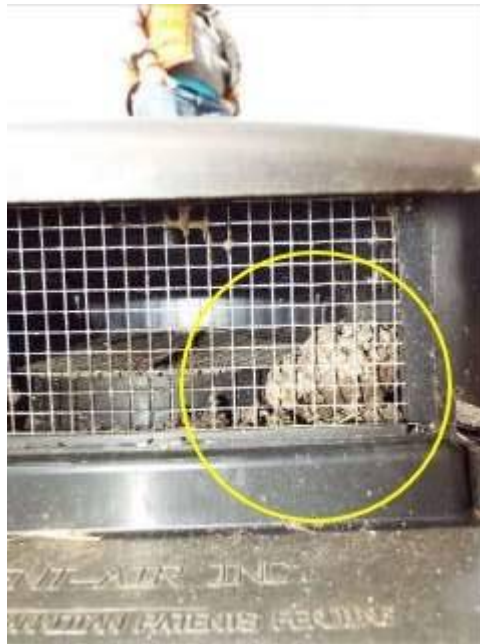
Debris such as leaves, needles, etc. have accumulated on the roof gutter covers and roof vents at numerous areas. Water may not readily drain from the roof. Therefore, seepage is possible. This is conducive to attracting wood-destroying organisms. I recommend cleaning debris from the roof now and as necessary in the future. Work to be completed by qualified person.

Photo 32-1
Debris in front of house

Photo 32-2
South side of roof in vent

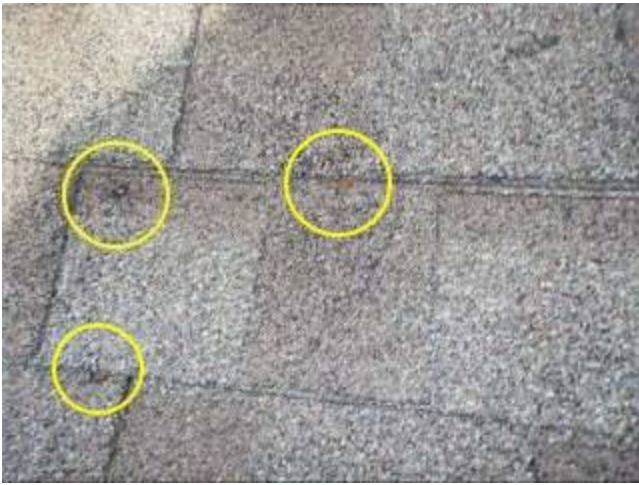
Nail heads were exposed at some of the shingles on the South side of the roof. More than just a few exposed nail heads may indicate a substandard roof installation. I recommend applying an approved sealant over exposed nail heads now and as necessary in the future to prevent leaks. Work to be completed by qualified person.

Photo 33-1
South side of roof

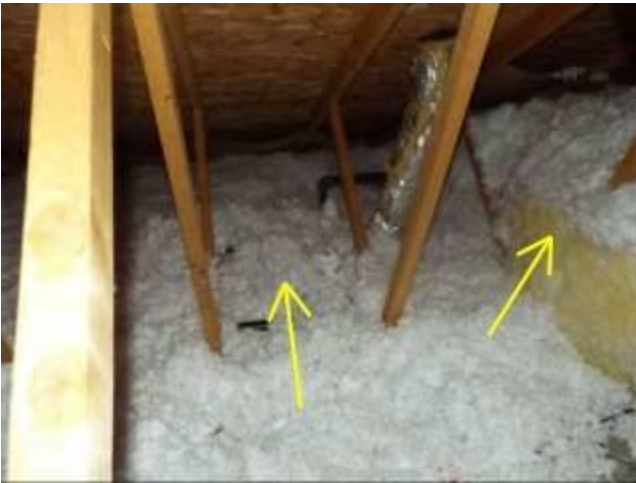
36) 🧰 The ceiling insulation in some attic areas was compacted or uneven. This reduces energy efficiency. I recommend that a qualified person repair, replace or install insulation as necessary and per standard building practices (typically R-38).

Photo 36-1
Attic

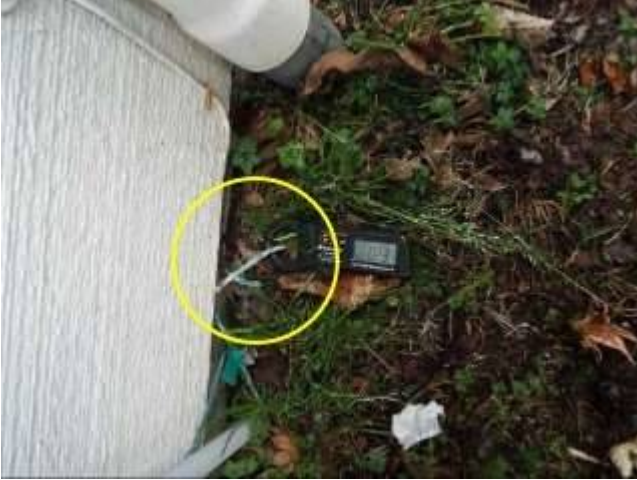
Grounding at an electric sub-panel appeared to be substandard. This is a safety risk. I recommend that a qualified electrician evaluate and repair if necessary.

Photo 37-1
East side of house

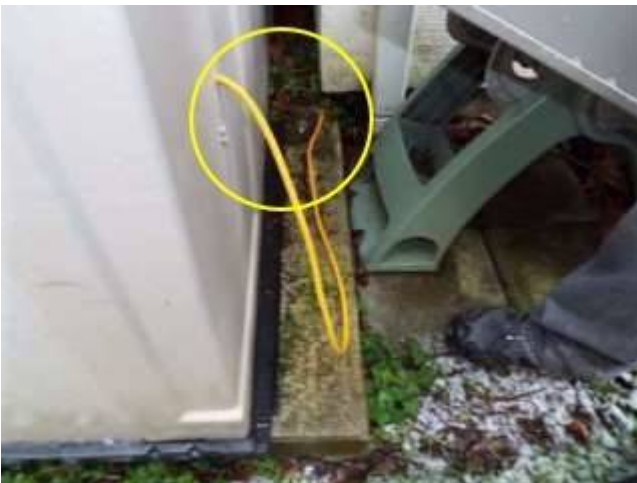
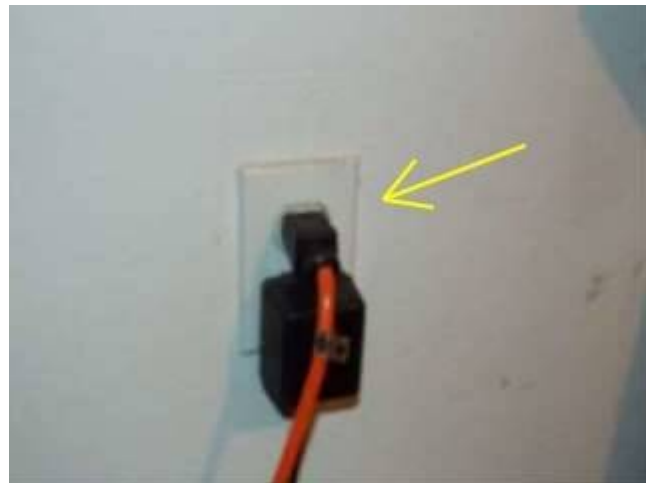
Extension cords were being used as permanent wiring. They should only be used for portable equipment on a temporary basis. Using extension cords as permanent wiring creates a safety hazard and indicates that wiring is inadequate and needs to be updated. Extension cords may be undersized. Connections may not be secure resulting in power fluctuations, damage to equipment, overheating and sparks that could start a fire. I recommend that a qualified electrician repair per standard building practices and eliminate extension cords for permanently installed equipment.

Photo 38-1
South East corner of house

Photo 38-2
South wall of Garage

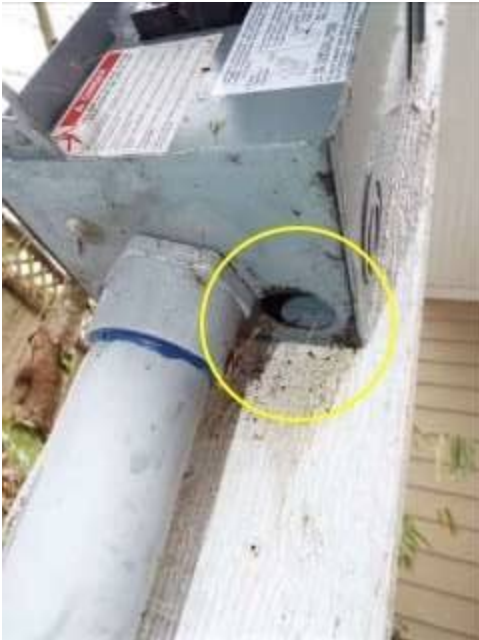
Knockout was missing from an electric panel on South West side of house. Possibly used for a spa that is no longer present. Holes in panels are a fire hazard if a malfunction ever occurs inside the panel. Also, rodents can also enter panels through holes. I recommend that a qualified person install knockout covers where missing and per standard building

Photo 39-1
South west corner of house

practices.

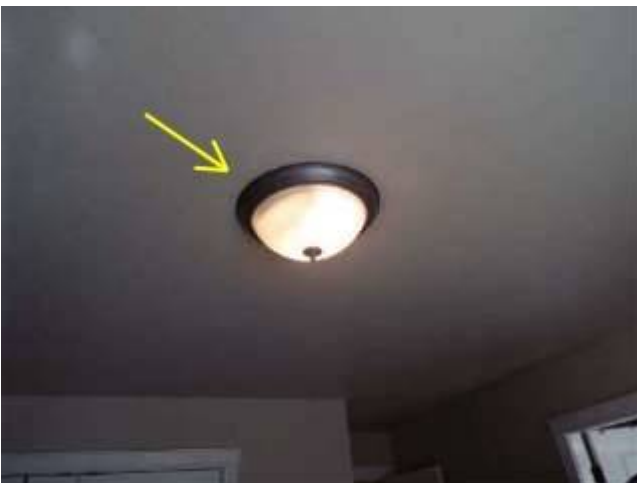
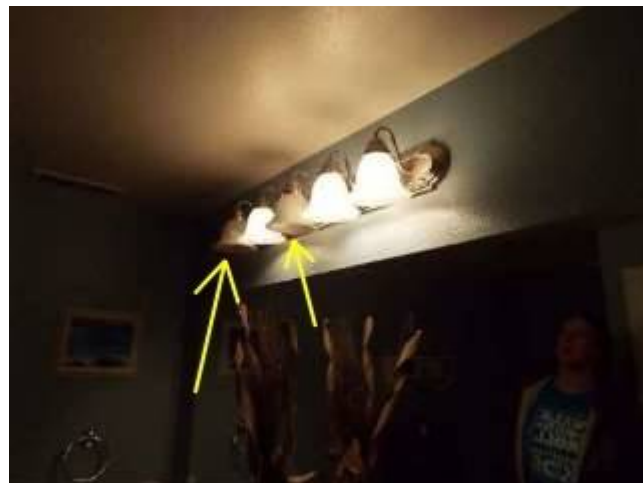
Some light fixtures were inoperable (didn't turn on when nearby switches were operated). I recommend further evaluation by replacing bulbs and/or consulting with the property owner. If replacing bulbs doesn't work and/or no other switch(es) can be found, then I recommend that a qualified electrician evaluate and repair or replace light fixtures as necessary.

Photo 41-1
Master bedroom

Photo 41-2
Master bath room

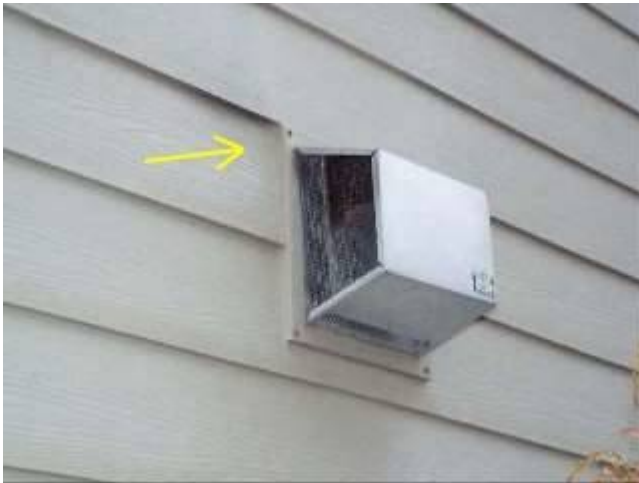
Photo 45-1

Soot or scorch marks were visible on the outside of the exterior wall above a gas fireplace vent terminations. This indicates incomplete combustion and may be caused by soot deposits on the ceramic logs or by the ceramic logs' burner ports being clogged. I recommend that a qualified specialist evaluate and perform maintenance or make repairs as necessary. The ceramic logs may need cleaning and/or repositioning. The soot on on the walls can usually be removed by washing with soap and water.

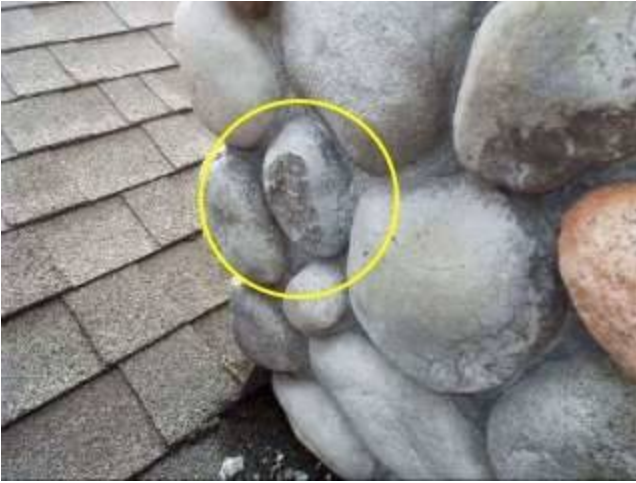
46) Faux stone spalling that can deteriorate and be prone to water leakage and rot. Recommend licensed chimney expert to assess damage and repair options.

Photo 46-1
East side of chimney

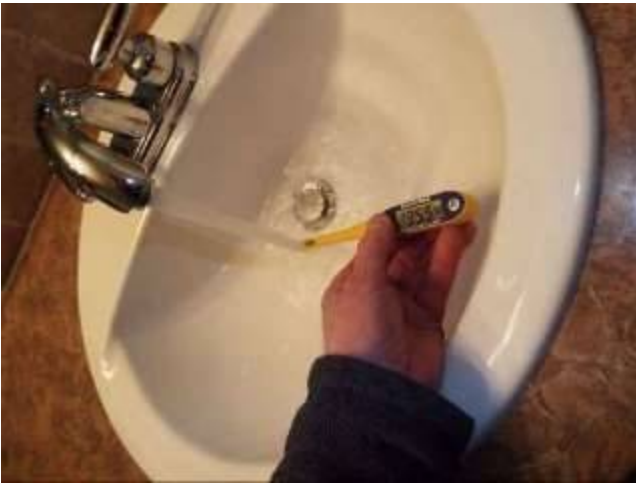
47) **+** The hot water temperature was greater than 120 degrees Fahrenheit. This is a safety hazard due to the risk of scalding. The thermostat should be adjusted so the water temperature doesn't exceed 120 degrees. If the water heater is powered by electricity, a qualified person should perform the adjustment, since covers that expose energized equipment normally need to be removed.

Photo 47-1
Basement Bath - 135.5 Degree

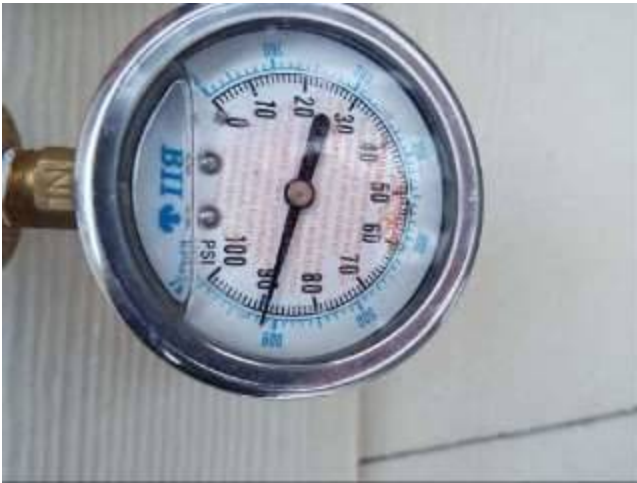
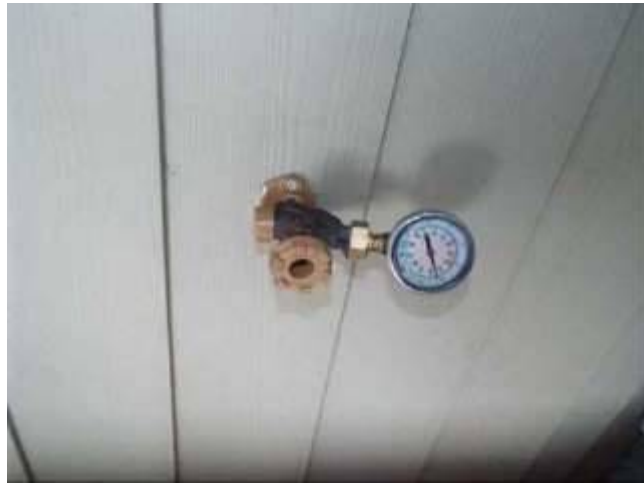
The water supply pressure was greater than 80 pounds per square inch (PSI). Pressures above 80 PSI may void warranties for some appliances such as water heaters or washing machines. Flexible supply lines to washing machines are likely to burst with higher pressures. 40-80 PSI is considered the normal range for water pressure in a home, and most plumbers suggest 50-60 PSI. Typically, the pressure cannot be regulated at the water meter. I recommend that a qualified plumber evaluate and make modifications to reduce the pressure to below 80 PSI.

Photo 48-1
Front yard - 90 PSI

Photo 48-2
Back yard - 80 PSI

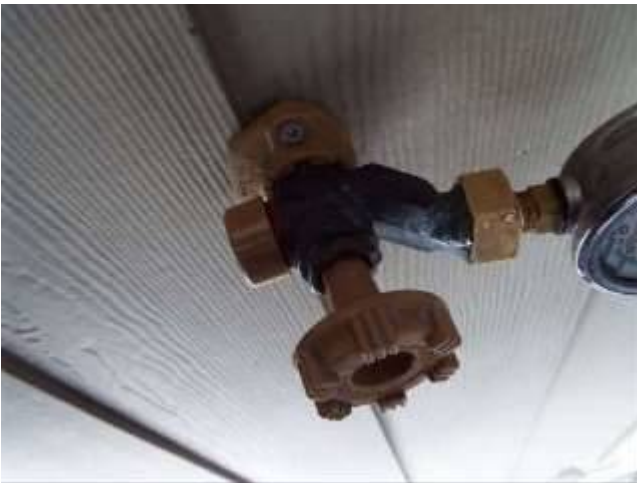
Leaks were detected in water supply fitting after it was shut off. This can cause excessive runoff against the foundation. A qualified plumber should evaluate and repair as necessary.

Photo 49-1
Front Porch

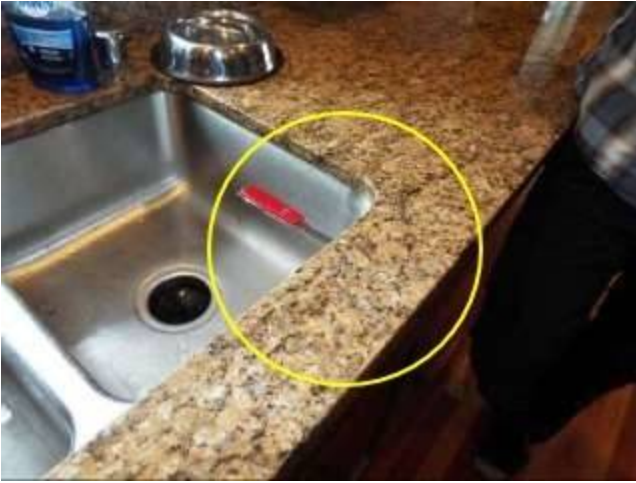
Gaps, no caulk, or substandard caulking were found around the sink. Water may penetrate these areas and cause damage. I recommend that a qualified person repair as necessary. For example, by installing caulk.

Photo 52-1
Kitchen

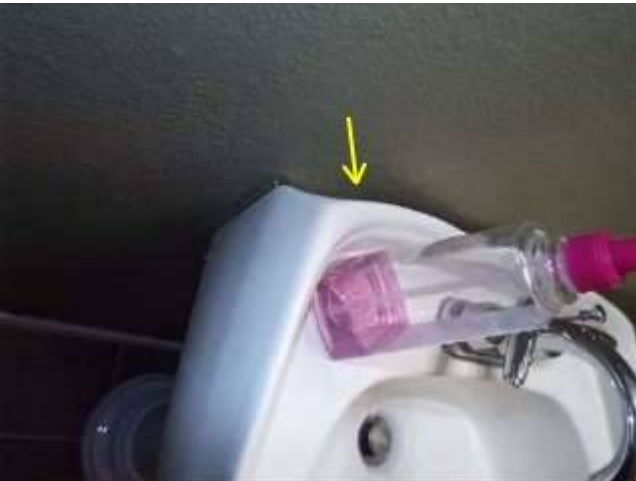
Gaps, no caulk, or substandard caulking was noted around the sink. Water can penetrate these areas and cause damage. I recommend that a qualified person repair as necessary. For example, by installing or replacing caulk.

Photo 53-1
Guest bath room on main floor

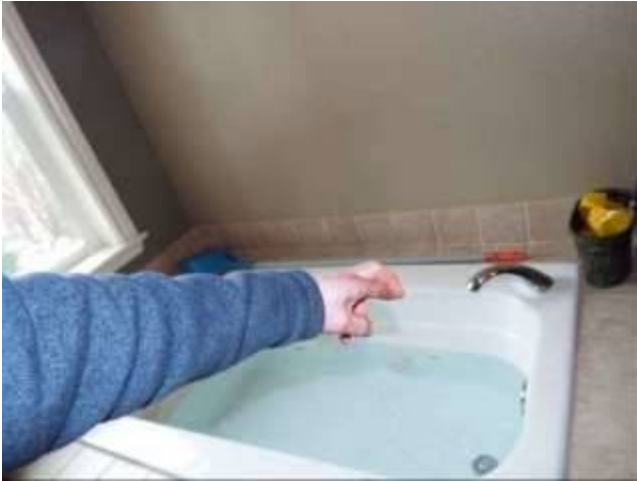
Photo 54-1

54) Master bathroom jetted tube inoperable. Can leak into inner home floor and cause rot and hold bacteria in the jets. Recommend licensed plumber assess condition and repair as necessary. Pump and associated equipment was not accessible for inspection and testing.

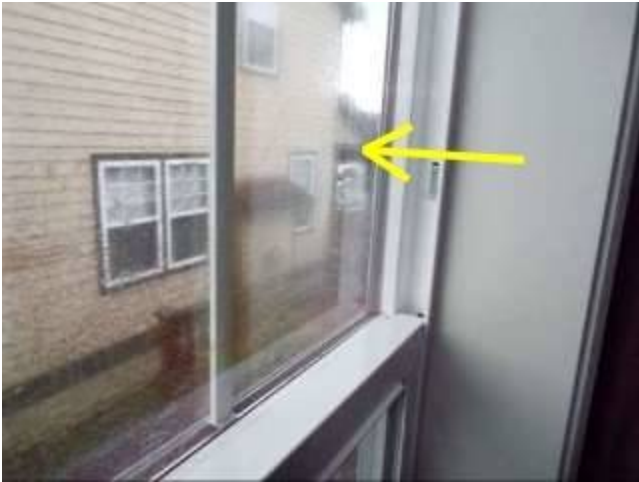
Photo 55-1

Condensation or staining was visible between multi-pane glass on two windows in the dining room. This usually indicates that the seal between the panes of glass has failed or that the desiccant material that absorbs moisture is saturated. As a result, the view through the window may be obscured, the window's U-value will be reduced, and accumulated condensation may leak into the wall structure below. I recommend that a qualified contractor evaluate and repair windows as necessary. Usually, this means replacing the glass in window frames.

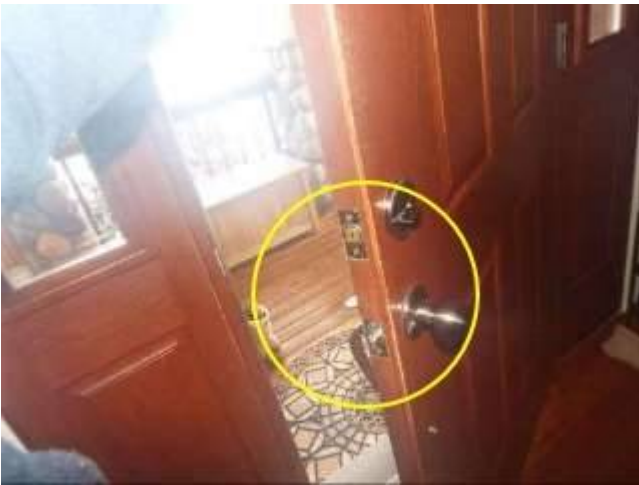
Photo 56-1

Front door doesn't have tight closures that prevents proper security. I recommend that a qualified person repair or replace as necessary.

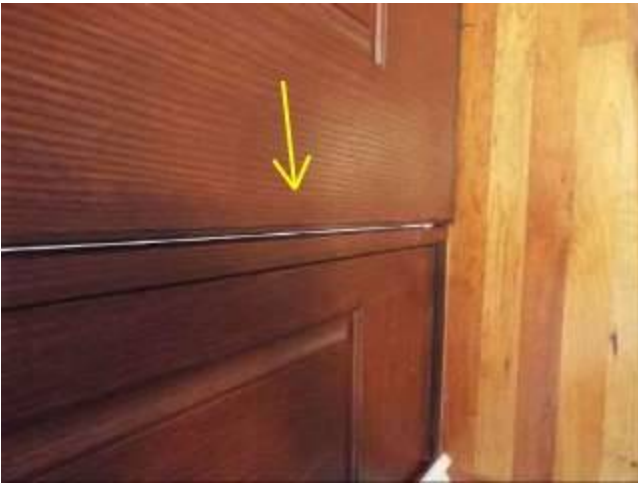
Front door has gap providing loss of heat that requires furnace to work harder causing a shorter life. Recommend licensed contractor to evaluate and repair.

Photo 57-1
Front door
