First Sergeant Inspection Services, LLC

Property Inspection Report

Property address: **123 Steele LN
Lacey, WA 98501**

Inspection date: **Wednesday, February 28, 2018**

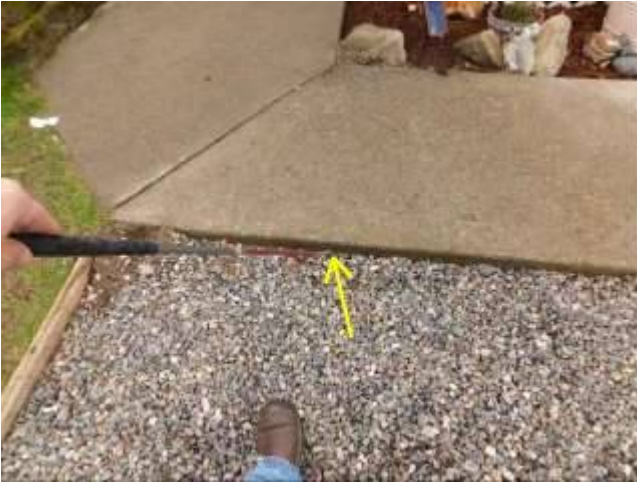
Photo 2-1

- 2) 🛠️🔧 Settlement and/or deterioration resulting in trip hazards were found in the driveway. For safety reasons, I recommend that a qualified contractor repair as necessary.

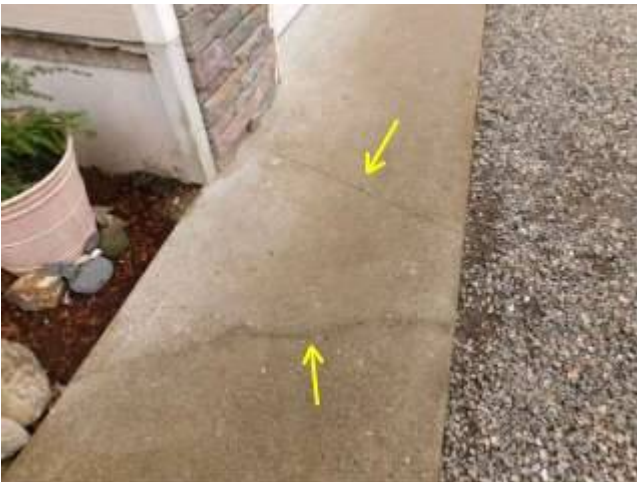
Photo 3-1

- 3) 🛠️📍 Minor cracks were found in the front of the house sidewalk, but no trip hazards were found. The client may wish to have repairs made for cosmetic reasons.

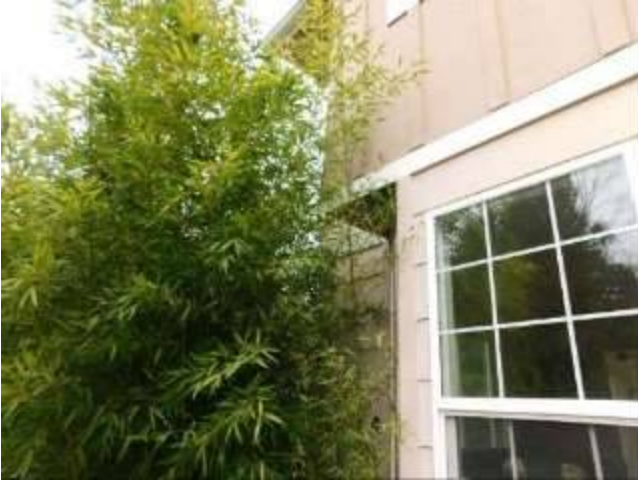
Photo 4-1

- 4) 🌳🔪 Tree was in contact with the building exterior in the front of the house. Vegetation can serve as a pathway for wood-destroying insects and can retain moisture against the exterior after it rains. This is a condition conducive to

attracting wood-destroying organisms. I recommend pruning, moving or removing vegetation as necessary to maintain at least 6 inches of space between it and the building exterior. A 1-foot clearance is better.

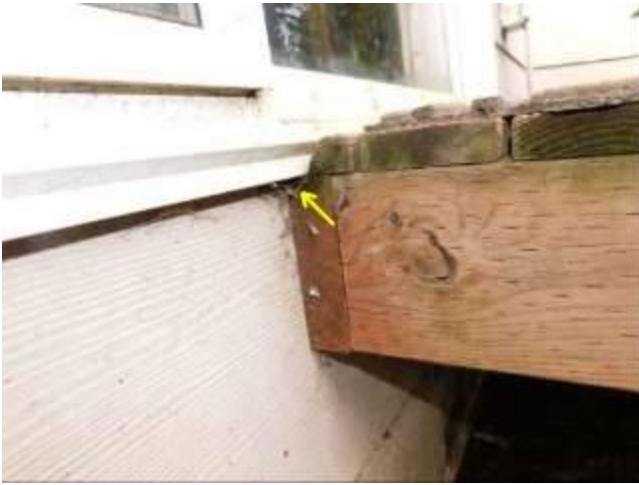
Photo 5-1

Flashing was missing from all three (3) landings. Missing flashing at this location can cause moisture to accumulate between the ledger boards and the building. Fungal rot may occur in this area and cause the ledger board fasteners to fail. The deck may separate from the building in this event. This is a potential safety hazard. I recommend that a qualified contractor install flashing above ledger boards per standard building practices.

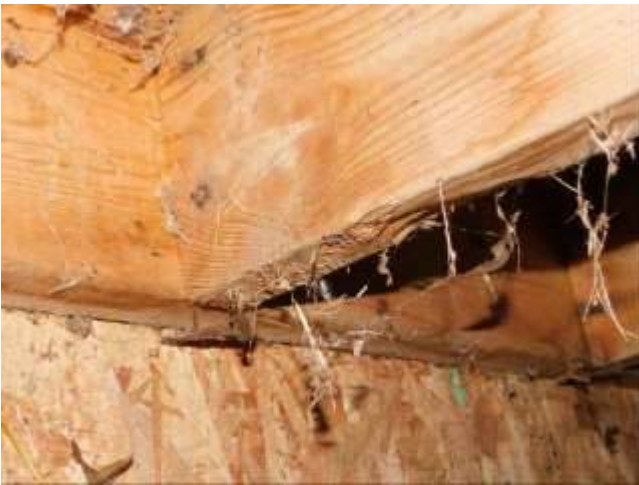
Photo 6-1

All three (3) landings and the south side cover were unstable due to substandard bracing to the main building. This is a safety hazard since severe movement may cause the cover to collapse. A qualified contractor should repair as necessary.

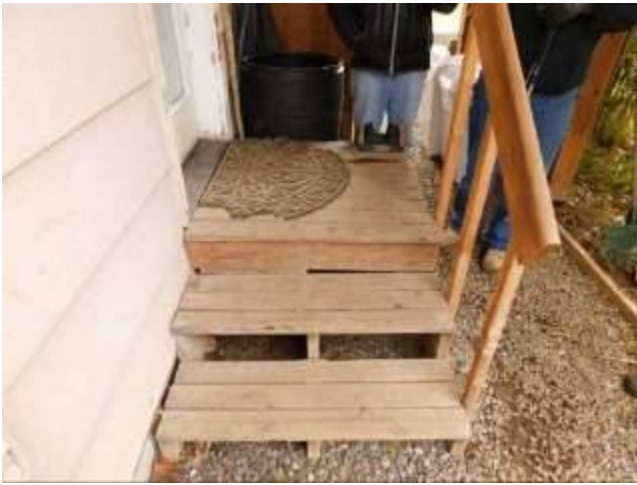
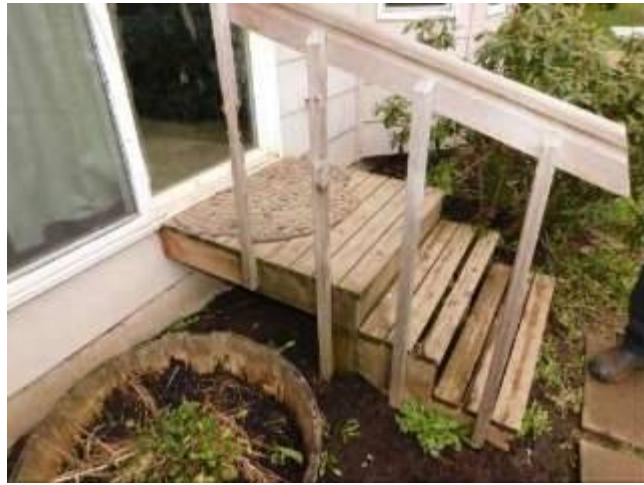
Handrails at exterior flights of stairs were loose and/or wobbly. This is a safety hazard. I recommend that a qualified person repair as necessary.

Photo 7-1
South side

Photo 7-2
East side

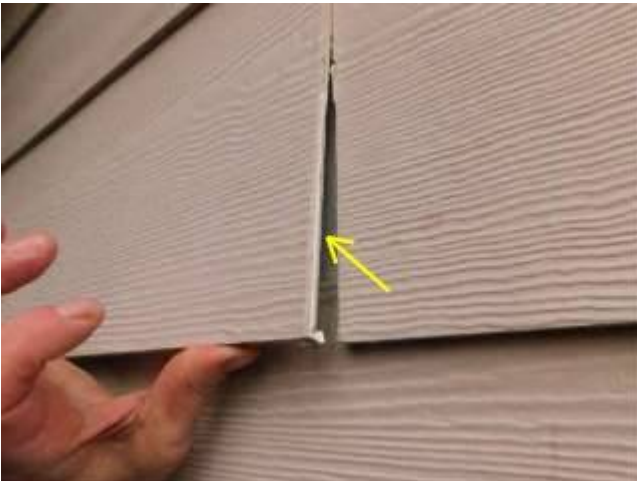
Photo 8-1

-
- 8) 🛠️ Flashing was missing behind butt joints. Water can get behind siding and deteriorate the sheathing. I would recommend maintaining caulking at butt joints, alternatively, qualified siding contractor to install flashings where necessary as per manufacturer recommendations.

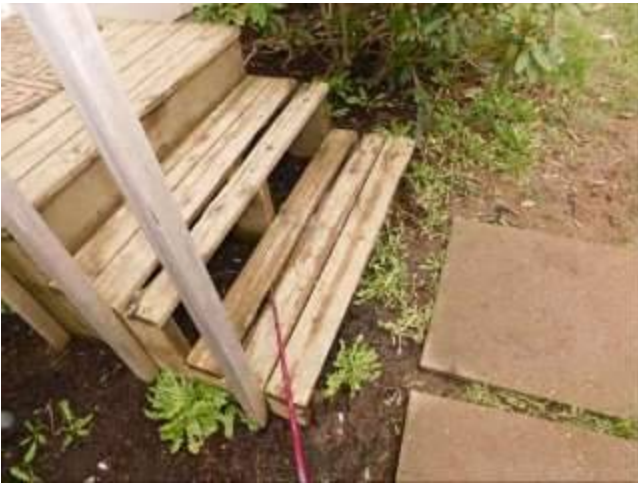
**Photo 9-1**

-
- 9) 🔍 Fungal rot was found in treads at east side exterior stairs. Fungal rot in some stair components may pose a safety hazard. I recommend that a qualified person evaluate and repair as necessary. All rotten wood should be replaced.

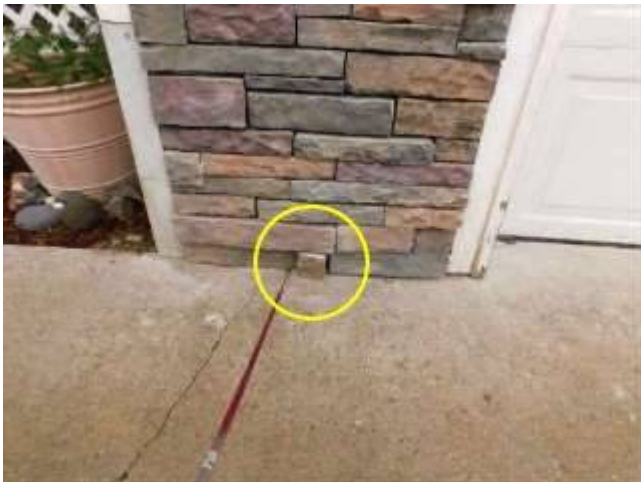
**Photo 10-1**

One of the stones is loose at the base and they were not installed as per manufactures specifications. There should be a gap at the base, some kind of a drip screed. Moisture/condensation will occur behind the stones in the water needs to escape at the base. I recommend reattaching the loose stone, and monitor.

Soil was in contact with or less than 4 inches from brick, stone or faux stone veneer in front of the house around garage door. For most residential installations of this type of veneer, this is a condition conducive to attracting wood-destroying organisms. Weep holes may be covered. Condensed water behind the veneer may not be able to escape, and moisture can accumulate in the wood structure behind. I recommend grading and/or removing soil as necessary to maintain a 4-inch clearance.

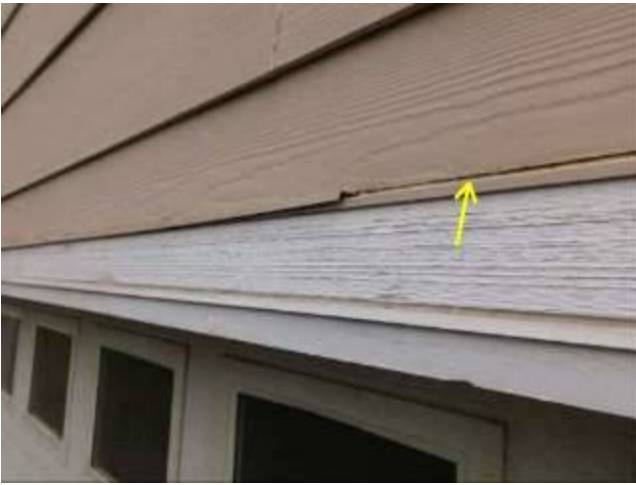
**Photo 11-1**

Siding material was placed directly in contact with the flashings. The intended purpose of the flashing is to collect and shed any water that occurs behind the siding. With no gap between siding and flashing, the intended function of the flashing has been significantly restricted. Ideally, a quarter inch gap would be visible and left on caulked. I recommend maintain caulking and monitor for future damage or decay.

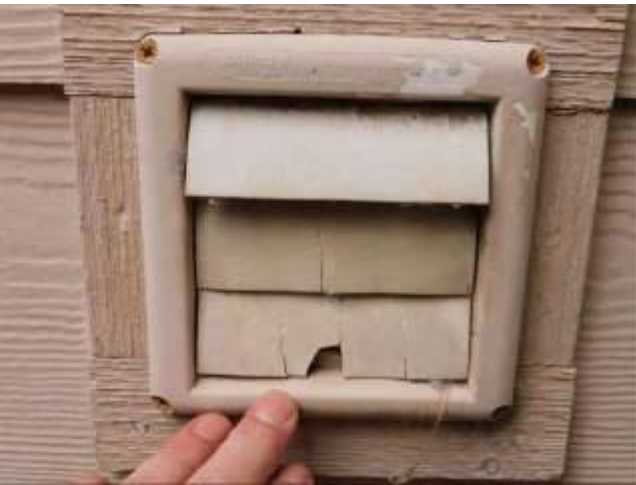
**Photo 12-1**

Exhaust vent back draft damper was damaged. The purpose of the back draft dampers is to prevent unconditioned air from entering the building. Blocked ducts can cause fan motors and/or clothes dryers to overheat and can pose a fire hazard. I recommend that a qualified person clean, repair or replace caps as necessary.

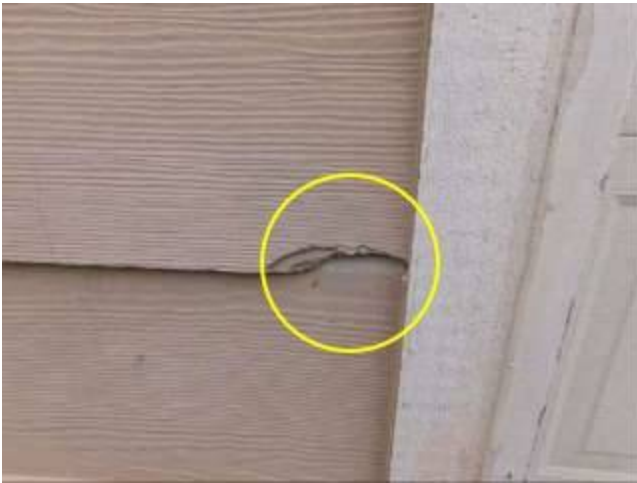
Photo 13-1

Some sections of siding was damaged. I recommend that a qualified person repair, replace or install siding or trim as necessary.

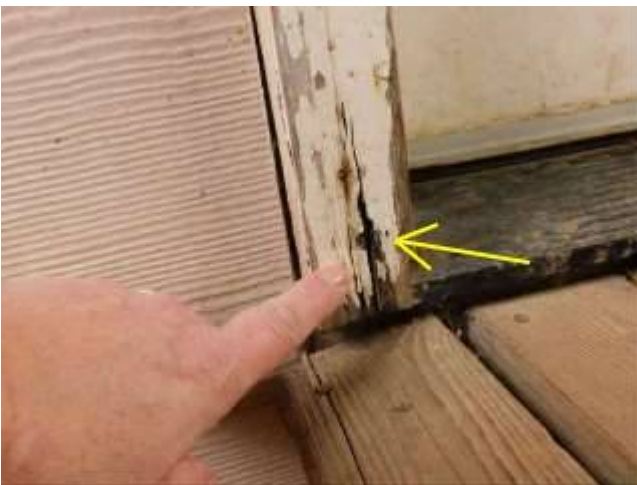
Photo 14-1

Fungal rot was found at sections of trim. Conducive conditions for rot should be corrected. I recommend that a qualified contractor repair as necessary. All rotten wood should be replaced.

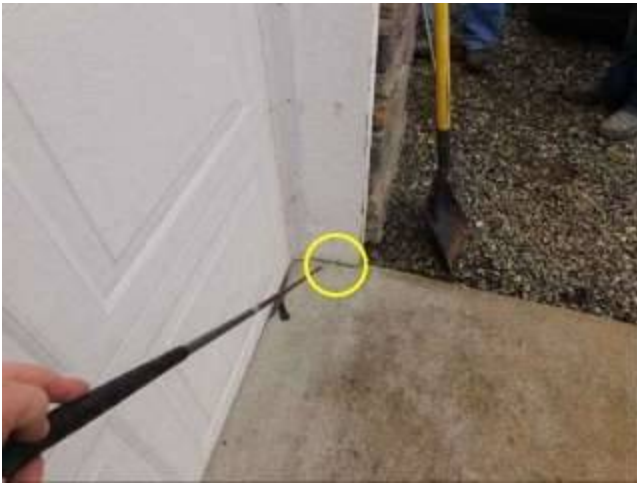
Untreated wood trim was in contact with concrete around the west and the garage entry door at the South side has wood trim and was in direct contact with soil. Moisture collected between the two materials or wicking up into the wood is a condition conducive to attracting wood-destroying organisms. Wood siding or trim should be installed with a minimum clearance of 1-2 inches between it and concrete or masonry below it at building exteriors. Monitor these areas for rot or infestation in the future and repair if needed. I recommend that a qualified person repair per standard building practices. For example, by trimming siding or trim as needed.

Photo 15-1
West side

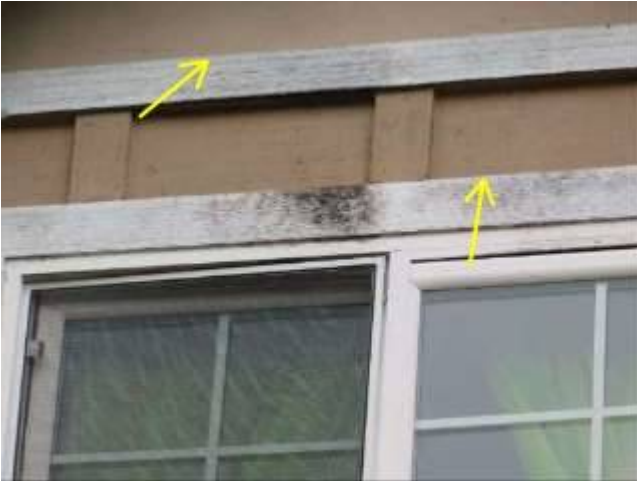
Photo 16-1

Flashings were installed sporadically and missing at some weather exposed locations. Better building practices call for such flashings, which greatly reduce the chance of leaks above windows and doors. Without this flashing, caulk and paint must be maintained or water can enter the wall structure and cause rot and possible structural damage. Depending on the exposure (e.g. roof overhang, height of exterior wall, direction of prevailing rain) this may or may not be an issue. The client should monitor these areas in the future and maintain caulk and paint as necessary. Consult with a qualified contractor about installing flashings where needed, and per standard building practices. Note that when trim or siding is removed to install flashing, damaged wood may be found and additional repairs may be needed.

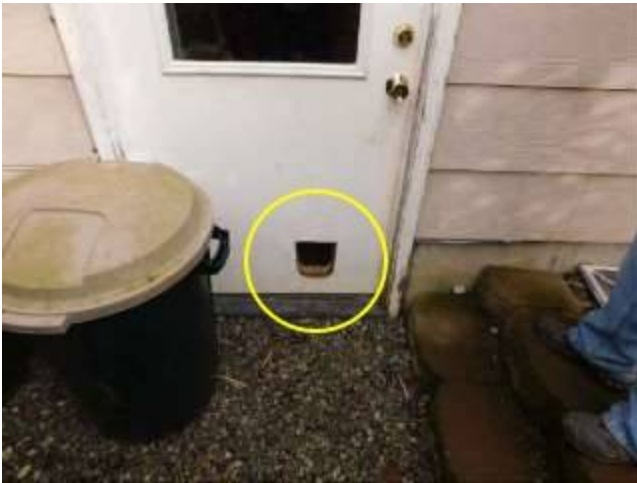
**Photo 17-1**

A open hole was found in the south side garage door. Vermin, insects or water may enter the structure. I recommend that a qualified person repair as necessary.

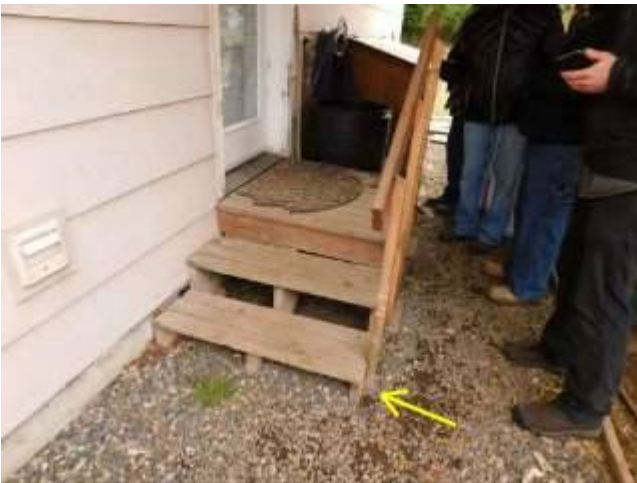
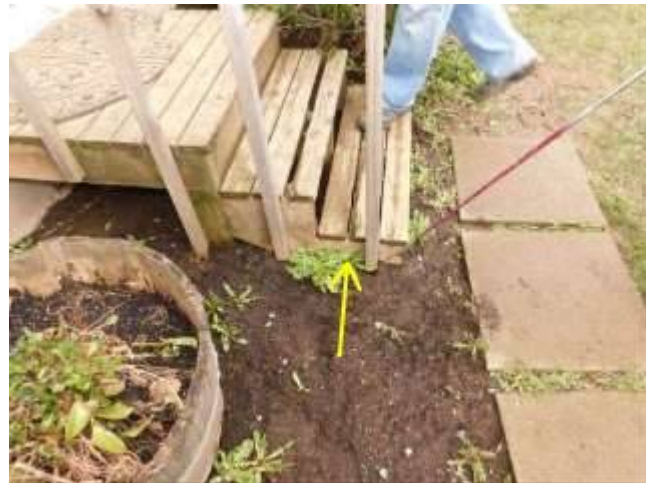
18) 🪛 Soil was in contact with wooden stairs at east and south side of house. This is a condition conducive to attracting wood-destroying organisms. Soil should be graded and/or removed so as to eliminate wood to soil contact. Any work to be completed by qualified individual.

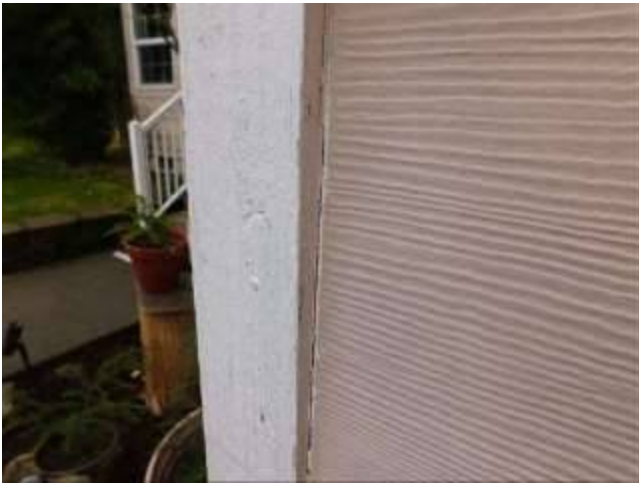
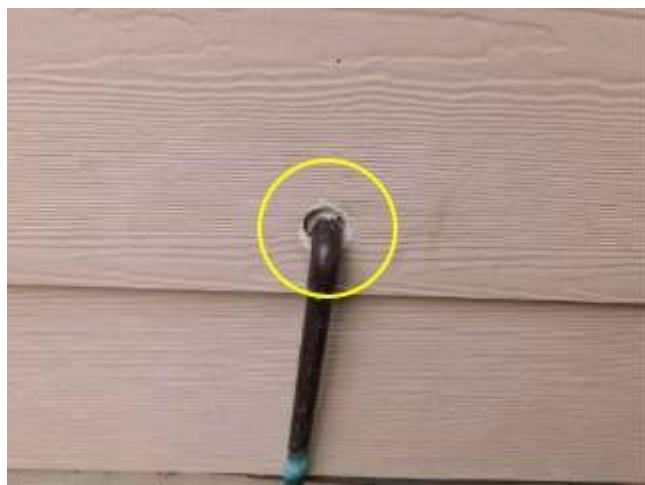
19) 🪛 Caulk was missing and/or deteriorated in some areas. For example, around windows, around doors and/or at siding butt joints. I recommend that a qualified person renew or install caulk as necessary. Where gaps are wider than 1/4 inch, an appropriate material other than caulk should be used. For more information, visit: <http://www.reporthost.com/?CAULK>

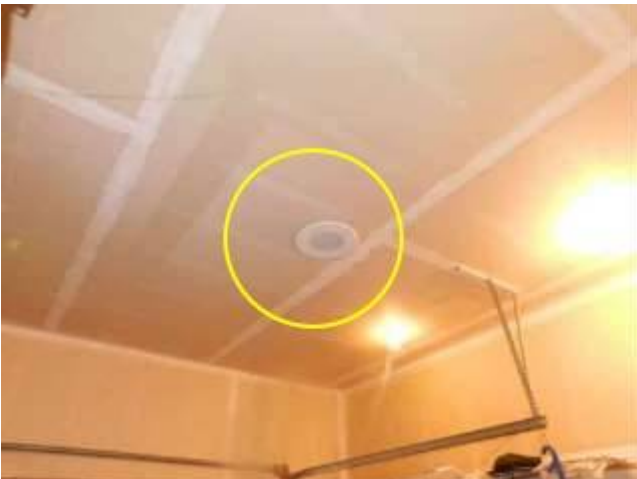
Photo 20-1

There were breaches in the fire resistance at the wall adjacent to the dwelling, speaker/intercom in the ceiling, and overall, fire resistance cannot be fully evaluated at this garage due to significant amounts of personal belongings, stored items. Much of the garage is excluded due to visual limitations. Standard building practices call for wooden-framed ceilings and walls that divide the house and garage to provide limited fire-resistance rating to prevent the spread of fire from the garage to the house. I recommend that a qualified person repair per standard building practices. For example, by patching openings or holes, firestopping holes or gaps with fire-resistant caulking, and/or installing fire-resistant wall covering (e.g. Type X drywall).

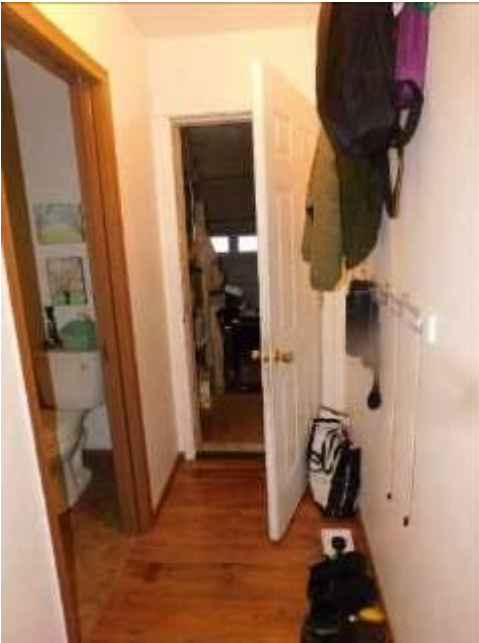
Photo 21-1

The door between the garage and house did not close and latch on its own. The door did have adjustable spring hinges, I would recommend qualified party to adjust as necessary.

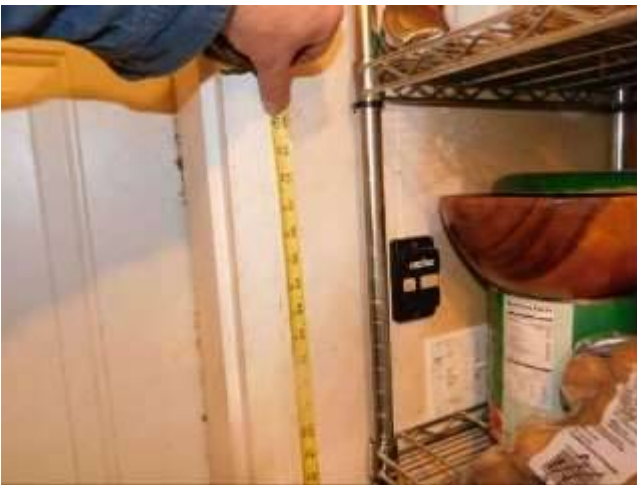
Photo 22-1

The wall-mounted control for the automatic garage vehicle door opener was less than 5 feet off the floor. This is a safety hazard -- children should not be able to operate automatic garage vehicle doors. A qualified person should relocate controls for door openers so they are at least 5 feet above floors and/or out of reach of children.

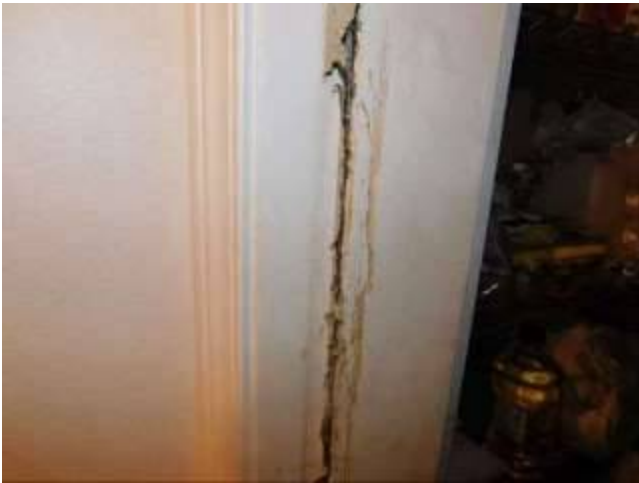
Photo 23-1

Weatherstripping around or at the base of the door between the garage and the house was damaged. House to garage doors should prevent fire and fumes from spreading from the garage to the house. Weatherstripping should form a seal around this door. This is a potential safety hazard. I recommend that a qualified person replace or install weatherstripping as necessary.

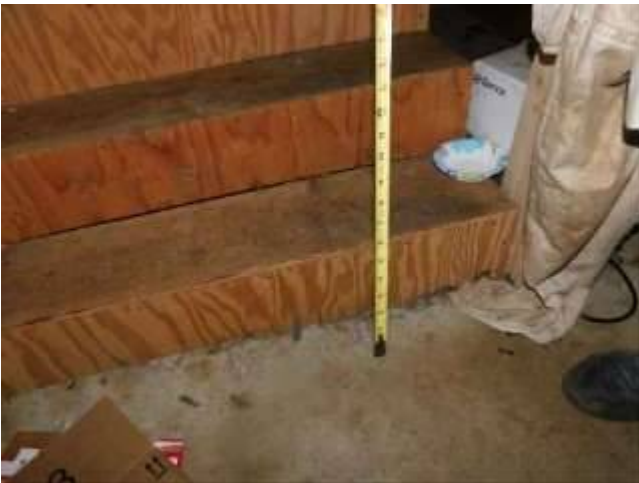
Photo 24-1

24) 🚑🔧 The steps varied in heights and missing hand rail. This is a trip and fall hazard. A qualified person should repair as necessary.

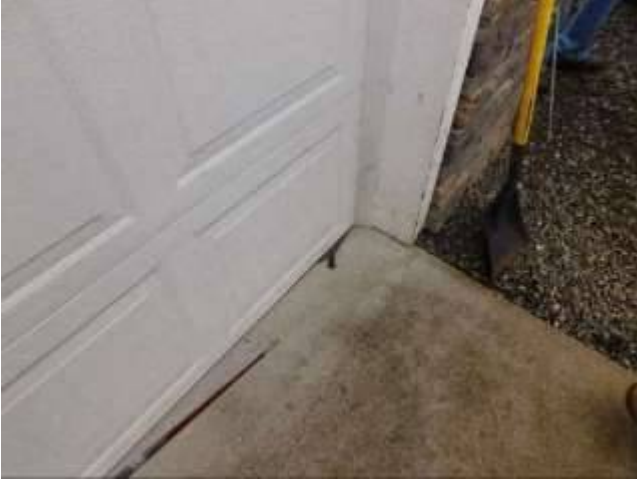
Photo 25-1

Significant gaps were found below the garage vehicle doors. Vermin and insects can enter the garage as a result. I recommend that a qualified person repair as necessary to eliminate or minimize gaps.

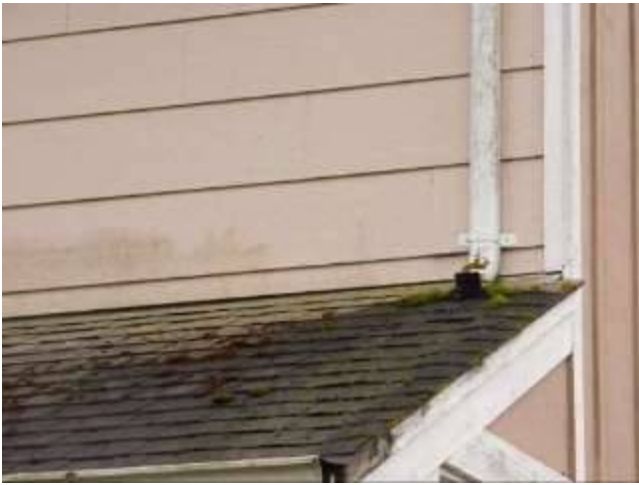
Photo 26-1

Moss was growing on the roof due to the upper downspout is dumping on lower roof surface, prematurely deteriorating asphalt shingles. Better building practices would recommend a continual downspout to the lower gutter to prevent premature damage of the surrounding roof surface. I recommend a qualified person evaluate, clean, and repair as necessary.

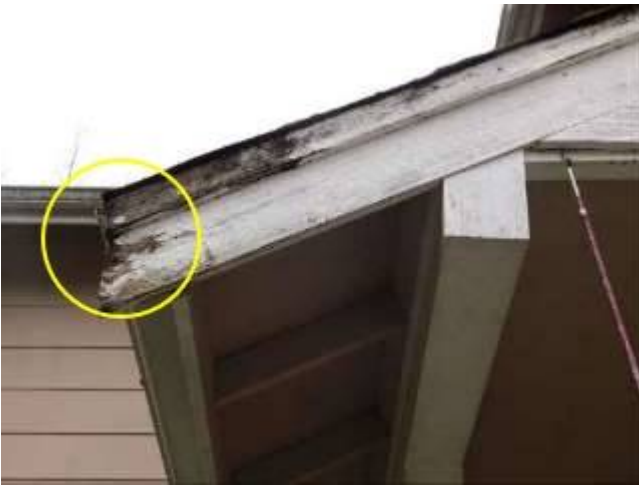
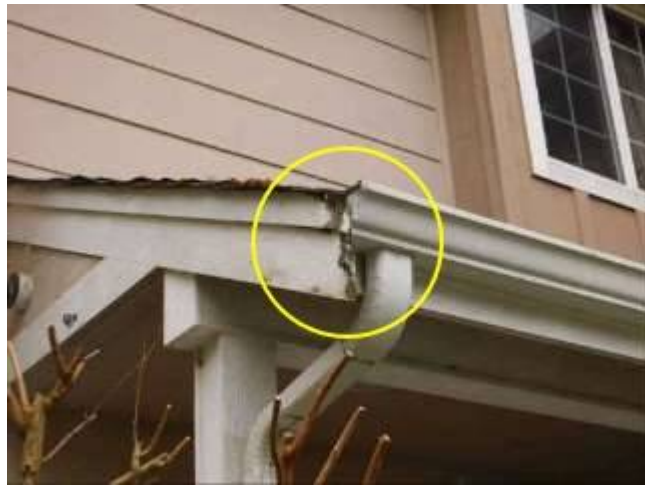
Fungal rot was found at roof areas near rafter tails. I recommend that a qualified contractor repair as necessary. For example, by replacing all rotten wood, priming and painting new wood and installing flashing.

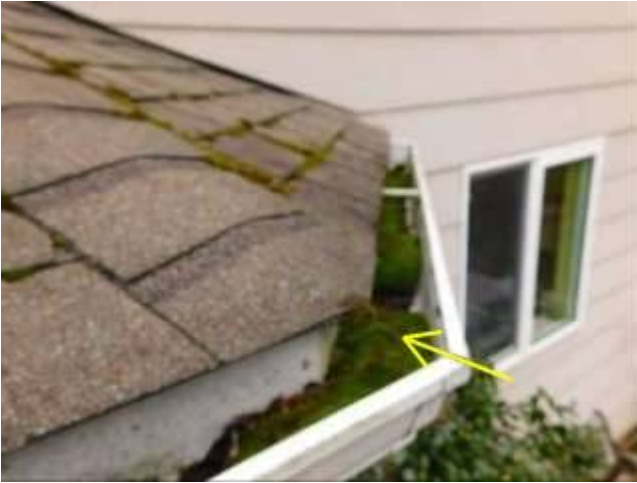
Photo 28-1

Significant amounts of debris have accumulated in gutters or downspouts. Gutters can overflow and cause water to come in contact with the building exterior, or water can accumulate around the foundation. This is a condition conducive to attracting wood-destroying organisms. I recommend cleaning gutters and downspouts now and as necessary in the future. Work to be completed by qualified person.

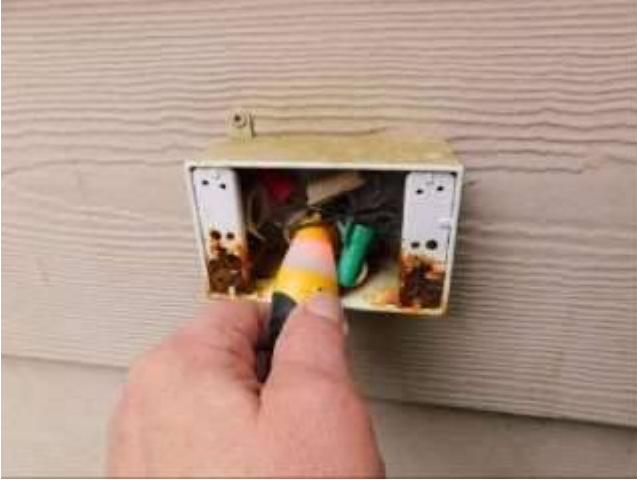
Photo 30-1

Substandard wiring was found at the building exterior and/or interior rooms. For example, exposed wiring and missing cover plate. This is a safety hazard. I recommend that a qualified electrician evaluate and repair as necessary and per standard building practices.

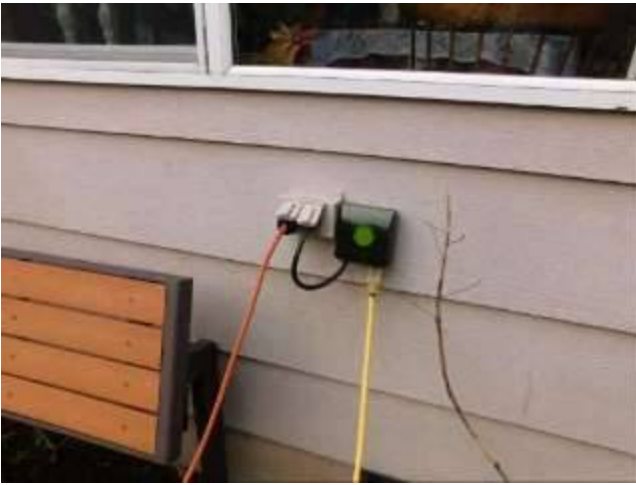
Photo 32-1

Some standard exterior electric receptacles were being used to power appliances or systems that were constantly in use. This is a safety hazard, since water can enter receptacle slots. I recommend that a qualified person install "while in use" receptacle covers as necessary.

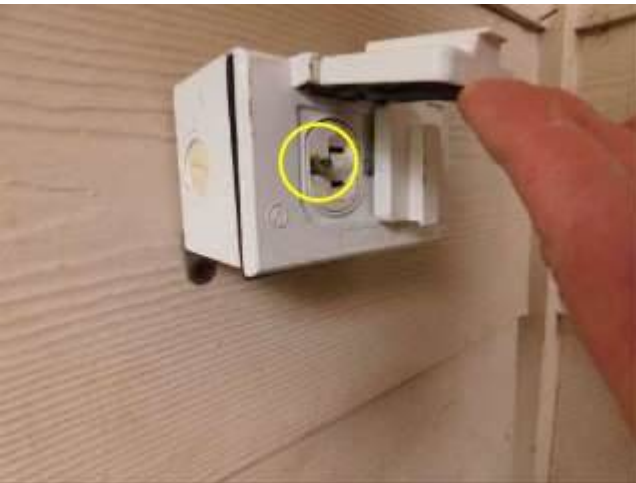
Photo 33-1

The front porch receptacle had a prong from a plug broken off in a slot. I recommend that a qualified electrician replace such receptacles as necessary.

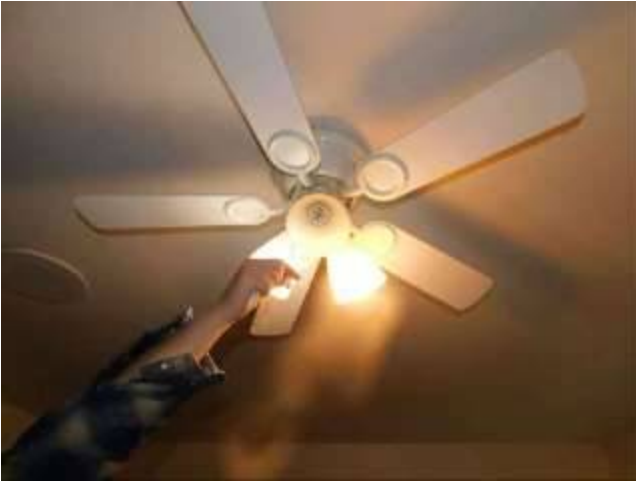
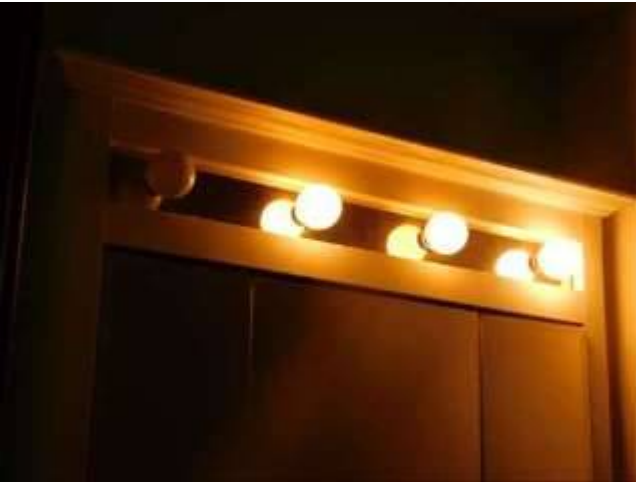
Bulbs in some light fixtures were missing. These light fixtures couldn't be fully evaluated. If replacement bulbs are inoperable, then I recommend that a qualified electrician evaluate and repair or replace light fixtures as necessary.

Some globes or covers for light fixtures were missing or damaged. I recommend replacing as necessary to avoid exposed bulbs. With closet lighting or where flammable stored objects are near light fixtures, missing or broken covers can be a fire hazard.

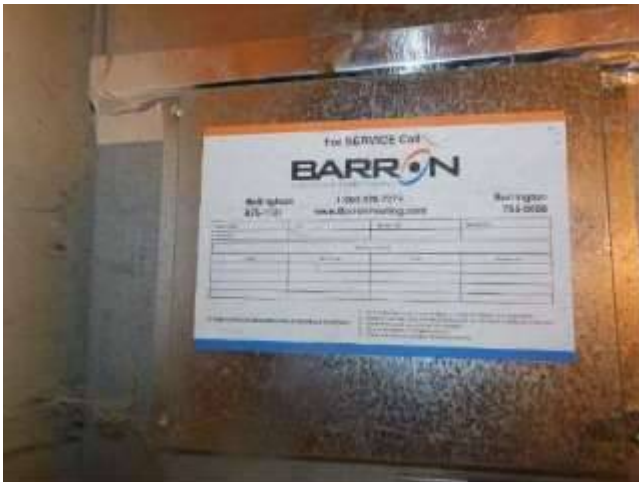
Photo 35-1

The last service date of the forced air heating/cooling system is unknown. Also, the system might be over filtered. The existence of the filters at the air handler and at the return air grill may restrict air airflow and overstress the fan motor. I would also recommend replacing filters as necessary.

I recommend further evaluation and service by an HVAC contractor: Professional review to include air-handler, airflow-balance, ducts, supply registers, connections, heat exchanger, combustible clearances and combustion air, vent for the length of its run, cleaning and, as applicable, gas piping, valves, carbon monoxide (CO) testing. Forced-air furnaces, per manufacturers' estimates, have a life expectancy of 15-20 years. Furnaces should be serviced annually to extend appliance life and to assure ongoing safety. A specialist could uncover deficiencies that were not identified at the time of a home inspection. When onsite, HVAC technician to explain routine maintenance procedures such as how to replace or clean filters.

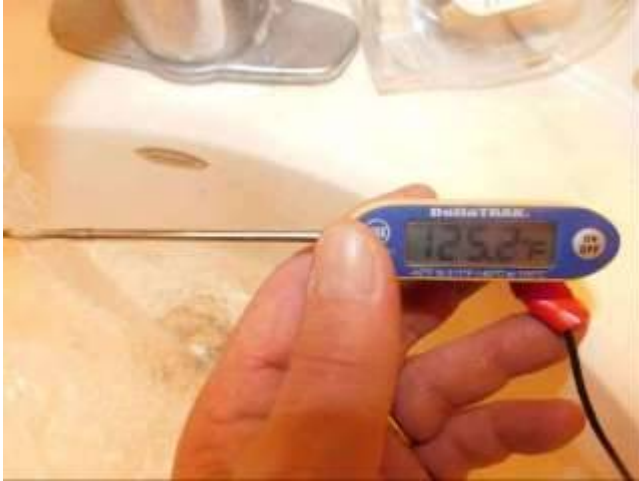
Photo 36-1

36) **+** The hot water temperature was greater than 120 degrees Fahrenheit. This is a safety hazard due to the risk of scalding. The thermostat should be adjusted so the water temperature doesn't exceed 120 degrees. If the water heater is powered by electricity, a qualified person should perform the adjustment, since covers that expose energized equipment normally need to be removed.

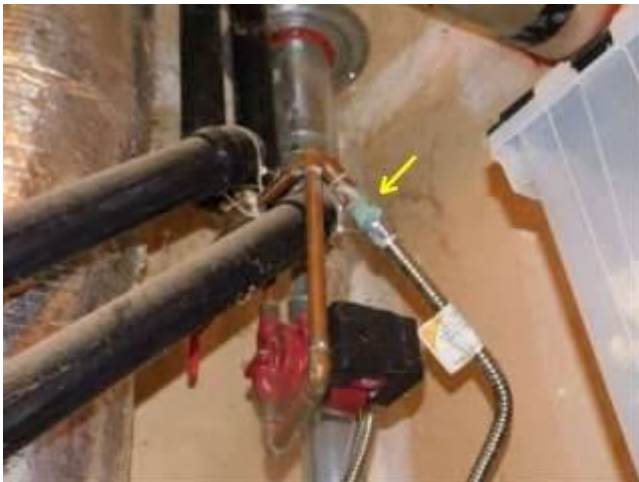
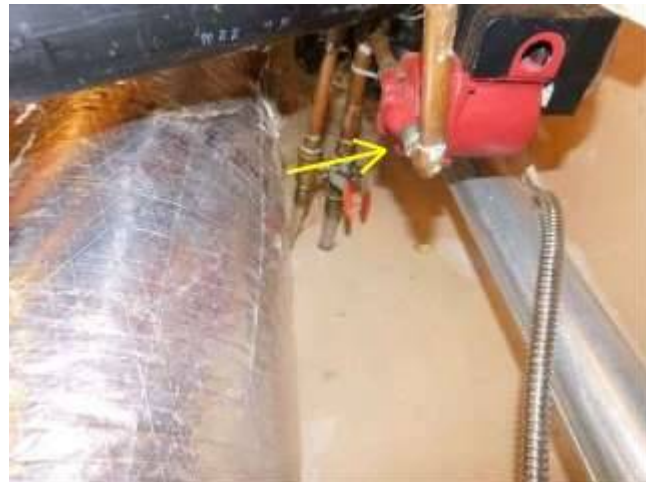
37) **🔧🔍** Significant corrosion or rust was found at the supply pipes or fittings. This can indicate past leaks, or that leaks are likely to occur in the future. I recommend that a qualified plumber evaluate and replace components or make repairs as necessary.

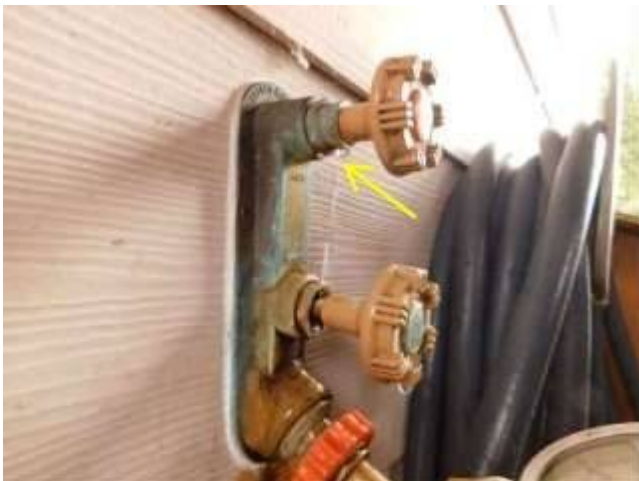
The hose bibb at the south side leaked at the stem when under pressure test. The hose bibb at the east side was damaged, leaking in the off position and not secured to the structure. The ongoing leak was getting into the crawlspace. The South hose bibb could likely be repaired, the east hose bibb should be replaced. When hose bibbs leak while turned off, it's often caused by a worn valve seat or a loose bonnet. When hose bibbs leak while turned on, it may be due to worn "packing" around the stem or a defective backflow prevention device. I recommend that a qualified plumber repair as necessary.

Photo 39-1
South side

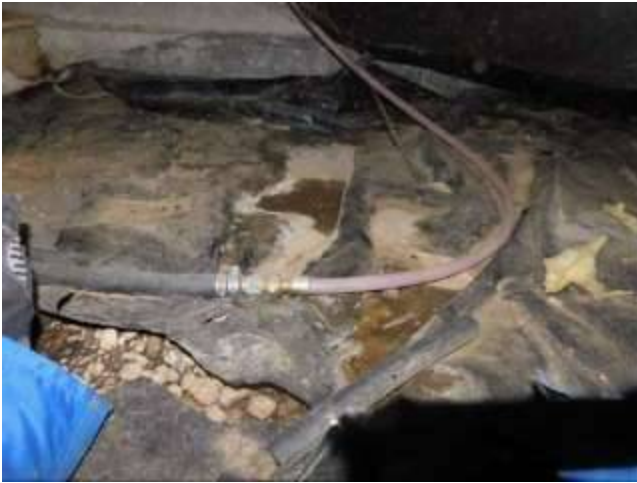
Photo 42-1

Evidence of prior water intrusion was apparent in the crawl space. For example, sediment stains on the vapor barrier or foundation, and/or efflorescence on the foundation. Standing water is a condition conducive to attracting wood-destroying organisms. I suggest that the client review any disclosure statements available and ask the property owner

about past accumulations of water. The crawl space should be monitored in the future for standing water, especially after prolonged periods of rain. If water does accumulate, I recommend that a qualified drainage professional further evaluate and correct the problem. Typical methods for controlling standing water in crawl spaces include:

- Repairing, installing or improving rain run-off systems (gutters, downspouts and extensions or drain lines)
- Improving perimeter grading
- Repairing, installing or improving underground footing and/or curtain drains

Ideally, water should not enter crawl spaces, but if water must be controlled after it enters the crawl space, then typical repairs include installing trenches, gravity drains and/or sump pump(s) in the crawl space.

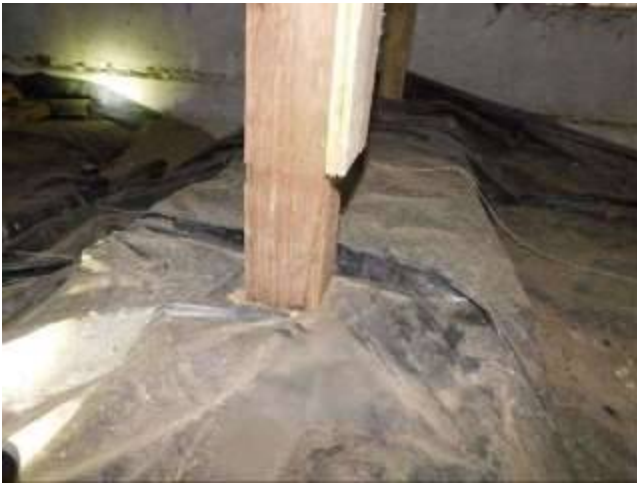
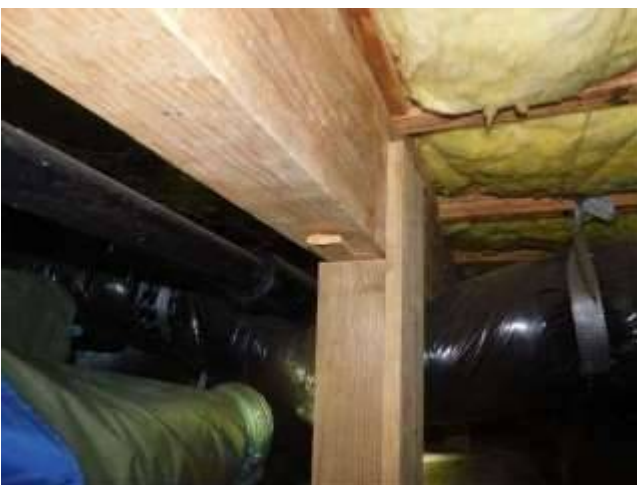
Support post(s) were not positively secured to the beams above. While this is common in older homes, current standards require positive connections between support posts and beams above for earthquake reinforcement. I recommend that a qualified contractor repair per standard building practices. For example, by installing metal plates, plywood gussets or dimensional lumber connecting posts and beams.

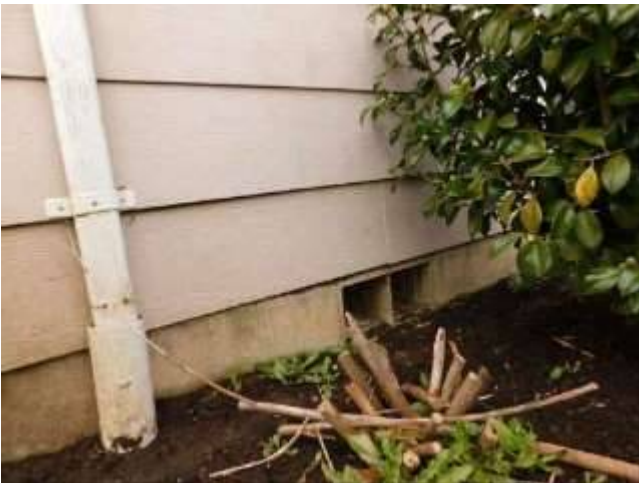
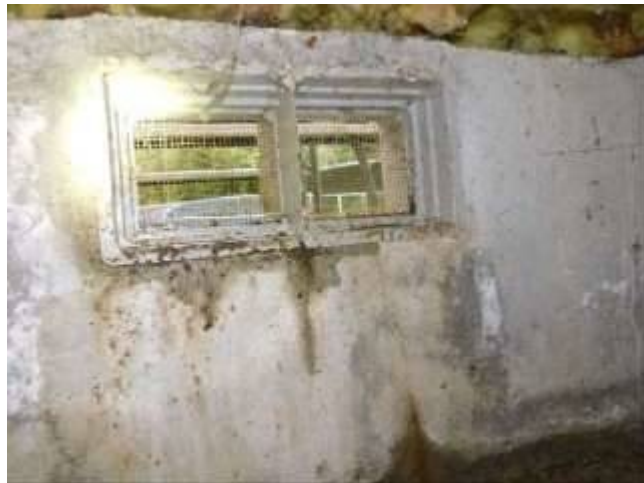
Some crawl space vents were below grade, and either no wells were installed, or wells were substandard. Vent wells should be installed when vents are at or near grade to prevent debris from blocking vents and/or water from entering vents. This is a condition conducive to attracting wood-destroying organisms. I recommend that a qualified person install, replace or repair vent wells per standard building practices.

Direct result of the ongoing leak at the hose bib at the exterior East side.

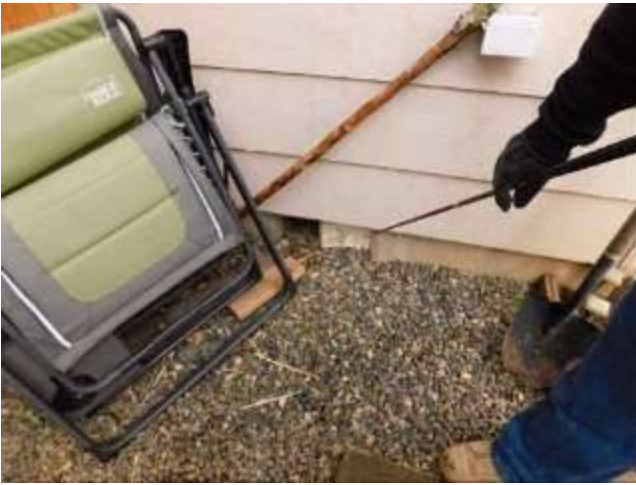
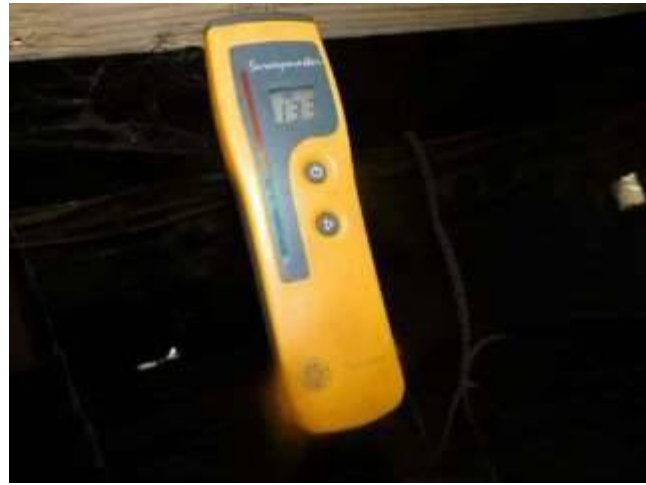
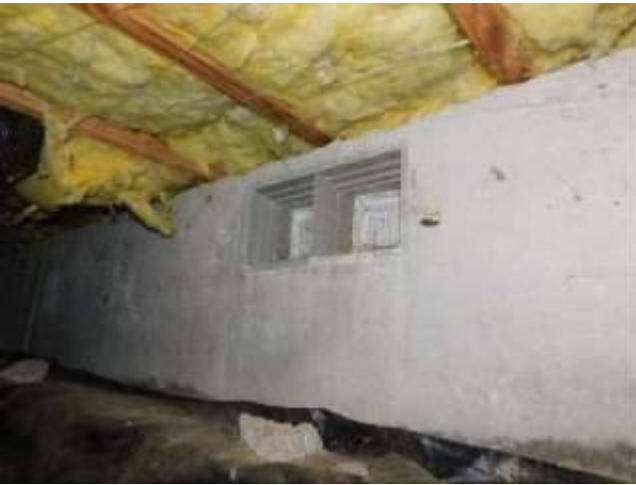
Some crawl space vents were intentionally blocked (e.g. removable panels, rigid foam). This restricts ventilation in the crawl space and can result in increased levels of moisture inside. This is a condition conducive to attracting wood-destroying organisms. Such vents should be left open at all times except during severe freezing weather. I recommend removing plugs or other materials that are blocking the vents.

Elevated moisture in substructure lumber could be greatly reduced with proper ventilation and a well-maintained vapor barrier covering all soil.

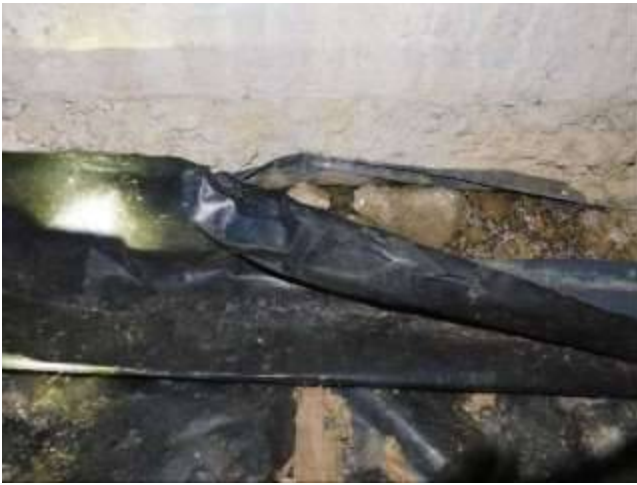
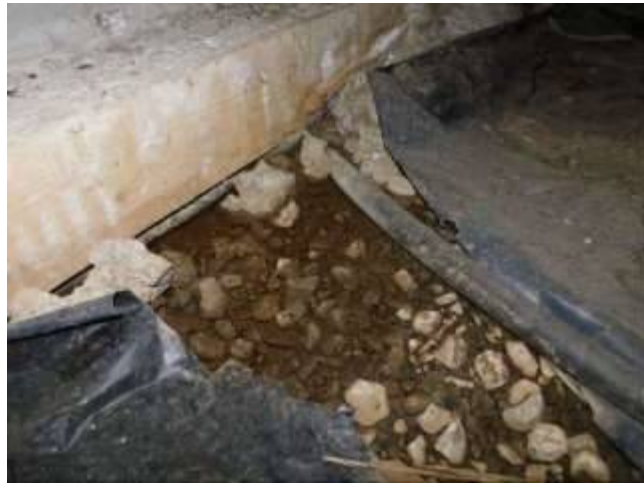
The vapor barrier in some areas of the crawlspace was loose or askew. Soil was exposed as a result and will allow water from the bare earth to evaporate up into the structure. This is a condition conducive to attracting wood-destroying organisms. A 6 mil black plastic sheet should be placed over all exposed soil with seams overlapped to 24 inches, and not in contact with any wood structural components. The sheeting should be held in place with bricks or stones, not wood. I recommend that a qualified person replace or repair the vapor barrier where necessary and per standard building practices.

Seasonal water can easily contain below the vapor barrier with a well-maintained vapor barrier. Wood form materials are still in place and I recommend that all nonstructural material from unconditioned substructures be removed.

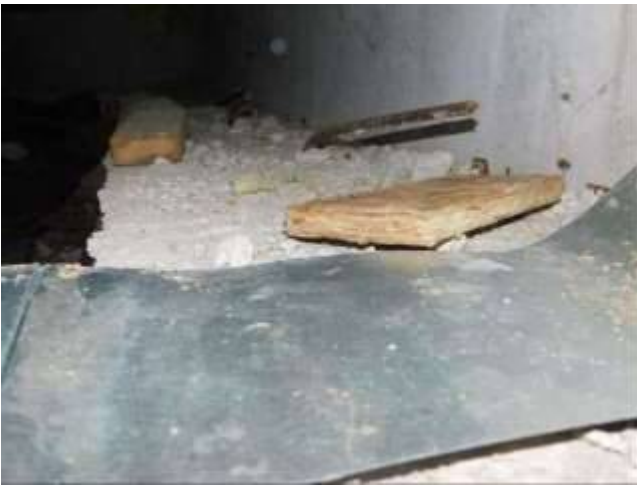
Photo 48-1

48) 🗑️ Cellulose material such as scrap wood was found in the crawl space. This is a condition conducive to attracting wood-destroying organisms. I recommend removing all cellulose-based debris or stored items.

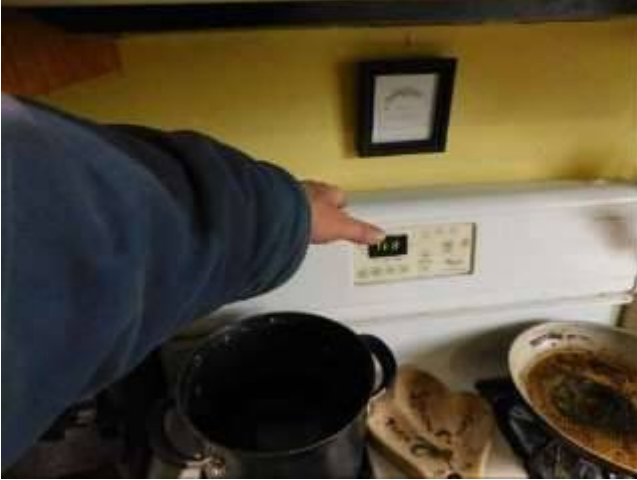
Photo 49-1

The range could tip forward. An anti-tip bracket may not be installed. This is a potential safety hazard since the range can tip forward when weight is applied to the open door, such as when a small child climbs on it or if heavy objects are dropped on it. Anti-tip brackets have been sold with all free-standing ranges since 1985. I recommend installing an anti-tip bracket to eliminate this safety hazard.

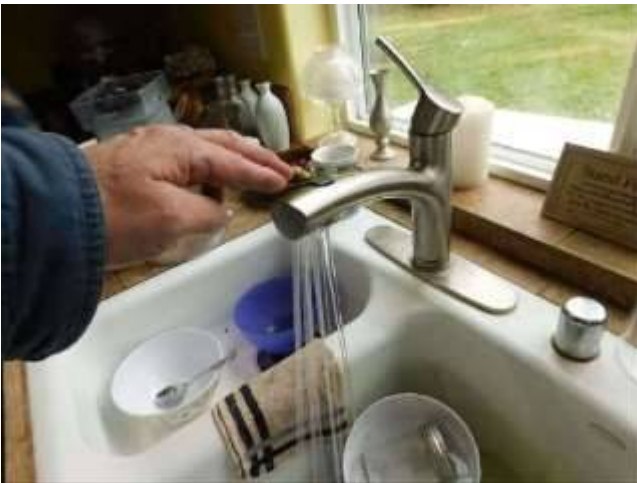
Photo 50-1

The sink sprayer was inoperable. I recommend that a qualified person repair or replace as necessary.

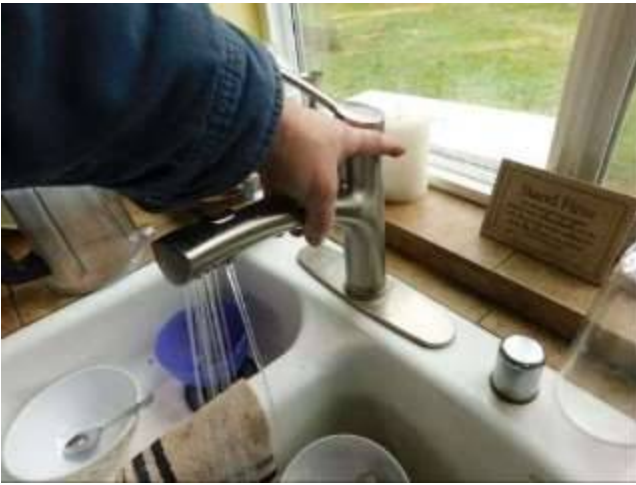
Photo 51-1

The sink faucet was loose. I recommend that a qualified person repair as necessary.

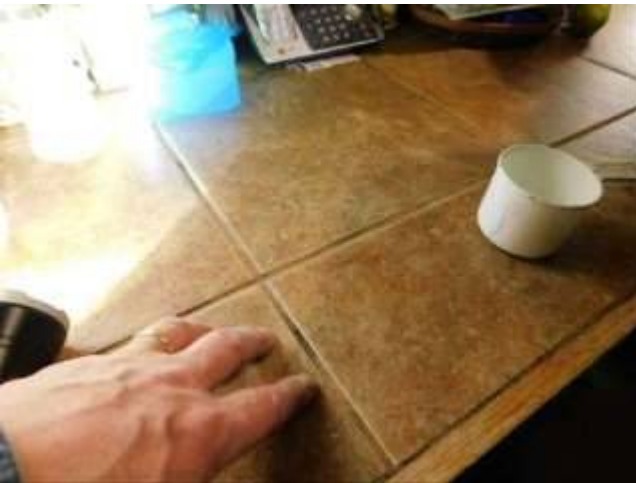
Photo 52-1

52) 🗝️ I recommend cleaning and sealing the grout at countertops now and in the future as necessary to prevent staining and to improve waterproofing.

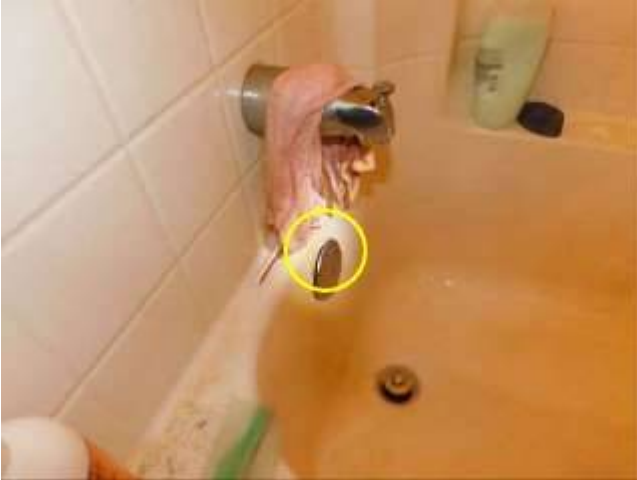
Photo 53-1

Bath tub overflow cover plate is installed upside down. Recommend having a qualified person to repair.
