First Sergeant Inspection Services, LLC

Property Inspection Report

Property address: **123 Steele LN
Lacey, WA 98501**

Inspection date: **Wednesday, February 28, 2018**

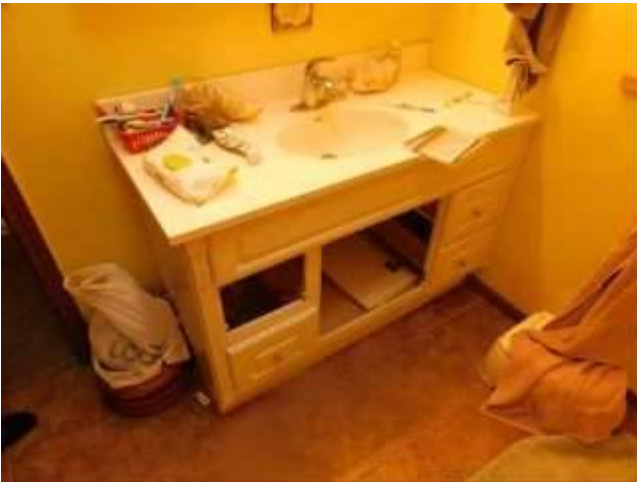
Photo 54-1

Upstairs hallway bath room had hinges, latches, closers, magnets or pulls were taken off. I recommend that a qualified person repair as necessary.

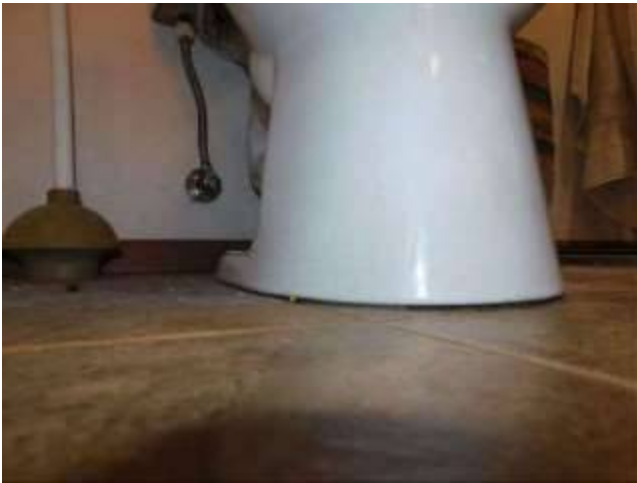
Photo 55-1

Caulk around the base of a toilet was missing. Modern standards require caulk to be installed around the entire toilet base where it meets the floor for sanitary reasons. Without it, soiled water can soak into flooring and sub-floor materials if the toilet overflows. Condensation from the toilet can also soak into the flooring. I recommend that a qualified person caulk around toilet bases per standard building practices.

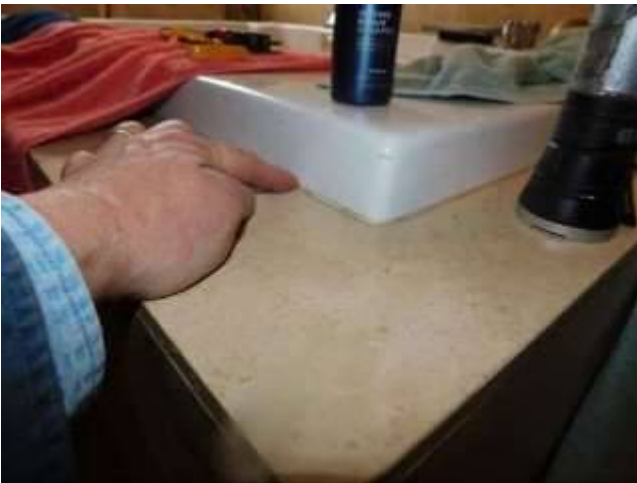
Photo 56-1

Caulking was deteriorated around the master bath room tub and tile. Water may penetrate these areas and cause damage. I recommend that a qualified person re-caulk or install caulking as necessary.

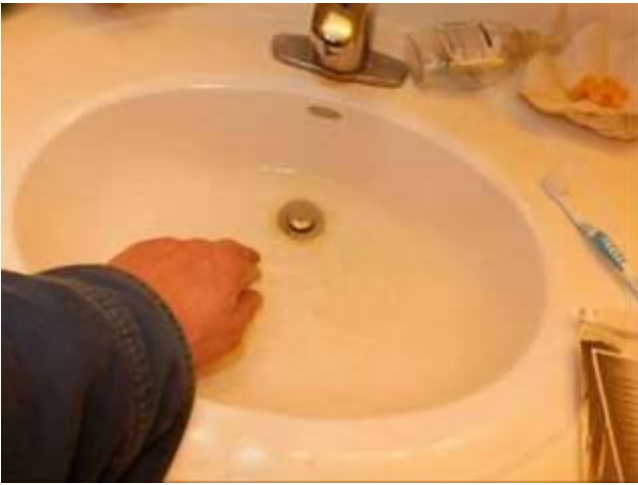
Photo 57-1

A sink was slow draining, appears to have a clogged drain. I recommend clearing drain and/or that a qualified plumber repair if necessary.

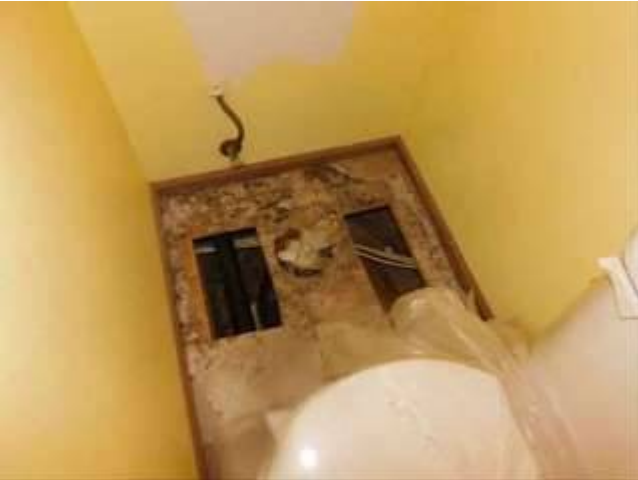
Photo 58-1

The floor by a shower was water-damaged. I recommend that a qualified person repair as necessary.

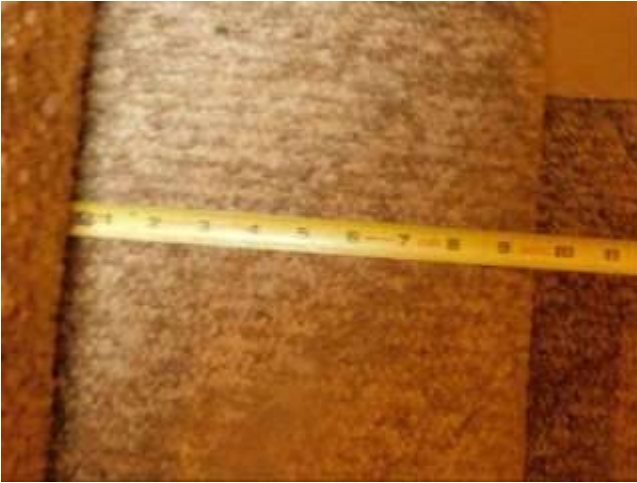
Photo 59-1

Treads for stairs were less than 10 inches deep and pose a fall or trip hazard. Stair treads should be at least 10 inches deep. At a minimum, be aware of this hazard, especially when guests who are not familiar with the stairs are present. I recommend that a qualified contractor repair per standard building practices.

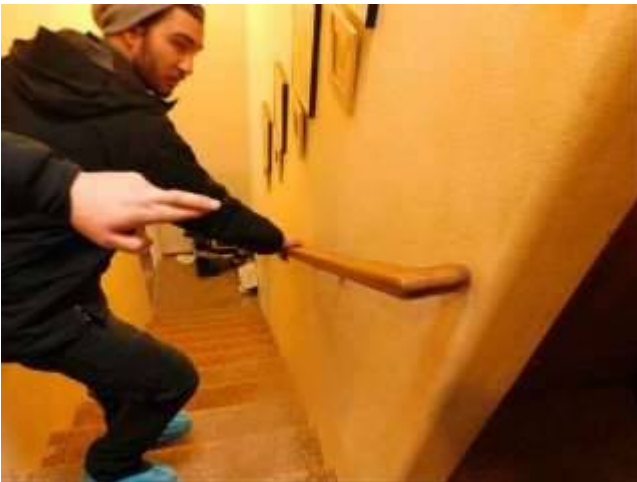
Photo 60-1

Handrails at stairs were loose and/or wobbly. This is a safety hazard. I recommend that a qualified person repair as necessary.

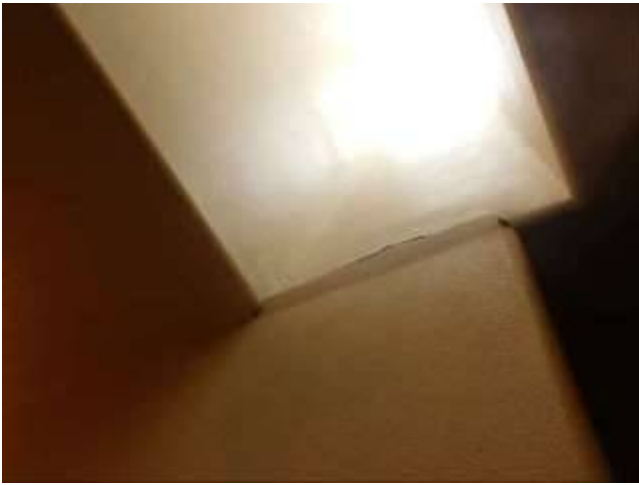
Photo 61-1

This structure appears to have settled based on the presence of cracks in ceiling. Also, it could have been damaged by the hydraulic jack in the substructure. I recommend that a qualified contractor and/or engineer evaluate further. Significant repairs may be needed. If so, a qualified contractor should make repairs.

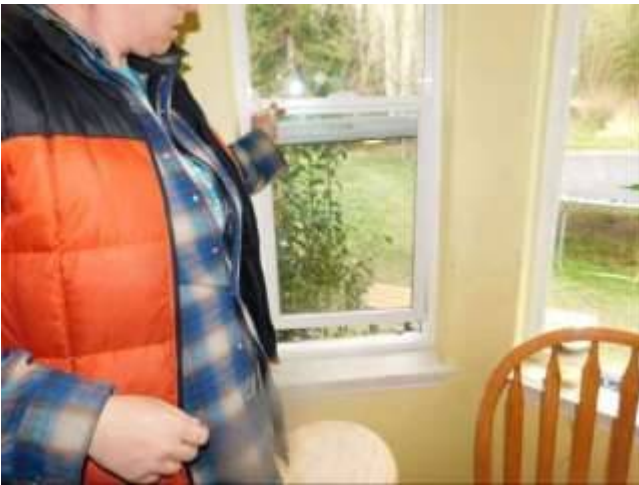
Photo 62-1

Some windows in the kitchen nook were unable to open/close as intended. I recommend that a qualified person repair windows as necessary so they open and close easily.

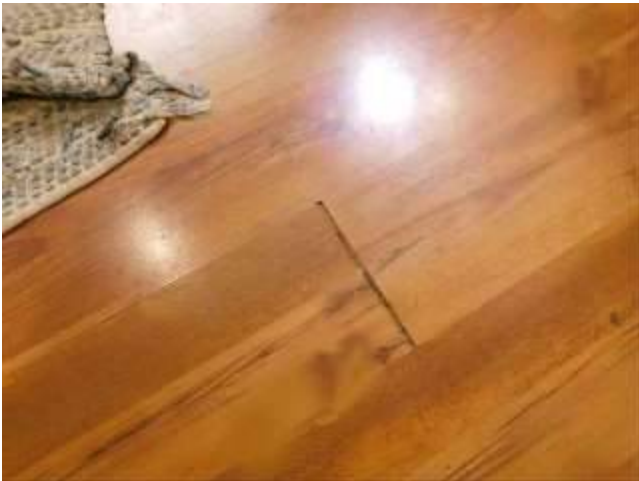
Photo 63-1

Kitchen flooring had gaps and was damaged. In wet locations, water that gets past the grout can damage sub-flooring. I recommend that a qualified contractor repair as necessary.
