First Sergeant Inspection Services, LLC

Property Inspection Report

Property address: **123 Steele LN**
Lacey, WA 98501

Inspection date: **Thursday, March 1, 2018**

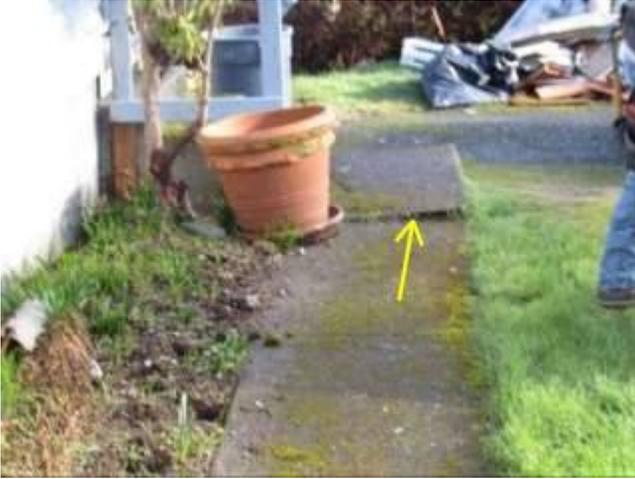
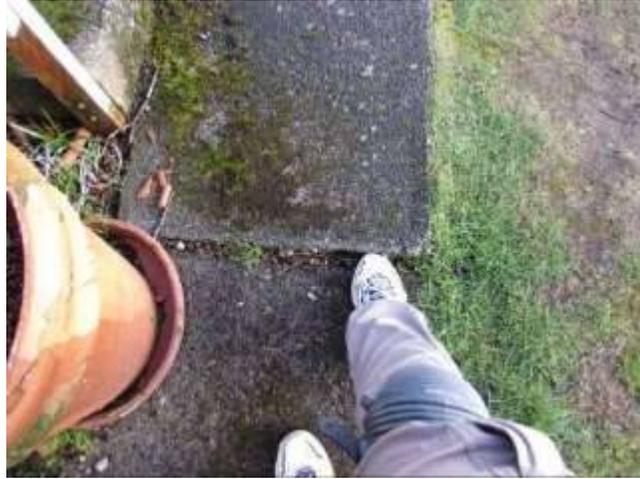
3) 🚧 Heaving resulting in trip hazards was found in the sidewalk in the front of the house. For safety reasons, I recommend that a qualified contractor repair as necessary to eliminate trip hazards.

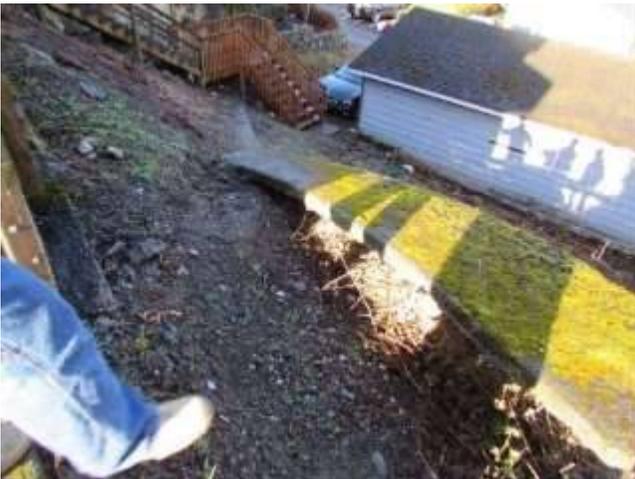
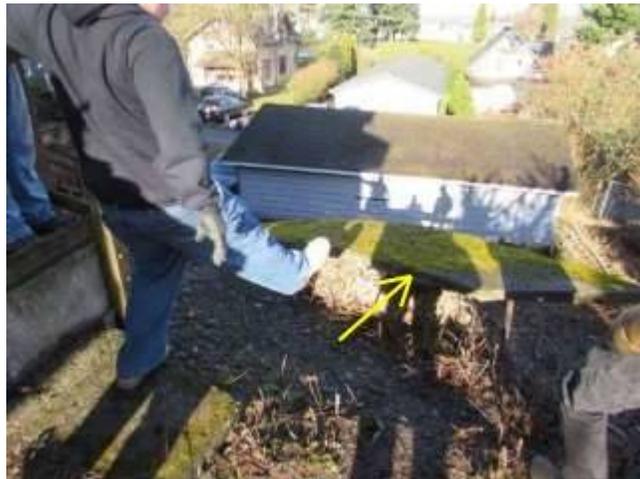
4) 🚧 Hillside on back of home is experiencing some erosion. Continued erosion could compromise footings, walks, decks and yard. Severe slopes may require evaluation of an engineer or landscape architect. I recommend a qualified engineer or landscape contractor evaluate and repair as necessary.

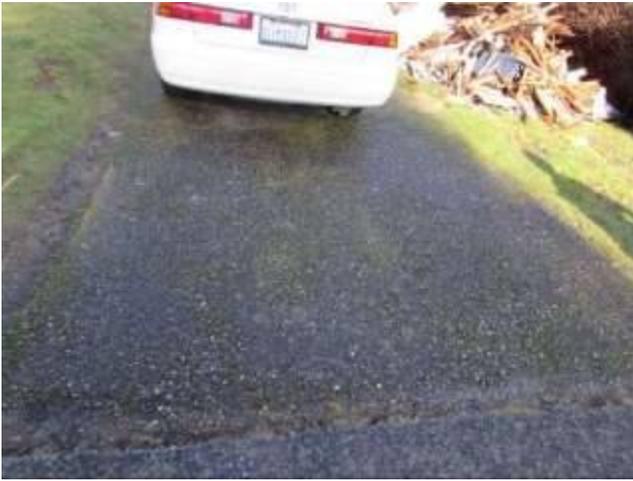
5) 🚧 Minor deterioration (e.g. cracks, holes, settlement, heaving, moss) was found in the driveway, but no trip hazards were identified. The client may wish to have repairs made for cosmetic reasons.

***Car was parked in driveway, so wasn't able to complete visual inspection.

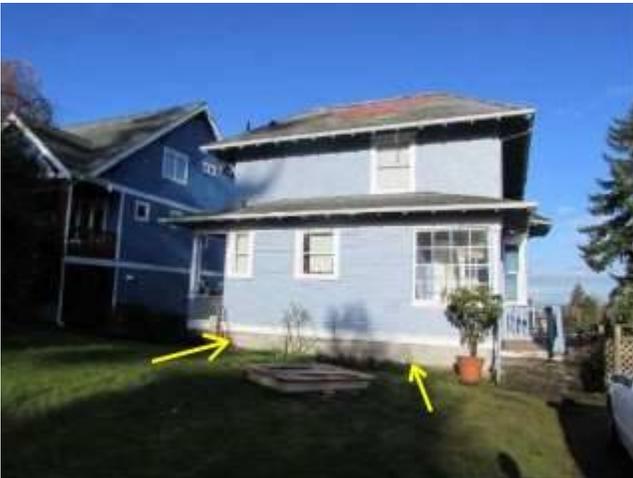
Photo 6-1

-
- 6) 🗑️🏠 The soil or grading sloped down towards building perimeters in some locations. This can result in water accumulating around building foundations or underneath buildings. At a minimum, monitor these areas, and areas under the structure in the future for accumulated water. If water does accumulate, I recommend grading soil so it slopes down and away from buildings with a slope of at least 1 inch per horizontal foot for a minimum 6 feet out from buildings.

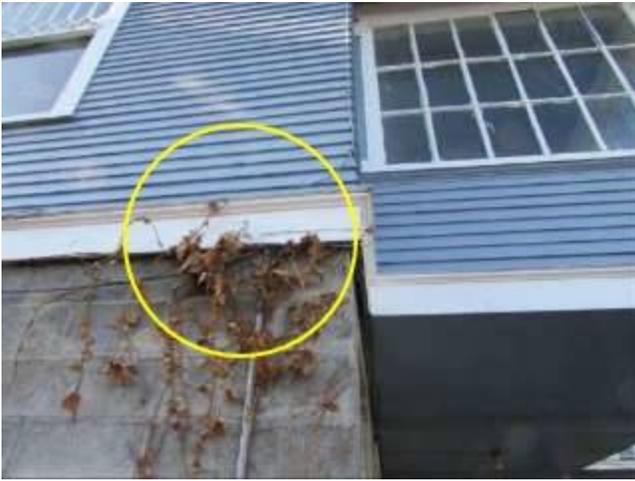
Photo 7-1

-
- 7) 🗑️ Vines was in contact with the building exterior. Vegetation can serve as a pathway for wood-destroying insects and can retain moisture against the exterior after it rains. This is a condition conducive to attracting wood-destroying organisms. I recommend pruning, moving or removing vegetation as necessary to maintain at least 6 inches of space between it and the building exterior. A 1-foot clearance is better.

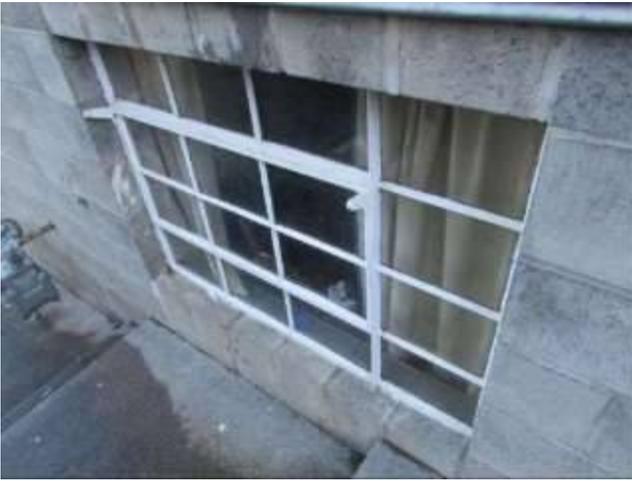
Photo 8-1

The inspector was unable to verify that the glass installed in the basement kitchen was approved safety glass. Glass located in areas subject to human impact that is not approved safety glass is a safety hazard. Standard building practices require that approved safety glass be used or guards installed. I recommend that a qualified contractor evaluate and replace glass if necessary, and per standard building practices.

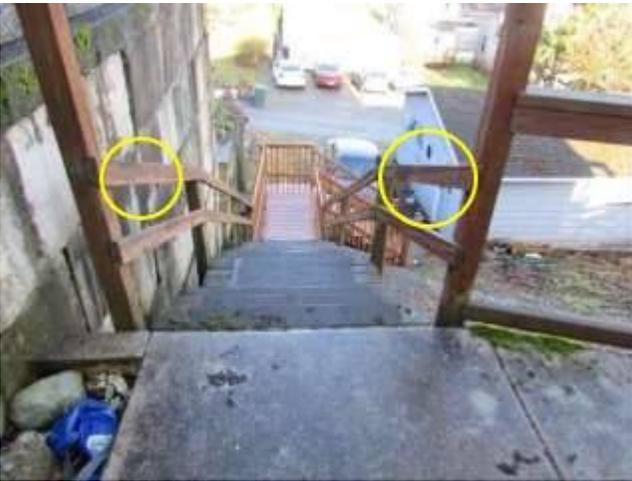
Photo 9-1

Handrails were missing. This is a potential fall hazard. Handrails should be installed at stairs with four or more risers or where stairs are greater than 30 inches high. I recommend that a qualified contractor install handrails where missing and per standard building practices.

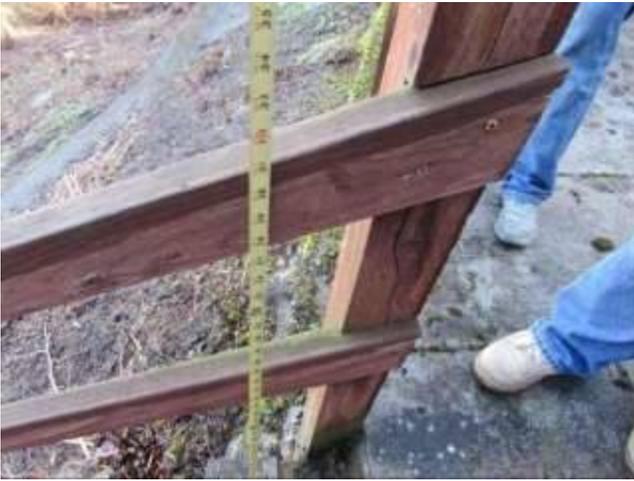
Photo 10-1
Rear stairs

Soil was in contact with wooden stairs at all locations. This is a condition conducive to attracting wood-destroying organisms. Soil should be graded and/or removed so as to eliminate wood to soil contact. Any work to be completed by qualified individual.

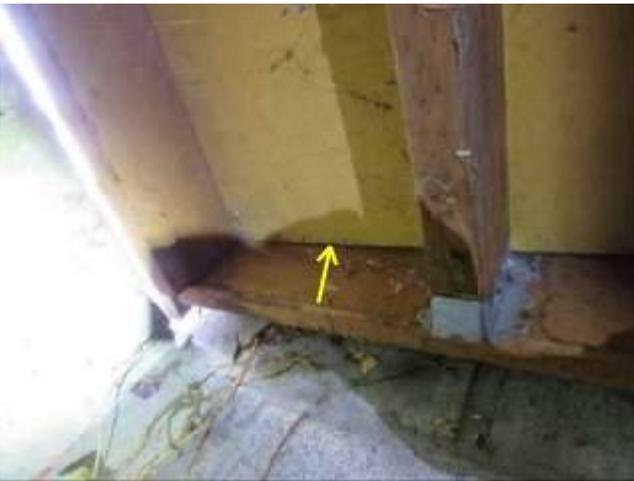
Photo 11-1

Flashing was missing from above porch ledger boards, or could not be verified. Missing flashing at this location can cause moisture to accumulate between the ledger boards and the building. Fungal rot may occur in this area and cause the ledger board fasteners to fail. The deck may separate from the building in this event. This is a potential safety hazard. I recommend that a qualified contractor install flashing above ledger boards per standard building practices.

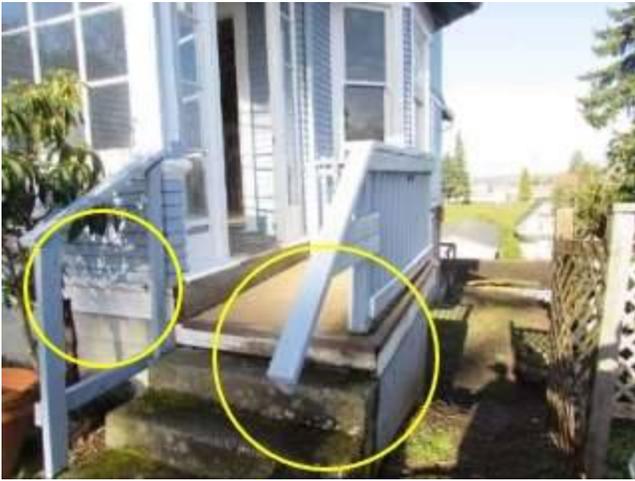
Photo 12-1
East corner

Guardrails were missing pickets. This makes the guardrails unstable and poses a fall hazard. Guardrails pickets should have no more than a 4 inch gap between each picket. I recommend that a qualified contractor install guardrails where missing and per standard building practices.

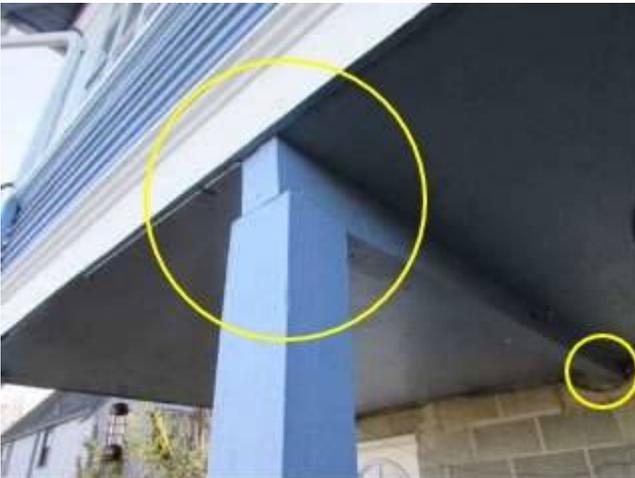
Photo 13-1

The enclosed balcony at the rear of the house was not properly attached due to substandard bracing, lack of diagonal bracing, and lack of attachment to the main building. This is a safety hazard since severe movement may cause the cover to collapse. A qualified contractor should repair as necessary.

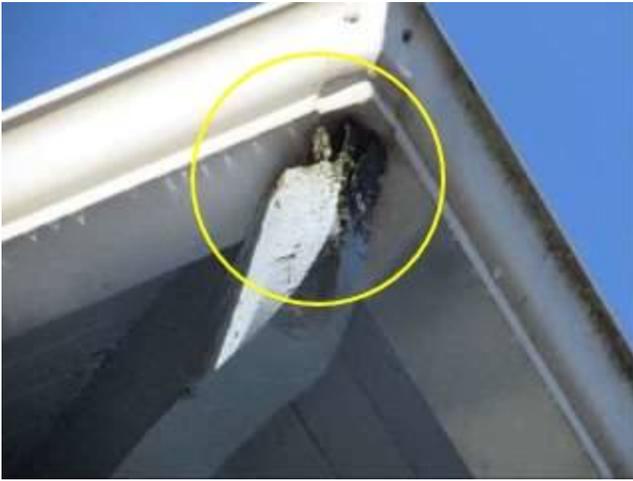
**Photo 14-1**

Fungal rot was found at rafter tails. Conductive conditions for rot should be corrected (e.g. wood-soil contact, reverse perimeter slope). I recommend that a qualified contractor repair as necessary. All rotten wood should be replaced.

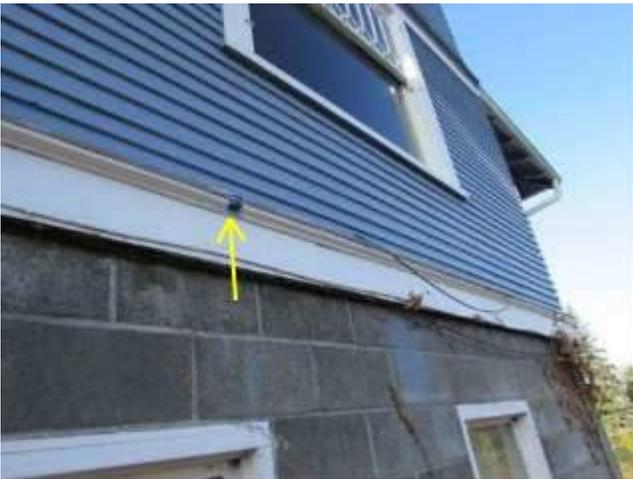
**Photo 15-1**

Some sections of horizontal trim boards had no "Z" flashing installed above them where they met siding. "Z" flashing should be installed above these boards to reduce the chance of leaks between the trim and siding. Without this flashing, caulk and paint must be diligently maintained, or water can enter wall cavities and cause rot and possible structural damage. I recommend that a qualified contractor install flashing above horizontal trim boards where missing and per standard building practices. Note that when trim or siding is removed to install flashing, damaged wood may be found and additional repairs may be needed.

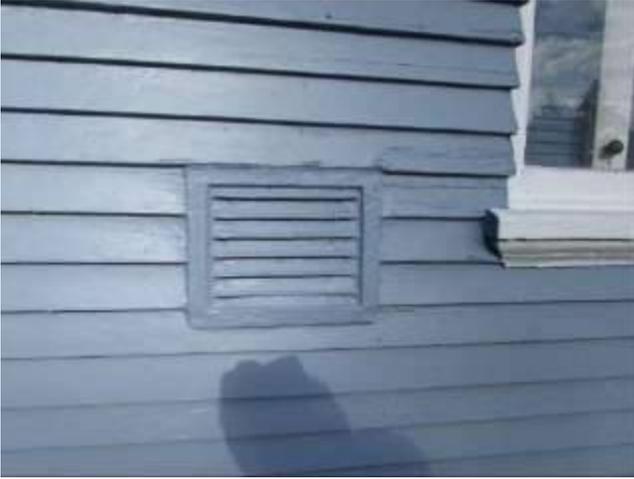
Photo 16-1

Some of the exhaust vent back draft dampers (flappers) were painted over restricting air to flow out. The purpose of the back draft dampers is to prevent unconditioned air from entering the building. Blocked ducts can cause fan motors and/or clothes dryers to overheat and can pose a fire hazard. I recommend that a qualified person repair or replace caps as necessary.

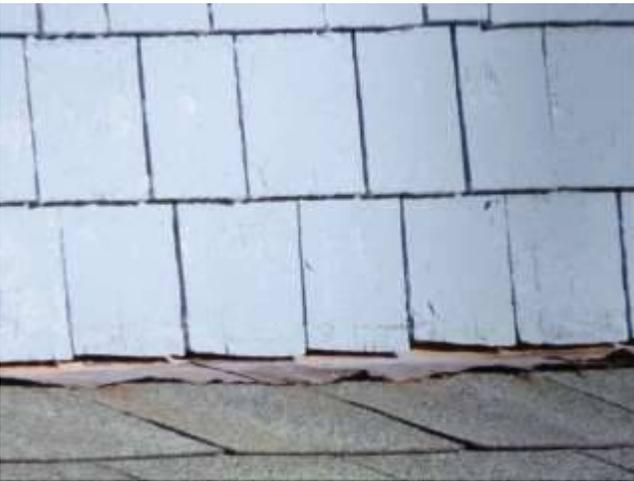
Photo 17-1

Many sections of siding and/or trim were warped. I recommend that a qualified person repair, replace or install siding or trim as necessary.

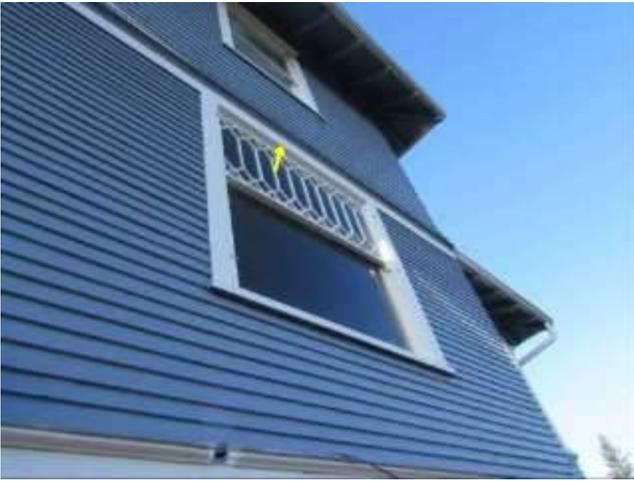
Photo 18-1

Some windows or doors were installed with no "drip cap" or "Z" flashings installed above them. Better building practices call for such flashings, which greatly reduce the chance of leaks above windows and doors. Without this flashing, caulk and paint must be maintained or water can enter the wall structure and cause rot and possible structural damage. Depending on the exposure (e.g. roof overhang, height of exterior wall, direction of prevailing rain) this may or may not be an issue. The client should monitor these areas in the future and maintain caulk and paint as necessary. Consult with a qualified contractor about installing flashings where needed, and per standard building practices. Note that when trim or siding is removed to install flashing, damaged wood may be found and additional repairs may be needed.

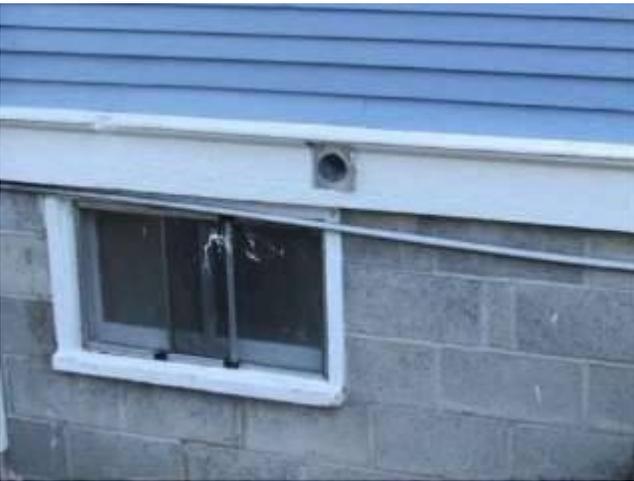
Photo 19-1

A few holes or gaps were found in siding or trim. Vermin, insects or water may enter the structure. I recommend that a qualified person repair as necessary.

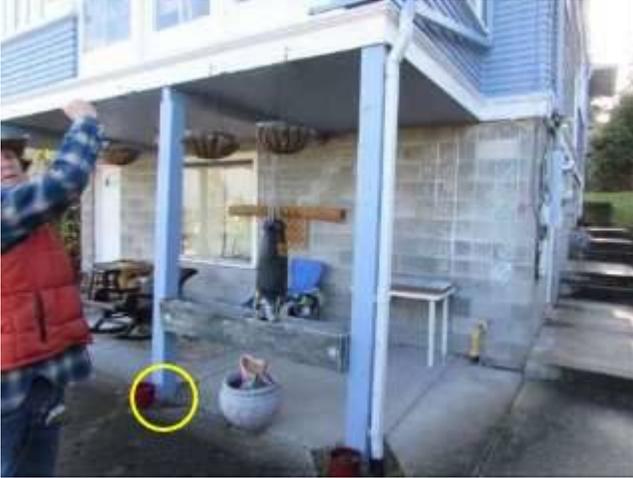
Photo 20-1

Soil was in contact with balcony support posts. This is a condition conducive to attracting wood-destroying organisms. Even if posts are made of treated wood, the cut ends below soil may not have been field treated. I recommend grading soil or repairing as necessary to prevent wood-soil contact.

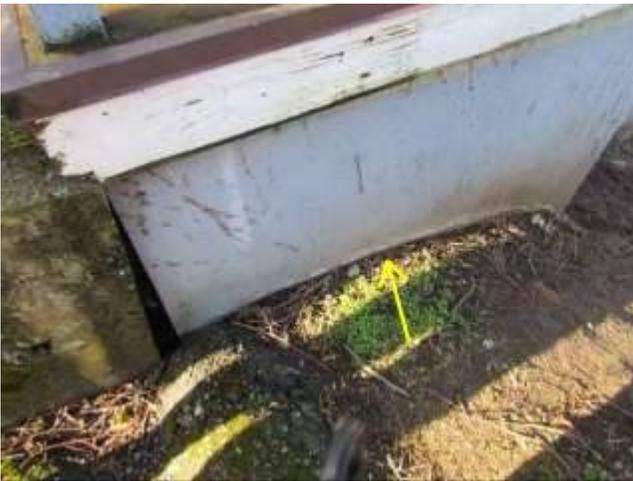
Photo 21-1

Soil was in contact with structural wood for the front porch. This condition is conducive to attracting wood-destroying organisms. I recommend grading or removing soil as necessary to maintain a 6-inch clearance. If that's not possible, have a qualified person replace untreated wood with rot resistant pressure-treated lumber. Since even pressure-treated materials can eventually decay, plan to periodically check the condition of any wood that is in contact with earth. Note that damage from fungal rot and/or insects may be discovered when soil is removed, and further repairs and wood replacement may be necessary.

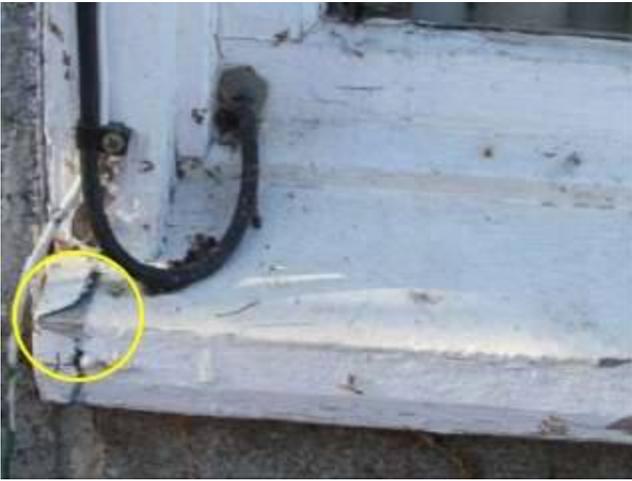
Photo 22-1

The paint or stain finish in some areas was failing (e.g. peeling, faded, worn, thinning). Siding and trim with a failing finish can be damaged by moisture. I recommend that a qualified contractor prep (e.g. clean, scrape, sand, prime, caulk) and repaint or restain the building exterior where necessary and per standard building practices. Any repairs needed to the siding or trim should be made prior to this.

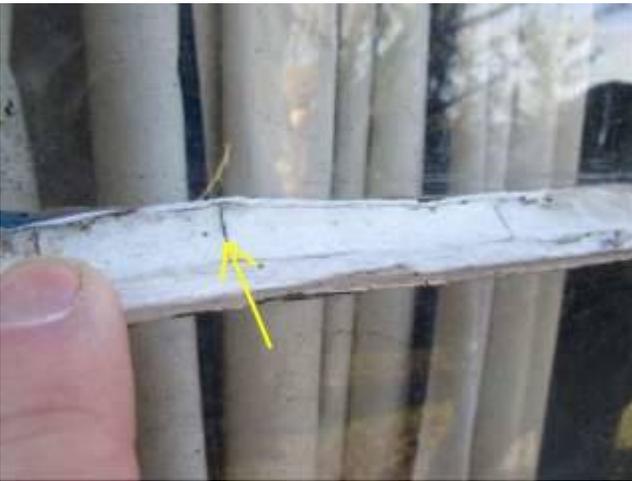
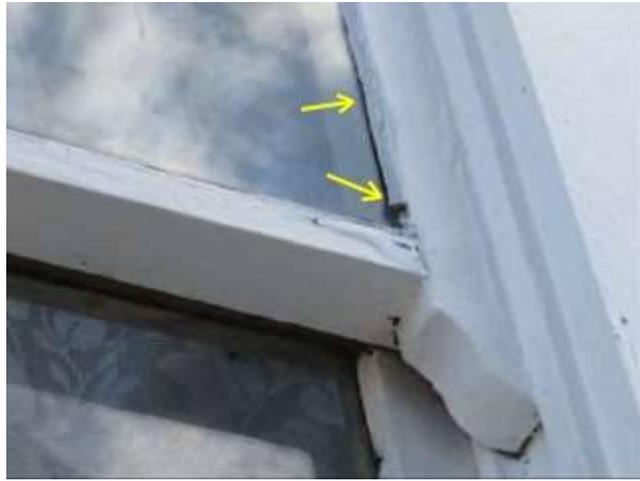
23) 🗝️ Window glazing putty is deteriorating on various windows and windows may be in need of some repair. This is not uncommon with the age of the home as the glazing dry out it become brittle and cracks and sills, stiles and sashes will need some repair. The client will have to evaluate repair versus replacement in some of these windows. I recommend having a qualified person or contractor evaluate and repair as necessary.

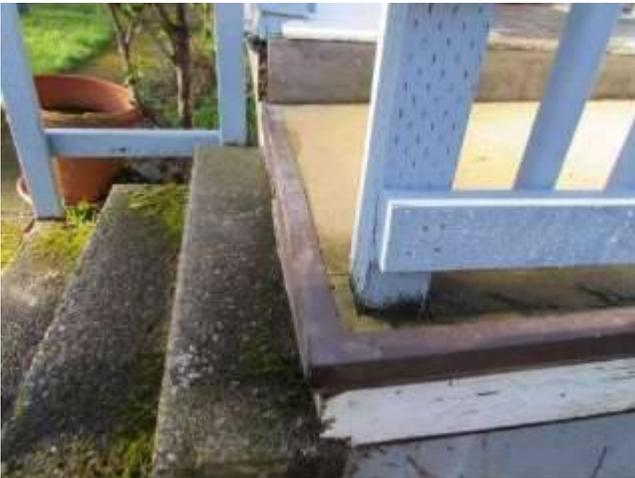
Photo 24-1

24) 🗝️ Wood deck or porch surfaces were overdue for normal maintenance. I recommend that a qualified person clean and preserve as necessary. Where decks have been coated with a finish such as opaque stains or paint, it may be too difficult to strip the finish and apply anything but paint or opaque stain. At areas where transparent stain or penetrating oil has been applied in the past, I suggest using a penetrating oil.

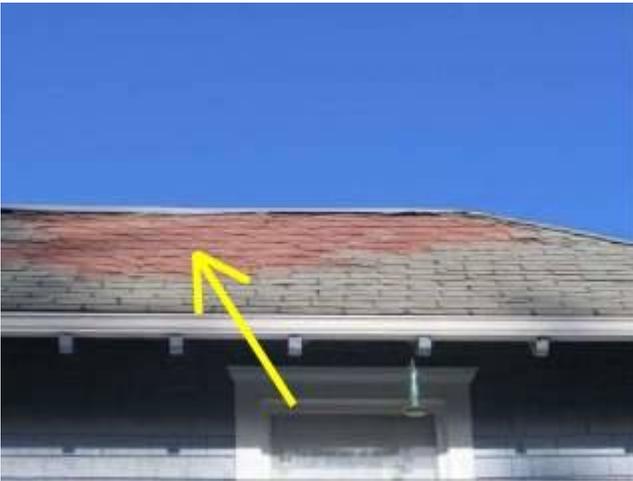
Photo 25-1

The roof was significantly deteriorated and appeared to be at or beyond its service life. It needs replacing now. I recommend discussing replacement options with a qualified contractor. Related roofing components such as flashings and vents should be replaced or installed as needed and per standard building practices.

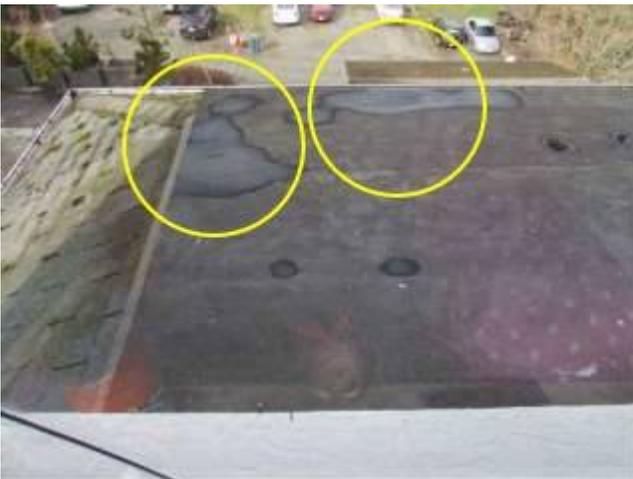
Photo 26-1

Ponding (pools of standing water) was found at various areas on the flat or low-slope roof. Even on a flat roof, water should be removed by a drainage system so that any remaining water evaporates within 48 hours after it rains. Prolonged standing water can result in roof leaks. This is a condition conducive to attracting wood-destroying organisms. I recommend that a qualified contractor evaluate and repair as necessary to prevent ponding.

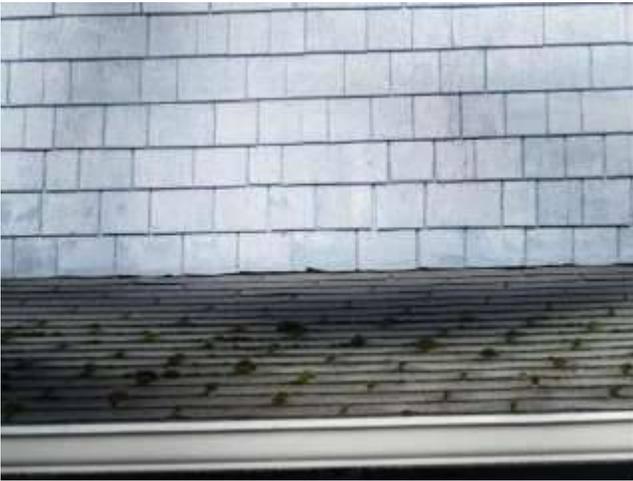
Photo 27-1

Moss was growing on the roof. As a result, roof runoff water is slowed down and leaks are more likely to occur. Efforts should be made to kill the moss during its growing season (wet months). Typically, zinc or phosphate-based chemicals are used for this and must be applied periodically. Work to be completed by qualified person. For information on various moss treatment products and their pros and cons, visit: <http://www.reporhost.com/?MOSS>

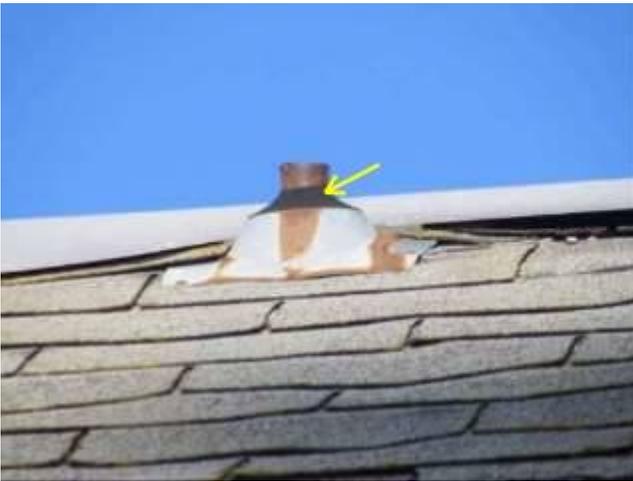
Photo 28-1

Rubber or neoprene pipe flashings were deteriorated. Leaks can occur as a result. This is a condition conducive to attracting wood-destroying organisms. I recommend that a qualified contractor further evaluate and replace flashings where necessary.

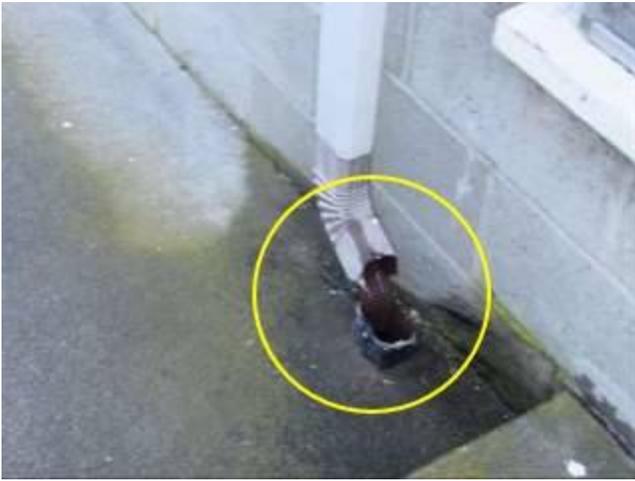
Photo 29-1

Downspout extensions such as splash blocks or drain pipes were misaligned. Water can accumulate around the building foundation or inside crawl spaces or basements as a result. I recommend that a qualified person install, replace or repair extensions as necessary so rainwater drains away from the structure.

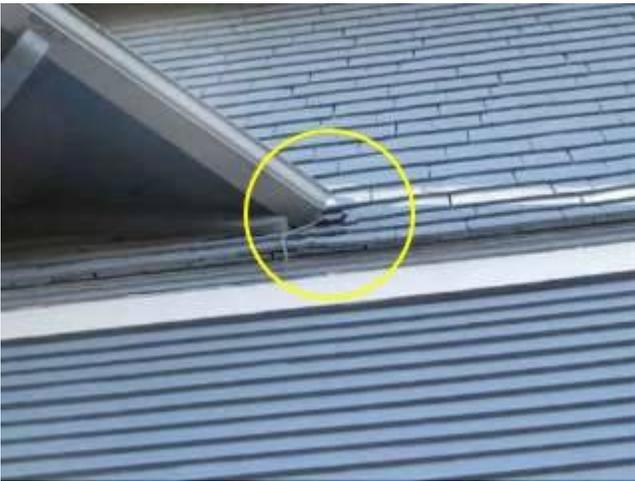
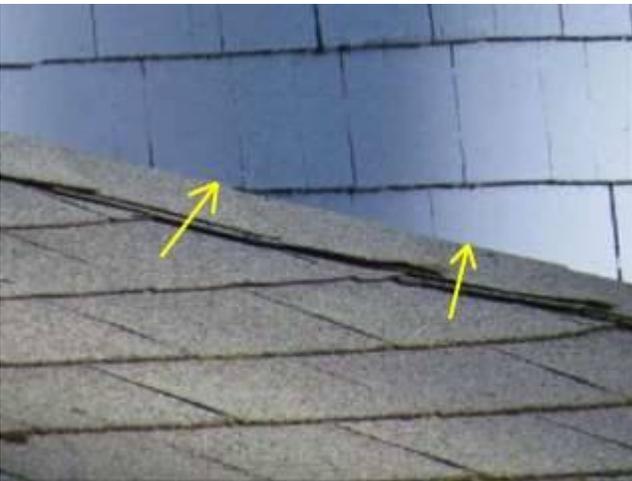
Some roof flashings were substandard. Leaks can occur as a result. This is a condition conducive to attracting wood-destroying organisms. I recommend that a qualified person repair as necessary.

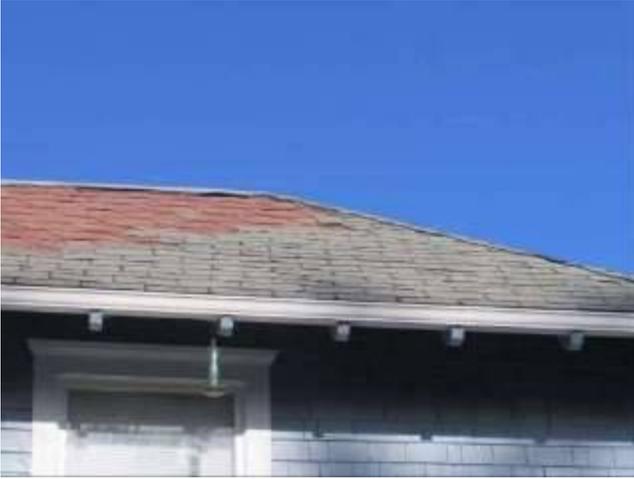
Photo 31-1

31) **i** This asphalt or fiberglass composition roofing material appears to have two or more layers of shingles. Additional layers of composition shingles typically last only 80% of their rated life, and the shingle manufacturer's warranty may be voided. The client should be aware that all layers of roofing will need to be removed when this roof is replaced, which increases the cost of re-roofing.

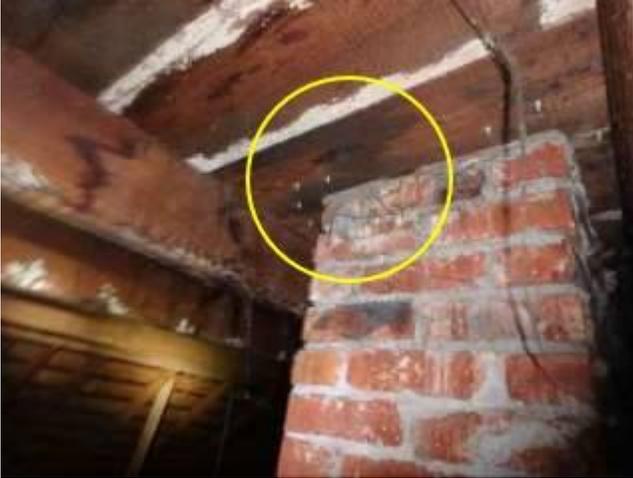
Photo 33-1

Water damage was seen in the attic around chimney. This is a condition conducive to attracting wood-destroying organisms. Also, the chimney flashing might be failing. I recommend that a qualified contractor evaluate and repair as necessary.

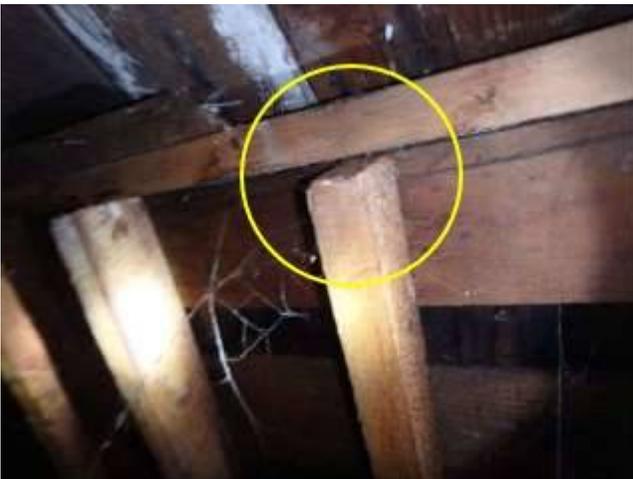
Photo 34-1

Several beams/joists were not positively attached to each other. This may weaken the roof structure. I recommend that a qualified contractor repair as necessary.

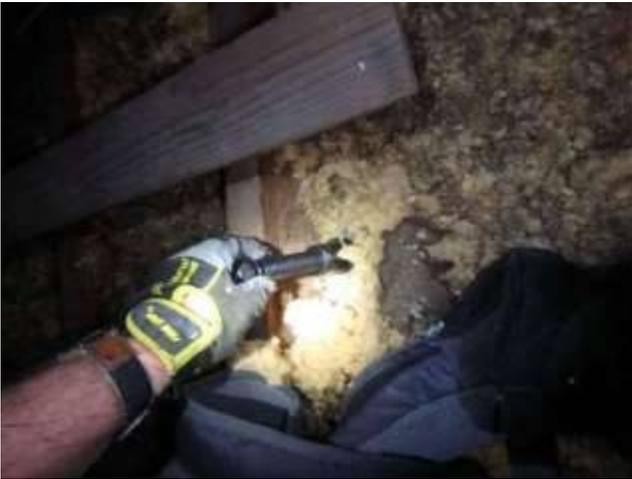
Photo 35-1

The ceiling insulation installed in the attic was substandard and appeared to have an R rating that's significantly less than current standards (R-38). Heating and cooling costs will likely be higher due to poor energy efficiency. I recommend that a qualified contractor install insulation for better energy efficiency and per standard building practices.

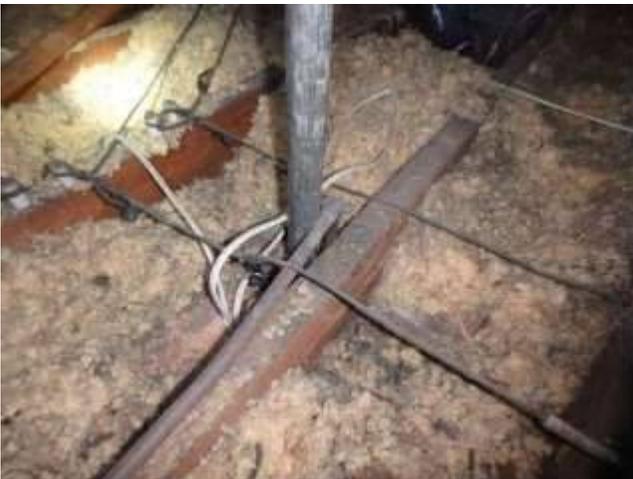
Photo 36-1

"Knob and tube" wiring or related components such as porcelain insulators were found. This type of wiring was commonly installed prior to 1950. It is lacking an equipment ground and it is considered obsolete by today's standards. Over time, the wire's insulation can become brittle or wear thin, resulting in exposed conductors and an increased risk of fire. Often homeowners make the situation worse by incorrectly splicing new wiring into a existing knob and tube circuits.

The inspector did not find any energized knob and tube wiring during the inspection. However, this is no indication that all the knob and tube wiring has been abandoned. It is not within the scope of this inspection to determine what percentage of this property's wiring is of the knob-and-tube type, or to determine what percentage of the knob and tube wiring is energized versus abandoned. I recommend that a qualified electrician evaluate this wiring and make repairs or replace wiring as necessary.

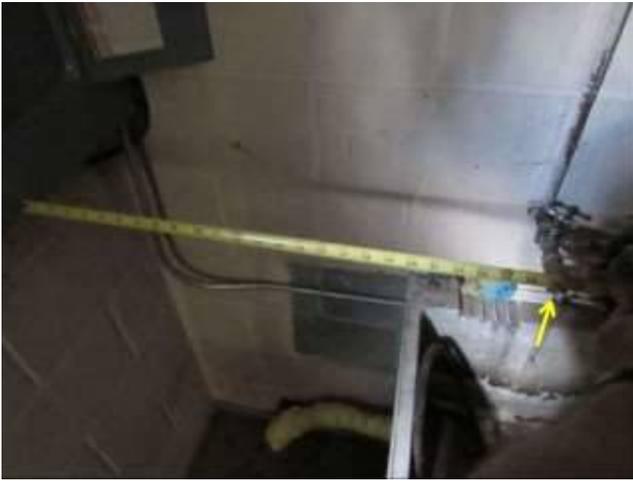
**Photo 39-1**

An electric panel had inadequate working space, insufficient clearances in front of it. This is a safety hazard when opening or working in a panel. Electric panels should have the following clearances:

I recommend that a qualified contractor repair or make modifications per standard building practices. If panels must be opened for repairs, then a qualified electrician should perform repairs.

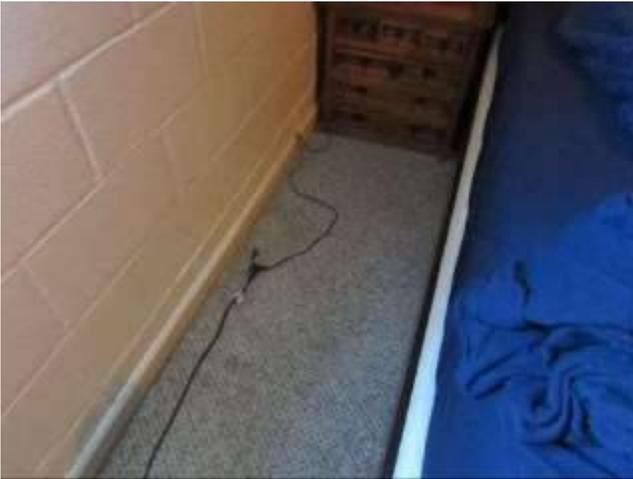
**Photo 40-1**

Extension cord was being used as permanent wiring in lower unit bedroom. They should only be used for portable equipment on a temporary basis. Using extension cords as permanent wiring creates a safety hazard and indicates that wiring is inadequate and needs to be updated. Extension cords may be undersized. Connections may not be secure resulting in power fluctuations, damage to equipment, overheating and sparks that could start a fire. I recommend that a qualified electrician repair per standard building practices and eliminate extension cords for permanently installed equipment.

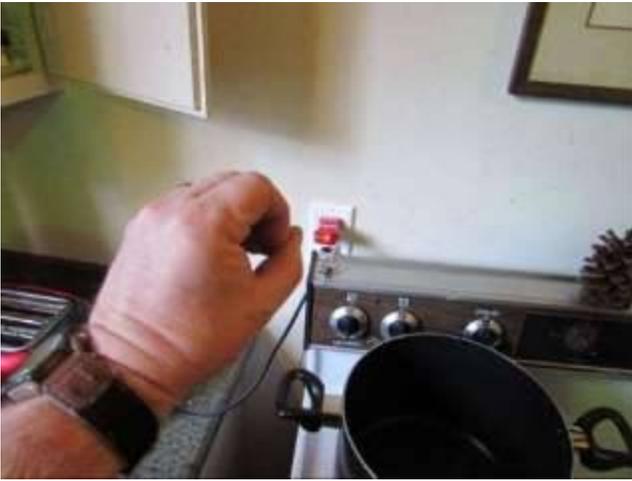
Photo 41-1

Several modern 3-slot electric receptacles, with an open ground, were identified in the lower unit. This is a safety concern when appliances that require grounds are used with these receptacles. Examples of such appliances include computers and related hardware, refrigerators, freezers, portable air conditioners, clothes washers, aquarium pumps, and electrically operated gardening tools. I recommend that a qualified electrician repair as necessary so all receptacles are grounded per standard building practices.

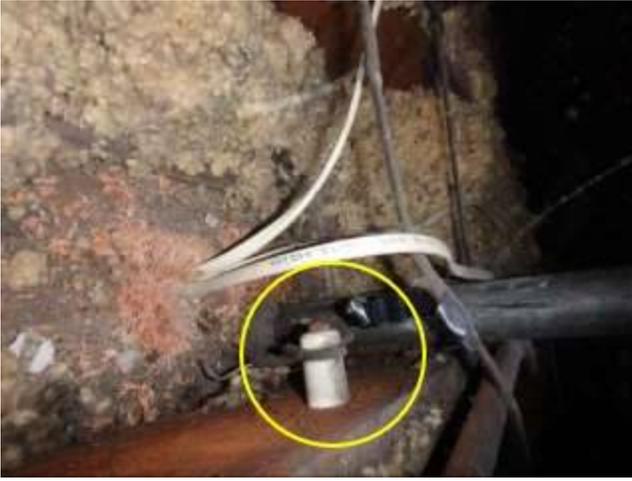
Photo 44-1

Branch circuit wiring installed in buildings built prior to the mid 1980s is typically rated for a maximum temperature of only 60 degrees Celsius. This includes non-metallic sheathed (Romex) wiring, and both BX and AC metal-clad flexible wiring. Knob and tube wiring, typically installed in homes built prior to 1950, may be rated for even lower maximum temperatures. Newer electric fixtures including lighting and fans typically require wiring rated for 90 degrees Celsius. Connecting newer fixtures to older, 60-degree-rated wiring is a potential fire hazard. Repairs for such conditions may involve replacing the last few feet of wiring to newer fixtures with new 90-degree-rated wire, and installing a junction box to join the old and new wiring.

It is beyond the scope of this inspection to determine if such incompatible components are installed, or to determine the extent to which they're installed. Based on the age of this building, the client should be aware of this safety hazard, both for existing fixtures and when planning to upgrade with newer fixtures. Consult with a qualified electrician for repairs as necessary.

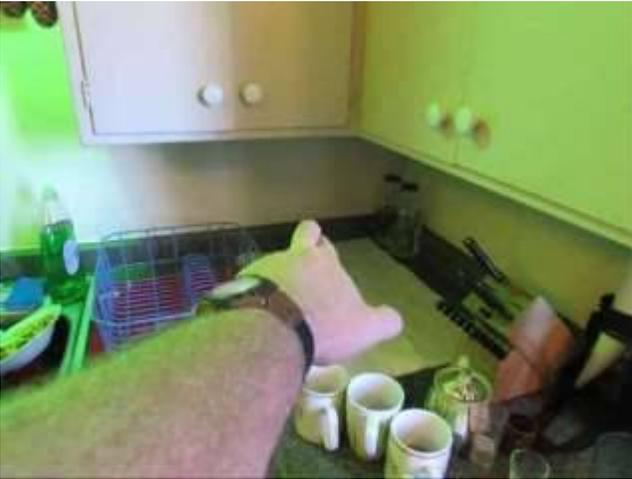
Photo 45-1

Very few receptacles, per modern standards, were installed throughout the lower unit. This can result in "octopus" wiring with extension cords, which is a fire hazard. Consult with a qualified electrician about upgrading circuits with additional receptacles per standard building practices.

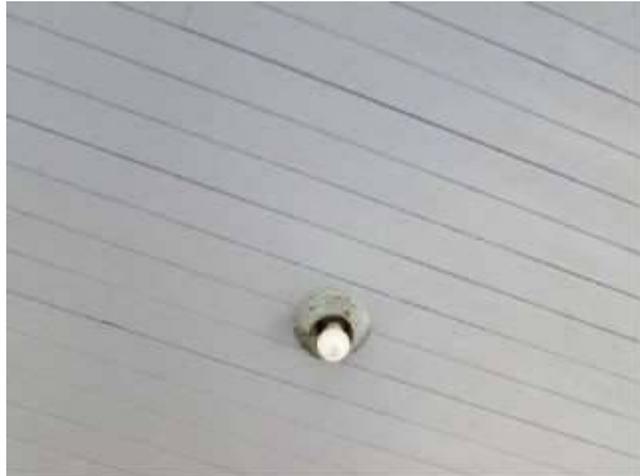
Photo 47-2

Some globes or covers for light fixtures were missing. I recommend replacing as necessary to avoid exposed bulbs. With closet lighting or where flammable stored objects are near light fixtures, missing or broken covers can be a fire hazard.

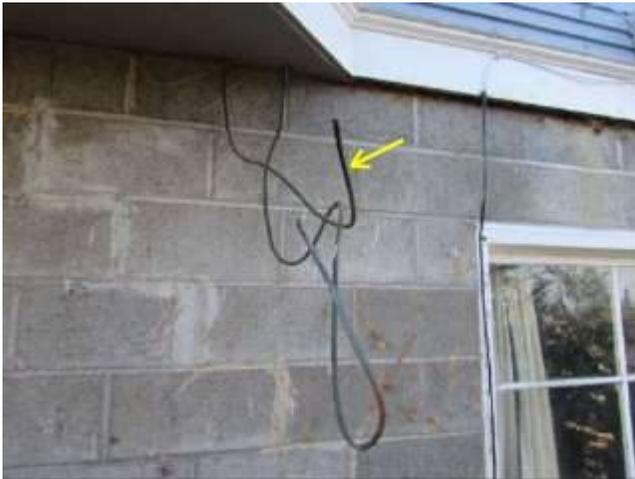
Photo 48-1

Evidence of what may be an abandoned underground oil storage tank was found (e.g. metal supply lines). I suggest attempting to determine if underground tank(s) exist on this property, and/or if tank(s) have been removed or legally decommissioned. If the tank(s) haven't been decommissioned or removed, then the client may be liable for decommission and/or cleanup of contaminated soil in the future. I recommend the following:

- That any non-decommissioned, abandoned underground tanks be legally decommissioned or removed as necessary
- That the soil be tested for oil contamination
- That contaminated soil be removed as necessary

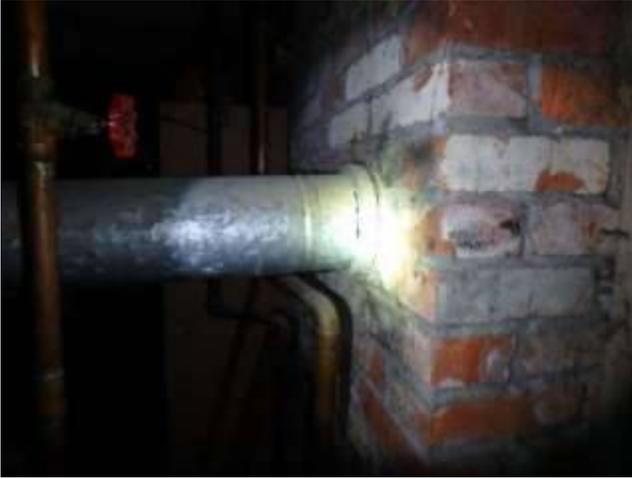
Photo 50-1

50) Boiler exhaust duct deteriorated. This cause toxic fumes to build up into room. Recommend HVAC contractor evaluate and repair as necessary.

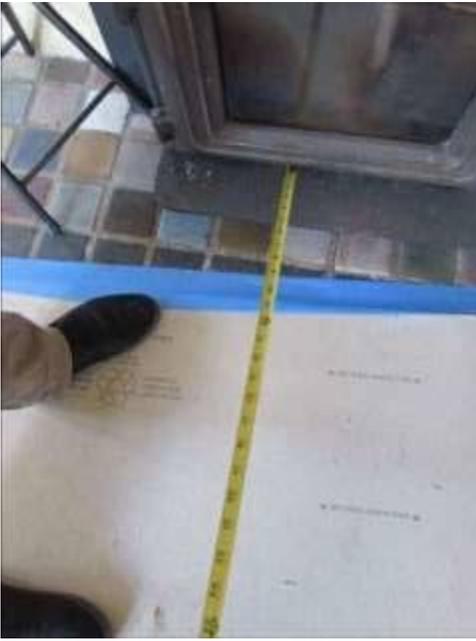
Photo 51-1

The fireplace hearth extension was undersized. Embers may ignite combustible surfaces nearby. This is a fire hazard. For fireplaces with a firebox less than 6 square feet in size, hearths should be at least 16 inches deep in front and extend at least 8 inches to the sides. For fireboxes more than 6 square feet in size, hearths should be at least 20 inches deep and extend 12 inches to each side. I recommend that a qualified person make repairs or modifications per standard building practices. For example, by installing a non-flammable hearth pad, or by extending the existing hearth.

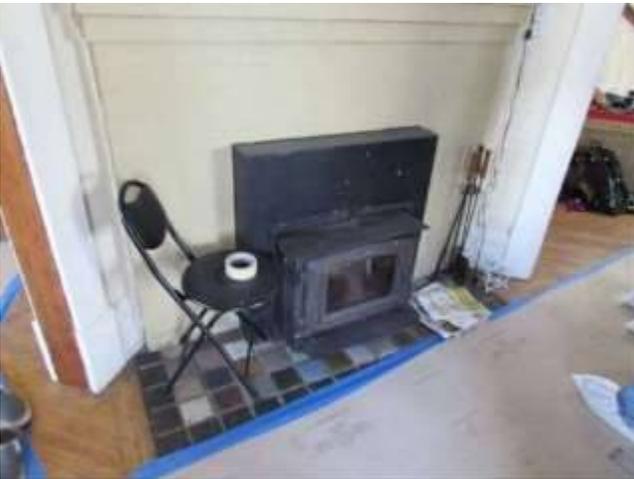
Photo 52-1

Solid fuel-burning fireplaces or stoves were present at the property. When such devices are used, they should be professionally inspected and cleaned annually to prevent creosote build-up and to determine if repairs are needed. The National Fire Protection Association states that a "Level 2" chimney inspection should be performed with every sale or transfer of property with a wood-burning device. I suggest consulting with the property owner about recent and past servicing and repairs to all wood-burning devices and chimneys or flues at this property. I recommend that a qualified specialist evaluate all solid fuel-burning devices and chimneys, and clean and repair as necessary. Note that if a wood stove insert is installed, it may need to be removed for such an evaluation. For more information, search for "chimney inspection" at:

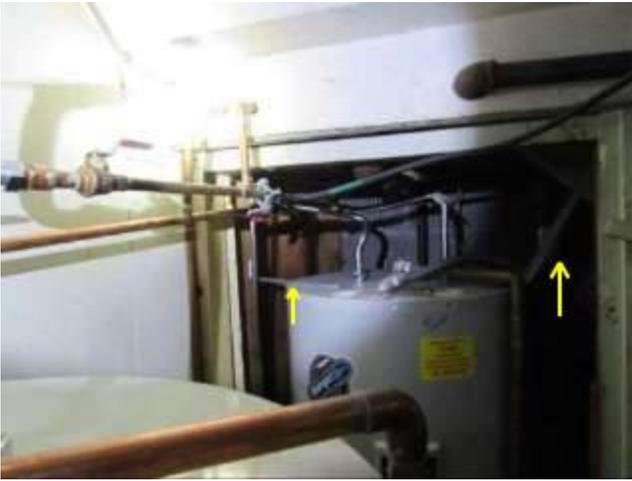
Photo 54-1

The water heaters earthquake straps were not secured properly. This is a safety hazard in the event of an earthquake due to the risk of the water heater tipping over, gas lines breaking if it's gas-fired, or electric wiring being damaged if powered by electricity. Leaks may also occur in water supply pipes or fittings. I recommend that a qualified person install earthquake straps per standard building practices.

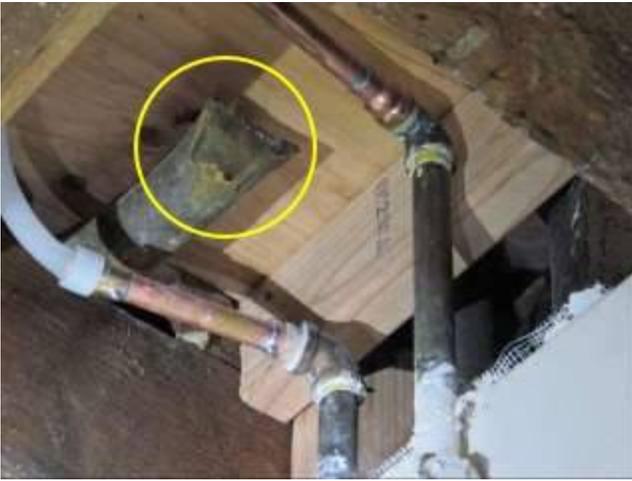
Photo 57-1

There was old lead pipes that looked like they have been discontinued, but can not verify throughout entire home. Lead service pipes are antiquated and should be replaced immediately to eliminate this hazard. Have a qualified plumber replace lead components in supply system as necessary. For more information visit: <http://www.reporthost.com/?LEAD>

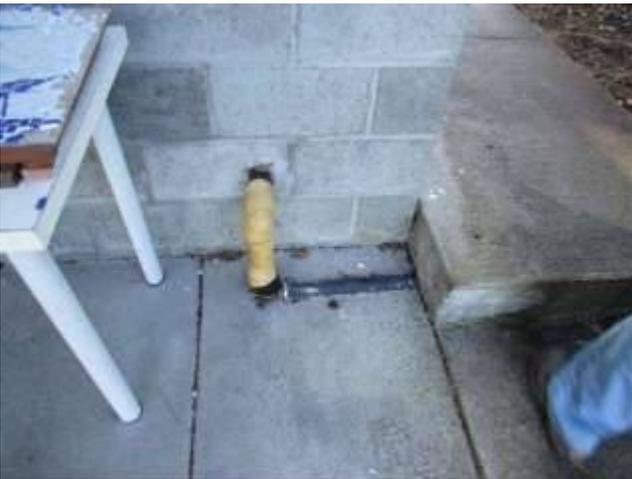
Photo 60-1

The inspector was unable to determine the output location for the basement sinks discharge pipe. Discharge pipes should terminate well away from foundations to soil sloping down and away so water doesn't accumulate around the foundation or in crawl spaces or basements. If it does terminate close to the foundation, I recommend that a qualified person repair per standard building practices.

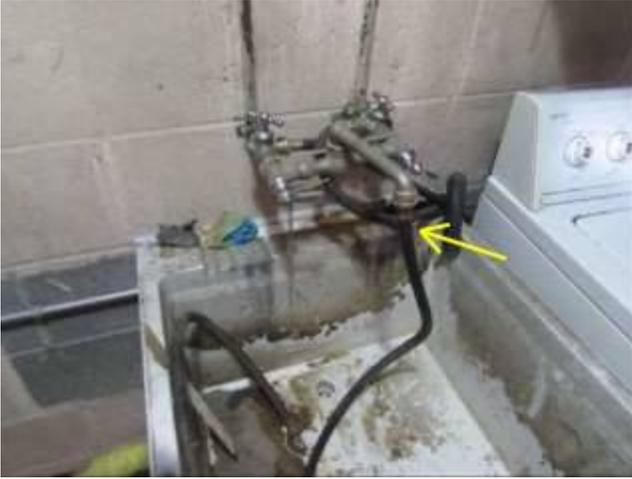
Photo 61-1

61) Basement sink had hose attachment into the sink. This could be a possible access point for cross contamination of unknown and/or hazard fluid into the main drinking water source. Recommend removal of hose.

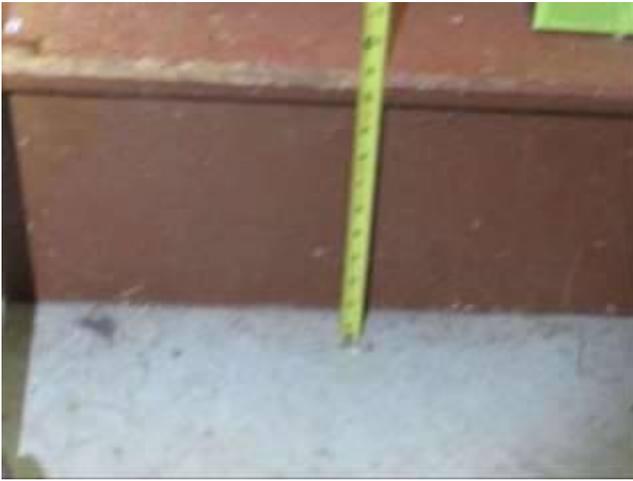
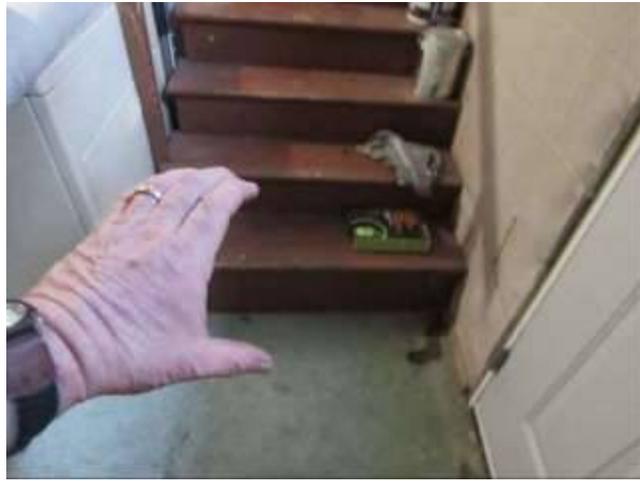
Risers for stairs in basement utility room were higher than 7 3/4 inches and posed a fall or trip hazard. Risers should be 7 3/4 inches or shorter. At a minimum, be aware of this hazard, especially when guests who are not familiar with the stairs are present. I recommend that a qualified contractor repair per standard building practices.

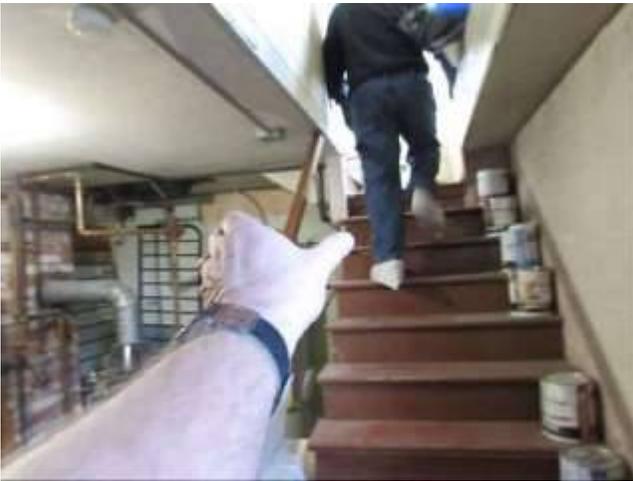
Photo 63-1

63) 🚧🔪 Handrails were missing in basement utility room and posed a fall hazard. Handrails should be 1 1/4 - 2 inches in diameter if round, or 2 5/8 inches or less in width if flat. I recommend that a qualified person install graspable handrails or modify existing handrails per standard building practices.

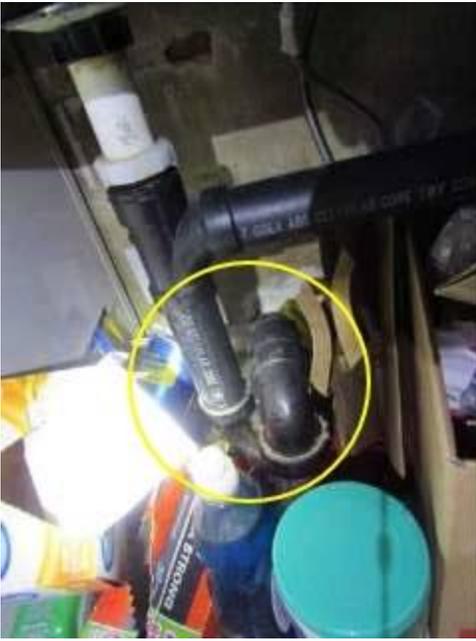
Photo 66-1

The sink drain pipe used an S-trap rather than a P-trap in the upper unit. Siphons and sudden flows of water in S-Traps can drain all the water out of the trap, leaving it dry. Sewer gases can then enter living areas. I recommend that a qualified plumber repair per standard building practices.
