First Sergeant Inspection Services, LLC

Property Inspection Report

Property address: **123 Steele LN**
Lacey, WA 98501

Inspection date: **Thursday, March 1, 2018**

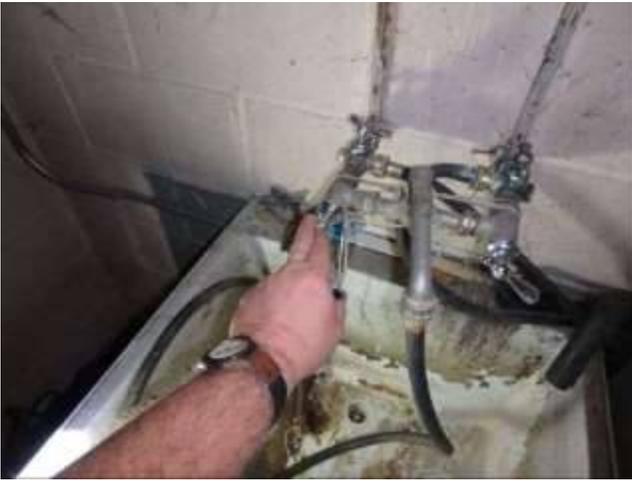
Photo 70-1

The sink faucet in utility room was damaged. I recommend that a qualified person repair as necessary.
