## **First Sergeant Inspection Services, LLC**

## **Property Inspection Report**

**Property address: 1234 Main St**

**Inspection date: Saturday, November 10, 2018**

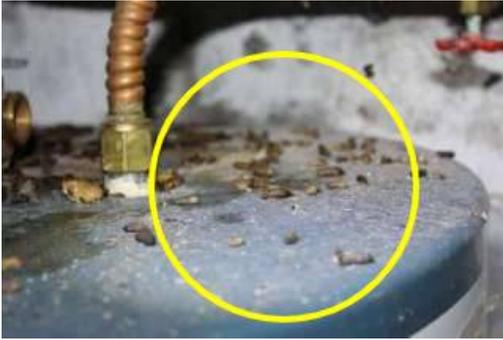
Photo 2-1

Evidence of bird infestation was found in chimney. Recommend having a qualified bird control contractor to evaluate and relocate as necessary.

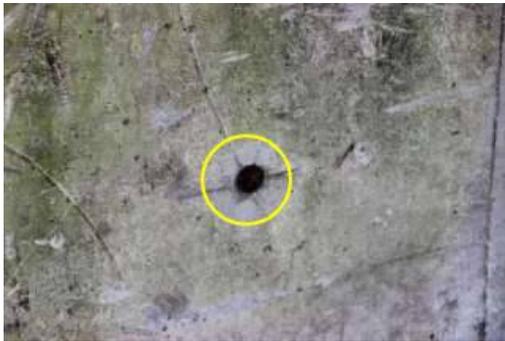
Photo 5-1

Hardware in the back concrete porch had pins that were significantly corroded. Corroded hardware is more likely to fail prematurely, and is a potential safety hazard. Also, holes that were not sealed that can collect water and corrode the concrete. Recommend that a qualified contractor replace significantly corroded hardware as necessary.

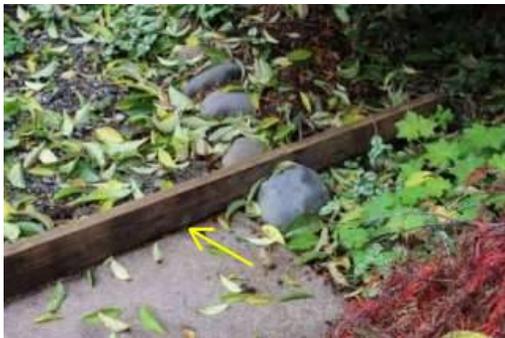
Photo 6-1

A landscaping timbers was in front of the walkway to the front door poses a trip hazard. Recommend that a qualified person replace landscaping timbers as necessary.

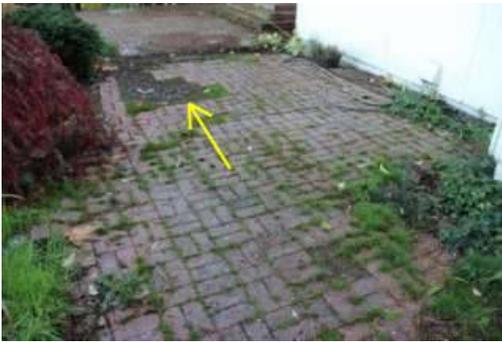
Photo 7-1

Brick used for the back of the residence for walkways and patios uneven and had gaps poses a trip hazard. Also, the front steps into the residence had several tiles broken or missing. For safety reasons, recommend that a qualified contractor repair as necessary to eliminate trip hazards.

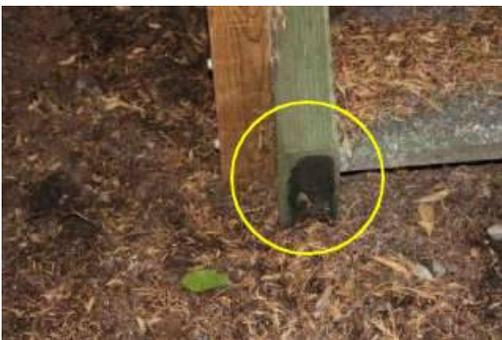
Photo 8-1

Fungal rot was found in two (2) stringers at the exterior stairs back side patio. Fungal rot in some stair components may pose a safety hazard. Recommend that a qualified person evaluate and repair as necessary. All rotten wood should be replaced.

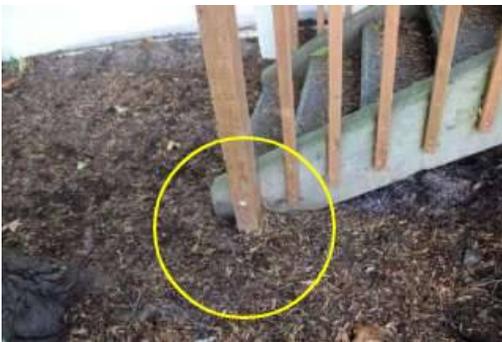
Photo 9-1

9) Soil was in contact with or close to wooden stairs at the rear of the residence. This is a conducive condition for wood-destroying organisms. Soil should be graded and/or removed so no wood-soil contact is present, if possible. Otherwise, installing products such as borate-based Impel rods may help to prevent infestation and damage. For more information, visit: <https://www.reporthost.com/?IMPEL>

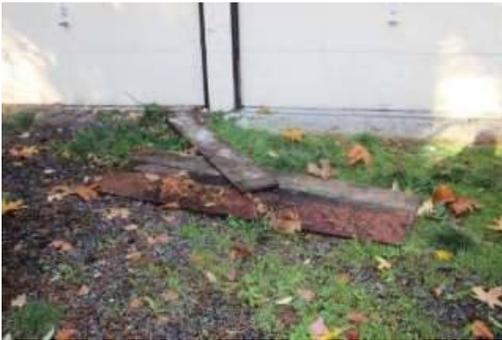
Photo 10-1

10) Significant amounts of debris and stored items was found in front of and on the side of the garage.

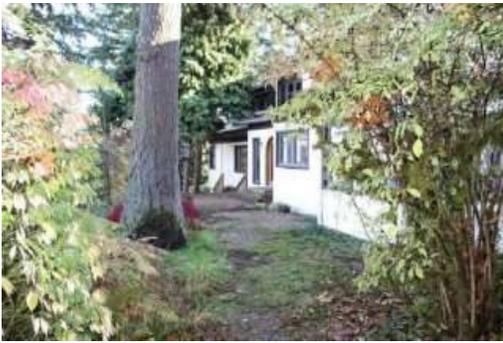
Photo 12-1

Multiple trees were very close to the foundation. Tree roots can cause significant structural damage to foundations, or may have already caused damage (see other comments in this report). Recommend that a qualified tree service contractor or certified arborist remove trees as necessary to prevent damage to foundations.

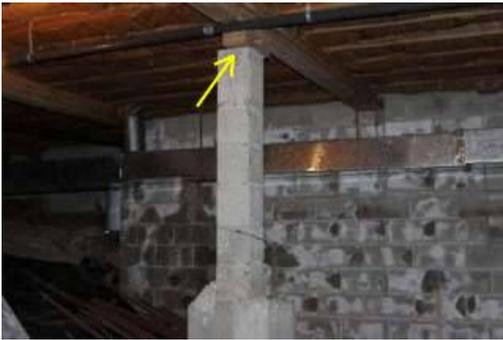
Photo 14-1

14) 🔍 There was a lack of positive connects at the top of support posts. Recommend that a qualified contractor evaluate and repair as necessary.

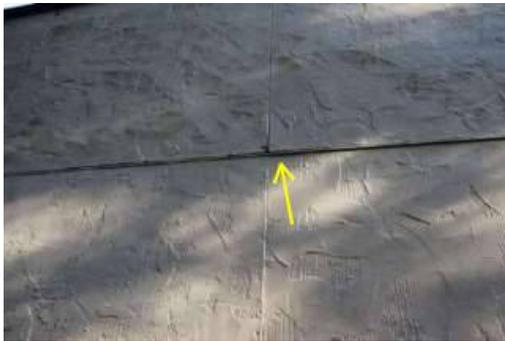
Photo 15-1

15) 🔍 Multiple gaps found in the siding. Vermin, insects or water may enter the structure. Recommend that a qualified person repair as necessary.

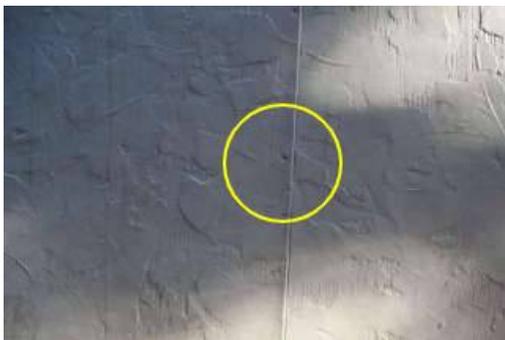
Photo 16-1

Some nail heads at the composition wood siding were protruding from the wood, or had been nailed in so as to break the surface of the siding, and caulk was missing. Most manufacturers of composition wood siding specify that nail heads should be flush with the surface, and that the surface of the siding should not be broken. If broken, then caulk should be applied to the nail heads to prevent water penetration and subsequent deterioration of the siding. Recommend that a qualified person repair per the siding manufacturer's specifications.

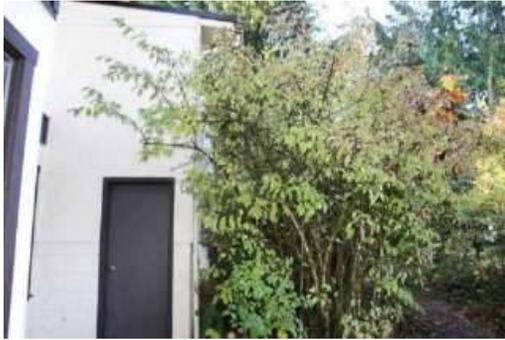
Photo 17-1

wood-destroying insects and can retain moisture against the exterior after it rains. This is a conducive condition for wood-destroying organisms. Recommend pruning, moving or removing vegetation as necessary to maintain at least 6 inches of space between it and the building exterior. A 1-foot clearance is better.

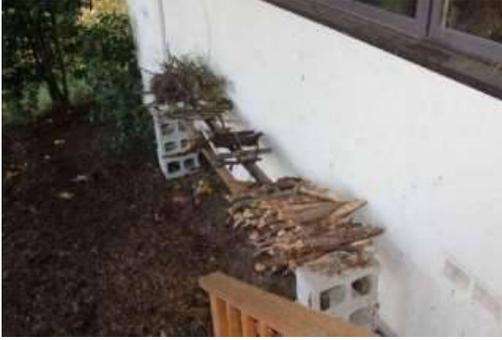
Photo 18-1

18) **i** Firewood was stored so that it was in contact with or close to the building exterior. This is a conducive condition for wood-destroying organisms. Recommend storing firewood outdoors in an open area, and as far away from buildings as practical to keep insects away from buildings. For more information visit:

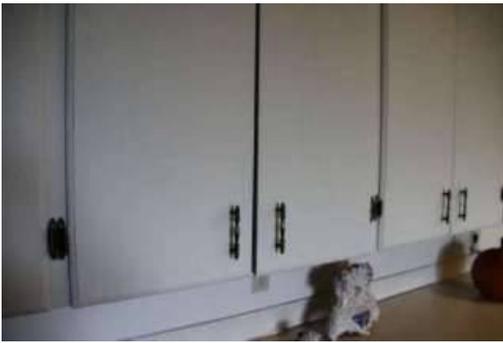
Photo 22-1

Two (2) cabinets were loose, or were secured with too few or substandard fasteners. An adequate number of appropriate fasteners should be used. For wall-hung cabinets, inadequate fasteners can pose a safety hazard if cabinets fall. Recommend that a qualified person repair as necessary.

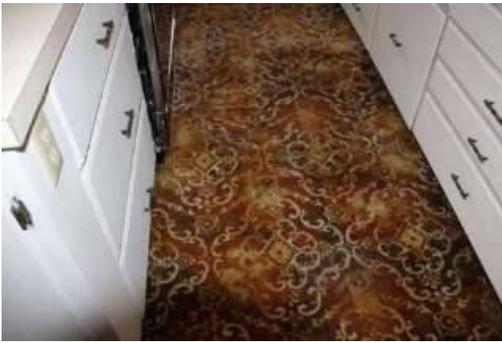
Photo 27-1

Carpeting in the kitchen was loose and posed a trip hazard. Recommend that a qualified contractor repair as necessary. For example, by stretching or replacing carpeting.

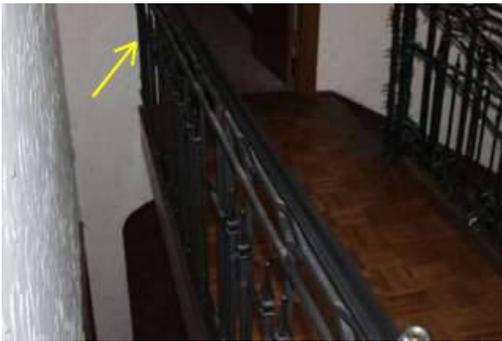
Photo 28-1

The guardrail on the second floor with drop-offs higher than 30 inches was loose and wobbly, and poses a fall hazard. Recommend that a qualified person repair guardrails as necessary.

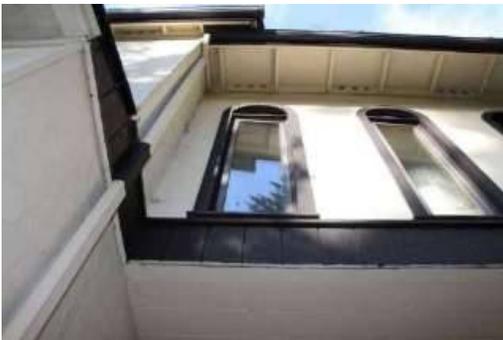
Photo 30-1

Based on height of windows from the ground and planned occupancy (children in home), recommend that the client consider installing window guards for child safety. For more information, visit: <https://www.reporhost.com/?WNDWGRDS>

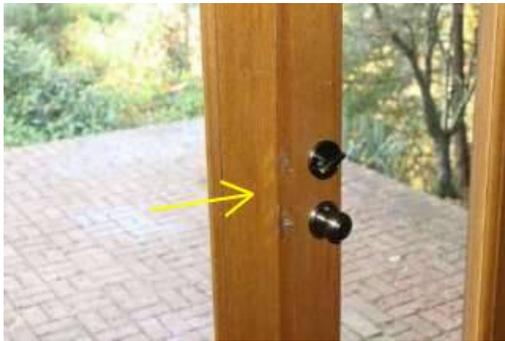
Photo 31-1

Dining room door was difficult to open/close and had obvious wear/damage on the exterior. Recommend that a qualified person repair as necessary.

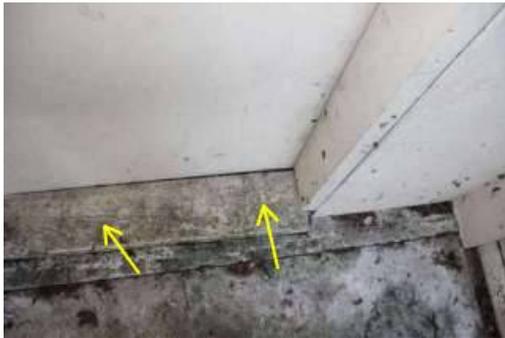
Photo 32-1

Trim to basement was damaged. Recommend that a qualified person repair, replace or install as necessary.

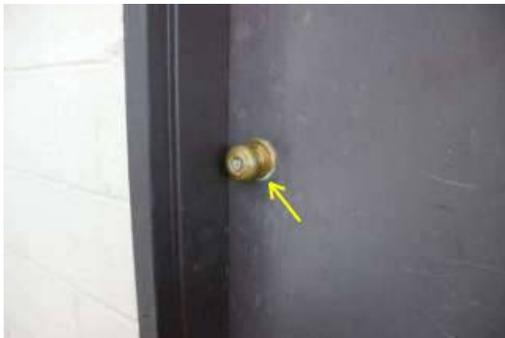
Photo 33-1

Exterior garage door hardware was corroded. Recommend that a qualified person repair or replace as necessary.

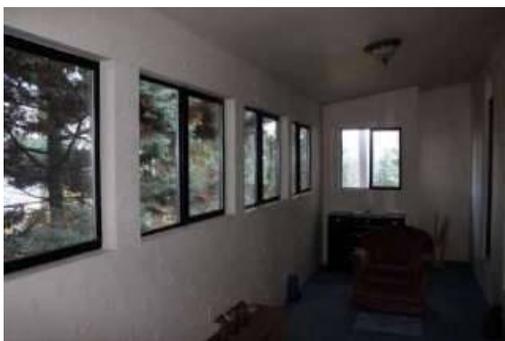
Photo 34-1

Several windows in the master bedroom sitting room were stuck shut. Recommend that a qualified person repair windows as necessary so they open and close easily.

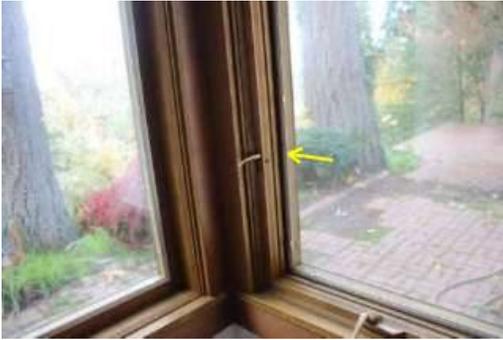
Photo 35-1

The lock mechanisms on the kitchen and master bedroom casement windows were difficult to open/lock. Recommend that a qualified person repair as necessary.

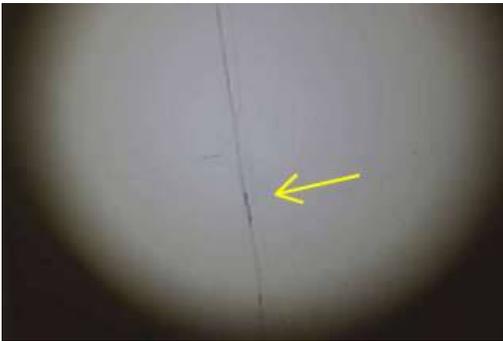
Photo 36-1

Multiple holes and cracks throughout residence. Recommend that a qualified person repair as necessary.

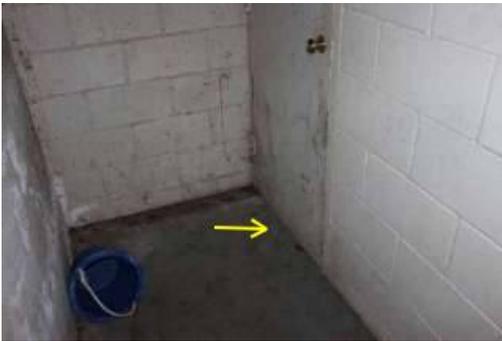
**Photo 37-1**

Weatherstripping around garage door was missing. Water may enter the building, or energy efficiency may be reduced. Recommend that a qualified person repair or replace weatherstripping as necessary.

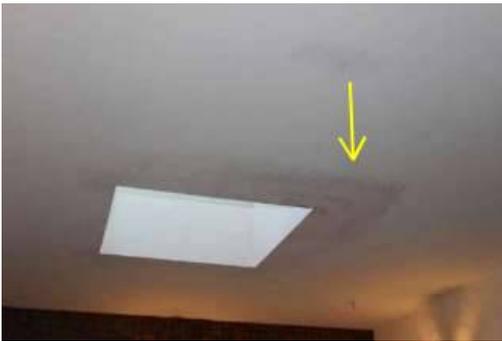
**Photo 38-1**

Master bathroom showed signs of damage, possibly by past condensation or water leaks. Recommend that a qualified person evaluate and repair as necessary.

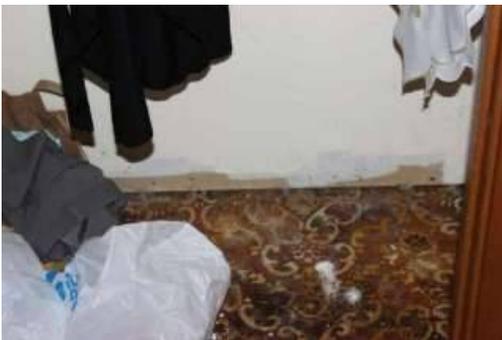
**Photo 39-1**

Trim was missing from the utility room. Recommend that a qualified person repair as necessary.

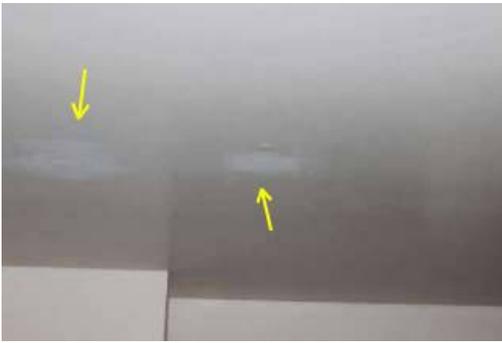
Photo 41-1

Patches or evidence of prior repairs was found in kitchen ceiling. Recommend asking the property owner about the repairs (e.g. why necessary, whether prior leaks have occurred).

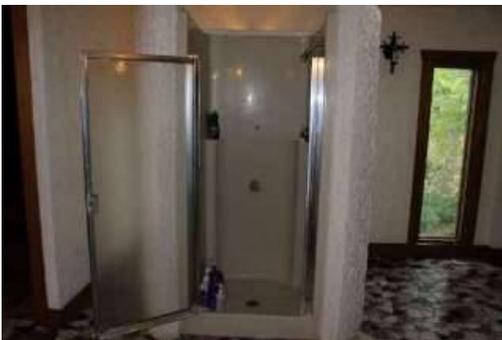
Photo 46-1

The inspector was unable to verify that the glass used in one or more by the shower and/or spa at location(s) #C was approved safety glass. Glazing that is not approved safety glass located in areas subject to human impact is a potential safety hazard. Standard building practices require that approved safety glass be used in enclosures for bathtubs, showers, spas, saunas and steam rooms, and in windows where the bottom edge of the window is less than 60 inches above the drain inlet or standing surface. Wire-reinforced glass is not acceptable. Recommend that a qualified contractor evaluate further to determine if glazing is approved safety glass, and replace glass if necessary, and per standard building practices.

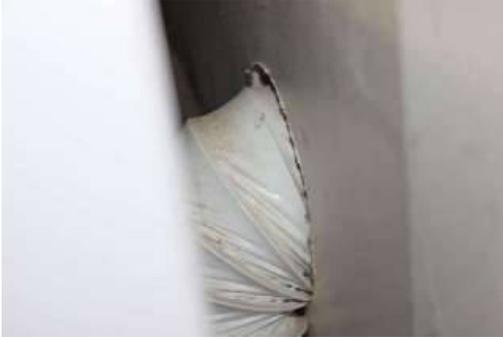
Photo 47-1

The clothes dryer's flexible exhaust duct was routed through a wall, building substructure or attic. This type of duct is easily damaged, prone to clogging and not suitable for this purpose. Clothes dryers may overheat. This is a potential fire hazard. It is acceptable for a short length of corrugated, semi-rigid metal duct (not accordion flex-duct) be used between the dryer and the wall or floor fitting, but duct runs through walls, building substructures and attics should be made of rigid metal, and wrapped in R-4 insulation if routed through an unheated space. Recommend that a qualified person replace

ducting per standard building practices.

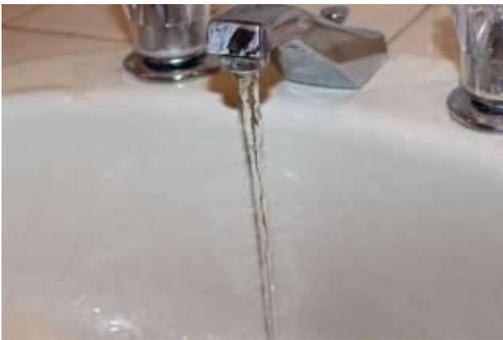
Photo 48-1

The cold water supply flow for the sink at location(s) #C was low or inoperable. Recommend that a qualified plumber evaluate and repair as necessary.

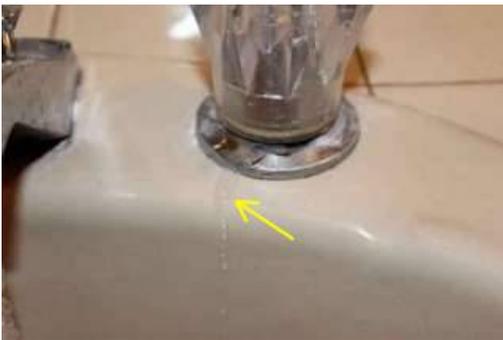
Photo 49-1

The right side sink faucet handles at location(s) #C was leaking. Recommend that a qualified person repair or replace as necessary.

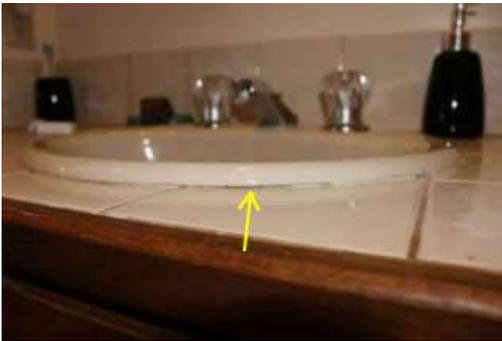
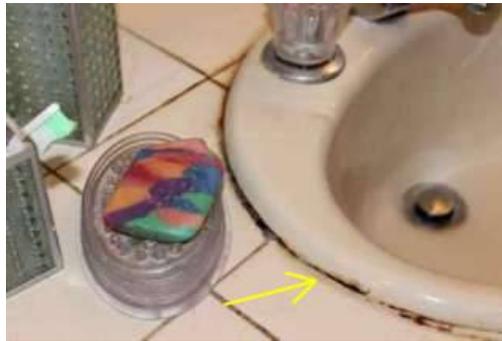
Substandard caulking was found around the sink at location(s) #B and C. Water can penetrate these areas and cause damage. Recommend that a qualified person repair as necessary. For example, by installing or replacing caulk.

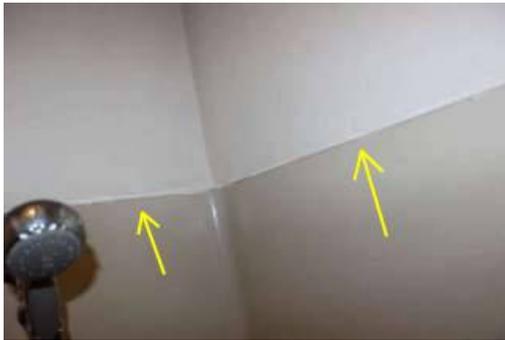
Photo 54-1

Substandard caulking was found between the bathtub and the walls at location(s) #B. Water may penetrate these areas and cause damage. Recommend that a qualified person re-caulk or install caulking as necessary.

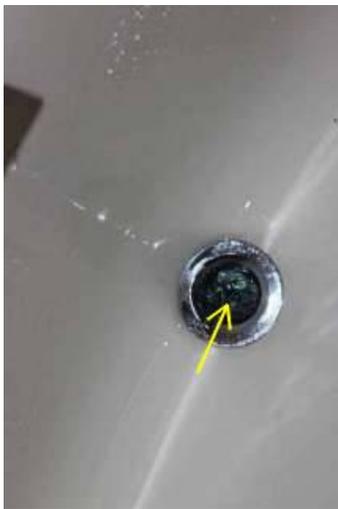
Photo 55-1

The bathtub drain stopper mechanism at location(s) #C was missing. Recommend that a qualified person repair or replace as necessary.

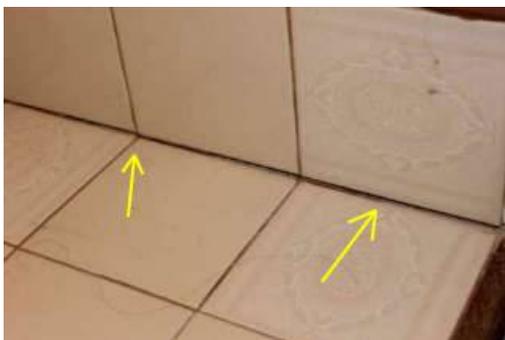
Photo 57-1

Recommend cleaning and sealing the grout at countertops at location(s) #C now and in the future as necessary to prevent staining and to improve waterproofing.

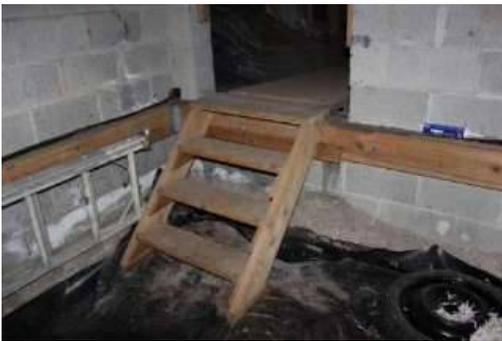
Photo 58-1

Guardrails at basement with drop-offs higher than 30 inches were missing. This poses a fall hazard. Guardrails should be installed where walking surfaces are more than 30 inches above the surrounding grade or surfaces below. Recommend that a qualified contractor install guardrails where missing and per standard building practices.

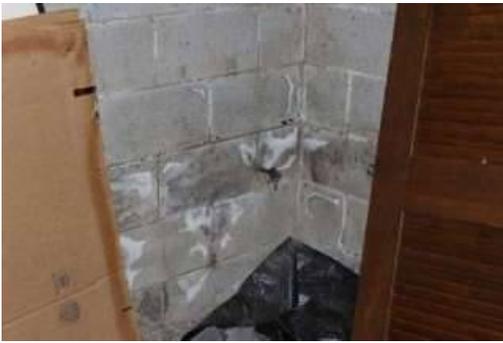
Photo 59-1

Evidence of prior water intrusion was found in one or more sections of the basement. For example, water stains or rust at support post bases, efflorescence on the foundation, etc. Accumulated water is a conducive condition for wood-destroying organisms and should not be present in the basement. Recommend reviewing any disclosure statements available and ask the property owner about past accumulation of water in the basement. The basement should be monitored in the future for accumulated water, especially after heavy and/or prolonged periods of rain. If water is found to accumulate, then recommend that a qualified contractor who specializes in drainage issues evaluate and repair as necessary. Typical repairs for preventing water from accumulating in basements include:

- Repairing, installing or improving rain run-off systems (gutters, downspouts and extensions or drain lines)
- Improving perimeter grading
- Repairing, installing or improving underground footing and/or curtain drains

Ideally, water should not enter basements, but if water must be controlled after it enters the basement, then typical repairs include installing a sump pump.

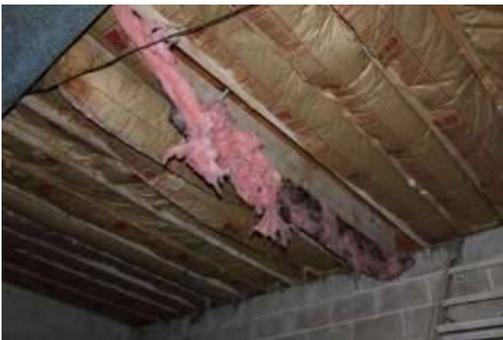
Photo 60-1

Under-floor insulation in the basement was damaged apparently by rodents. This may result in reduced energy efficiency and may produce unpleasant odors. For energy efficiency and sanitary reasons, recommend that a qualified contractor replace all under-floor insulation.

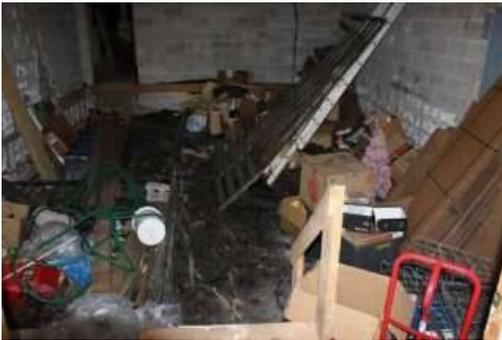
Photo 62-1

62) ⓘ Some areas in the basement was not evaluated due to lack of access from stored items and/or debris. These areas are excluded from the inspection.

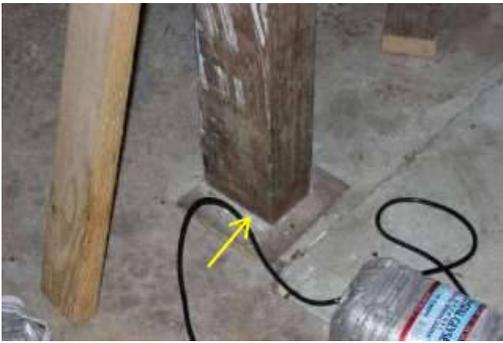
Photo 67-1

Several garage support posts were not positively secured to the beam above and/or the foundation below. While this is common in older homes, current standards require positive connections between support posts and beams above for earthquake reinforcement and for impact resistance from vehicles. Recommend that a qualified contractor repair per standard building practices. For example, by installing metal plates, plywood gussets or dimensional lumber connecting posts and beams, and/or installing anchors to the slab/footing below. Note that some support posts have concealed fasteners at their bases that are not visible.

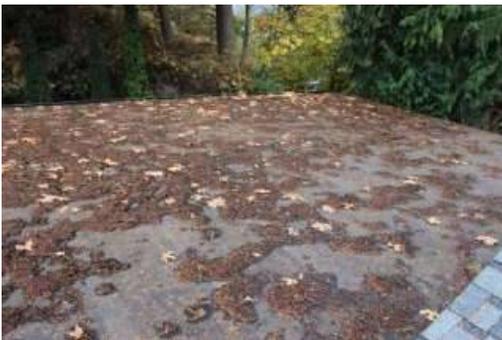
Photo 72-1

Significant amounts of debris such as leaves, needles, seeds, etc. have accumulated on the roof surface. Water may not flow easily off the roof, and can enter gaps in the roof surface. Leaks can occur as a result. This is a conducive condition for wood-destroying organisms. Recommend cleaning debris from the roof surface now and as necessary in the future.

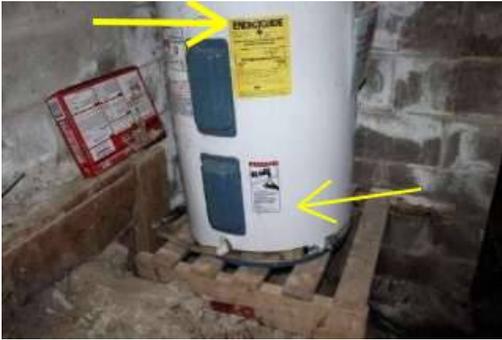
Photo 73-1

The water heater did not have earthquake straps installed in basement. This is a potential safety hazard in the event of an earthquake due to the risk of the water heater tipping over, gas lines breaking if it's gas-fired, or electric wiring being damaged if powered by electricity. Leaks may also occur in water-supply pipes or fittings. Recommend that a qualified person install earthquake straps per standard building practices.

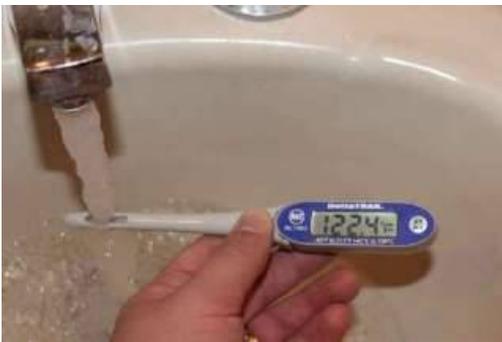
Photo 77-1

77) **+** The hot water temperature was greater than 120 degrees Fahrenheit. This is a safety hazard due to the risk of scalding. The thermostat should be adjusted so the water temperature doesn't exceed 120 degrees. If the water heater is powered by electricity, a qualified person should perform the adjustment, since covers that expose energized equipment normally need to be removed. For more information on scalding dangers, visit: <https://www.reporthost.com/?SCALD>

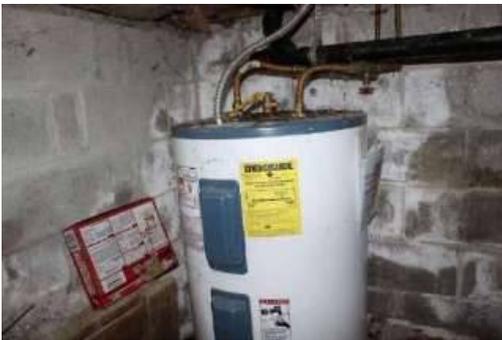
Photo 78-1

78) **🔧🔍** No thermal expansion tank was installed at any of the three (3) water heaters, and the plumbing system may be "closed" based on the possible installation of a backflow prevention device in the water supply system. In a closed system an expansion tank should be installed to allow room for water in the system to expand. Without one, the water heater's temperature-pressure relief valve can leak or become damaged, or toilets can "run" due to excess pressure overcoming the fill valve. Recommend that a qualified plumber install an expansion tank per standard building practices.

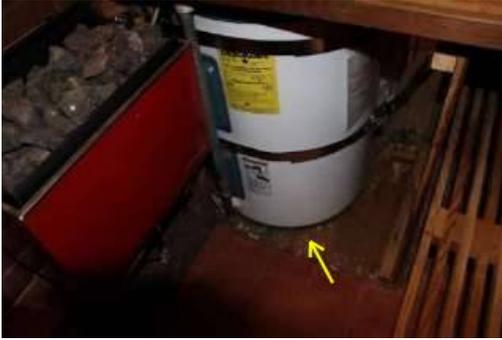
Photo 80-1

80) **📘** A water heater was installed over a finished living space and no catch pan or drain was installed in the sauna. Catch pans and drains prevent water damage to finished interior spaces below if or when the water heater leaks or is drained. If concerned, consult with a qualified contractor about installing these. Note that drain lines for catch pans are usually installed below the floor level and are difficult at best to install in an existing home.

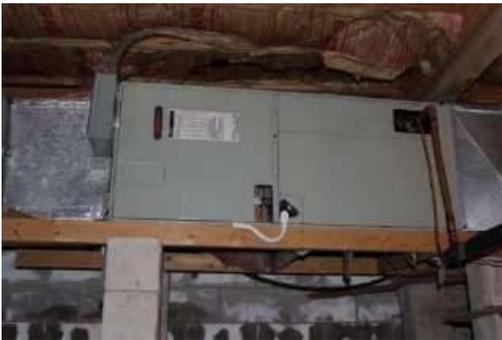
Photo 81-1

The estimated useful life for most forced air furnaces is 15-20 years. This furnace appeared to be near this age and/or its useful lifespan and may need replacing or significant repairs at any time. Recommend budgeting for a replacement in the near future.

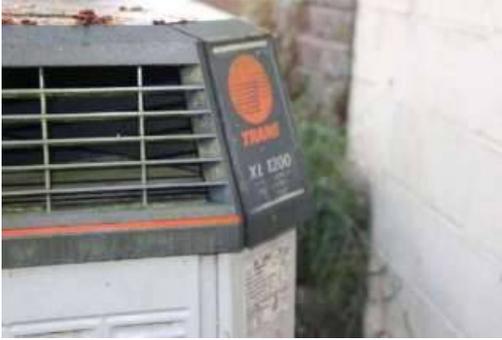
**Photo 82-1**

The estimated useful life for most heat pumps and air conditioning condensing units is 10-15 years. This unit appeared to be beyond this age and/or its useful lifespan and may need replacing or significant repairs at any time. Recommend budgeting for a replacement in the near future.

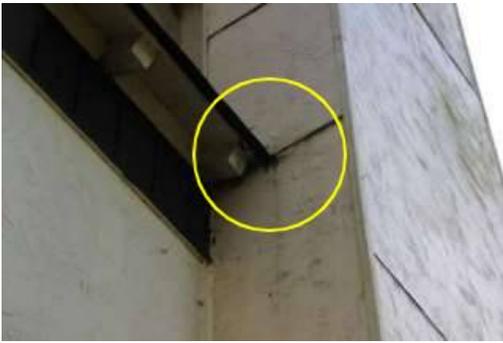
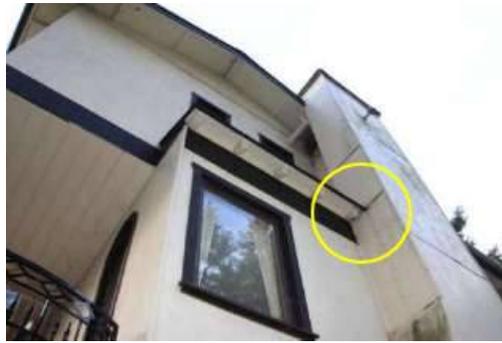
Kick-out flashing was missing at the chimney. Such flashing should be located at the bottom of slopes where roof surfaces intersect with exterior walls above. It directs rainwater away from exterior walls and into gutters so that rainwater is less likely to run down the front surfaces of siding or flow behind siding. Recommend that a qualified contractor install kickout flashings where missing and per standard building practices.

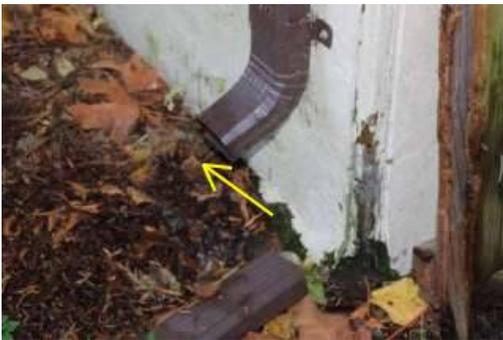
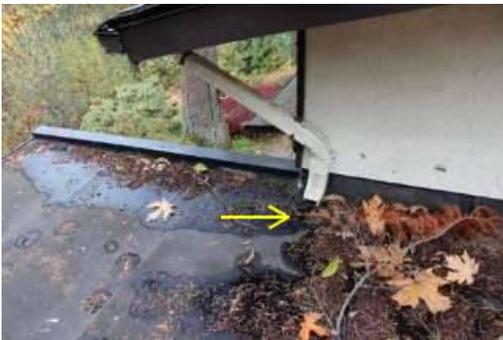
90) Extensions such as splash blocks or drain pipes for several downspouts was missing on top of garage and first/second floor on back side of residence. Water can accumulate around the building foundation or basement and/or cause excessive wear on shingles as a result. Recommend that a qualified person install, replace or repair extensions as necessary so rainwater drains away from the structure.

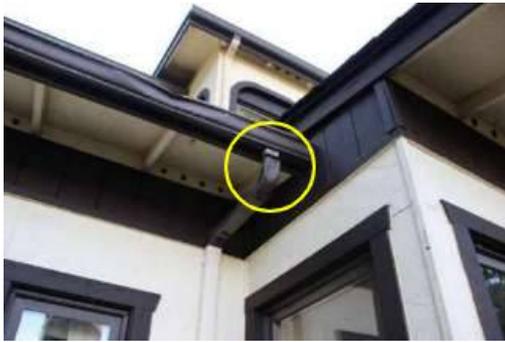
Photo 92-1

Downspouts on NE side detached. Rainwater can come in contact with the building exterior or accumulate around the foundation as a result. This is a conducive condition for wood-destroying organisms. Recommend that a qualified person repair as necessary.
