Thermographic Inspection at

Our Clients Office

Nov-19

Hope Electrical

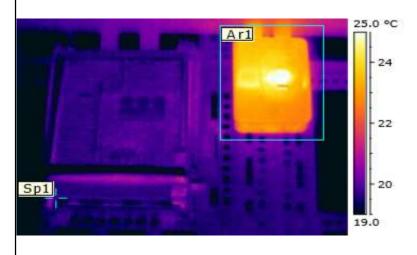
Location Plant room Equipment Fused switch

Type Fuses fault 2
Recommendation Upgrade

Fused switch running hot in comparison

Loading and circuit design to be checked

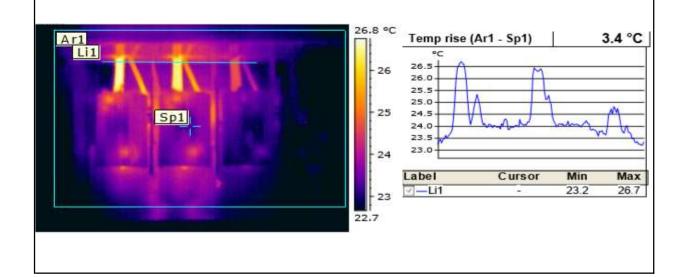
Location	Income room	
Equipment	Main fuses	
Туре	Fuses	
fault	2	
Recommendation	Check balance

This image and graph shows an imbalanced supply

Check loadings and balance where possible.

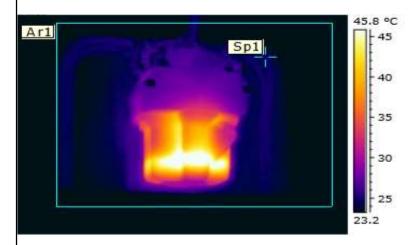
Location	Plant room
Equipment	Contactor
Туре	Oil filled
fault	1
Recommendation	Monitor

Oil filled contactor running hot possible cause low oil level or poor contacts.

Check oil level and contacts.

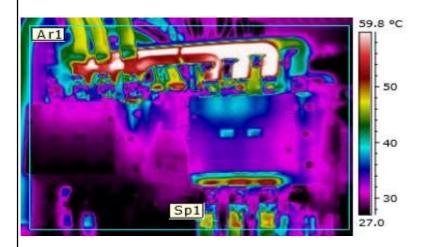
View of top changeover contactor running hot on red & yellow phases.

Check connections and circuit design.

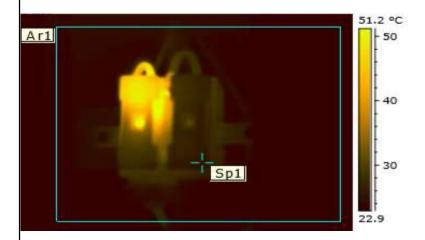
Location	Switch room
Equipment	Distribution board
Туре	Fuses
fault	2
Recommendation	Replace

Top part of fuse holder and cable running hot which points to a poor connect

Check and re-terminate connection.

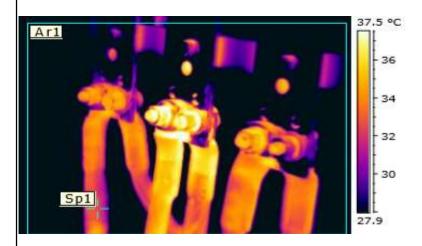
Location	Income room
Equipment	Main terminals
Туре	Income room
fault	2
Recommendation	Inform board

L2 phase running hot possible poor connection

Re-terminate at next available shutdown.

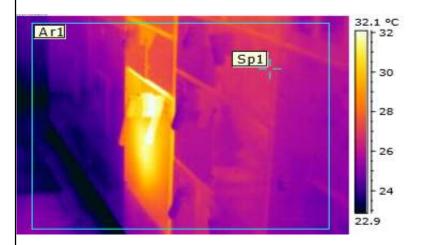
Location	Income room
Equipment	Main terminals
Туре	Income room
fault	2
Recommendation	Inform board

Switch front running hot, this is being heated from connections / fuses inside.

Requires internal visual investigation.

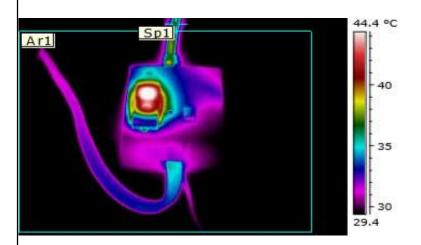
Location	Income room
Equipment	Main terminals
Туре	Income room
fault	2
Recommendation	Inform board

Fuse holder running hot due to poor connection.

Re-terminate and check for damage / Replace

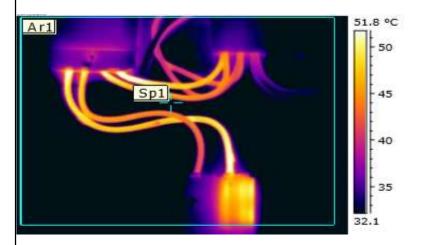
Location	Income room	
Equipment	Main terminals	
Туре	Income room	
fault	2	
Recommendation	Inform board

Fuse holder running hot due to loading which can be seen at meter and service connector. Phase cable at meter has a poor connection due to being under stress caused by being too short.

Check maximum demand and resize supply as required.

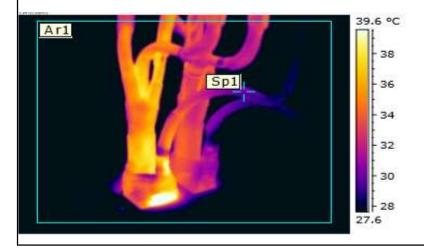
Location	Mains room
Equipment	Incoming supply
Туре	Supply cable
fault	2
Recommendation	Investigate

Image shows dual supply cables with one cable running hotter in comparison

To be investigated

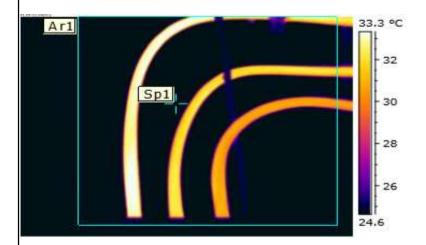
Location	Switch room
Equipment	Sub main
Туре	Tails
fault	2
Recommendation	Investigate

Supply running out of balance.

Balance where possible.
