OFFICE BUSINESS SOLUTIONS INC.

SUBJECT: SC542 OCCURS SYMPTOM:

LANIER – MP 6002/MP 7502/MP 9002 RICOH – AFICIO MP 6002/MP 7502/MP 9002
SAVIN – MP 6002/MP 7502/MP 9002

SUBJECT: MULTIPLE SYMPTOM:

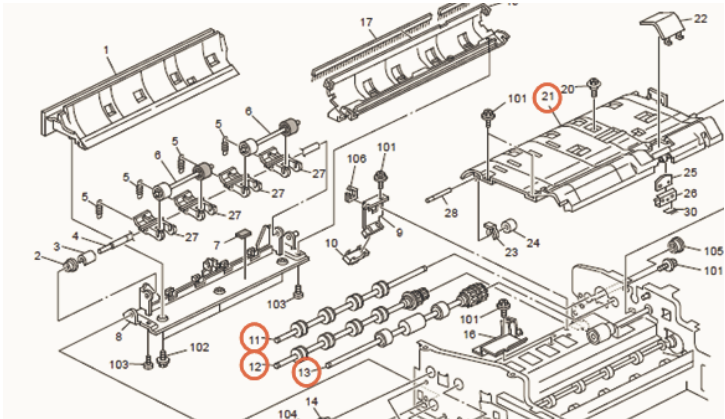
- Item 21: D4122252 - Guide: Paper Feed: Lower
- Item 13: D4122111 - Roller: Pull Out: Drive
- Item 12: B6522411 - Roller: Scanning: Entrance: Drive
- Item 11: D4122121 - Roller: Middle: Drive

Step 1: Perform a thorough physical inspection and check the following parts for wear. Replace the worn parts.
