# Inspection Report

Elma WA 98541

**Prosser Inspections**

<b>Date:</b> 1/14/2021	<b>Time:</b> 01:00 PM	<b>Report ID:</b>
<b>Property:</b>	<b>Customer:</b>	<b>Real Estate Professional:</b> Floyd Sheldon Windermer Yelm

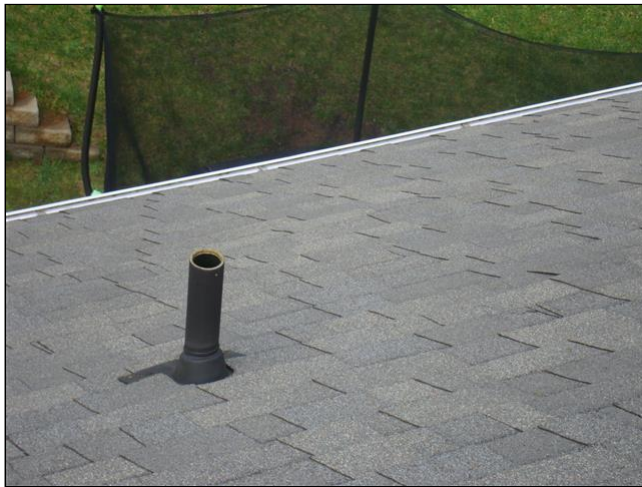
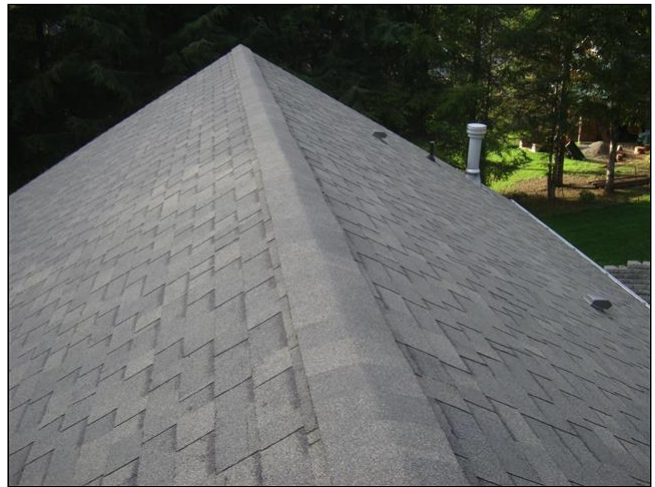
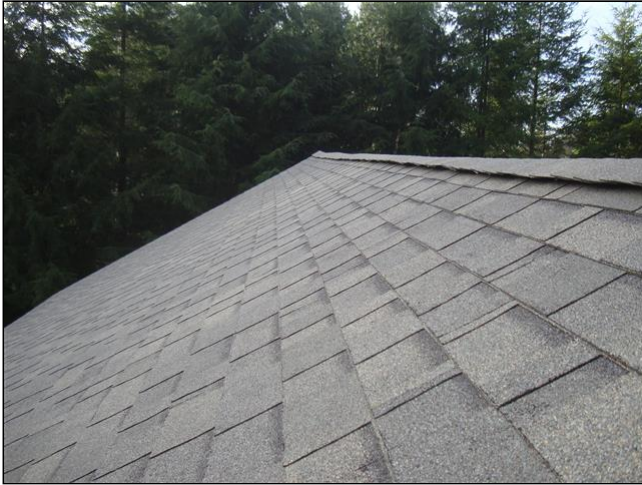
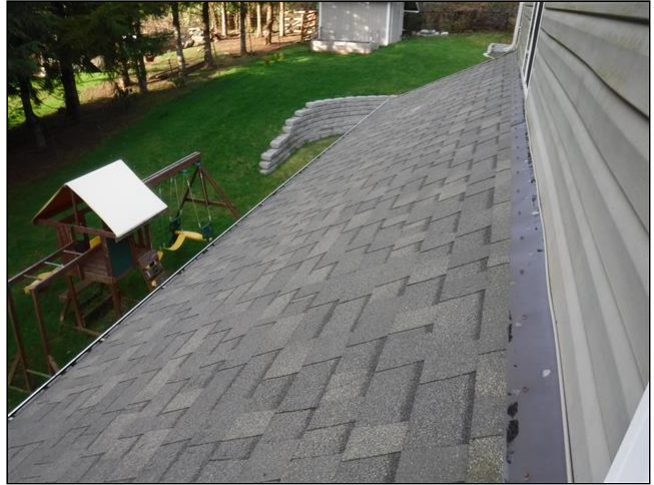
**1.0 (1)** At the time of the inspection a non-invasive visual examination of the roof revealed no obvious major issues. We make every effort to uncover any issues at the time of the inspection, however, underlying issues may be present and events after the inspection may cause issues to arise.

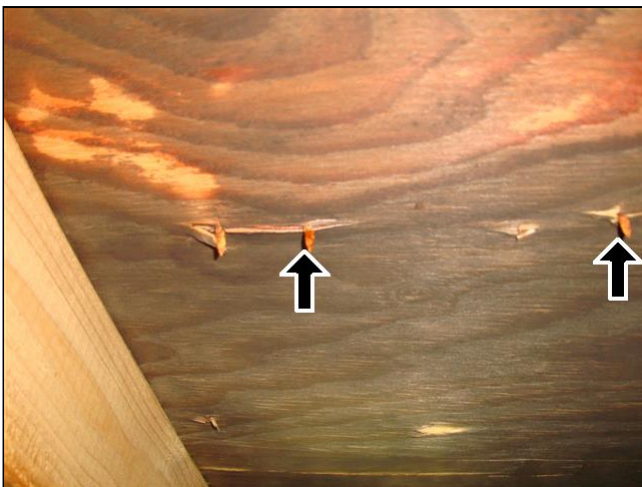
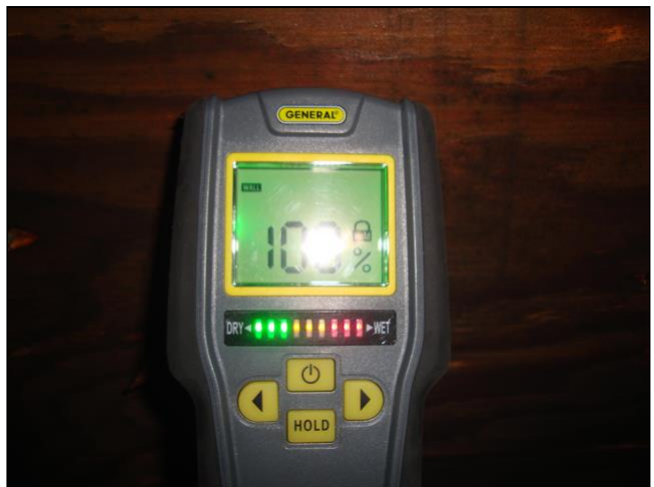
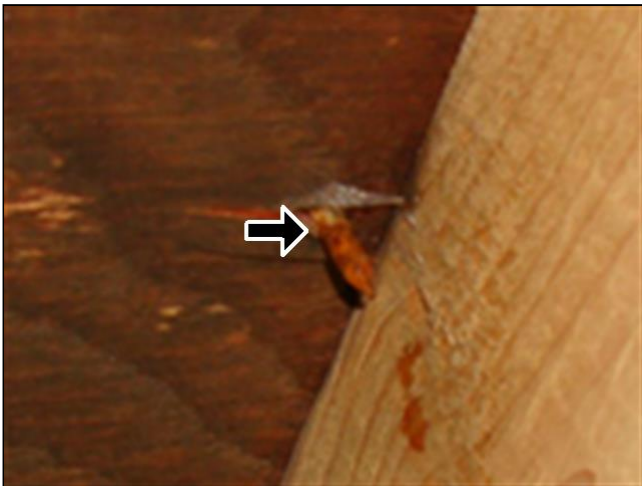
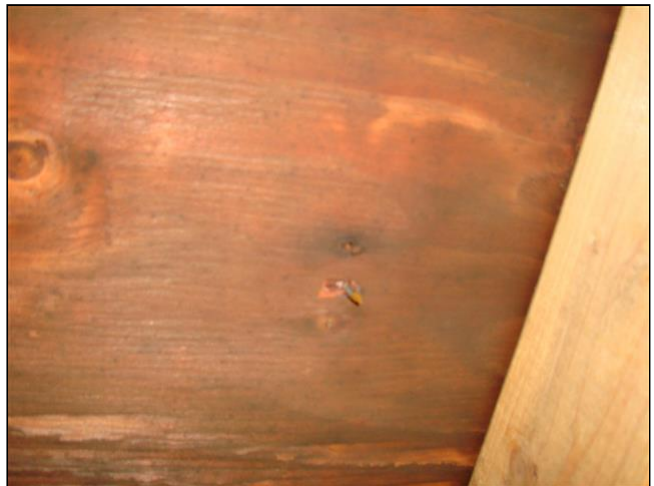
**1.0 (2)** Minor leak observed on rear side 2nd level. Water was observed in attic on nails exposed through roof sheathing. The issue did not appear to be major. We were unable to identify the cause. The roof surface was observed in good condition with no evidence of damage. The moisture could be moisture build up from bath exhaust fans venting into the attic. We recommend further evaluation by a qualified roofing contractor.

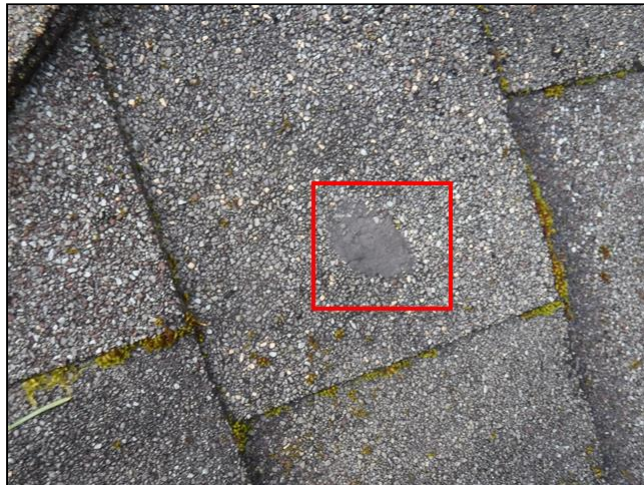
1.0 Item 9(Picture)

**1.0 (3) Minor asphalt shingle roof is patched.** Repaired areas should be closely monitored for indications of degradation that could affect the ability of the roof surface to protect against water infiltration. No adverse affects observed at the time of the inspection.

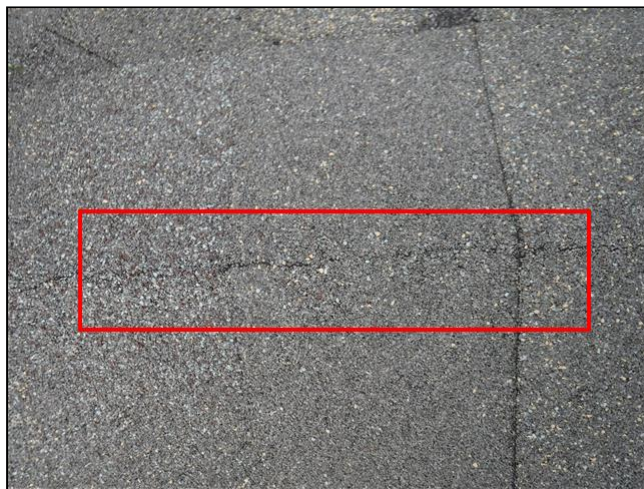
1.0 Item 10(Picture)

**1.0 (4) Minor asphalt shingle crack.** Shingle cracks should be closely monitored for indications of degradation that could affect the ability of the roof surface to protect against water infiltration. No adverse affects observed at the time of the inspection.

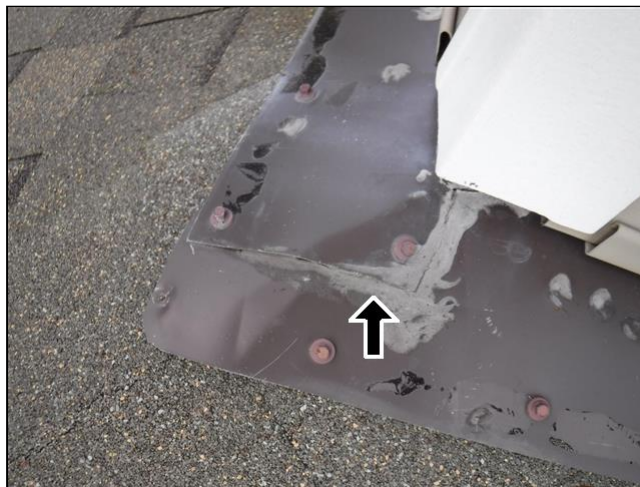
1.2 Item 1(Picture)

**1.2 (2)** Flashing caulking will need to be replaced in the near future. No adverse affects noted at the time of the inspection.

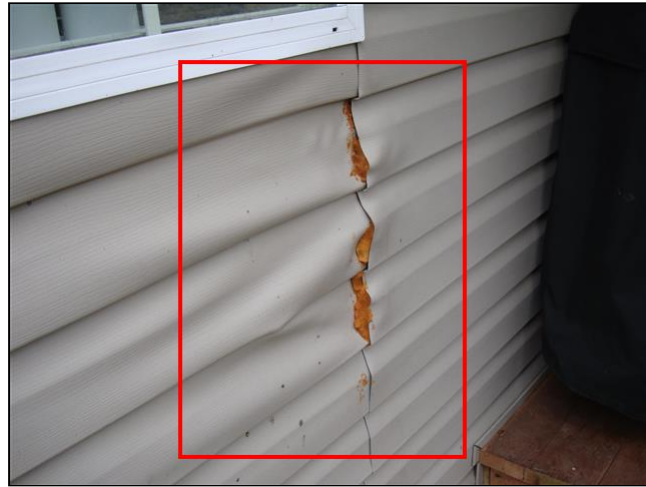
2.0 Item 1(Picture)

2.0 (2) Warped vinyl siding observed at the rear of the home. It appears to be from potential BBQ to close to the siding. No adverse affects noted at the time of the inspection.

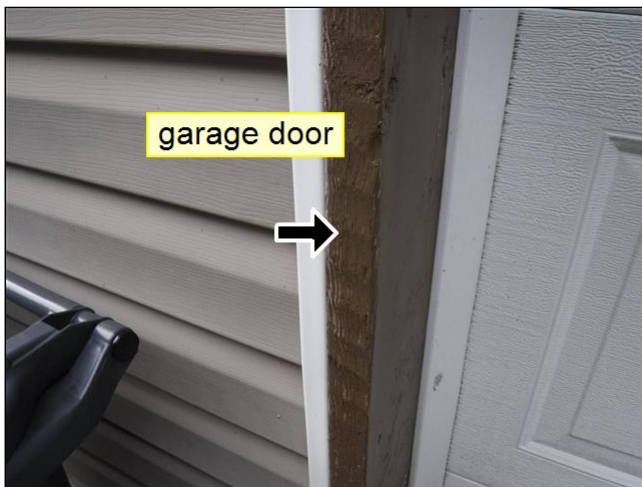
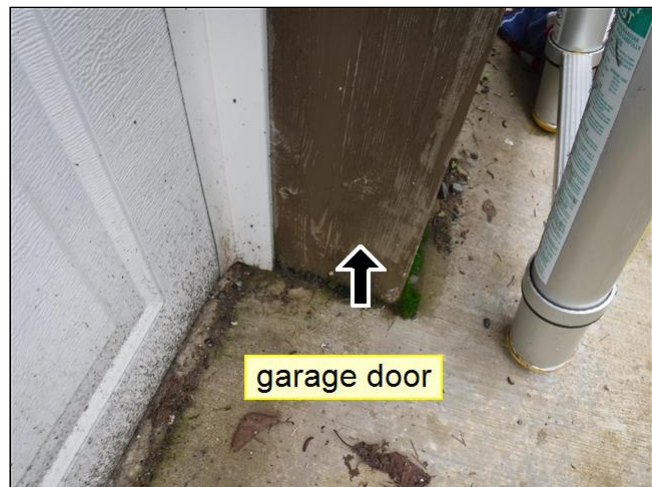
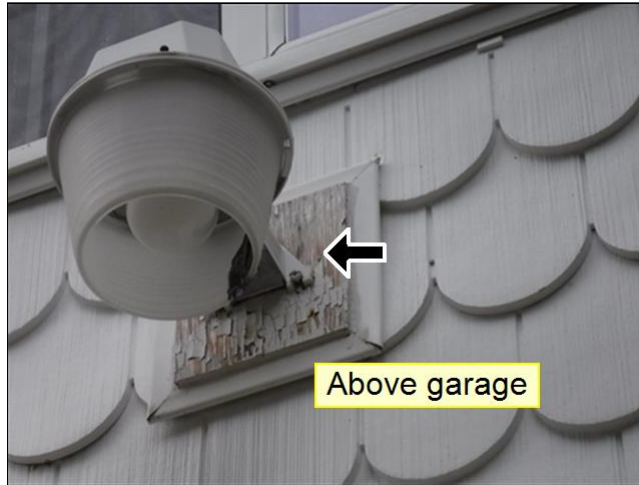
2.0 (3) **The wood trim is weathered and needs preparation and paint.** Ideally, all wooden surfaces should be stripped or sanded down to the bare wood, primed, and painted. No adverse affects observed at the time of the inspection.

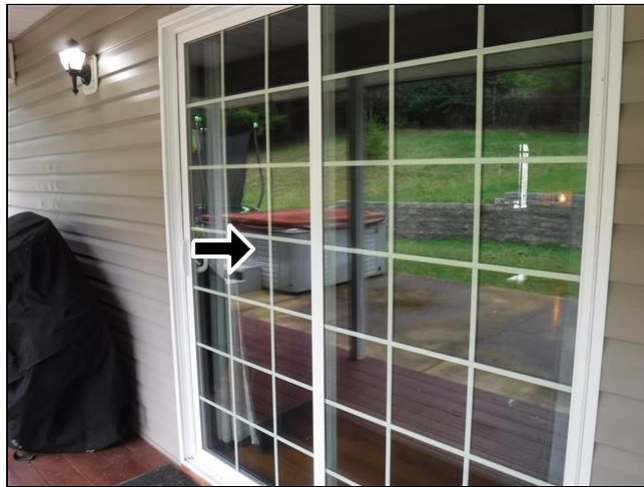
2.2 Item 1(Picture)

**2.2 (2)** Rear sliding door missing screen.

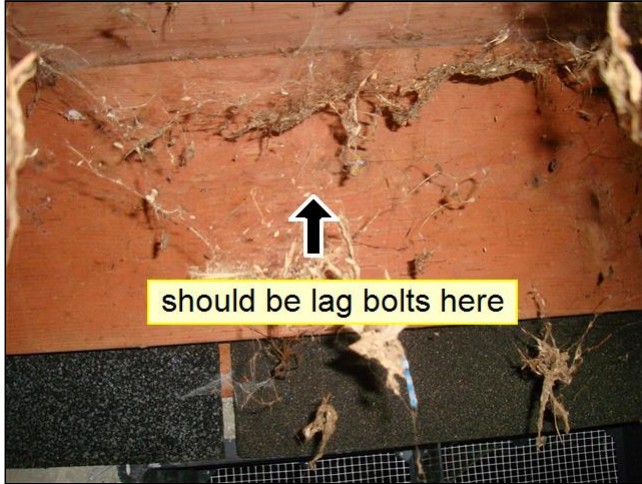
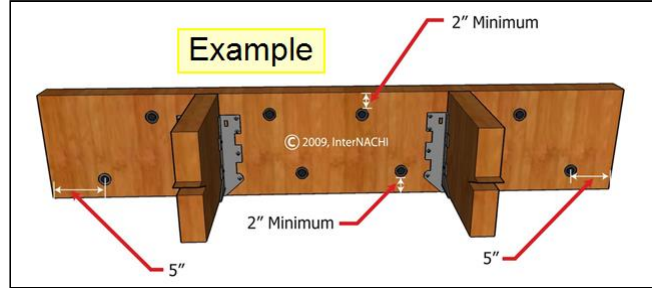
FAILURE CAN BE DRAMATIC AND WITHOUT WARNING. No adverse affects observed at the time of the inspection.

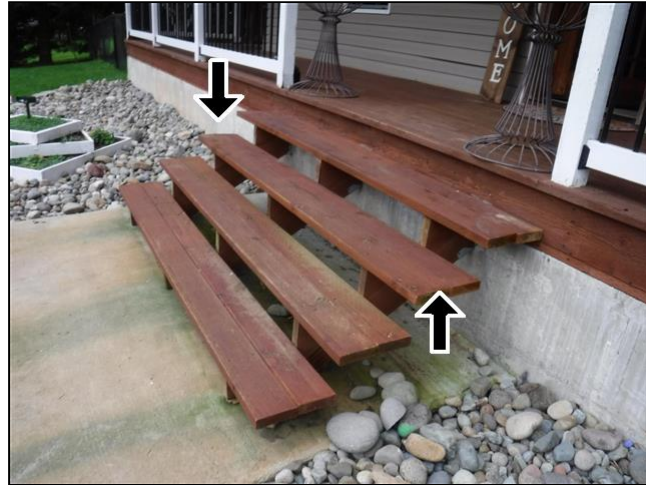
2.3 Item 3(Picture)

**2.3 (3) Stair railing is missing at a location where there is a risk of injury from falls.** Railings should be installed at exterior stairs having 4 or more risers. Absence of adequate stair railings is a safety concern, and in some cases may have legal consequences where a person is injured as a result of neglecting to provide adequate safety provisions at stairs.

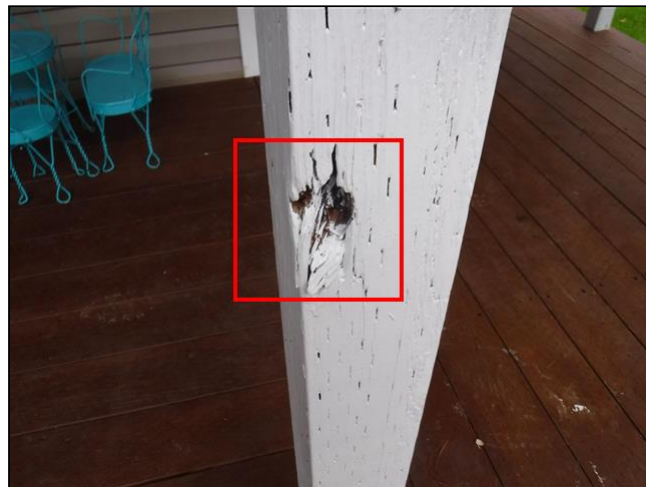
2.3 Item 4(Picture)

**2.3 (4) Rear porch post minor damage.** Recommend monitor periodically and repair as needed. No adverse affects observed at the time of the inspection.

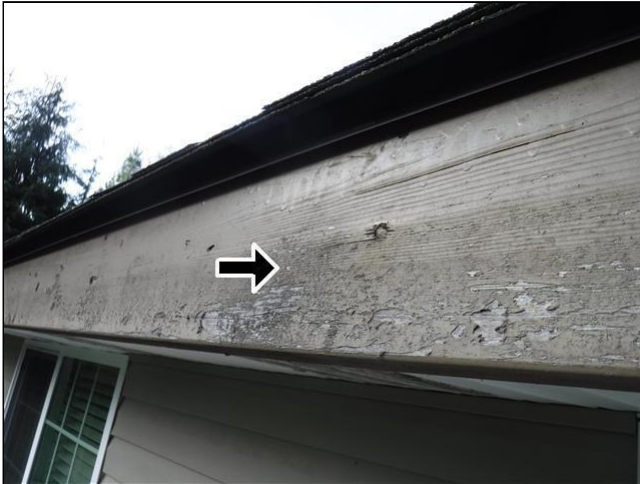
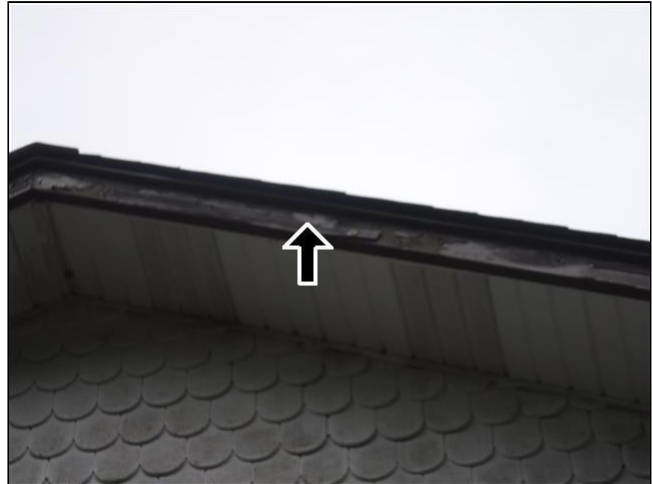
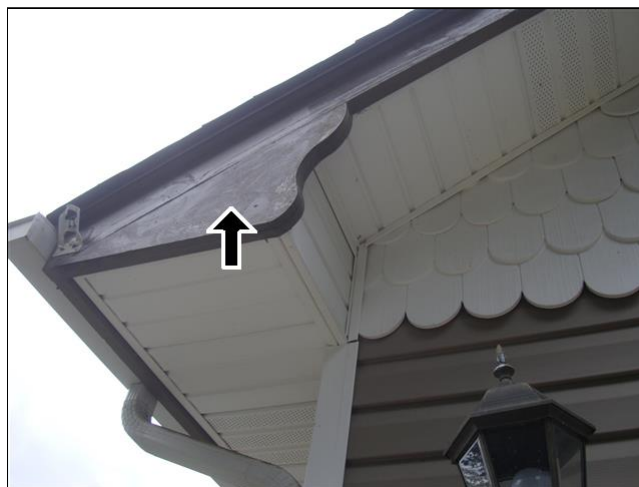
**2.5 (2) Fascia requires painting.** The paint on the fascia's is observed to be deteriorated. Paint is required to preserve the fascia's from weather damage. Deteriorated paint on wood fascia's will result in rot and damage to the wood. Failure to provide periodic painting as part of normal preventative maintenance actions will result in deterioration of the fascia. No adverse affects observed at the time of the inspection.

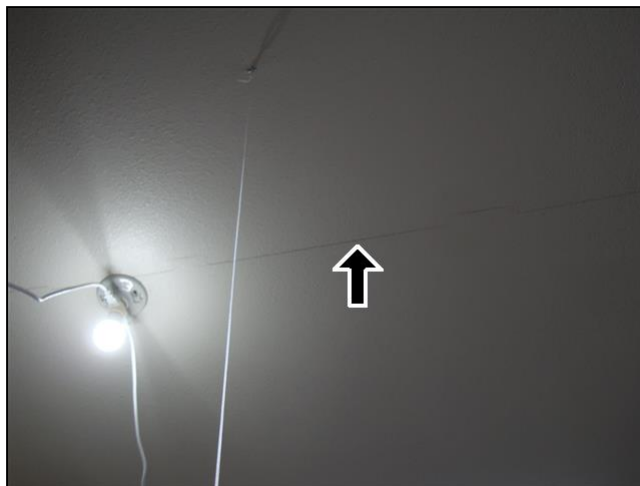
3.3 Item 1(Picture)

**3.3 (2) Drywall is cracked.** Minor cracks in drywall and plaster are normally a cosmetic issue, which can be readily repaired. No adverse affects observed at the time of the inspection.

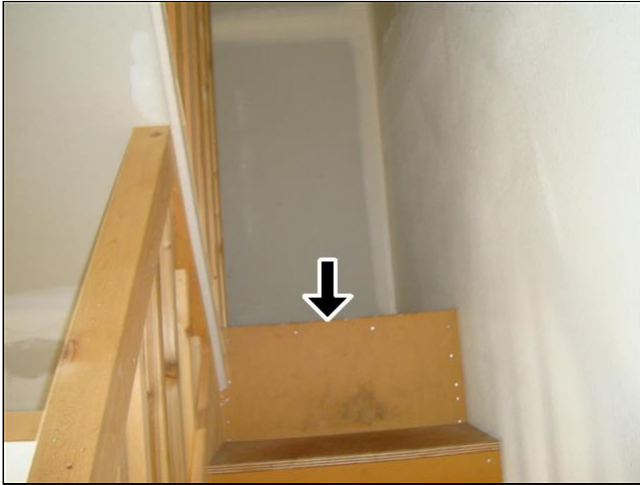
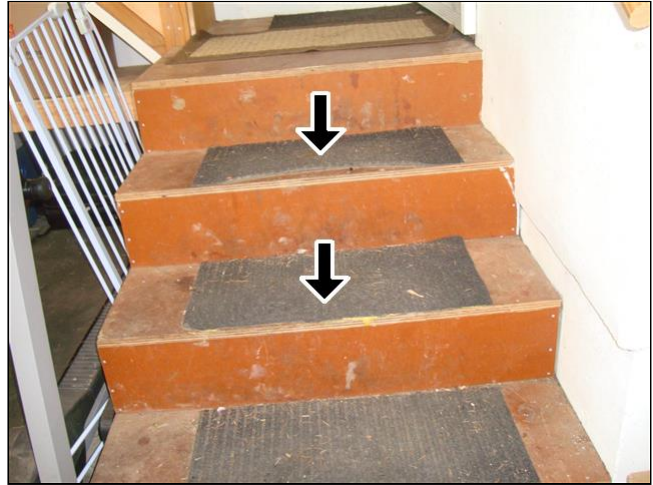
**3.4 (2)** Stairs in garage going to loft and occupant door rise/run was observed to be uneven. This a safety caution.

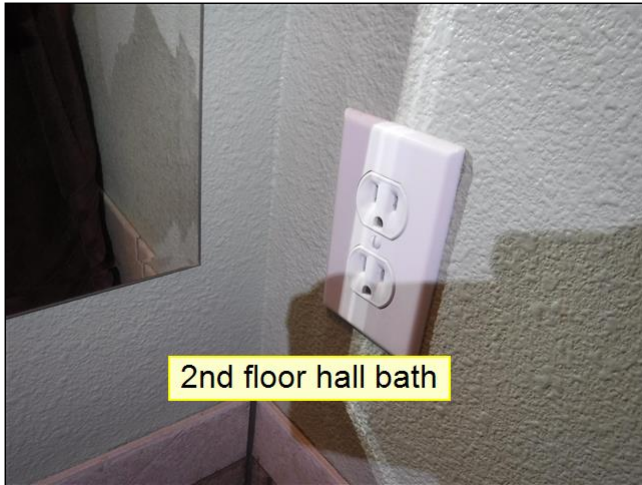
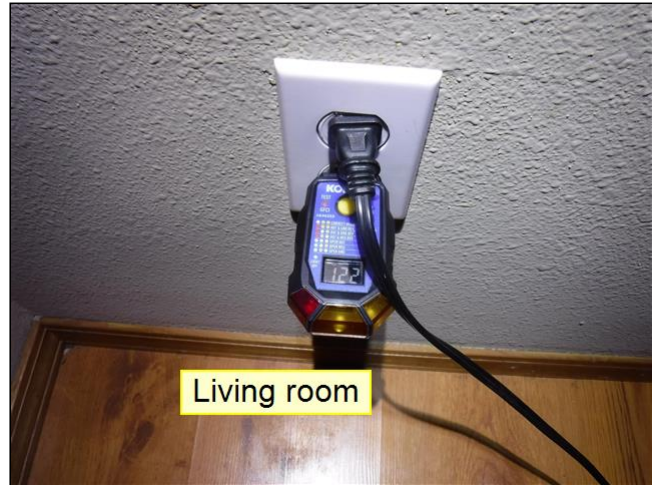
**4.2 (2) An electrical outlet is observed to be not adequately secured to its outlet box.** A loose receptacle may in certain circumstances present a risk of fire and electrical shock should the receptacle or exposed copper on wires come in contact with the side of the metal outlet box. Loose receptacles should be repaired to ensure they are properly positioned and secured in their outlet boxes. Regular home maintenance routines should include checking for and correcting loose receptacle. Bathrooms and kitchen.

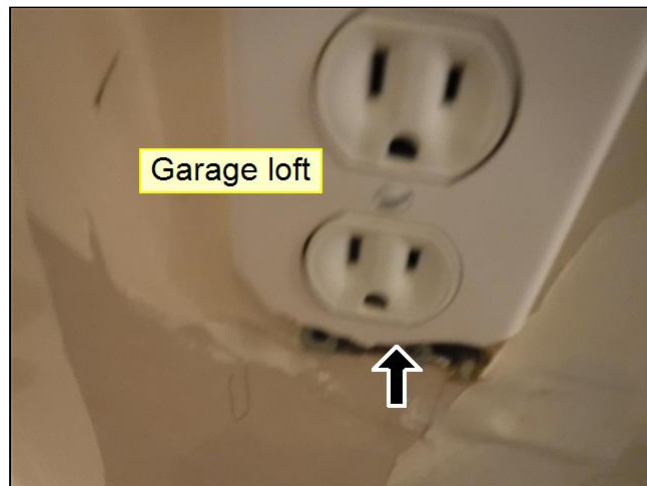
4.2 Item 3(Picture)

**4.2 (3) An outlet or switch has a damaged or missing receptacle cover.**

An outlet with a missing or damaged cover, is subject to damage and deterioration. Receptacles displaying damage or deterioration should be immediately replaced and a suitable cover installed

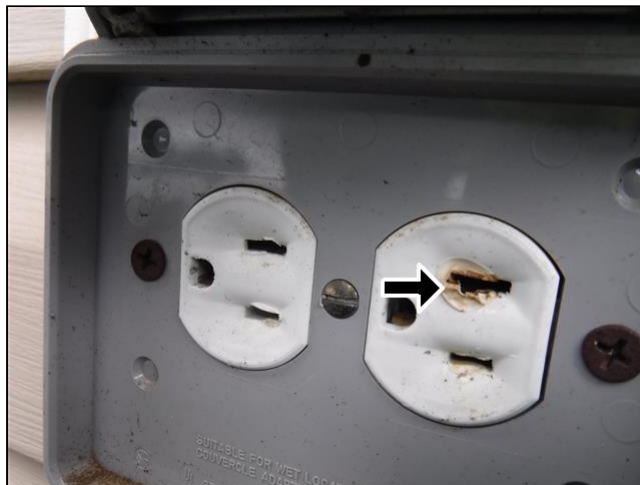
4.2 Item 4(Picture)

**4.2 (4)** Recommend replacing this exterior outlet due to burn marks. Rear of home next to AC unit.

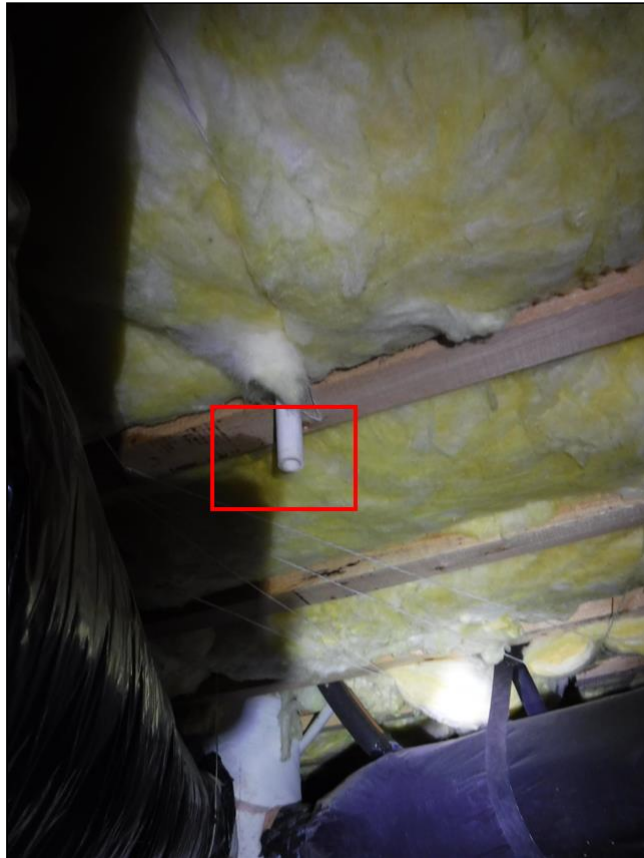
5.0 Item 1(Picture)

**5.0 (2)** Water heater or HVAC drip line terminates in crawl space. This should terminate outside to prevent unwanted moisture in the crawl space. No adverse affects observed at the time of the inspection.

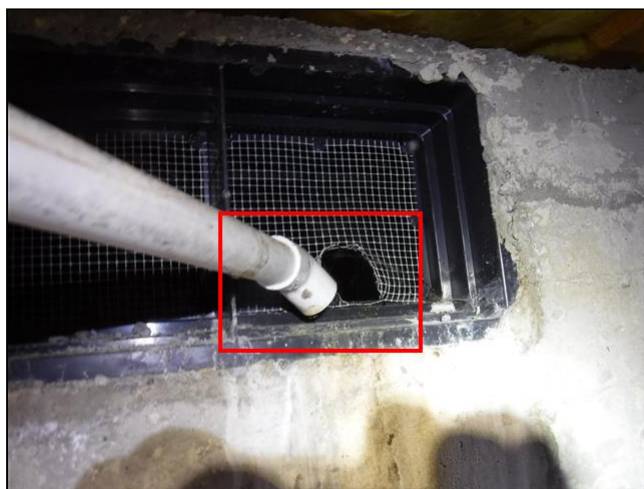
5.0 Item 2(Picture)

**5.0 (3)** Drip line disconnected. Recommend connecting to prevent unwanted moisture in the crawl space. No adverse affects observed at the time of the inspection.

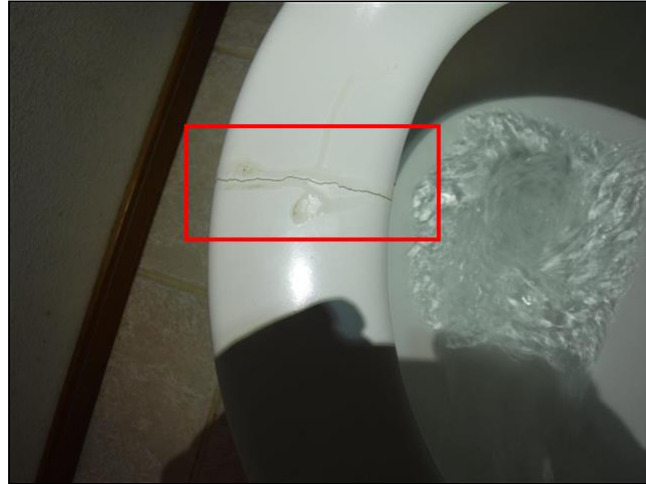
5.1 Item 1(Picture)

**5.1 (2)** Toilet seat master bath damaged.

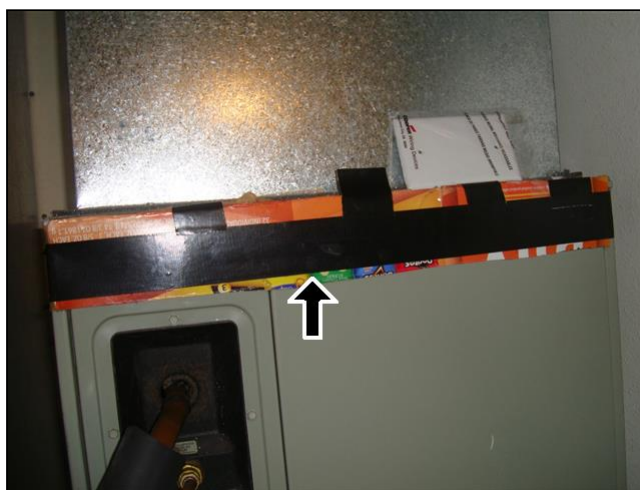
6.0 Item 1(Picture)

**6.0 (4)** Recommend removing cardboard from HVAC unit. Could be a potential fire hazard.

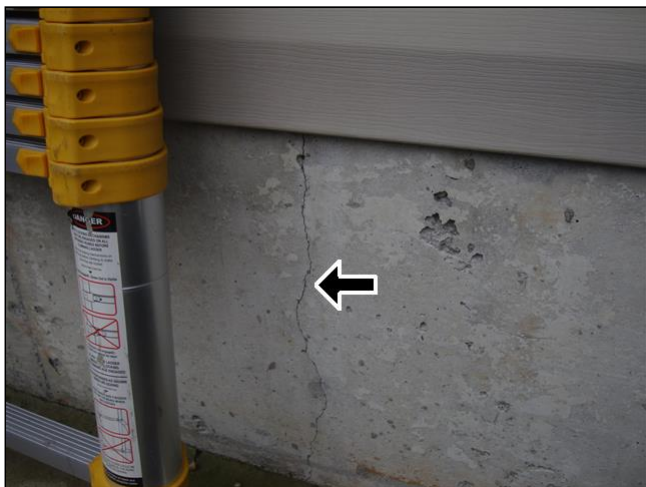
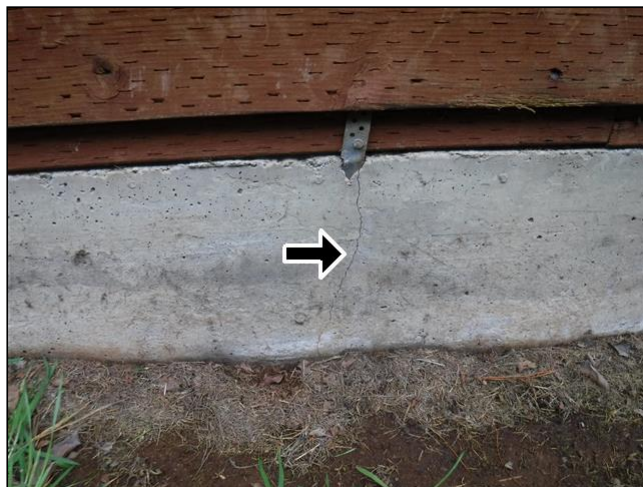
**7.0 (2) Cracks in the foundation wall are observed during examination of the exterior of the home.** At the time of inspection, the crack(s) are regarded to be **minor**. Ascertaining the cause of a crack cannot be readily determined during a home inspection, but are typically due to shrinkage of the concrete during curing, settlement of soils below the footings, pressure of soils against the foundation wall, or from a physical shock, seismic or hydrological event. No adverse affects observed at the time of the inspection.

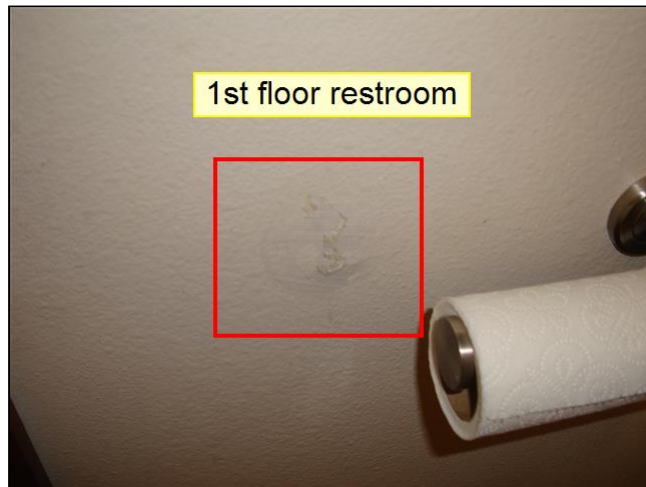
8.1 Item 1(Picture)

Areas of wall repair are cosmetic issue and represent a reduced visual appearance. .

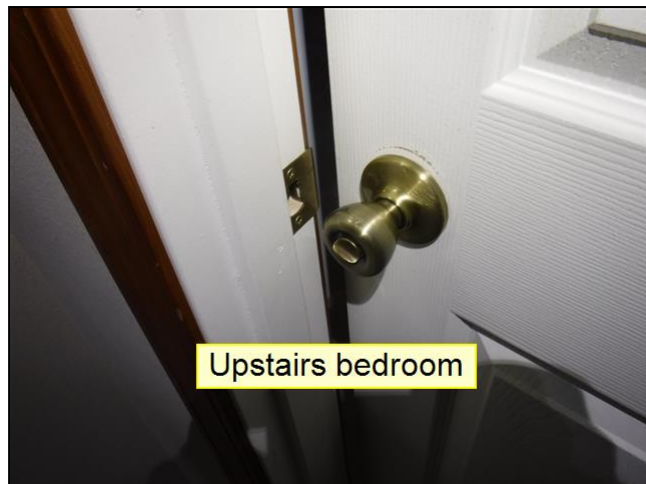
8.3 Item 1(Picture)

Hardware required for latching or locking the door needs adjustment. A primary function of the door is to operate in a manner that ensures the door will open and close with relative ease, and to meet the privacy needs of the home's occupants

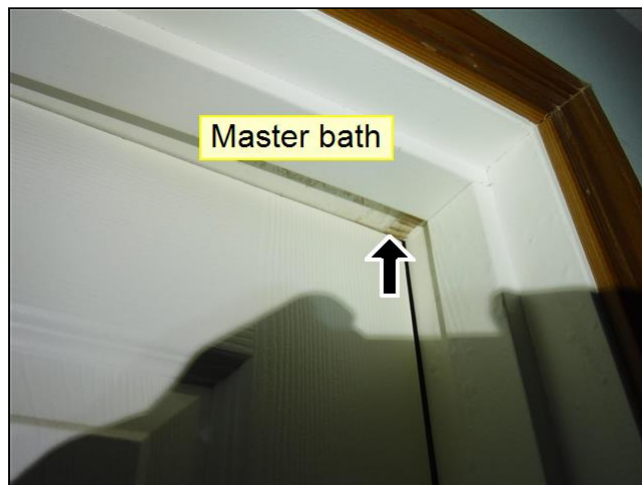
8.3 Item 2(Picture)

Interior door exhibits poor fit characteristics, such that the door contacts, rubs or binds with the door frame when the door is being opened and closed. Binding or sticking that requires extra or excessive force will in time affect the functionality of the door, its frame and/or its hardware. If it is light contact a minor adjustment will resolve the problem

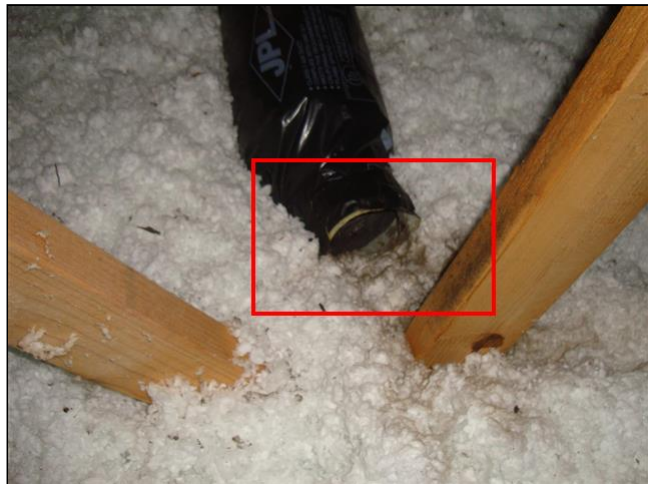
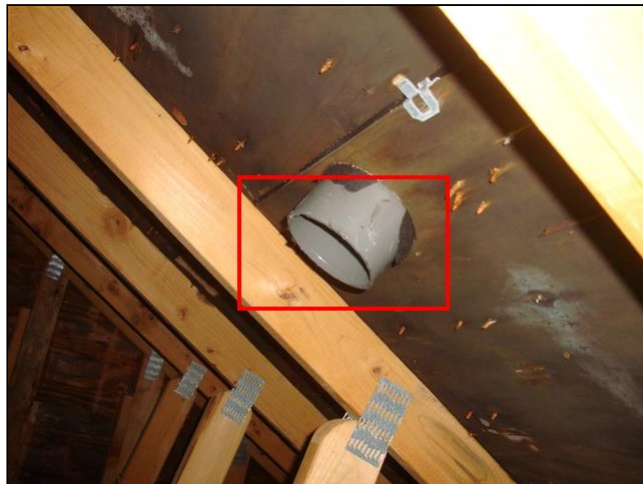
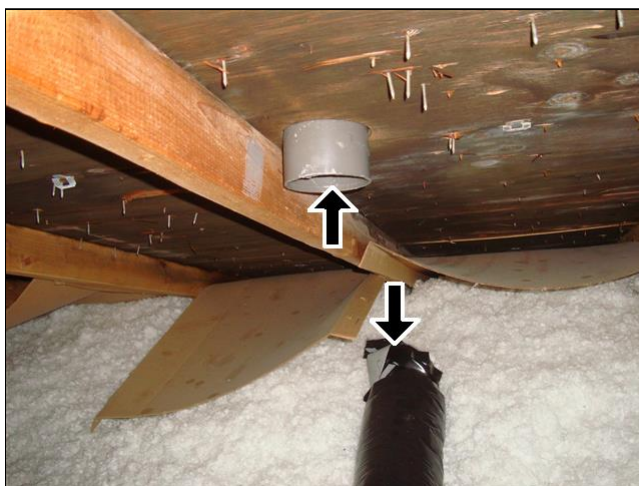
**9.5 (2) Both 2nd floor bathroom exhaust fan duct is disconnected in attic.** Ducts not properly venting may result in moisture-related issues to the attic area, with mold and rot as possible consequential problems.

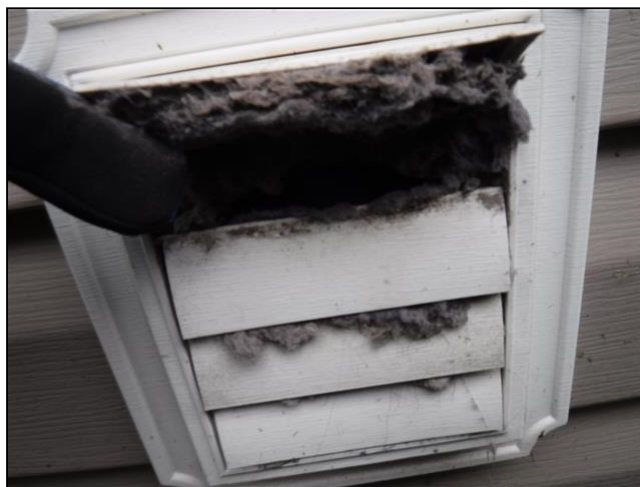
9.5 Item 4(Picture)

**9.5 (3) Recommend cleaning dryer vent.** Clogged or dirty dryer vents are a main source of residential fires.
