**COGGESHALL
HOME
INSPECTIONS**

Home Inspection Report

2870 W Polk Ave., Anaheim , CA 92801

Friday, August 16, 2019

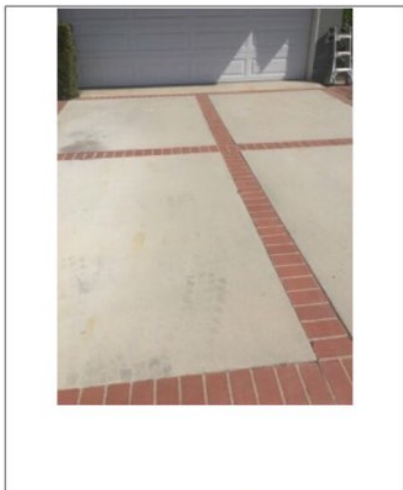
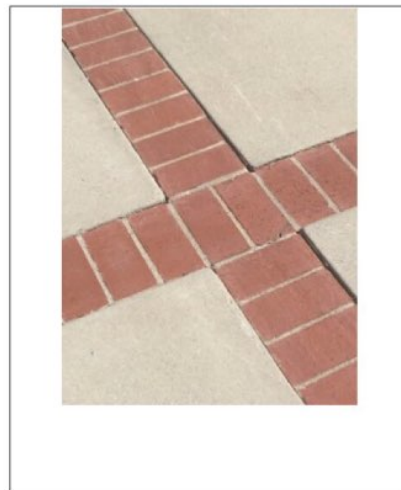
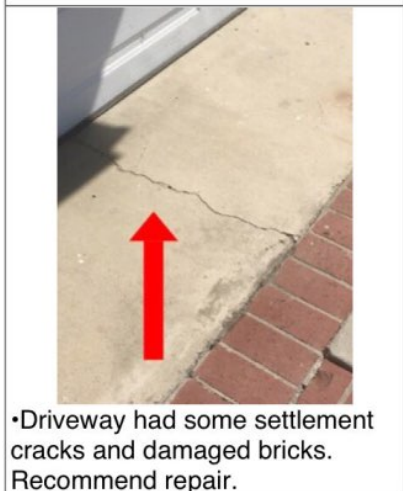
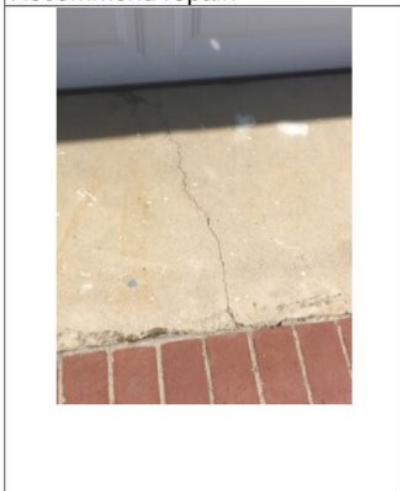
•Driveway had some settlement cracks and damaged bricks. Recommend repair.

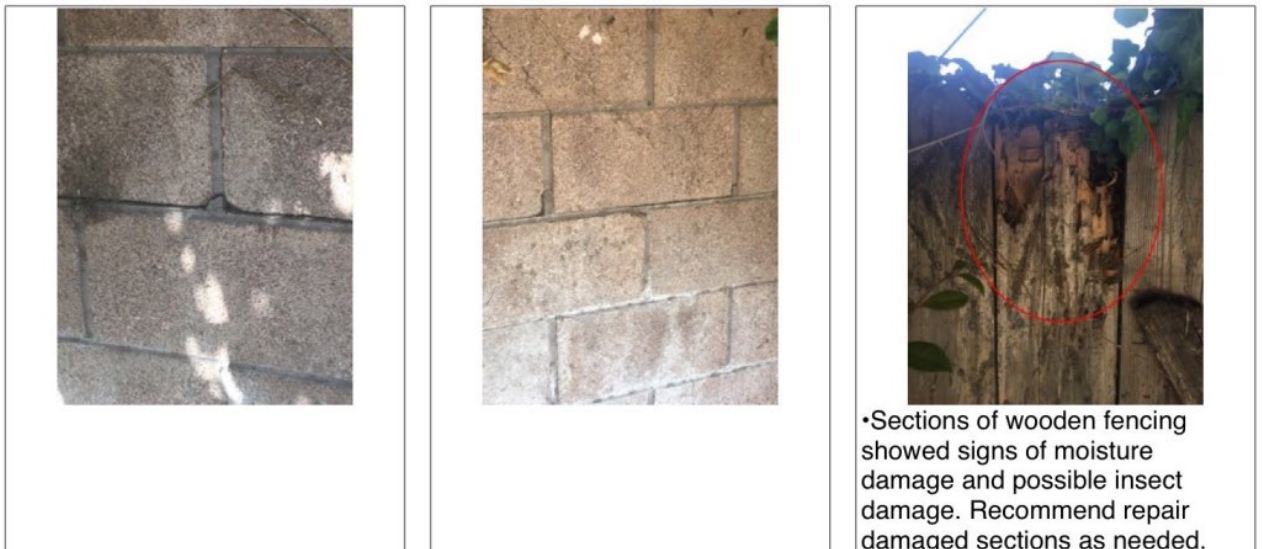
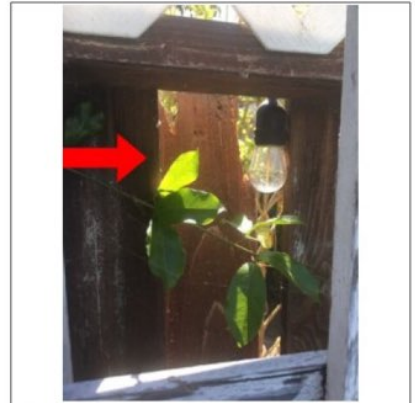
•Sections of wooden fencing showed signs of moisture damage and possible insect damage. Recommend repair damaged sections as needed.

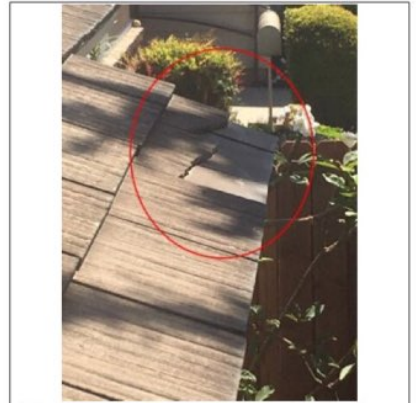
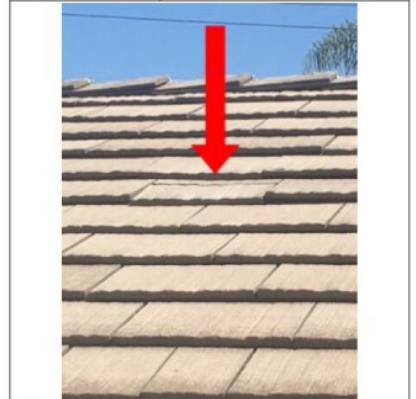
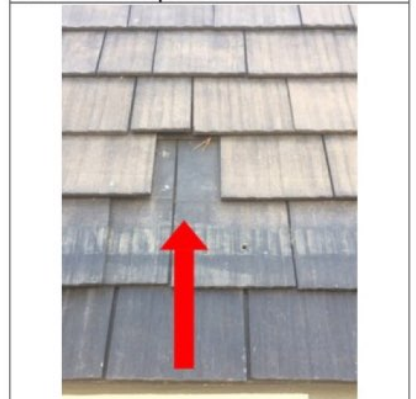
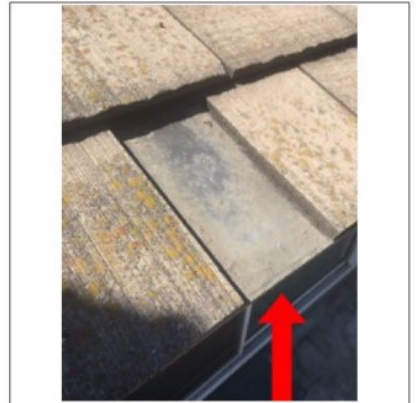
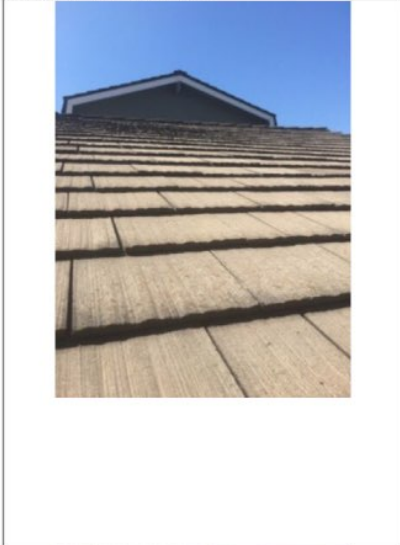
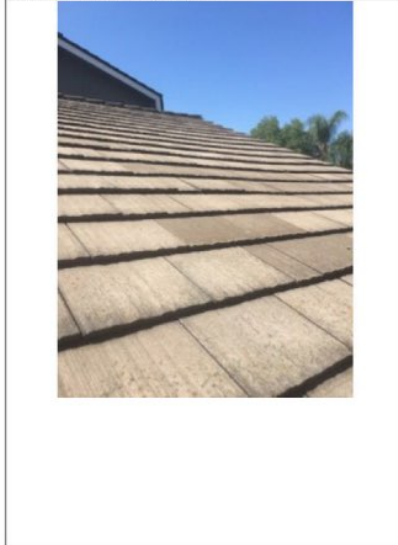
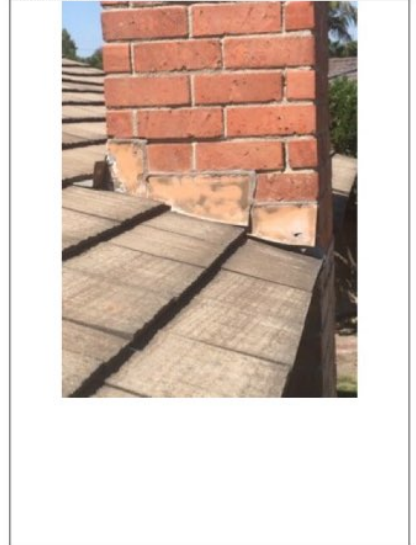
•Roof had damaged and missing concrete tile shingles. Recommend licensed roofing contractor inspect and evaluate further for repairs.

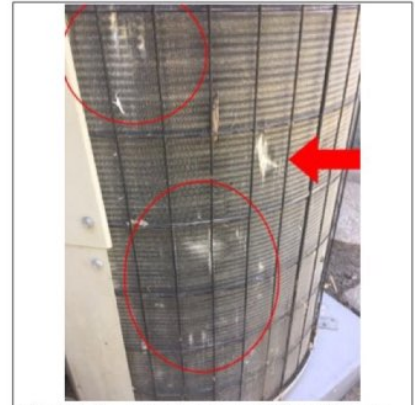
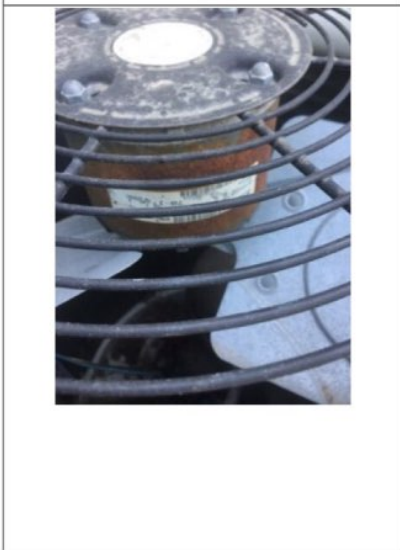
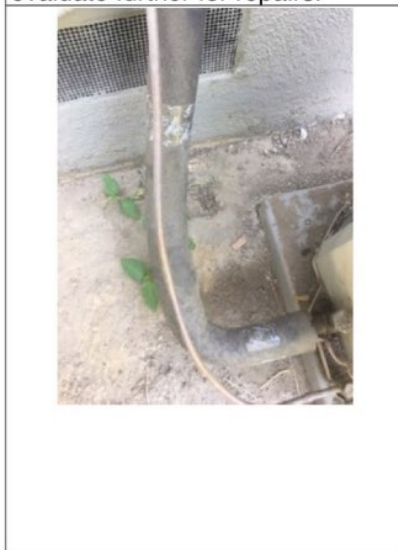
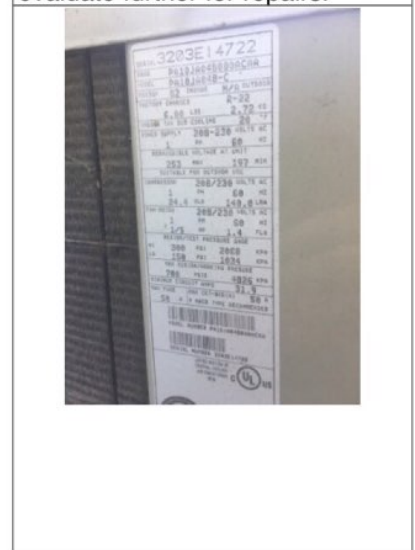
•Outside condenser unit coils on AC unit were damaged. Recommend licensed HVAC technician inspect and evaluate further for repairs.

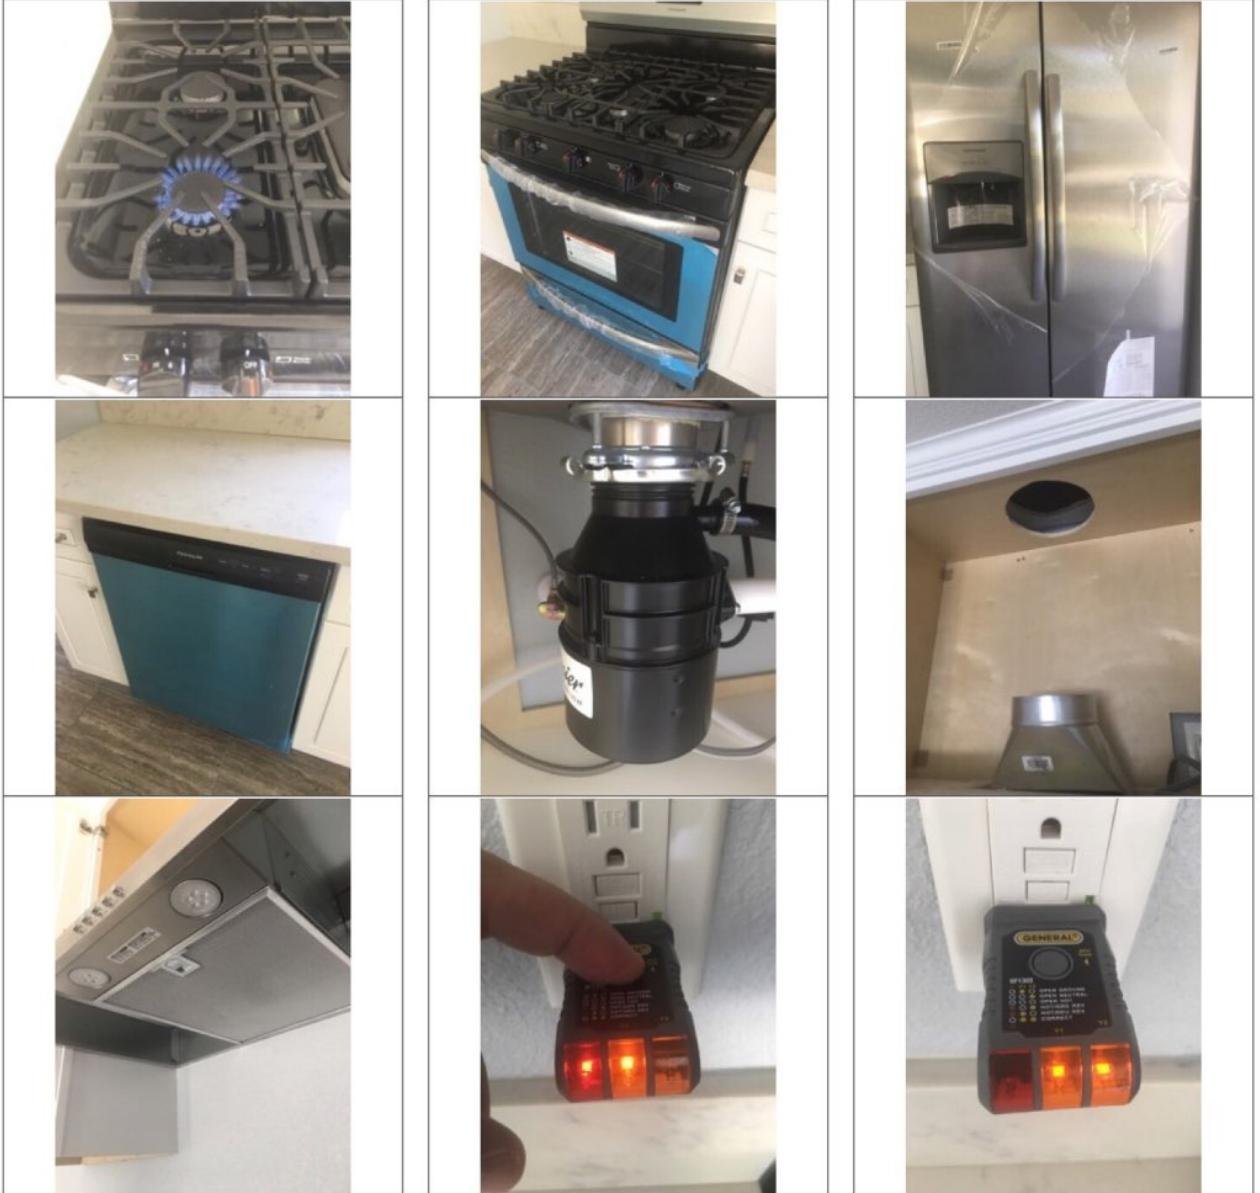
Comments **One electrical receptacle in kitchen was ungrounded. Recommend upgrading to grounded electrical receptacle.**

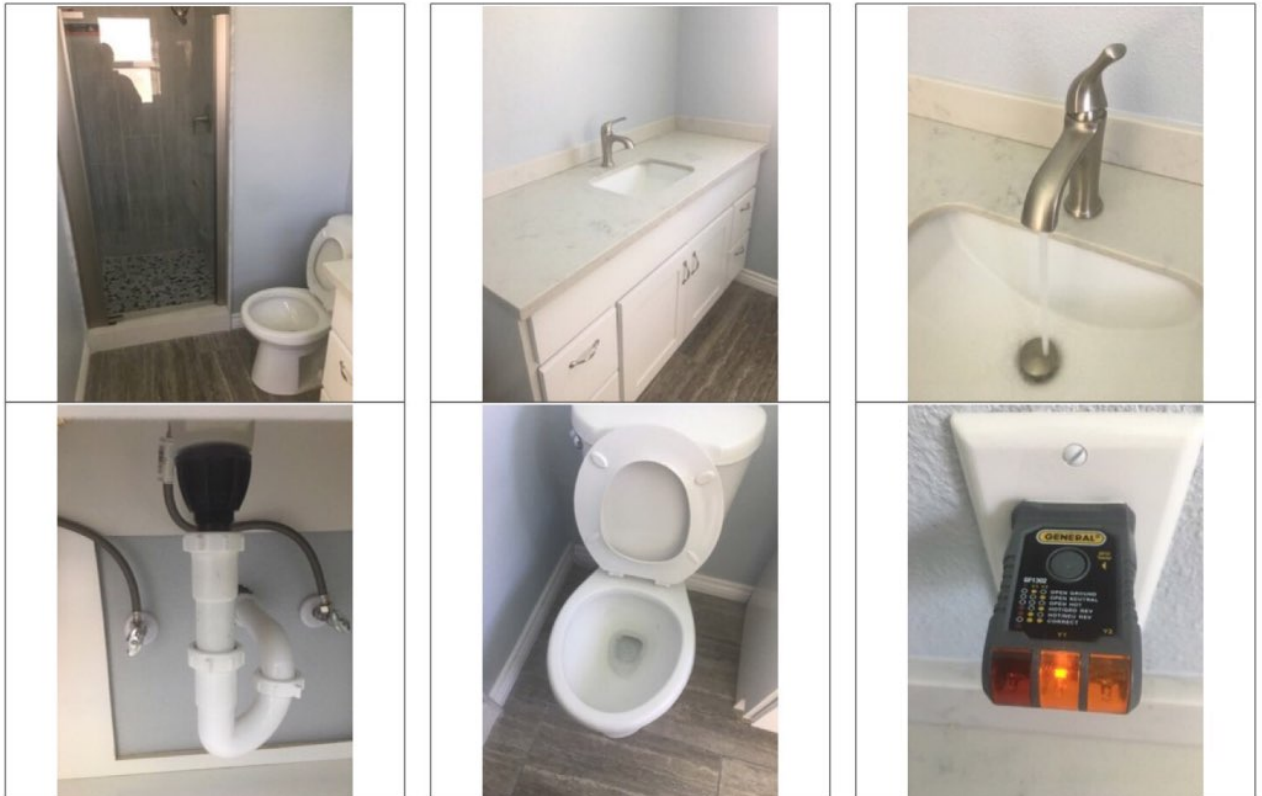
- Water flow for shower was extremely poor. Recommend licensed plumber inspect and evaluate further for repairs.
- Ungrounded non GFCI electrical receptacles were found in master bathroom. Potential safety hazard. Recommend licensed electrician inspect and evaluate further for repairs.
- Shower door in master bathroom was loose and improperly installed. Recommend repair.

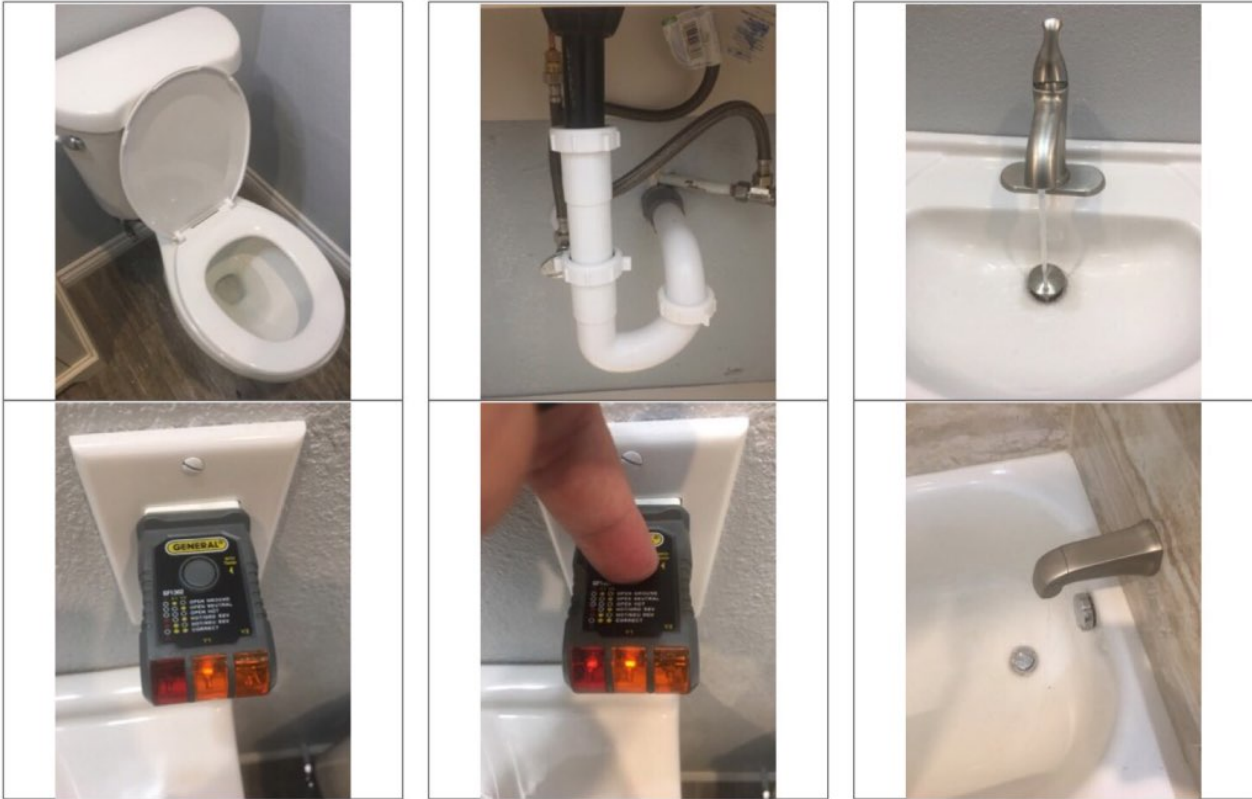
Comments
 -Water flow for shower in hallway bathroom was extremely poor. Recommend licensed plumber inspect and evaluate further for repairs.
 -Ungrounded non GFCI electrical receptacles were found in hallway bathroom. Potential safety hazard. Recommend licensed electrician inspect and evaluate further for repairs.

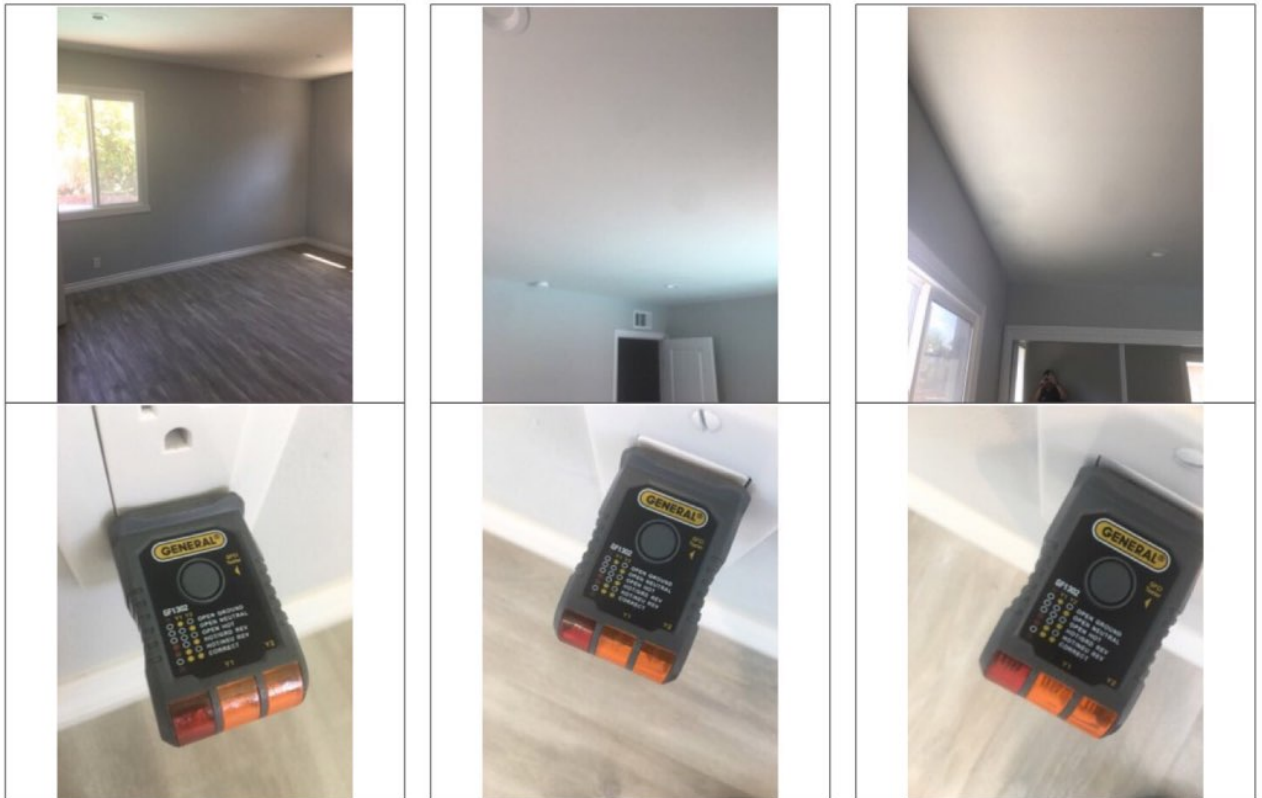
Comments **Electrical receptacles in master bedroom did not have power when tested with a voltage meter or a GFCI tester. Recommend licensed electrician inspect and evaluate further for repairs.**

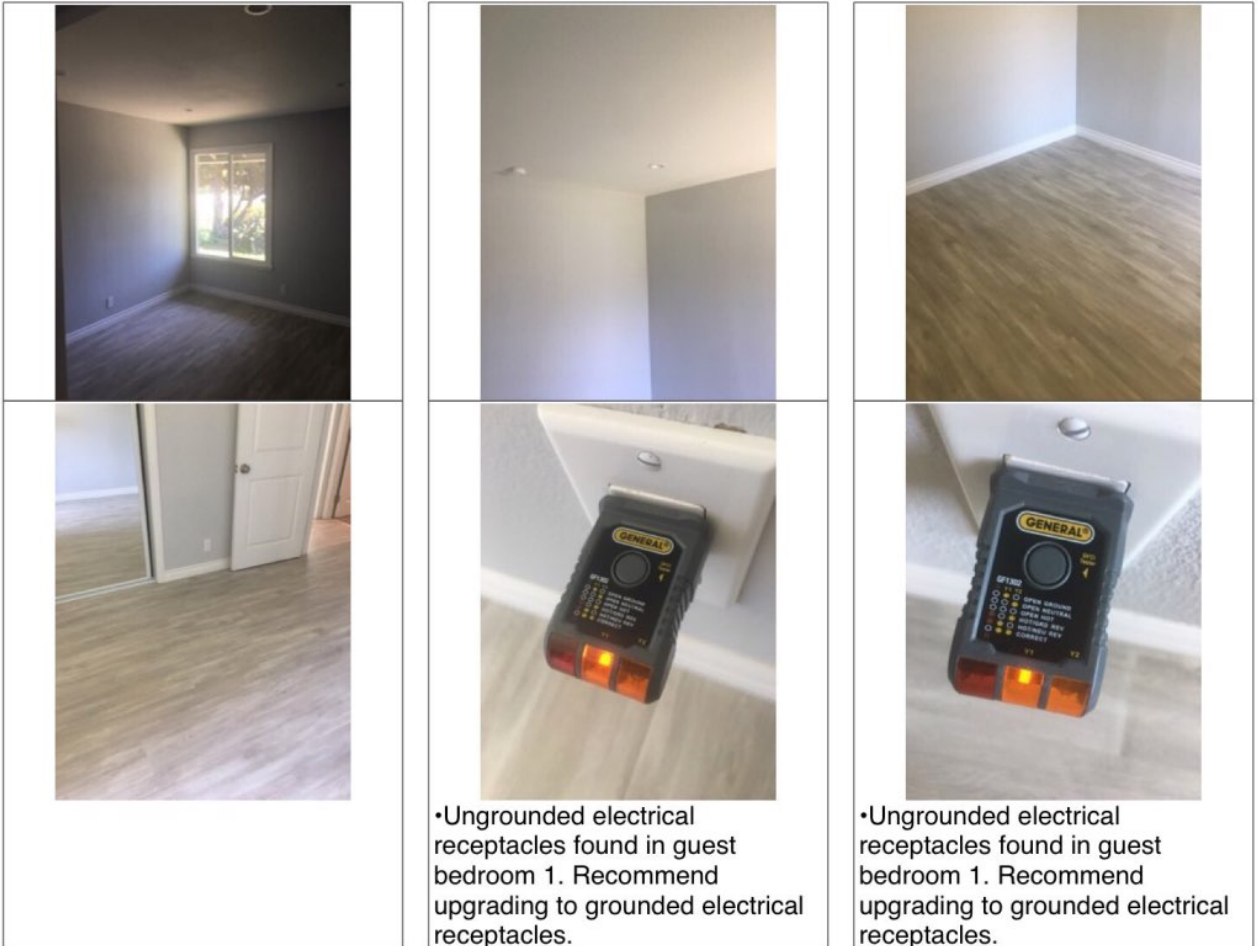
Comments •Ungrounded electrical receptacles found in guest bedroom 1. Recommend upgrading to grounded electrical receptacles.

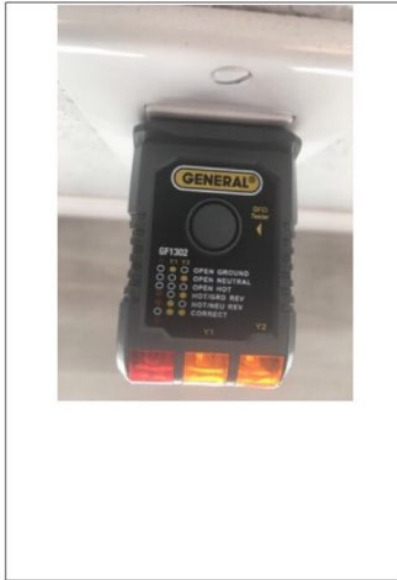
•One electrical receptacle did not have power when tested with Voltage meter and GFCI detector. Recommend licensed electrician inspect and evaluate further for repairs.

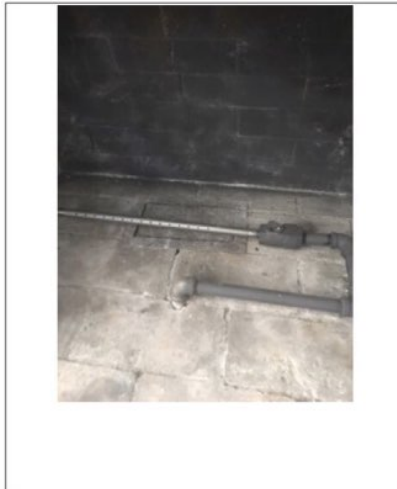
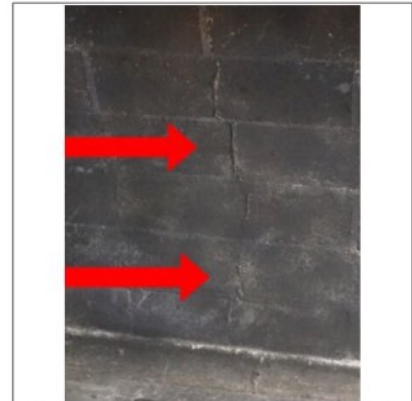
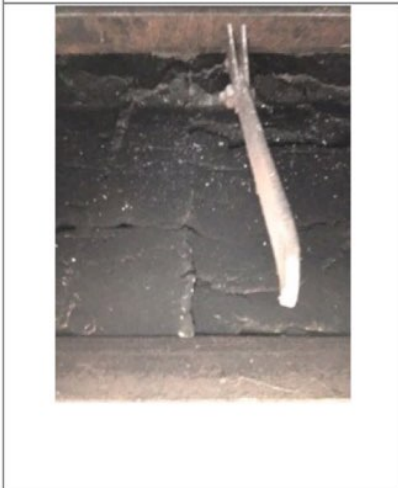
•Open joints or cracks in firebrick of fireplace. Recommend properly sealing and repair.

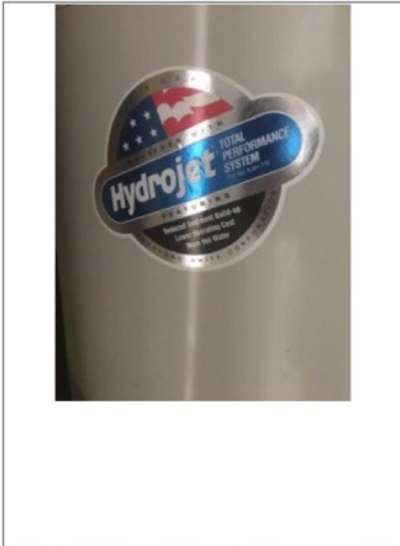
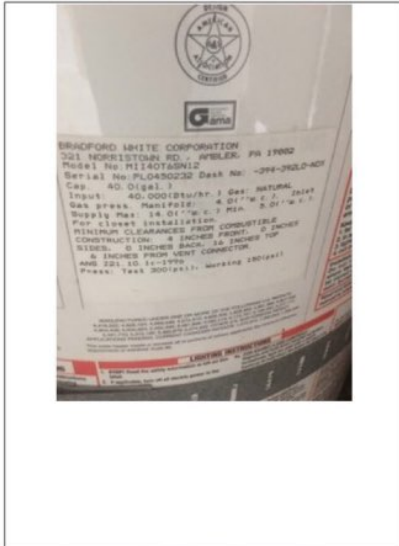
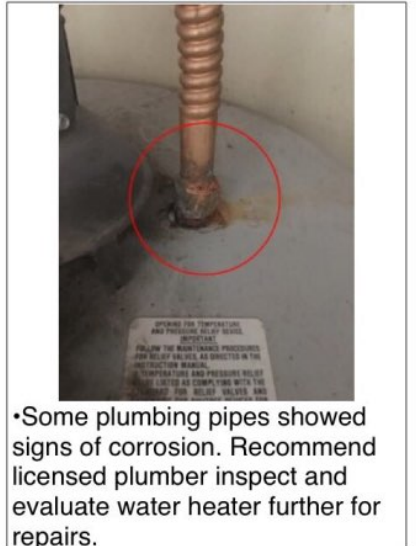
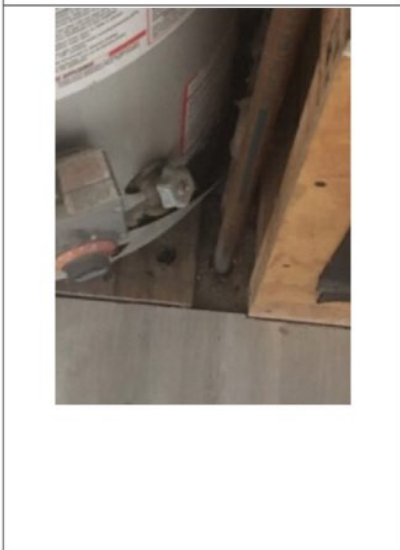
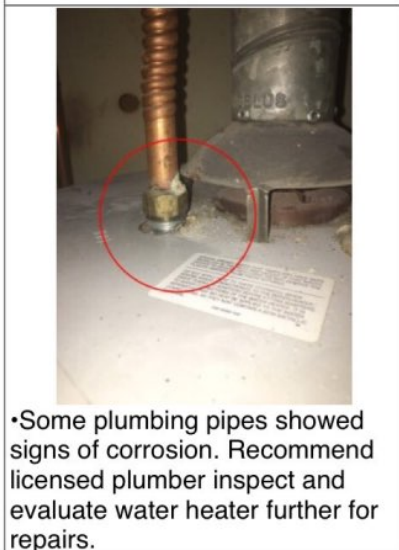
•Some plumbing pipes showed signs of corrosion. Recommend licensed plumber inspect and evaluate water heater further for repairs.

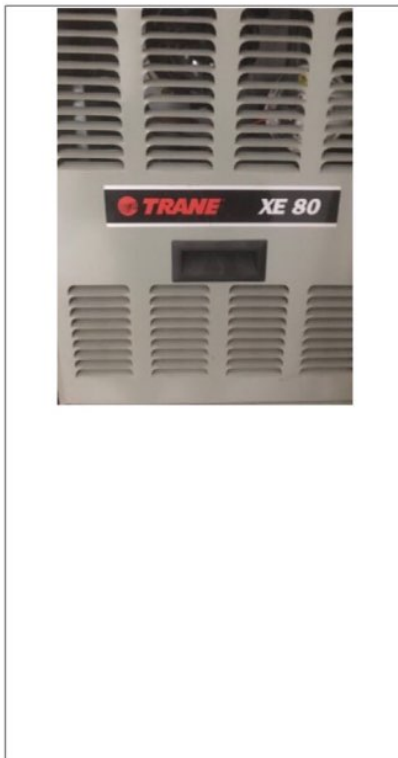
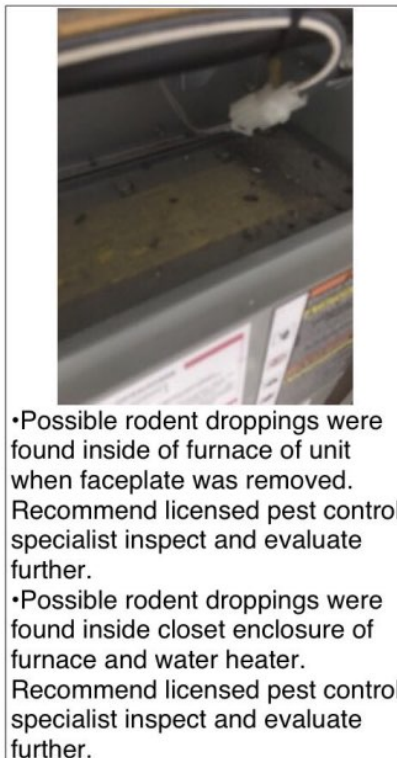
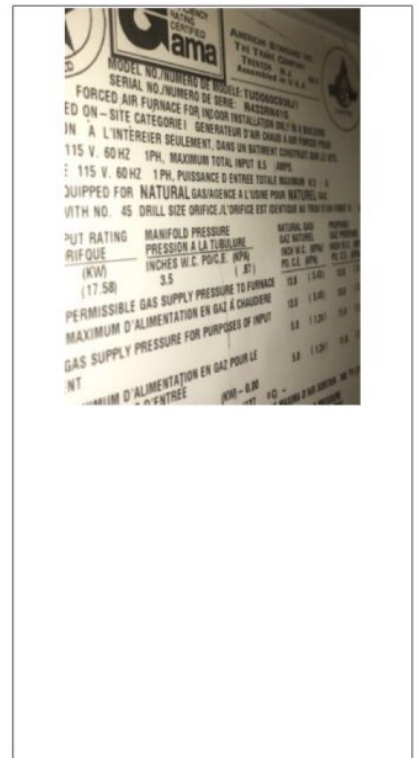
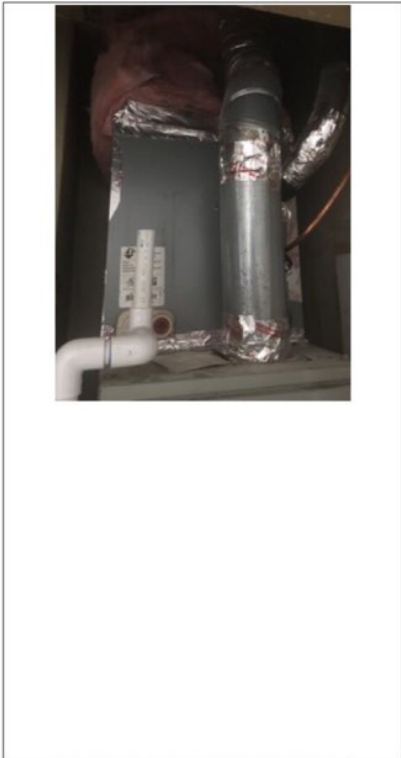
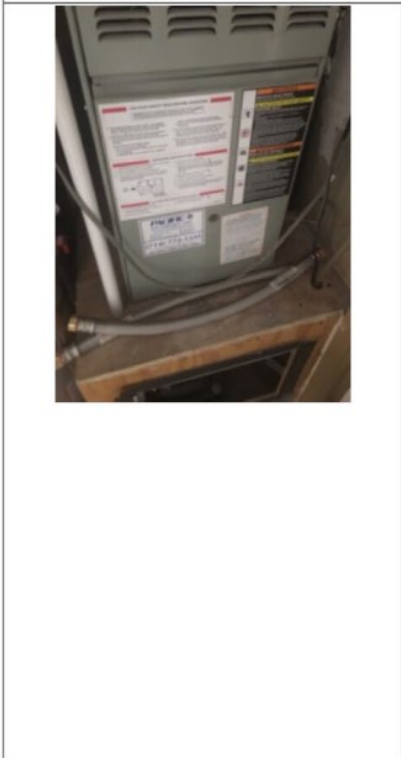
- Possible rodent droppings were found inside of furnace of unit when faceplate was removed. Recommend licensed pest control specialist inspect and evaluate further.
- Possible rodent droppings were found inside closet enclosure of furnace and water heater. Recommend licensed pest control specialist inspect and evaluate further.

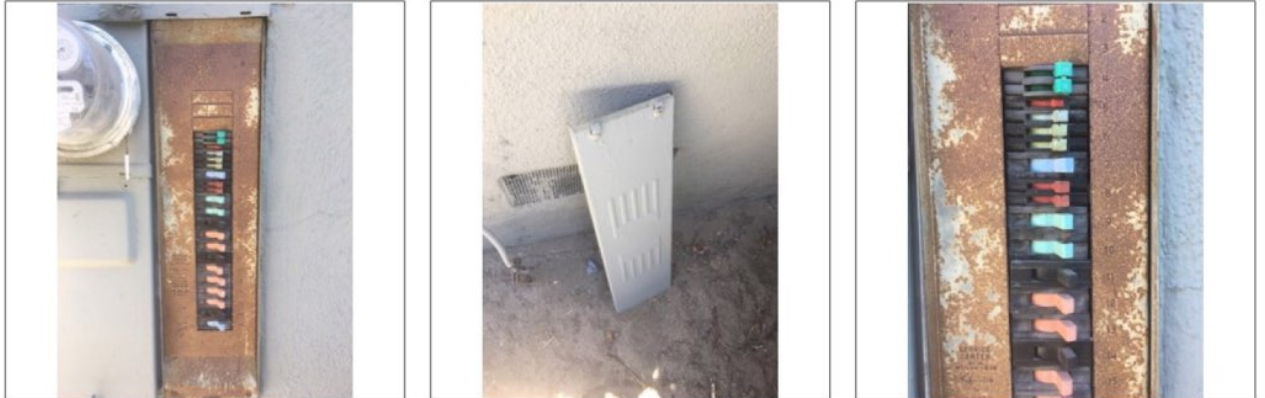
•Main electrical panel showed signs of extensive rusting and the main panel cover was detached and broken at time of inspection. Recommend licensed electrician inspect and evaluate further for repairs.
