**COGGESHALL  
HOME  
INSPECTIONS**

## Home Inspection Report

**2614 184th St., Redondo Beach , CA 90278**

Monday, March 11, 2019

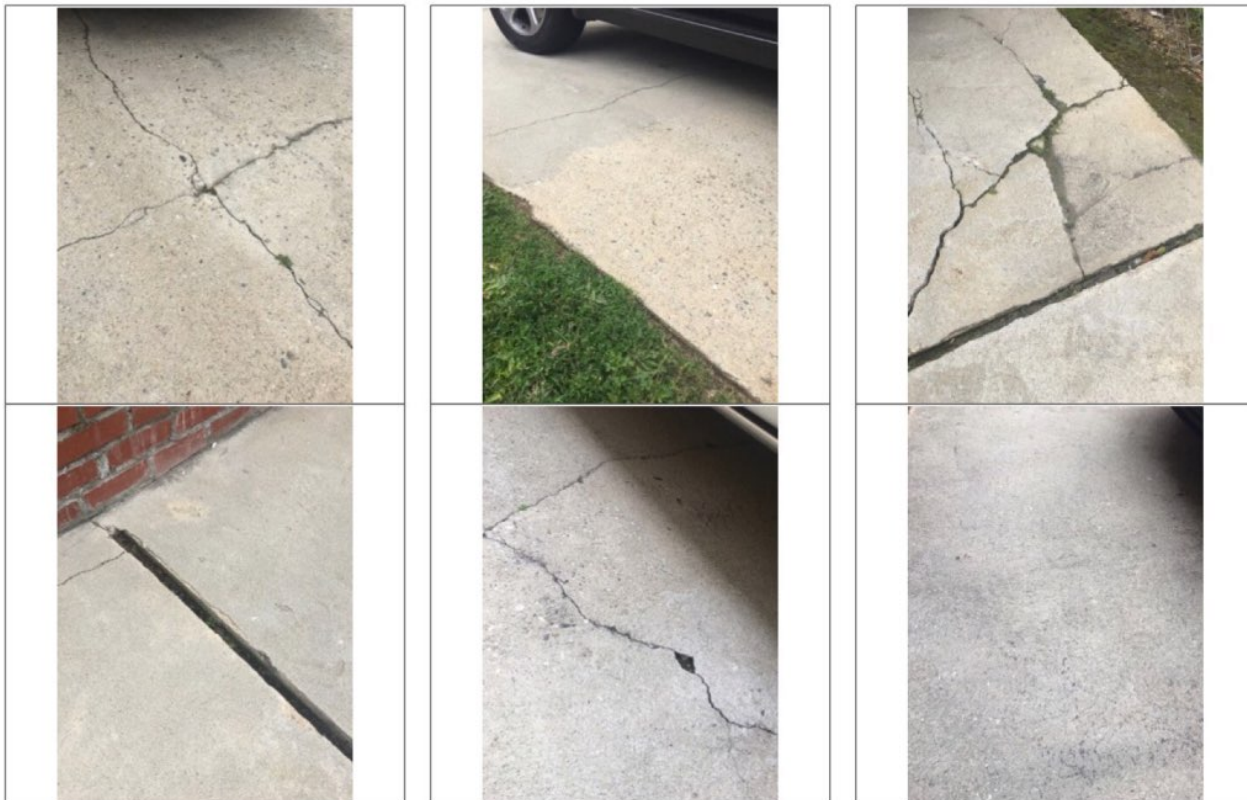
**Comments** Driveway had some settlement, but usable, recommend repair as needed.

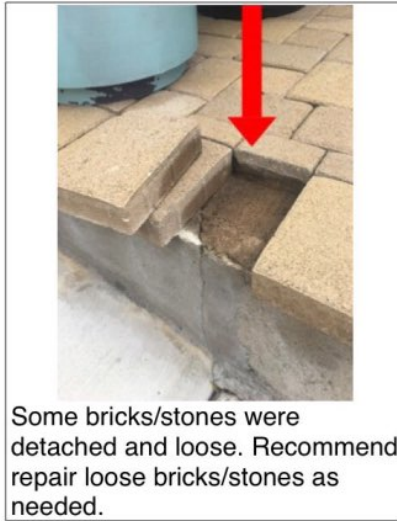
Some bricks/stones were detached and loose. Recommend repair loose bricks/stones as needed.

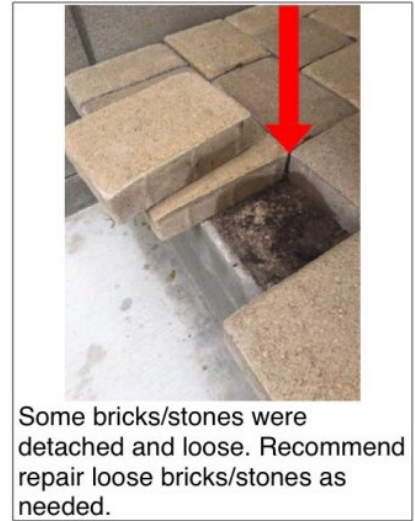
Some bricks/stones were detached and loose. Recommend repair loose bricks/stones as needed.

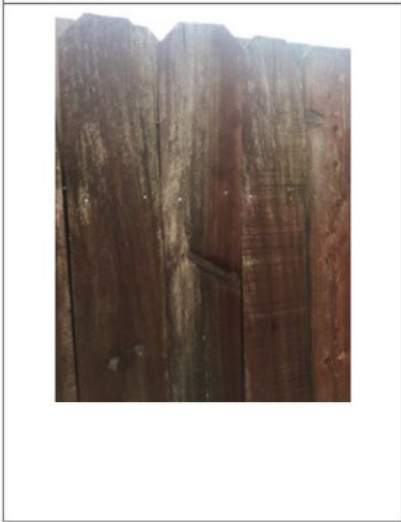
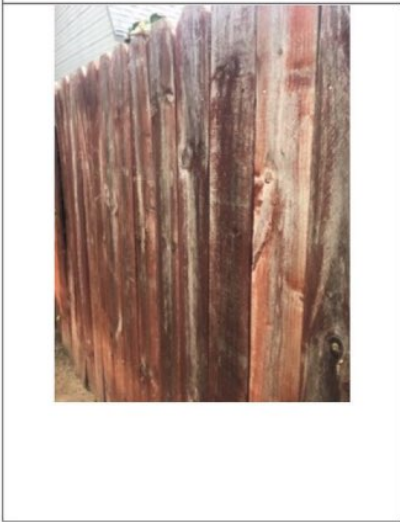
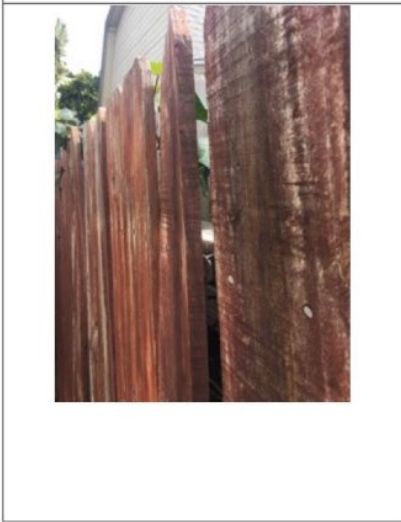
Backyard wooden fence had some damaged/rotted wooden planks. Recommend repair or replace as needed.

Backyard wooden fence had some damaged/rotted wooden planks. Recommend repair or replace as needed. Evidence of termite damage found in some of the wooden planks. Recommend licensed termite contractor inspect and evaluate further for repairs.

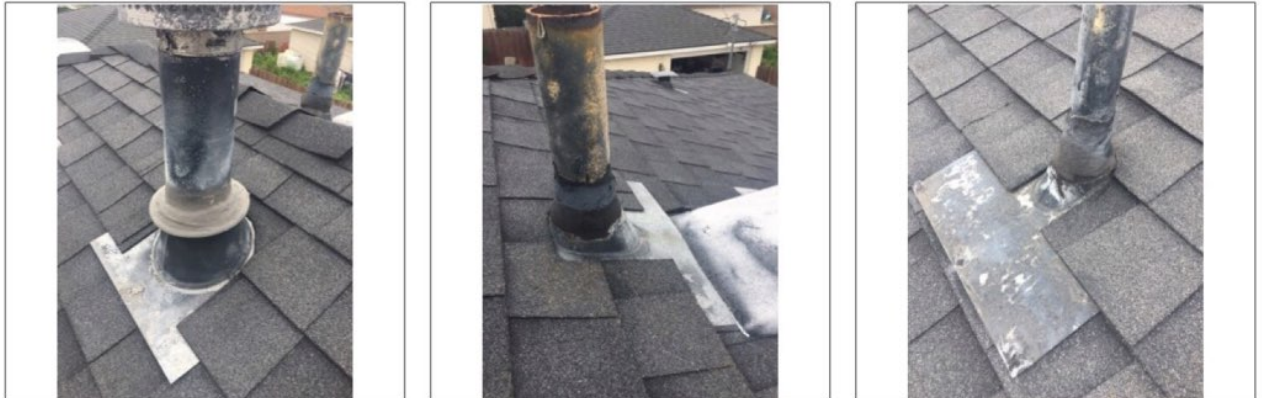
Vent stacks were in overall satisfactory condition but did have some rusting on entrance of hole. Recommend monitoring for replacement in future.

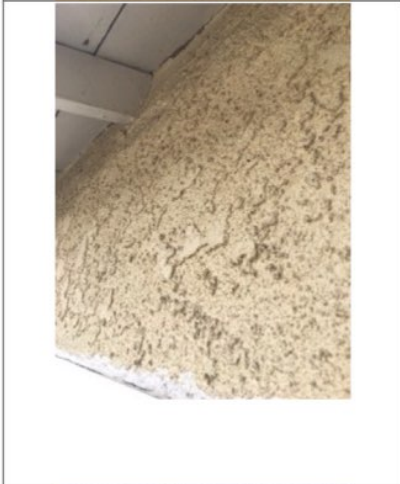
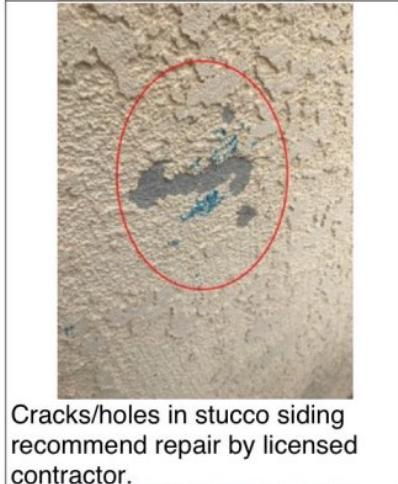
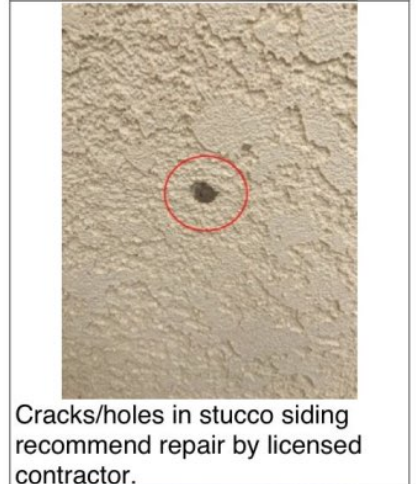
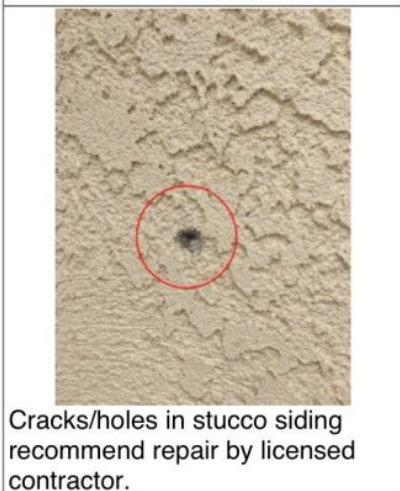
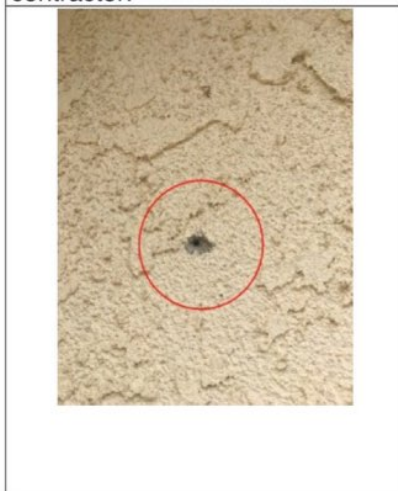
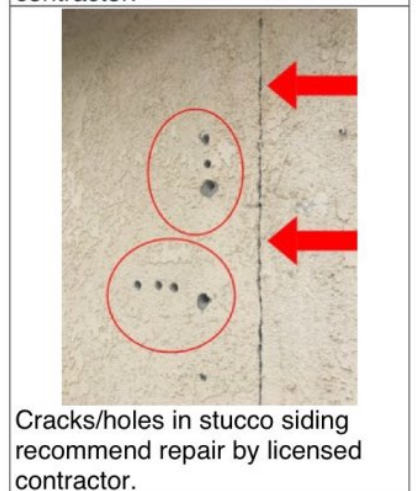
Cracks/holes in stucco siding recommend repair by licensed contractor.

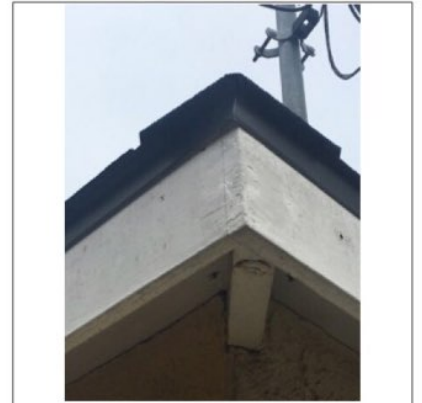
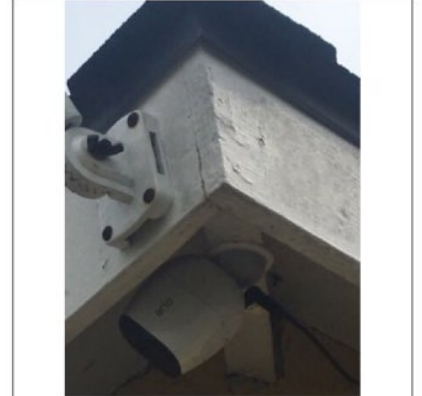
**Comments** Trim had some deterioration recommend repair and painting. Some loose and missing trim recommend repair. Some rotted/damaged trim boards recommend repair/replacing damaged sections. Recommend repair of damaged trim by a qualified licensed contractor.

Trim had some deterioration recommend repair and painting. Some loose and missing trim recommend repair. Some rotted/damaged trim boards recommend repair/replacing damaged sections. Recommend repair of damaged trim by a qualified licensed contractor.

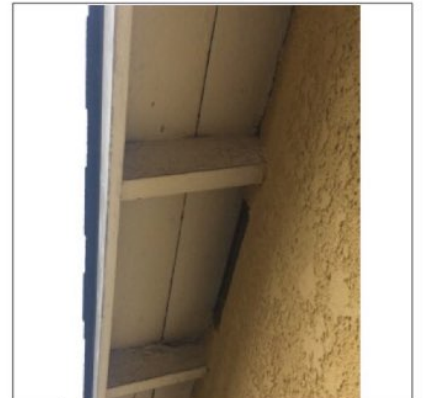
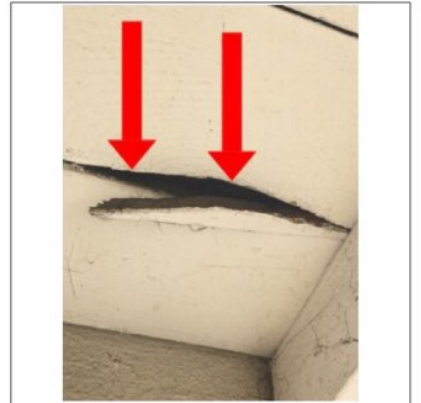
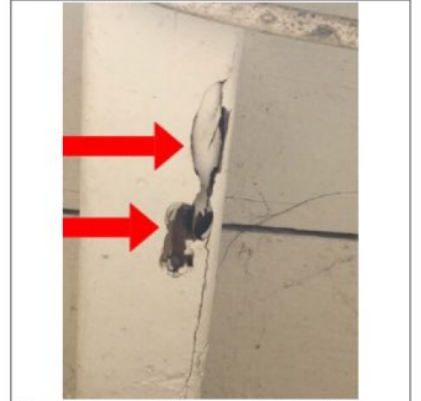
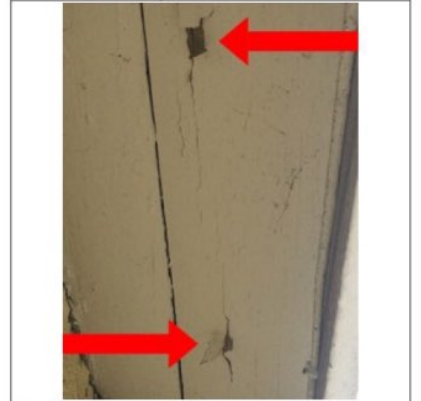
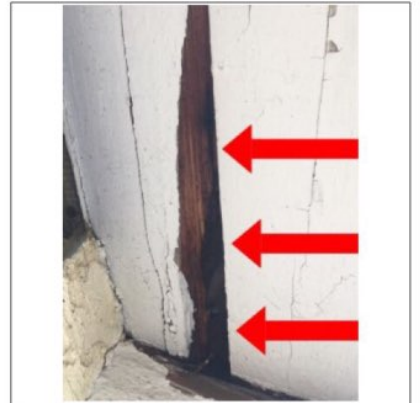
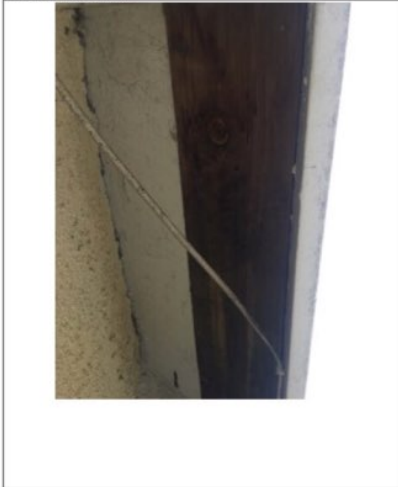
**Comments**  
 Soffit damaged/rotted, recommend repair by licensed contractor. Evidence of termite damage found in wooden soffit beams. Recommend licensed termite contractor inspect and evaluate further for repairs.

Soffit damaged/rotted, recommend repair by licensed contractor.

Recommend licensed termite contractor inspect and evaluate further for repairs.

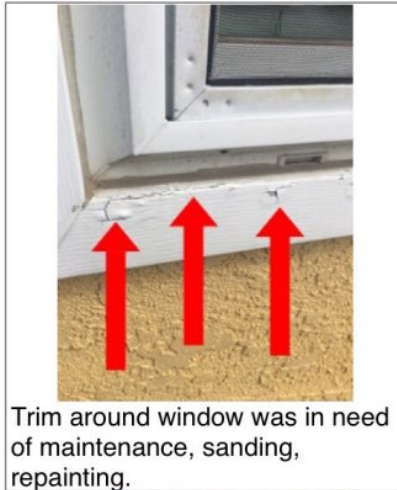
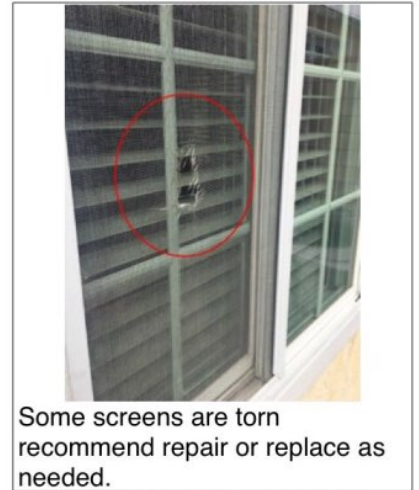
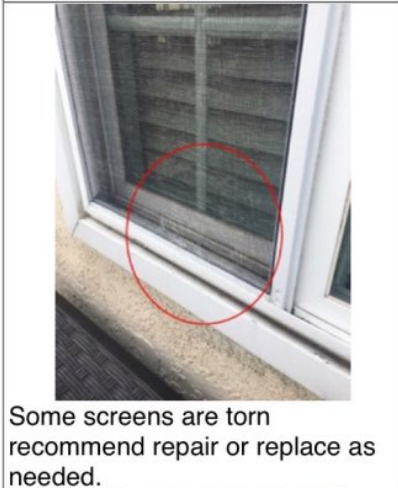
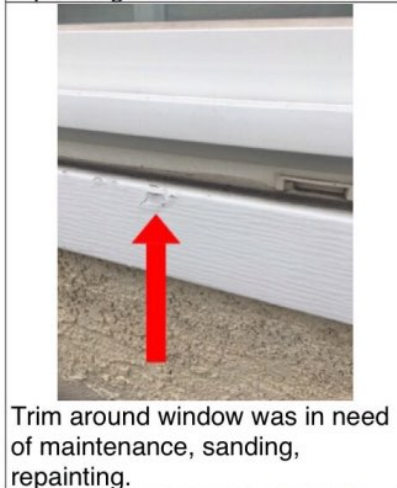
Trim around window was in need of maintenance, sanding, repainting.

Some screens are torn recommend repair or replace as needed.

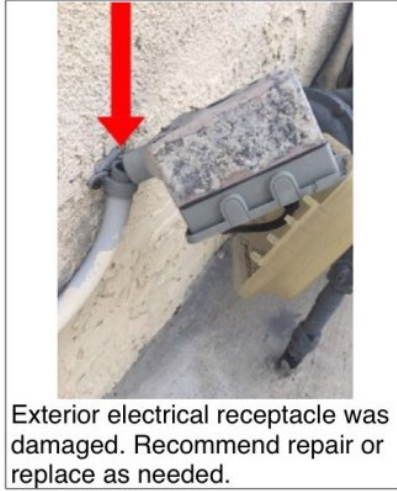
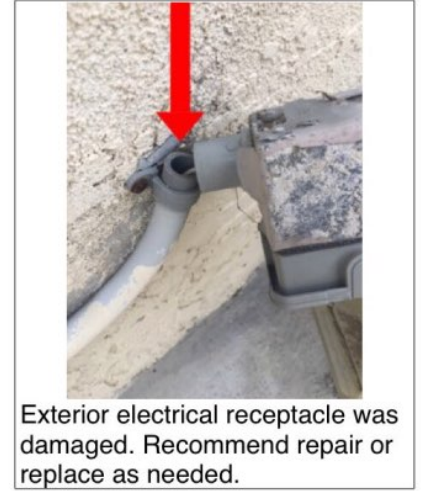
Exterior electrical receptacle was damaged. Recommend repair or replace as needed.

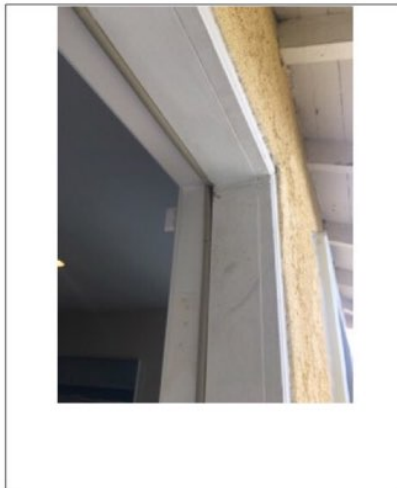
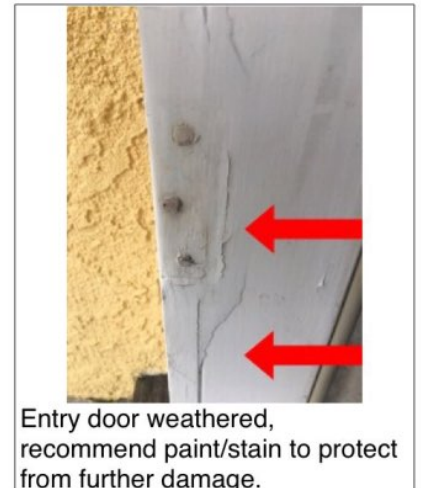
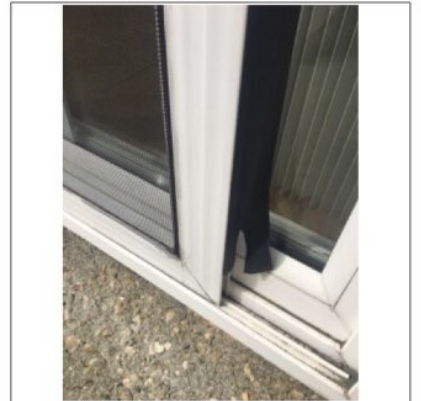
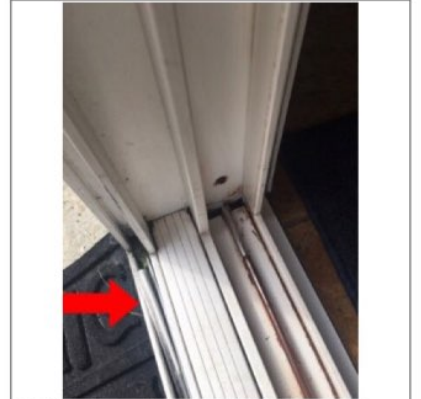
Entry door weathered, recommend paint/stain to protect from further damage.

Screen patio door was damaged and torn. Recommend replace.

Patio door does not slide easily, rollers damaged. Recommend repair/replace as needed.

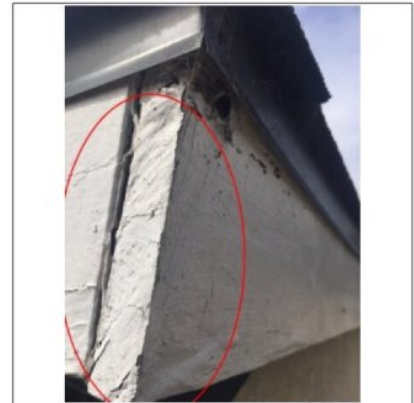
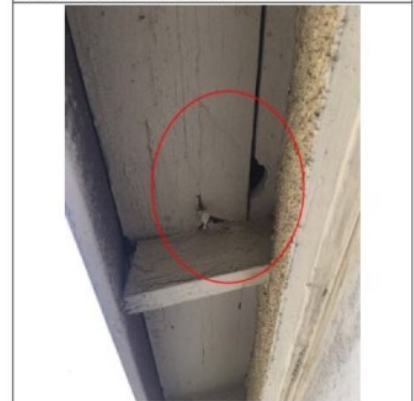
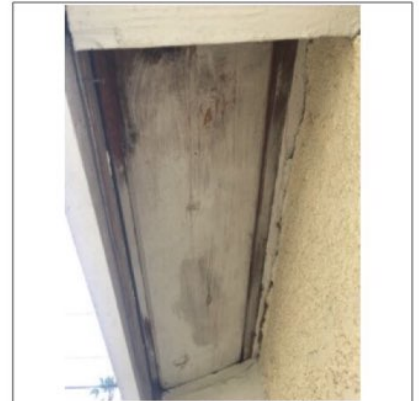
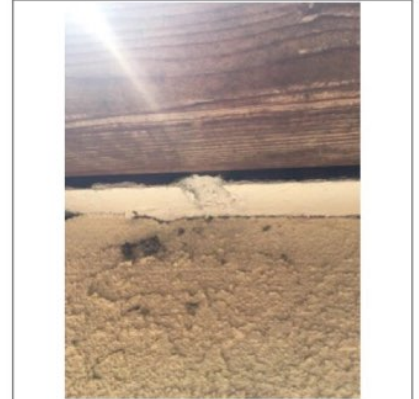
Garage Trim and soffit had some damage recommend repair by licensed contractor.

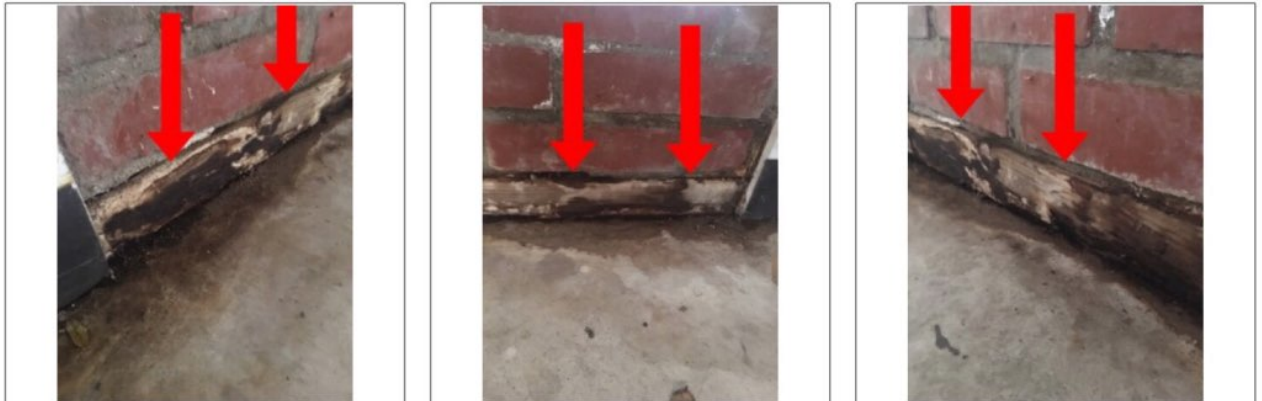
- None    Not Visible  
 Floor level    Elevated  
 Rotted/Damaged    Recommend repair  
**Comments** Sill plates in garage were rotted/water damaged recommend repair/replacement by qualified licensed contractor.

Sill plates in garage were rotted/water damaged recommend repair/replacement by qualified licensed contractor.

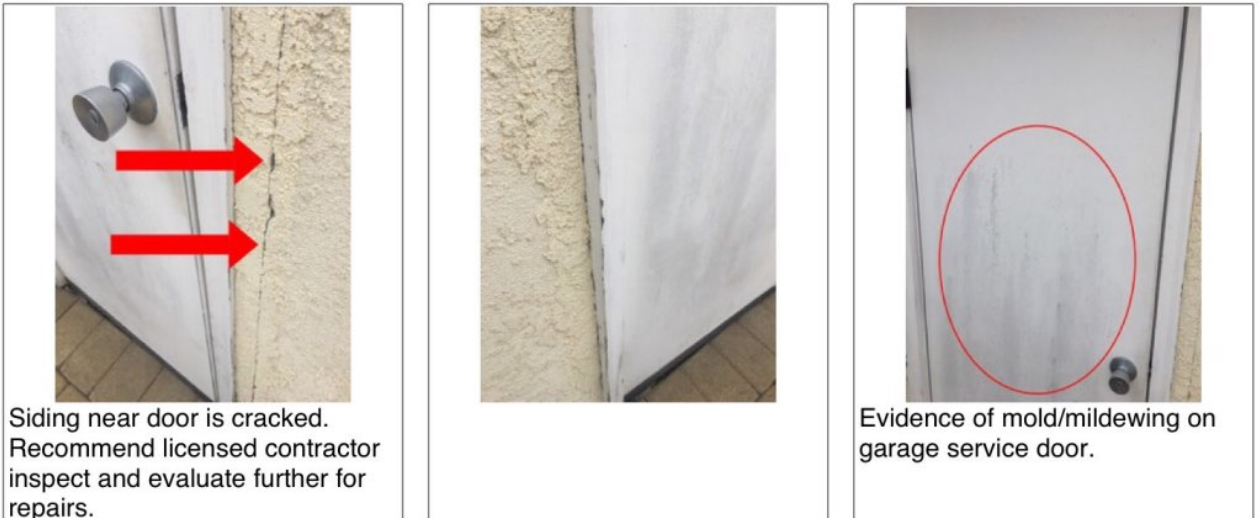
Entrance floor from service door to garage had large crack which is a possible entrance for moisture intrusion related to garage sill plate. Recommend licensed contractor inspect and evaluate further for repairs. Siding near garage service door is cracked. Recommend licensed contractor inspect and evaluate further for repairs. Evidence of mold/mildewing on garage service door.

Siding near door is cracked. Recommend licensed contractor inspect and evaluate further for repairs.

Evidence of mold/mildewing on garage service door.

Entrance floor from service door to garage had large crack which is a possible entrance for moisture intrusion related to garage sill plate. Recommend licensed contractor inspect and evaluate further for repairs.

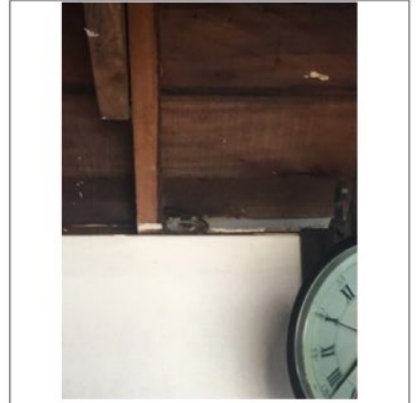
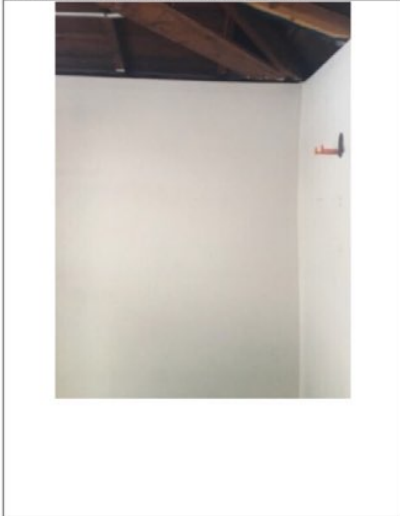
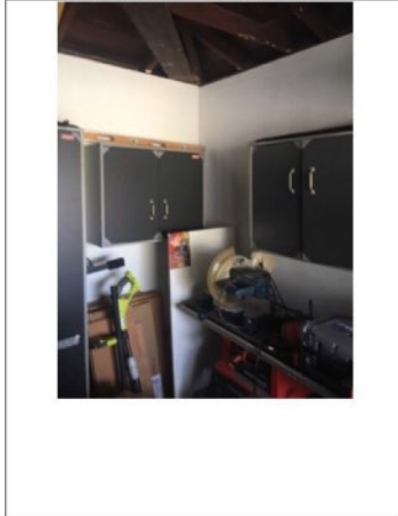
Damaged roof planks in ceiling of garage roof. Recommend licensed contractor inspect and evaluate further for repairs.

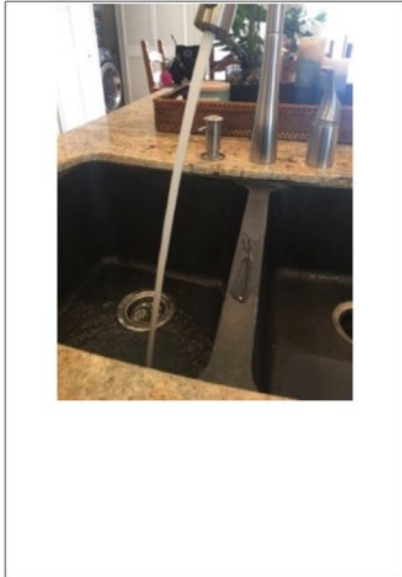
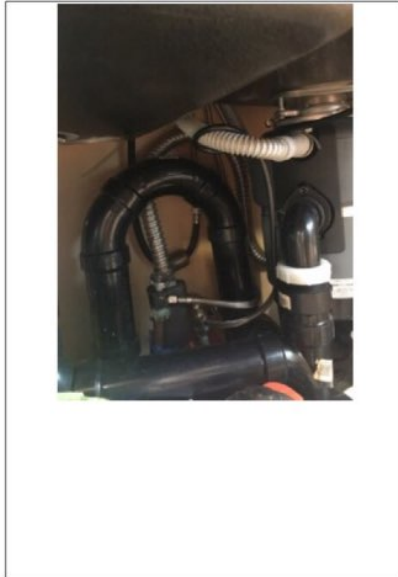
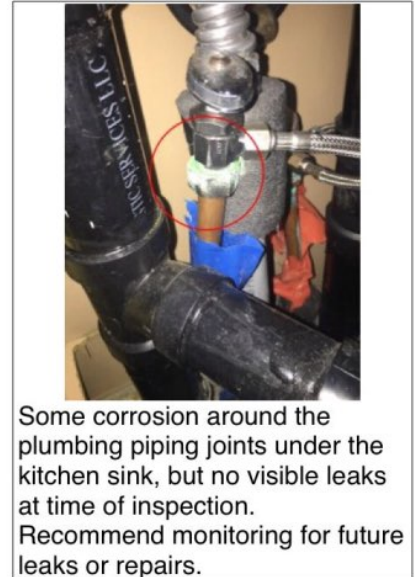
**Comments** Some corrosion around the plumbing piping joints under the kitchen sink, but no visible leaks at time of inspection. Recommend monitoring for future leaks or repairs.

Some corrosion around the plumbing piping joints under the kitchen sink, but no visible leaks at time of inspection. Recommend monitoring for future leaks or repairs.

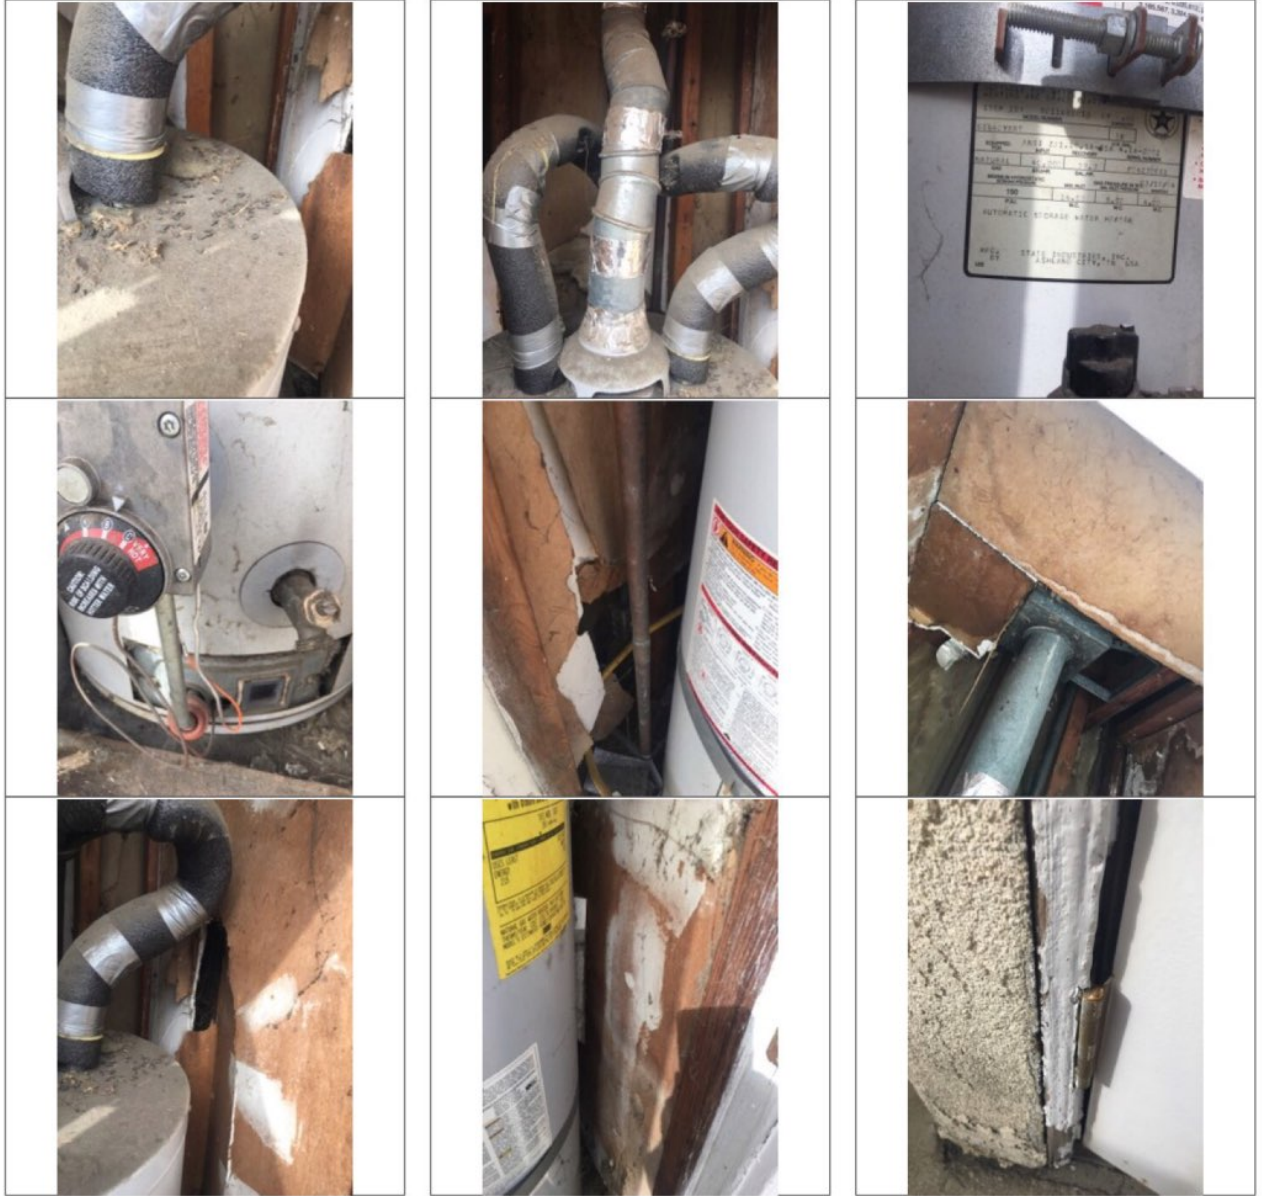
**Comments cont.** evaluate further for repairs of exterior water heater enclosure damage. Extensive drywall damage found and moisture intrusion found in enclosure. Evidence of rodent droppings found on water heater case. Recommend licensed pest control specialist inspect and evaluate further.
