As a result of my inspection and meeting with you at your home on October 19th, the following report documents my comments and observations about the metal roof installation performed by XX Roofing, Inc. (XXX). Also in attendance was the installation manager for XX Roofing, Mr. XX and Mr. XX a representative from XX Building Supply (XXX), the metal roof material manufacturer.

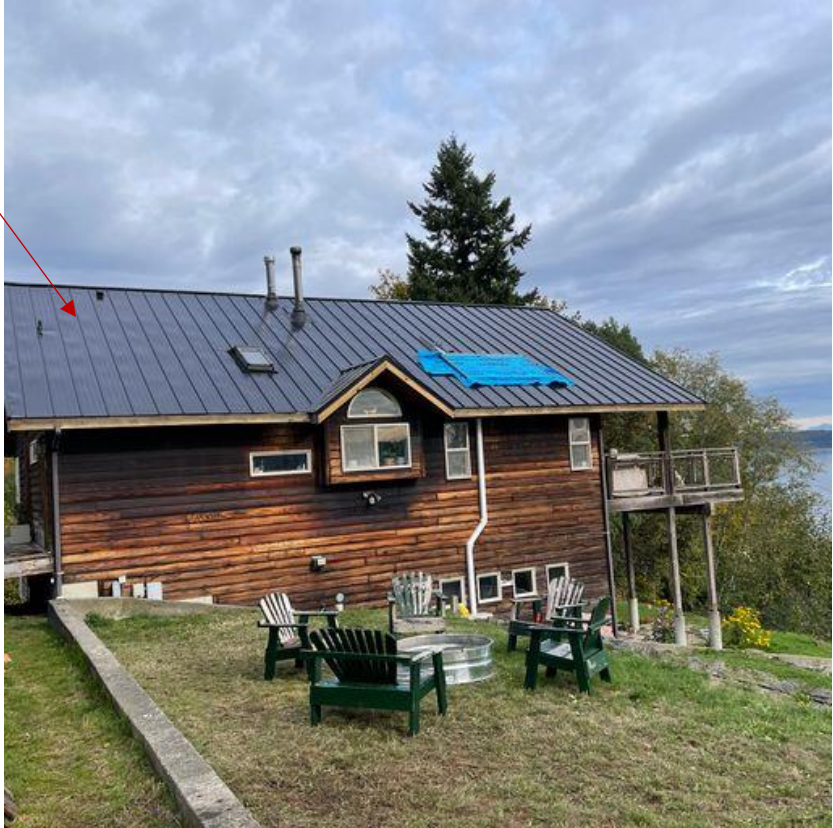
Photo #1

The third condition that induces oil canning in metal roof panels is the installation methods. Excessive pressure to the screw fasteners installed in the attachment flange of the panel often accentuate oil canning. It is my conclusion this is the major cause of this excessive condition on this project. See **photos 1-4** to illustrate these conditions. The consistency of pattern in **photo 1** is a clear indication of fastening pattern over surface or material causes.

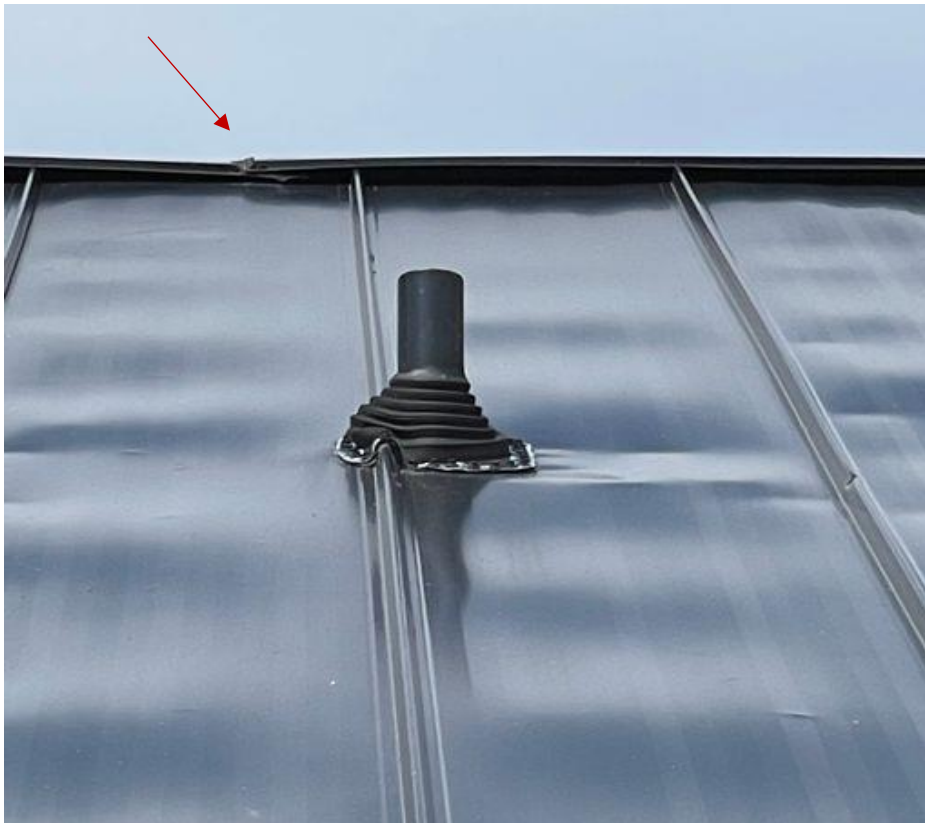
Photo #5

The ridge overlap conditions were not installed properly as shown with significant distortion and exorbitant use of caulking to fill large gaps. **photo #5** The end of the ridge line above the main entry has a patched small piece of gable under the ridge end that is unsightly. See **photo 6**. Large sections were used elsewhere as should have been the case here as well.

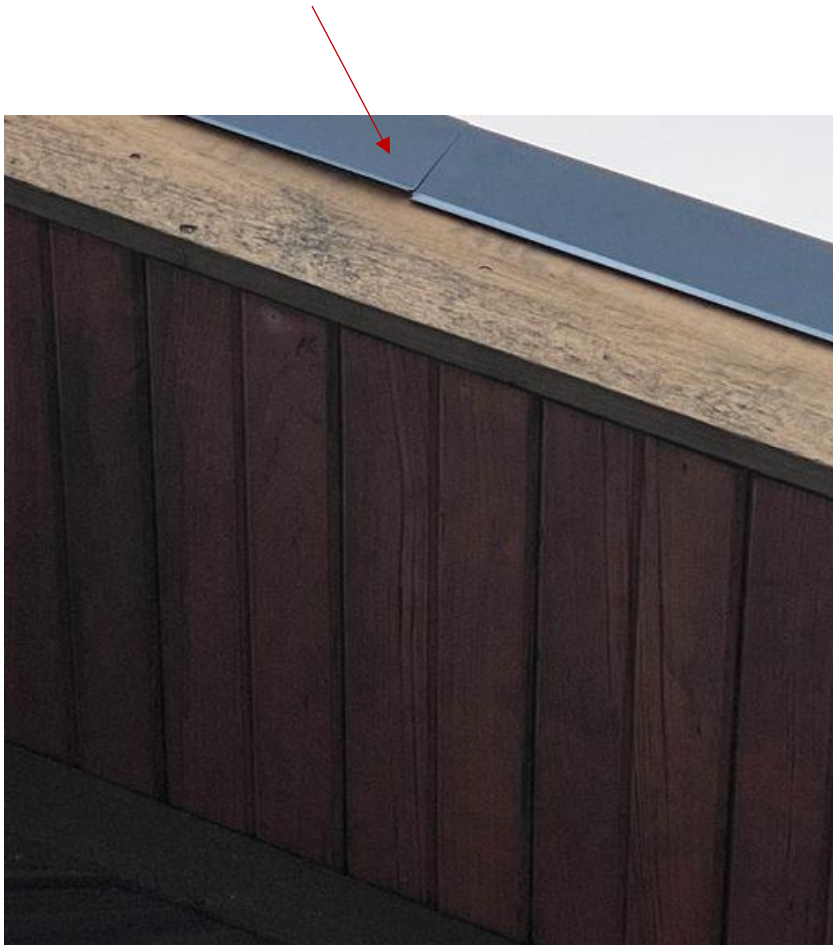
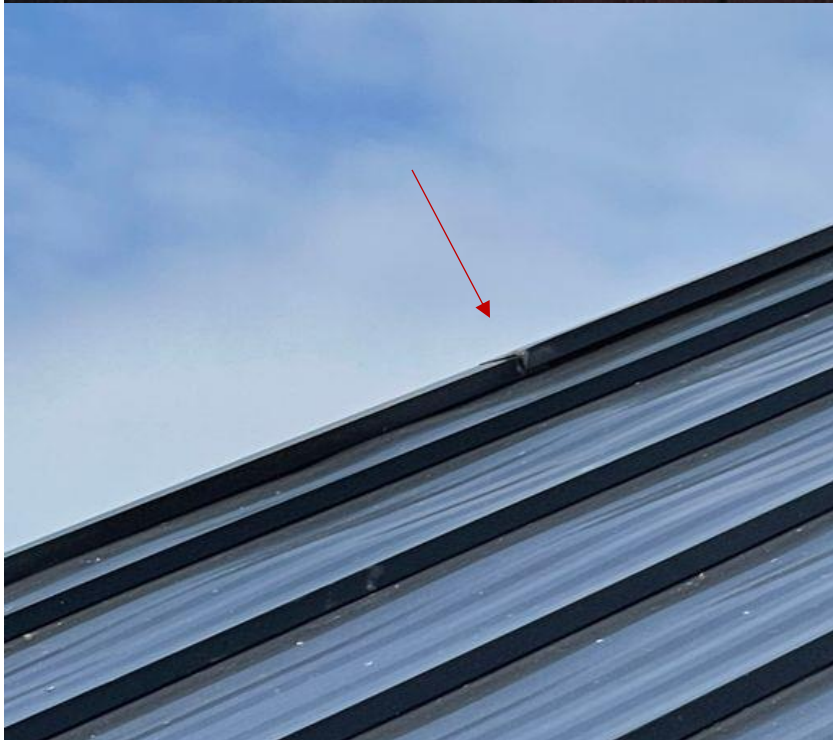
There are a number of problems with the gable/rake flashing details. **Photos 7 & 8** illustrate the improper overlap with significant gaps and lack of hem modification to allow a proper overlap. **Photos 9 & 10** show different gable on each side of the roof slope. The left gable has exposed fasteners and the right side does not. Both gables are different and the right side gable is not a manufacturers detail and is not installed in accordance with manufacturer standards. Notice the top fasteners on the gable in **photo 10**. The inconsistent gable flashings, lack of proper overlaps, excessive use of caulking to overcome poor craftsmanship and lack of following the manufacturers details suggest all gable flashings should be replaced and installed appropriately. The gable attachments may also contribute to the significant soffit staining and damage. See additional comments and photos in the “soffit” section later in the report.

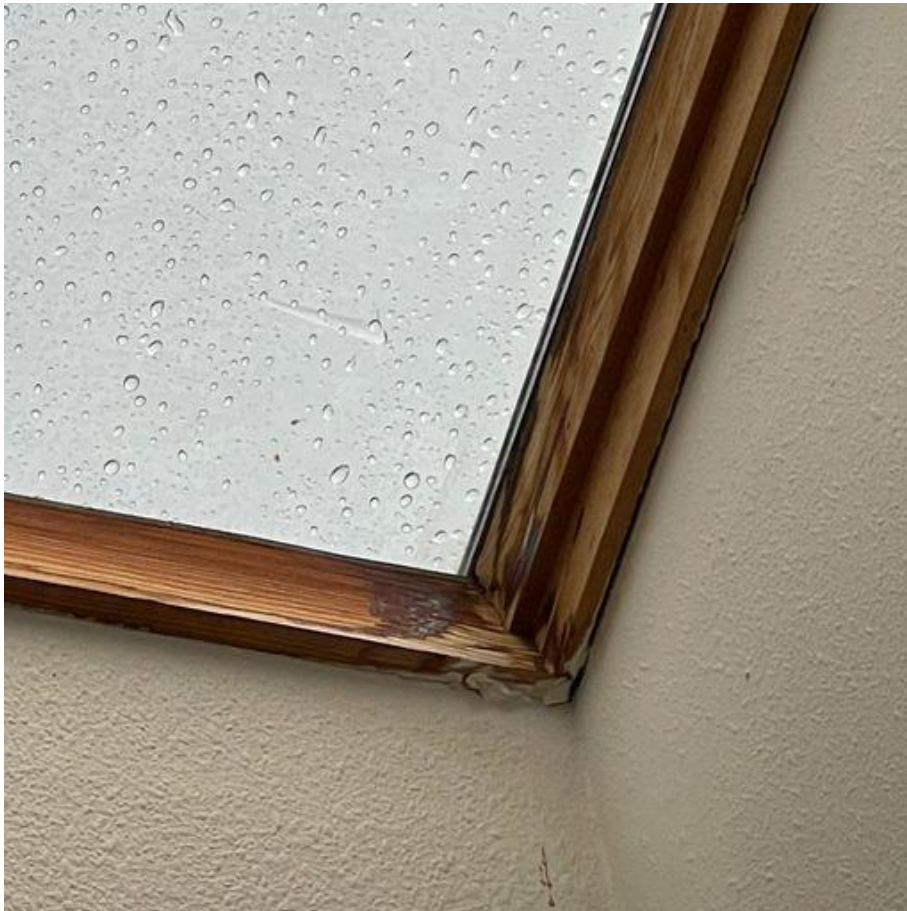
Photo #11

The master bedroom opening skylight leaked from the original installation. Upon repair after a significant time under a tarp, the correcting installer noted the original installation was incorrect. The opening Velux skylights have very specific flashings that are required to work with the gasketed system detail of the Velux opening skylights. Exact Velux or exact match flashings must be used to properly seal these skylights. The remaining skylights are suspect due to the incorrect installation of the master bedroom skylight. The attached **photos 11 & 12** illustrate the interior water staining. The location of the staining illustrates the gaskets were not in the appropriate location with the new flashing.

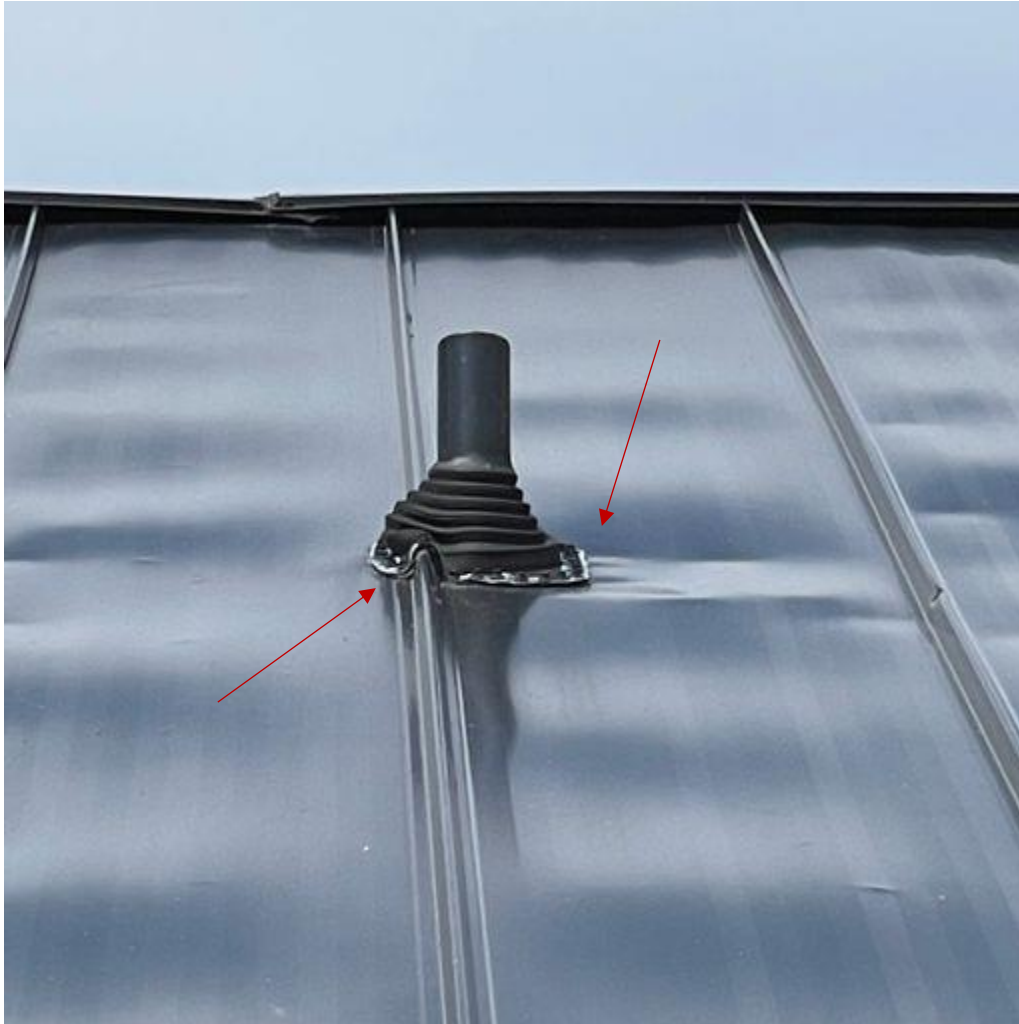
Photo #13

The plumbing vent flashing as illustrated in **photo 13** is installed in the panel seam. Although this may be unavoidable, when encountered there must be a custom box flashing made as required by the manufacturer of this part or there must be a relief cut in the panel seam to ensure that moisture collected with the seam above the pipe vent can escape prior to entering inside the flashing and dripping inside the roof envelope. The attachment of fasteners in this area also accentuated oil canning due to the use of excessive force.

Panels dents and lack of care are also evidenced **photo 13**.

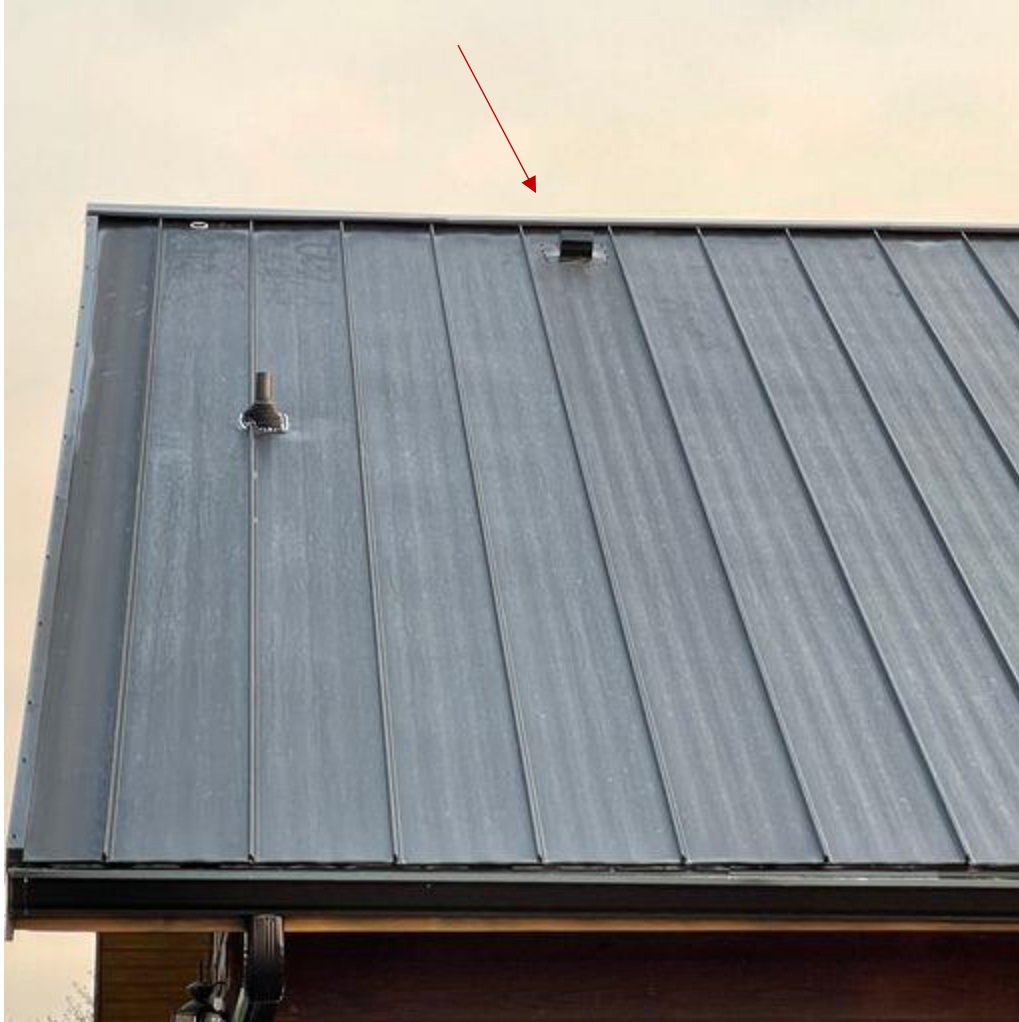
Photo #14

The exhaust hood in **photo 14** appears to be a standard part used with traditional roofing products and is not appropriate for metal roof installations. Any roof penetration should be “shingled” into the roof panel and not surface mounted as shown. This mounting practice requires total dependency on sealants on a sloped plane which has proven to have a very limited life expectancy and is not in accordance with industry standard practices. The sealant is also applied in a very haphazard manner.

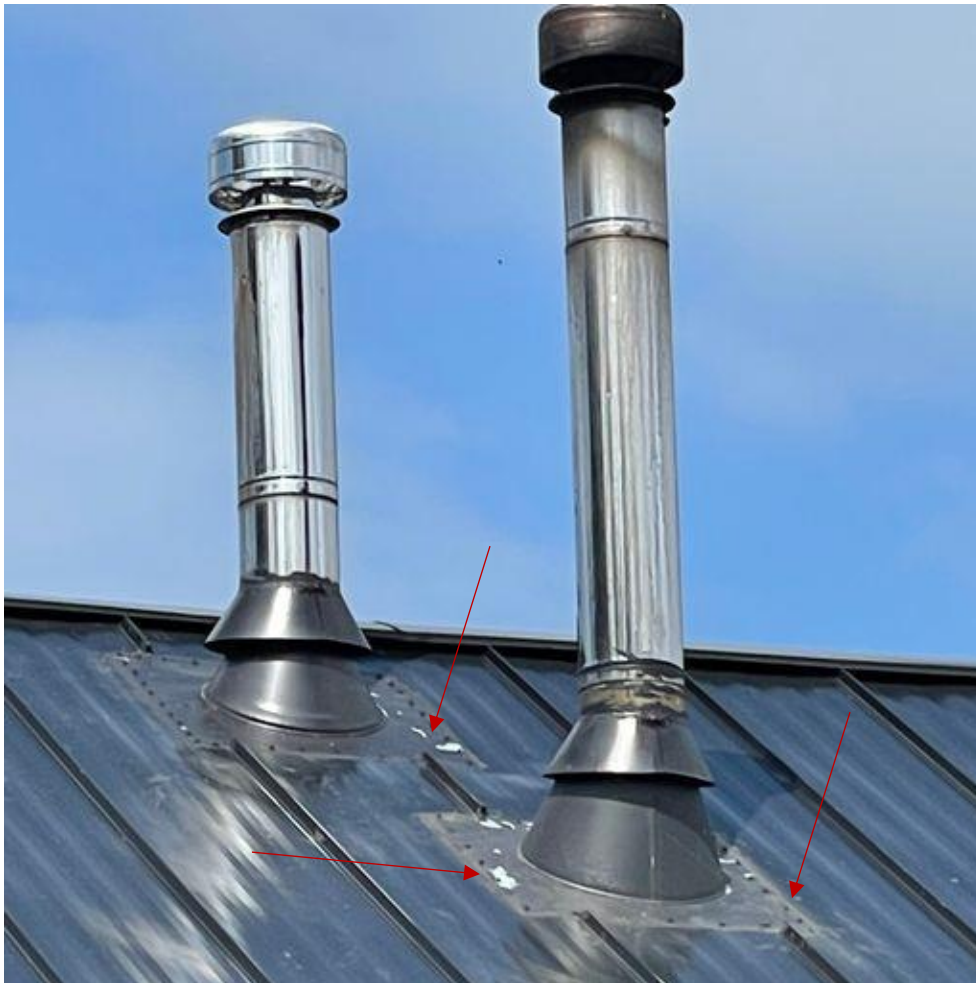
Photo #15

The two chimney penetrations also have standard roof penetration flashings that were field painted in a similar color to the roof. There are multiple problems with this installation as follows:

- The nature of these flashings are not compatible with standing seam metal roof panels
- They are surface mounted requiring dependency on sealant
- The panel ribs were cut out and filled with sealant for weathertightness. This will fail in a very short time.
- The flashings are not “shingled into the roof panels as required.
- The field painting does not match the roof panels and is already failing/chipping off.

Photo 15 illustrates the deficiencies noted above

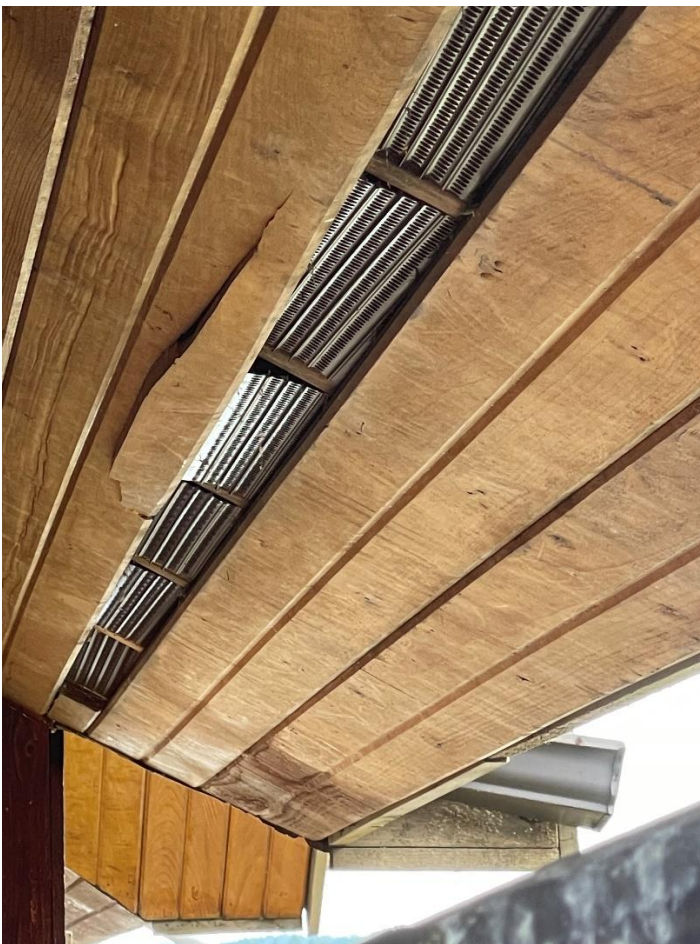
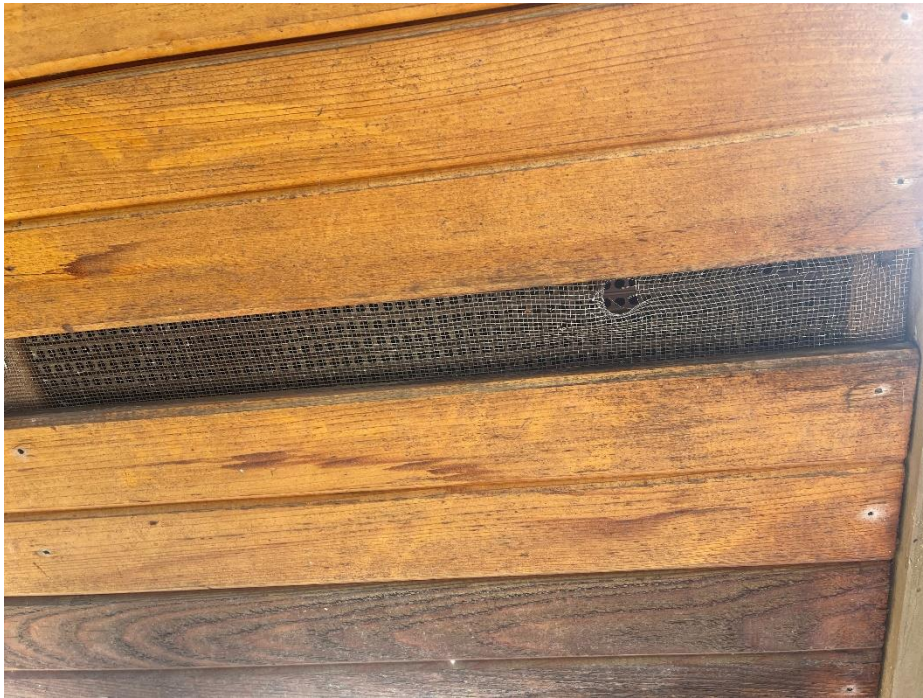
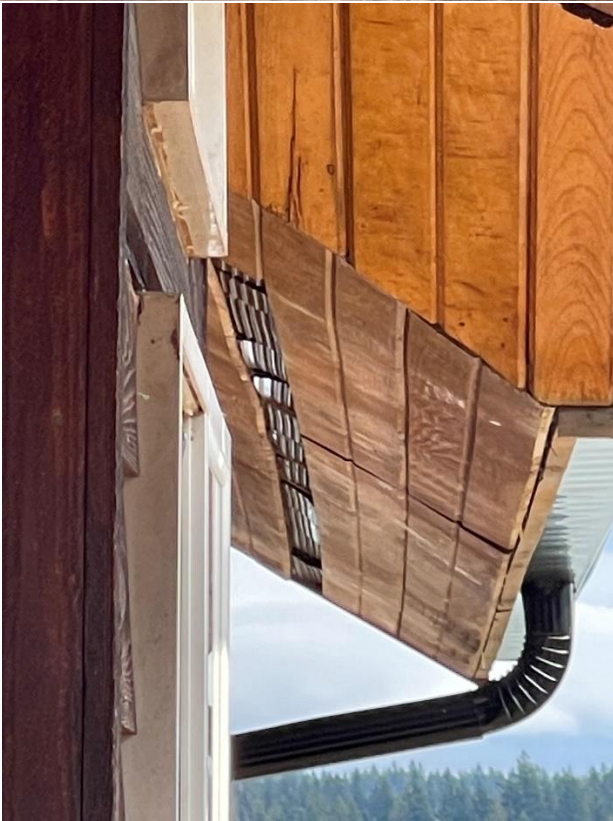
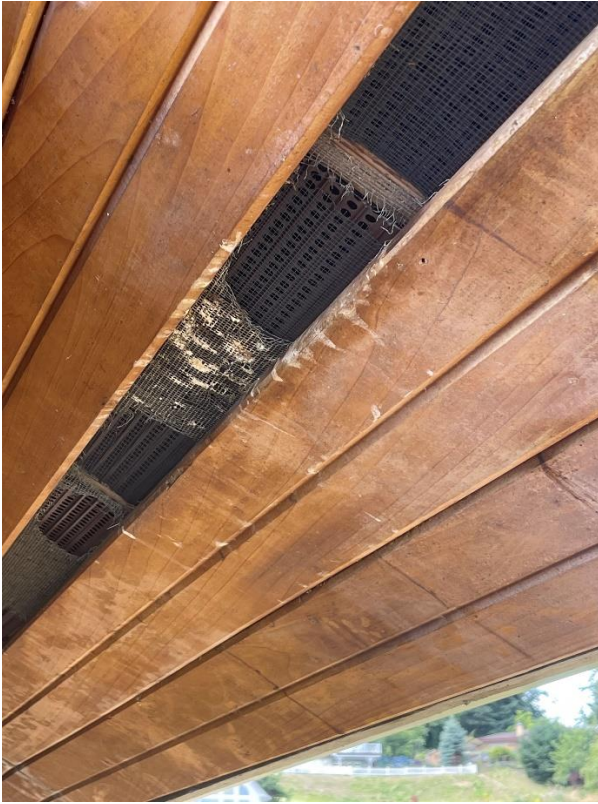
The contract notes to verify venting were to your understanding to verify and replace as necessary. The following **photos 16-19** illustrate the ineffective use of new brown plastic vent material installed in a manner with open gaps and inconsistent appearance. In some cases the vent material was installed over the original damaged screen. Notice the broken soffit section that was from a workers foot stepping on the soffit from the top side and not performing an appropriate repair remedy.
