Milestone Phase I Report
Parador Condominium Association, Inc.

Report Date: ⌚ 6/26/2024

Inspection Date: ⌚ 4/17/2024

1200 Gulf Shore Blvd N, Naples, FL, 34102

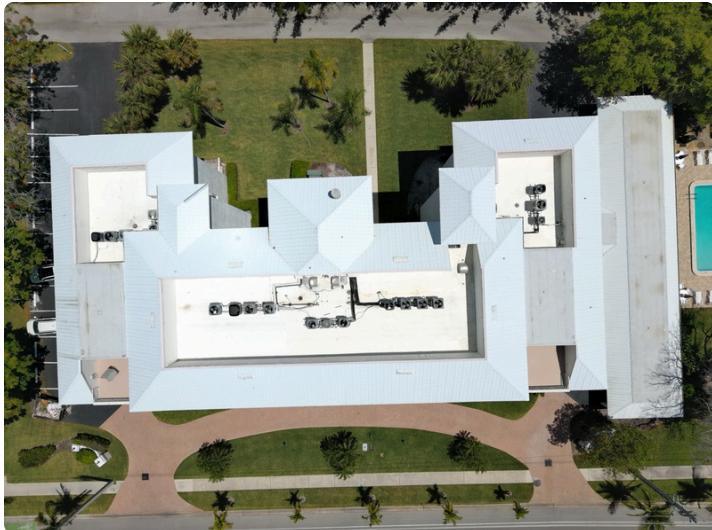
Top down roof overview

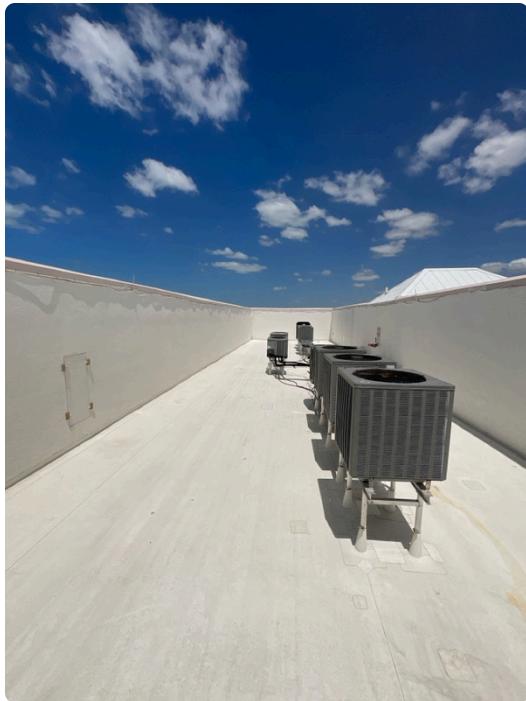
TPO roof surface in good condition

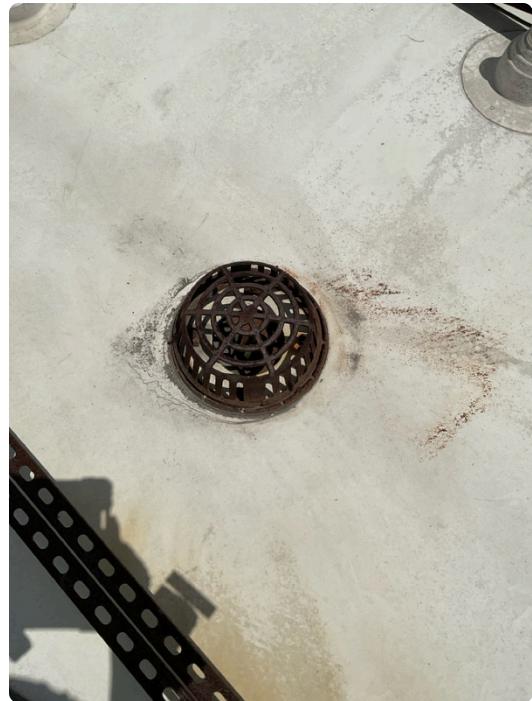
Corrosion on drain screen

Deficiencies	No deficiencies observed.
Maintenance	<p>Recoat the corroded drain screen with a corrosion-resistant coating as necessary .</p> <p>For water stain, add sloping to prevent ponding.</p> <p>Replace the rusted anchor bolts on the metal roof mansard with stainless steel equivalents to reinforce structural integrity and prevent water infiltration.</p>
Condition	Good

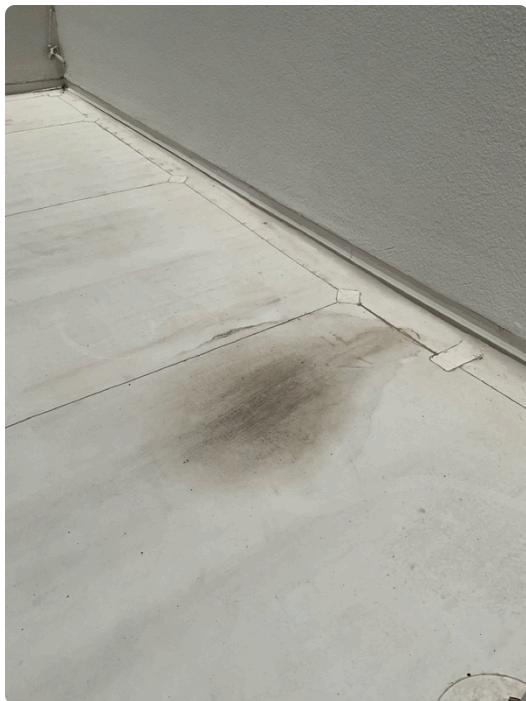
Water stain indicative of water pooling issue

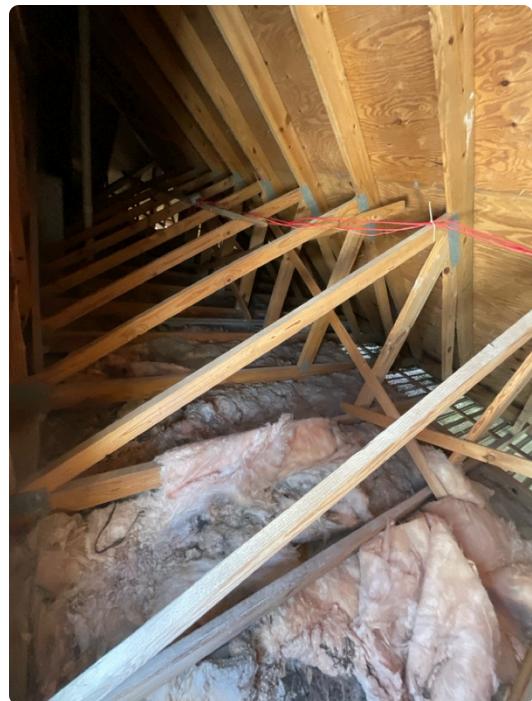
Mansard interior reveals wood structure

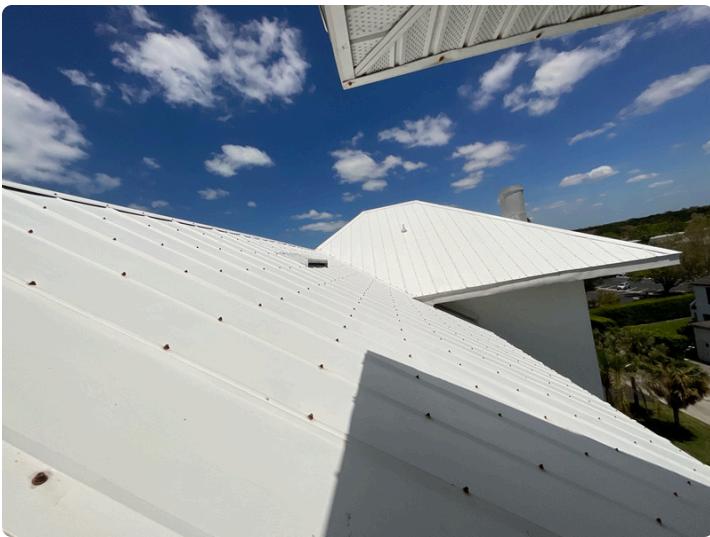
Rusted anchor bolts on metal roof mansard

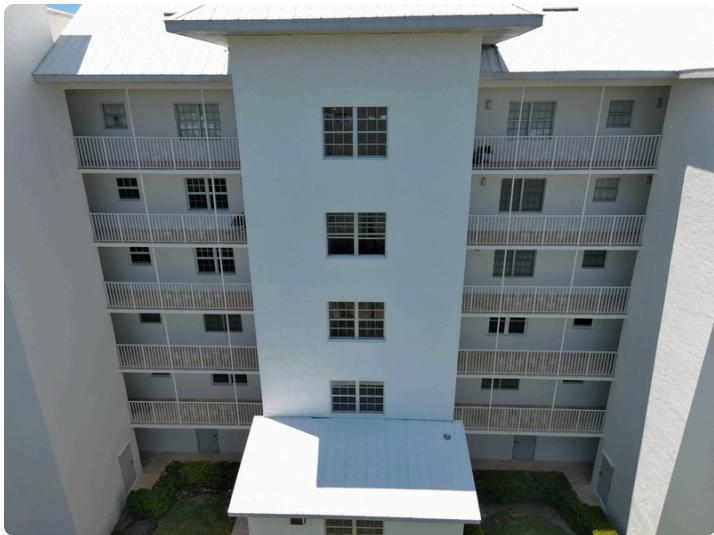
Rear wall overview

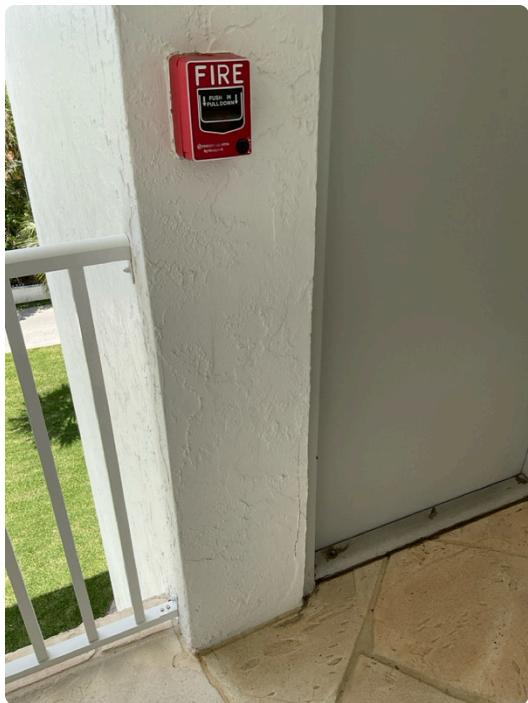
Crack at left of south stairwells entrance at unit 401

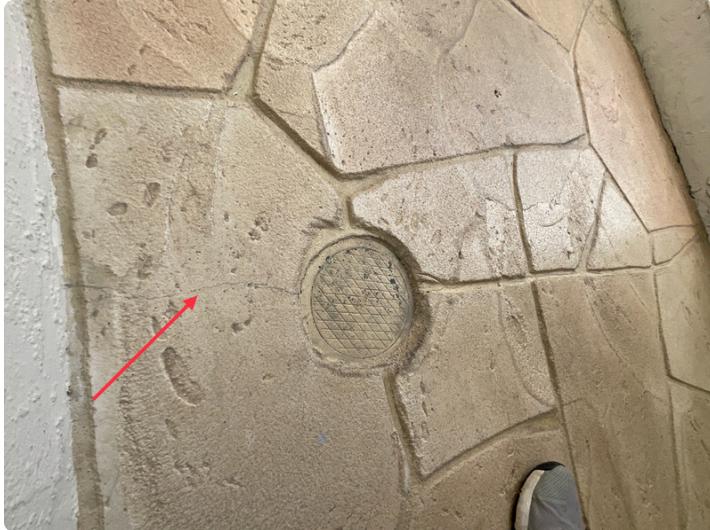
Crack on the walkway at ground floor between storage rooms and south stairwells

Deficiencies	No deficiencies observed.
Maintenance	<p>Repair the crack on the ground floor walkway with concrete epoxy patch.</p> <p>Fill the cavity at the base of the railing post with structural-grade epoxy or grout.</p> <p>RegROUT all the applicable cracks on the walkways.</p>
Condition	Average

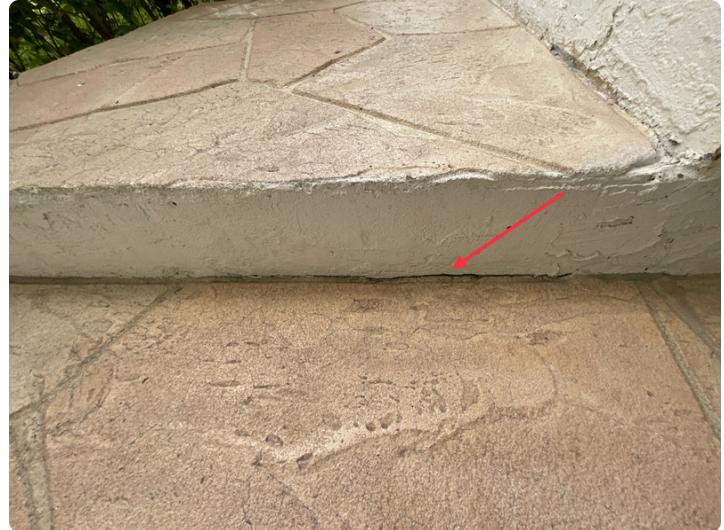
Gap at slab and walkway interface at ground floor, between storage rooms and south stairwells

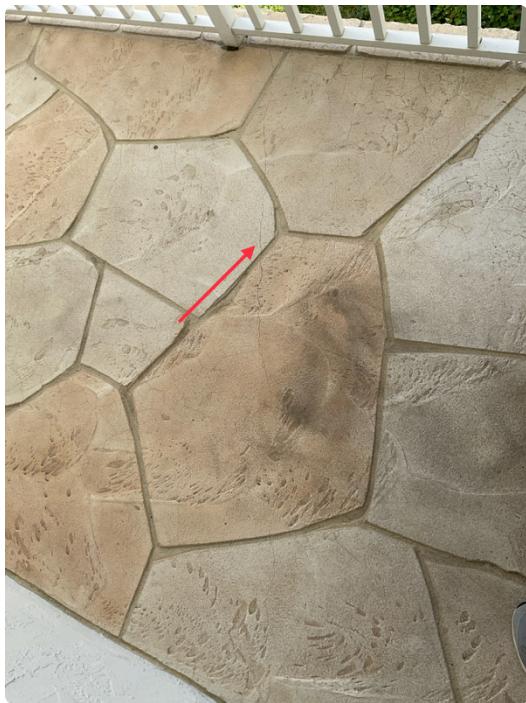
Cracks all over the walkway extending from wall to edge at unit 101

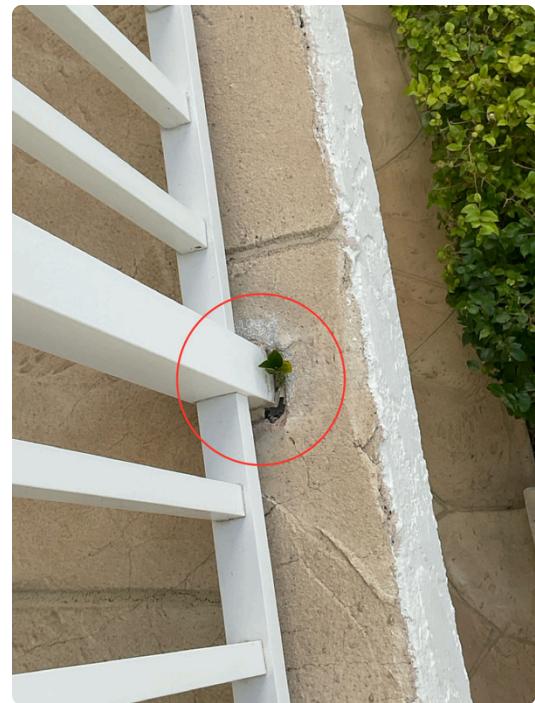
Cavity at the base of the railing post between units 101 and 102

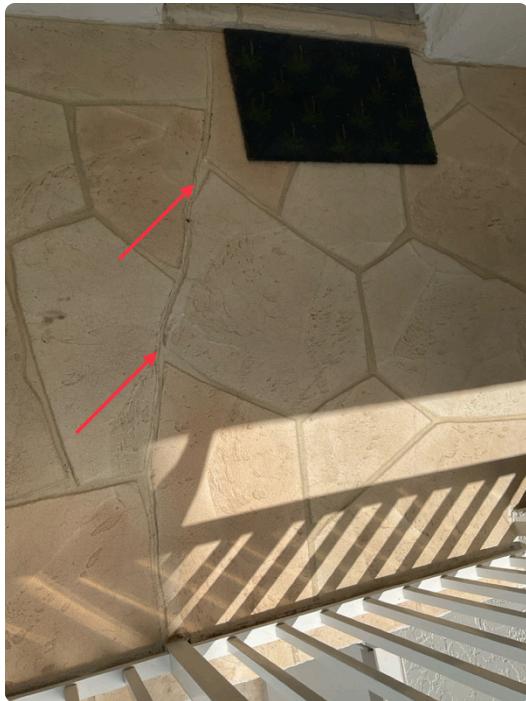
Crack on the sealant by unit 102

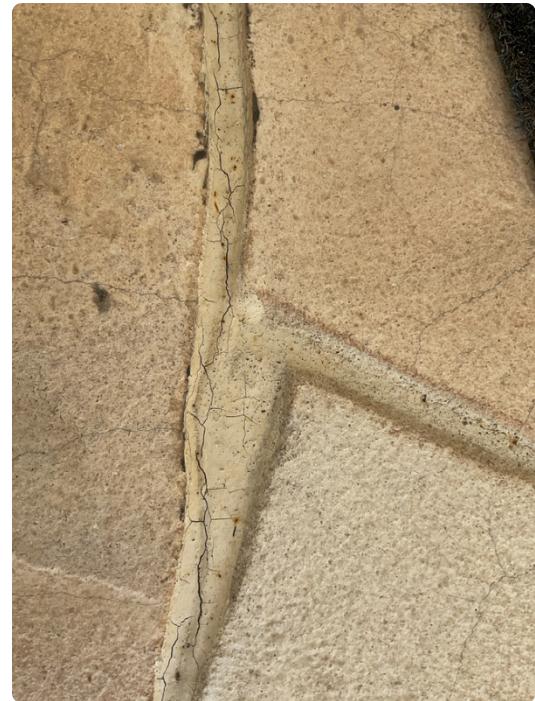
Crack on the sealant

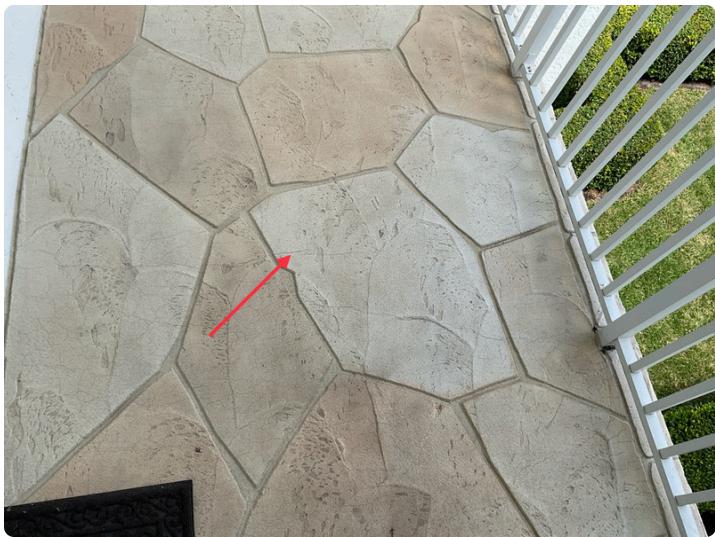
Cracks on walkway by unit 203

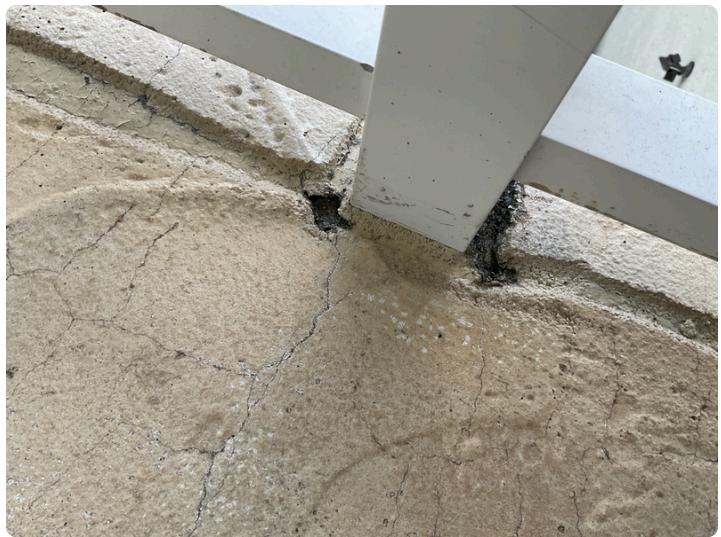
Cavity at the base of the railing post between units 301 and 302

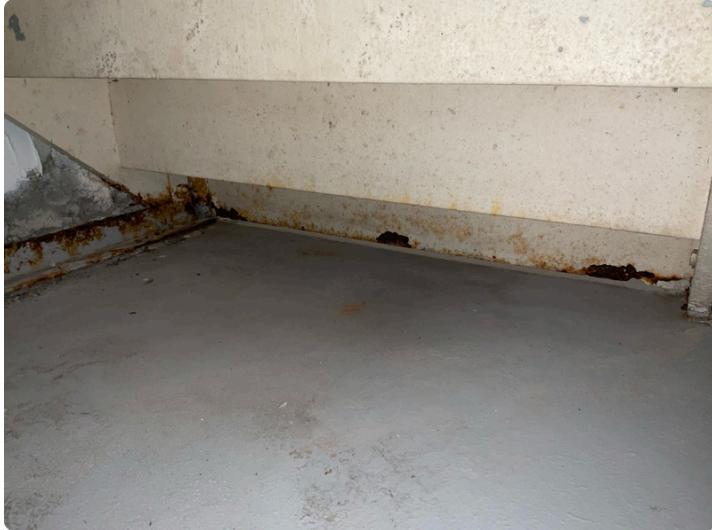
Corrosion on metal constituent underneath the treads of the south stair at ground floor

Deficiencies	No deficiencies observed.
Maintenance	<p>Treat corrosion on metal constituents beneath the treads of the south stair with a rust inhibitor followed by application of a corrosion-resistant coating.</p> <p>Repair edge chipping at the stairs by filling with a durable epoxy-based repair mortar.</p> <p>Rectify the crack on the landing of the south stairs by routing and sealing.</p> <p>Conduct regular inspections and maintenance to ensure the structural integrity and safety of the stairs.</p>
Condition	Average

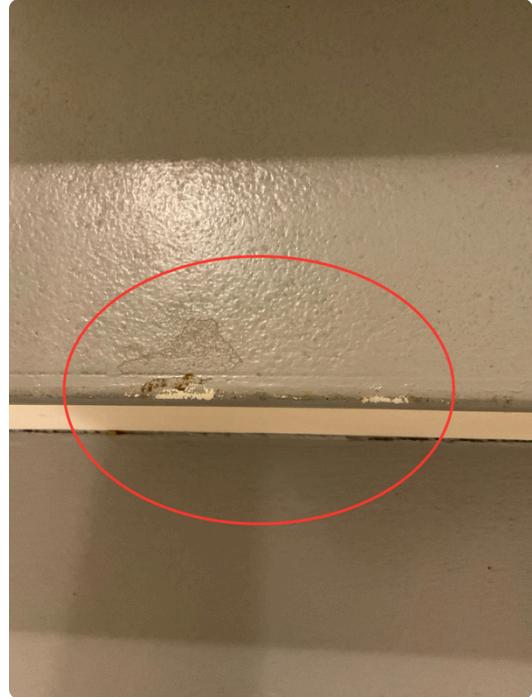
Edge chipping at the south stairs at 2nd floor

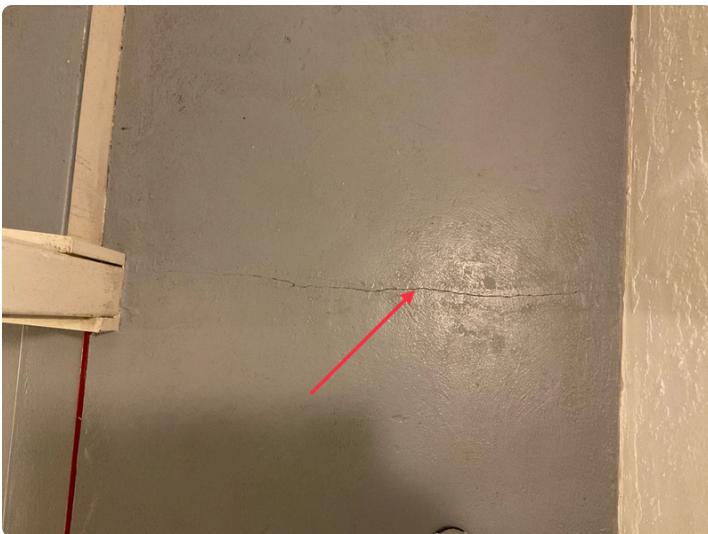
Crack on the landing of south stairs between 3rd and 4th floor

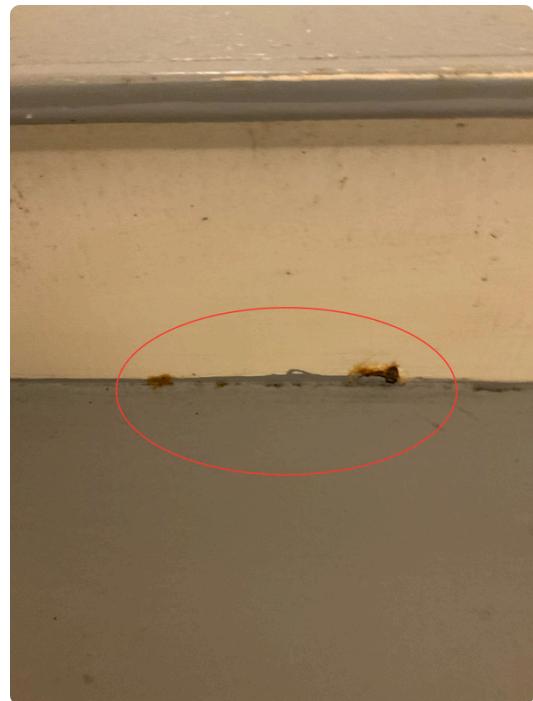
Signs of corrosion at south stairs at 3rd floor

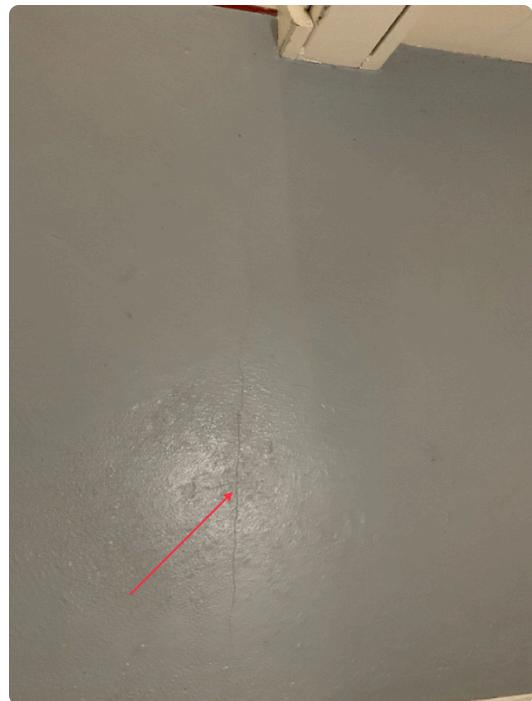
Crack on the landing if south stairs between 5th floor and roof

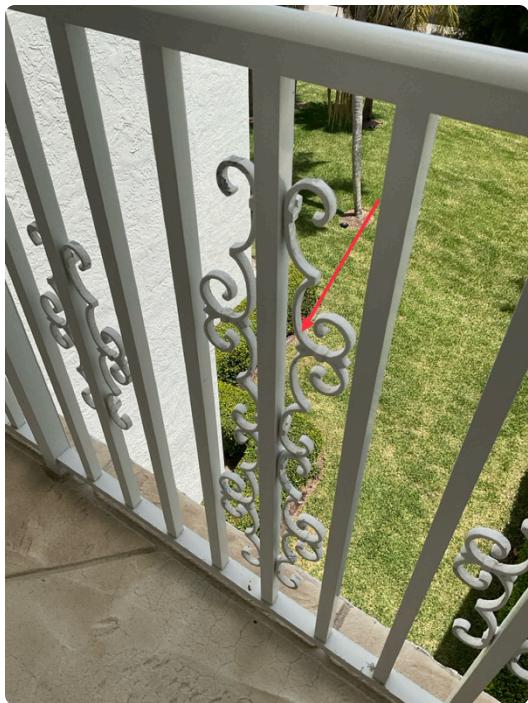
Loosely attached railing decoration infill at unit 303

Deficiencies	No deficiencies observed.
Maintenance	Securely fasten the piece of railing decoration using appropriate hardware such as screws or bolts.
Condition	Good

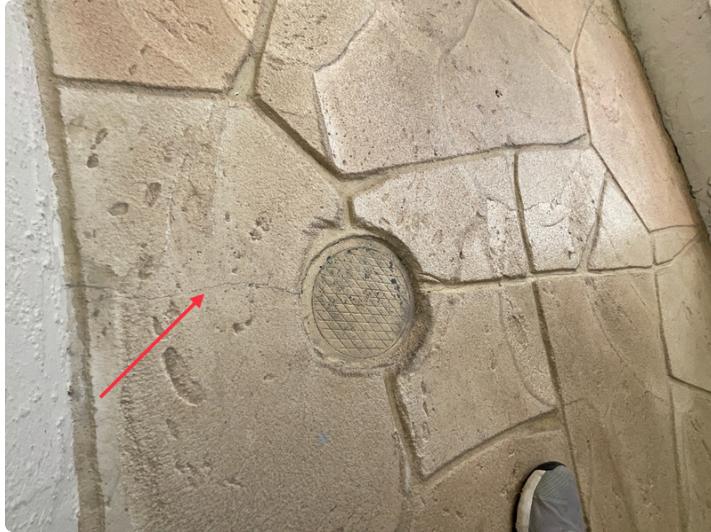
Crack on the walkway at ground floor, between storage rooms and south stairwells

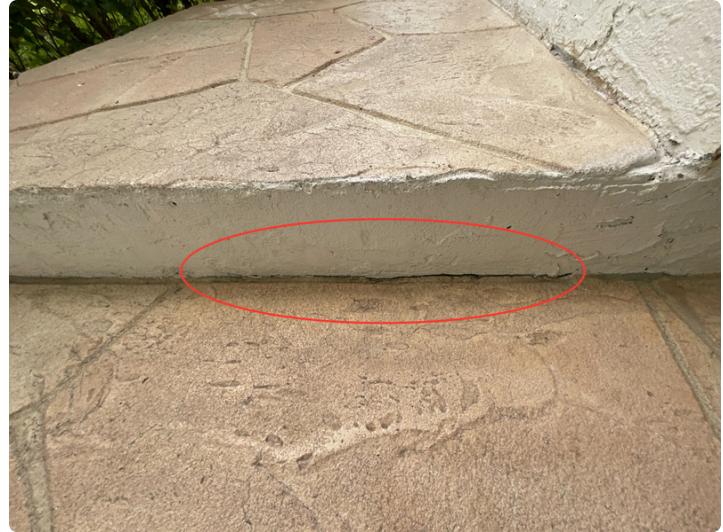
Gap at slab and walkway interface at ground floor, between storage rooms and south stairwells

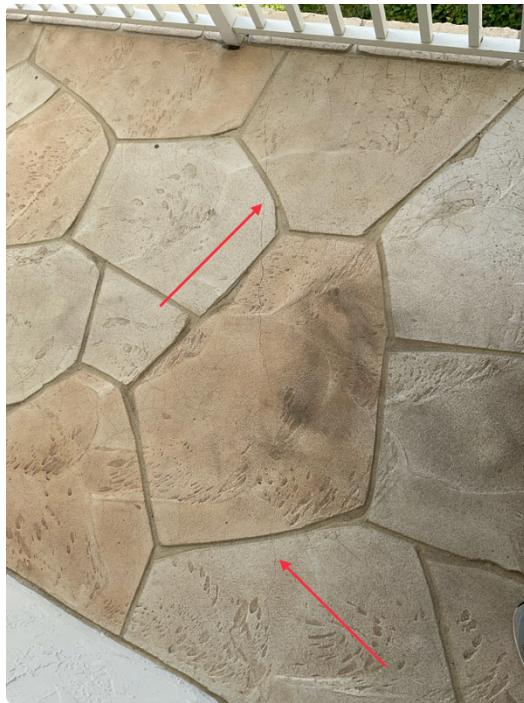
Cracks all over the walkway extending from wall to edge at unit 101

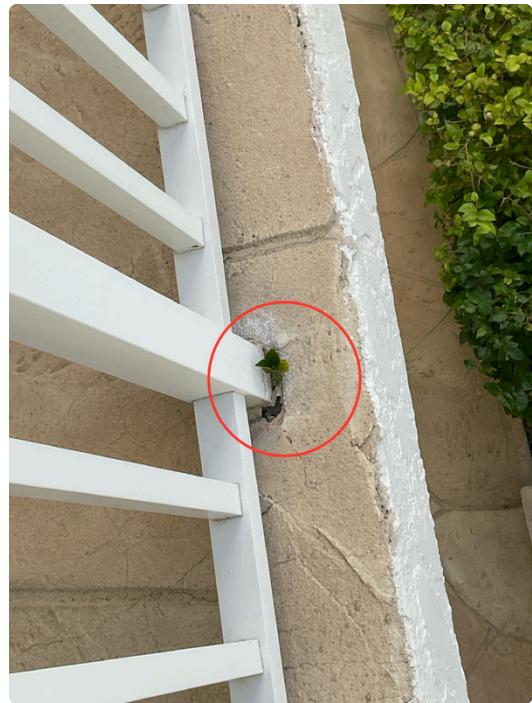
Cavity at the base of the railing post between units 101 and 102

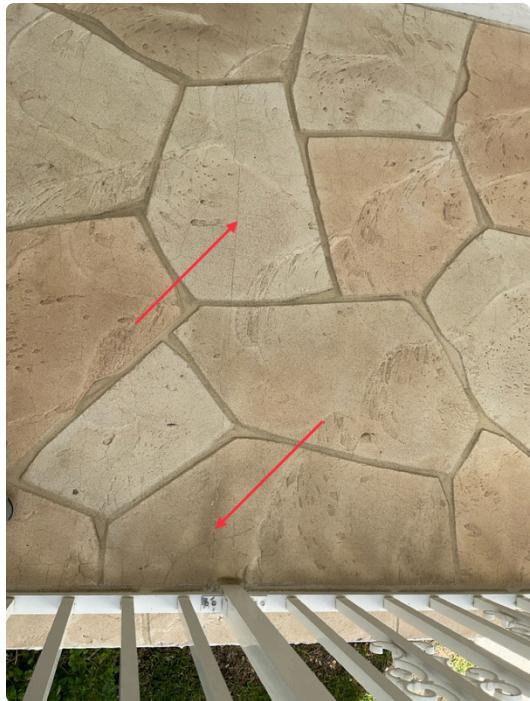
Crack on walkway between units 101 and 102

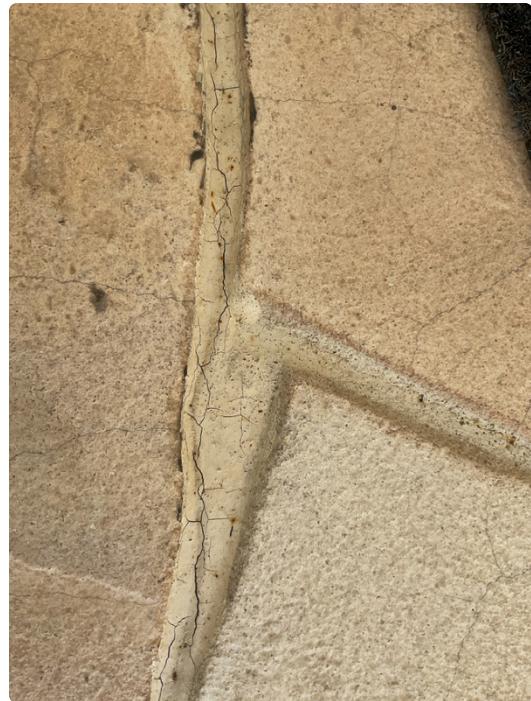
Crack walkway grout by unit 102

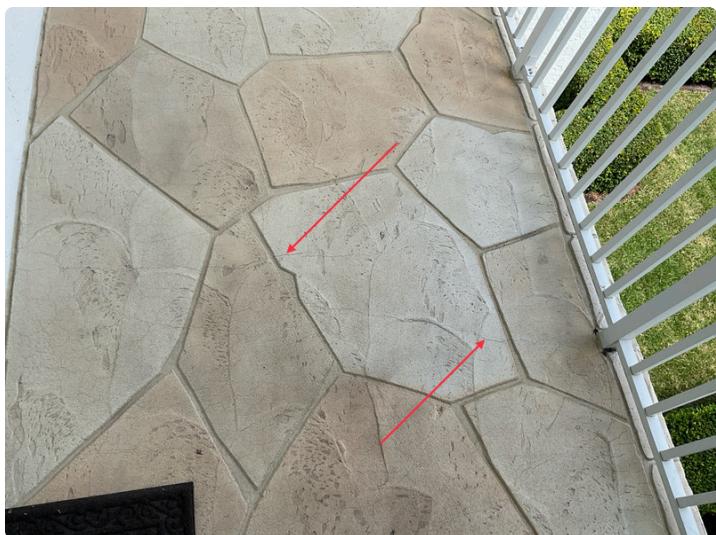
Cracks on walkway at unit 203

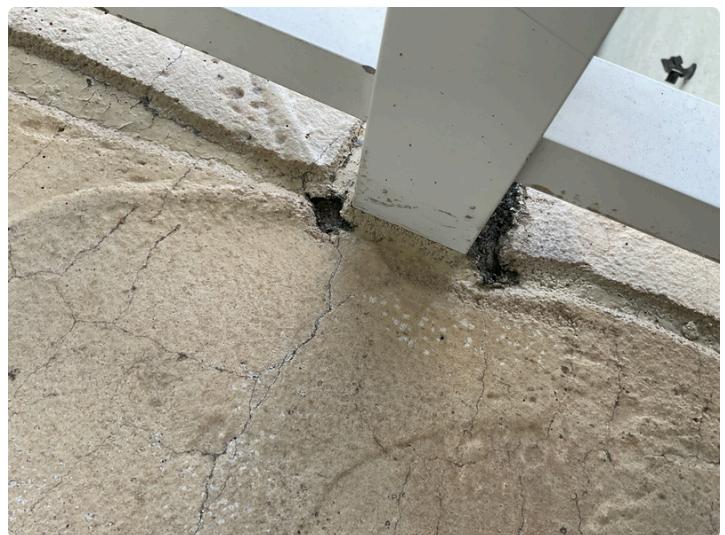
Cavity at the base of the railing post between units 201 and 202

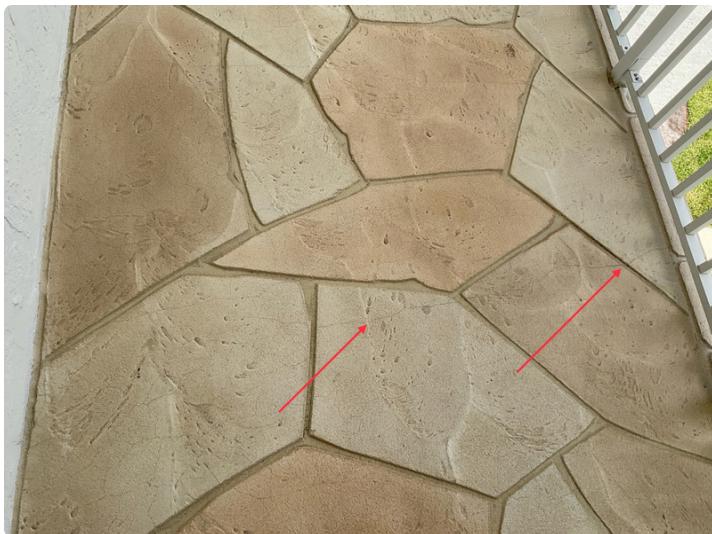
More cracks on the walkway on 3rd floor

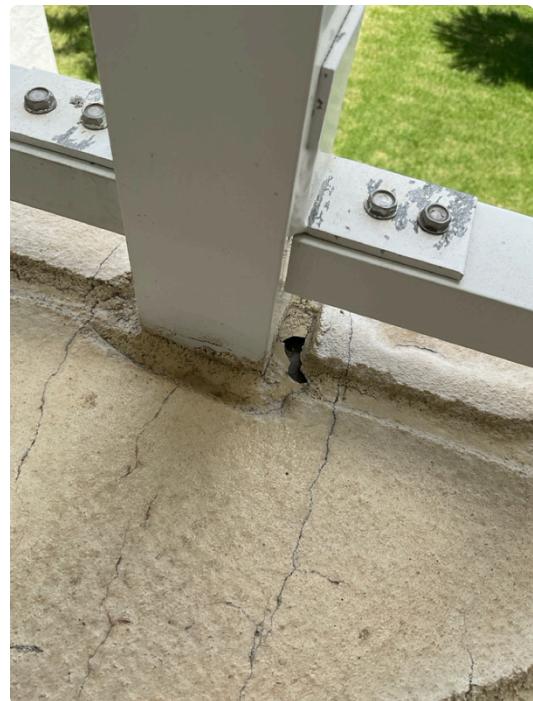
Cavity at the base of the railing post between units 301 and 302

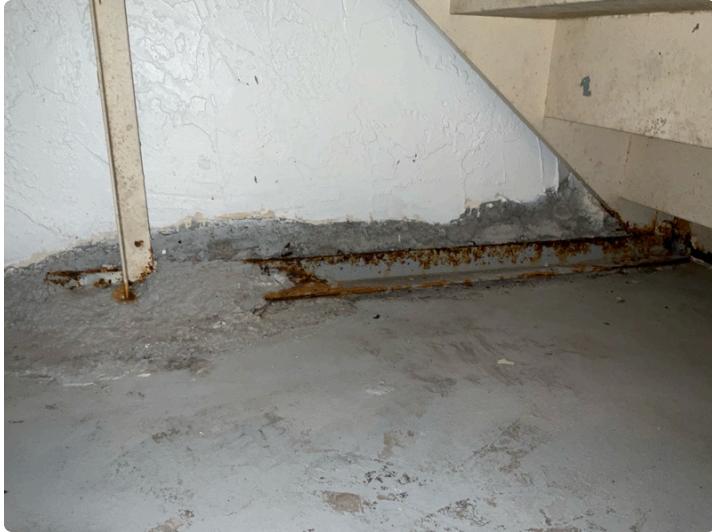
Corrosion on metal constituent of the south stair at ground floor

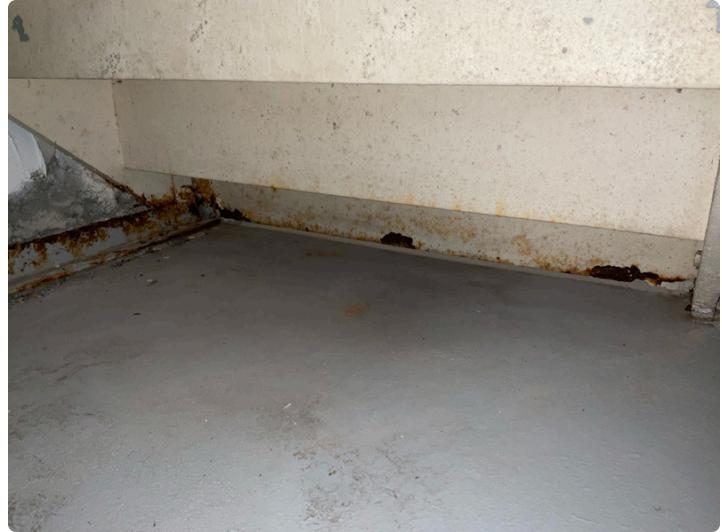
Corrosion on metal constituent underneath the treads of the south stair at ground floor

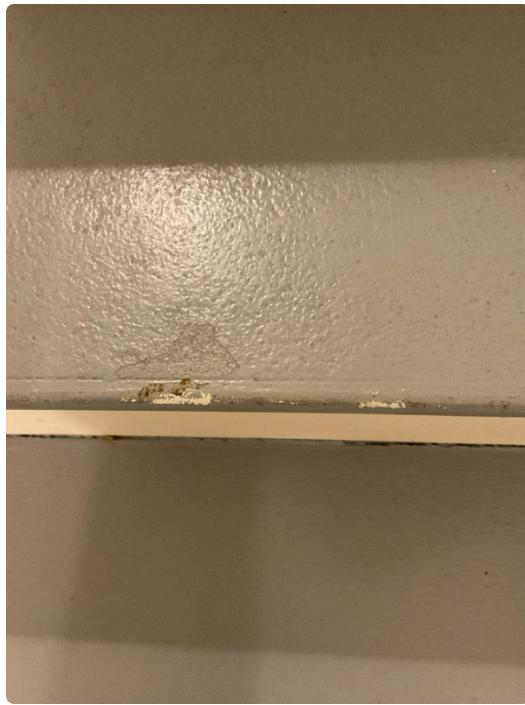
Edge chipping at the south stairs at 2nd floor

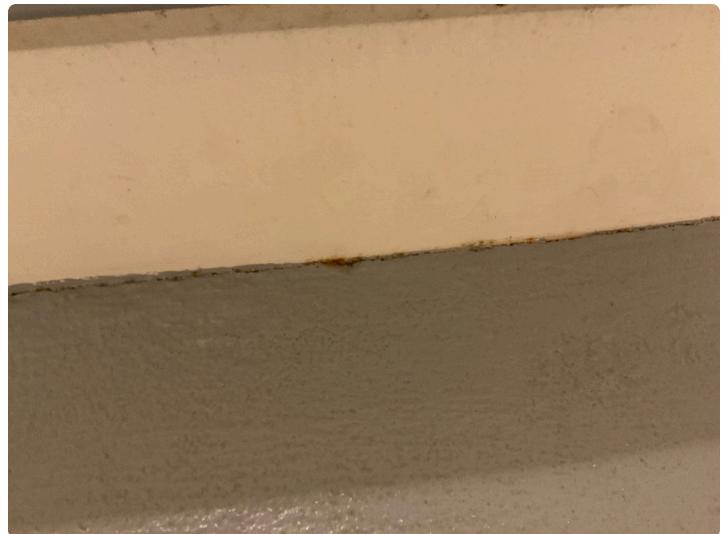
Signs of corrosion at south stairs at 3rd floor

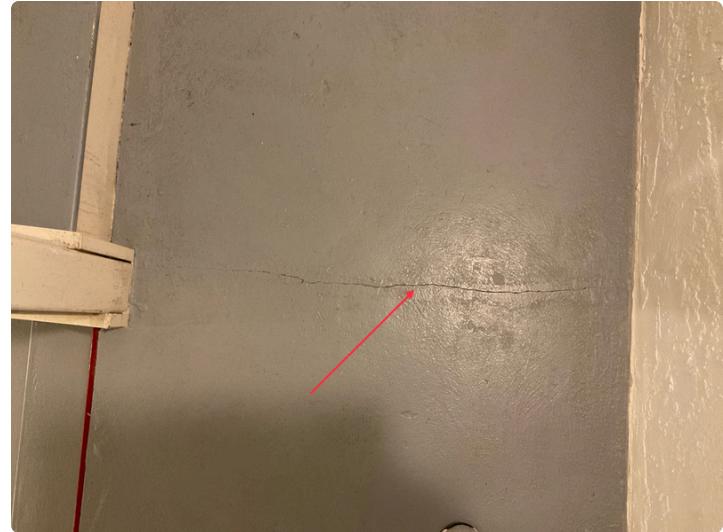
Crack on the landing of south stairs between 3rd and 4th floor

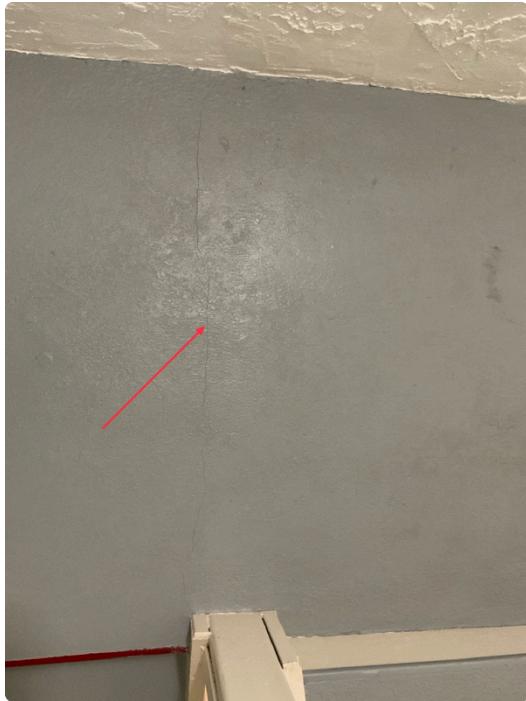
Crack on the landing of north stairs between 3rd and 4th floor

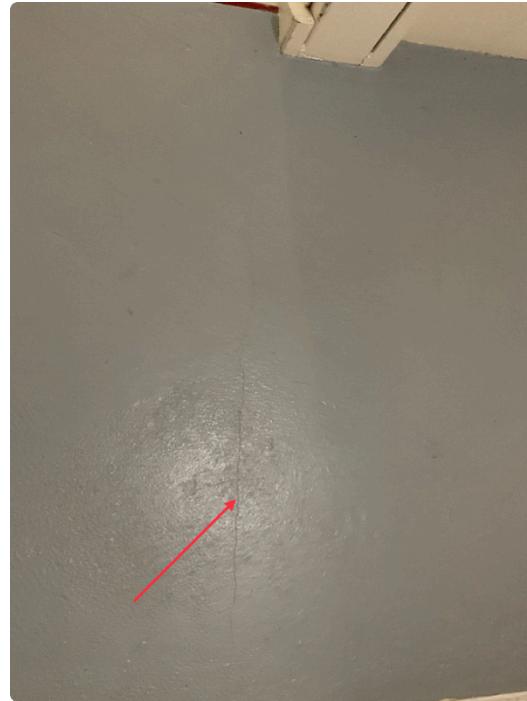
Crack on the landing of south stairs between 5th floor and roof

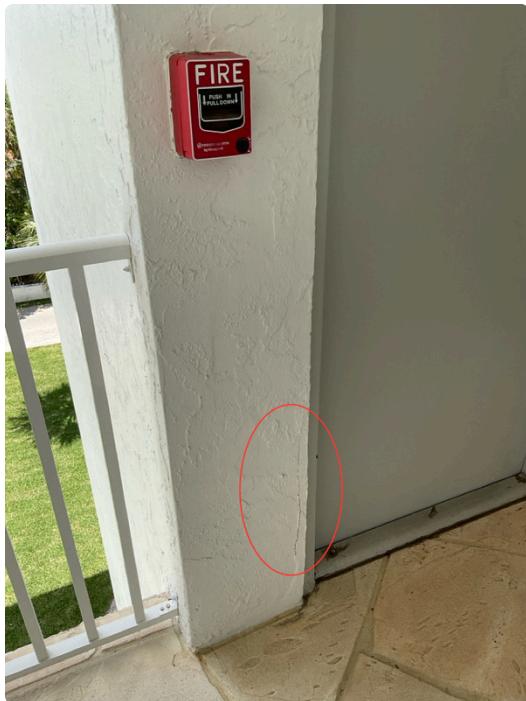
Crack on the wall left of South stairwells entrance at unit 401

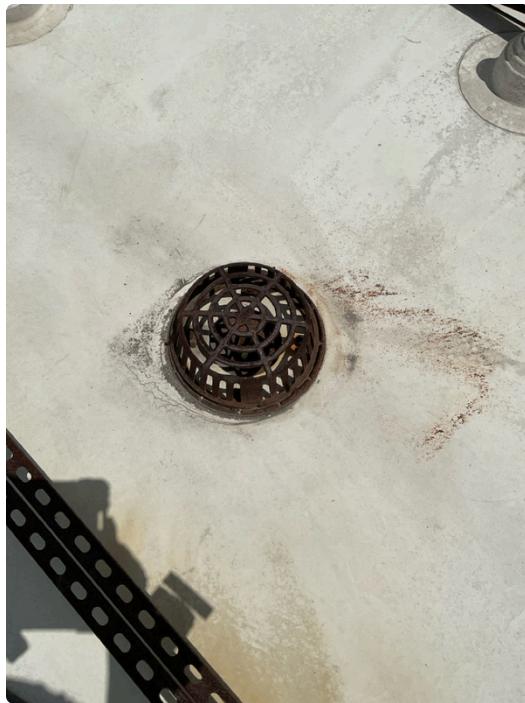
Corrosion on drain screen at the roof

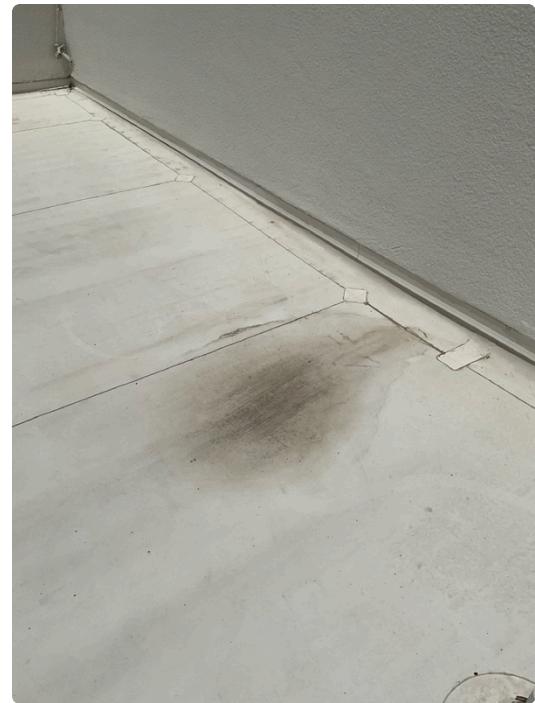
Water stain indicating water pooling at the roof

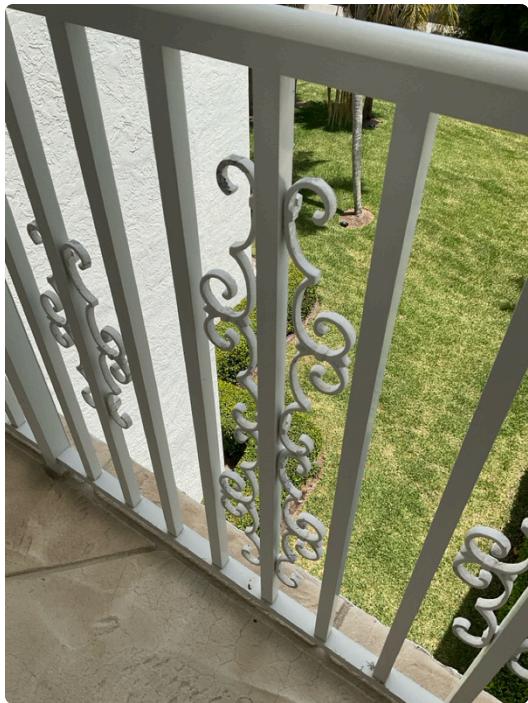
Loose railing decoration at unit 303
