Tennessee Real Estate Inspections

Property Inspection Report

Property address: **123 Main St
Anywhere USA**

Inspection date: **Friday, March 02, 2018**

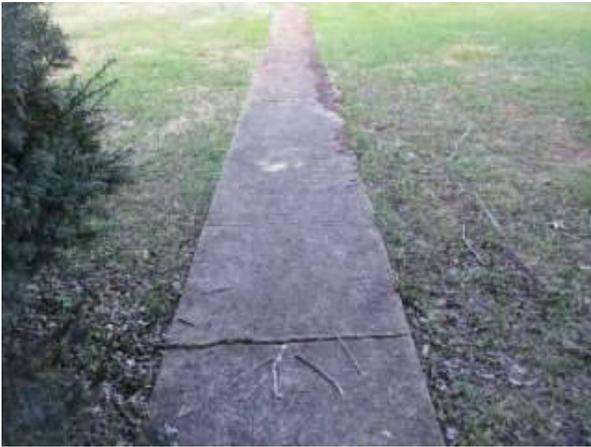
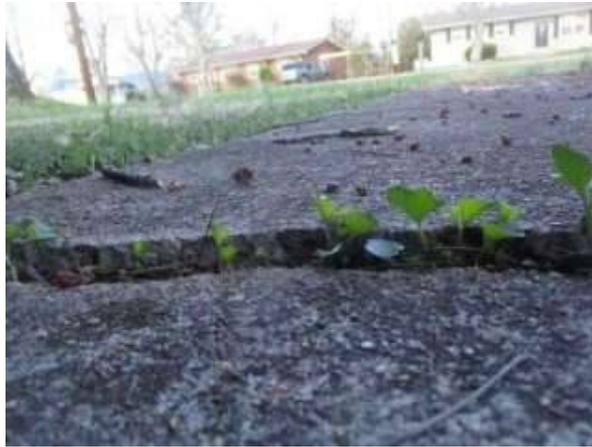
2) Safety, Repair/Replace, Evaluate - One or more trip hazards were found in sidewalk sections due to cracks, settlement, heaving and/or deterioration. A qualified contractor should evaluate and repair or replace sections as necessary to eliminate trip hazards.

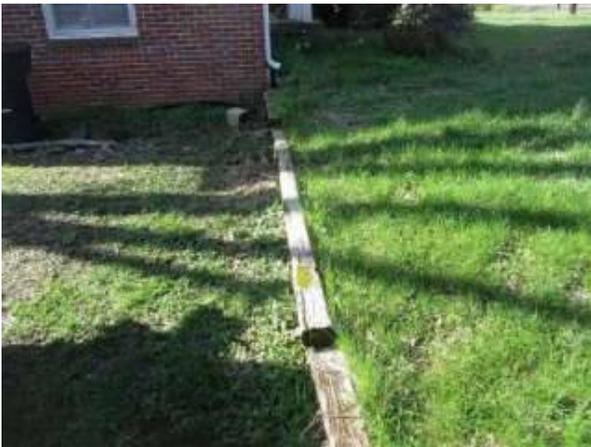
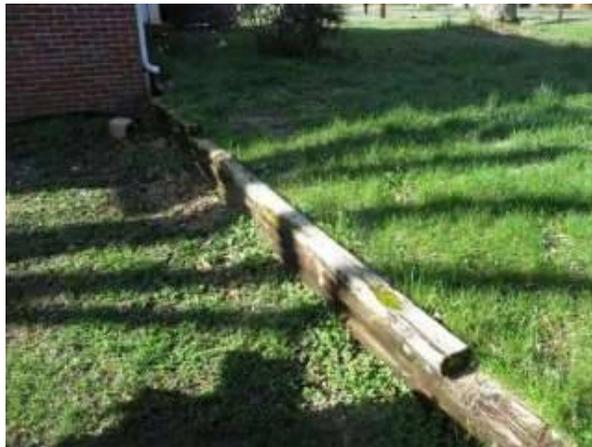
3) **Repair/Replace, Evaluate** - Wooden timbers in retaining wall were leaning and deteriorated. A qualified person should evaluate and repair or replace sections as necessary.

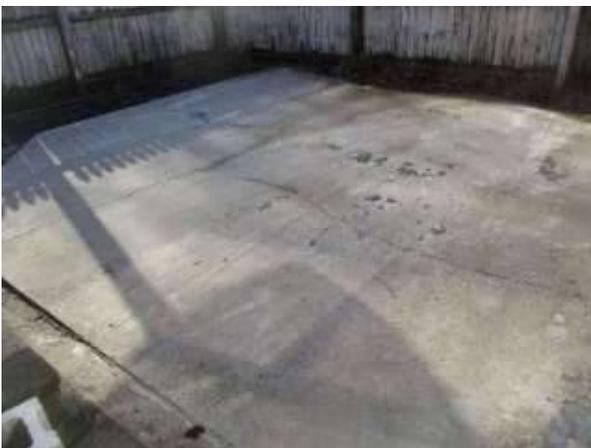
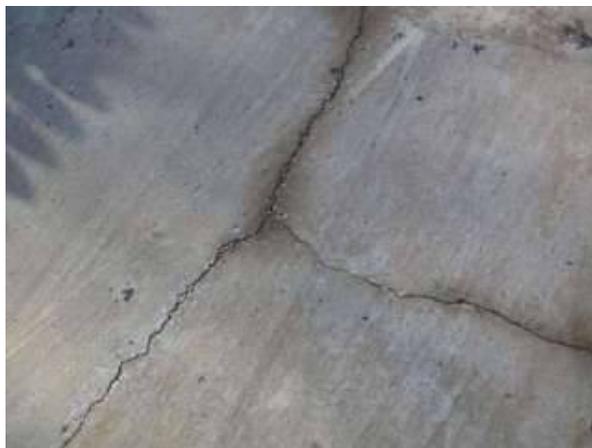
4) **Comment** - Cracks were found in the patio sections. However they don't appear to be a structural concern and no trip hazards were found. No immediate action is recommended, but the client may wish to have repairs made or have cracked sections replaced for aesthetic reasons.

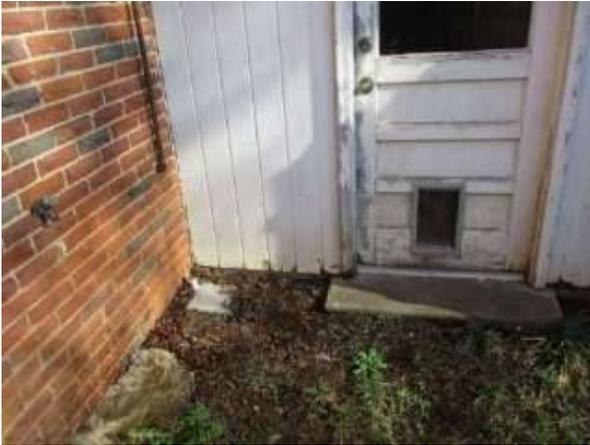
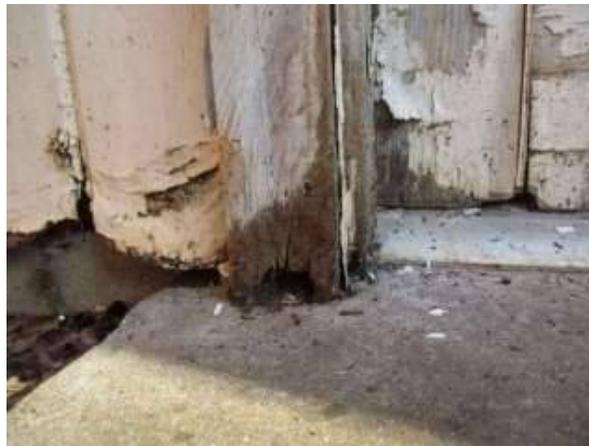
5) Repair/Replace, Evaluate - Rot or water damage was found at one or more sections of siding and/or trim. A qualified person should evaluate and repair as necessary. All rotten wood should be replaced.

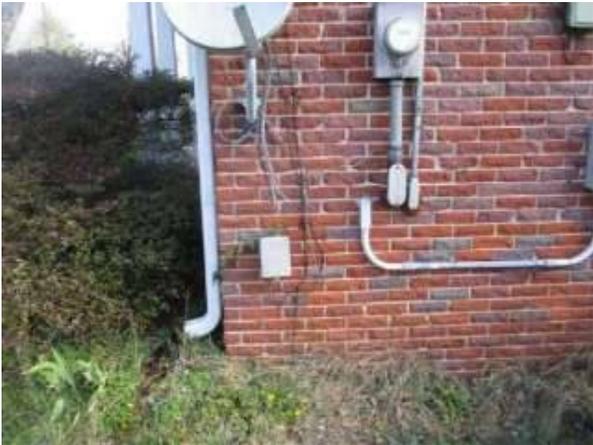
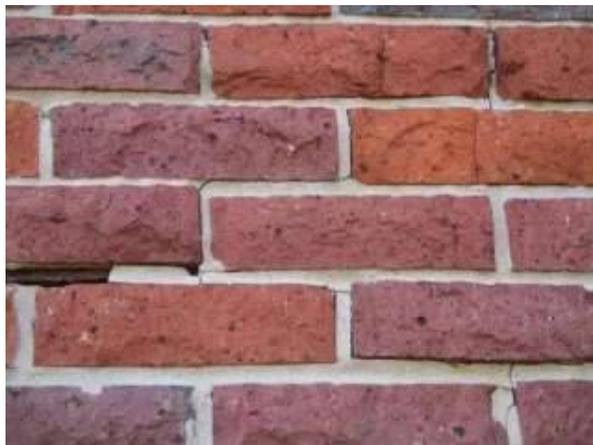
6) Repair/Replace, Evaluate - Cracks or deterioration were found in one or more sections of brick veneer. A qualified contractor should evaluate and make repairs as necessary, such as repointing mortar, replacing bricks and/or sections of veneer.

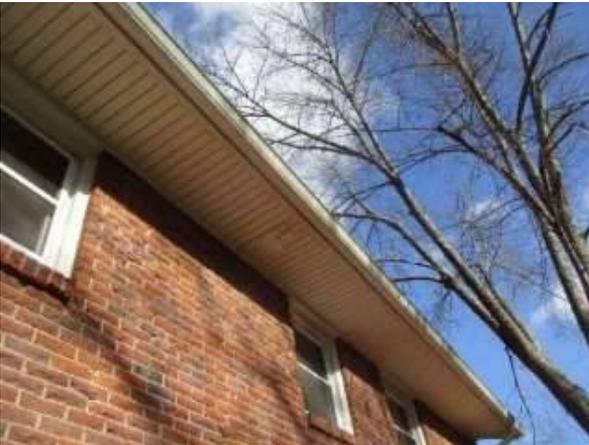
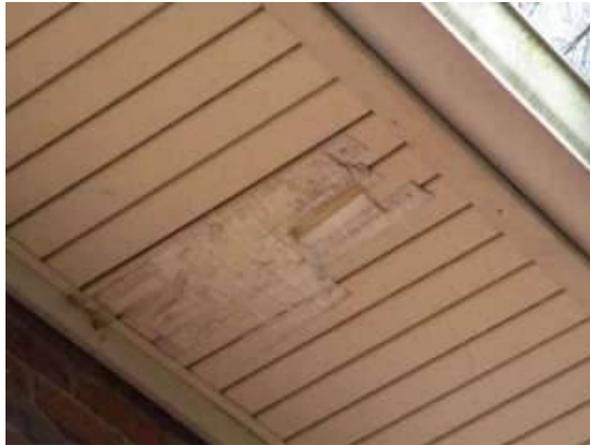
7) Repair/Replace, Evaluate - One section of soffit was damaged. A qualified person should evaluate and repair, replace or install siding or trim as necessary.

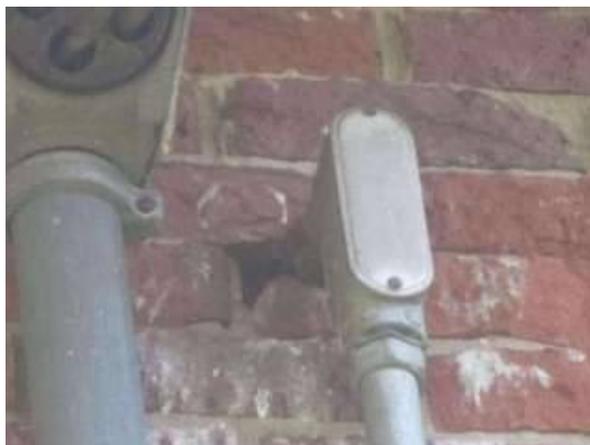
Photo 8-4

8) **Repair/Replace** - Gaps existed at one or more openings around the exterior, such as those where electric lines, refrigerant lines, and/or gas supply pipes penetrate the exterior. Gaps should be sealed as necessary to prevent moisture intrusion and entry by vermin.

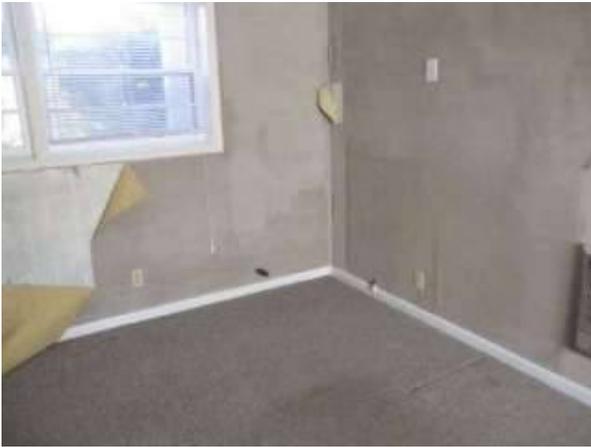
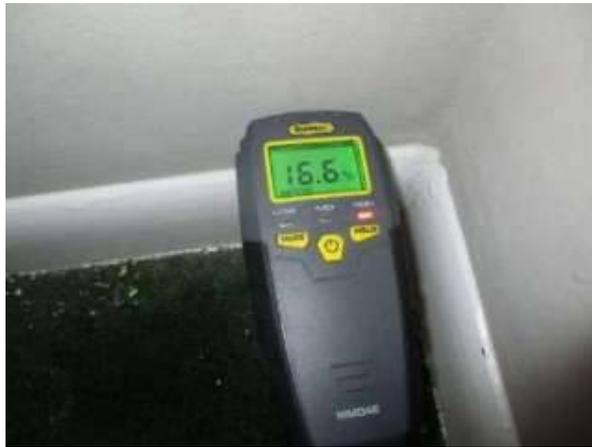
9) **Repair/Maintain, Evaluate** - Elevated levels of moisture and/or bowing was found in the basement walls. The client should consider hiring qualified contractors and/or engineers as necessary for further evaluation with repairs as necessary.

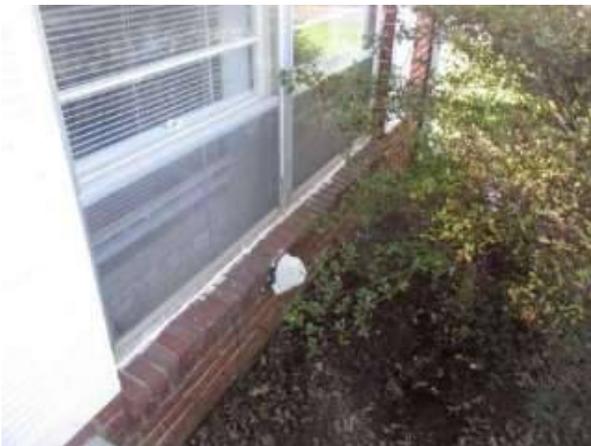
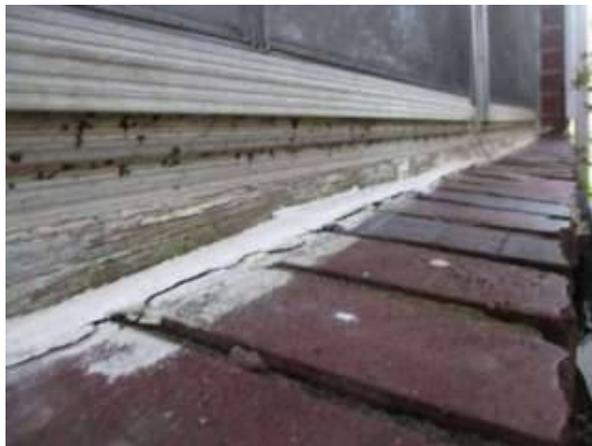
10) Repair/Maintain - Caulk was deteriorated around some windows. A qualified person should repair or replace as necessary.

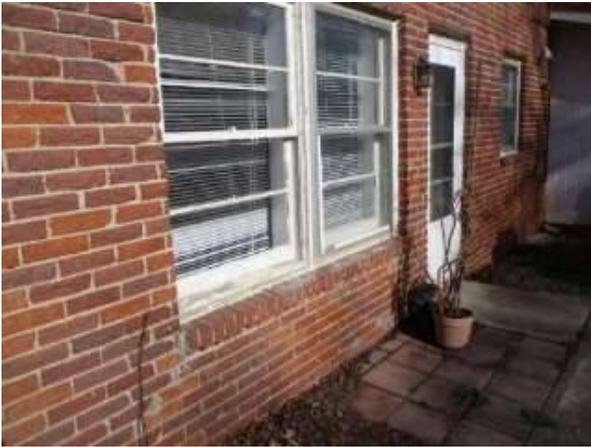
Photo 11-1

11) Maintain - The exterior finish in some areas was failing. A qualified contractor should prep (pressure wash, scrape, sand, prime caulk, etc.) and repaint or restrain areas as needed and as per standard building practices.

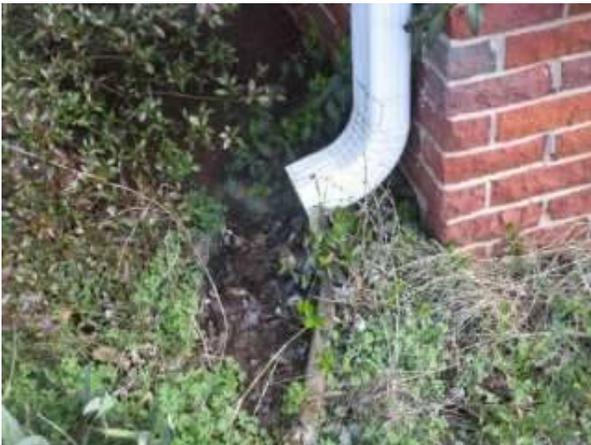
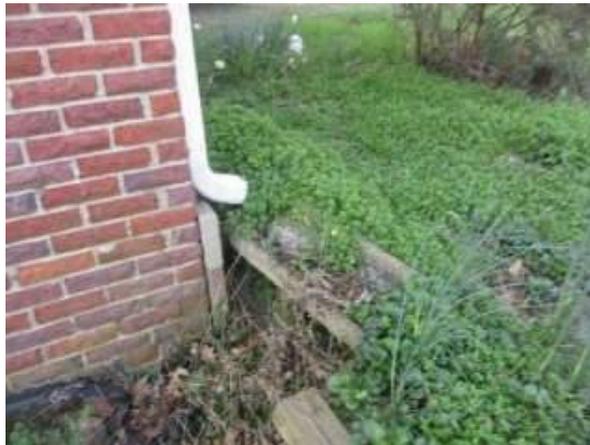
12) Repair/Replace, Evaluate - Extensions such as splash blocks for some downspouts were missing and/or mis-aligned. Water may accumulate around the building foundation as a result. A qualified person should evaluate and repair, replace or install as necessary

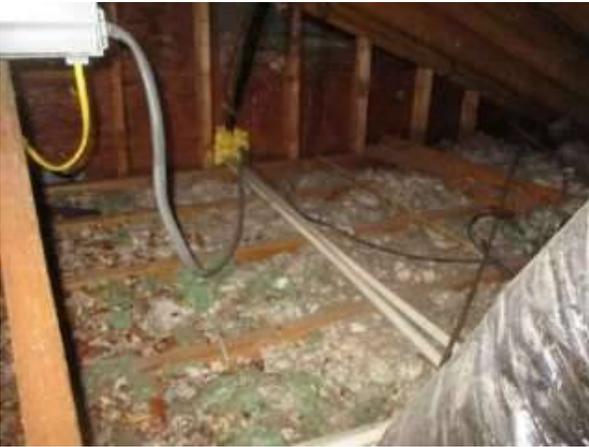
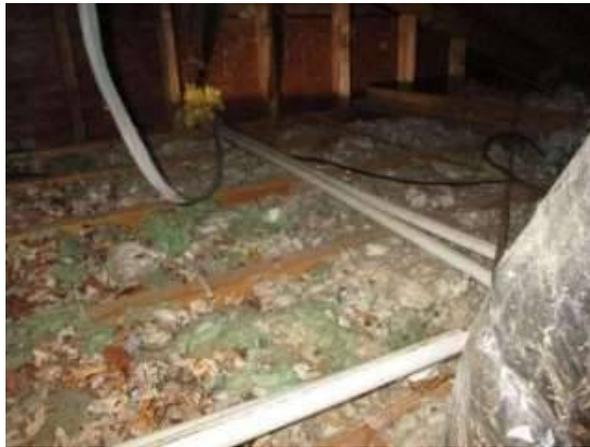
13) Repair/Replace - The ceiling insulation's R rating was significantly less than what's recommended for this area. Recommend having a qualified contractor install additional insulation as per standard building practices for better energy efficiency. For more information, visit:

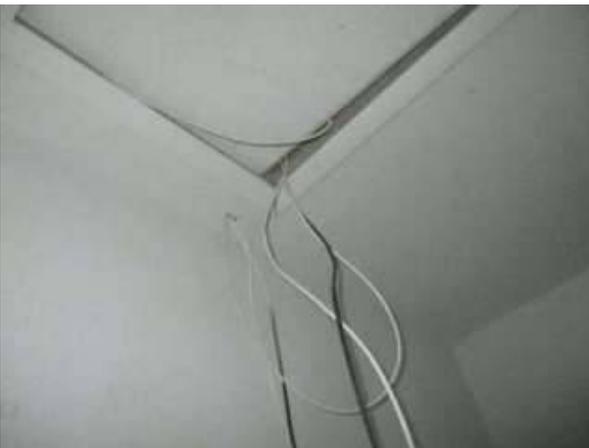
Photo 14-1

14) **Minor Defect** - No insulation was installed at the attic access hatch. Wires also kept the hatch from closing completely. Recommend installing insulation at hatches where missing for better energy efficiency. For more information, visit: <http://www.reporhost.com/docs/atticaccess.pdf>

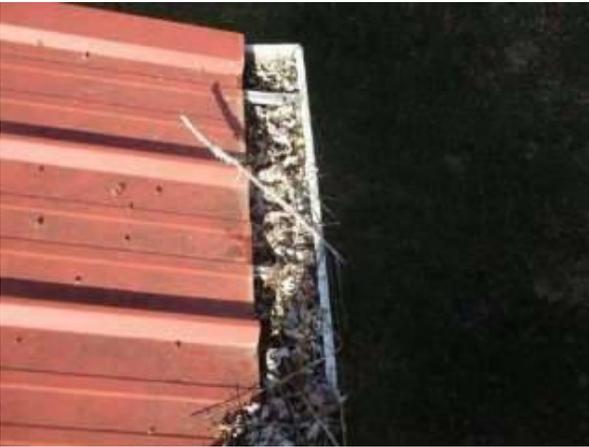
Photo 15-1

15) **Maintain** - Debris had accumulated in one or more gutters. This is a conducive condition for wood destroying insects since gutters may overflow and cause water to come in contact with the building exterior or make water accumulate around the foundation. Gutters should be cleaned now and as necessary in the future.

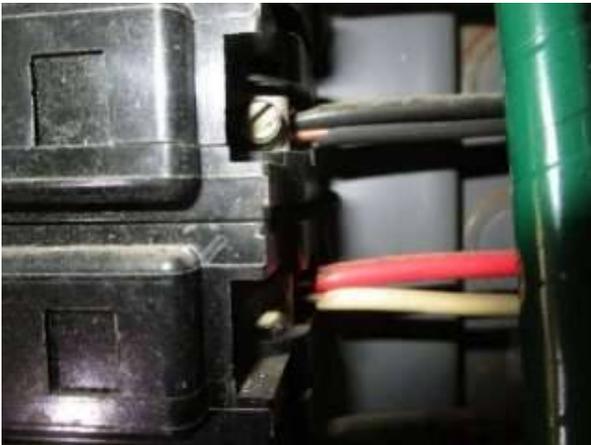
Photo 18-1

18) Safety, Repair/Replace, Evaluate - One or more overcurrent protection devices (circuit breakers or fuses) in panel #A were "double tapped", where 2 or more wires were clamped in a terminal designed for only one wire. This is a safety hazard since the bolt or screw may tighten securely against one wire, but leave others loose. Arcing, sparks and fires may result. A qualified electrician should evaluate and repair as necessary.

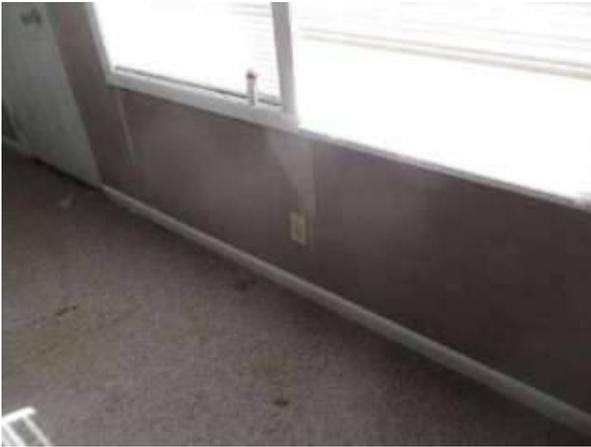
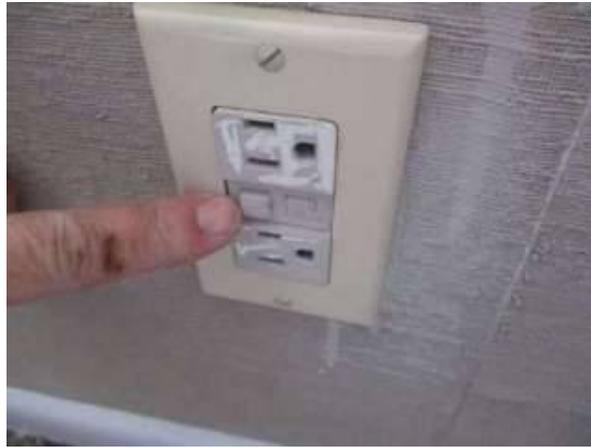
20) Safety, Repair/Replace, Evaluate - A ground fault circuit interrupter (GFCI) electric receptacle wouldn't reset in the basement. This is a safety hazard due to the risk of shock. A qualified electrician should evaluate and repair as necessary.

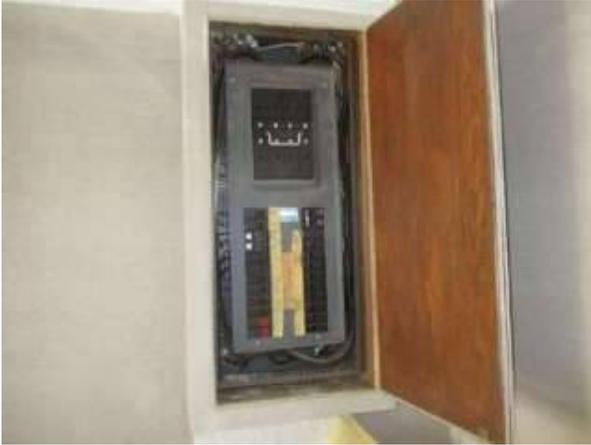
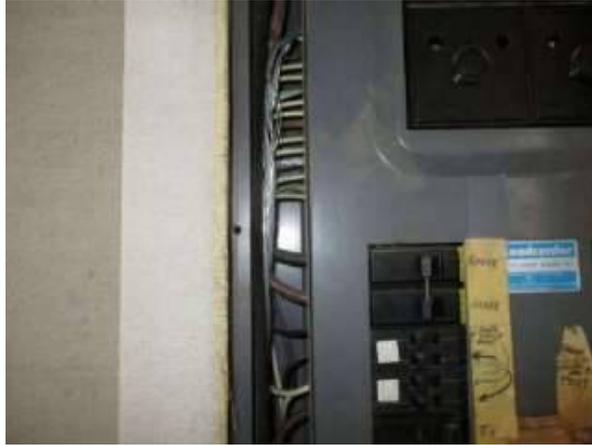
23) Safety, Repair/Replace - The cover to panel #A was missing or not installed. This is a safety hazard for shock. A qualified person should replace missing components as necessary.

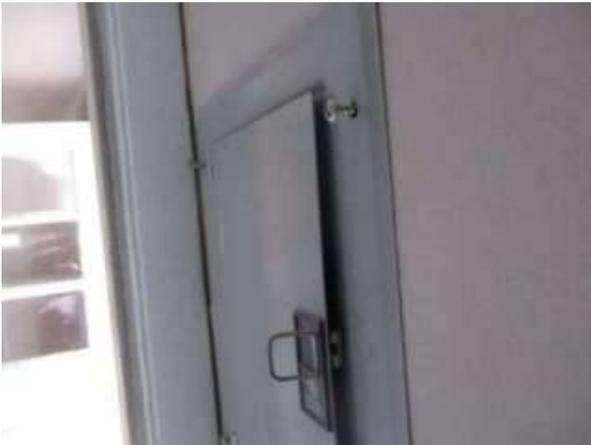
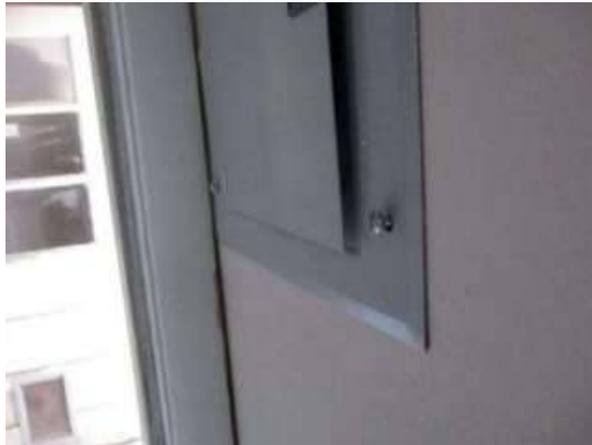
24) Safety, Repair/Replace - One or more screws used to secure the cover to panel #B were too long. This is a safety hazard for shock since the screw(s) may cut through the wire insulation and cause a short circuit. Long and/or pointed screws should be replaced as necessary with the correct screws. A qualified person should repair as necessary, such as moving conductors inside the panel, so screws don't come in contact with the conductors.

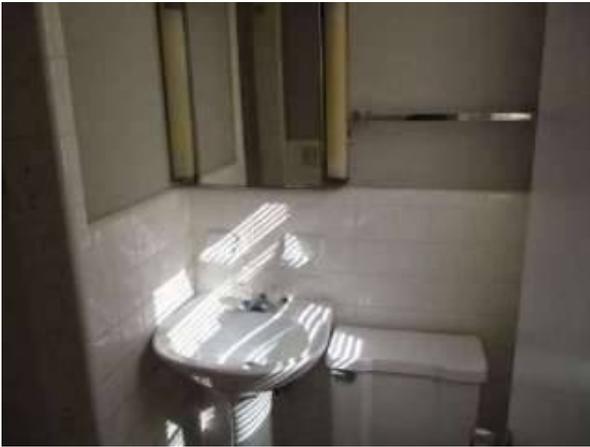
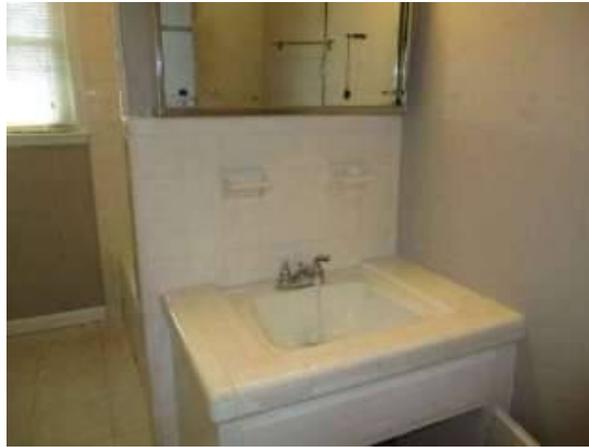
25) Safety, Repair/Replace - No electric receptacles were visible in the bathrooms. This is an inconvenience and potential safety hazard since it may result in extension cords being used. Recommend having a qualified electrician install ground fault circuit interrupter (GFCI) protected receptacle(s) as per standard building practices.

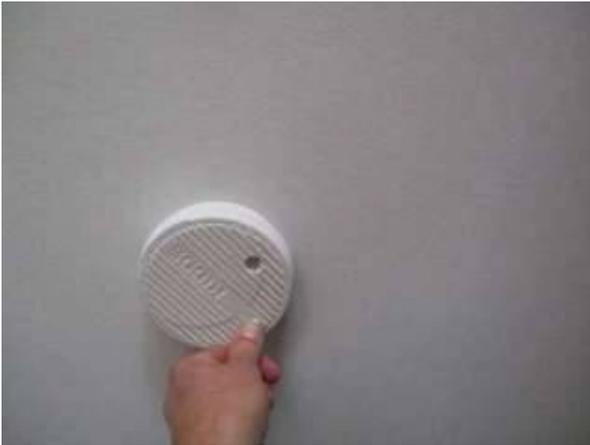
Photo 26-1

26) Safety, Repair/Replace - One or more smoke detectors didn't respond when tested. A qualified person should evaluate and replace smoke detectors, replace batteries or make repairs as necessary. For more information, visit:

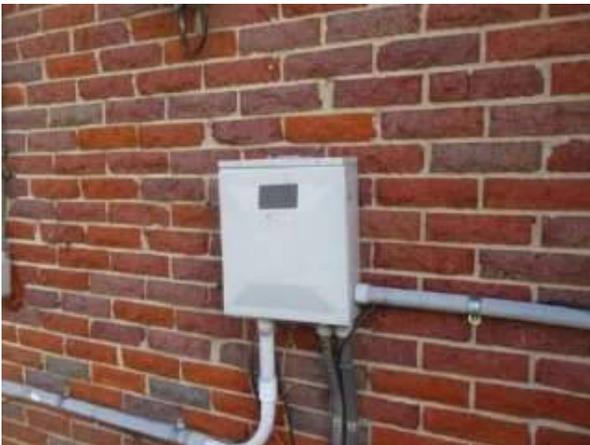
Photo 27-1

27) Repair/Replace, Evaluate - The legend for overcurrent protection devices (breakers or fuses) in panels #A and C were missing and/or substandard. Recommend installing, updating or correcting the legend as necessary so it's accurate. Evaluation by a qualified electrician may be necessary.

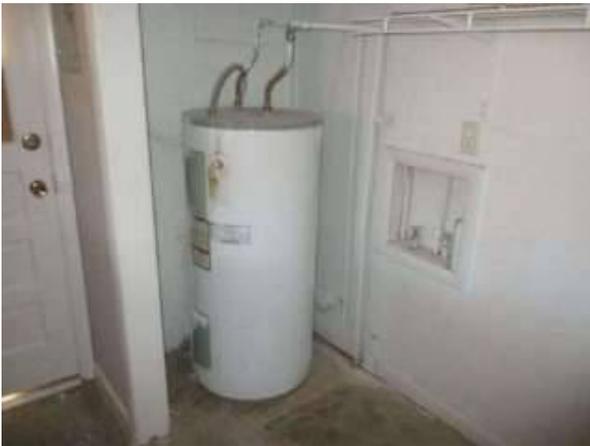
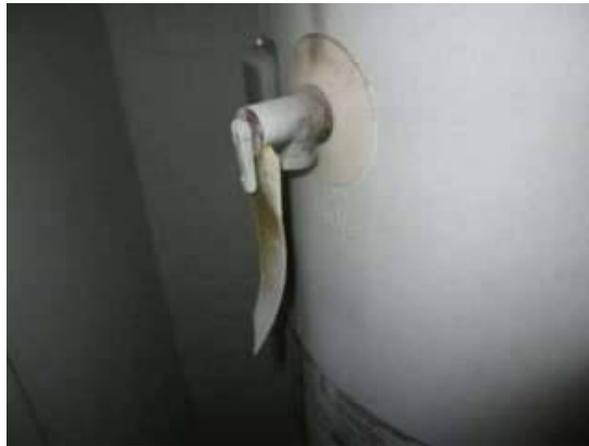
29) Safety, Repair/Replace - No drain line was installed for the temperature-pressure relief valve. This is a potential safety hazard due to the risk of scalding if someone is standing next to the water heater when the valve opens. A qualified plumber should install a drain line as per standard building practices. For example, extending to 6 inches from the floor, or routed so as to drain outside.

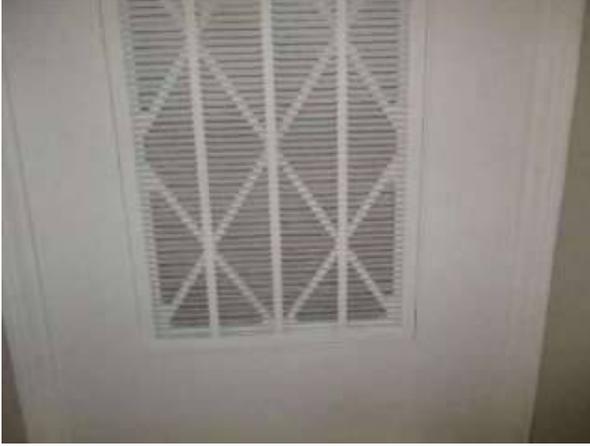
Photo 32-1

32) *Maintain* - One or more air filters were dirty. A qualified person should replace filter(s) as necessary. Filters should be checked monthly and maintained as necessary in the future.

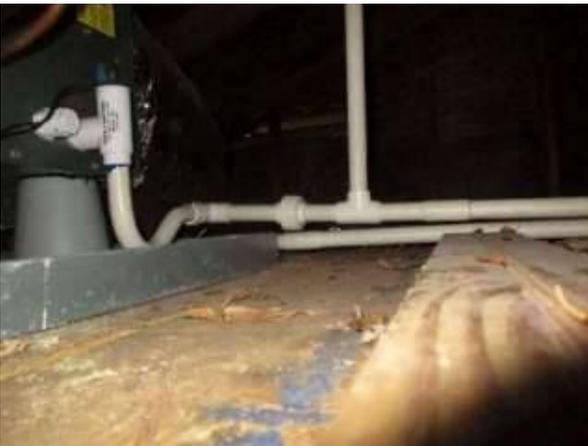
Photo 36-1

36) Minor Defect, Evaluate - The condensate line in the attic has substandard slope. Drain lines should be installed pitched toward their discharge point. Manufacturers often recommend a drop of about ¼-inch per foot; most codes allow for 1/8-inch per foot. Recommend further evaluation by a qualified professional with repairs as necessary.

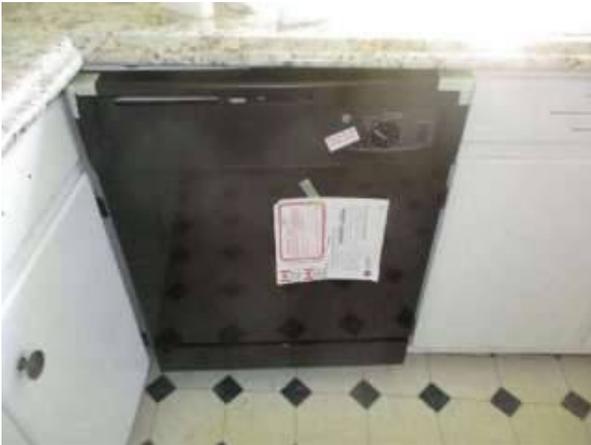
Photo 45-1

45) **Repair/Replace, Evaluate** - The dishwasher was inoperable. A qualified person should evaluate and repair or replace as necessary.

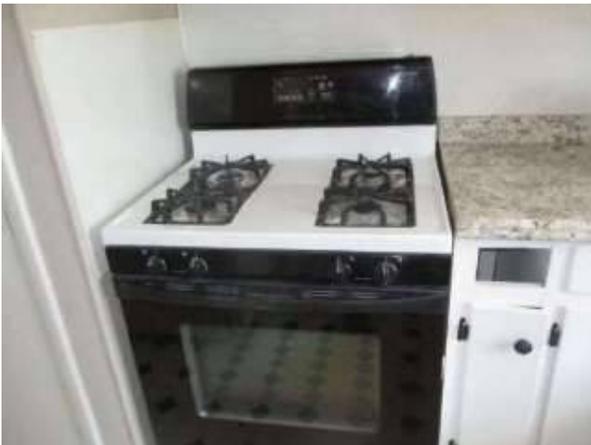
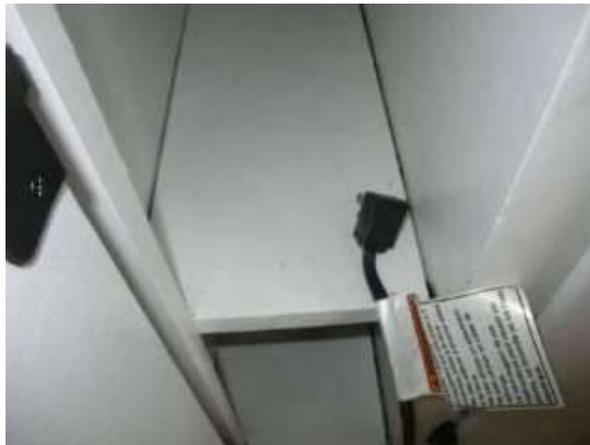
46) Repair/Replace, Evaluate - The oven was inoperable. No electric receptacle was near enough to plug it in. A qualified person should evaluate and repair as necessary.

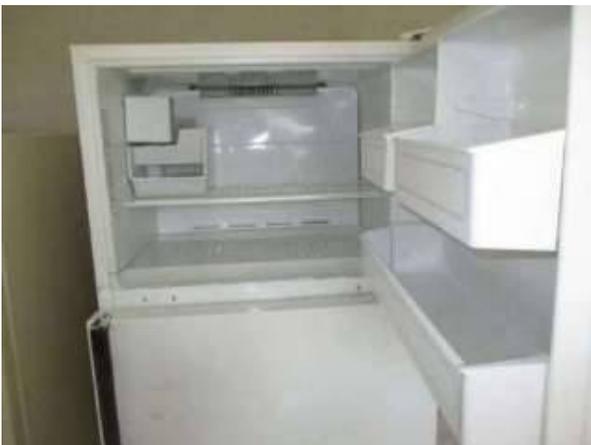
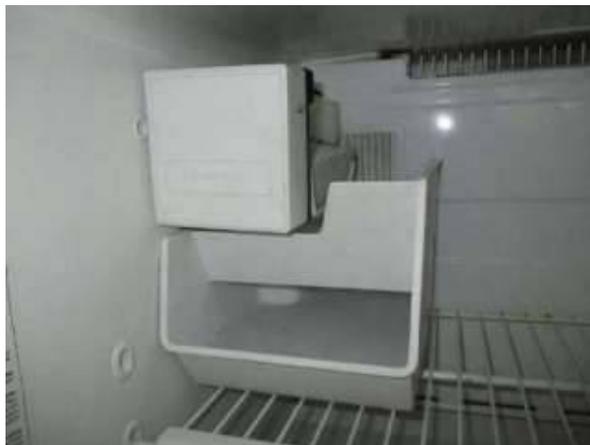
47) Repair/Replace, Evaluate - The refrigerator's ice maker was inoperable. A qualified person should evaluate and repair as necessary.

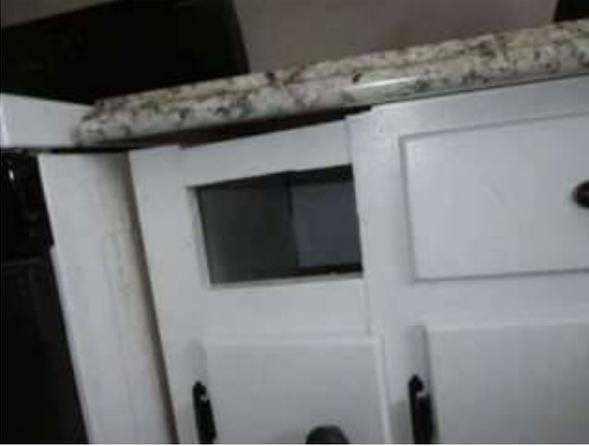
Photo 48-1

48) Repair/Replace - Some components were missing from one or more cabinets. Missing shelving and/or components should be

replaced, and by a qualified contractor if necessary.

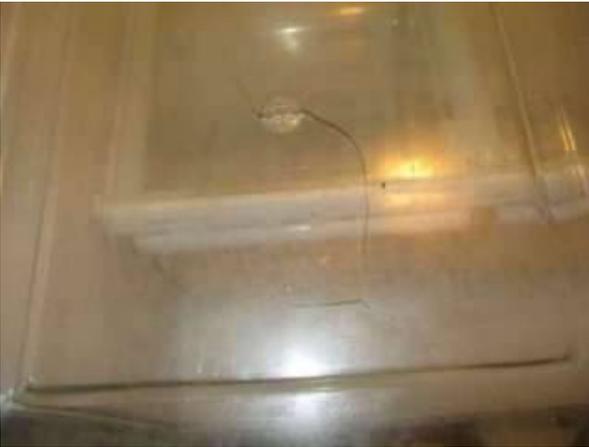
Photo 49-1

49) Repair/Replace - Refrigerator shelving was damaged and should be replaced or repaired as necessary.

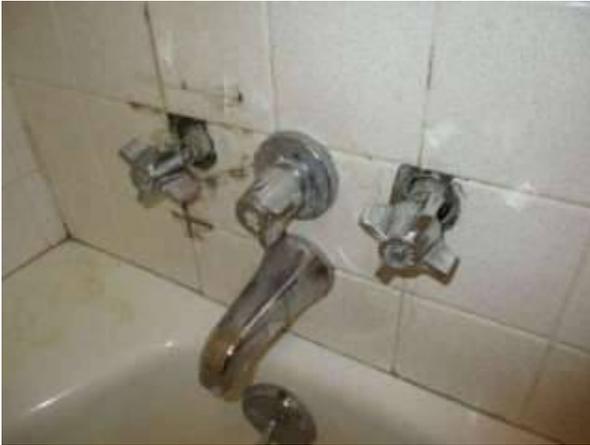
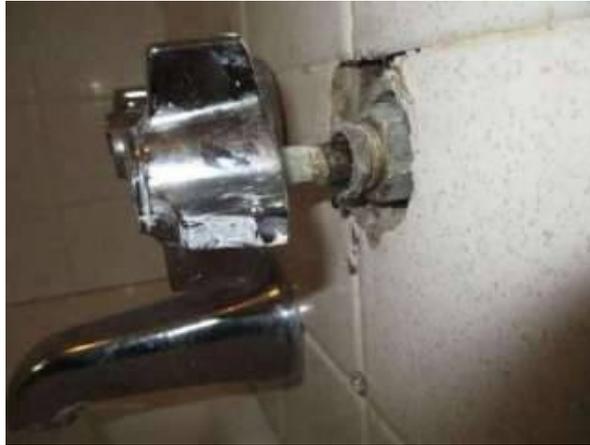
50) Repair/Replace, Evaluate - Leaking or dripping was found at the bathtub supply valves at location #. A qualified plumber should evaluate and repair as necessary.

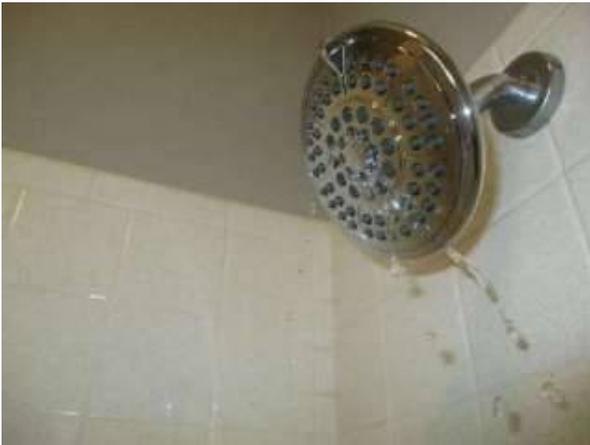
Photo 51-1

51) Repair/Replace, Evaluate - There was no water from the faucet at the shower at location #B. A qualified person should evaluate and repair as necessary.

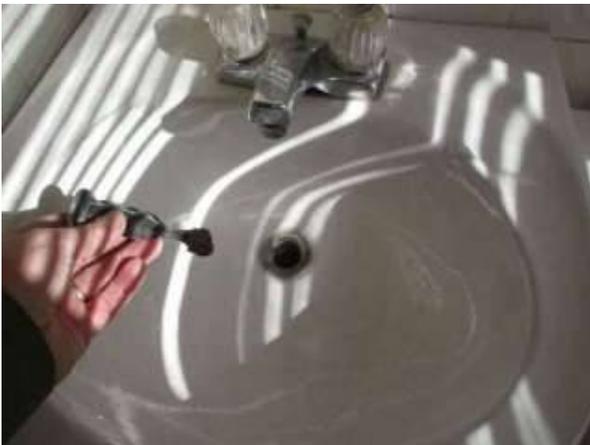
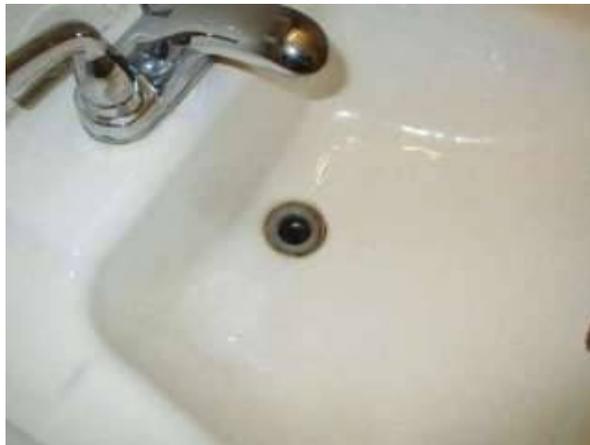
52) Repair/Replace - The sink drain stopper mechanisms at locations #A and B were missing and/or damaged. A qualified person should repair or replace as necessary.

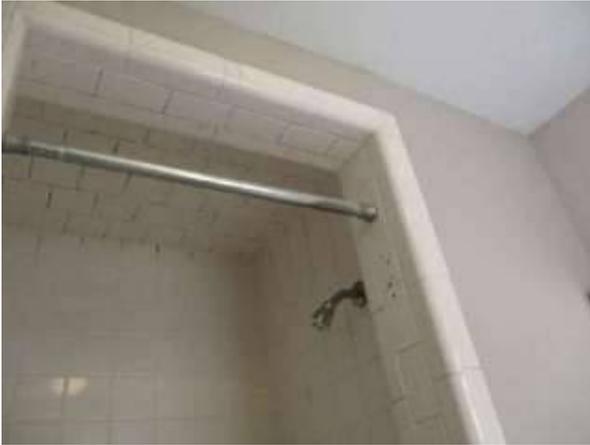
Photo 53-1

53) Repair/Replace - The bathrooms with showers at locations #A and B didn't have exhaust fans installed. Moisture accumulation will occur and may damage the structure. Even if the bathroom has a window that opens, it likely does not provide adequate ventilation, especially during cold weather when the window is closed. A qualified contractor should install exhaust fans as per standard building practices where missing in bathrooms with showers.

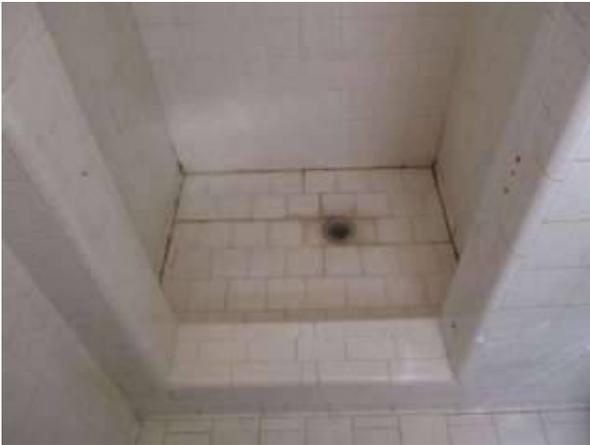
Photo 54-1

54) Repair/Maintain - The grout between the shower enclosure and the floor at location #A was deteriorated. A qualified person should repair as necessary.

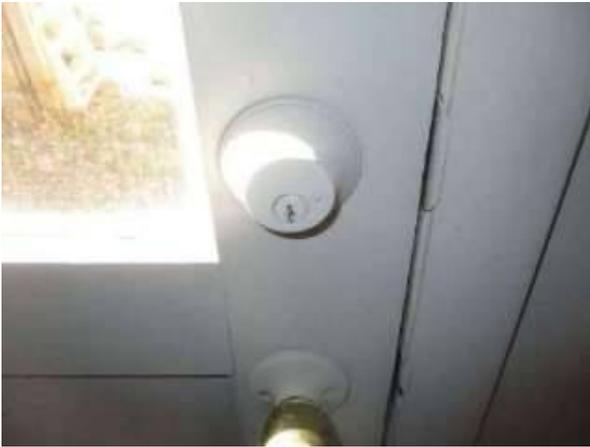
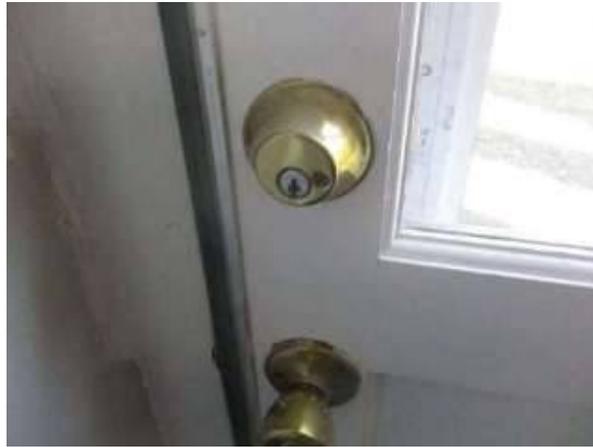
56) Safety, Repair/Replace - One or more exterior doors had deadbolts installed with no handle, and require a key to open them from both sides. This can be a safety hazard in the event of a fire when the key is not available. The door cannot be used as an exit then, causing entrapment. Key-only deadbolts should be replaced with deadbolts that have a handle on the inside on exterior doors in rooms with no other adequate egress nearby.

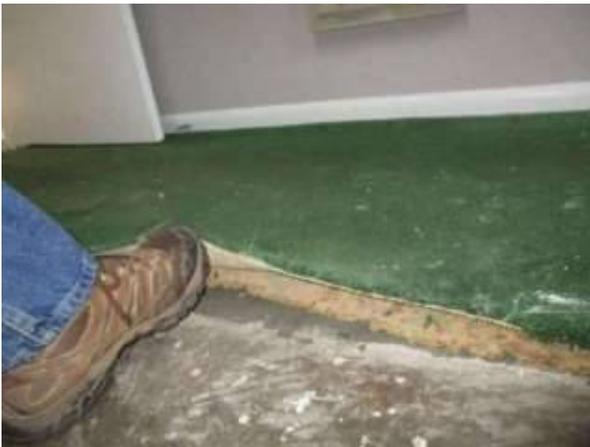
Photo 57-1

57) Safety, Repair/Replace - Carpeting in one or more areas was loose and posed a trip hazard. A qualified contractor should repair or replace as necessary.

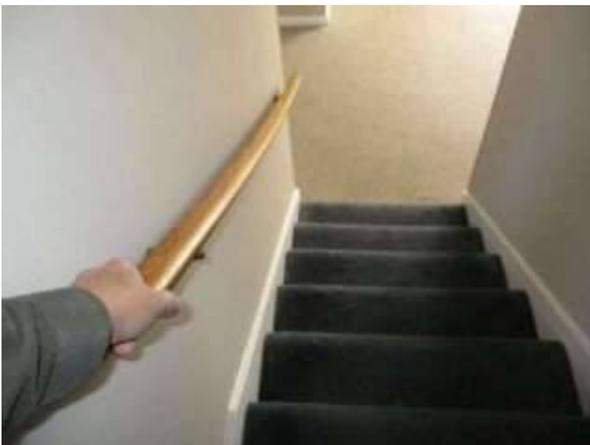
Photo 58-1

58) Safety, Repair/Replace - Handrails at one or more flights of stairs were loose. This is a safety hazard. A qualified person should repair or replace as necessary and as per standard building practices.

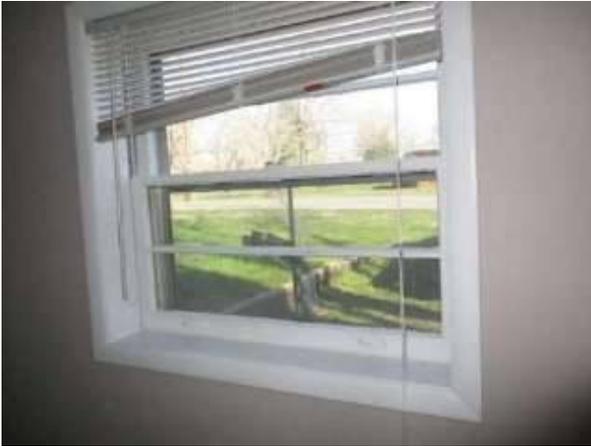
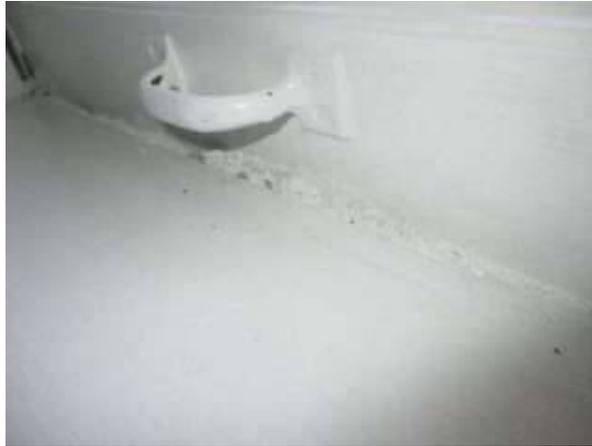
59) Repair/Replace, Evaluate - The wood windows that were built to open wouldn't open. A qualified person should evaluate and repair

as necessary.

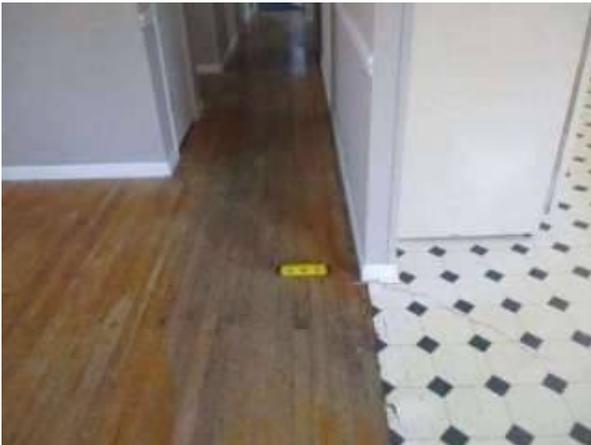
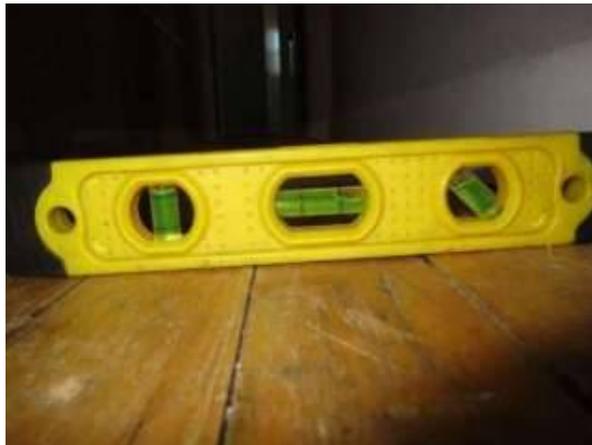
60) Repair/Replace, Evaluate - Floors in one or more areas were not level. A qualified contractor should evaluate and make repairs as necessary.

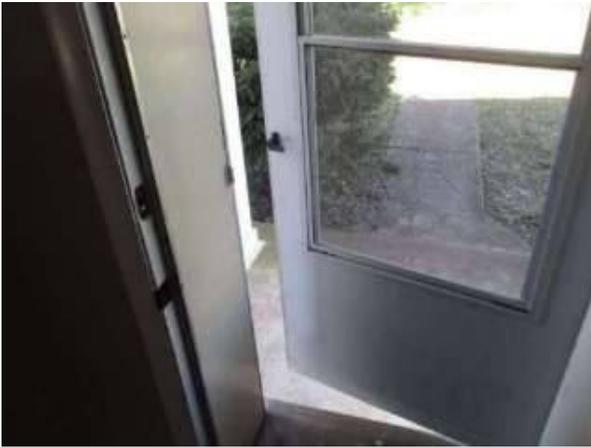
Photo 61-1

61) Repair/Replace, Evaluate - The front door's storm door will not close completely. Recommend repair or replacement by a qualified professional.

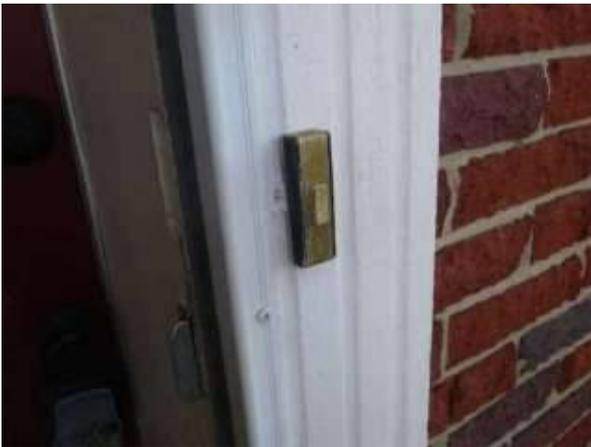
Photo 62-1

62) Repair/Replace, Evaluate - The front door's doorbell appeared to be inoperable. A qualified person should evaluate and repair as necessary.

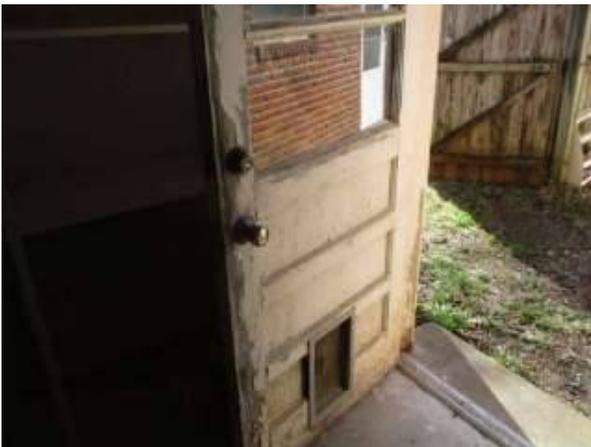
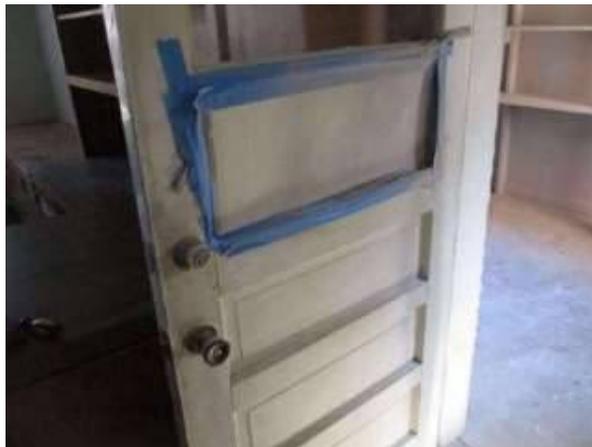
63) Repair/Replace - One or more exterior doors were deteriorated. A qualified person should repair or replace as necessary.

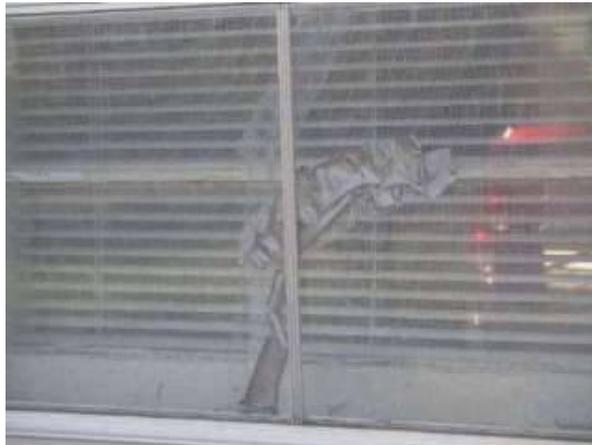
**Photo 67-2**

67) Repair/Replace - Glass in one or more windows was cracked or broken. A qualified contractor should replace glass where necessary.
