# Technical Memorandum

**To:** [REDACTED] Orland Select Board  
**From:** Gillian Williams, P.E. and Charles Grant, P.E., S.E. (MA)  
**cc:** Narramissic Watershed Coalition  
**Date:** August 18, 2025  
**Re:** Phase I – Site Visit and Due Diligence Assistance  
 Alamoosook (ME00144) and Toddy Pond (ME00146) Dams  
 Orland, Maine  
**Project No.** 2502852

## Toddy Pond Dam

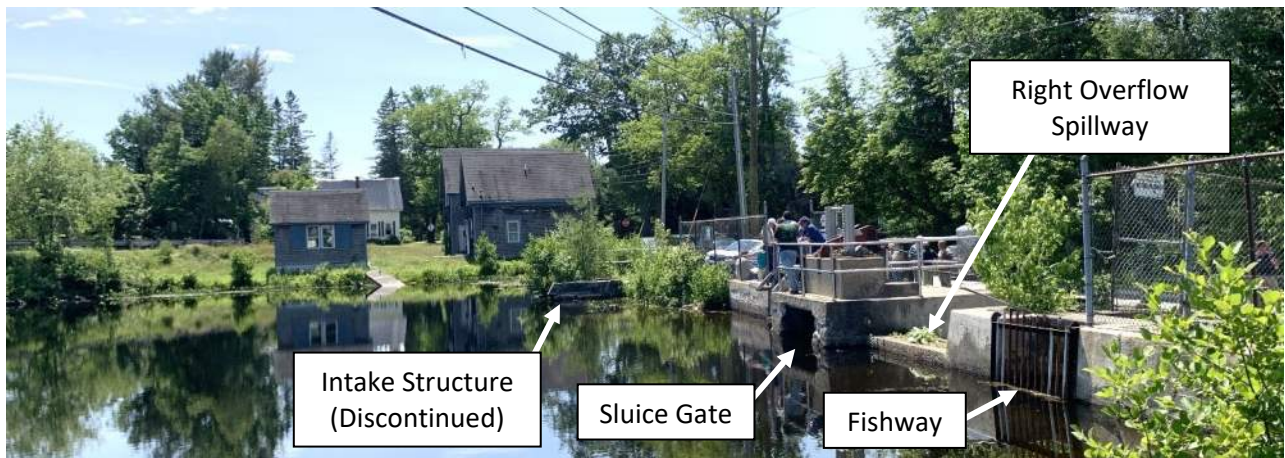
Photo No. 1 – View of dam from right upstream shore, looking left/downstream.

Gina Bushong reported that the old intake pipe is speculated to have been once connected to a power generation plant, though a plant no longer exists. There is significant vegetation growth on top of the old intake structure and along the embankments on either side (Photos 1 and 12). An outlet for the intake pipe was not found during the inspection.

The fishway was in fair condition. At least four of the bars of the trash rack in front of the fishway intake appeared to have been replaced with stainless steel bars (Photos 1 and 18). The other bars show signs of rust, but no obvious section loss was observed. Debris was observed at the top of the fishway but was blocked from traveling farther downstream by the first fishway baffle. A prior concrete repair was evident on the top of the left wall of the fishway, near the inlet (Photo 16). The new concrete appeared to be separating from the original concrete. Cracking was observed on the inner face of the right wall near the inlet (Photo 22). The grassy area to the right of the fishway appeared to be recently mowed, but vegetation was observed in the area between the fishway and the right spillway and along the section of

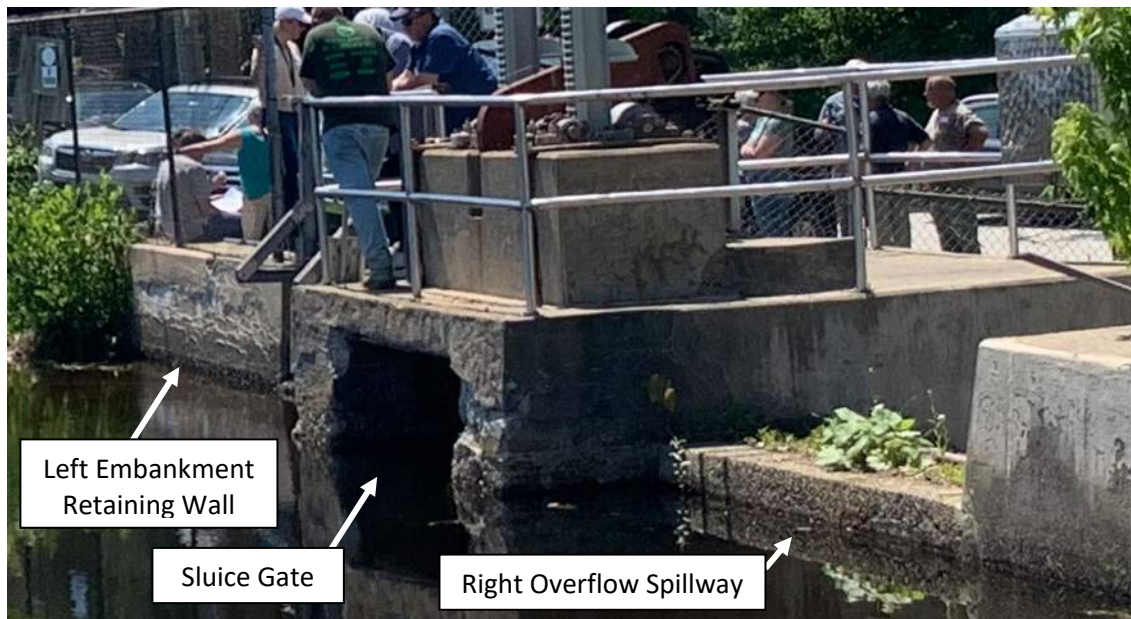
The embankment between the left concrete retaining wall and Hatchery Road was partially mowed (Photo 5). The embankment downstream of Hatchery Road was estimated to be approximately 2V:1H. Heavy vegetation, including mature trees, was observed on the embankment downstream of Hatchery Road (Photo 6). Vegetation was also observed upstream of the left retaining wall (Photo 2). Spalling and efflorescence were observed on the left retaining wall (Photos 3, 4, and 5).

The condition of the granite block overflow spillways was consistent with previous inspection reports. Young vegetation was observed growing on the crest and the downstream face of the right overflow spillway (Photos 3 and 7). Branches were observed on both spillway crests. Voids between granite blocks were observed on the downstream faces of the spillways. Seepage was observed coming from the bottom of the spillway walls. The rate of the seepage was estimated to be approximately 1 to 2 gallons per minute for each of the spillways (Photo 23).

The gate structure was in poor condition. Section loss was evident on the concrete piers of the gate structure at the interface of the piers and the apron. Concrete was also observed to be missing from the inner face of the right pier. Plywood appeared to have been placed over an area of concrete loss on the inner face of the right pier, as well as at the inner face of the left pier where it meets the apron (Photos 7, 9, and 10). Horizontal cracking was observed on the piers of the gate structure approximately 1 to 2 feet above the apron. Concrete loss was observed on the approximately 1 to 1.5 feet of concrete above

the headwater elevation on the upstream walls of the gate structure (Photos 3 and 4). The railing around the operator platform on top of the gate structure is stainless steel and appears to be in good condition.

The concrete apron downstream of the spillways and gate structure was in poor condition (Photo 7). Significant cracking and section loss was observed. Exposed steel mesh reinforcing was observed. Branches and vegetation were observed on the apron. The concrete was patched in the past but appeared to be separating from the original concrete. When the gate was opened, water was observed to flow under portions of the concrete. Epoxy grout was reported to have been applied to the upstream faces of the dam by divers in 2012 or 2013. While Figure 1 indicates that the sills of the left and right overflow spillways are both at El. 165, observations during the field visit indicate that the sill at the right spillway is approximately 2 inches higher than the left spillway (Photos 3 and 4).

Photo No. 3 – Close up view from right upstream shore, looking left/downstream. Note concrete loss on gate structure and left embankment upstream retaining wall. Note the difference in the height of the spillway crest above the headwater of the right overflow spillway (pictured here) and the left overflow spillway (pictured in the following photo).

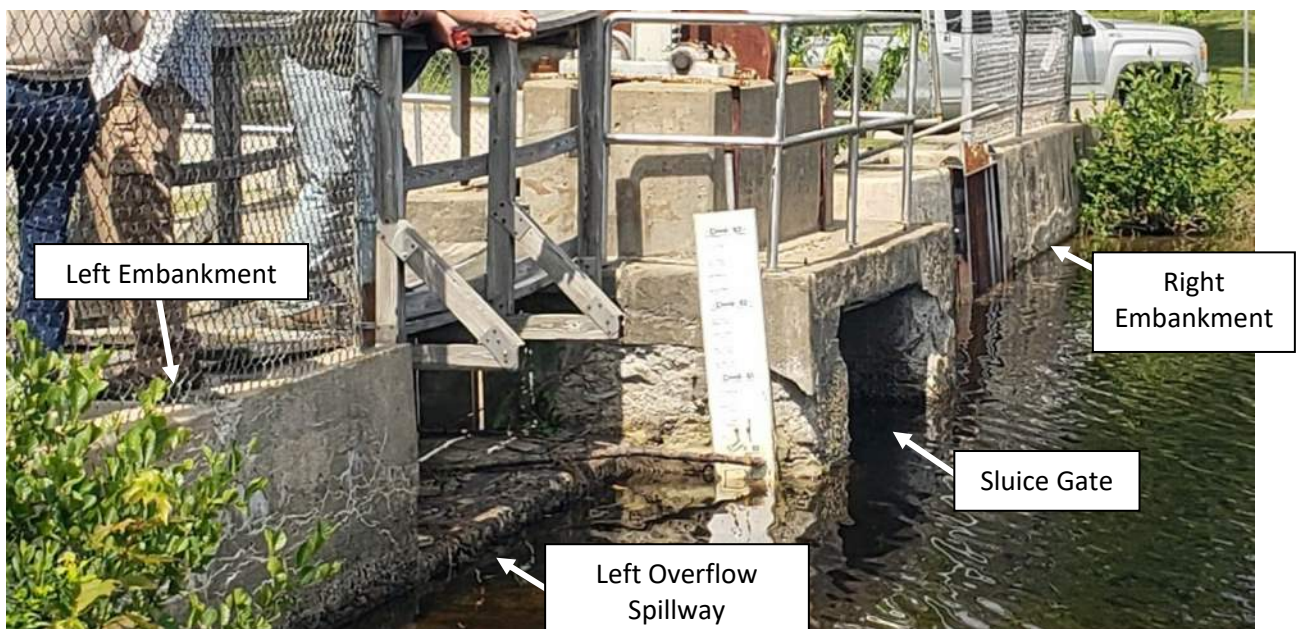
Photo No. 4 – Close up view from discontinued intake structure, looking right. Note concrete loss on the gate structure. Note the difference in the height of the spillway crest above the headwater of the right overflow spillway (pictured in the previous photo) and the left overflow spillway (pictured here).

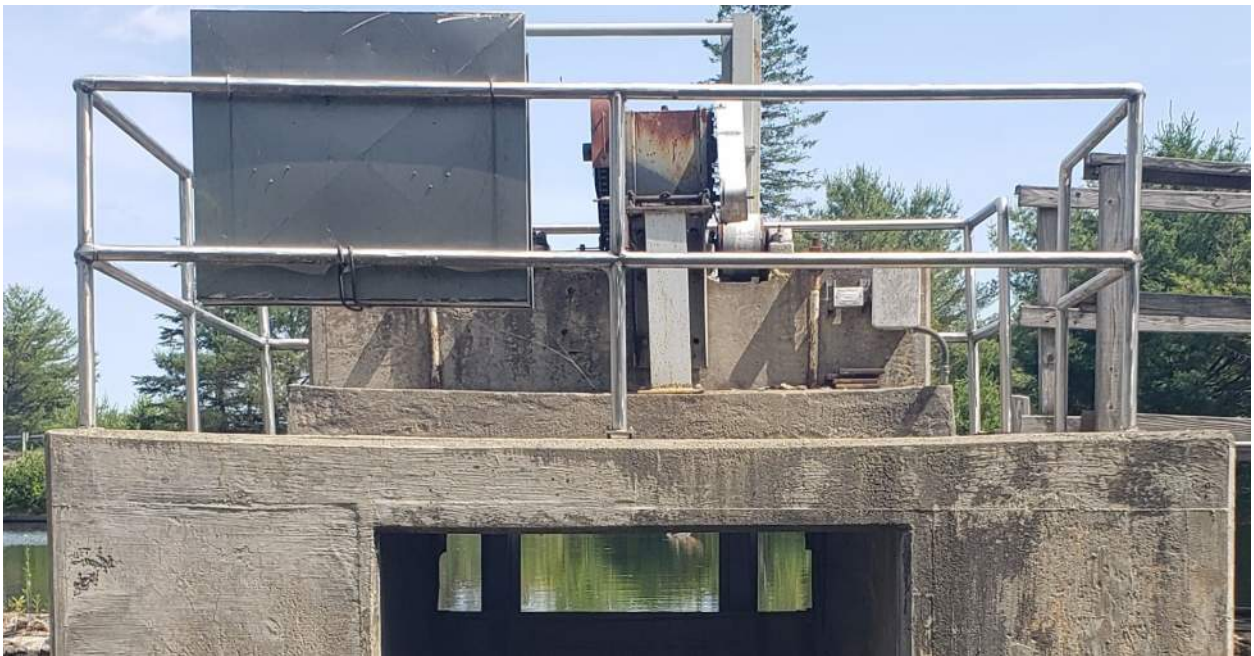
The deck of the gate structure appears to be deflected. This is evidenced by the connection of the stainless-steel railing to the concrete slab (Photo 8). The bottoms of the two outer downstream-most railing posts are flush with the concrete slab of the gatehouse, but the bottom of the center downstream-most railing is approximately  $\frac{1}{4}$  to  $\frac{1}{2}$  inch above the concrete slab. This suggests that the center of the concrete slab sags below the edges of the slab. The gate was reported to have been replaced in 2015. Beavers are reported to periodically block the gate and fishway intakes with mud. The gate intake is cleared by opening the gate. The gate is operated with a handheld battery-operated drill. Rust was observed on the gate mechanism on the operator platform (Photo 25). The gate was opened several inches during the inspection using a battery powered hand drill. No issues with gate operation were noted during the inspection. The gate components and gears were reported to have been recently greased.

Photo No. 8 – View of the gate structure/operator platform from Hatchery Road bridge, looking upstream. Note the deflection of the concrete slab.

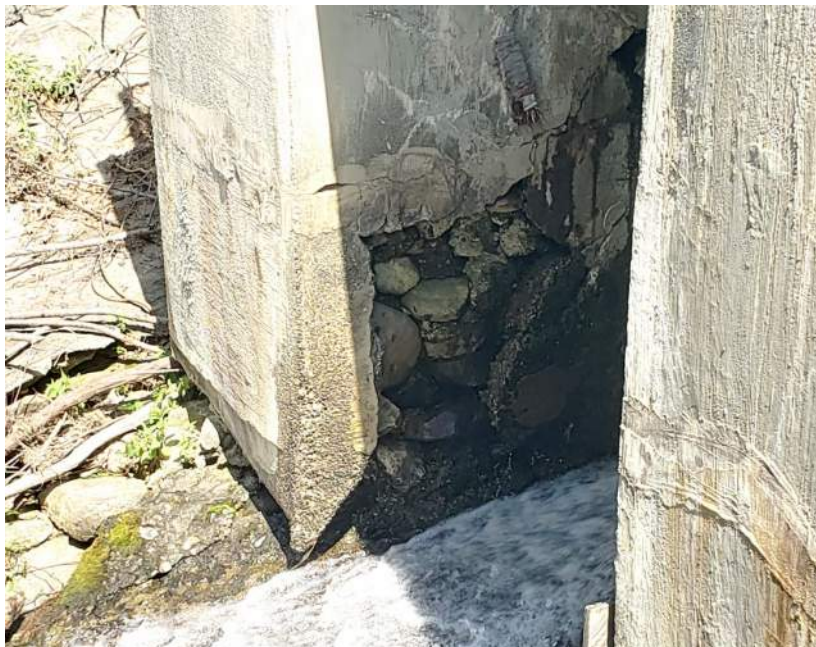
Photo No. 10 – Close up view of gate structure from the left embankment, looking right/upstream while the gate was opened. Note concrete loss.

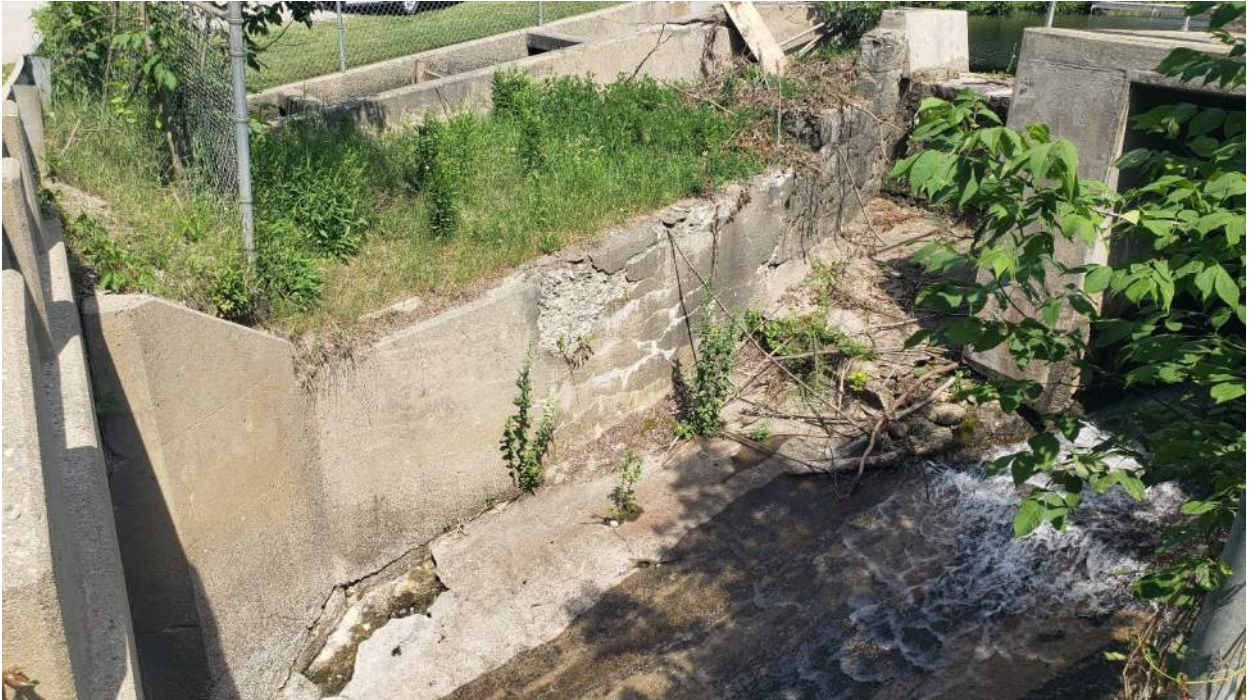
Spalling and efflorescence were observed on the right retaining wall adjacent to the spillway channel. (Photo 11). The wall is granite masonry immediately downstream of the spillway. It transitions to concrete after approximately 5 feet.

Photo No. 11 – View of dam from Hatchery Road bridge, looking upstream while the gate was opened. Note concrete loss on the right training wall and apron.

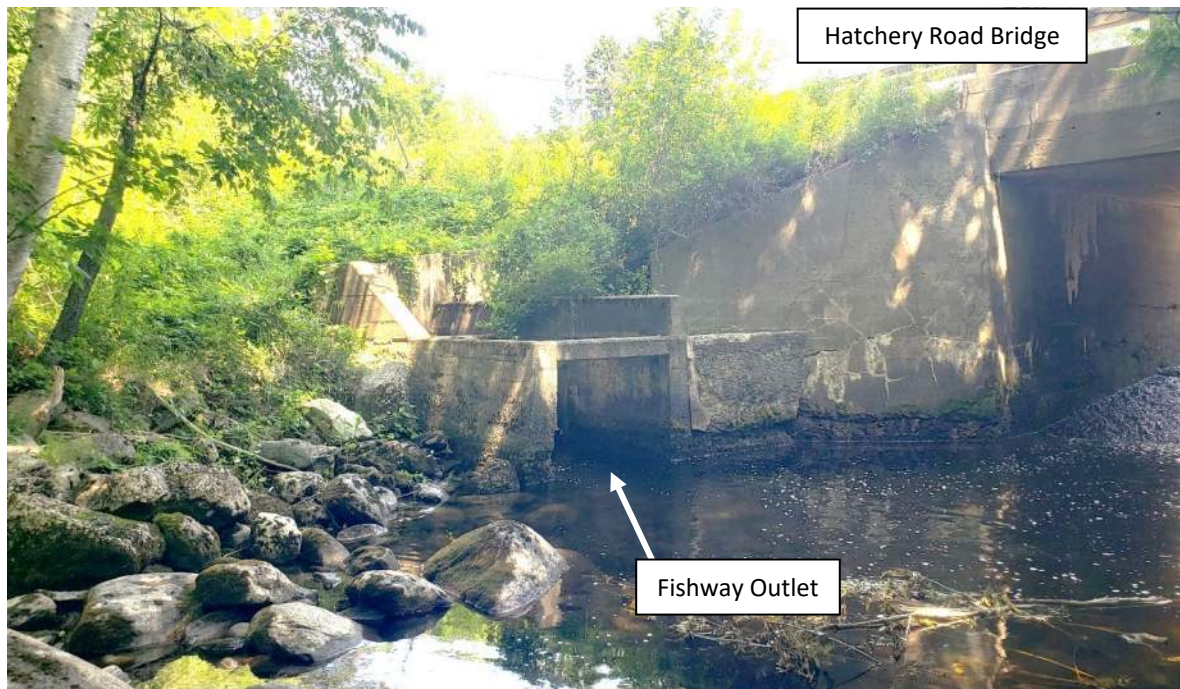
The embankment between the right upstream concrete retaining wall and Hatchery Road was mowed (Photo 21). The embankment downstream of Hatchery Road was estimated to be approximately 2V:1H. Heavy vegetation was observed on the embankment downstream of Hatchery Road (Photo 13).

Photo No. 13 – View from left downstream shore, looking upstream toward the fishway outlet and Hatchery Road bridge. Note concrete loss and vegetation on the embankment.

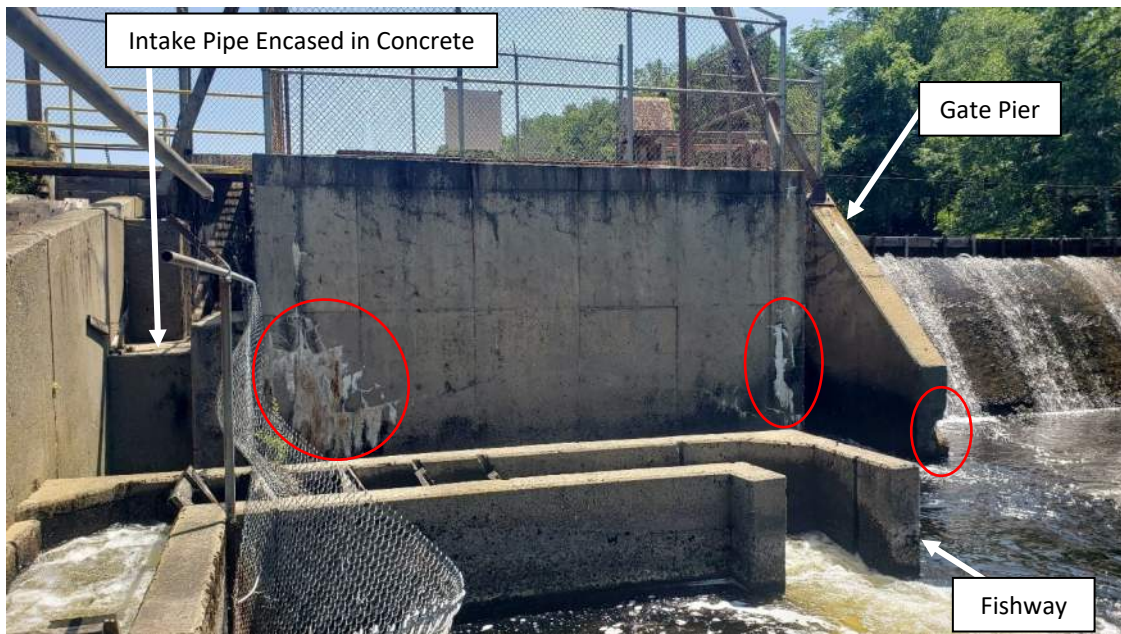
Photo No. 8 – View of fishway, intake structure, gate outlet, and spillway from right downstream shore, looking upstream. Note efflorescence on the intake structure, concrete loss on the gate pier, and the broken chain link fence.

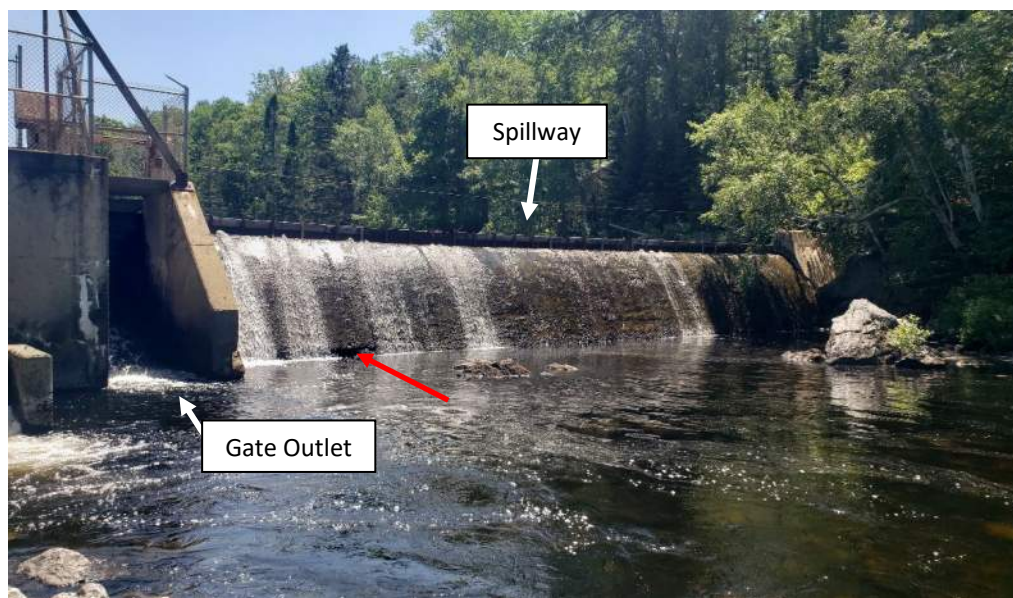
Photo No. 9 – View of gate outlet and spillway from right downstream shore, looking upstream. Note deterioration at concrete lift joint (red arrow).

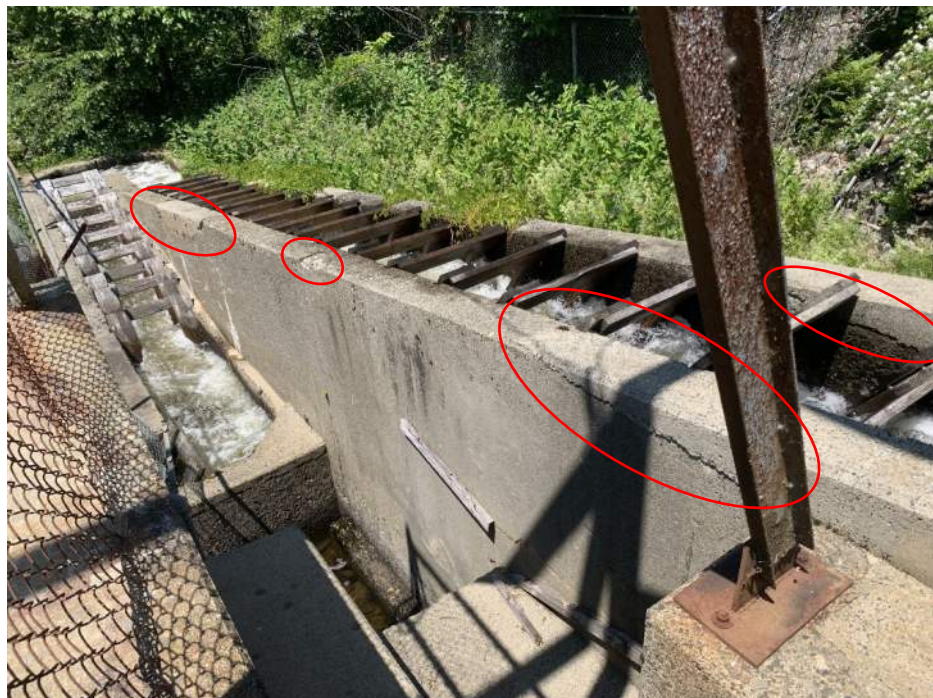
Photo No. 11 – View of fishway from operator platform. Evidence of prior concrete repairs visible. Some concrete spalling.
