Valle Verde Ranch

Reconnaissance Level – Preliminary Drainage Analysis

By Ben Lomeli, Hydrologist CFM

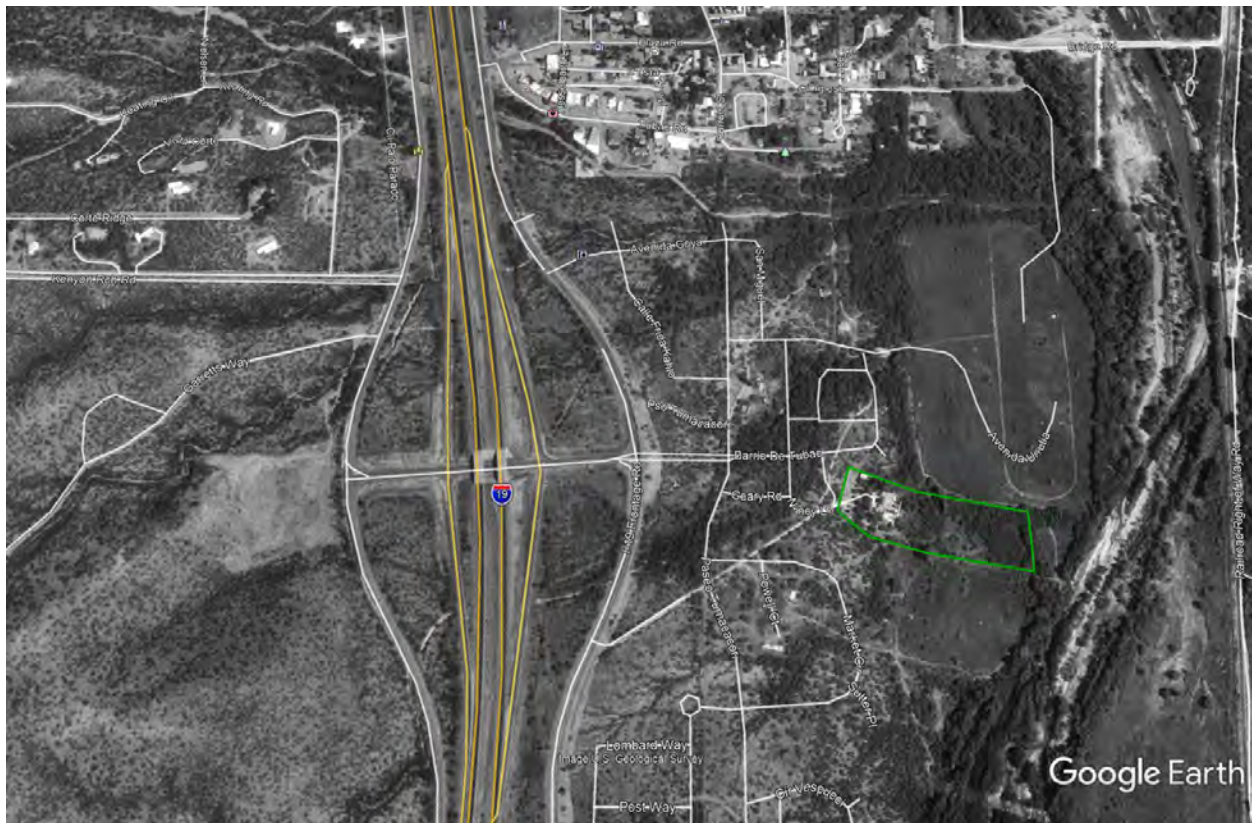
9/4/1992: Note “Natural” NE flow direction of wash as shown by vegetated drainage towards old racetrack. (Valle Verde Ranch property shown within green polygon).

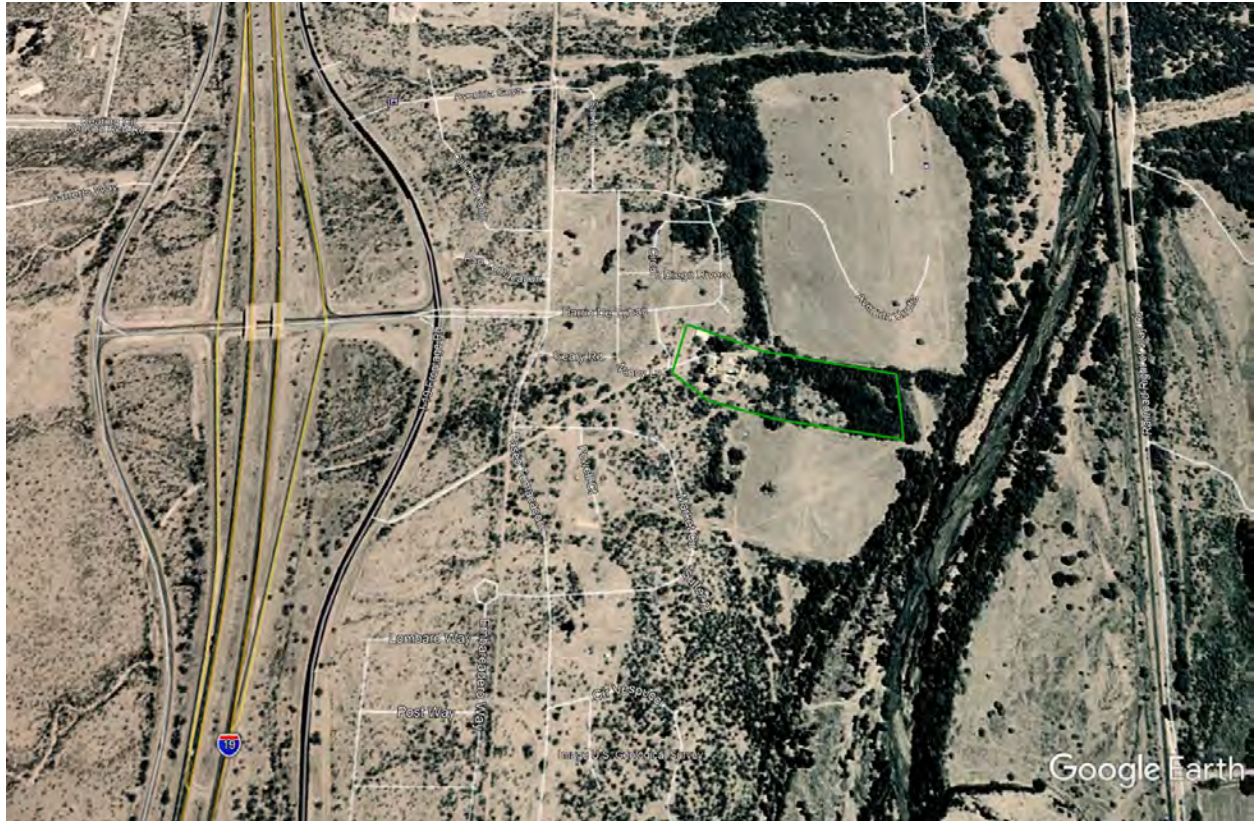
6/18/1996: Borrow Pit area appears scarified, probably in preparation for excavation.

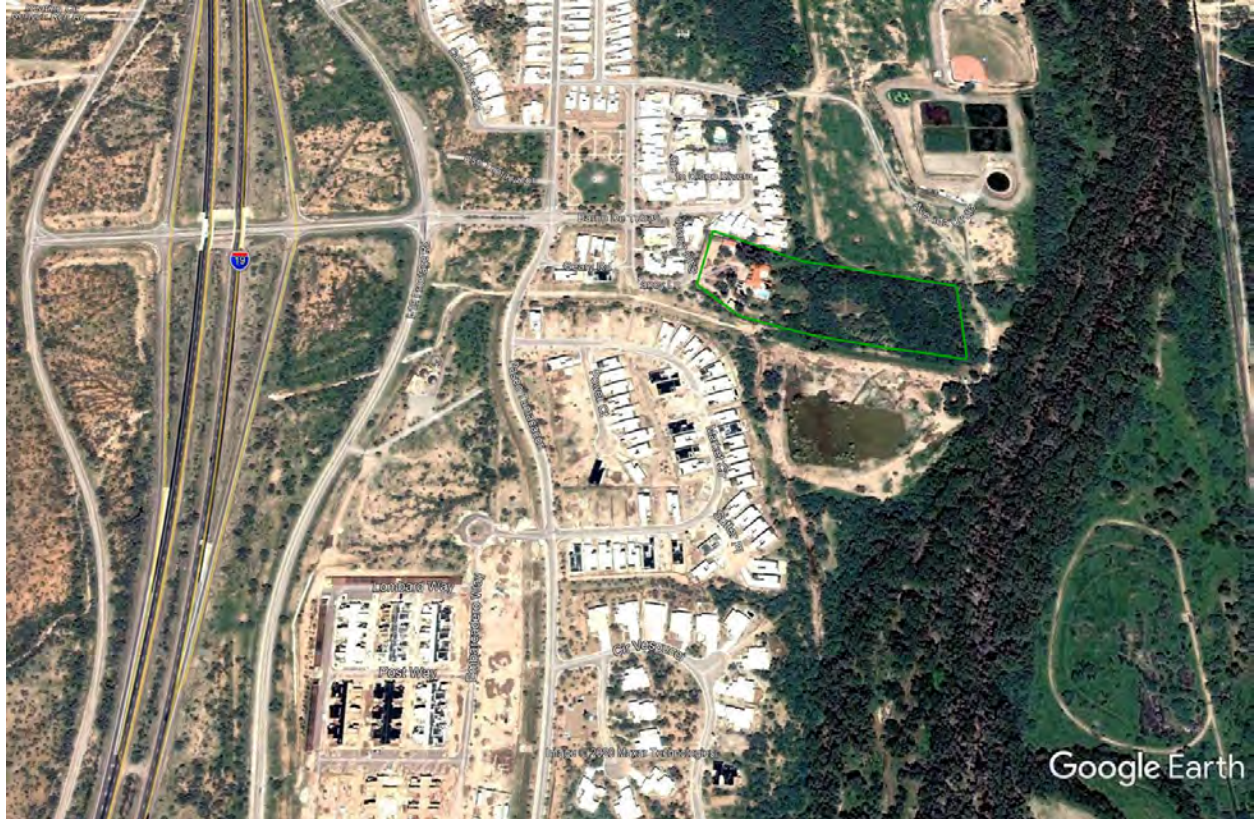
8/26/2006: Borrow Pit ponding water.

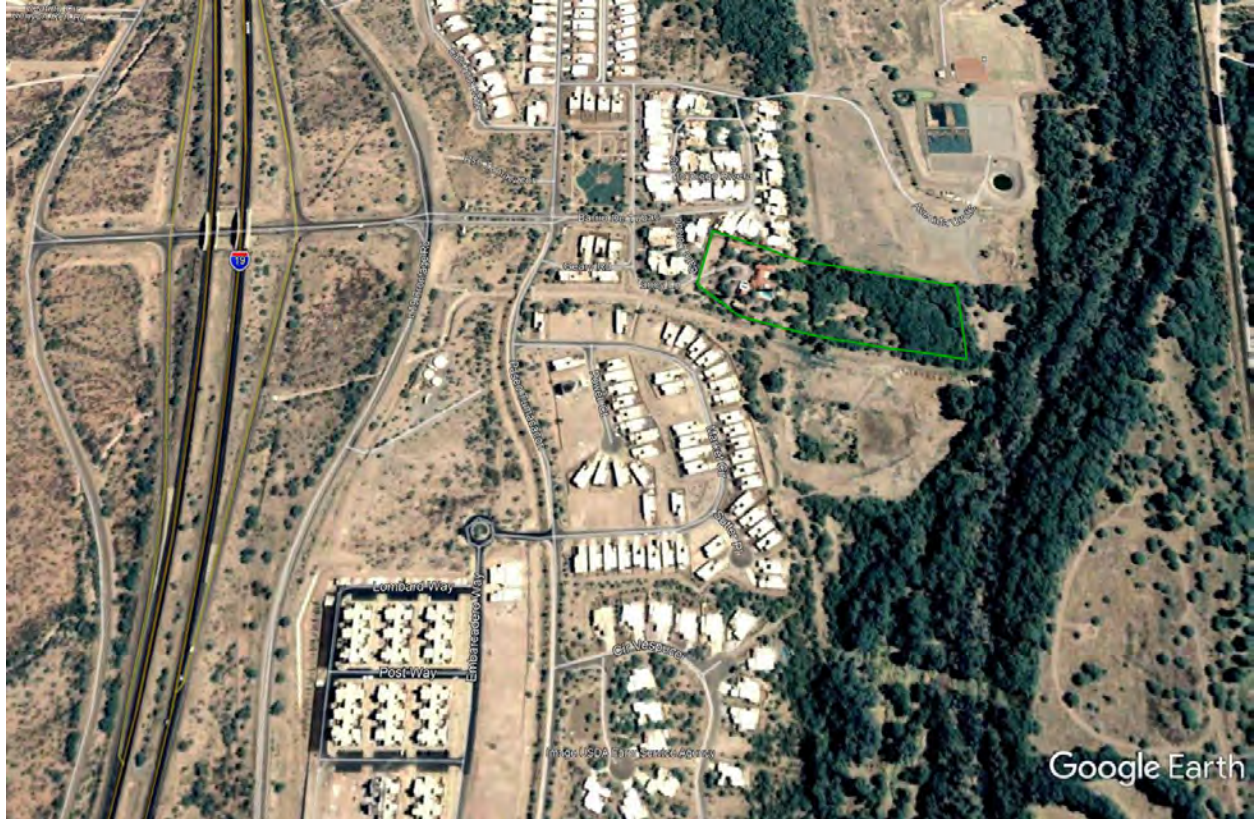
6/7/2007: Borrow Pit dry in Summer.

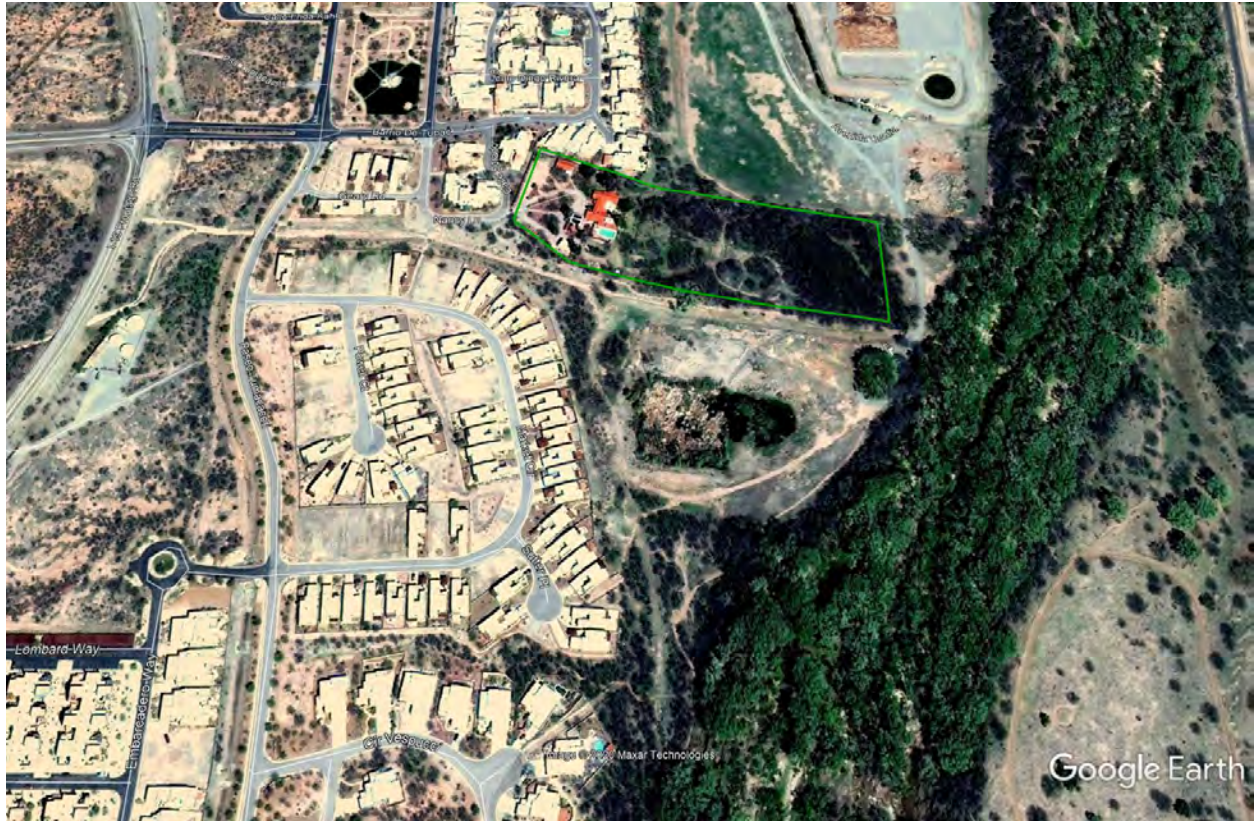
3/16/2010: Only a small pond in Borrow Pit in early Spring.

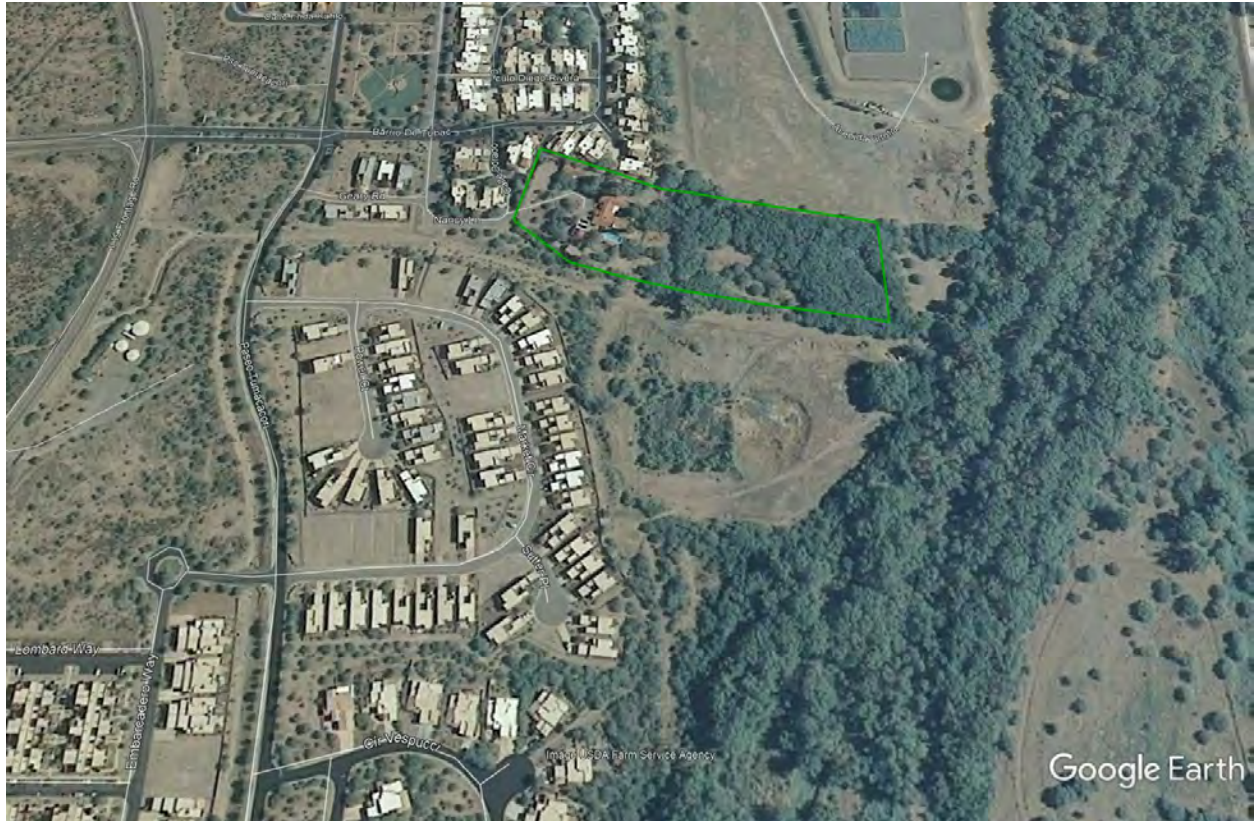
6/4/2010: Borrow Pit dry again in Summer.

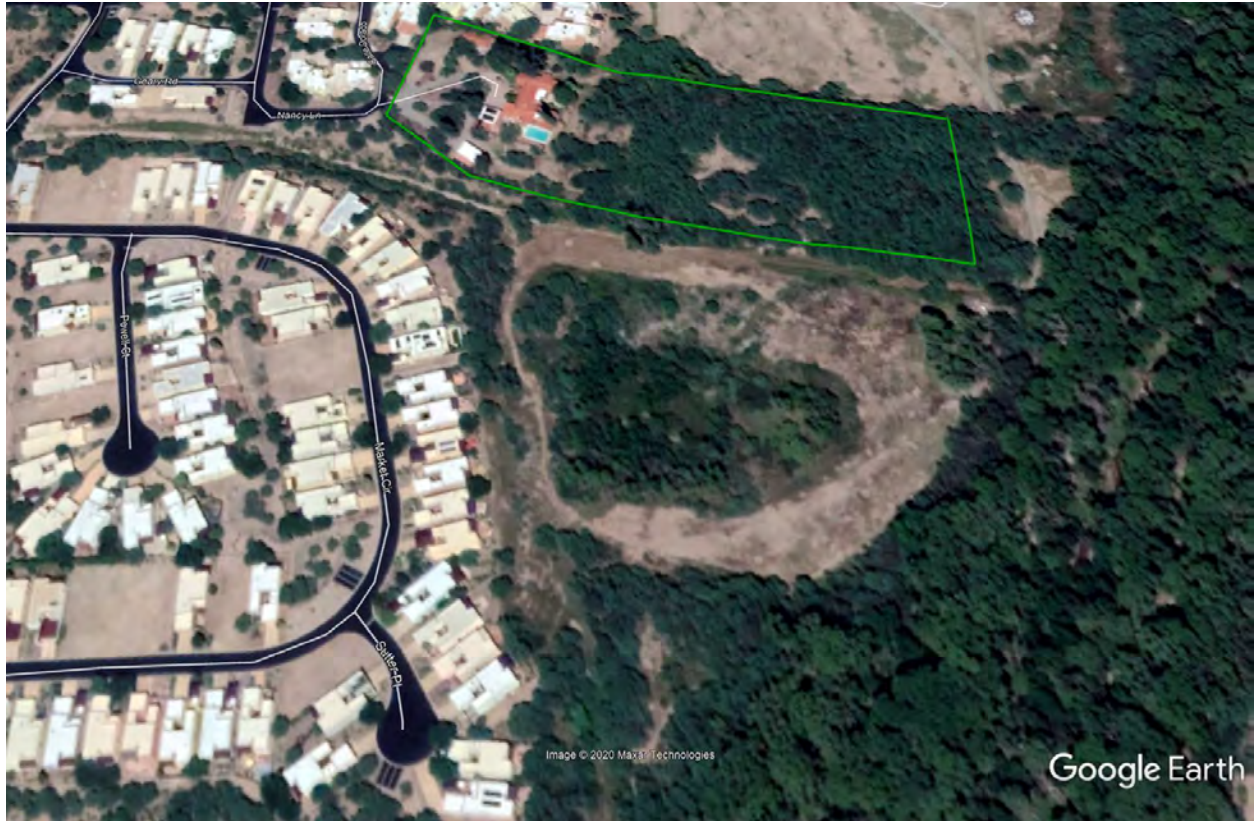
9/26/18: More trees and less ponding evident in Borrow Pit in Fall images since the Spring of 2010.

The borrow pit immediately south of the wash is a desirable site for a bird-watching wetland but has been “filling-in” with sediment deposits.

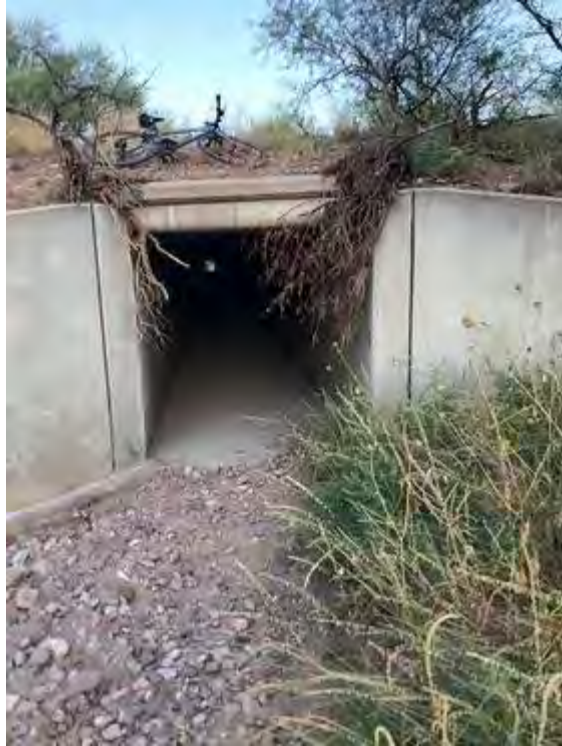
Box culvert under I-19 much larger than the 3 CMPs at Anza Trail (*outlet to river*).
(Photo by Rich Kiker)

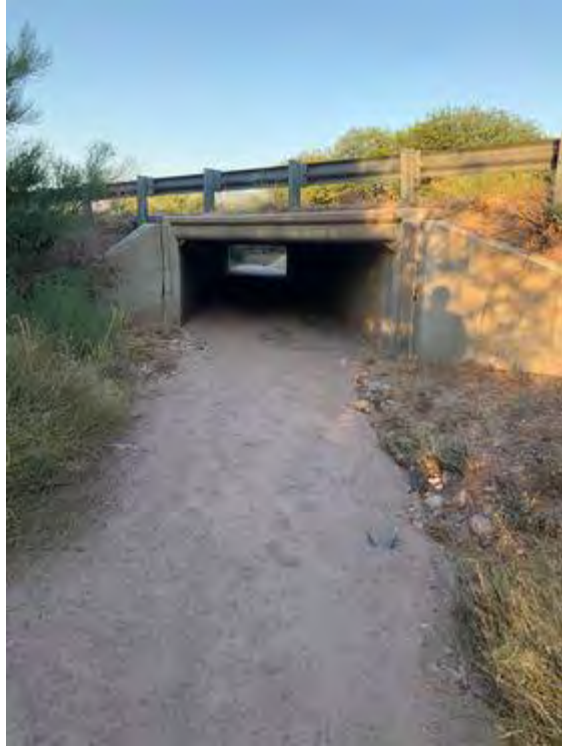
Box culvert at East Frontage Road also much larger than the 3 CMPs at Anza Trail (*outlet to river*).
(Photo by Rich Kiker)

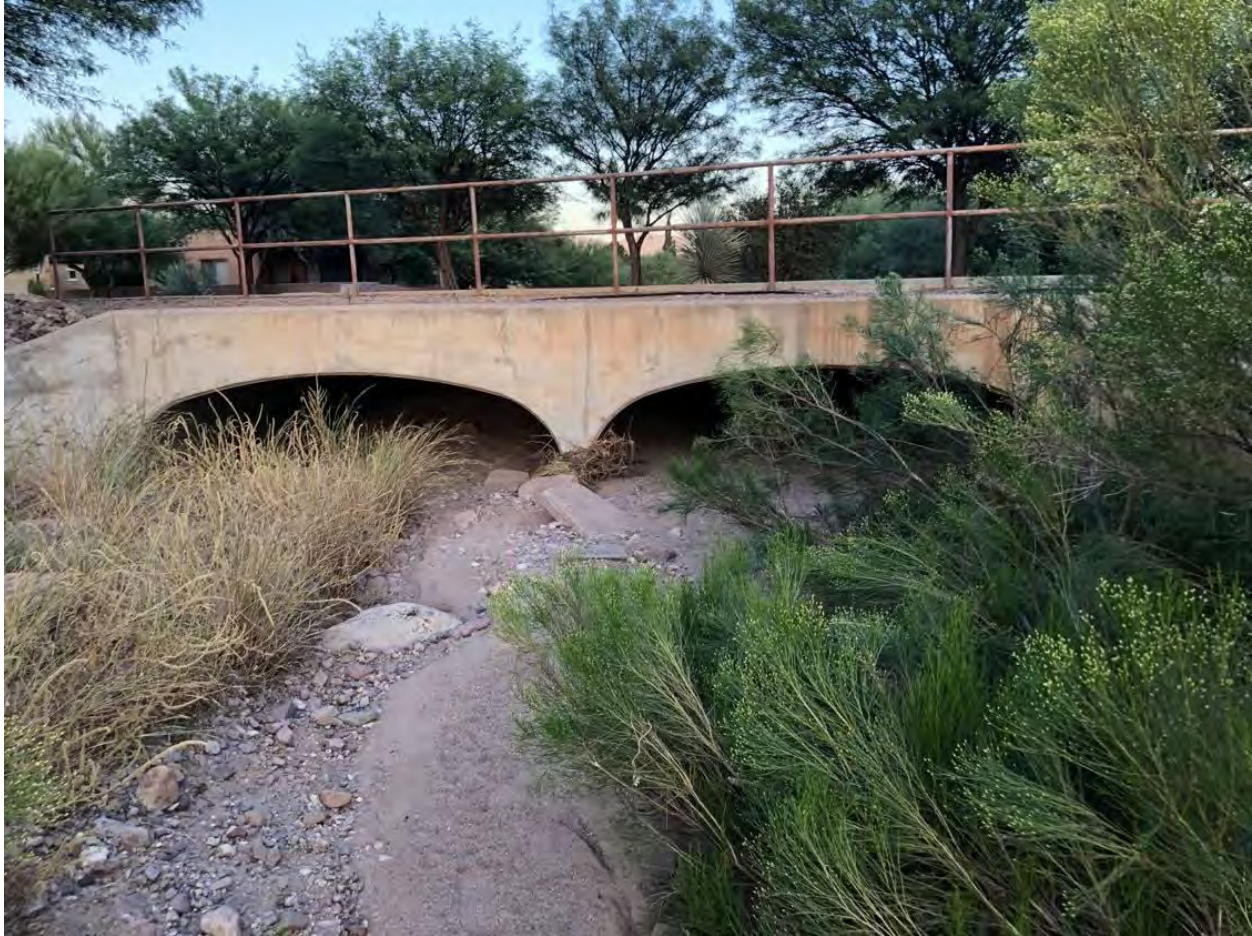
Arch culverts under Paseo de Tumacacori. Possible sediment build-up likely reducing hydraulic capacity.

The wash receives additional lateral inflows from both banks from adjacent residential subdivision streets, roofs, sidewalks, and other impervious surfaces.

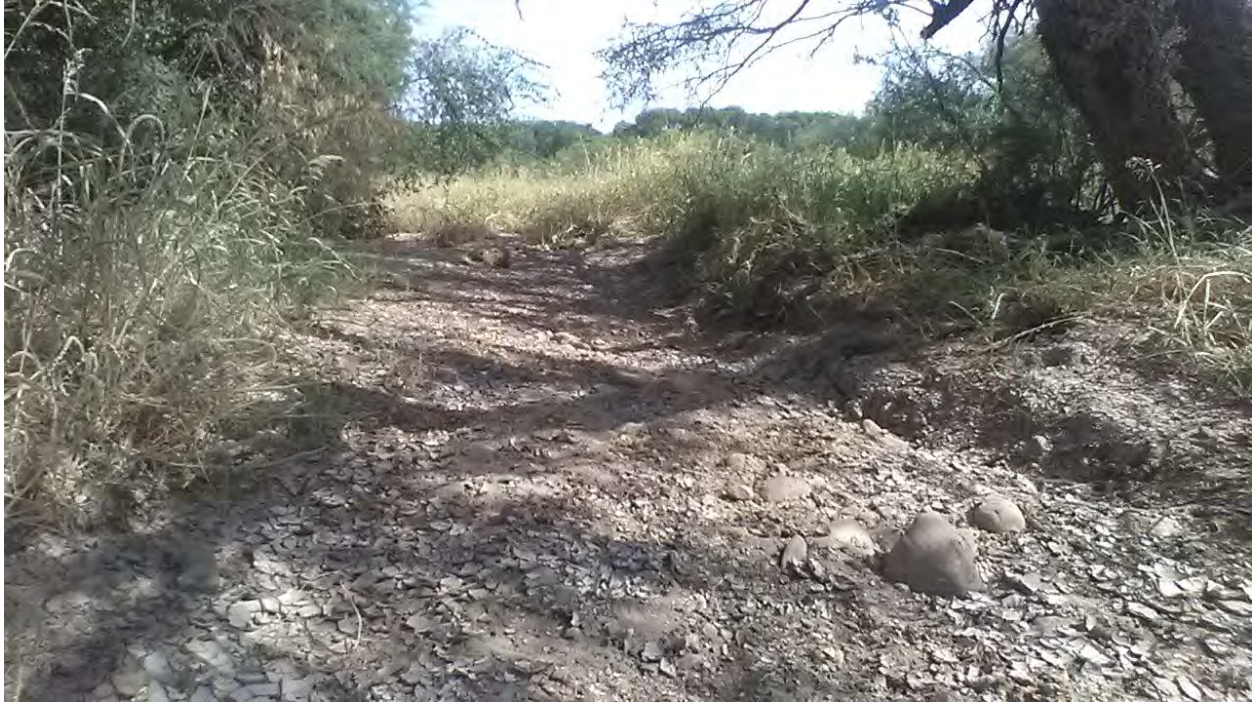
Looking downstream towards river at beginning of sediment high spot.

Sediment deposits are currently semi-stabilized with dense tall grass (*Johnson grass?*). Excess sediment deposits have accumulated to create a “high-spot” that effectively forms a low crossflow berm that partially obstructs downstream low flows. The obstructive crossflow sediment berm causes upstream backwater ponding and consequent overflow flooding and sedimentation, primarily NE towards Valle Verde Ranch. Water and sediment flows both follow the laws of physics and seek the “Natural” NE flow direction.

1. Reestablish (*clear with sufficient conveyance*) channel at lower end of wash to **return flows** towards Santa Cruz River and direct overflows towards borrow pit (*desired wetland*), instead of towards Valle Verde Ranch.
2. Create earthen berm and/or bank with protective native vegetation (*at a minimum*) to keep flows heading down towards river instead of entering Valle Verde Ranch.
3. Provide adequate wash conveyance and outlet capacity to Santa Cruz River by replacing/upgrading the 3 CMPs at Anza Trail with either an open-span foot bridge, a properly sized box culvert, con-arch culvert(s), additional CMP barrels, or any other hydraulically equivalent structure.
4. Provide erosion protection for the potable water supply well at Anza Trail (*outlet to river*) with appropriately designed toe-down scour cut-off wall and riprap-lined “*banks/side-slopes*”.

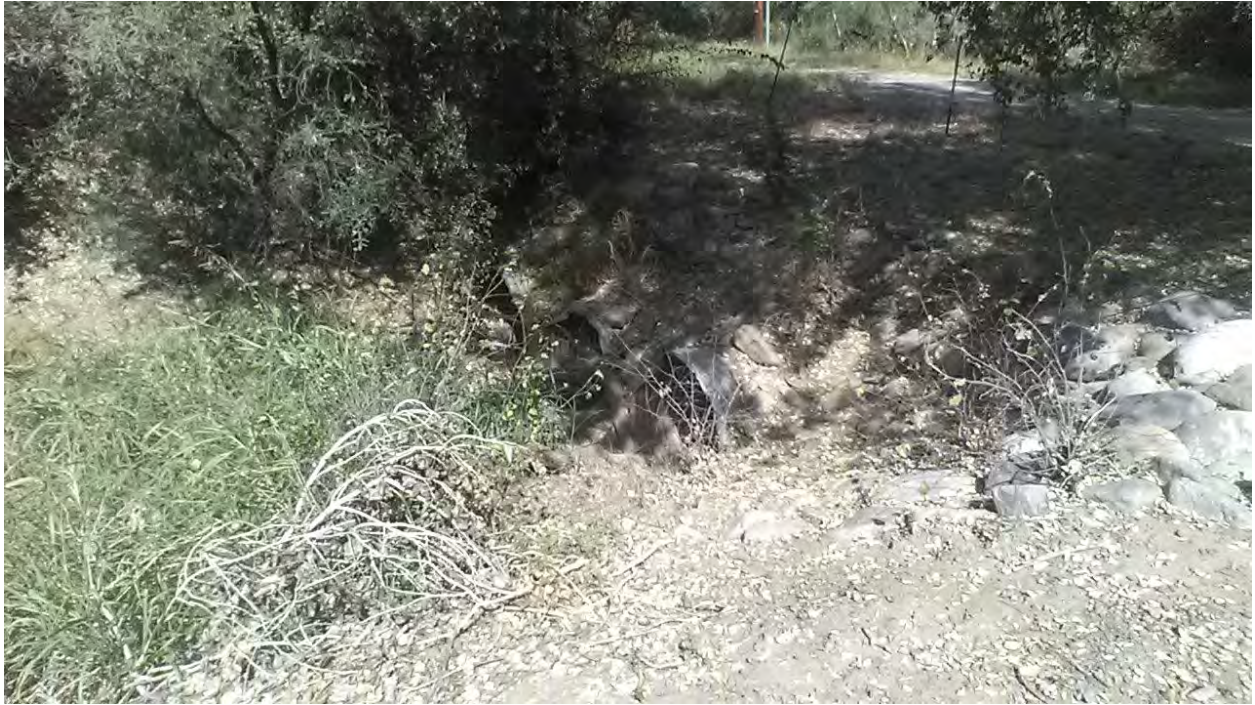
3 CMPs at Anza Trail appear to be undersized.

(Much less conveyance capacity than all upstream box and arch culverts).

The 3 CMPs at Anza Trail appear to be undersized and causing “backwatering” at the lower end of the subject wash. This outlet structure is considerably smaller with considerably less hydraulic conveyance capacity than the upstream box culverts under I-19 and East Frontage Road and the arch culverts under Paseo de Tumacacori.
