## Schematic Design Report

**The Metropolitan Condo  
5320 N Sheridan Road  
Chicago, IL**

**ZS Project Number: 257018.1**

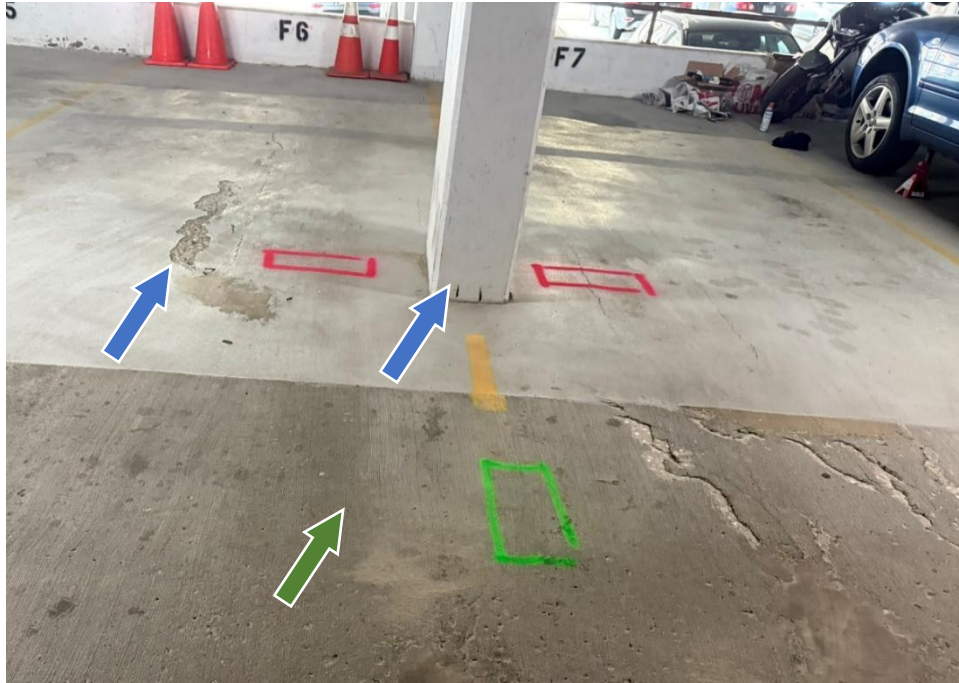
columns ( Photo 1 ), as the primary tendon groupings are typically centered around these structural elements. The high point of the temperature tendons was located in line with the column.

*Photo 1: Main Tendon Location Markings – Green Arrow Indicates Temperature Tendon Location Marking*

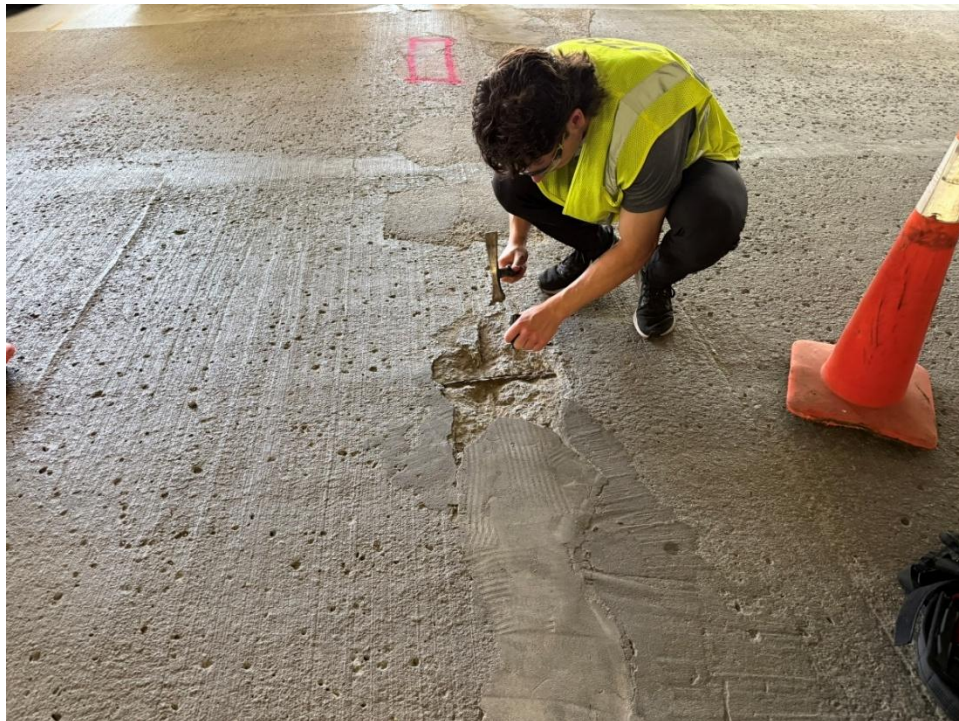
*Photo 2: Tendon Exposed at Concrete Spall*

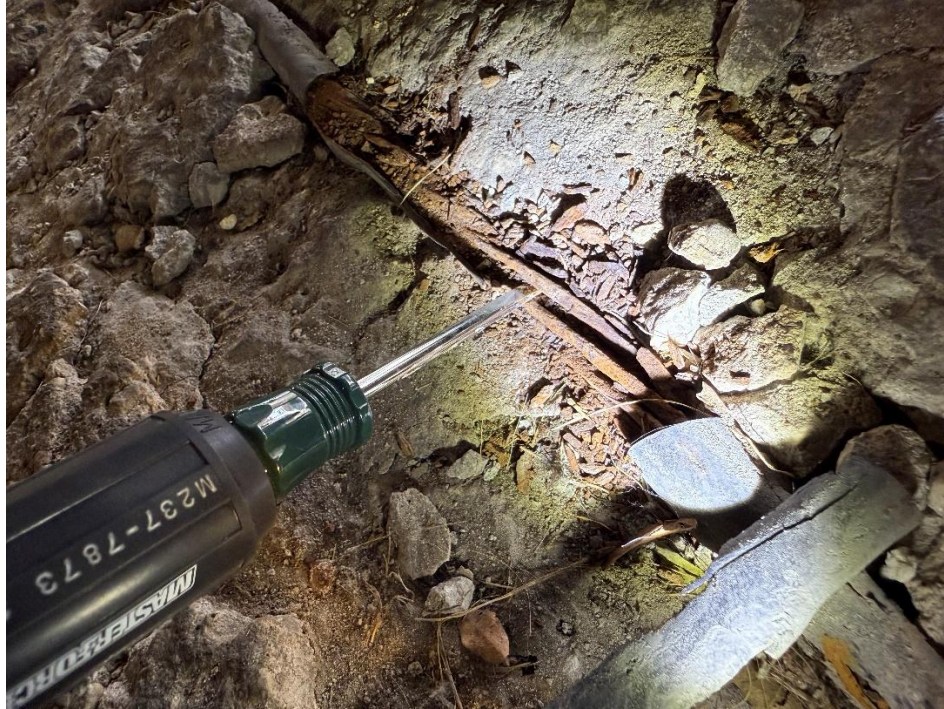
*Photo 3: Tenson Testing*

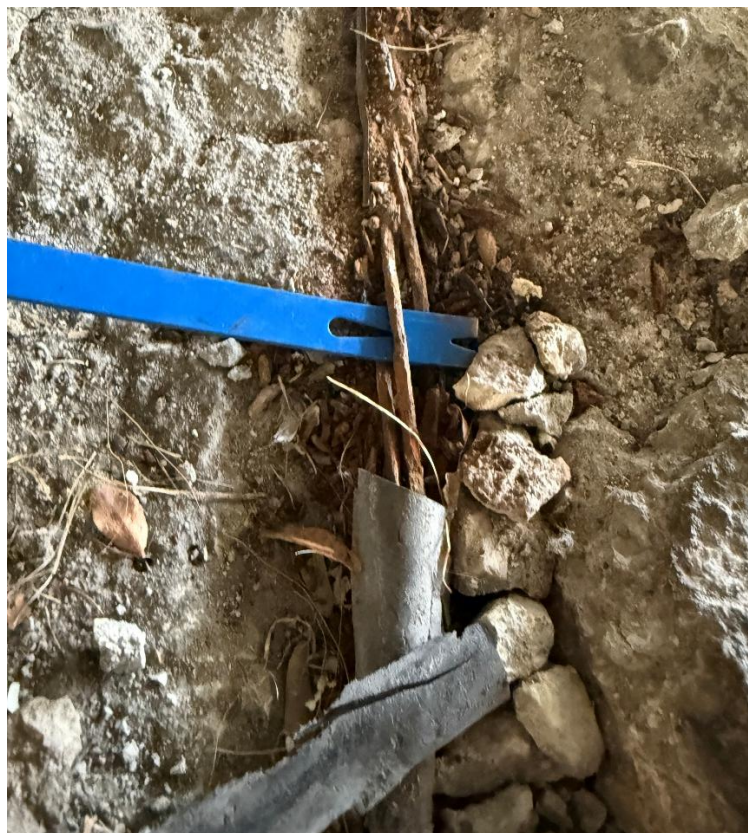
While on site, several locations where tendons had been exposed at spalled concrete were tested to verify that the standard testing methodology would be valid at the Metropolitan parking structure. The test involves driving a metal tool into the tendon; a flat screwdriver and small pry bar were used for the testing ( Photo 2 and Photo 3 ). If the tendon still holds tension, the tool will not separate the metal strands that make up the tendon. Where the tendon has failed, the tool will separate the strands ( Photo 4 ).

*Photo 4: Failed Tendon Test*

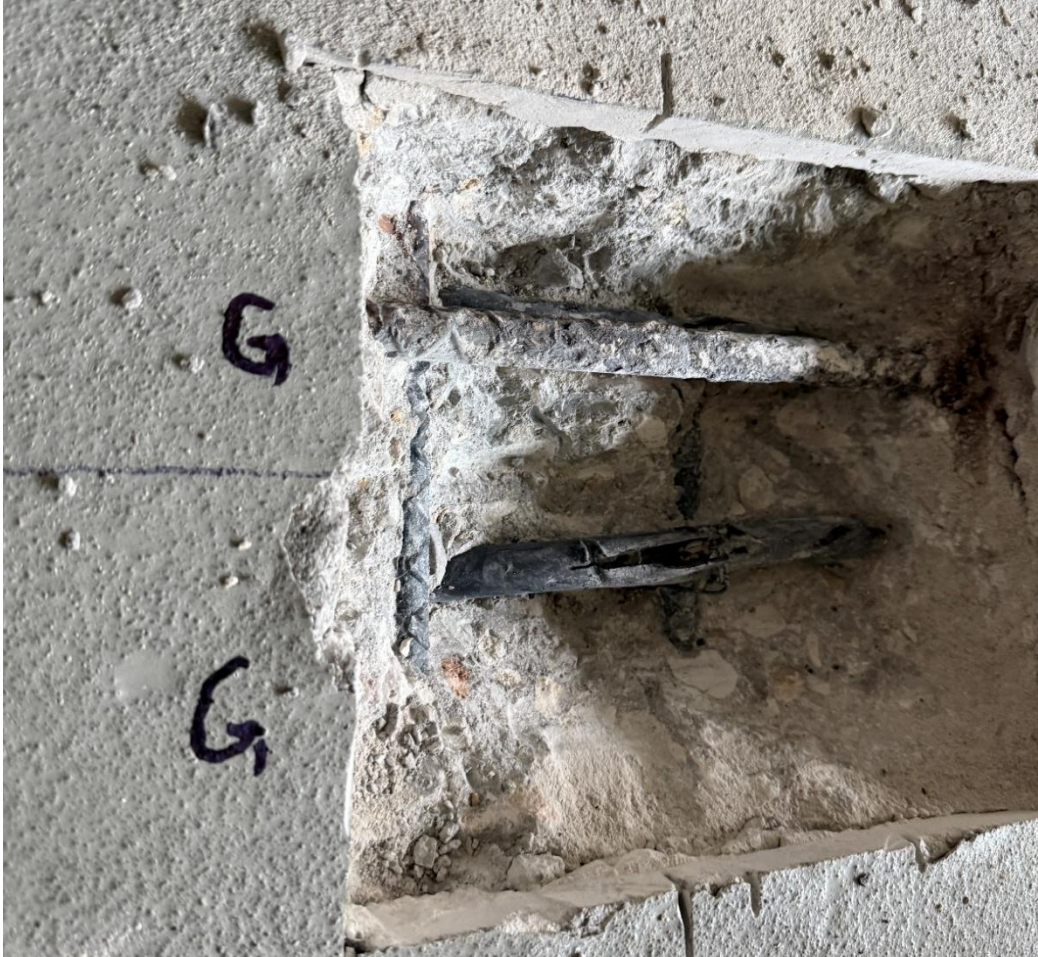
*Photo 5: Cut in Tendon Sheathing*

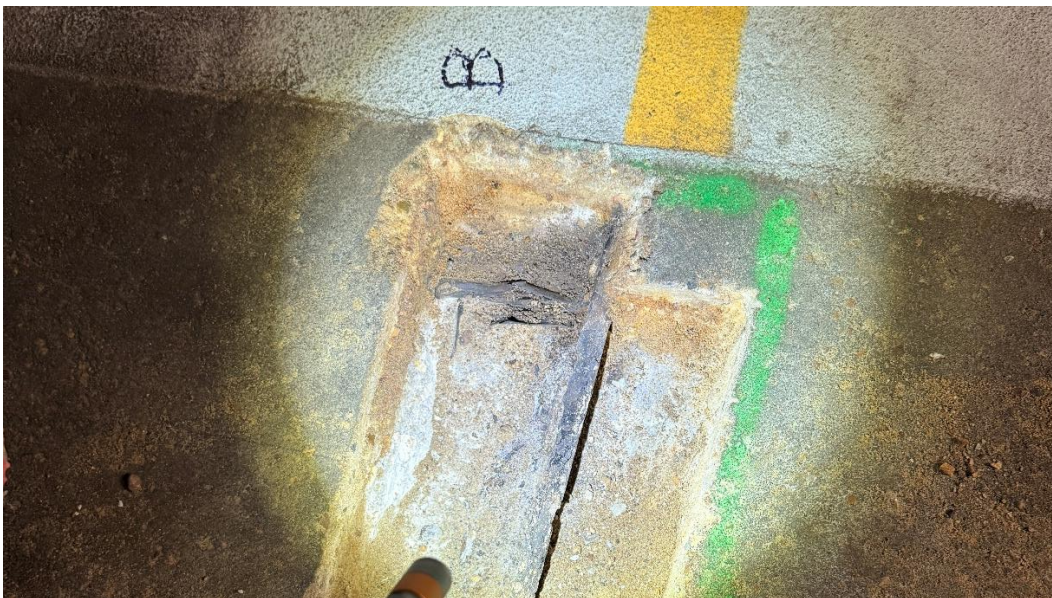
- A failing tendon required no preparation ( Photo 6 ).
  - A passing tendon requires more excavation around the tendon in order to apply grease and waterproofing tape. Grease was applied into open sheathing and anywhere steel tendons were exposed. Waterproofing tape was wrapped around entire tendon where sheathing was cut or steel was exposed ( Photo 7 ).

*Photo 6: Abandoned Failed Tendon*

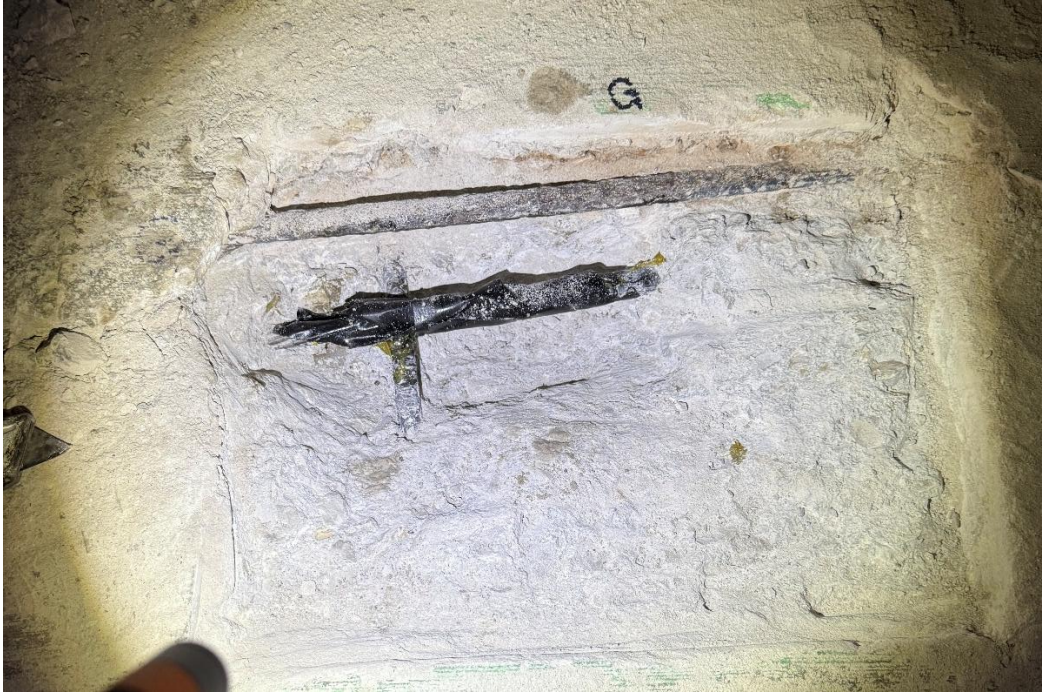
*Photo 7: Good Tendon; Greased and Wrapped*

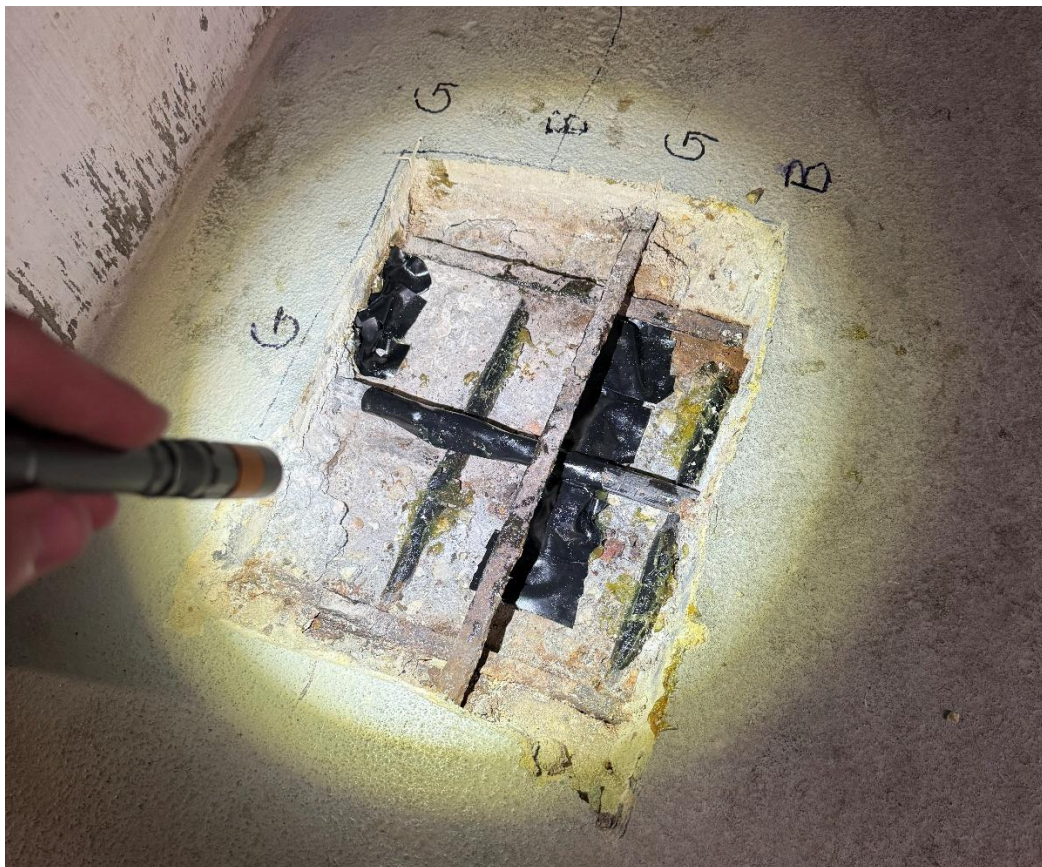
*Photo 8: Tendon Protection Where Tendon Could Not be Fully Wrapped*

- For tendons located at a depth of approximately 4½ inches, or in areas where adjacent tendons were present, concrete was not removed from the underside of the tendon. This approach was taken to avoid working too close to the bottom surface of the slab, which could risk creating holes through the entire slab or was limited by lack of access to the underside. Despite this, grease and waterproofing tape were applied to the top side of the tendon at the location of the cut sheathing to provide protection ( Photo 8 ).
