# Sample/Chapter 19

## The 55<sup>th</sup> Wing and a Prayer

## Chapter 19

On 30 April 2015, RC-135V 64-14848 experienced a fire in the rear cabin during takeoff roll. The aircraft had reached a speed of about 50 knots when crewmembers in the rear compartment reported seeing a fire above the galley. The pilots aborted the takeoff.

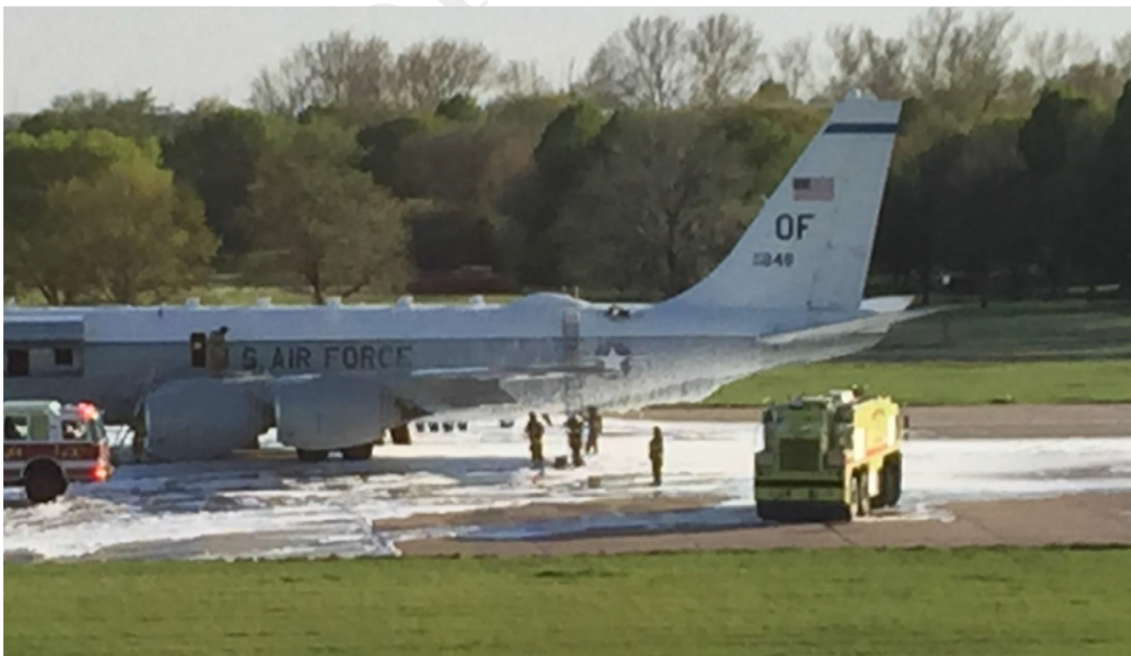
The pilots and all 27 mission crewmembers safely evacuated. Fire crews arrived and extinguished the flames. The fire burned a hole through the upper fuselage above the rear galley area, causing structural damage and damage to aircraft control and mission related systems. Four crewmembers received treatment for minor smoke inhalation. The aircraft was out of service for over two years.

The Accident Investigation Board (AIB) findings determined that the cause of the mishap was a leak in the high-pressure oxygen system due to poor assembly of the system tubing during the aircraft's previous overhaul at Depot. [Click here for the final report \(1341 pages\)](#). It is widely believed that the aircraft would have crashed had it left the ground.

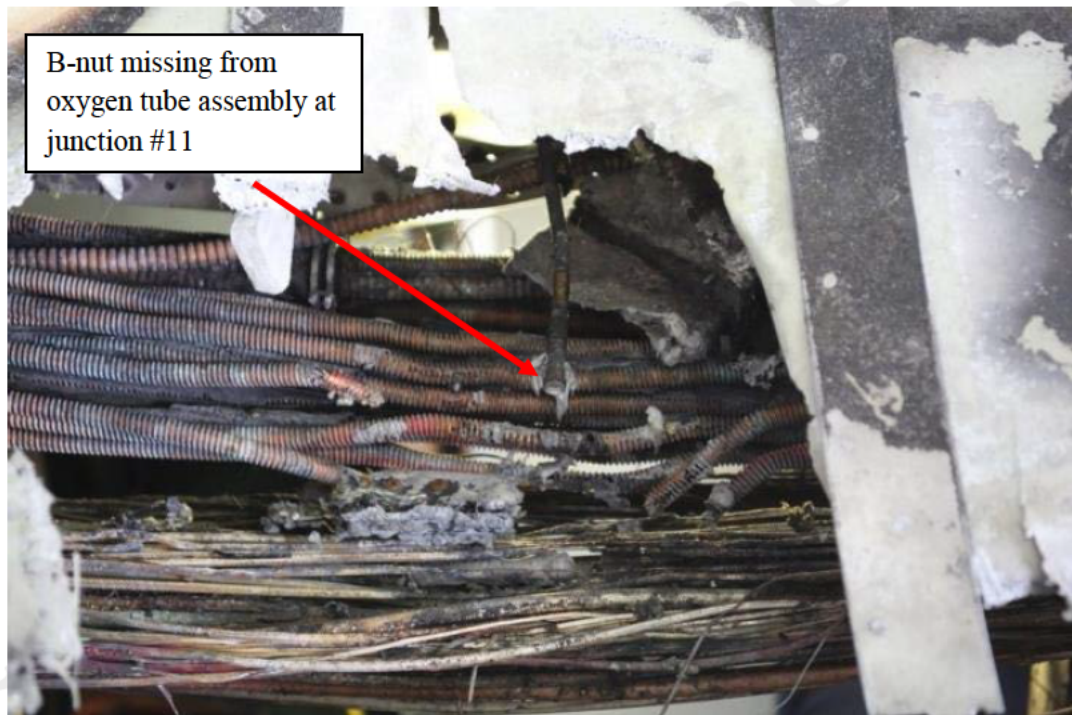
1. The aluminum B-nut connecting a section of oxygen tube to an aluminum fitting at Junction #11, was missing. **Melted fragments** of the missing B-nut were found on the floor behind the galley. (Ref AIB Report J-30)

2. The AIB Report recognized a defect known as “pitting” (i.e., tiny holes or “pits”) around the oxygen tube assembly at junction #11. A substantial section of the report was dedicated to identifying the type of pitting. This particular type of pitting is caused by electrical arcing rather than corrosion. (Ref. AIB Report J-37 & J-38)
3. The AIB Report determined that several under torqued oxygen line B-nut fittings in the area of the galley were leaking, including that of junction #11. (AIB Report Tab J-9).
4. Junction #11 is located in an area surrounded by a large number of tightly bound coax cables, electrical wires, insulation, plastics, and common aircraft hardware.
