# The 55<sup>th</sup> Wing and a Prayer

A Whistleblower's Story

## Chapter 19

### **Fire! Fire! Fire!**

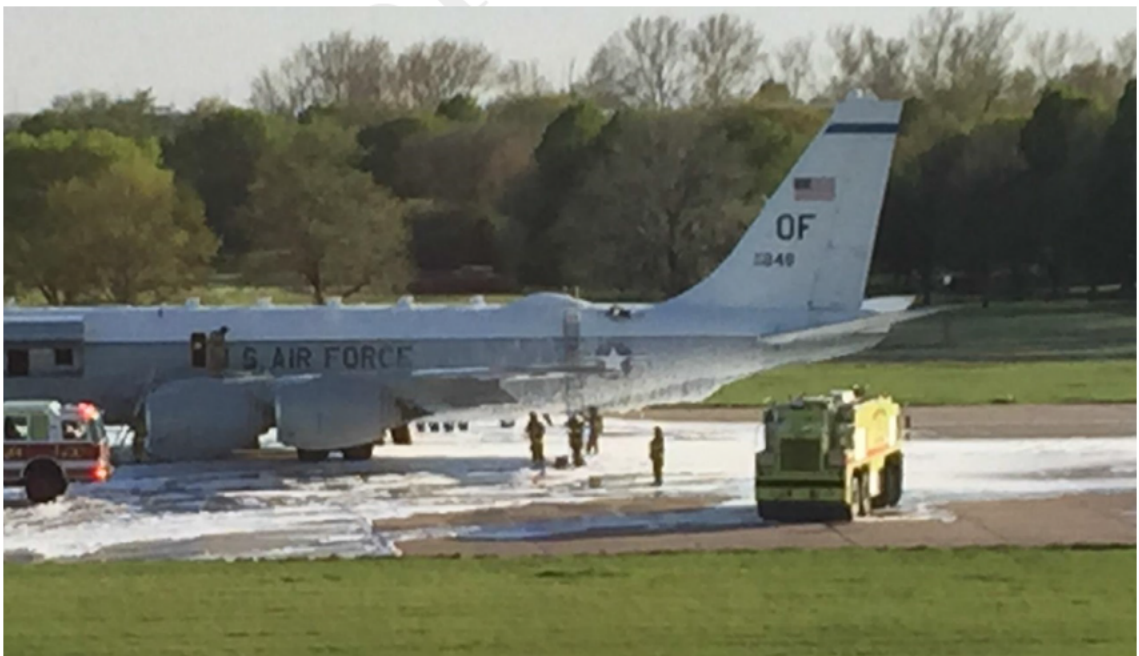
The pilots and all 27 mission crewmembers safely evacuated. Fire crews arrived and extinguished the flames. The fire burned a hole through the upper fuselage above the rear galley area, causing structural damage and damage to aircraft control and mission related systems. Four crewmembers received treatment for minor smoke inhalation. The aircraft was out of service for over two years.

The Accident Investigation Board (AIB) findings determined that the cause of the mishap was a leak in the high-pressure oxygen system due to poor assembly of the system tubing during the aircraft's previous overhaul at Depot. [Click here for the final report \(1341 pages\)](#). It is widely believed that the aircraft would have crashed had it left the ground.

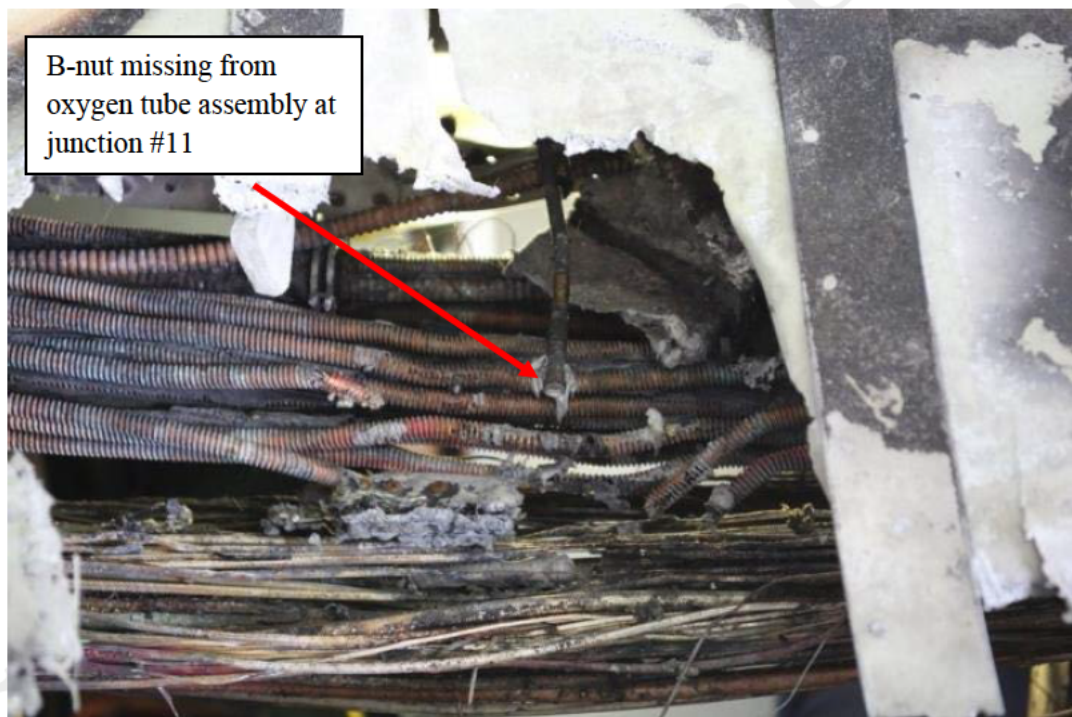
1. The aluminum B-nut connecting a section of oxygen tube to an aluminum fitting at Junction #11, was missing. **Melted fragments** of the missing B-nut were found on the floor behind the galley. (Ref AIB Report J-30)

2. The AIB Report recognized a defect known as “pitting” (i.e., tiny holes or “pits”) around the oxygen tube assembly at junction #11. A substantial section of the report was dedicated to identifying the type of pitting. This particular type of pitting is caused by electrical arcing rather than corrosion. (Ref. AIB Report J-37 & J-38)
3. The AIB Report determined that several under torqued oxygen line B-nut fittings in the area of the galley were leaking, including that of junction #11. (AIB Report Tab J-9).
4. Junction #11 is located in an area surrounded by a large number of tightly bound coax cables, electrical wires, insulation, plastics, and common aircraft hardware.

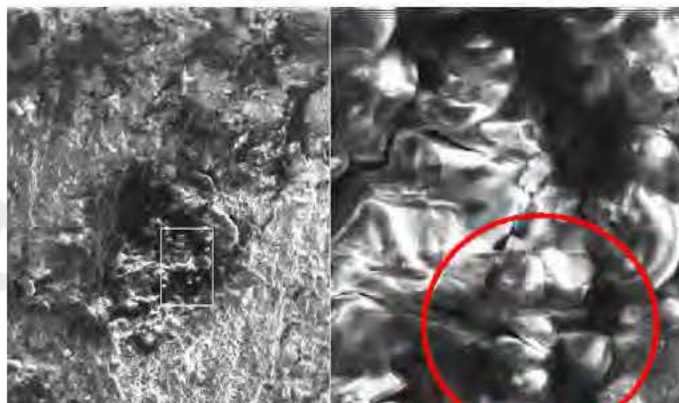
The AIB Report did not consider the above-mentioned electrical system anomalies. Likewise, the AIB Report ignored the ‘electric arcing’ that caused tiny pits to form in the oxygen tube at junction #11. The AIB Report did not discuss the physics behind an electric arc, such as voltage, conditioned cabin air, cabin pressure, and trace gasses within an RC-135. To be direct, the AIB Report failed to consider electrical arcing at junction #11, as a possible source of ignition.

Figure 26: Evidence of pitting on junction #11 tube adjacent to sleeve after cleaning by acetate replication. Similar to the sleeve, the pitting was more prevalent on one side of the tube. A secondary electron image at the bottom of the figure shows nodular formations, circled in red, in the pit. The nodular formations are consistent with melting. Melting damage was localized in the pitted features. (Ref Tab J-38)

Adding the unresolved electrical system discrepancies into the equation, it is conceivable that stray voltage from a compromised electrical circuit bled into the aluminum oxygen tube assembly. Each time the loose B-nut at junction #11 “broke ground”, an electric arc occurred.

Repeated arcing, exasperated by an elevated concentration of oxygen due to the loose B-nut, further damaged the oxygen tube, possibly forming a small pinhole. The damaged oxygen tube, and/or the loose B-nut at junction #11, created a localized high velocity flow of pure oxygen gas. The pure oxygen gas became ionized by the persistent electric arc, resulting in a spontaneous oxygen plasma arc similar to that used in a modern-day [oxygen plasma cutting torch](#).

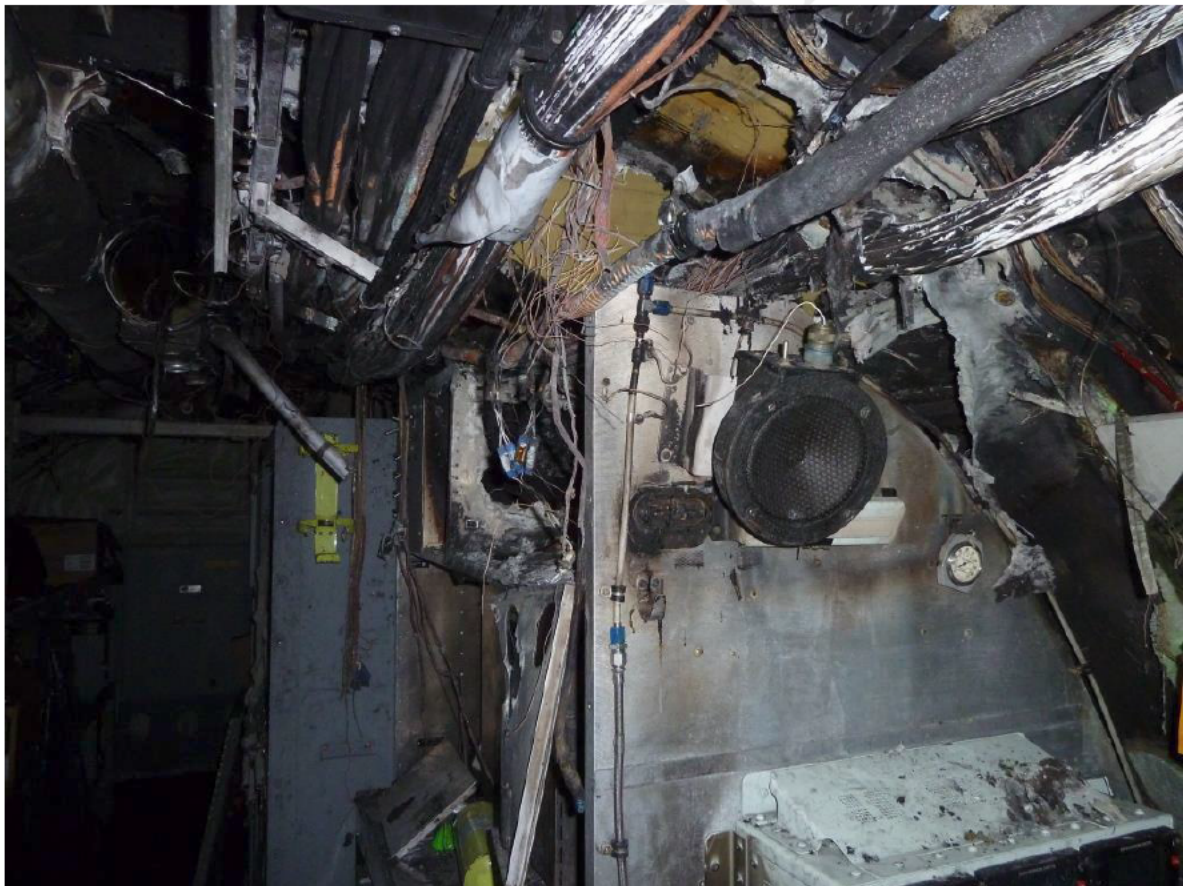
Interior damage caused by the fire. (Image via USAF AIB Report)
