# The 55<sup>th</sup> Wing and a Prayer

A Whistleblower's Story

## Chapter 19

### **Fire! Fire! Fire!**

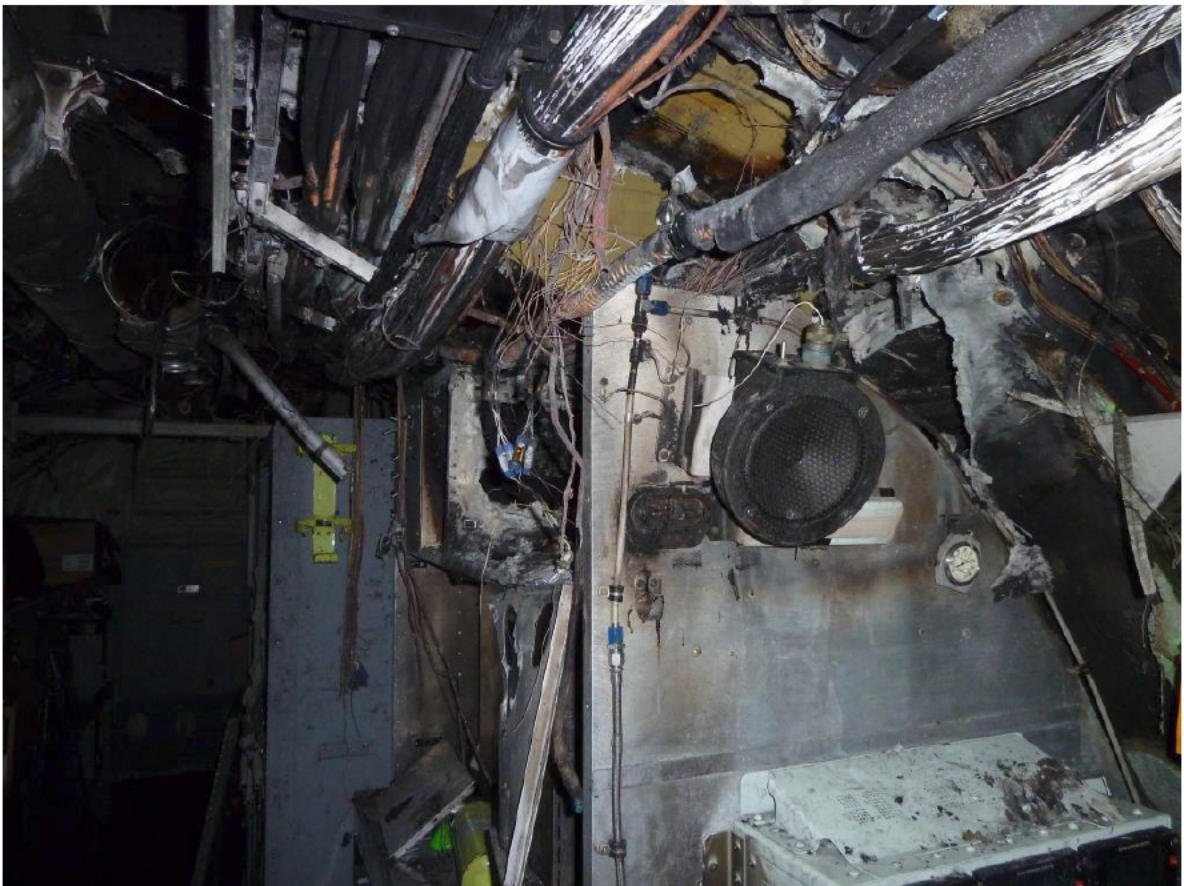
Interior damage caused by the fire. (Image via USAF AIB Report)
