The 55th Wing and a Prayer

A Whistleblower's Story

Chapter 19

Fire! Fire! Fire!

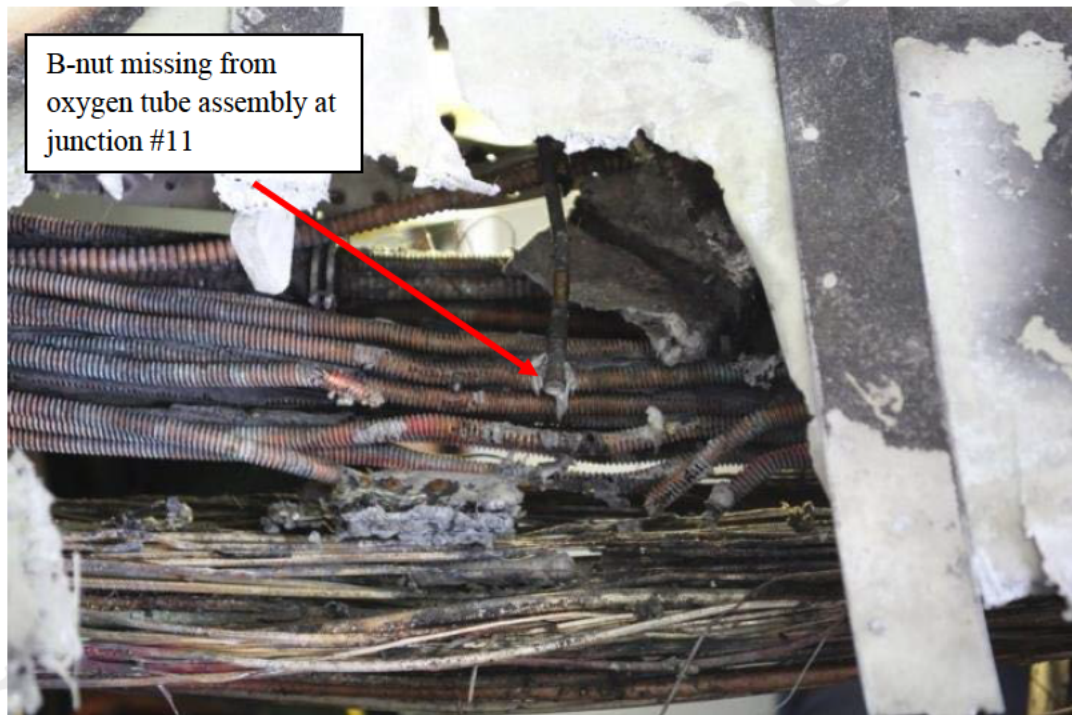
1. The aluminum B-nut connecting a section of oxygen tube to an aluminum fitting at Junction #11, was missing. **Melted fragments** of the missing B-nut were found on the floor behind the galley. (Ref AIB Report J-30)

2. The AIB Report recognized a defect known as “pitting” (i.e., tiny holes or “pits”) around the oxygen tube assembly at junction #11. A substantial section of the report was dedicated to identifying the type of pitting. This particular type of pitting is caused by electrical arcing rather than corrosion. (Ref. AIB Report J-37 & J-38)
3. The AIB Report determined that several under torqued oxygen line B-nut fittings in the area of the galley were leaking, including that of junction #11. (AIB Report Tab J-9).
4. Junction #11 is located in an area surrounded by a large number of tightly bound coax cables, electrical wires, insulation, plastics, and common aircraft hardware.

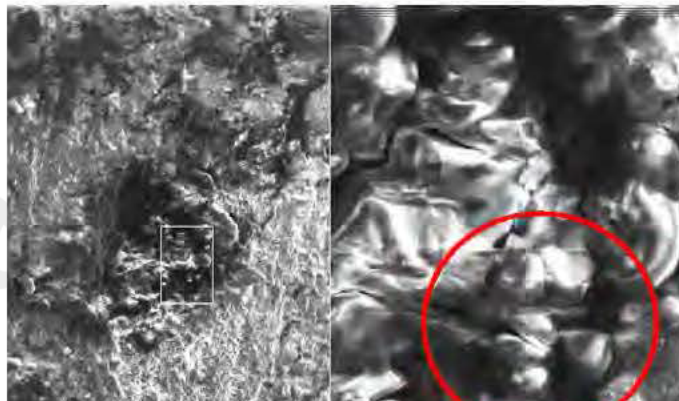
The AIB Report did not consider the above-mentioned electrical system anomalies. Likewise, the AIB Report ignored the ‘electric arcing’ that caused tiny pits to form in the oxygen tube at junction #11. The AIB Report did not discuss the physics behind an electric arc, such as voltage, conditioned cabin air, cabin pressure, and trace gasses within an RC-135. To be direct, the AIB Report failed to consider electrical arcing at junction #11, as a possible source of ignition.

Figure 26: Evidence of pitting on junction #11 tube adjacent to sleeve after cleaning by acetate replication. Similar to the sleeve, the pitting was more prevalent on one side of the tube. A secondary electron image at the bottom of the figure shows nodular formations, circled in red, in the pit. The nodular formations are consistent with melting. Melting damage was localized in the pitted features. (Ref Tab J-38)

Adding the unresolved electrical system discrepancies into the equation, it is conceivable that stray voltage from a compromised electrical circuit bled into the aluminum oxygen tube assembly. Each time the loose B-nut at junction #11 “broke ground”, an electric arc occurred.

Repeated arcing, exasperated by an elevated concentration of oxygen due to the loose B-nut, further damaged the oxygen tube, possibly forming a small pinhole. The damaged oxygen tube, and/or the loose B-nut at junction #11, created a localized high velocity flow of pure oxygen gas. The pure oxygen gas became ionized by the persistent electric arc, resulting in a spontaneous oxygen plasma arc similar to that used in a modern-day [oxygen plasma cutting torch](#).
