# The 55<sup>th</sup> Wing and a Prayer

A Whistleblower's Story

## Chapter 19

### **Fire! Fire! Fire!**

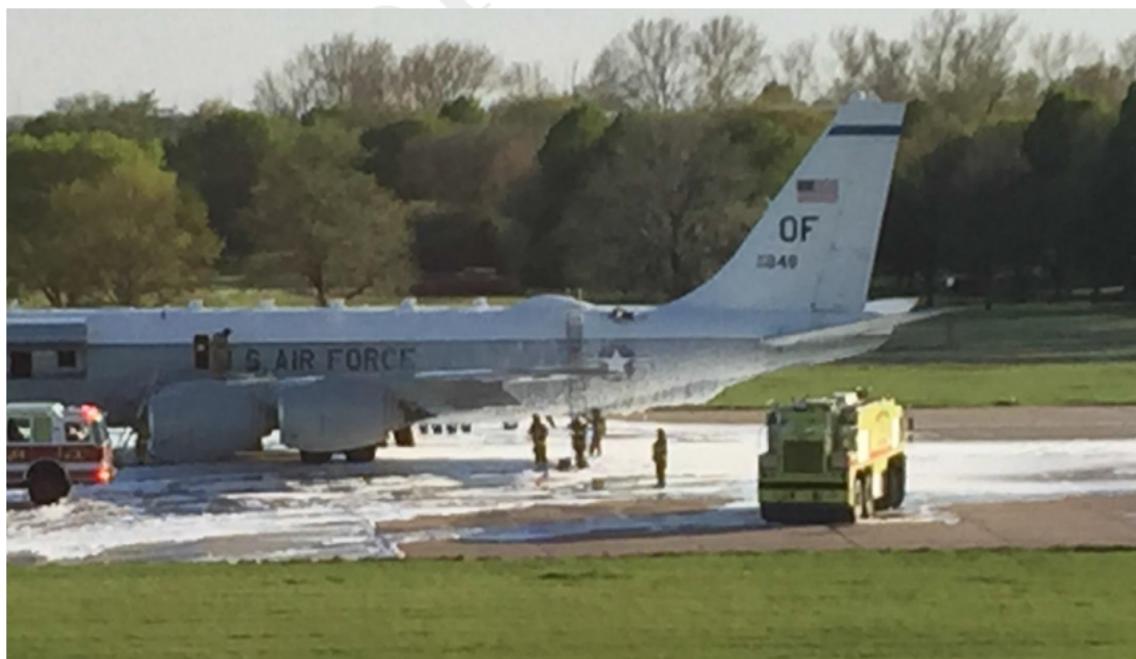
The pilots and all 27 mission crewmembers safely evacuated. Fire crews arrived and extinguished the flames. The fire burned a hole through the upper fuselage above the rear galley area, causing structural damage and damage to aircraft control and mission related systems. Four crewmembers received treatment for minor smoke inhalation. The aircraft was out of service for over two years.

The Accident Investigation Board (AIB) findings determined that the cause of the mishap was a leak in the high-pressure oxygen system due to poor assembly of the system tubing during the aircraft's previous overhaul at Depot. [Click here for the final report \(1341 pages\)](#). It is widely believed that the aircraft would have crashed had it left the ground.

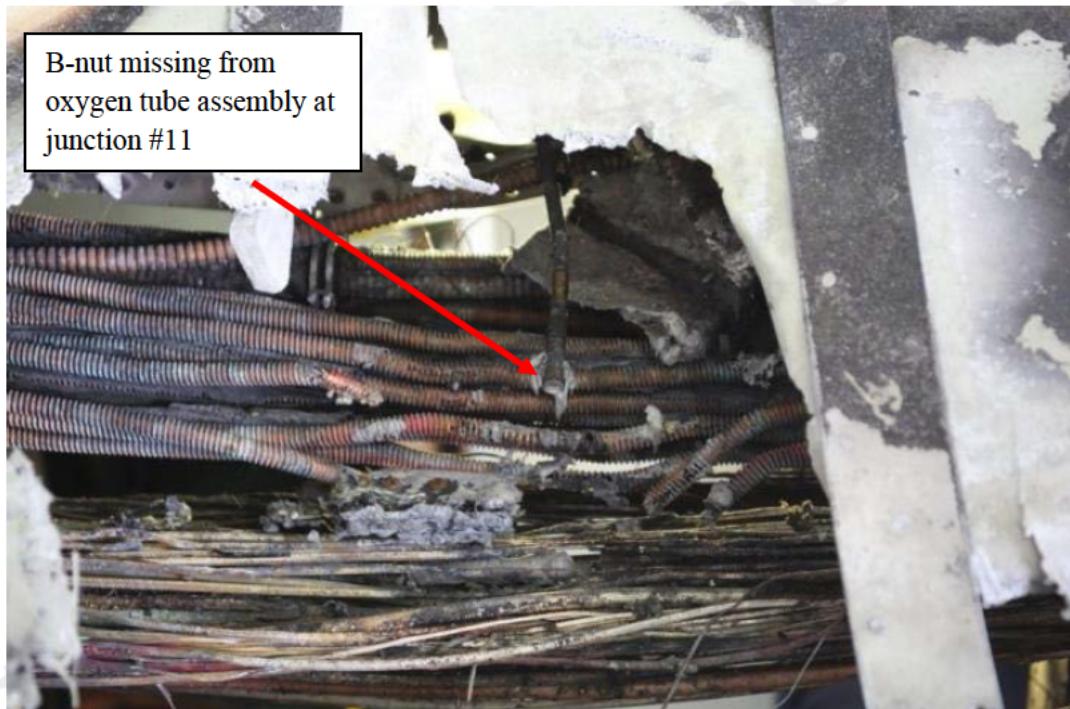
1. The aluminum B-nut connecting a section of oxygen tube to an aluminum fitting at Junction #11, was missing. Melted fragments of the missing B-nut were found on the floor behind the galley. (Ref AIB Report J-30)

2. The AIB Report recognized a defect known as “pitting” (i.e., tiny holes or “pits”) around the oxygen tube assembly at junction #11. A substantial section of the report was dedicated to identifying the type of pitting. This particular type of pitting is caused by electrical arcing rather than corrosion. (Ref. AIB Report J-37 & J-38)
3. The AIB Report determined that several under torqued oxygen line B-nut fittings in the area of the galley were leaking, including that of junction #11. (AIB Report Tab J-9).
4. Junction #11 is located in an area surrounded by a large number of tightly bound coax cables, electrical wires, insulation, plastics, and common aircraft hardware.

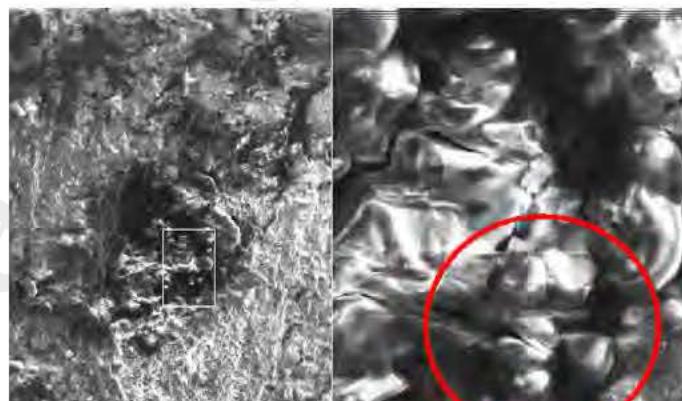
The AIB Report did not consider the above-mentioned electrical system anomalies. Likewise, the AIB Report ignored the ‘electric arcing’ that caused tiny pits to form in the oxygen tube at junction #11. The AIB Report did not discuss the physics behind an electric arc, such as voltage, conditioned cabin air, cabin pressure, and trace gasses within an RC-135. To be direct, the AIB Report failed to consider electrical arcing at junction #11, as a possible source of ignition.

Figure 26: Evidence of pitting on junction #11 tube adjacent to sleeve after cleaning by acetate replication. Similar to the sleeve, the pitting was more prevalent on one side of the tube. A secondary electron image at the bottom of the figure shows nodular formations, circled in red, in the pit. The nodular formations are consistent with melting. Melting damage was localized in the pitted features. (Ref Tab J-38)

Adding the unresolved electrical system discrepancies into the equation, it is conceivable that stray voltage from a compromised electrical circuit bleed into the aluminum oxygen tube assembly. Each time the loose B-nut at junction #11 “broke ground”, an electric arc occurred.

Repeated arcing, exasperated by an elevated concentration of oxygen due to the loose B-nut, further damaged the oxygen tube, possibly forming a small pinhole. The damaged oxygen tube, and/or the loose B-nut at junction #11, created a localized high velocity flow of pure oxygen gas. The pure oxygen gas became ionized by the persistent electric arc, resulting in a spontaneous oxygen plasma arc similar to that used in a modern-day [oxygen plasma cutting torch](#).

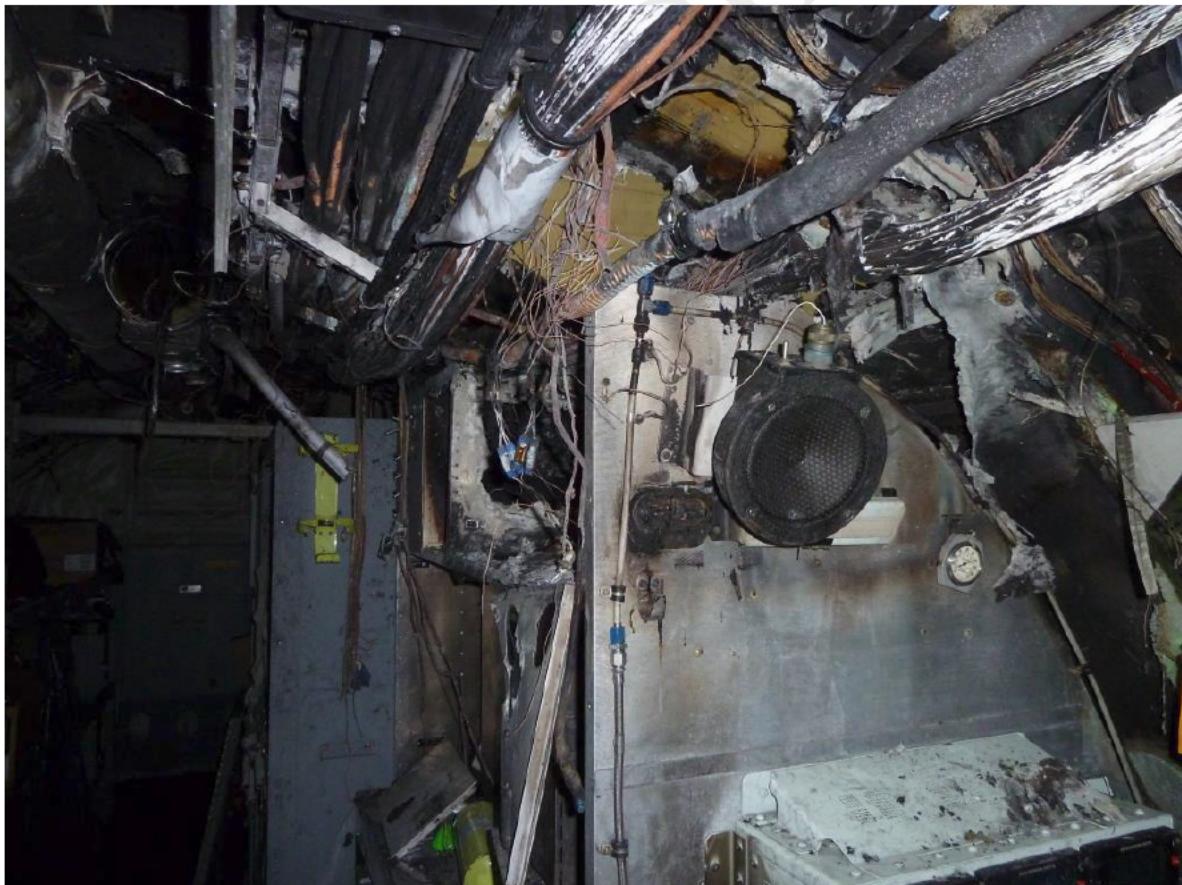
In part, the [fire onboard aircraft RC-135V 64-14848](#) was a result of negligent aircraft maintenance practices passed down through the generations.

Interior damage caused by the fire. (Image via USAF AIB Report)
