# The 55<sup>th</sup> Wing and a Prayer

A Whistleblower's Story

## Chapter 19

### **Fire! Fire! Fire!**

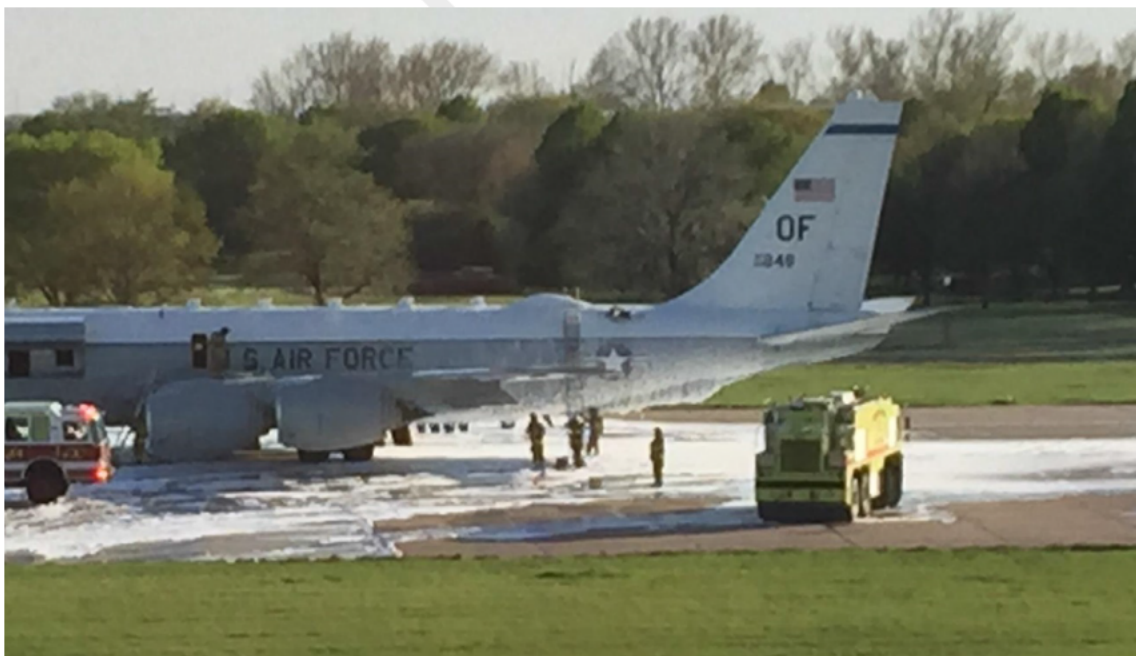
The pilots and all 27 mission crewmembers safely evacuated. Fire crews arrived and extinguished the flames. The fire burned a hole through the upper fuselage above the rear galley area, causing structural damage and damage to aircraft control and mission-related systems. Four crewmembers received treatment for minor smoke inhalation. The aircraft was out of service for over two years.

The Accident Investigation Board (AIB) findings determined that the cause of the mishap was a leak in the high-pressure oxygen system due to poor assembly of the system tubing during the aircraft's previous depot level overhaul. [Click here for the final report \(1341 pages\)](#). It is widely believed that the aircraft would have crashed had it left the ground.

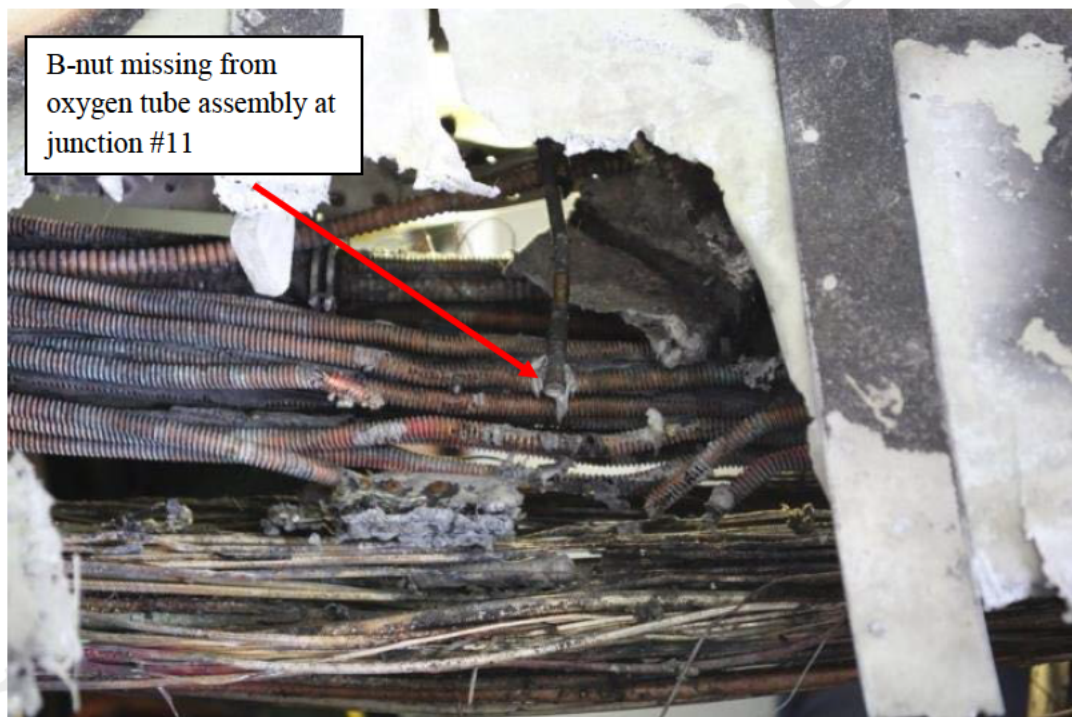
1. The aluminum B-nut connecting a section of oxygen tube to an aluminum fitting at Junction #11, was missing. **Melted fragments** of the missing B-nut were found on the floor behind the galley. (Ref AIB Report J-30)

2. The AIB recognized a defect known as “pitting” (i.e., tiny holes or “pits”) around the oxygen tube assembly at junction #11. A substantial section of the report was dedicated to identifying the type of pitting. This particular type of pitting is caused by electrical arcing rather than corrosion. (Ref. AIB Report J-37 & J-38)
3. The AIB determined that several under torqued oxygen line B-nut fittings in the area of the galley were leaking, including that of junction #11. (AIB Report Tab J-9).
4. Junction #11 is located in an area surrounded by a large number of tightly bound coax cables, electrical wires, insulation, plastics, and common aircraft hardware.

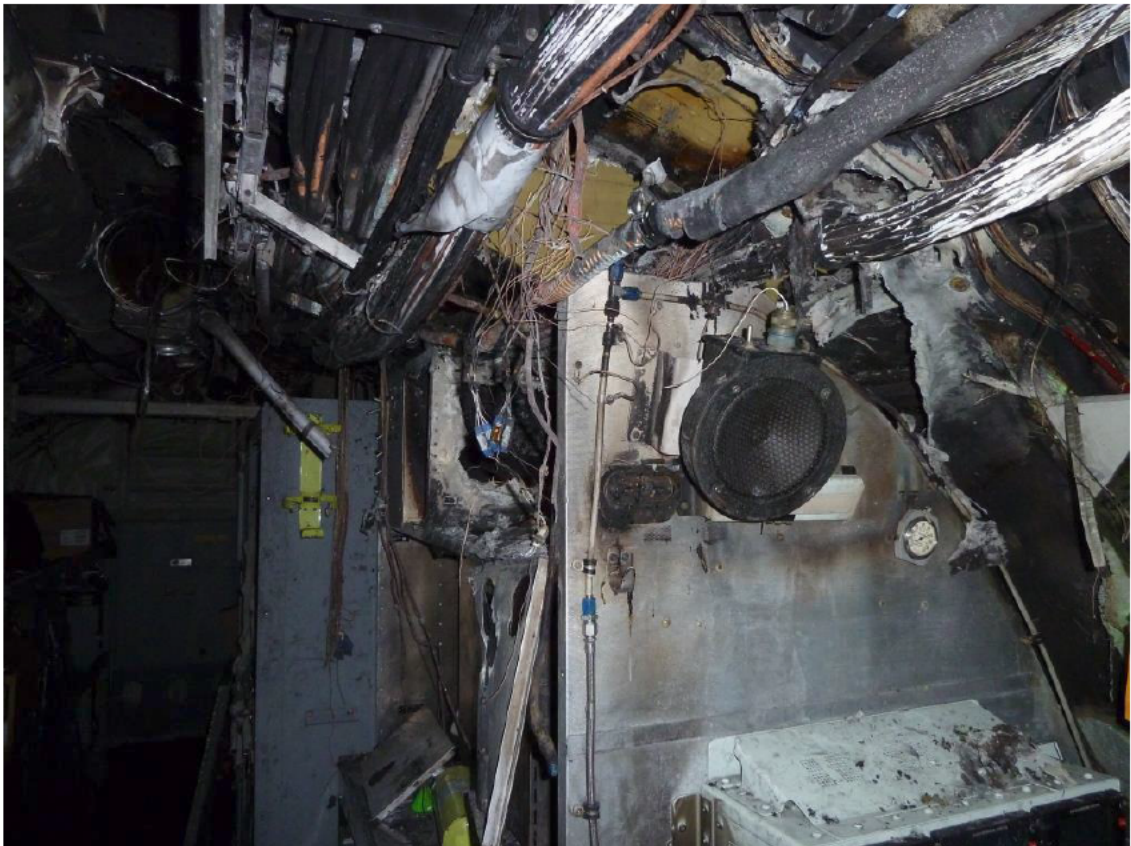
Interior damage caused by the fire. (Image via USAF AIB Report)
