Wesley Szanyi
226 Timbercreek Pines Circle
Winter Garden, FL 34787

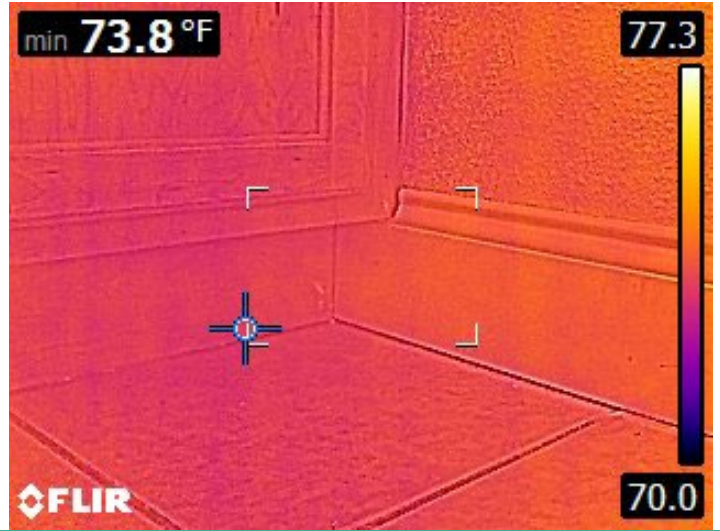
Wallboard/baseboard replaced, continued - adjacent to den

- Remove the replaced wallboard and baseboards, and assess the underlying building materials for damage. If damage is discovered, with photographic proof, remove as needed.

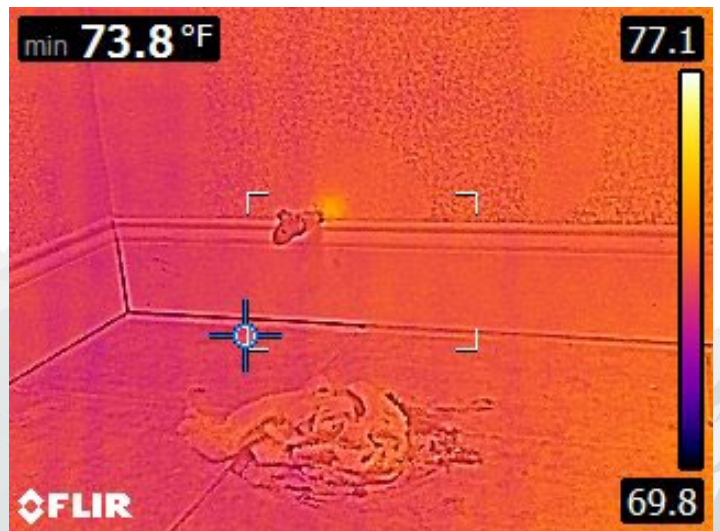
FLIR camera detected no thermal anomalies

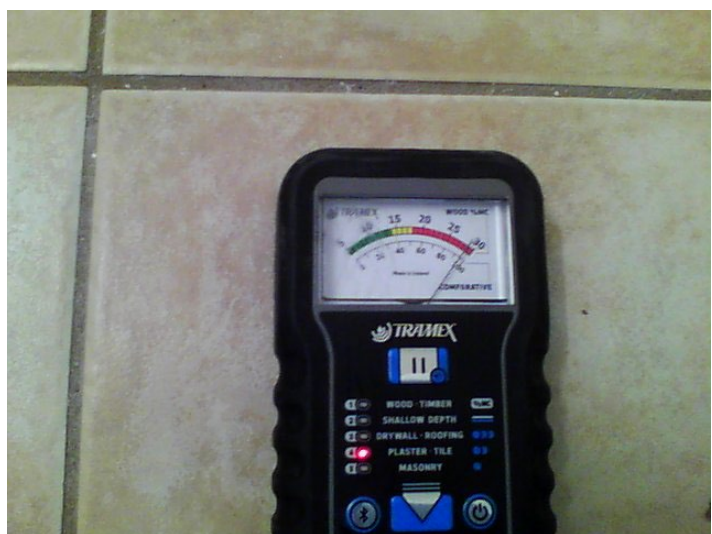
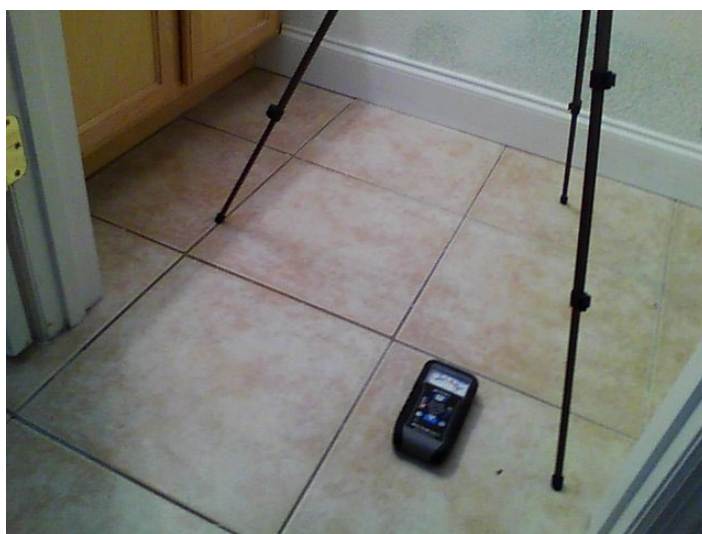
Tile floor moisture reading 98%

- Remove the affected bathroom/hall/den tile flooring, starting near the walls of the bathroom and wallboards adjacent to the bathroom, continuing two square feet past damage or wetness.

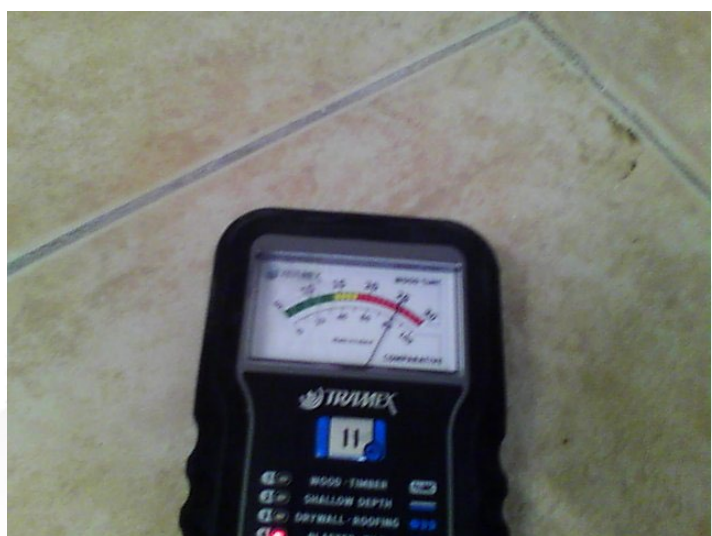
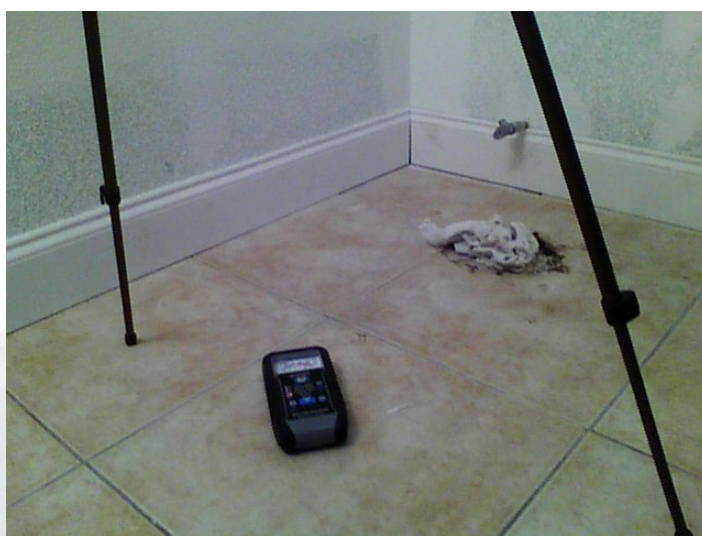
Tile floor moisture reading 80%

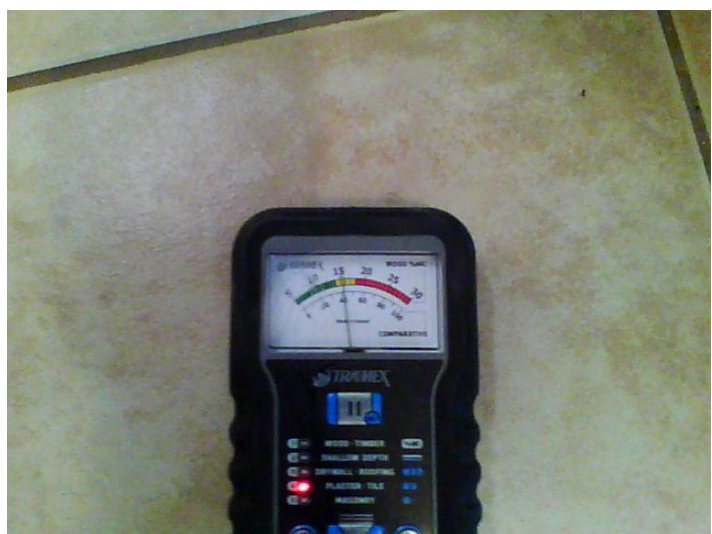
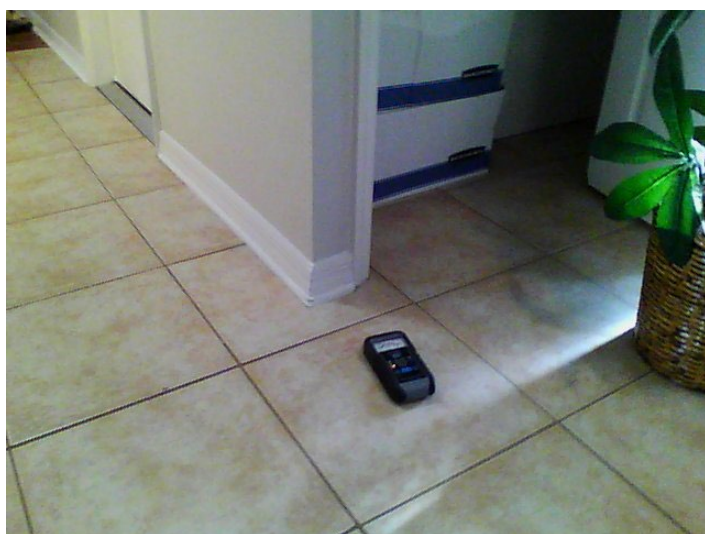
Tile floor moisture reading 40%

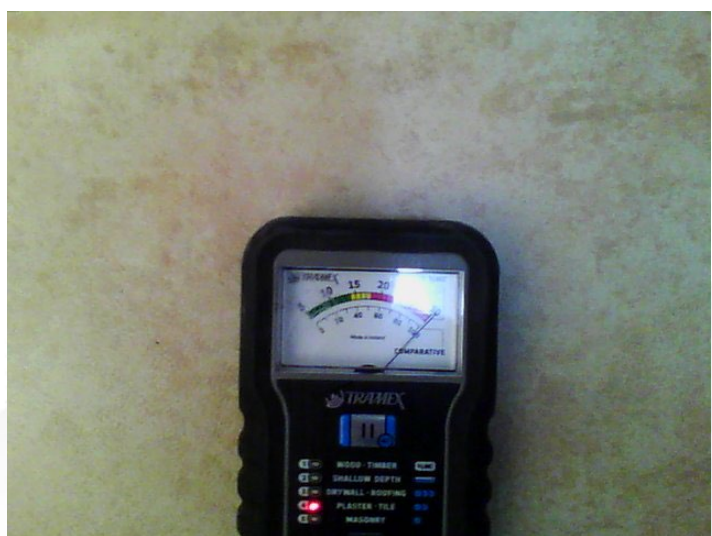
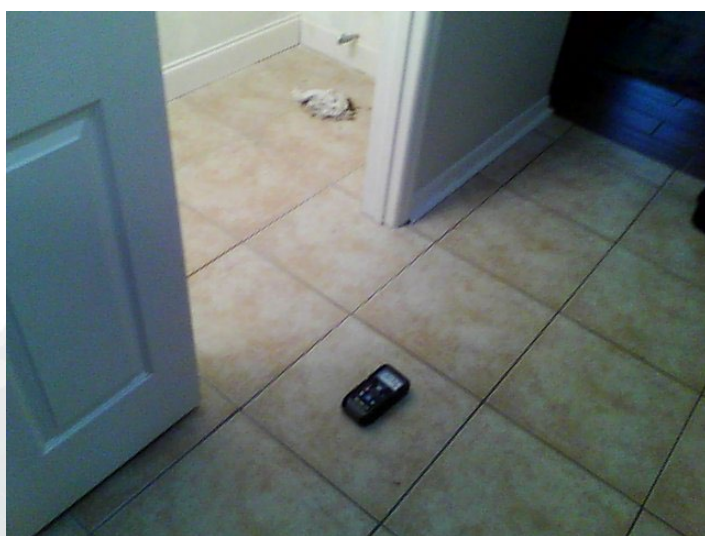
Tile floor moisture reading 100%

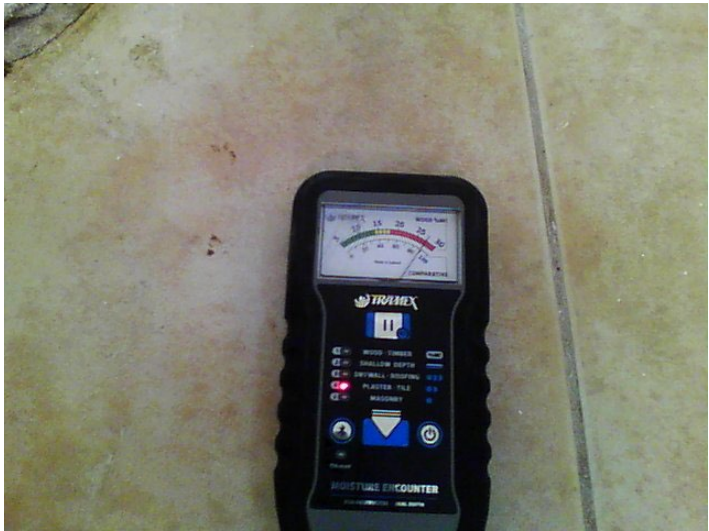
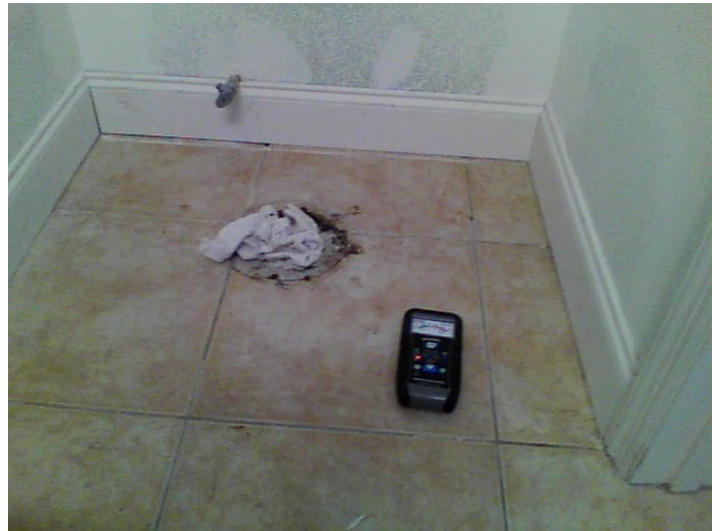
Tile floor moisture reading 90%

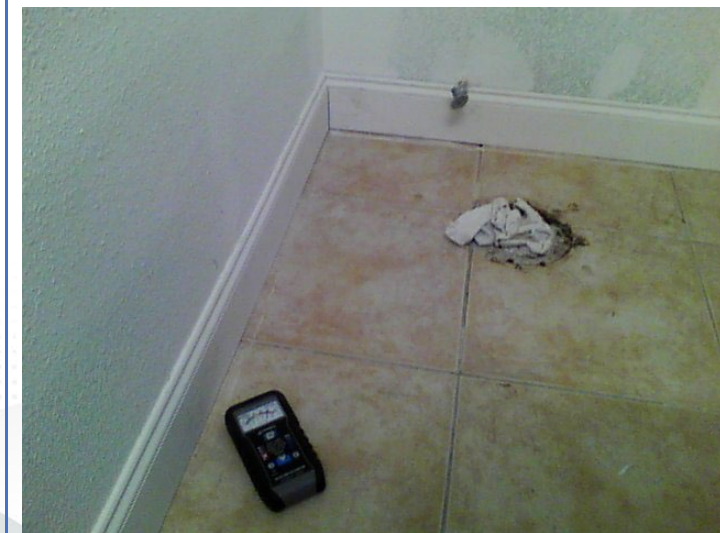
Tile floor moisture reading 80%

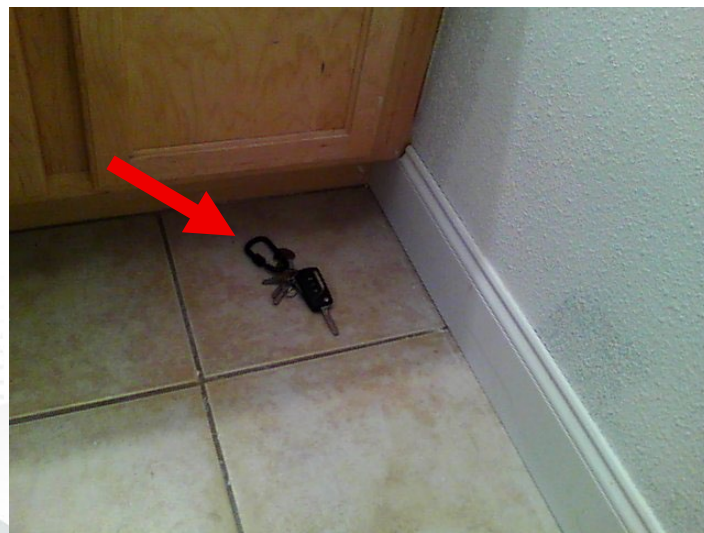
Hollow tile floor detected where keys lay

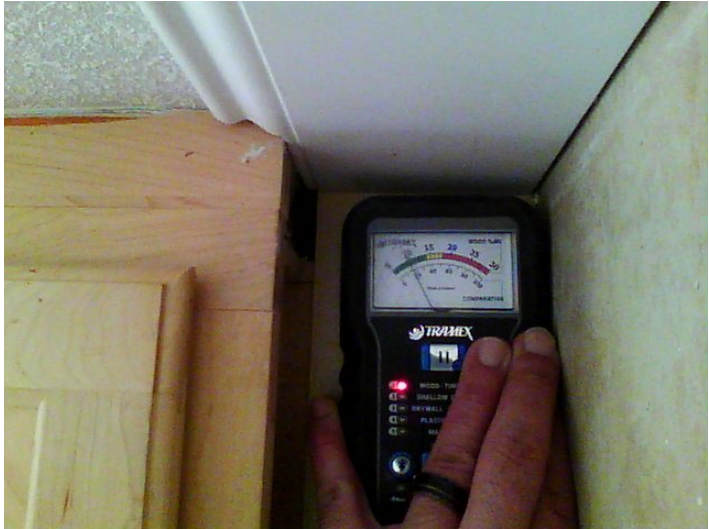
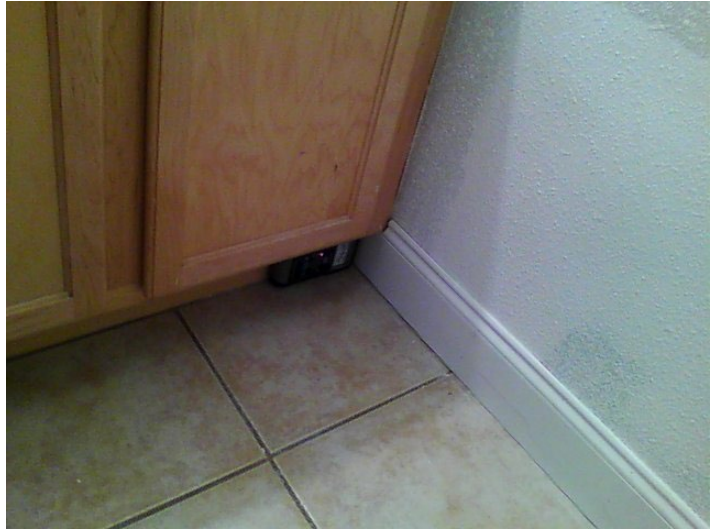
Vanity moisture reading 20%

- Detach the bathroom vanity, and assess the vanity backing and nearby building materials for further damage. If damage is discovered, with photographic proof, remove as needed.

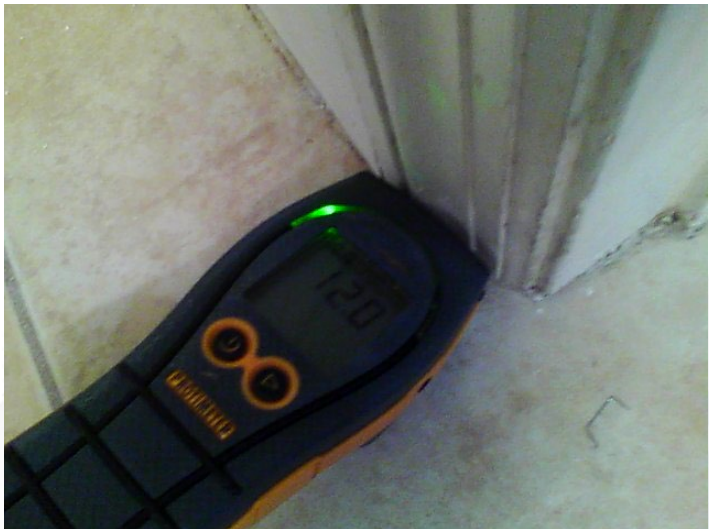
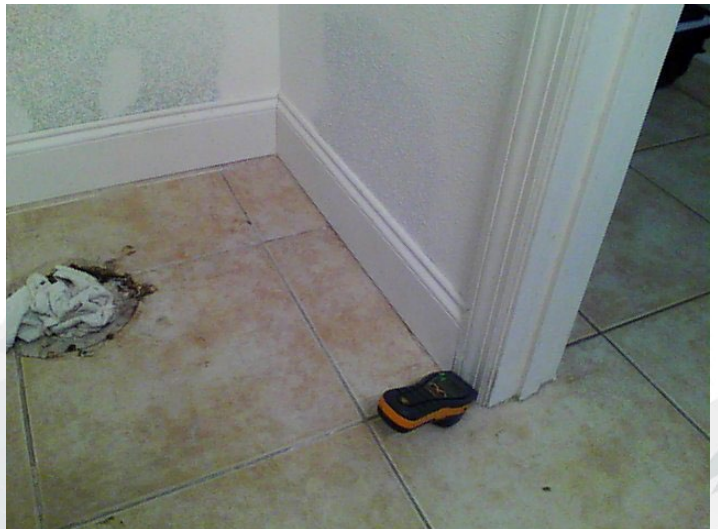
Door trim moisture reading 12.0%

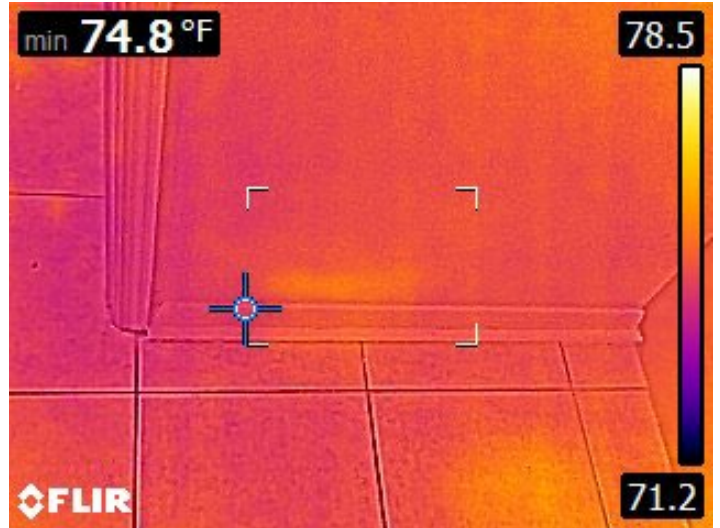
Visible hallway baseboard separation and staining adjacent to bathroom

- Remove the affected hallway and den wallboards and baseboards adjacent to the bathroom, continuing two square/linear feet past damage, discoloration, or wetness.

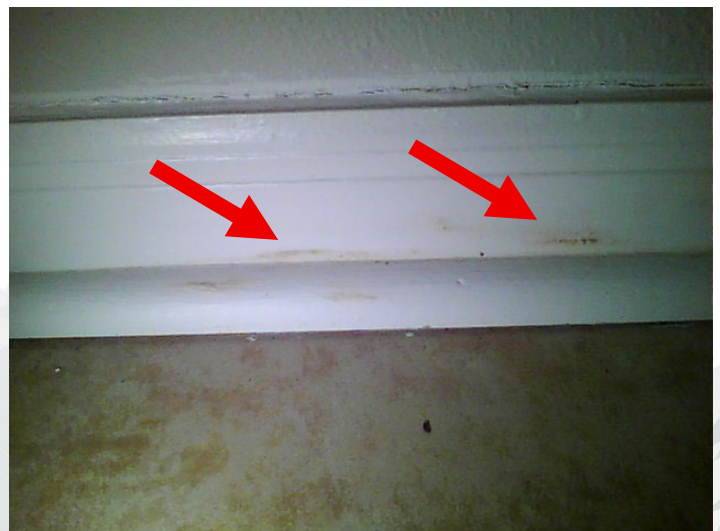
Visible Hallway Baseboard Staining

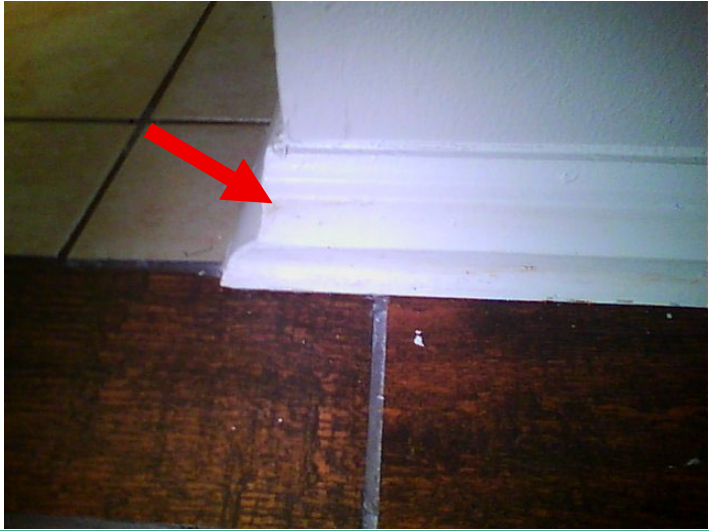
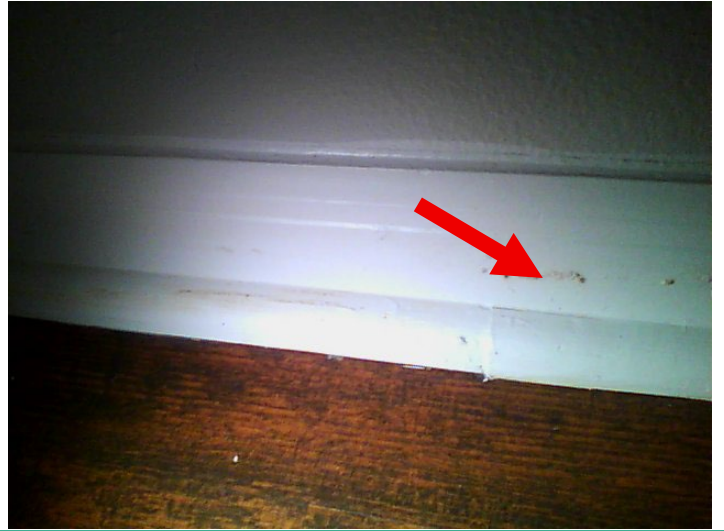
Den baseboard adjacent to hall bath staining and separation, continued

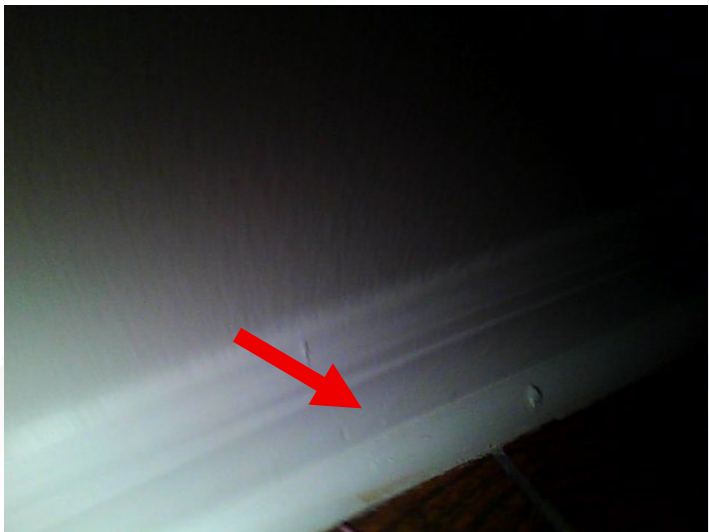
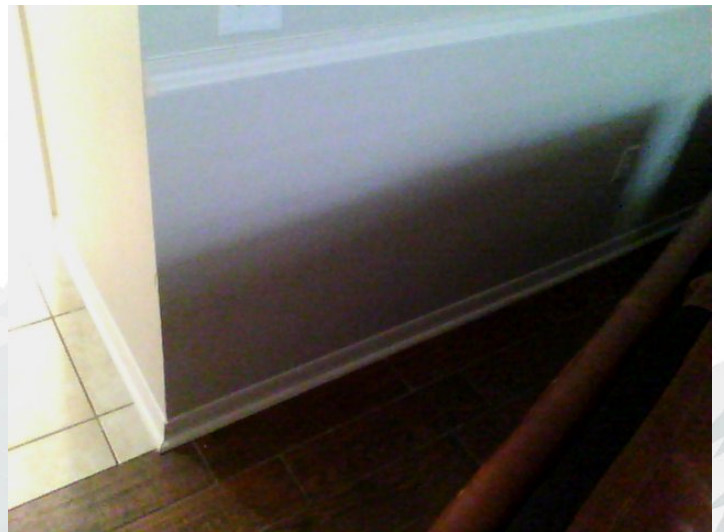
Staining continued on baseboard adjacent to bathroom

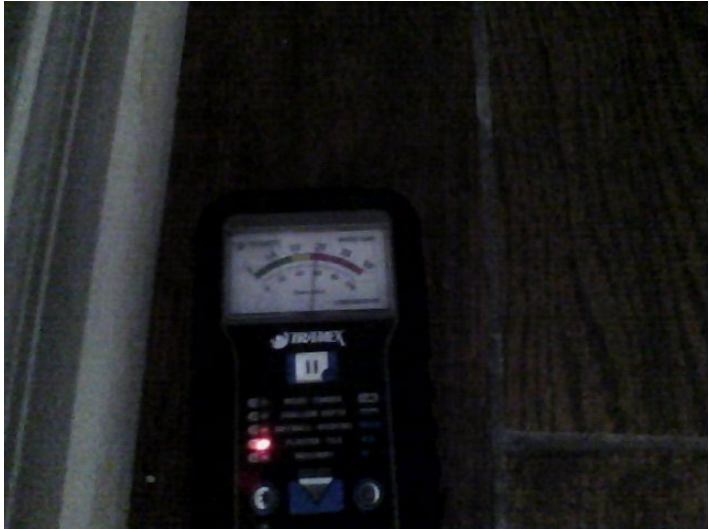
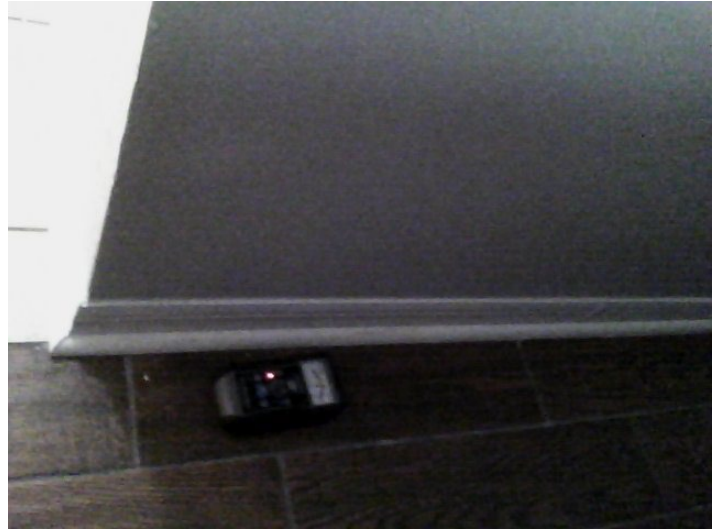
Den tile floor moisture reading 59%

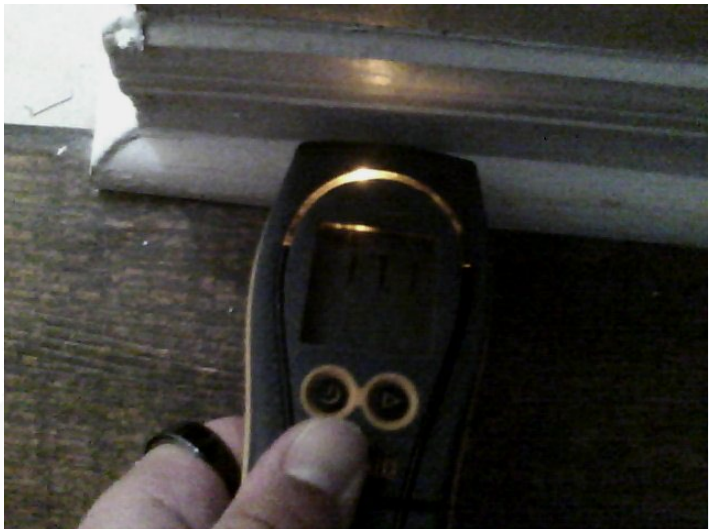
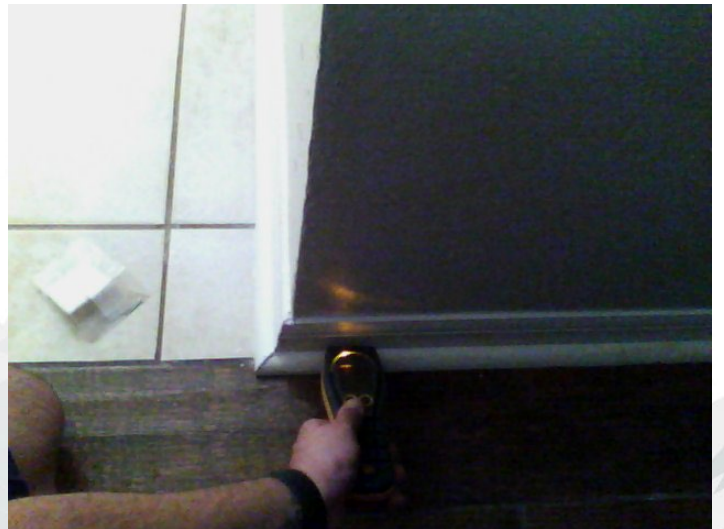
Baseboard moisture reading 17.1%

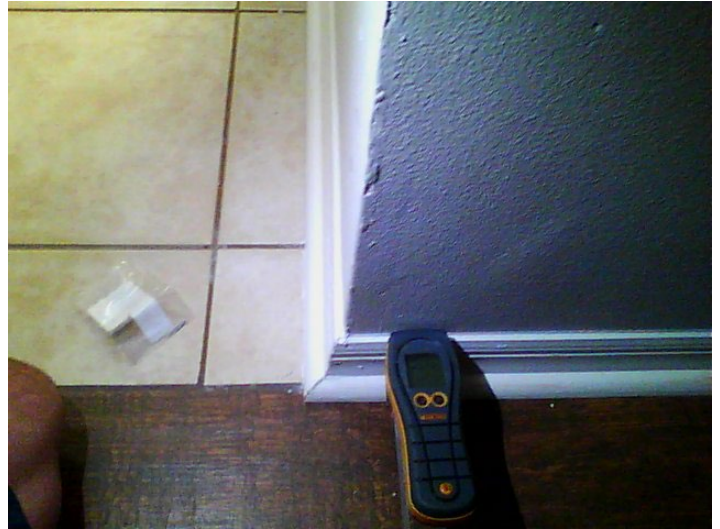
Drywall moisture reading <7%

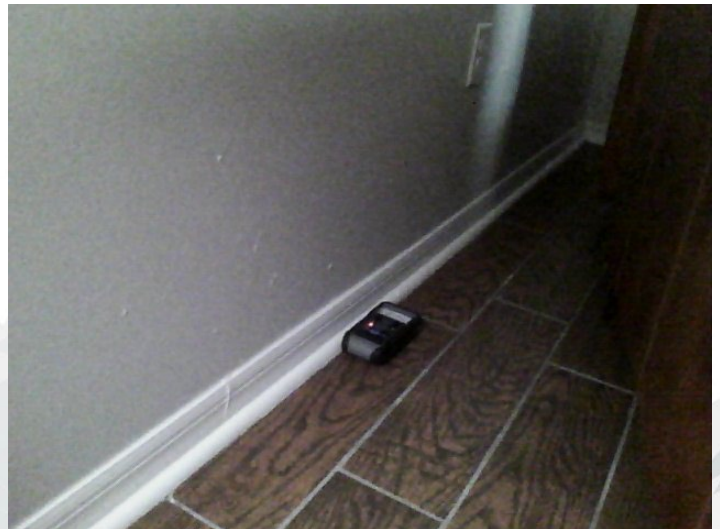
Den tile floor moisture reading 60%

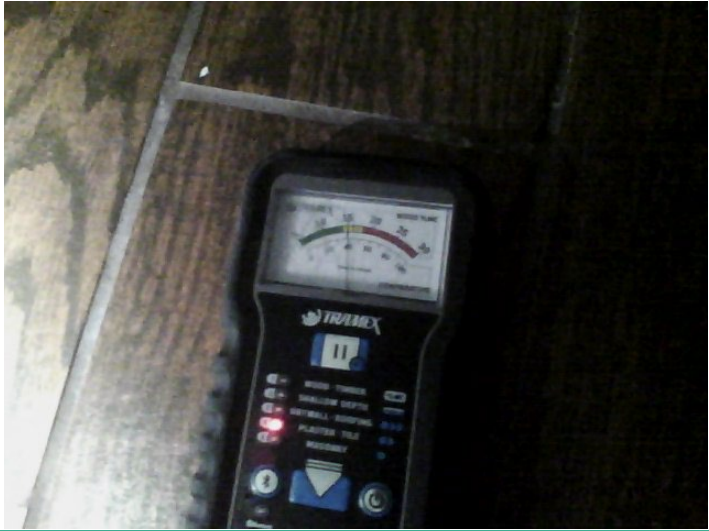
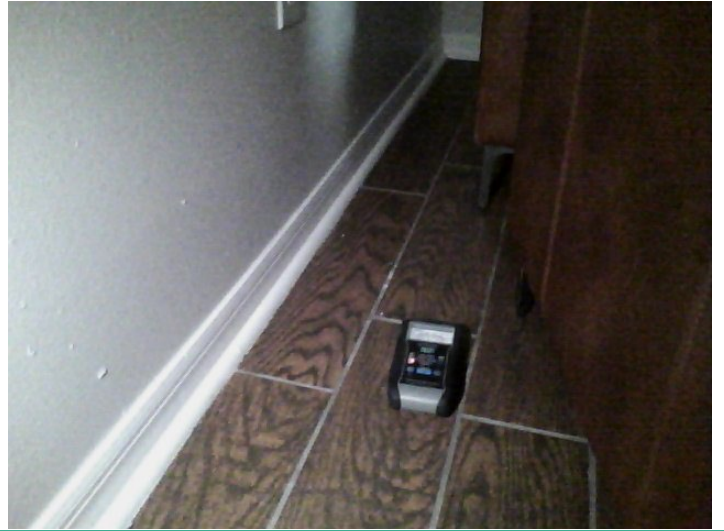
Tile floor moisture reading 40%

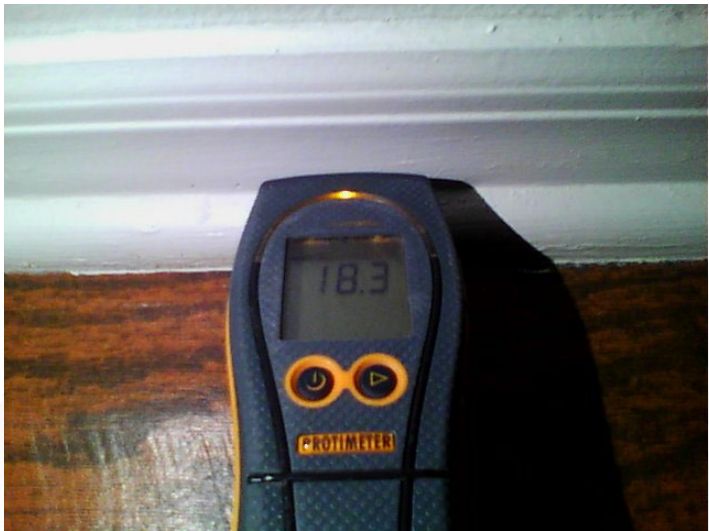
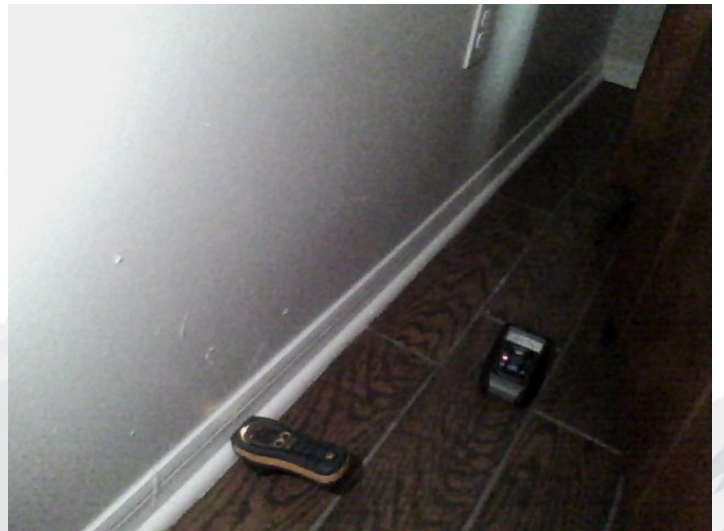
Baseboard moisture reading 18.3%

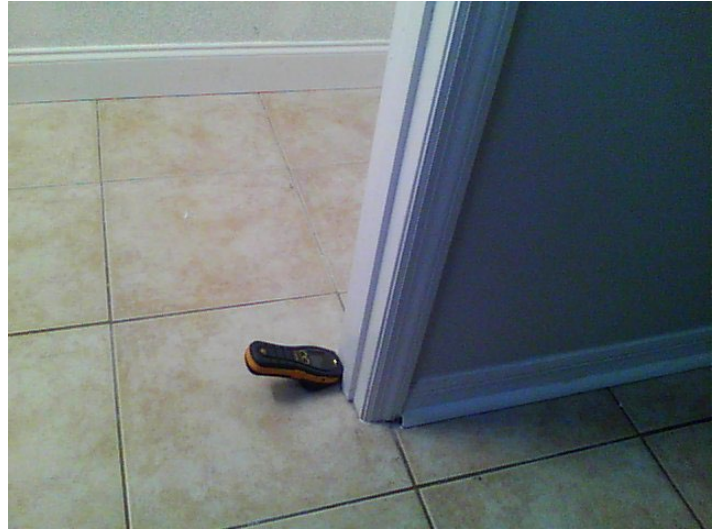
Bathroom door trim moisture reading 17.3%

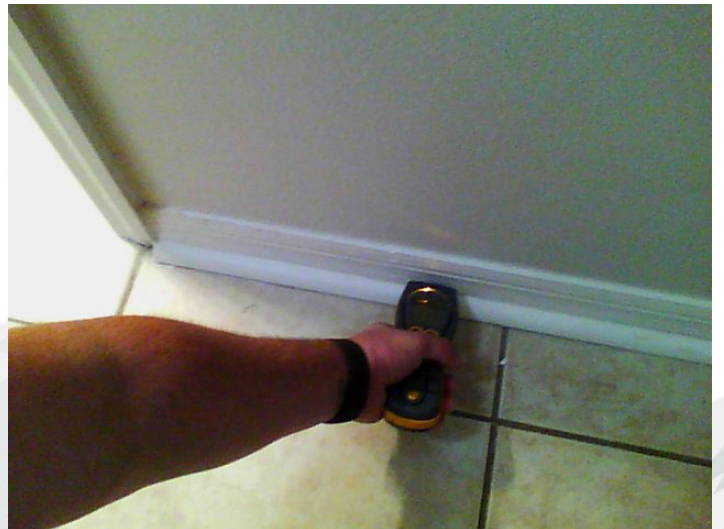
Baseboard moisture reading 17.6%

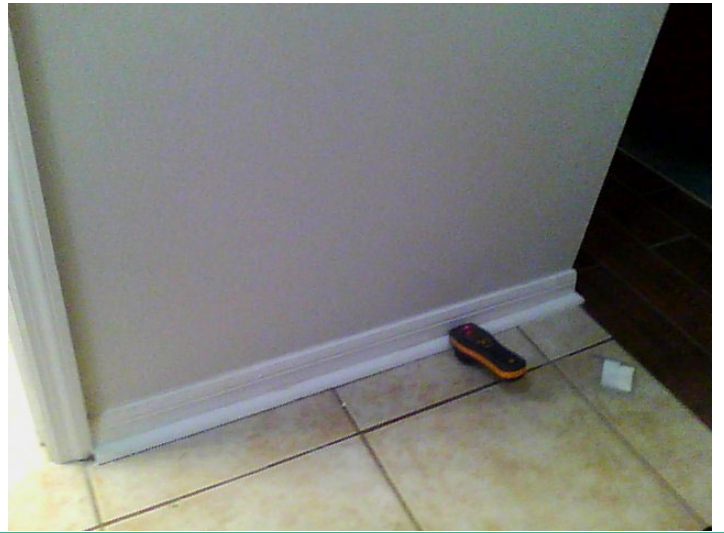
Baseboard moisture reading 20.1%

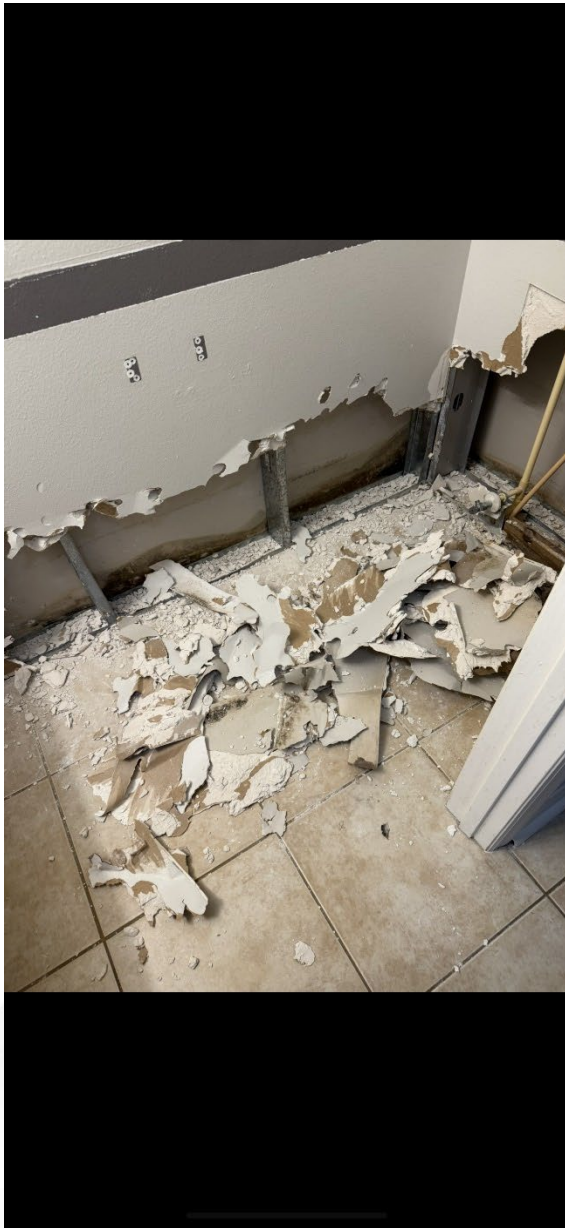
Pictures provided by tenant showed visible damage and suspect growth on wallboard backings of the laundry/den

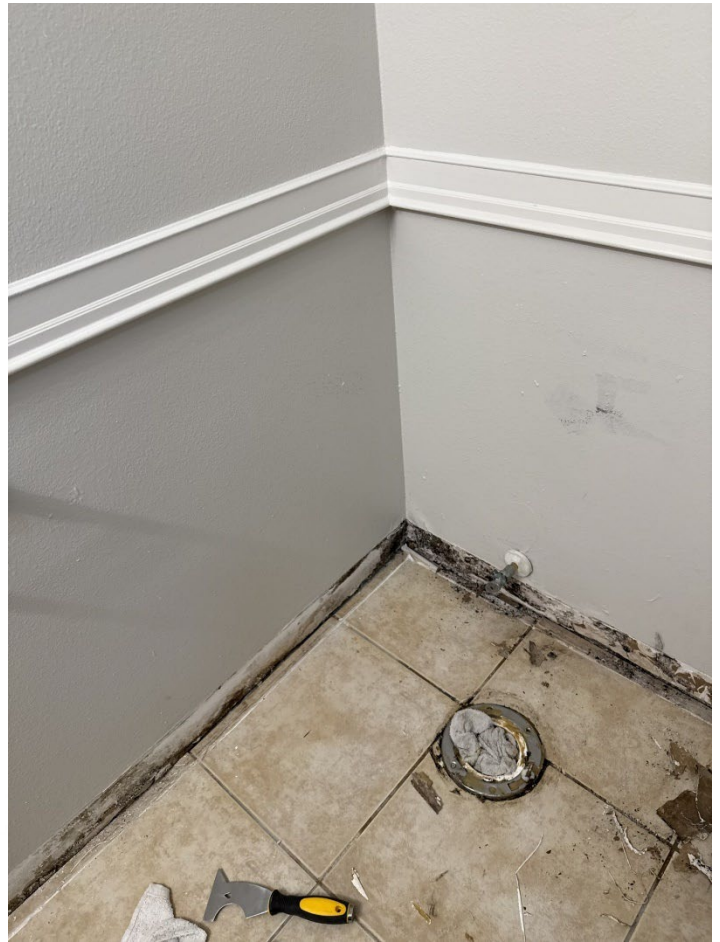
Bathroom wallboard prior to removal showed visible suspect growth near baseboard level

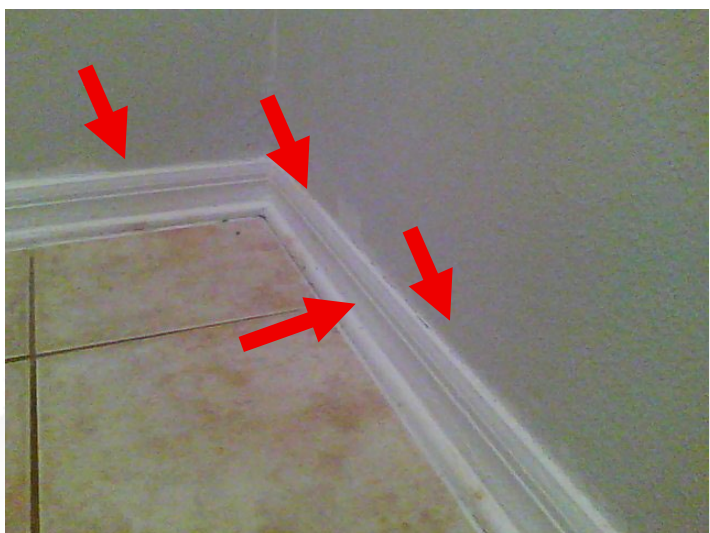
The east and north baseboards showed visible staining and separation, with the north baseboard showing elevated moisture. The tile flooring also showed elevated moisture, with multiple hollow tiles detected. Suspect growth was visible.

North and east baseboards showed visible separation and staining

- Remove the affected wallboards and baseboards adjacent to the hallway bathroom and den, continuing two square/linear feet past damage, discoloration, or wetness.
- Remove the affected tile flooring, starting near the north and east wallboards and continuing two square feet past damage or wetness.
- Remove the affected insulation (if applicable), and assess for further damage.
- Detach all the nearby baseboards, and assess the underlying building materials for further damage. If damage is discovered, with photographic proof, remove as needed.
- Observe the underlying building material for further damage and, with photographic proof, remove as needed.

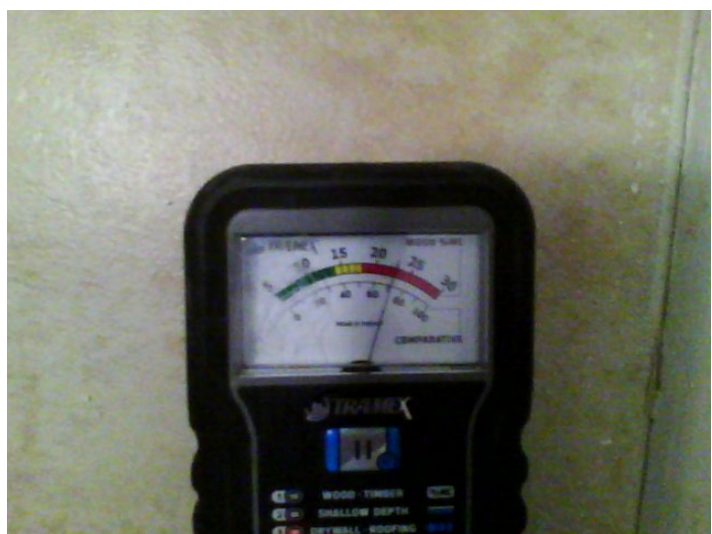
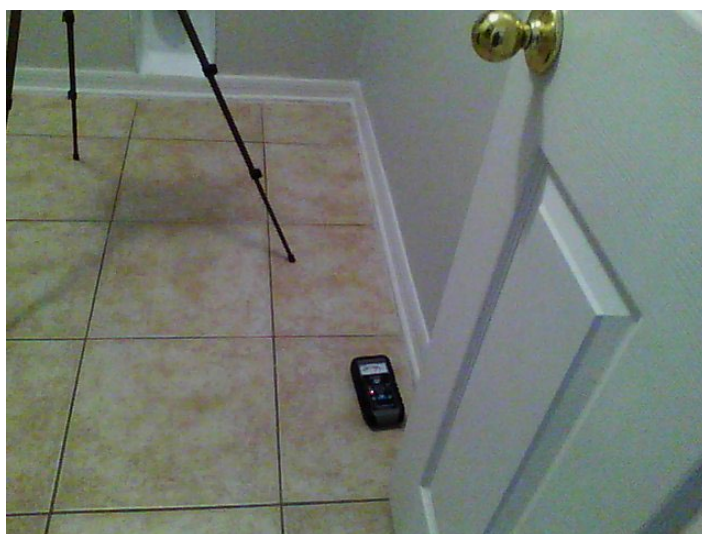
Tile floor moisture reading 70%

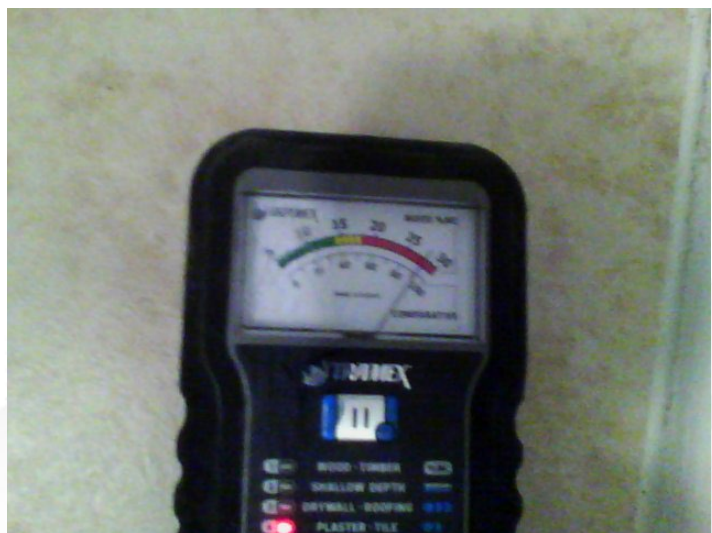
Tile floor moisture reading 91%

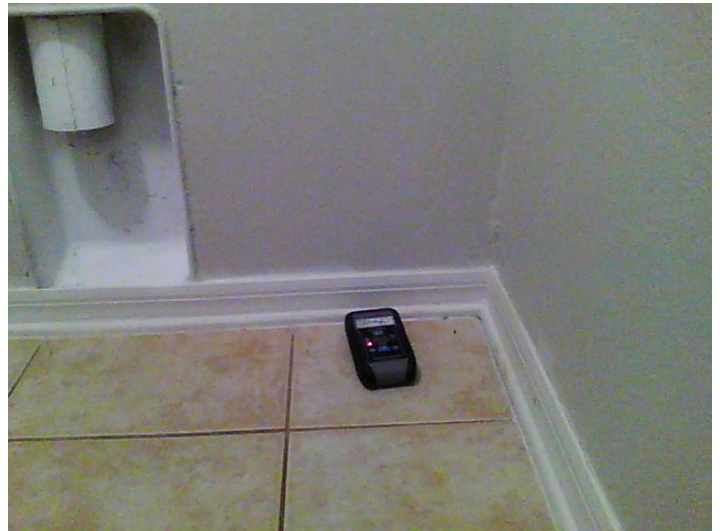
Tile floor moisture reading 81%

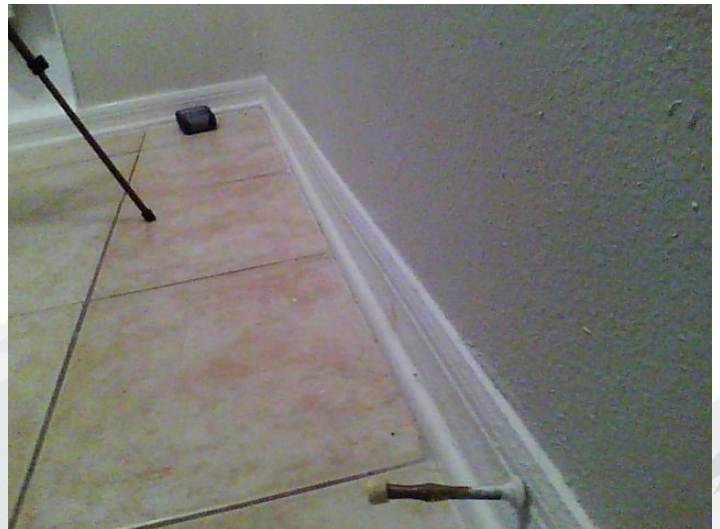
Visible Baseboard staining, up close

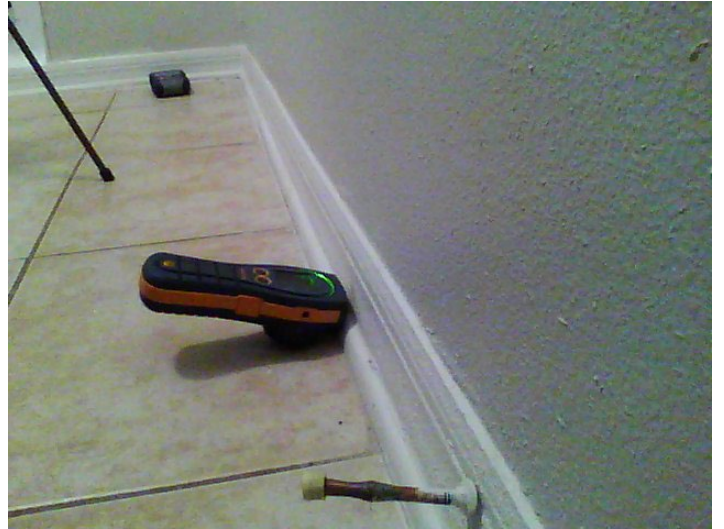
Baseboard moisture reading 13.4%

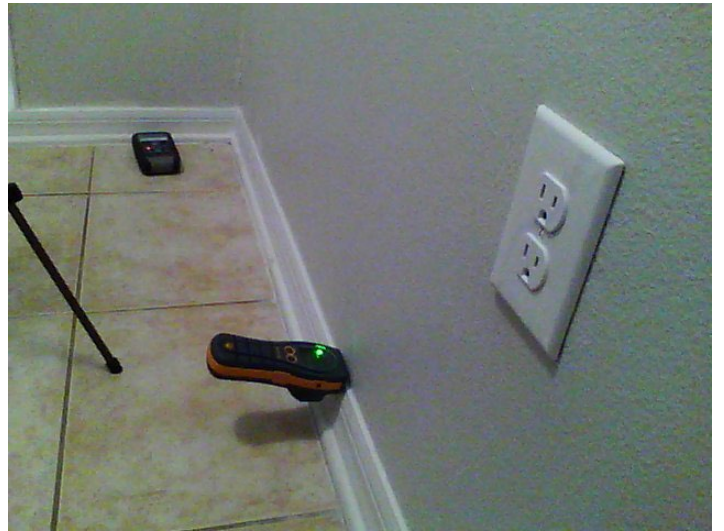
Drywall moisture reading 10.4%

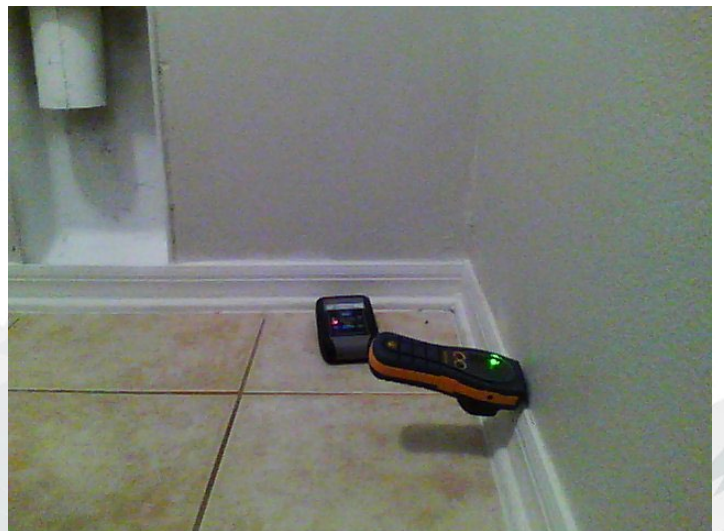
Drywall moisture reading 9.5%

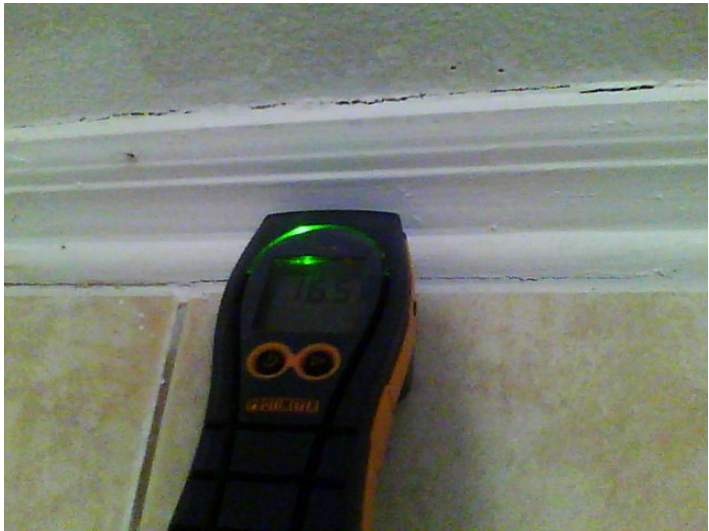
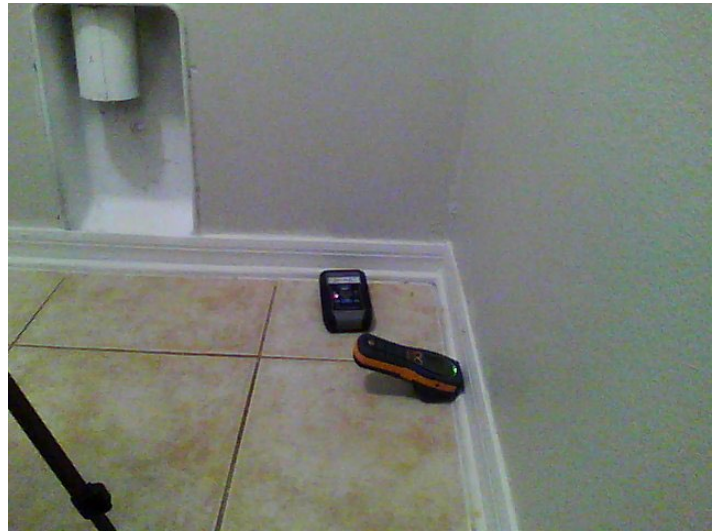
Baseboard moisture reading 16.5%

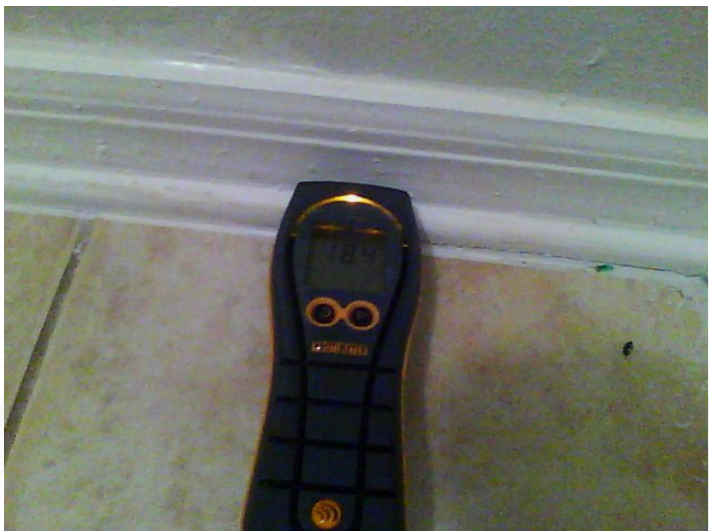
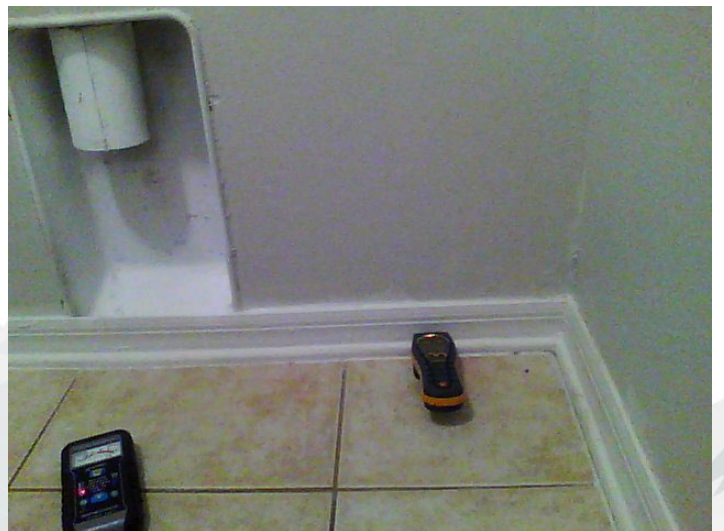
North baseboard moisture reading 18.4%

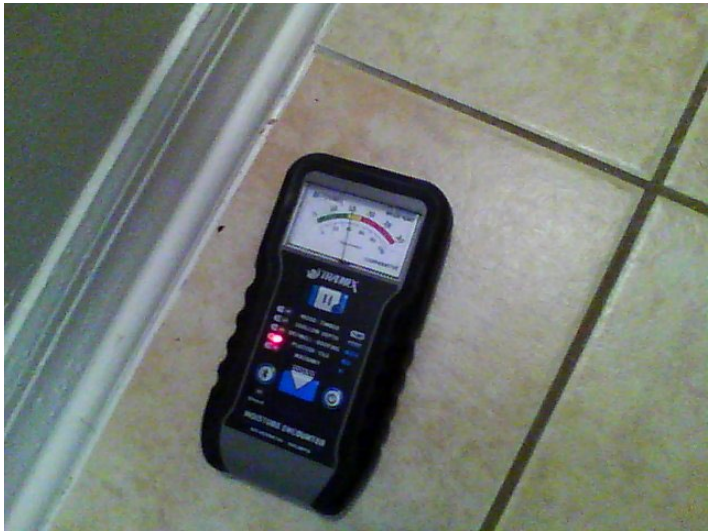
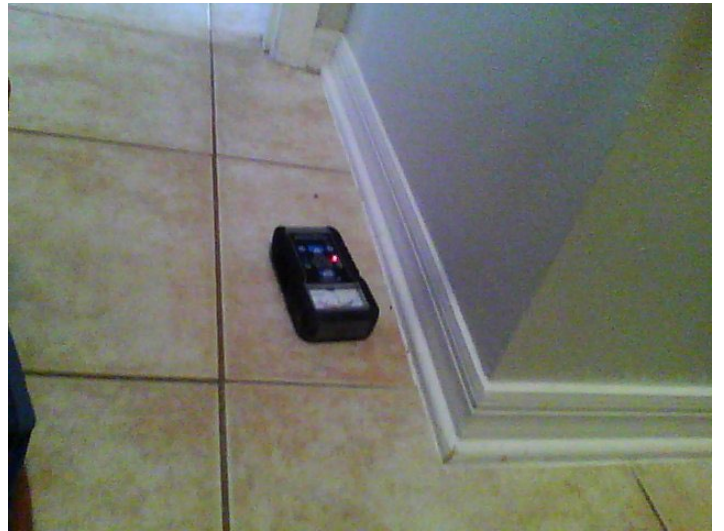
Tile floor moisture reading 40%

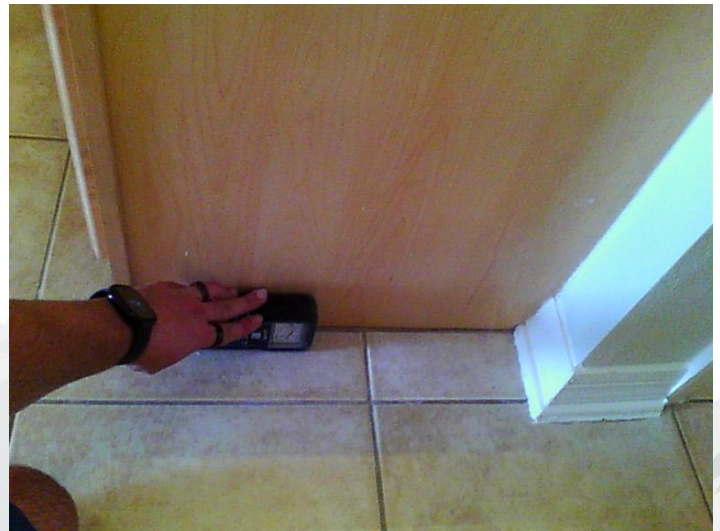
Vanity moisture reading 22%

- Detach the vanity, and assess the vanity backing and underlying building materials for damage. If damage is discovered, with photographic proof, remove as needed.

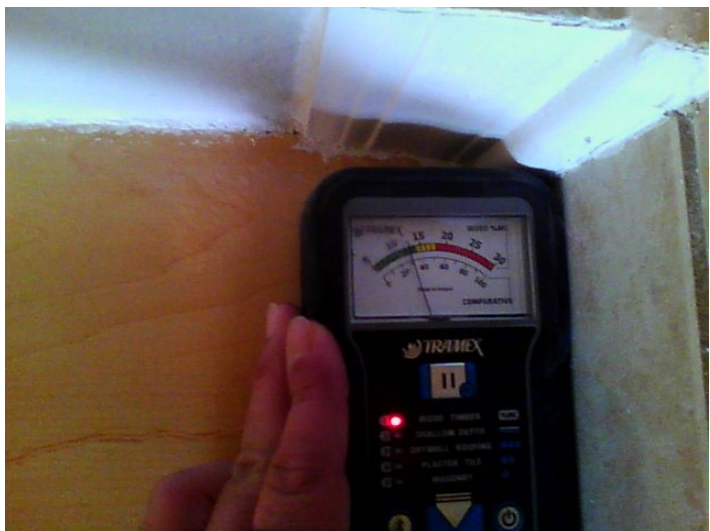
Vanity moisture reading 30%
