Wesley Szanyi
226 Timbercreek Pines Circle
Winter Garden, FL 34787

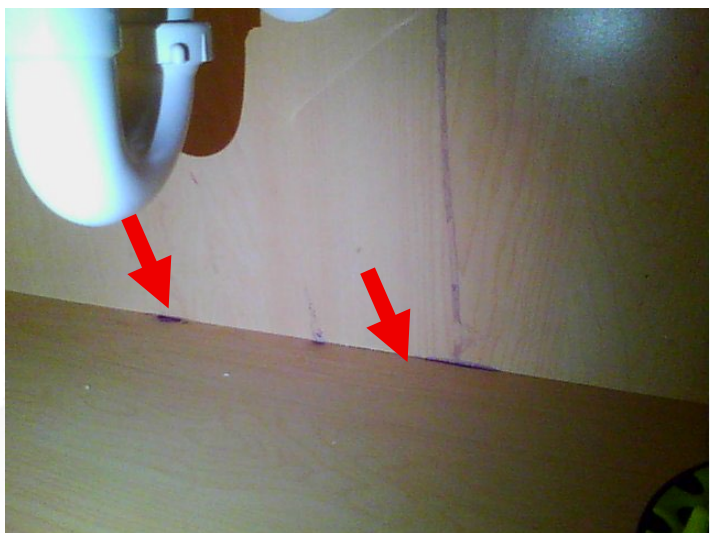
Peace of mind testing was requested. In the master bathroom, the vanity showed visible bloating in multiple areas, with no elevated moisture detected at the time of the assessment. The bedroom flooring showed visible warping and crowning in multiple areas as well. In the A/C closet, the A/C coils post filter showed visible suspect growth. Suspect growth and debris were also visible on the air intake HVAC A/C plenum, entering the attic and ceiling of the A/C closet.

Vanity showed multiple areas of visible bloating

- Detach the vanity, and assess the vanity backing and underlying building materials for damage. If damage is discovered, with photographic proof, remove as needed.

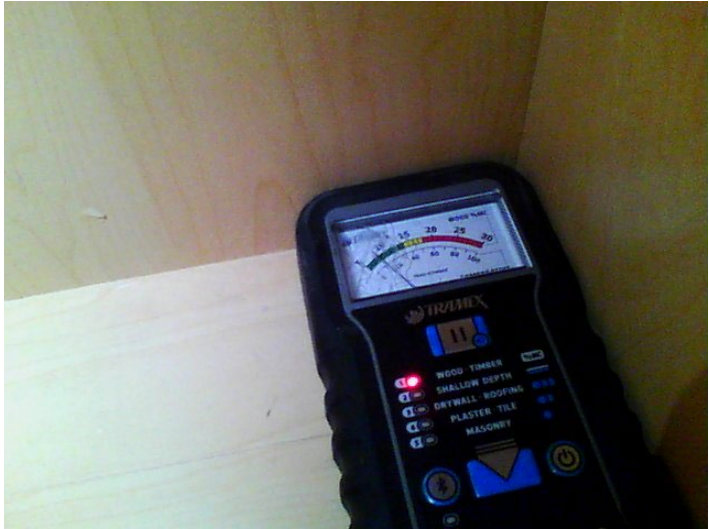
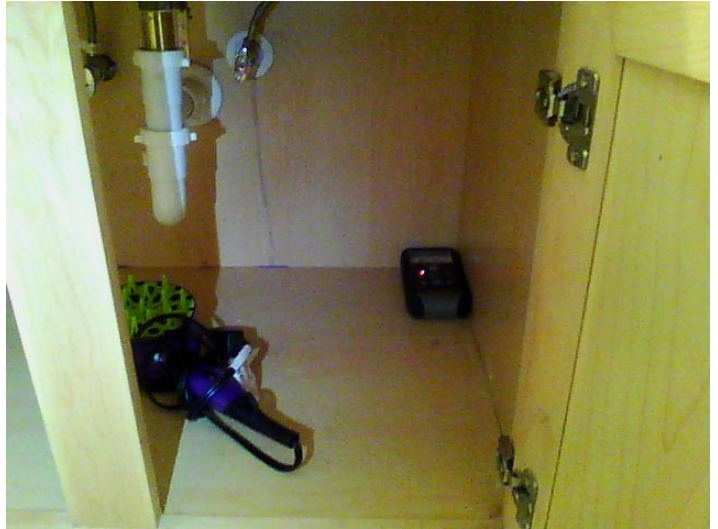
Vanity moisture reading 10%

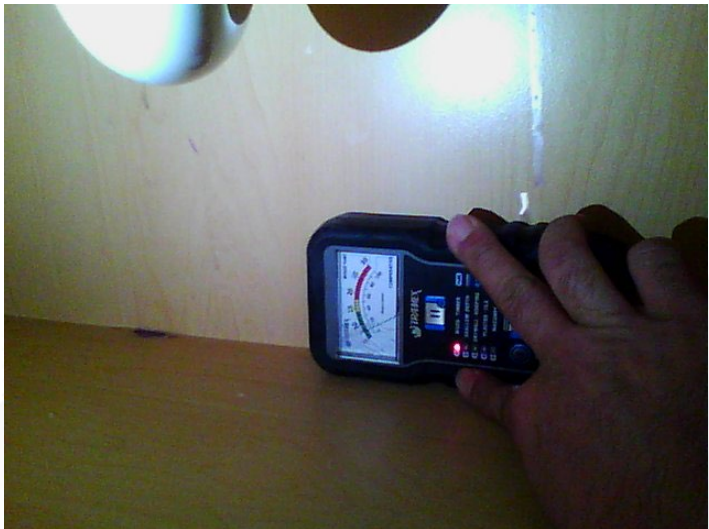
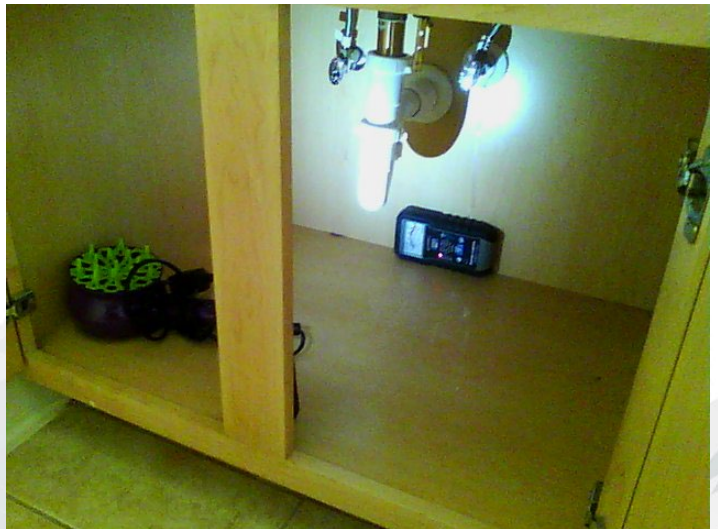
Vanity moisture reading 10%

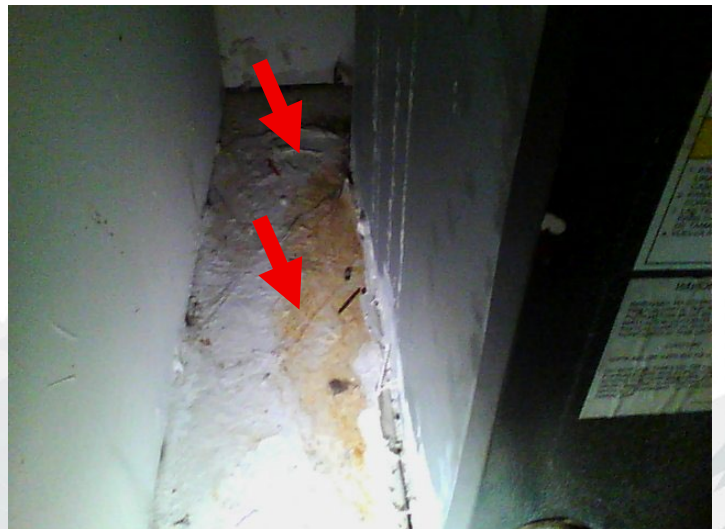
Visible staining and warping on the A/C shelf

- Professional cleaning of the air handler and ducts is recommended. A licensed HVAC contractor should assess the condition of the systems, the air handlers, and the ducts, following the National Air Duct Cleaners Association (NADCA) cleaning standard ACR 2021 – Assessment, Cleaning, and Restoration 2021, or the most recent version. The NADCA standard gives the contractor guidance as to what must be cleaned, how to clean, and when to replace HVAC systems and ducts.

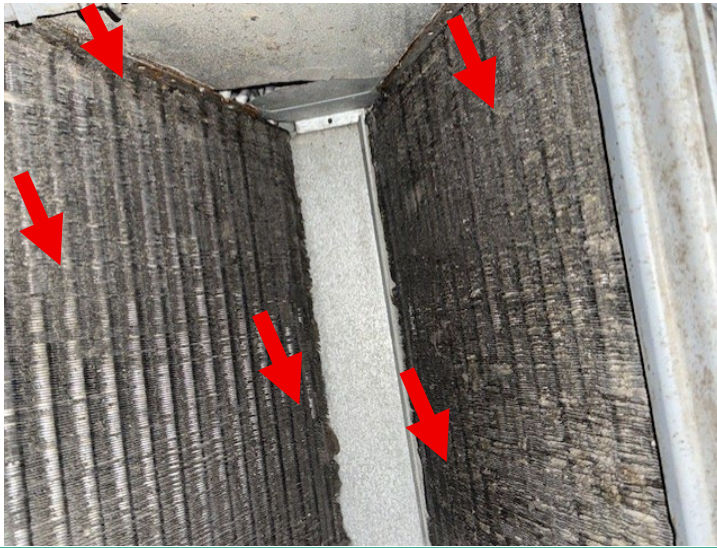
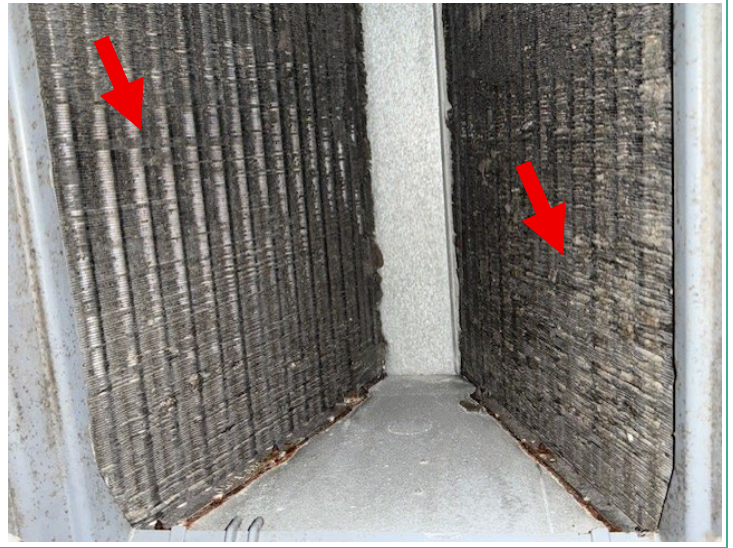
AC/ coils showed visible suspect growth and debris
