FAA
Aviation Safety

SPECIAL AIRWORTHINESS INFORMATION BULLETIN

SAIB: 2026-10R1

SUBJ: Equipment / Furnishings - Restraint Systems

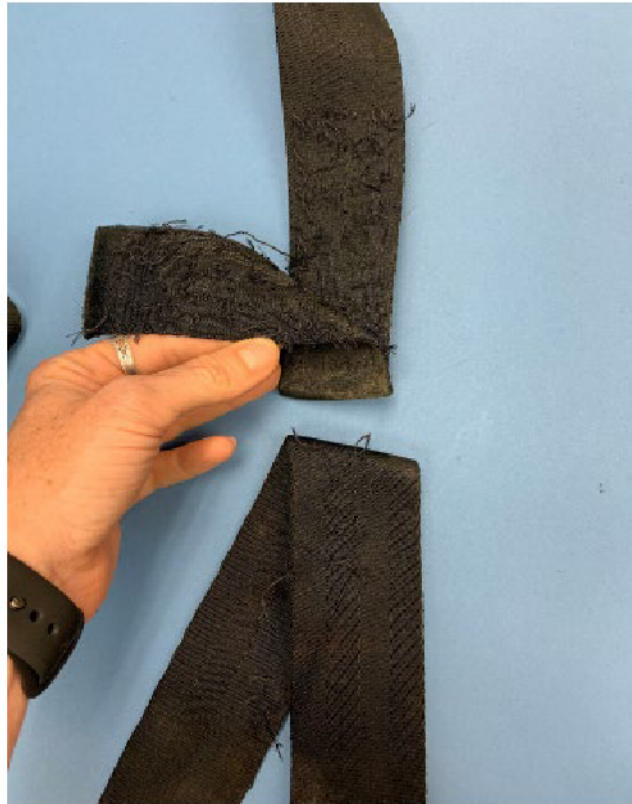
A search of NTSB public dockets identified at least fifteen other general aviation accidents resulting in full or partial failure of the occupants' restraint system. Many of these failures occurred at the Y-junction threading as shown in Figure 2. These accidents often involved serious or fatal injuries of the occupants. Further inspection of the accident findings revealed that these restraints are often designed to obsolete TSO requirements. Minimum torso restraint system performance requirements are currently prescribed in [TSO-C114](#) dated March 27, 1987. Minimum safety belt performance requirements are currently prescribed in [TSO-C22g](#) dated March 5, 1993. Both TSOs provide standards equivalent to SAE Aerospace Standard (AS) Document No. AS8043, "Torso

Figure 2
Four-point restraint assembly with separation at shoulder harness Y-junction threading

- Perform routine preflight and annual visual inspections of both the shoulder and pelvic restraints to check for signs of wear, deformation, discoloration, defects, or fraying. Special attention should be paid to the threading on the Y-junction that separates the two shoulder straps and connects to the fuselage attach strap behind the occupant’s head as well as the fastener hardware.
- Report findings of damage to the FAA point of contact. Please include the make, model, and serial number of the restraint and aircraft; a description of the damage; photographs; recommended inspection techniques to locate the damage; the damaged parts’ time in service; and any other information that may assist in our evaluation of this issue.

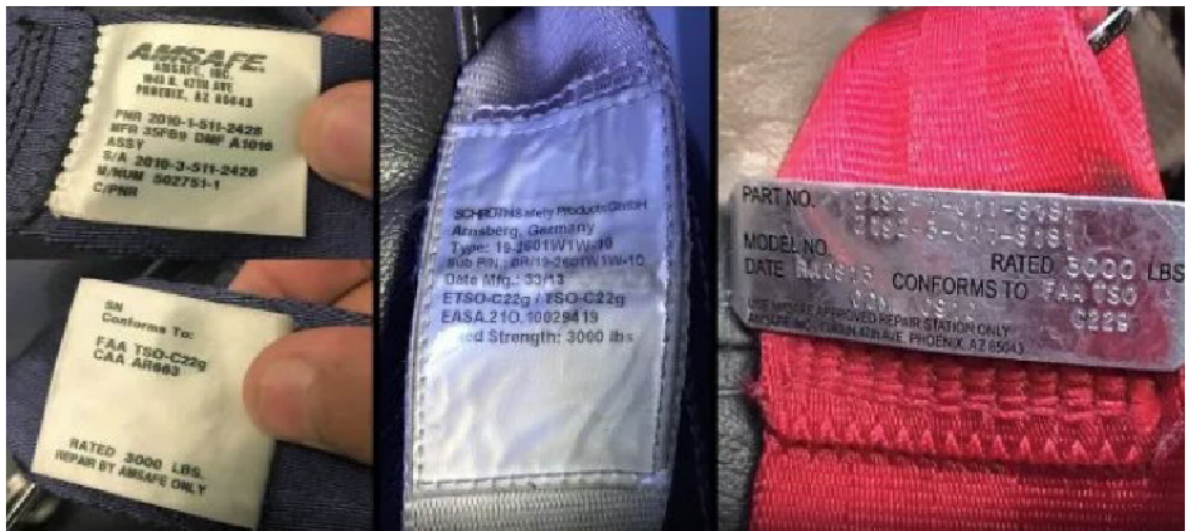
Figure 3
 Example label markings of restraints that do meet TSO-C114 or TSO-C22g requirements
 (Photo credit: AeroSavvy Aviation Insight)

- Positively identify that their restraints meet these minimum performance requirements through visual inspection of the manufacturer’s label markings on the restraint assemblies. These markings may list the TSO numbers and/or the rated strength of the restraint assembly. The assembly’s rated strength to meet the current performance requirements is 3000 lbs or more. Figure 3 and Figure 4 show examples of label markings of restraints which do and do not meet TSO-C114 or TSO-C22g requirements.

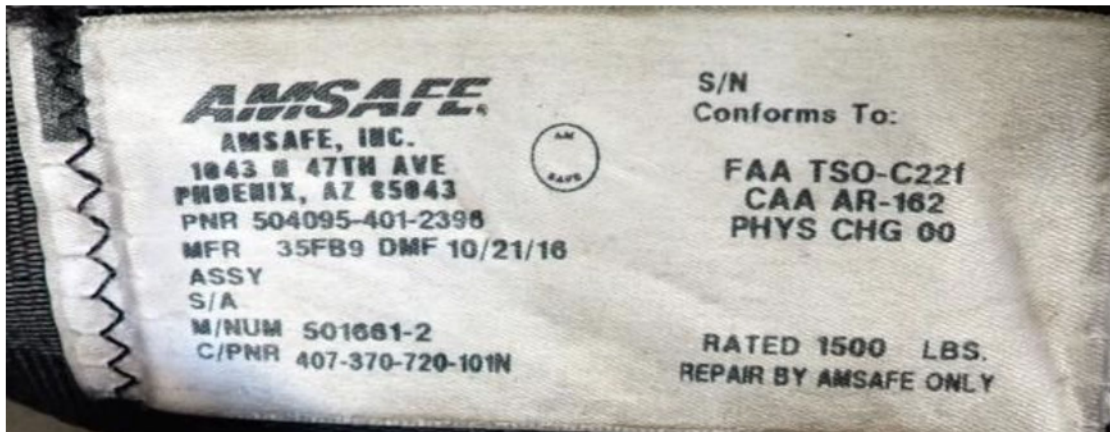
Figure 4
 Example label marking of restraint that does not meet TSO-C114 or TSO-C22g requirements

- Replace torso and pelvic restraints which are not labeled as meeting TSO-C114 or TSO-C22g or later revisions, respectively; which do not meet or exceed an assembly rated strength of 3000 lbs or more; or which have a missing, illegible, or unreadable label or marking on the restraints with restraints which meet these TSO minimum performance requirements.
