PROPERTY INSPECTION REPORT

123 Sesame Street, Virginia Beach, VA 23457

Inspection prepared for: Clint Dagger

Date of Inspection: 4/29/2020 Time: 12pm

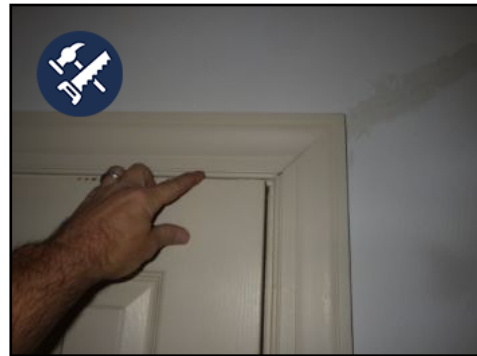
- Some doors require door stops to be installed to prevent damage to interior walls.
- Door(s) sticking/rubbing on door frame in places and require adjustment for normal operation.

Missing Door Stops

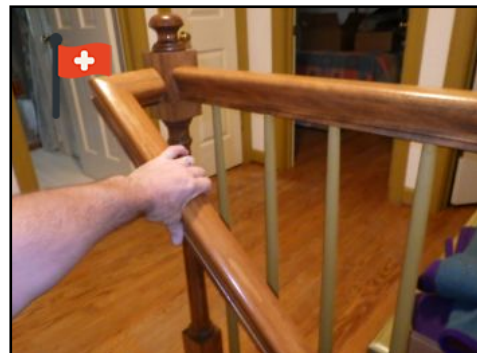
Secure Railings

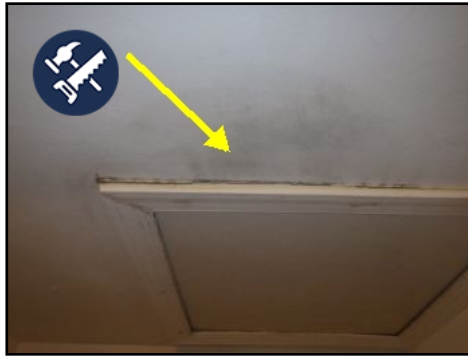
- Small stains noted on the ceiling. They tested dry at the time of the inspection.

Moisture Stains

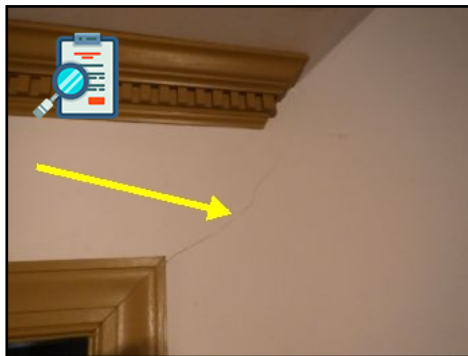
- Typical flexion and settlement cracks were observed on the walls. These cracks do not represent structural issues and can be repaired as needed.

Typical Cracks

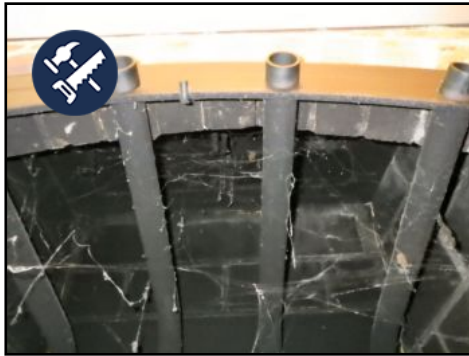
Fireplace requires cleaning

- Recommend professional cleaning of fireplace before first use to mitigate potential for chimney fires.

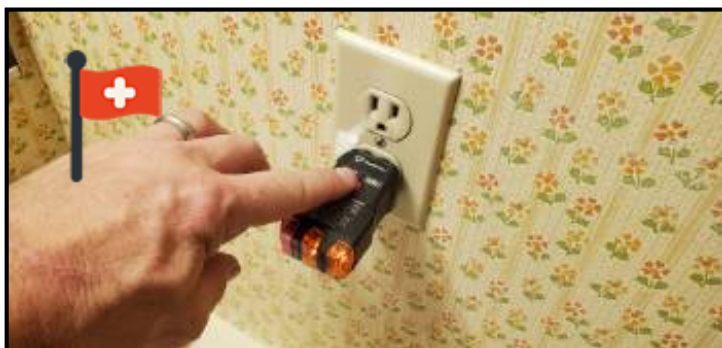
No GFCI Present

- Recommend upgrading All receptacle to **GFCI** protection within 6 feet of all potential wet locations.

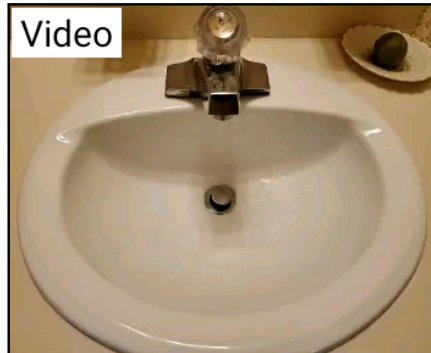
- Faucet is leaking and requires repair or replacement

Faucet drips

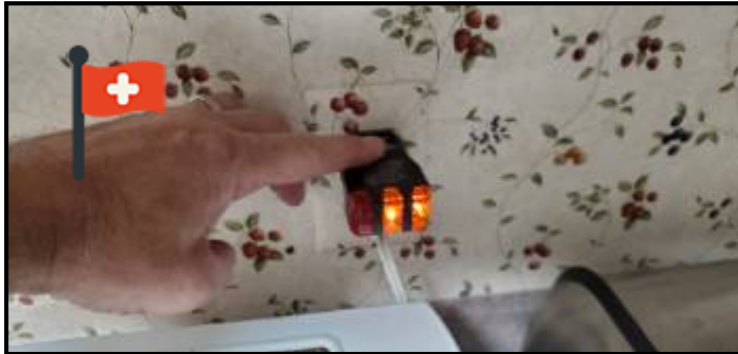
- No GFCI protection present in kitchen, recommend licensed electrician for installation of GFCI protected receptacles for safety.

GFCI Required

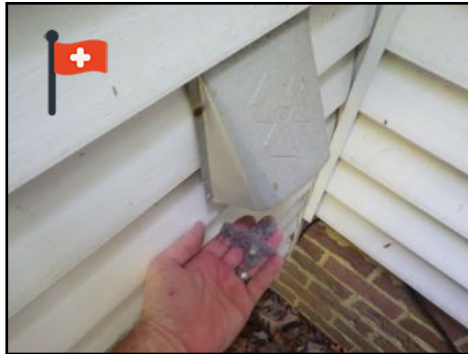
- Dryer vent has a buildup of lint and requires cleaning to prevent fires and/or damage to dryer unit.

Clean Vent pipe

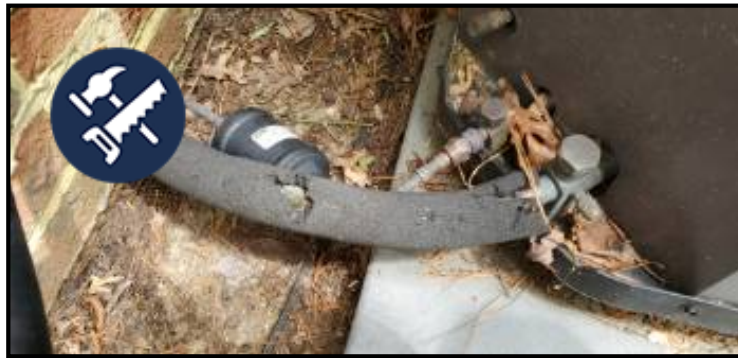
- Reinsulate lines for efficiency

Damaged Insulation

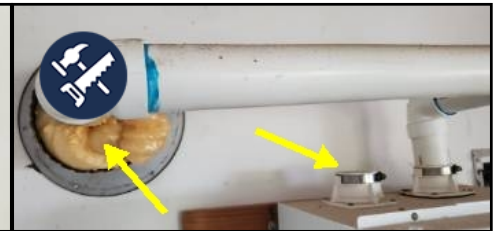
- A Temperature Pressure Relief (TPR) valve present. This safety valve releases water (and thus relieves pressure) if either the temp or pressure in the tank gets too high. The **TPR valve** discharge tube must be made of copper, iron, or CPVC (NOT regular **PVC**). It must terminate within 6" above the floor--the end cannot be threaded or have a fitting.
- High efficiency ventilation intake is not installed to current standards of practice. Recommend further evaluation and repairs from a licensed plumber.

Ventilation improperly installed

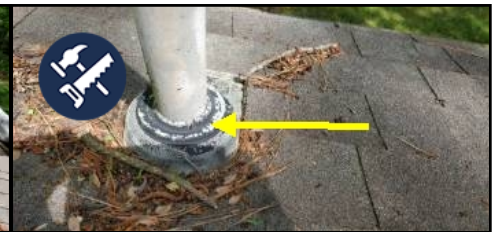
Cracked pipe boots

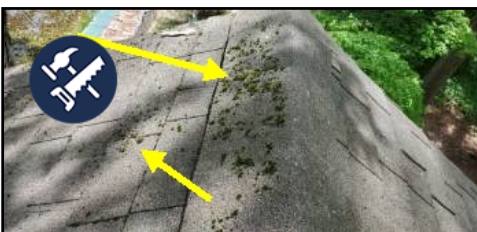
Moss

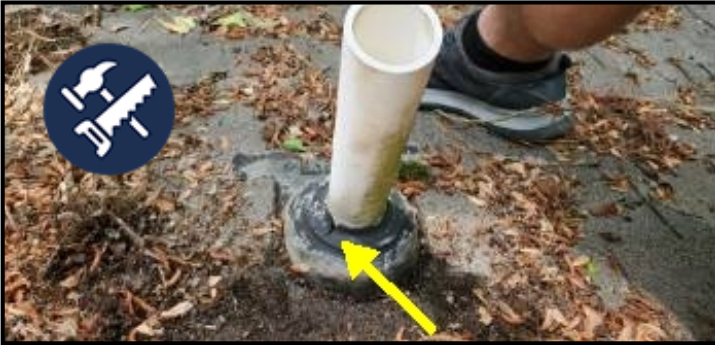
Cracked pipe boots

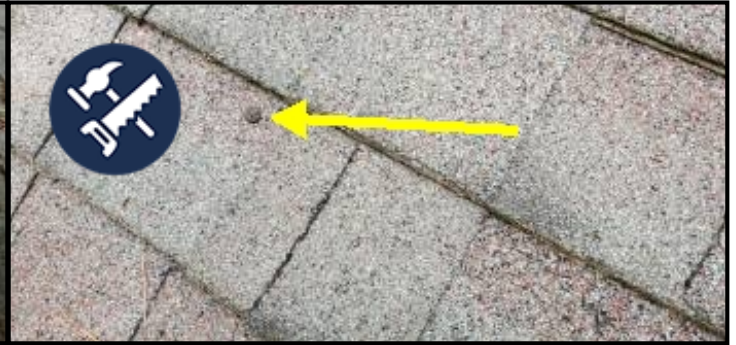
- Exposed nail heads observed on roofing materials. Recommend sealing all fastener heads.
- Clean Roof Areas: Significant amounts of organic debris was observed, which can lead to the premature failure of the roof and subsequent leaks.
- Excessive debris was observed on roof at time of inspection. Recommend cleaning debris from roof to preserve the remaining useful life of roofing materials.

Exposed Nail Heads

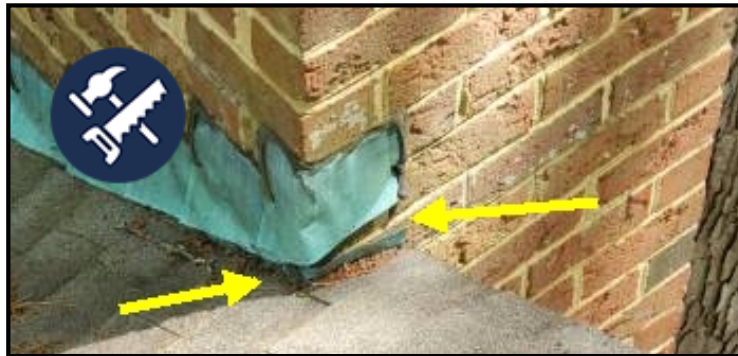
Damaged Flashing

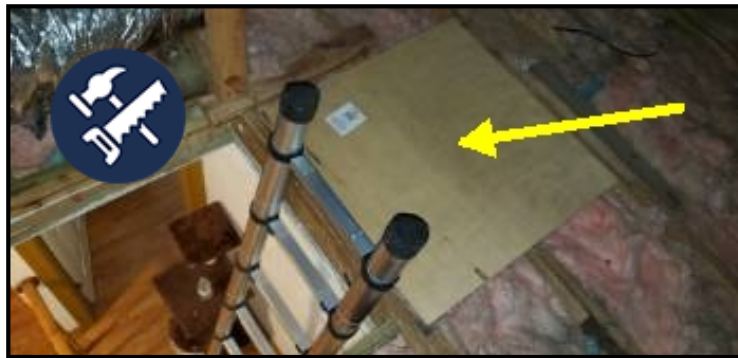
- Recommend adding insulation to top of access door for improved efficiency.
- Scuttle Hole located in upstairs hallway

Insulate Access Cover

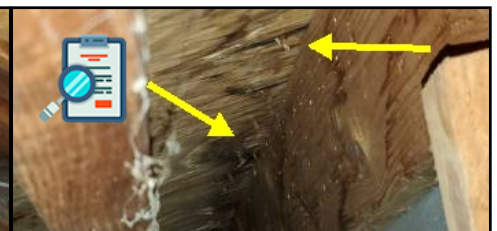
- Conventional or "Stick build" construction was observed in attic space with no issues noted.
- Evidence of past or present leaks, dry at time of the inspection. Monitor for leaks &/or have roofing contractor evaluate.
- Holes/gaps observed around penetrations into attic space with visible light shining through. Recommend sealing all gaps to prevent wildlife penetrations.

Moisture Damage

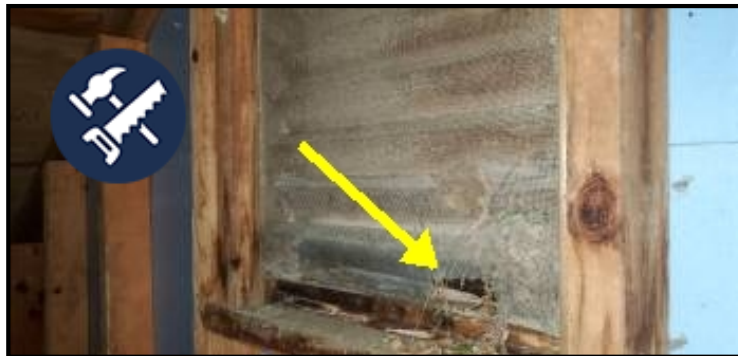
- Vent screens are damaged or missing, suggest repairing or replacing screens as necessary.

Damaged Screen

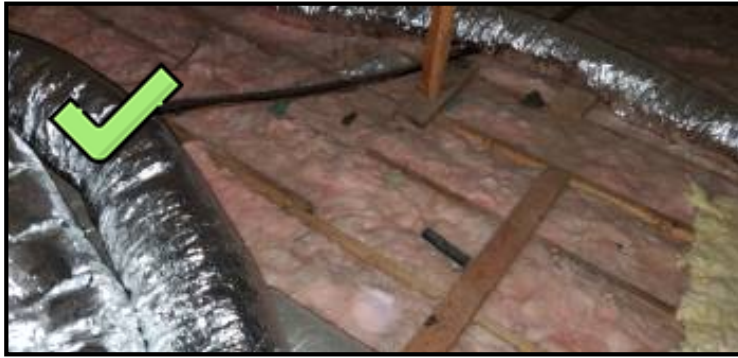
Depth: Insulation averages about 4-6 inches in depth; more recommended.

Batt Insulation

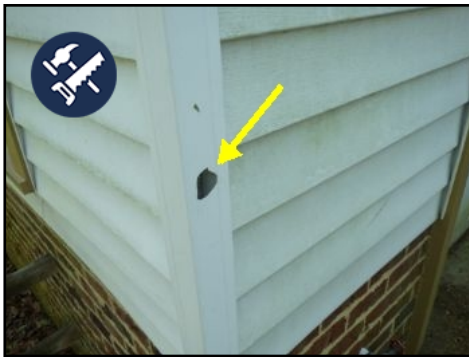
- Recommend power washing siding.
- Holes in vinyl siding observed in areas. Repair siding to prevent water penetration and damage.
- Loose vinyl siding was observed on back side of house. Recommend qualified contractor for repairs to prevent wind damage.

Holes in Siding

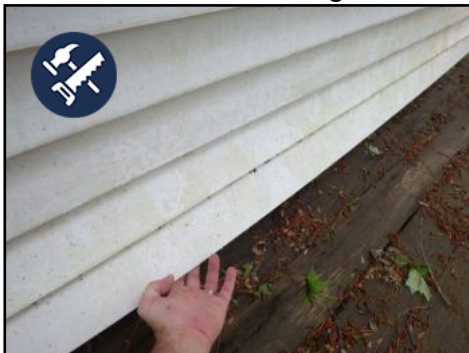
Loose Siding

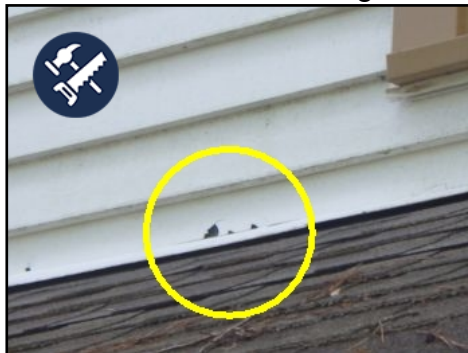
Holes in Siding

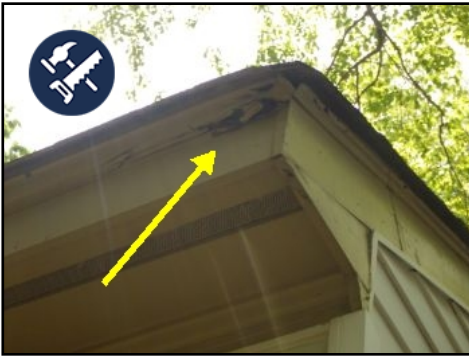
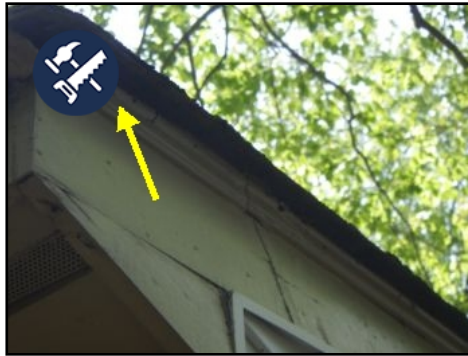
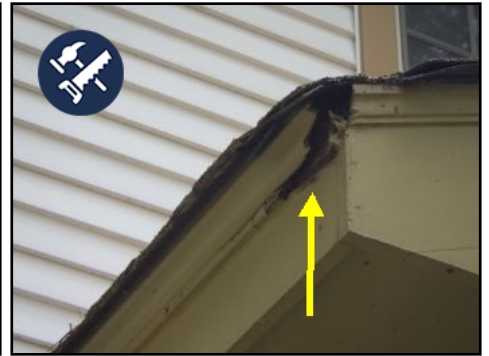
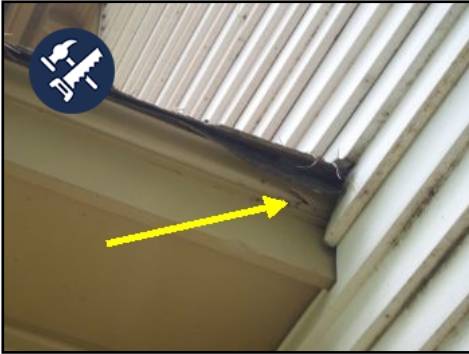
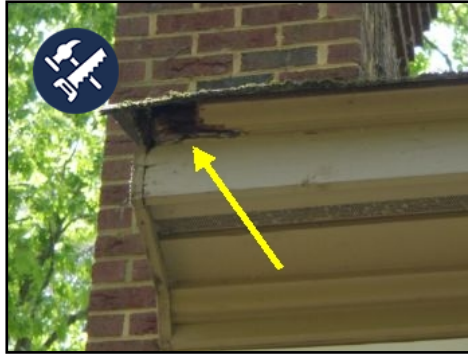
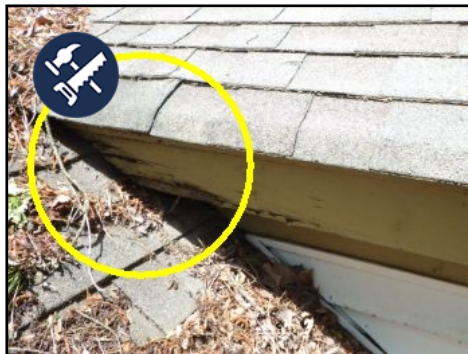
- Moisture damage, wood rot, observed on wood trim work. Recommend a licensed siding contractor for further evaluation and repairs to prevent further damage.
- Recommend filling all gaps on fascia boards to prevent insects from entering attic area.

Deterioration Noted

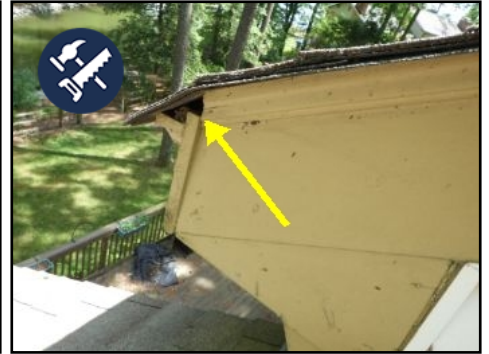
Fill gaps in Fascia

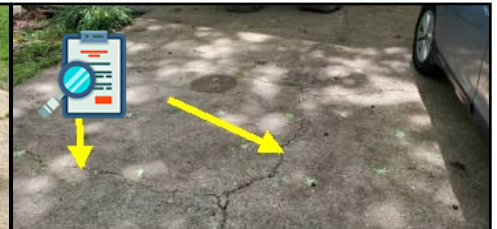
- Typical cracking was observed at the concrete surfaces. Further deterioration will occur as water expands and contracts from freeze and thaw cycles. Recommend sealing the cracks to prolong the life of the concrete.
- Moderate cracks in sidewalk. Repair and / or monitor for expansion and development of trip hazards.
- Driveway is settled and cracked in one area and is a potential trip hazard. Repairs are recommended for safety.

Typical Cracks

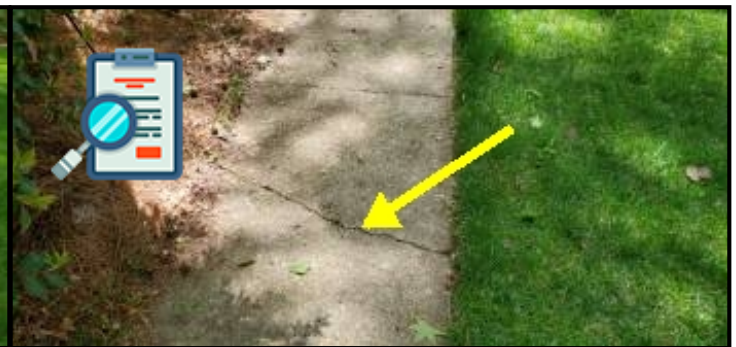
Typical Cracks

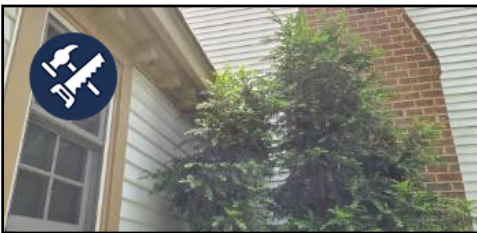
- Trim trees that are in contact or proximity to home, as branches can abrade roofing or siding. Tree limbs within 10 feet of roof be trimmed away to provide air and sunlight to roof, while minimizing debris & dampness. Will also help to minimize debris buildup in gutters to ensure full useful life of roof and soffits. Damage may occur if limbs are in physical contact with house.
- Ivy growth was observed on exterior of house. Recommend removing Ivy to prevent further growth on exterior portions of house.

Tree Branches

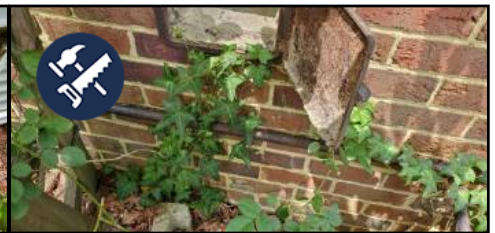
Ivy

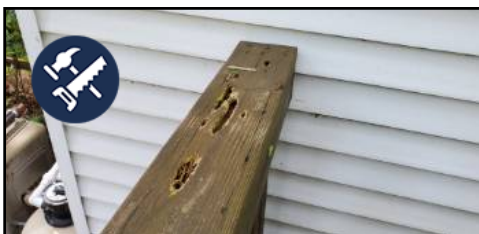
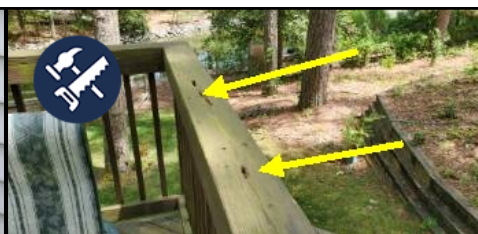
- Deck railings show signs of apparent woodpecker damage and require repairs by qualified contractor
- Recommend power washing and sealing deck on an annual basis to preserve the integrity of the wood components.
- Piers under deck are not properly secured at the ground and do not provide support for the middle portion of the deck. Recommend licensed and insured contractor for further evaluation and repairs.

Woodpecker Damage

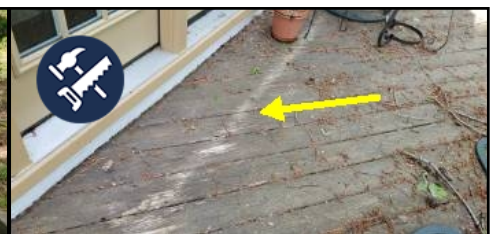
Powerwash and Seal Deck

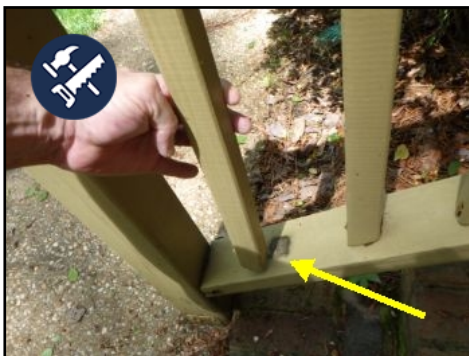
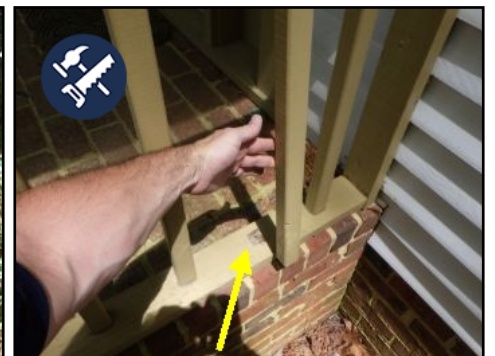
- Water deterioration damage was noted on railings. Recommend qualified contractor for repairs.
- Loose spindles were observed and should be resecured for safety

Secure Railings

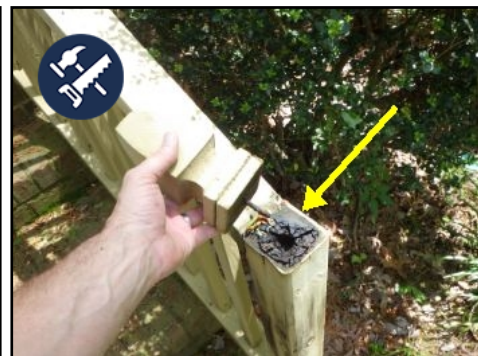
Deterioration noted

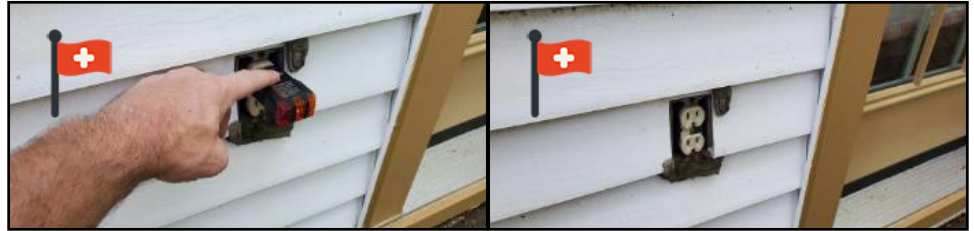
- No Ground Fault Circuit Interrupter (GFCI) protection of home electrical outlets was provided in the home at the time of inspection. Although GFCI protection may not have been required at the time the home was built, for safety reasons, consider upgrading the electrical system to include GFCI protection at all exterior locations.
- Weatherproof outlets—Exterior outlet / switch cover(s) not waterproof. Have certified electrician evaluate and repair as necessary.

Add Exterior GFCI Outlet

Weatherproof outlet needed

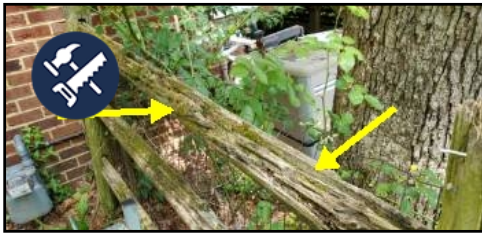
- Wood deterioration and/or damage was noted on wood fencing materials. Recommend qualified contractor for repairs.
- Fence leaning in areas. Recommend qualified contractor for repairs or replacement.

Deterioration Noted

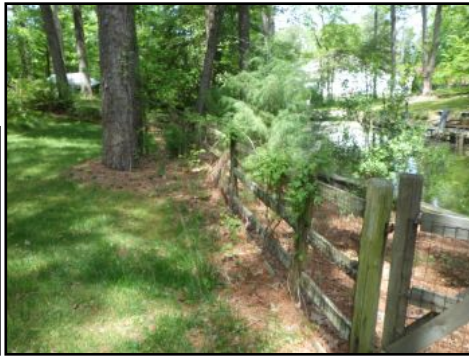
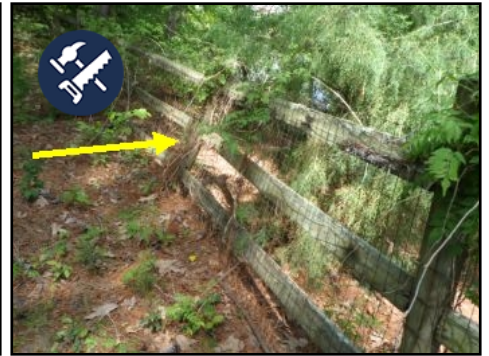
Fence Leaning

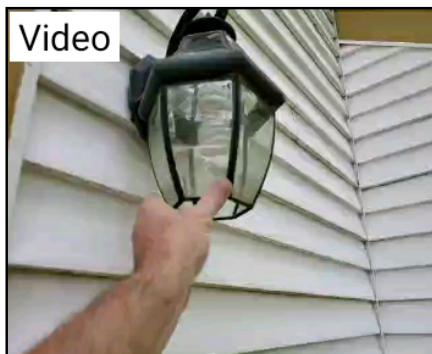
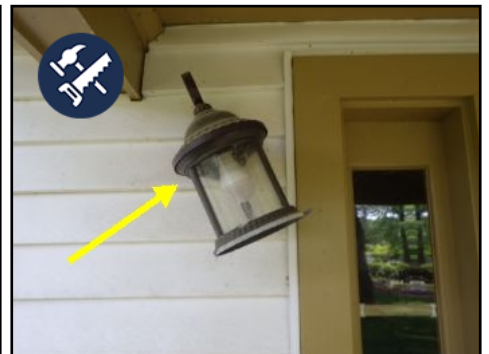
- Secure and caulk lighting fixture to exterior wall.
- Exterior lighting fixture is damaged or missing components. Recommend replacement of fixture.

Secure and Caulk

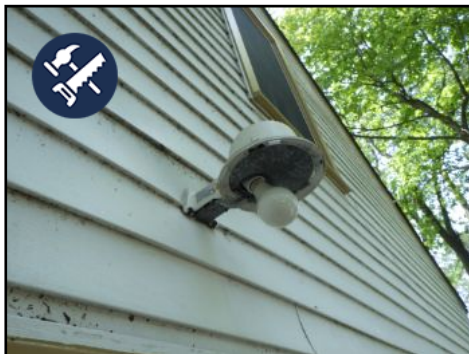
Damaged Fixture

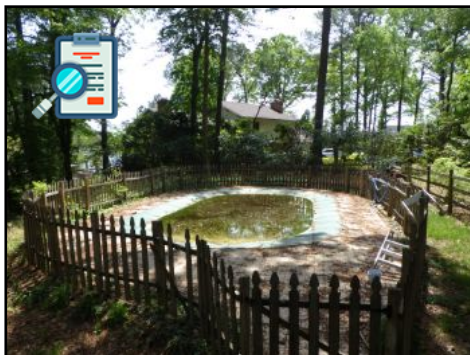
- Pool was winterized at time of inspection. Recommend full inspection of all pool components once pool is open and operational.

Pool Winterized

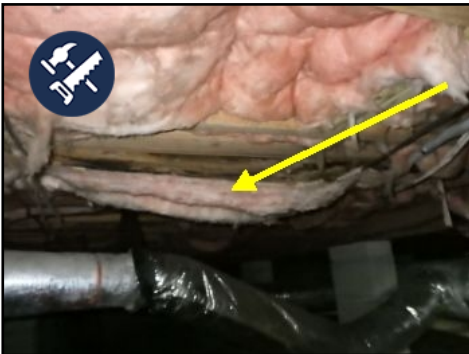
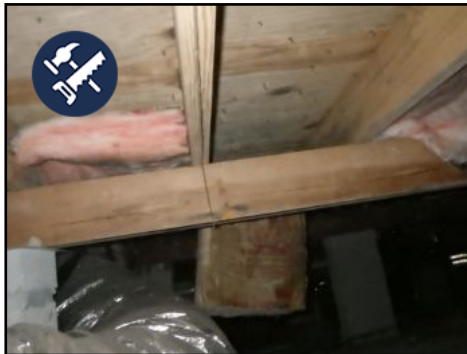
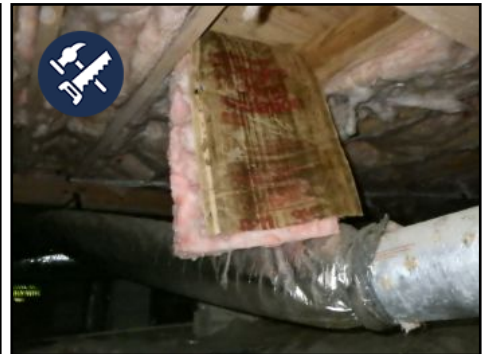
- Insulation in crawlspace is fallen in areas and should be re-secured to prevent moisture absorption and to improve efficiency of the home.

Fallen Insulation

Fallen/missing Insulation

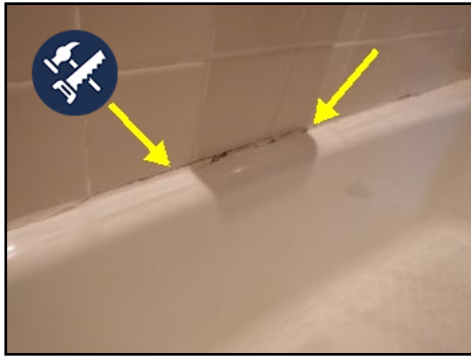
- Shower/Tub requires caulking along floor to prevent moisture damage to subfloor.
- Caulking is required at wall and tub/shower to prevent moisture damage to walls.

Caulking required

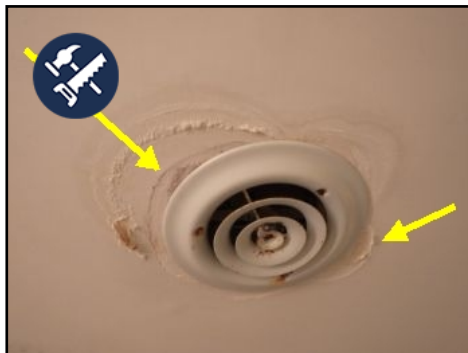
- There were signs of paint blistering on the ceiling. The areas tested dry at the time of the inspection, but should be monitored for further damage or possibly water intrusion.

Condensation stains

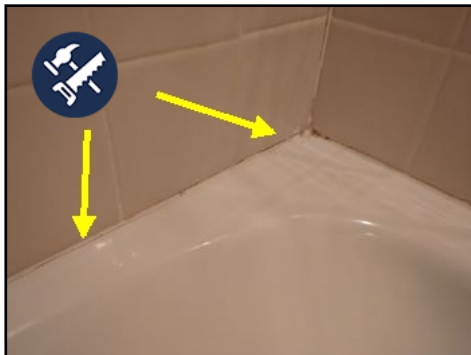
- Shower/Tub requires caulking along floor to prevent moisture damage to subfloor.
- Caulking is required at wall and tub/shower to prevent moisture damage to walls.

Caulking required

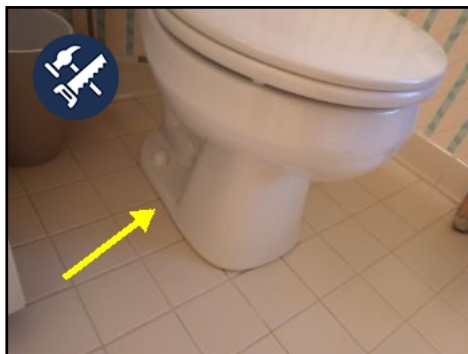
- Toilet is loose at floor and requires tightening to prevent sub-floor damage from leaks.

Loose Toilet
