Level I – FULL Reserve Study Report **For Fiscal Year Beginning January 1, 2023**

Sample Condo

Your Town, WA

January 4, 2023

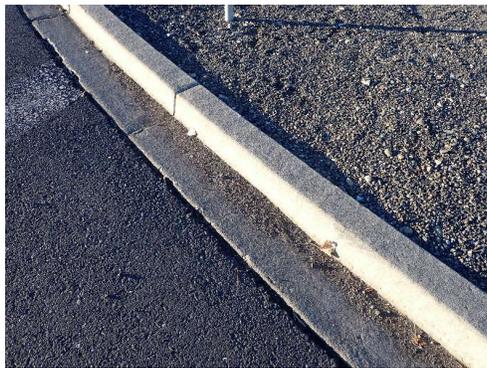
Concrete - Repair - 2027

Concrete appeared generally intact, with no major damage or deterioration observed. Typically, concrete surfaces have a predictable useful life which exceeds the scope of this report, however we have included a rotating funding allowance for periodic repairs and spot replacements. Because this is a rotating component, the date in service represents the approximate last repair date.

Inspect and repair concrete as needed through annual operating budget. Clean periodically to remove stains and organic debris, and repair any trip hazards (defined as ¼" or more of vertical change at any joint or crack by the 1990 Americans with Disabilities Act) immediately.
