Level I – FULL Reserve Study Report

For Fiscal Year Beginning January 1, 2024

Sample Condo

January 18, 2024

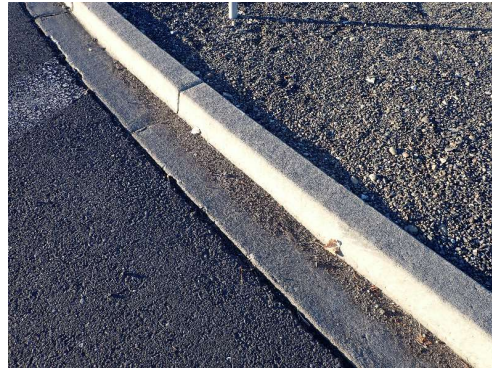
Concrete - Repair - 2028

Concrete appeared generally intact, with no major damage or deterioration observed. Typically, concrete surfaces have a predictable useful life which exceeds the scope of this report however we have included a rotating funding allowance for periodic repairs and spot replacements.

Inspect and repair concrete as needed through annual operating budget. Clean periodically to remove stains and organic debris, and repair any trip hazards (defined as ¼" or more of vertical change at any joint or crack by the 1990 Americans with Disabilities Act) immediately.

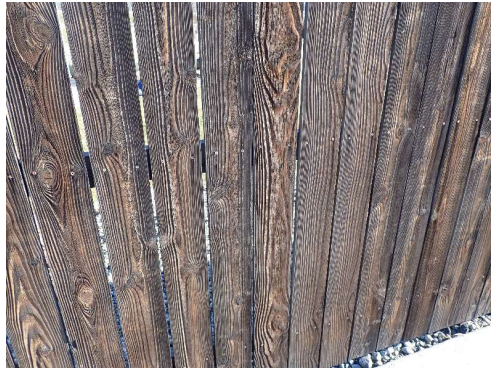
Wood Fence - Repair & Stain - 2027

Component History: Stained 2022 \$2,800
