FINEGAN INSPECTION SERVICES, INC.
TERRY FINEGAN
27 LAURELWOOD DRIVE
MILFORD, OHIO 45150
683-0733-PHONE

1). EXTERIOR WALL SURFACE

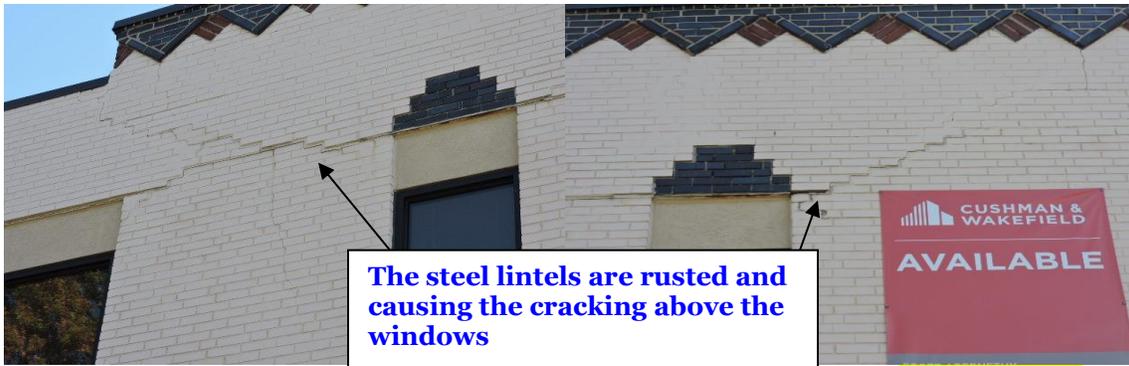
There was no observed settlement cracking at any corners of the building but there are vertical expansion cracks that run between the various windows on the left and front of the building. These are caused by the expansion and contraction of the steel lintels that are above the windows. When water rusts the steel, it expands and cracks the mortar in the surrounding brick. **The best repair would be to grind down the rusted steel and seal it, then tuck point the mortar on those walls that have these cracks. Painting all exposed steel with a rust inhibiting paint is also advised.**

The steel lintels are rusted and causing the cracking above the windows

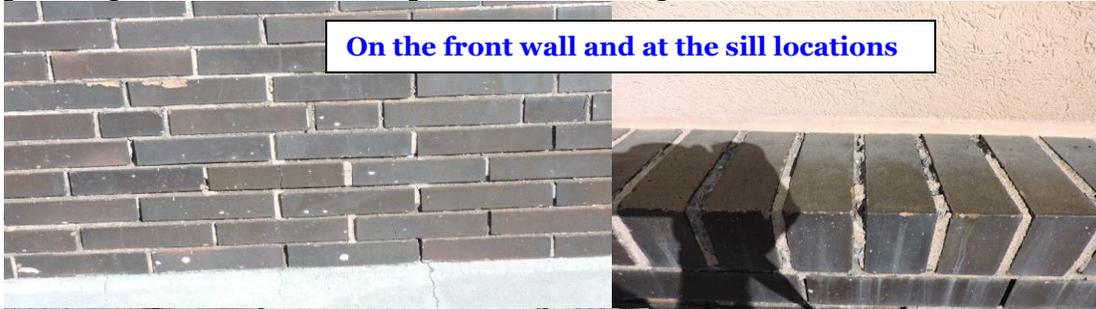
There are many locations on the front of the building where the **mortar has deteriorated and needs to be ground out and tuck pointed**. This is not unusual in an older brick and mortar building and has been recommended on several old buildings by this inspector in the past. This building needs tuck pointing at this time in multiple locations along the front wall.

On the front wall and at the sill locations

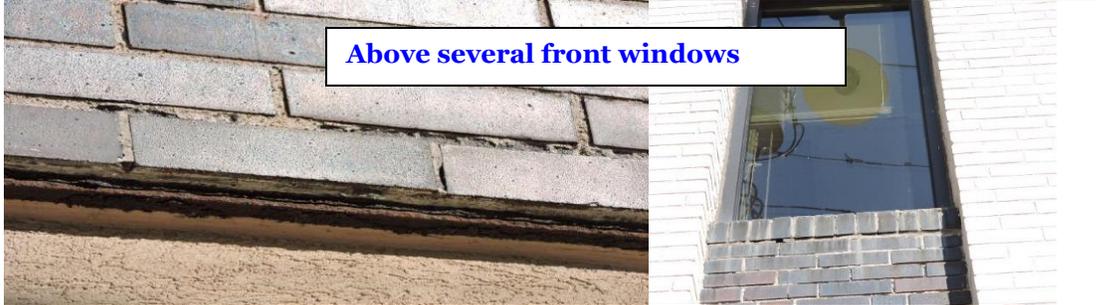
Above several front windows

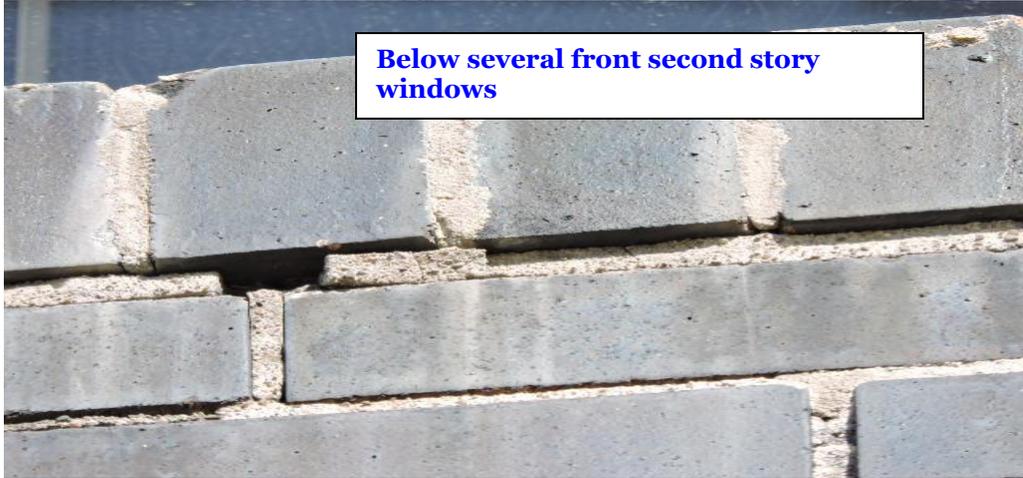
Below several front second story windows

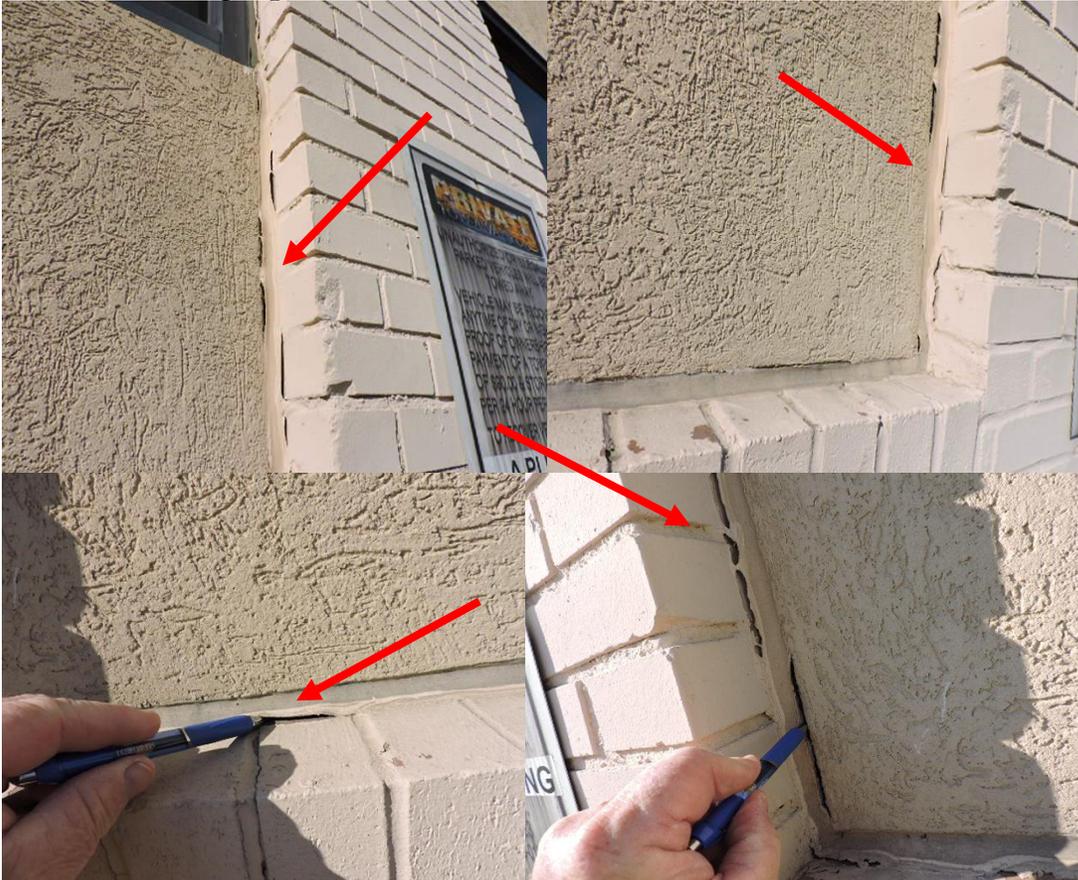
1). At the **right wall there are locations where the caulking has failed where the EIFS touches different material**. Have all these areas cut out and the caulking replaced with new closed cell backer rod behind the caulking.

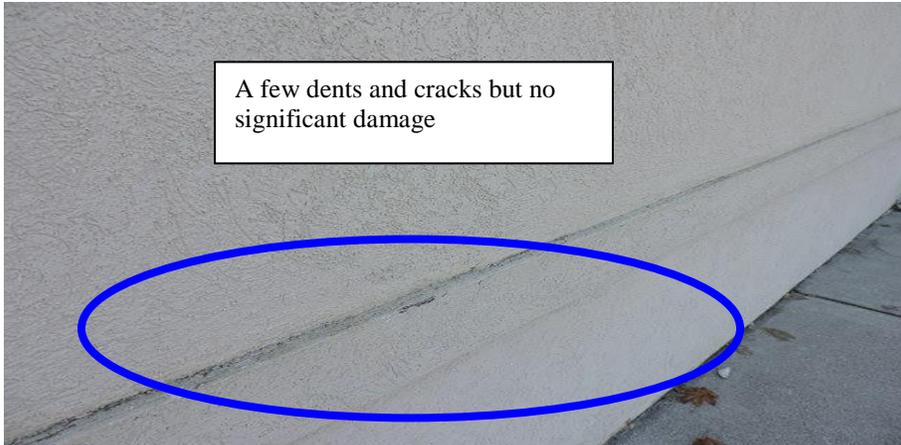
The EIFS appears to be in good condition on the wall surfaces and there are only a few dents and impact cracks in the finish. These can be easily repaired and re-coated. The EIFS poses no issues at this time.

A siloxane coating on these EIFS finishes is advised for aesthetics and for extension of the life of the EIFS system. Sto and Dow Corning make very good silicone based paints.

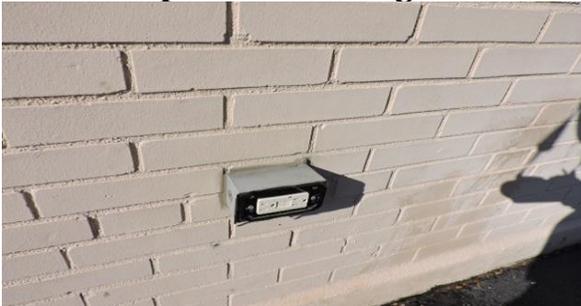
1). The electrical outlet on the right rear wall does not function and the cover plate is missing at this time.

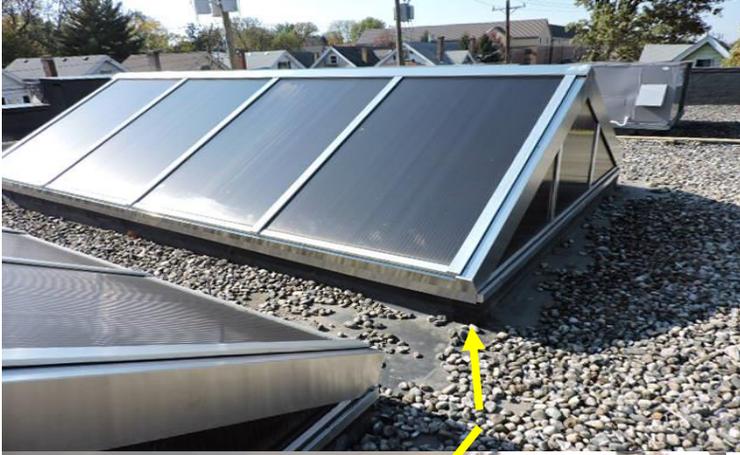
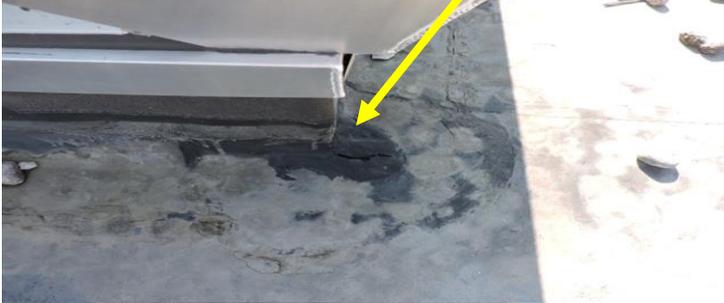
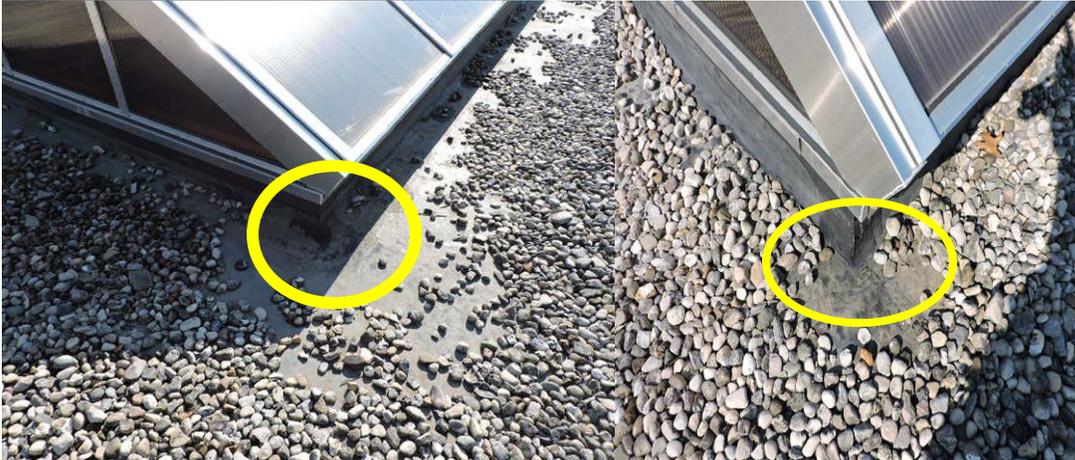
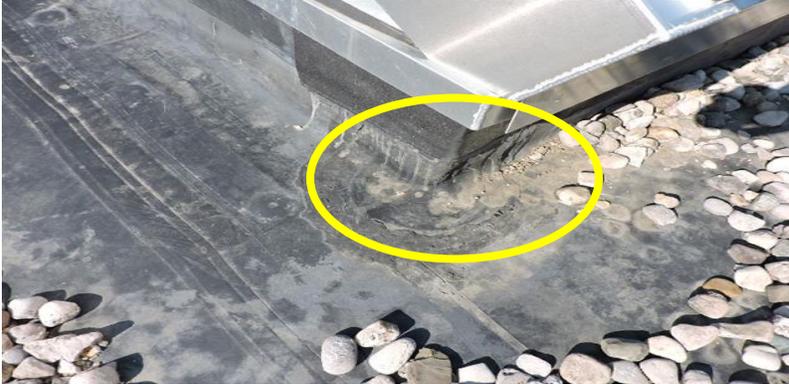
There are large skylights on the roof surface and at the base of these skylights there has been built a curb. **At the outside corners of the curb the EPDM has been doubled as is the requirement for the installation due to the natural expansion and contraction of this material. Where the corners have been doubled the EPDM has pulled apart. This needs to be corrected by a professional in this type of work**

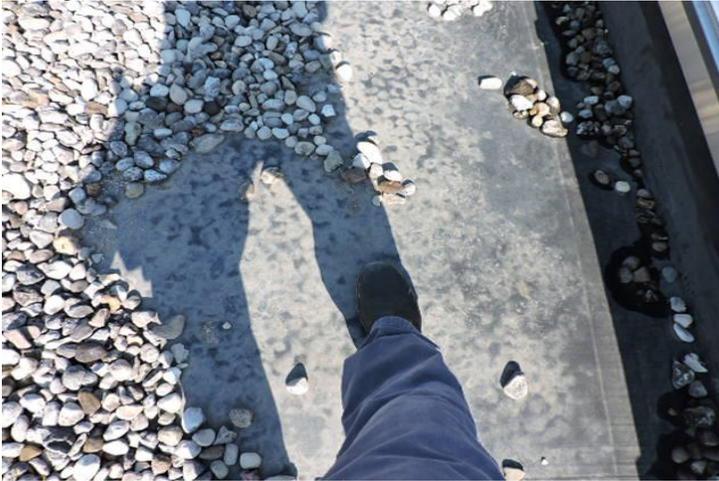
2). At the rear and near a few of the HVAC units there were noted **screws and debris mixed in with the rocks.** It these locations a strong magnet

should be run over the stones to pull out all material that might be stepped on and penetrate the rubber.

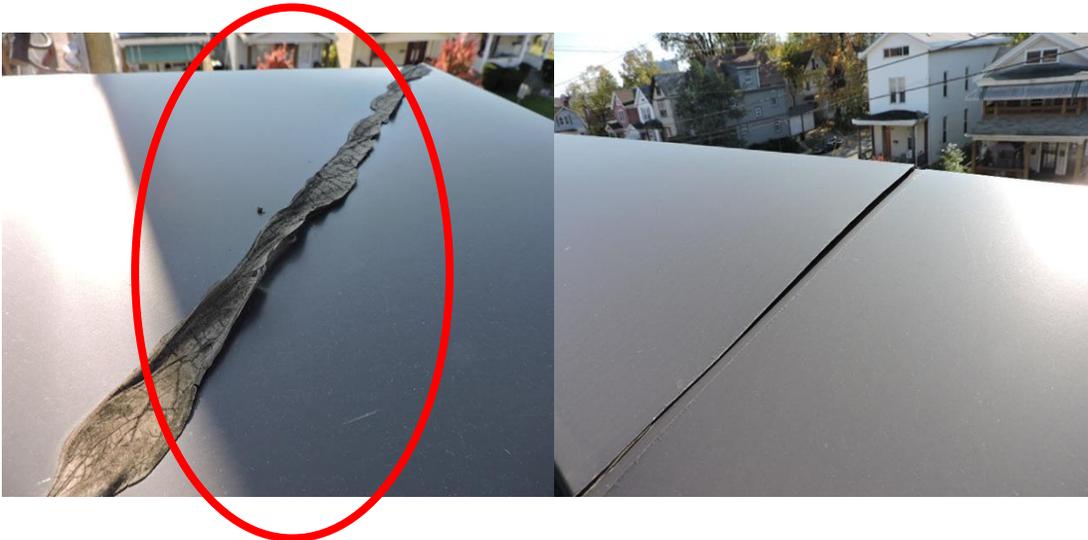
4). There is **failed sealant at the joints of some parapet caps.** Have these joints re-sealed with the proper type of sealant.

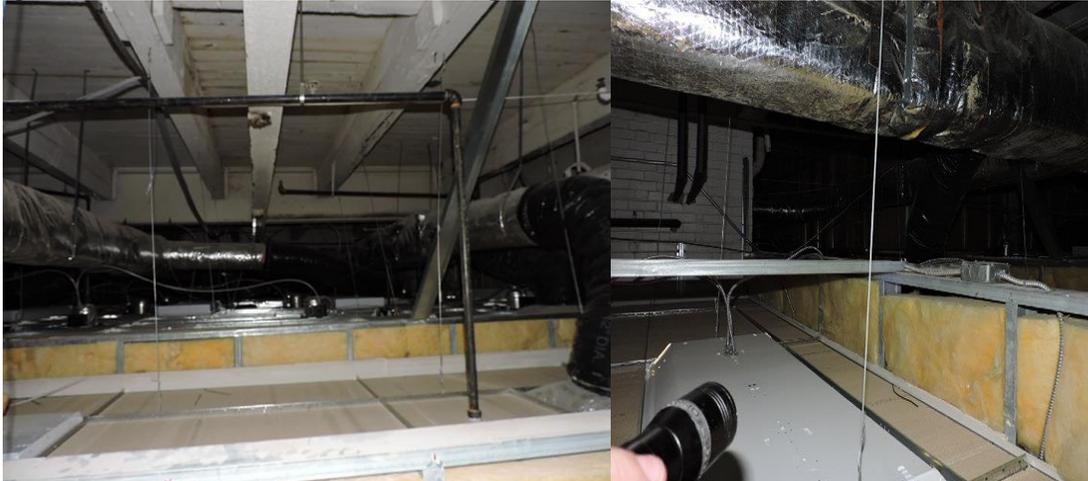
The ceiling in all areas is noted without damage or evidence of a chronic leaking. There are some water stains in the first floor ceiling near the sprinkler system. These water stains were dry at this time.

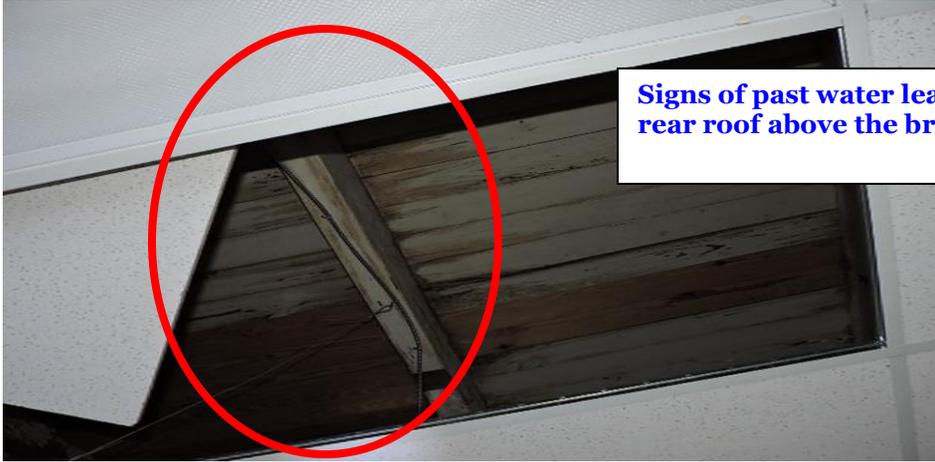
The stains are on the rear roof deck of the area above the break room/kitchen are more concerning. It appears that the lower EPDM roof has leaked in the past near the drain system that is in the center of the lower roof. The movement of the rock ballast was not attempted by the inspector but this may need to be done for a more exhaustive inspection of that lower rear roof.

Signs of past water leaking at the rear roof above the break area

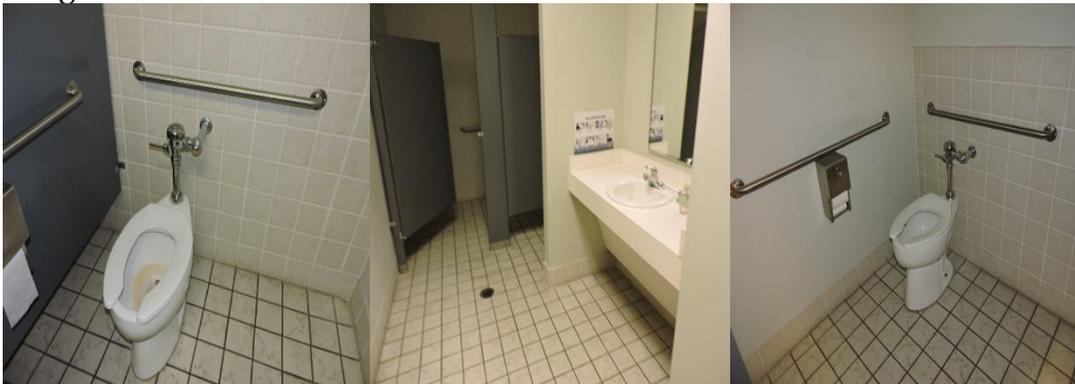
There are several rooms in the building with plumbing. The bathrooms, the break room and the mop closet. All plumbing was tested in the various rooms but the **bathroom commodes were dry and not functioning**. Have all made operational and check all for function. A camera may be considered to be run through these lines.

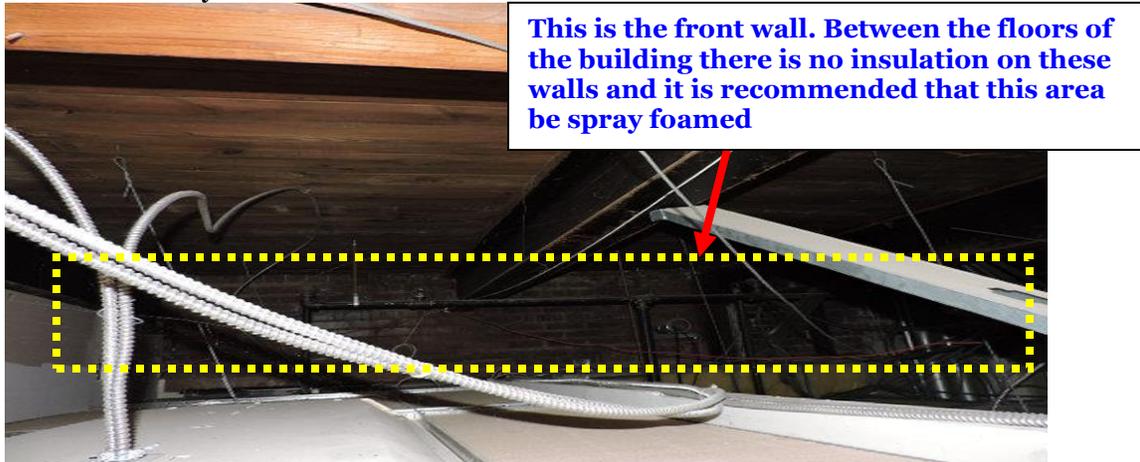
The attic was accessed at the panels on the front and rear ceilings. There is **no insulation in the attic areas at the perimeter walls. This may be considered via a spray foam application so that there is a thermal break between the double masonry exterior walls and the interior.** The drywall walls do have fiberglass insulation between the metal studs that compose the finish wall systems.

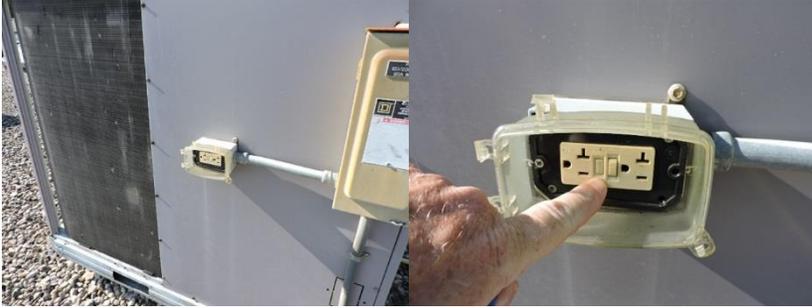
There is a GFCI outlet at the side of this unit. It will not stay on and needs to be replaced.
