FINEGAN INSPECTION SERVICES, INC.
TERRY FINEGAN
27 LAURELWOOD COURT
MILFORD, OHIO 45150
683-0733-PHONE

RESIDENCE

1234 Anystreet, Cincinnati, Ohio

EIFS moisture testing inspection

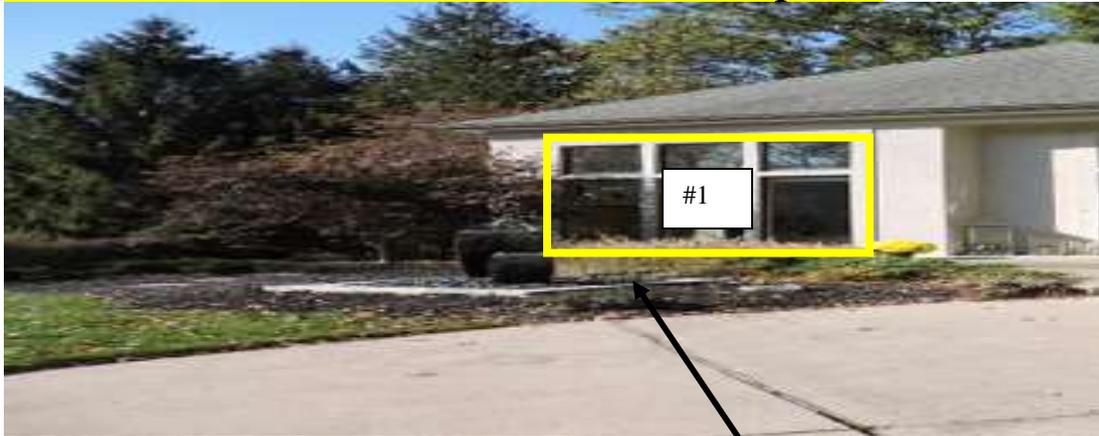
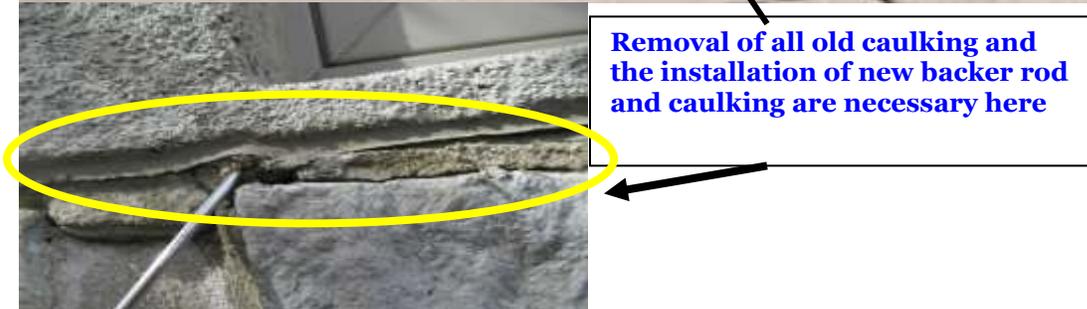
1). **Front Left wall**

There are no elevated moisture readings below the front left windows. There is **caulking that is adhesively failing. It is no longer attached to the surfaces intended to be sealed and should be replaced.**

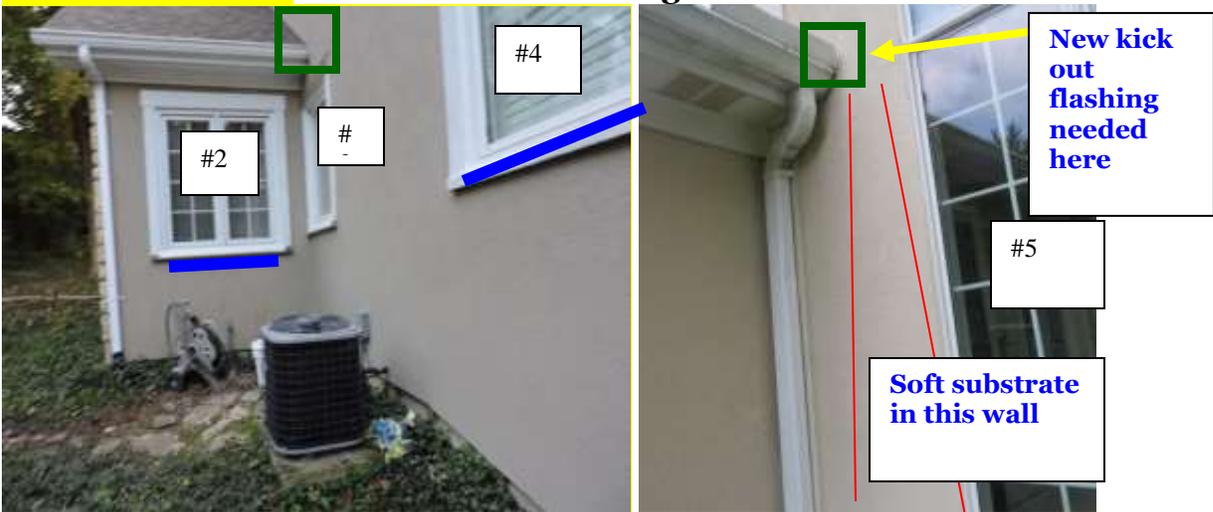
2). Front wall, left of front porch

Most moisture readings at the front left wall areas were elevated with several above 20 on the impedance meter. **Sill drains and new caulking is needed at these windows.** A new kick out flashing is needed at this wall

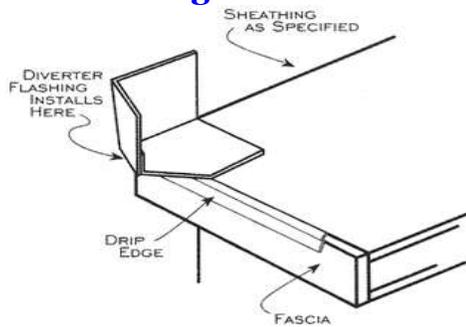
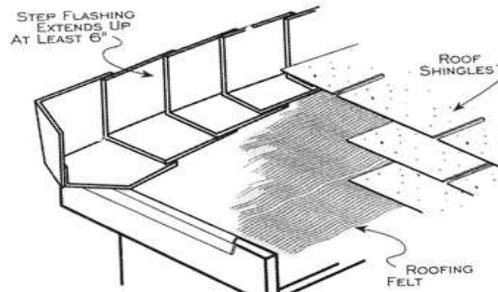
Diverter Flashing

Intended Purpose: Accumulating water runoff should be directed out and away from the structure. Roof-to-wall flashing requires a kickout/ diverter at its termination to insure that water is directed to the outside.

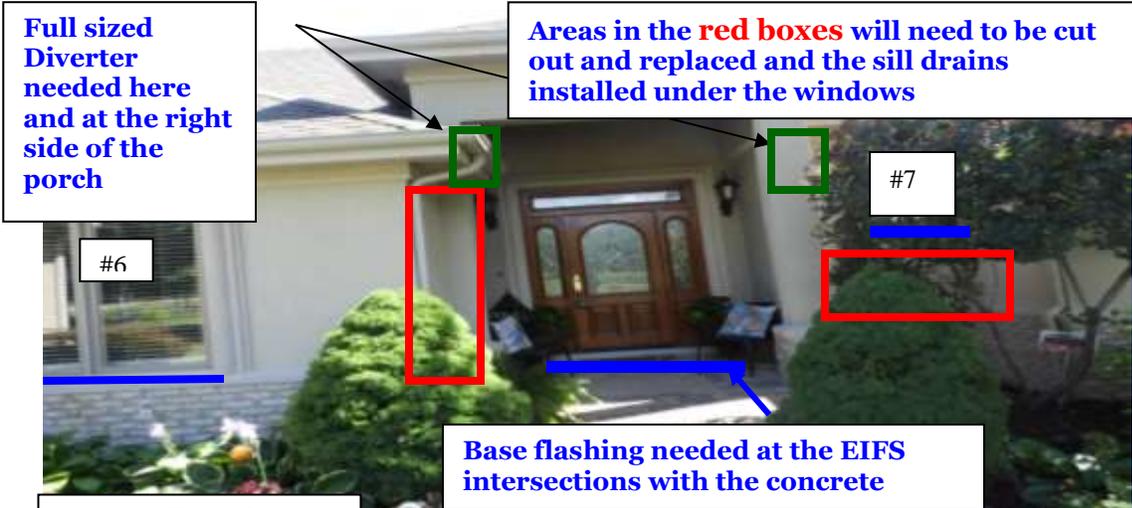
3). Front Porch Walls

At the front porch and at the right side of the porch water has accessed behind the EIFS at the left side of the archway and between the windows #6 and #7. There is very high moisture noted at these locations from the upper walls down to the first story floor line.

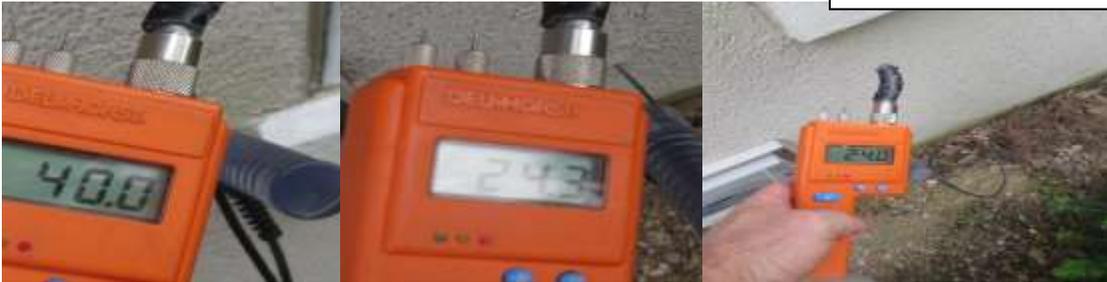
Window #6

The moisture readings are exceedingly elevated and the substrate is very soft below these windows and next to these windows #6 and #7.

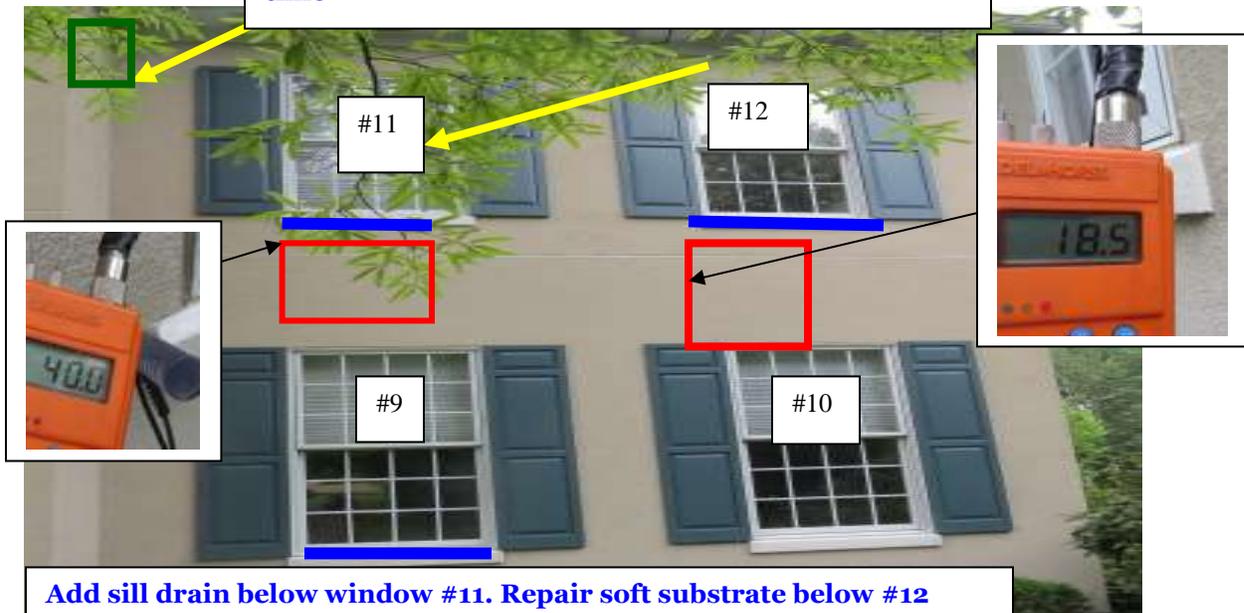
5). Front Right Wall

There was some elevation at the window #12. A **sill drain is needed at these windows** and to balance this, a sill drain is needed at the window #11.

A full sized diverter is recommended at this location. Moisture readings were normal at this time

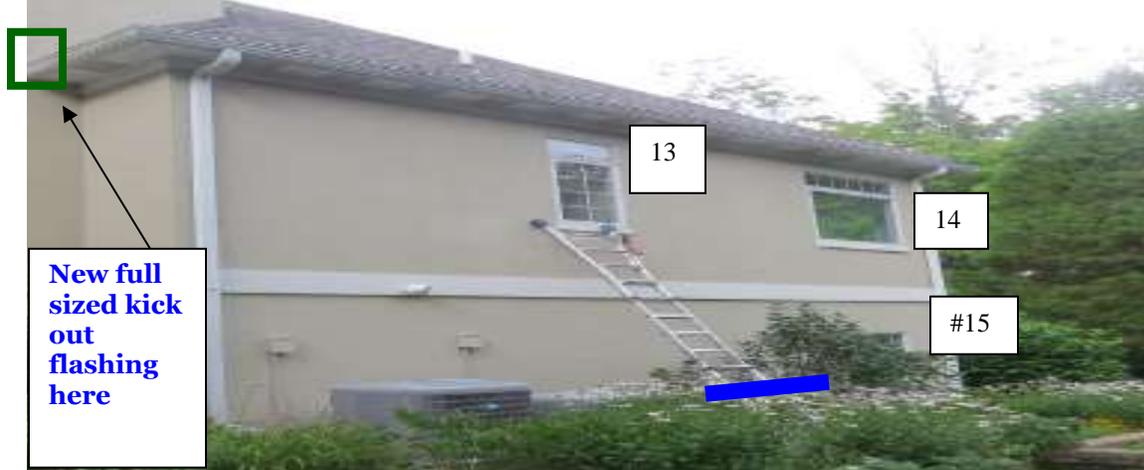
6). Right Rear Wall

Elevated readings and soft substrate below window #15. The rest of the windows and wall penetrations need new caulking but there are no other issues.

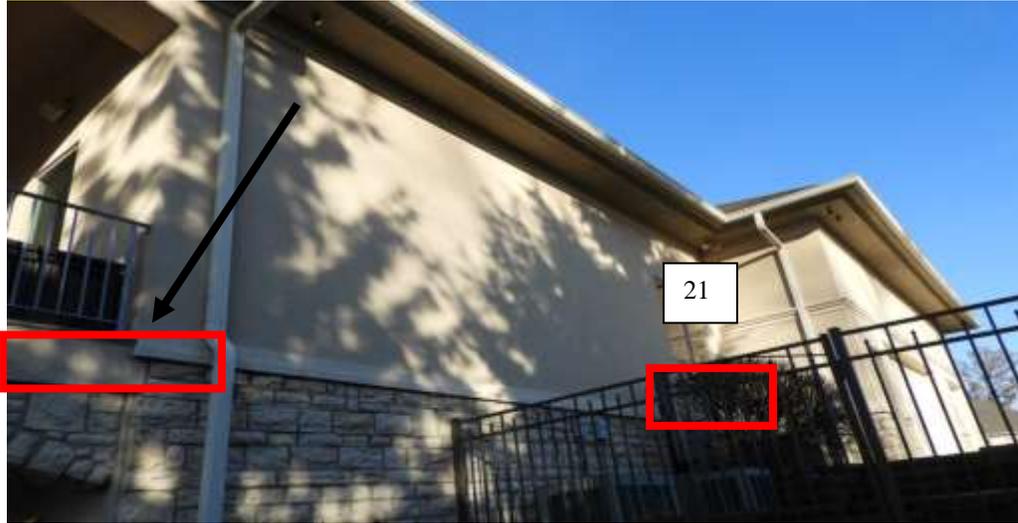
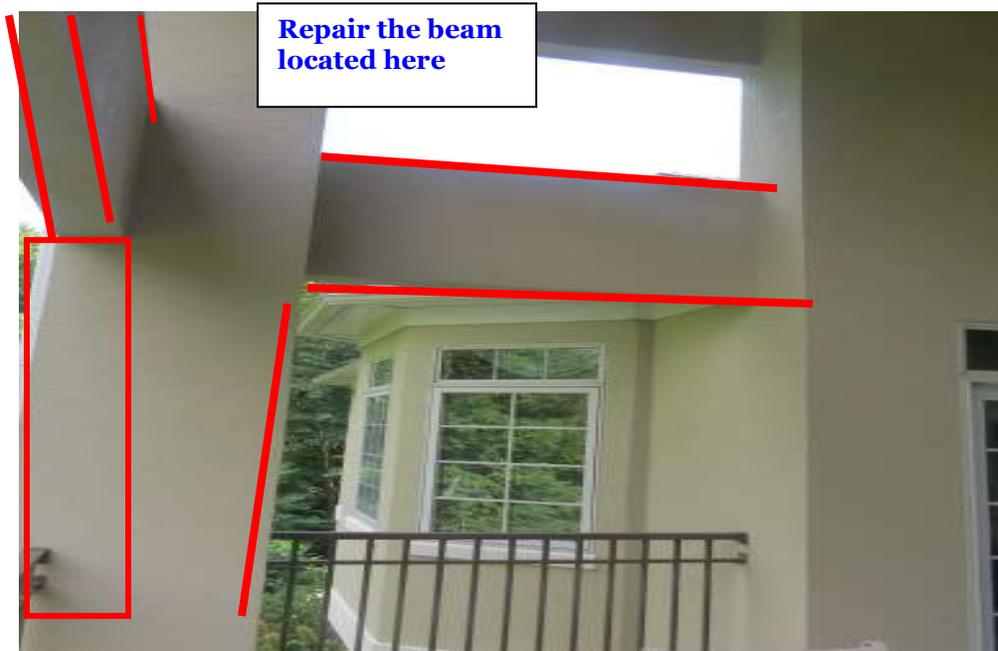
7). Rear Left Walls

There are **elevated moisture readings on the rear wall below one window** and along the length of the rear deck. The window can get a sill drain and some wall repair and be repaired. **The rear porch however will need more significant repairs. The post surfaces below the porch are very soft.**

The horizontal sections and vertical columns are all showing elevated moisture readings at all surfaces

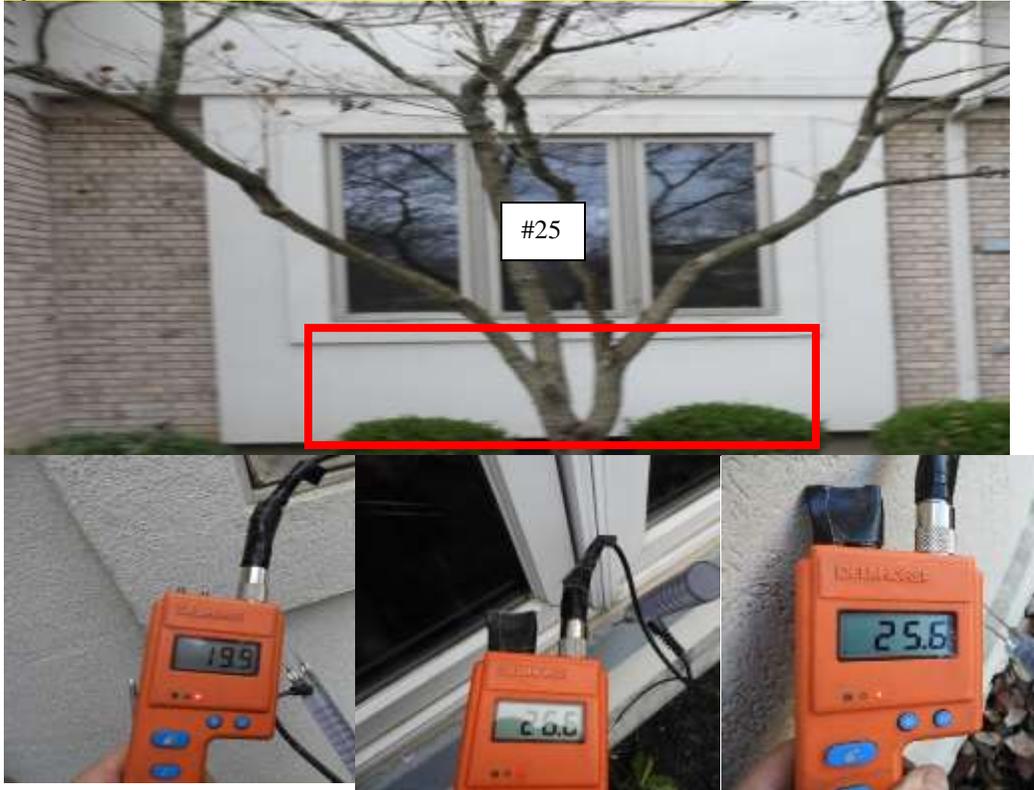
8). Left side wall

Wall replacement will be needed below window #25. There is soft substrate and high moisture readings at all tested locations. The repair of the wall and replace any water damaged studs and substrate will be needed. To prevent future moisture intrusion, a sill drain system should be installed below the window.
