FINEGAN INSPECTION SERVICES, INC.
TERRY FINEGAN
27 LAURELWOOD DRIVE
MILFORD, OHIO 45150
683-0733-PHONE

Specific Site Conditions

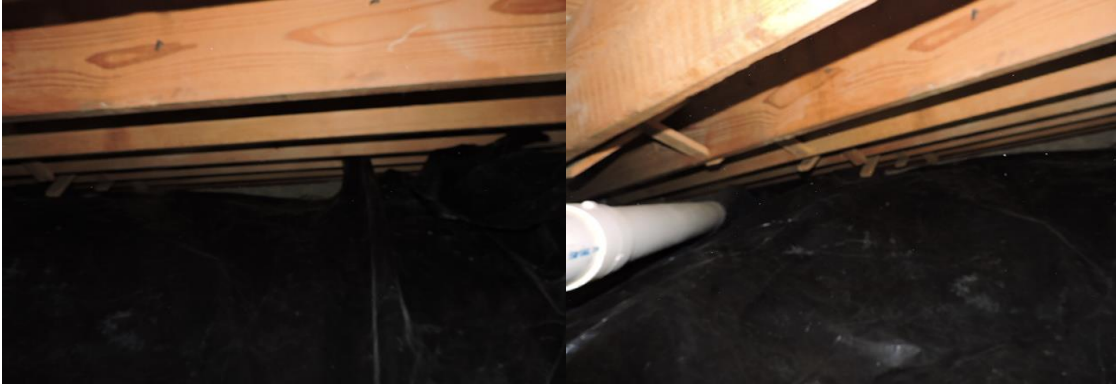
Front storage room crawlspace showing cleaned joist, no mold

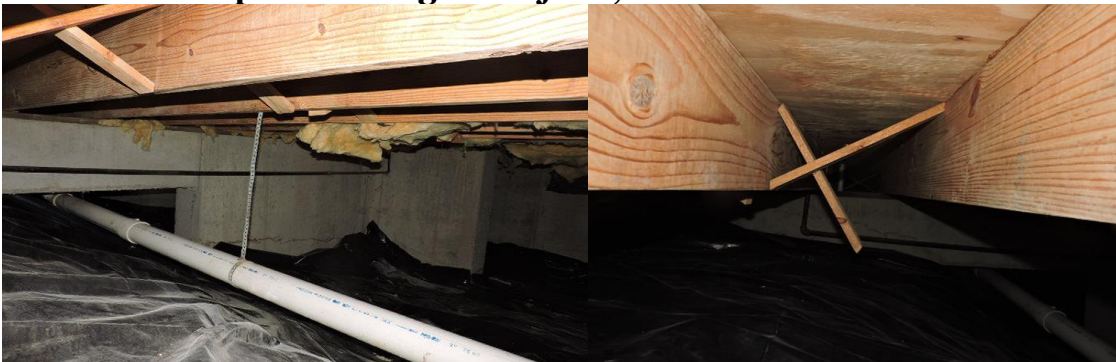
Center Crawlspace showing clean joist, no mold.

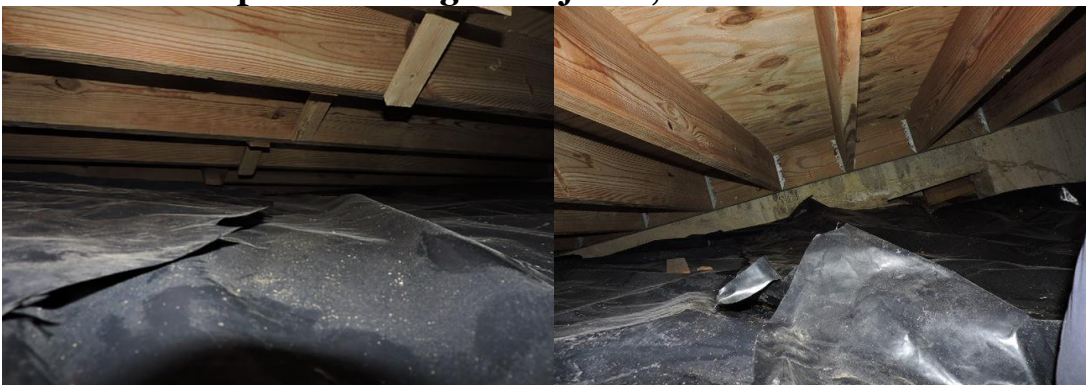
Far left crawlspace showing clean joists, no mold
