FINEGAN INSPECTION SERVICES, INC.
TERRY FINEGAN
27 LAURELWOOD DRIVE
MILFORD, OHIO 45150
683-0733-PHONE

This is a **specialty construction report** as per the clients' request. The report is designed to discuss the conditions of the **foundation**, at the above address. The above mentioned conditions were observed on _____ between _____ p.m.

OBSERVATIONS

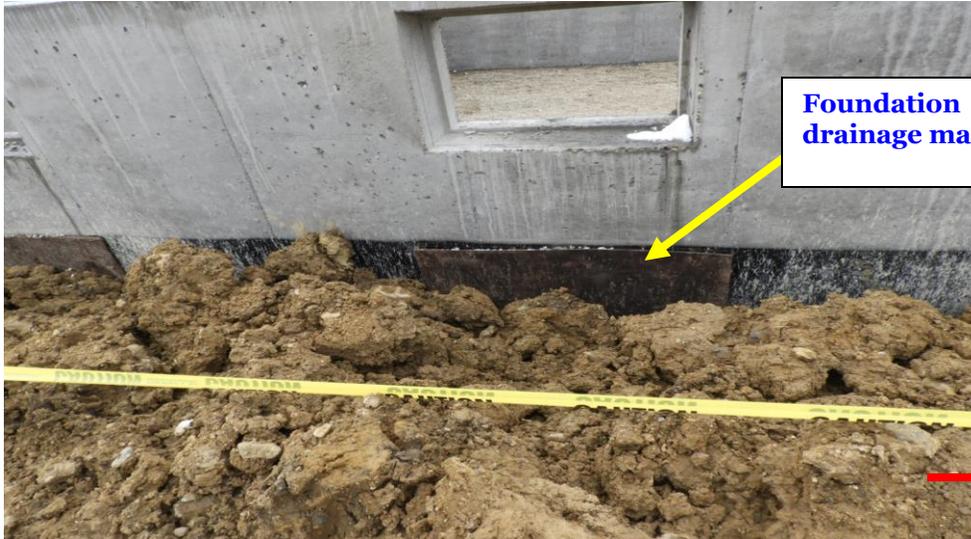
1). There is also a drainage mat system applied to the surface of the foundation below all foundation windows. This will insure that the foundation will properly drain all surface water at the wall surfaces.

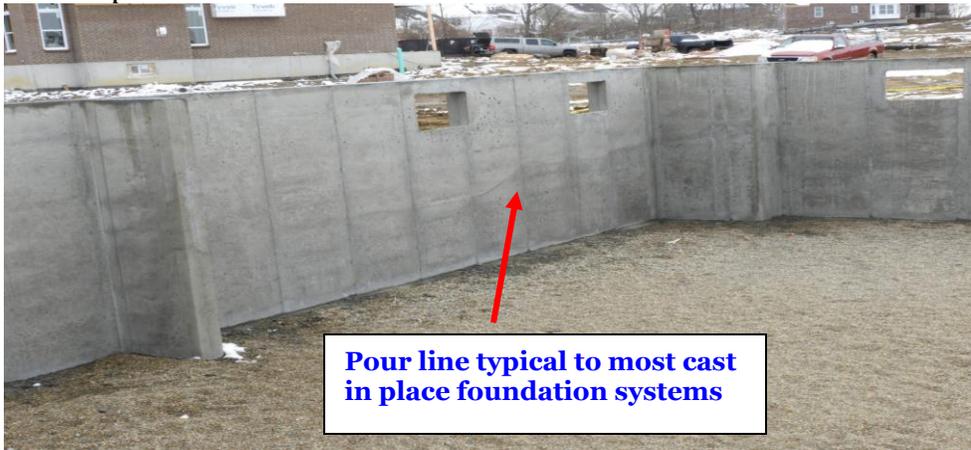
2). There was a concrete cast-in-place **foundation** installed on the site. It was noted to be plumb and square. With all the offsets in the foundation no calculations were attempted to determine the exact foundation conditions as in comparison to the drawings.

There were no significant gravel pockets in the foundation, (that would be indicative of poor quality pouring and/or concrete), nor was there evidence of improper concrete materials or bowing to any of the wall surfaces. There were minor “pour lines” in the concrete.

These are caused by the different batches of concrete being poured into the forms. It is a common color variation, but has no impact on the structural integrity of the foundation. There were no cracks or “cold lines” in this concrete application. There may be a future crack at the foundation surfaces where it **bridges between the garage footings** which are set at 30” below the frost line and the deep footings of the basement, but these types of cracks are not abnormal and have no structural significance to the foundation system.

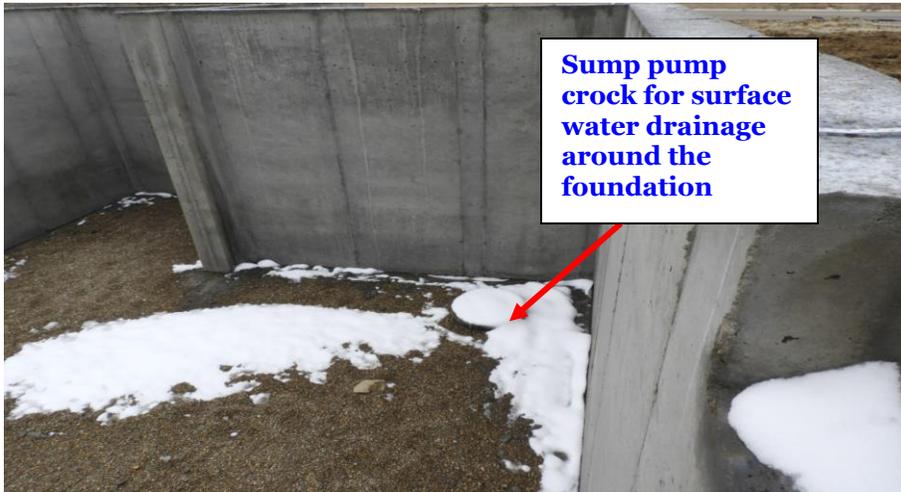
The wall ties had been removed from the wall surfaces and patched on the exterior wall surfaces. The foundation is straight and noted with no leaning or deviations from plumb.

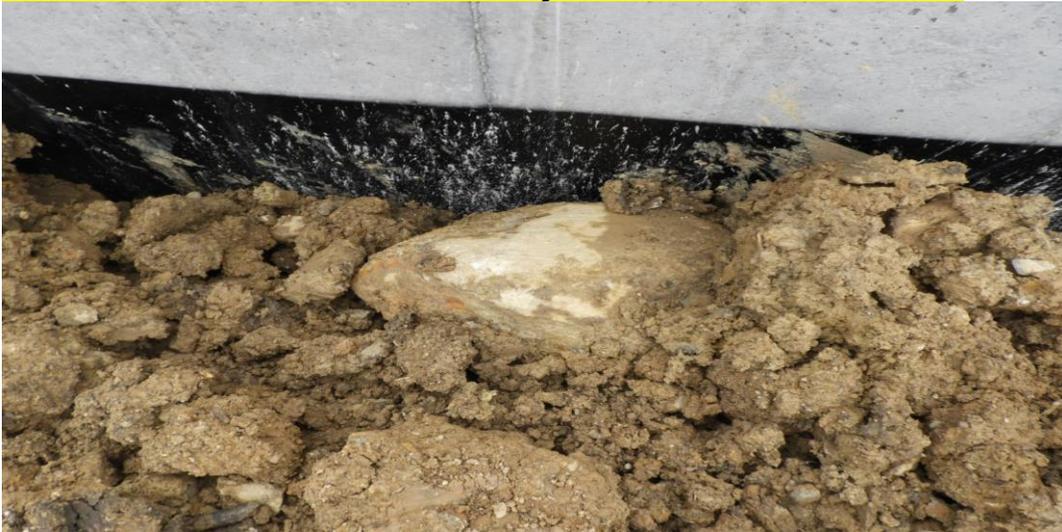
NOTE: On the left wall there is a very large stone that has been backfilled against the concrete foundation. This will place a great deal of concentrated pressure against the foundation in that spot. It is likely that the foundation will crack at this location if the stone is not removed. Have the stone carefully removed at this location.

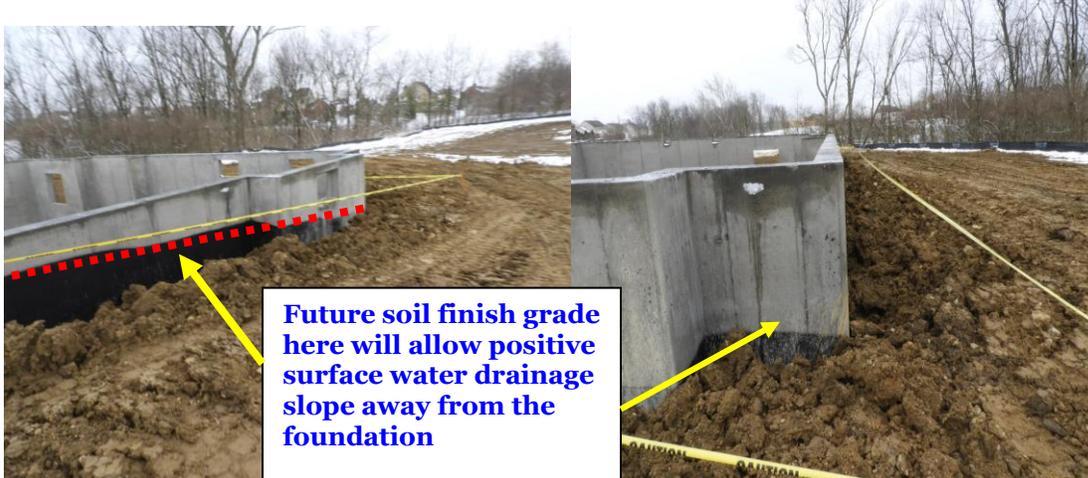
4). The **site** was noted to be without problems in terms of elevation of the foundation out of the grade. The height of the foundation above the level of the soil is sufficient to allow the back fill to be accomplished and to allow surface water to drain away from the basement without low spots that would allow water drainage toward the foundation.

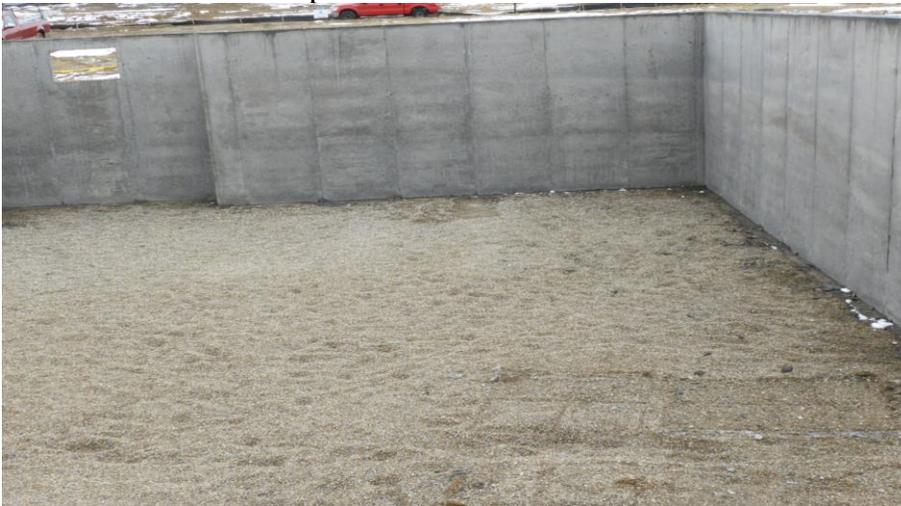
5). There is **gravel in the basement** at this time. It is the proper type of gravel to provide compaction and water drainage and is at a level that is above the height of the tops of the footings. This gravel will provide drainage of water under the future concrete slab and it will provide a low compaction type of base for the concrete slab to rest upon.

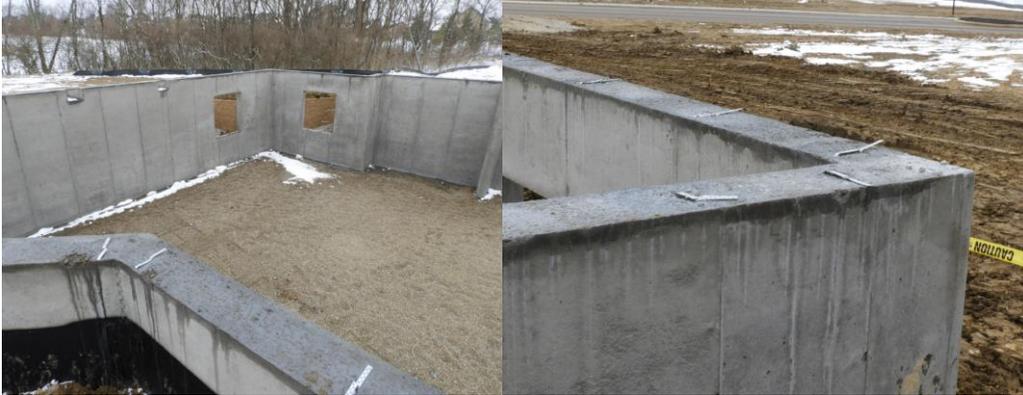
7). Foundation straps are noted in the surface of the foundation. These types of securement systems are typical to many framing system to a foundation.
