FINEGAN INSPECTION SERVICES, INC.
TERRY FINEGAN
27 LAURELWOOD DRIVE
MILFORD, OHIO 45150
683-0733-PHONE

RESIDENCE

This is a **punch list report** so as to review the framing items in the house that are in need of modification or completion by the carpenter and other subcontractors as a part of the predrywall walk through process. This inspection was made on _____.

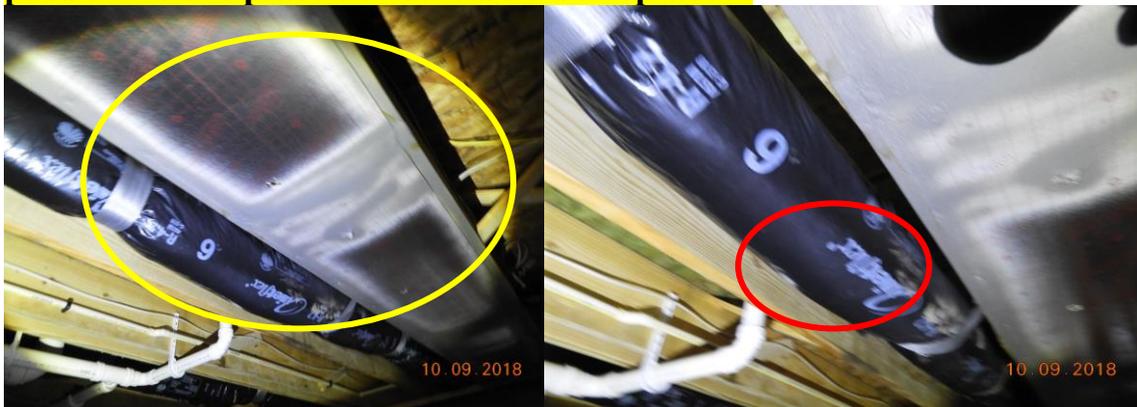
NOTE: At this time the roof is complete and there is no evidence of water intrusion **except in the basement HVAC supply vent and return panning. The installation new panning and drain the supply vent is needed. The part of the supply vent that was opened by pushing a probe into the plastic should be also replaced.**

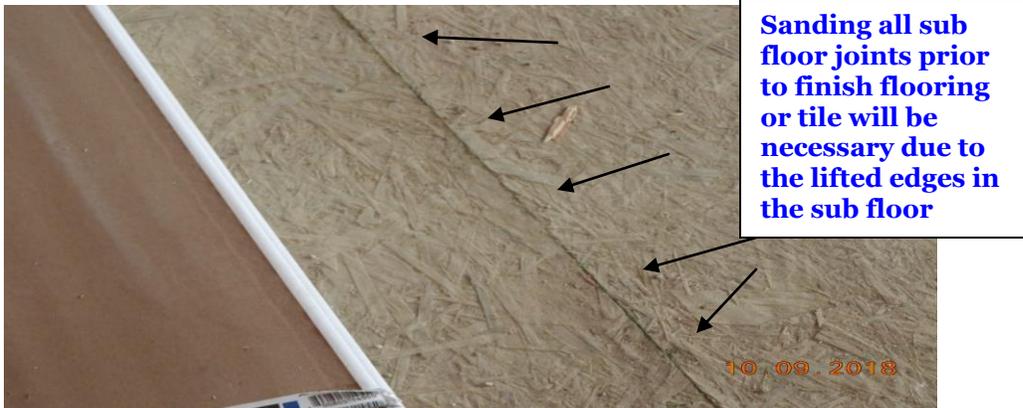
2). The sub-floor material is very resistant to deterioration caused by water. The floor area here and in the of the house will be **sanded by the builder prior to finish flooring.** If the area has any warping or irregular surfaces, the builder can cut out any floor section and replace any significantly warped sub floor. Mold is not a concern at this time.

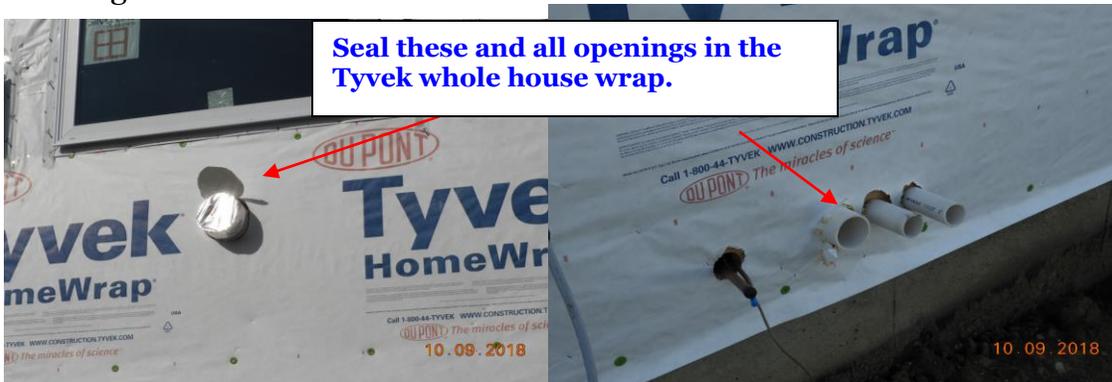
3). There was a house wrap on the exterior walls at this time. There was **brick ledge flashing at the foundation line**. This has been properly installed and seals the intersection of the foundation and the house walls.

Have all wall penetrations and openings in the Tyvek sealed prior to brick or siding installation.

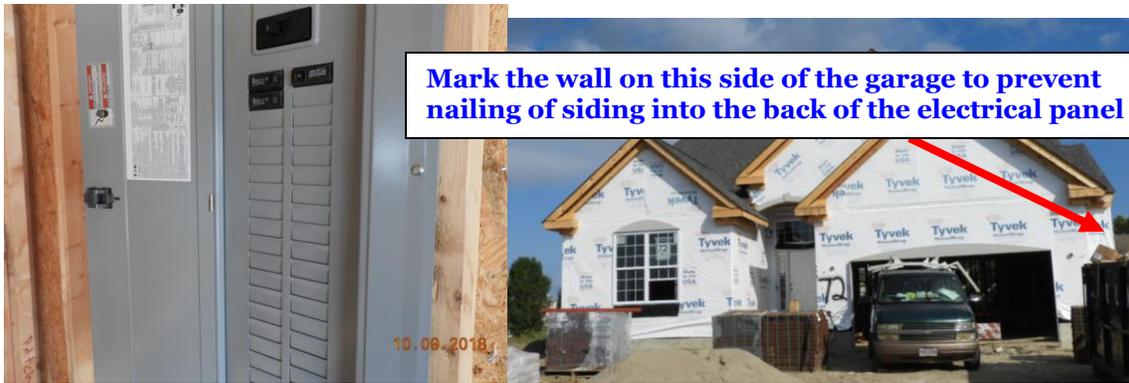
4). **The brick installation** is not yet accomplished. Proper installation technique will include an air gap at the back of the brick and the front of the substrate in all locations. Brick ties should be installed at least every 6th course and every 48" into the studs, not the substrate only.

5). The location of the electrical meter is on an outside wall of the garage. **Have the location of the electrical meter marked on the outside wall** so that the siding installation team does not drive any nails into the back of the electrical panel.

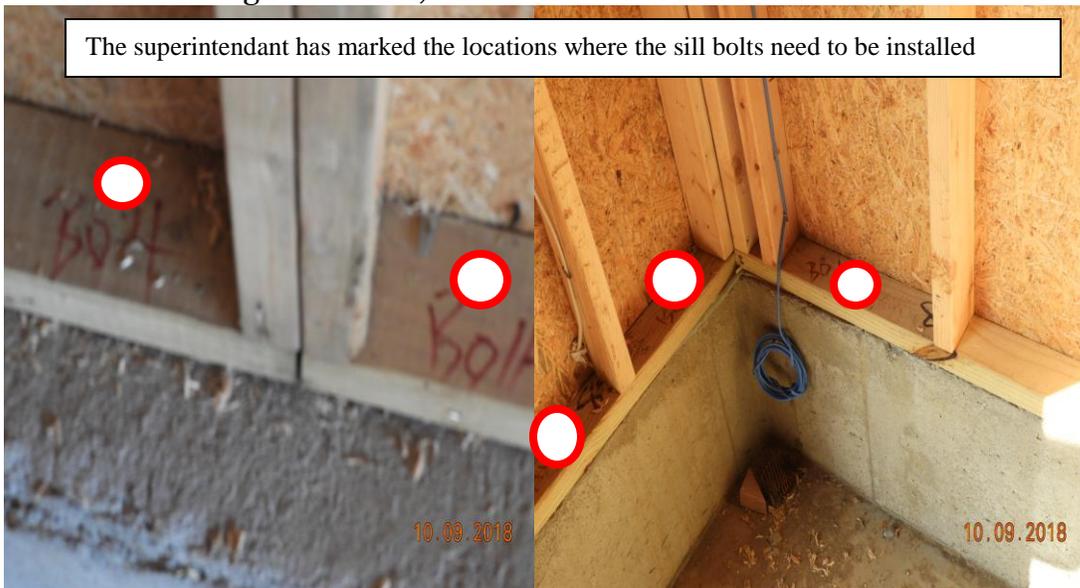
6). **Truss joist layout and wall layout** are consistent and properly accomplished. The wall studs and floor joist are aligned so that there is good transfer of the wall and roof load and so that all mechanicals can be easily accomplished.

7). **At the sill plate in the garage there needs to be added sill bolts** to the plate into the concrete foundation where there is a connection of two wall sections on the right side wall, and at the front left corner of the foundation.

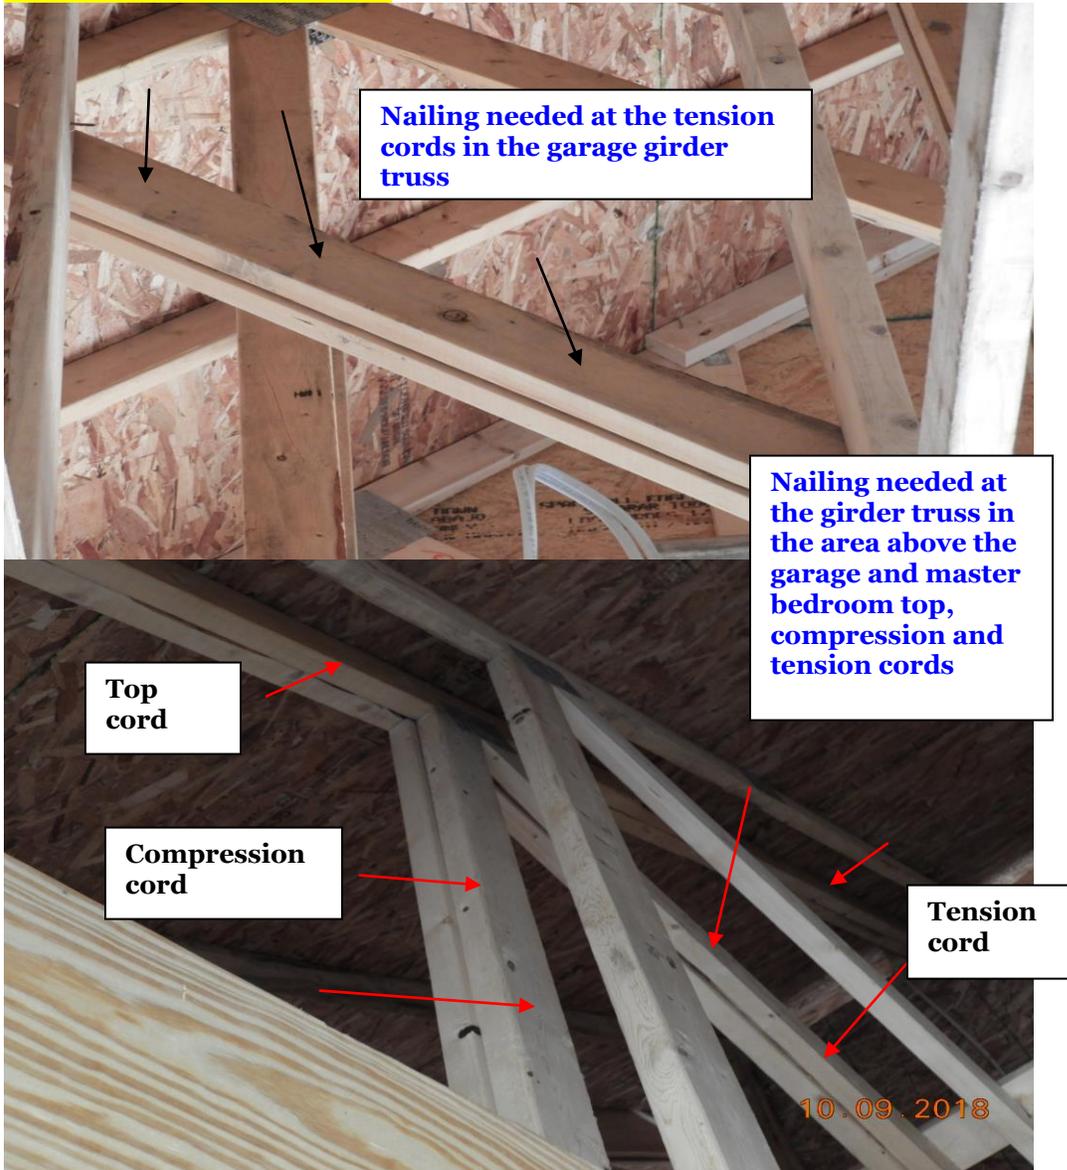
8). There are a few **girder trusses**. These are larger trusses that not only support the weight of the roof but also support the weight of other common trusses. These trusses are doubled against each other and should be nailed into each other so the two large trusses work like one big support.

In all truss cords of these trusses there should be nailing. There is a drawing supplied by the truss manufacturer that will show the locations of the

nails into the two truss members and the nailing “schedule” meaning the amount of nails and the spacing of the nails.

In the case of the girder truss in the garage and the master bedroom, there are some cords of the trusses noted without nails. All cords need to be nailed together at the top cords, tension cords compression cords and bottom cords.

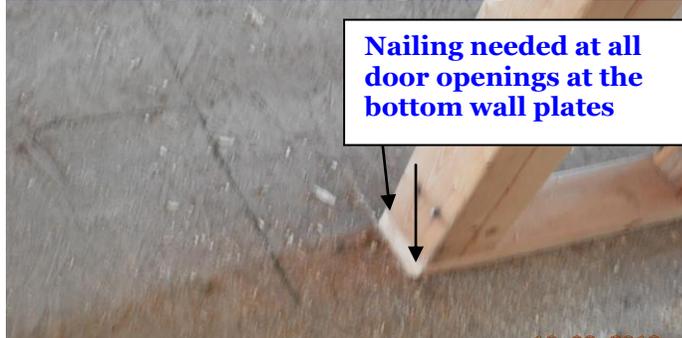
****9).** When the house is framed the framing crew sets a wall and leaves the bottom plate intact even where it passes through a future door opening. Once the wall is supported and the house is braced and secured, the bottom wall plate is cut out where it passes through a future door opening. On each side of the door

opening a few nails need to be driven into the wall plate into the sub floor. This will aid in keeping the future door straight and secure in the wall. **In this house the nailing at the door openings needs to be accomplished.**

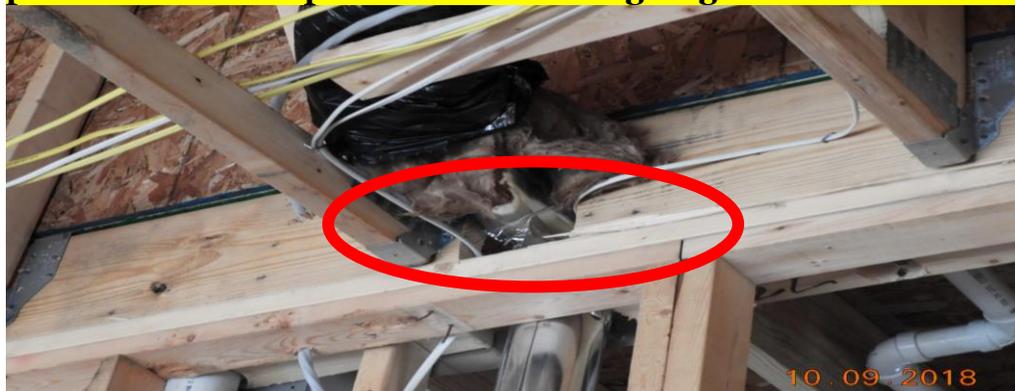
10). In the attic and unfinished areas where the **bathroom fan and other vents** are located, any vent that is above the insulation level needs to be insulated with a sleeve to prevent condensation from developing and leaking. All vent fans appear to have been sealed **but there is a gap in the ducting where it passes from the top of the wall in that garage. Have this sealed.**

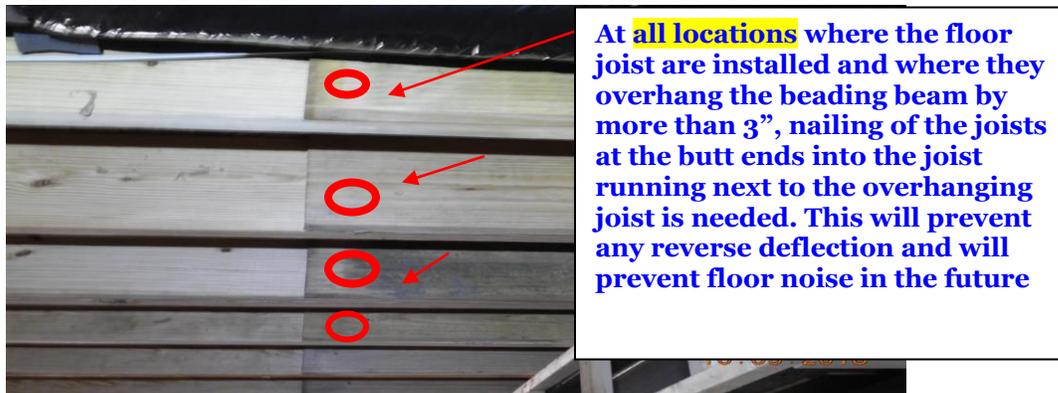
****11).** **Nail all floor joists that overhand the beam in the basement.** Any joist that extends past the beam by more than 3" must be nailed off so that it will not cause floor noise in the future

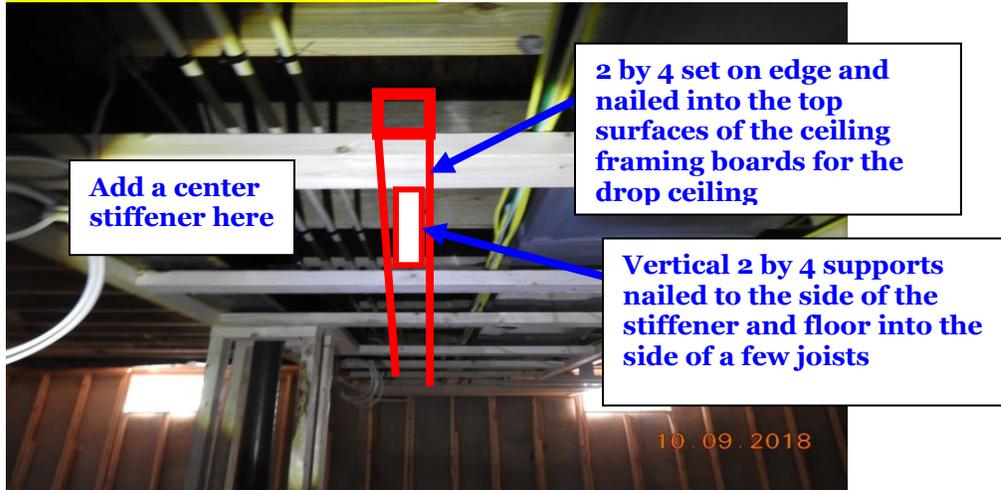
****12).** In the basement there will be a drop in the height of the ceiling that runs below the steel I beam and the HVAC trunk line and other plumbing and electrical lines. At the bottom of the drop 2 by 4 wood was used to support the future ceiling of the drop area. The center support is often times called a “stiffener” **A two by 4 run parallel with the drop and the center of the drop that is set on edge and nailed into the floor joist in a few locations with support 2 by 4 boards will insure that the drop ceiling does not deflect over time.**
