***FINEGAN INSPECTION SERVICES, INC.***  
***TERRY FINEGAN***  
***27 LAURELWOOD DRIVE***  
***MILFORD, OHIO 45150***  
***683-0733-PHONE***

**RESIDENCE**

This is a **Pre-Sale inspection report**. The purpose of a pre-sale inspect report is to review the information observed at the inspection on \_\_\_\_\_  
\_\_\_\_\_. This constitutes the entire report and serves as an informational report for the Seller(s) only. The purpose of which is to define for the seller(s) those areas that may need future or present repairs or modifications so as to prepare the home sale.

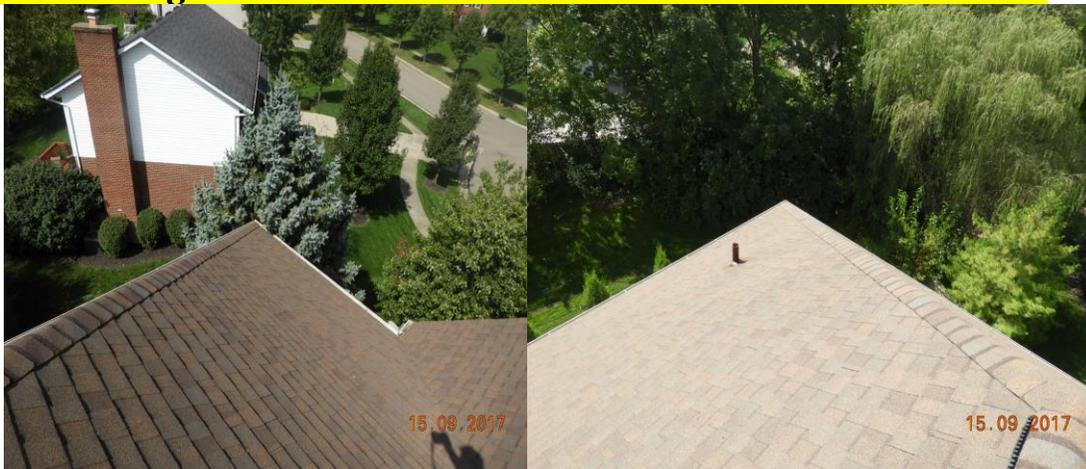
1). The **roof surface** was composed of fiberglass composition shingles. There were no missing shingles nor damaged shingles and no problems noted with the installation of these shingles. The front right and the front left trees are starting to encroach on the roof surfaces.

**\*\*Trimming back the branches in contact with the roof is advised**

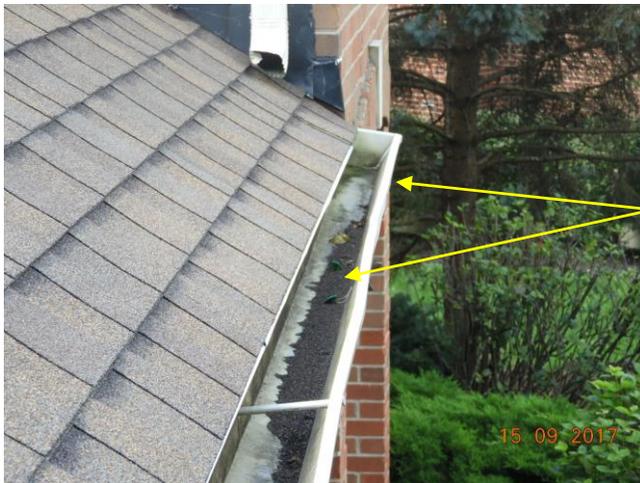
2). The gutters are in good general condition with a small volume of shingle granulate noted at the bottom of the gutter located on the front center area above the garage. **Flush out the debris is recommended.**

Install a few gutter clips here

**\*\* The gutter on the front of the garage and at the rear right second story house corner need to be better secured. Have gutter clips installed where there are none at this time.**

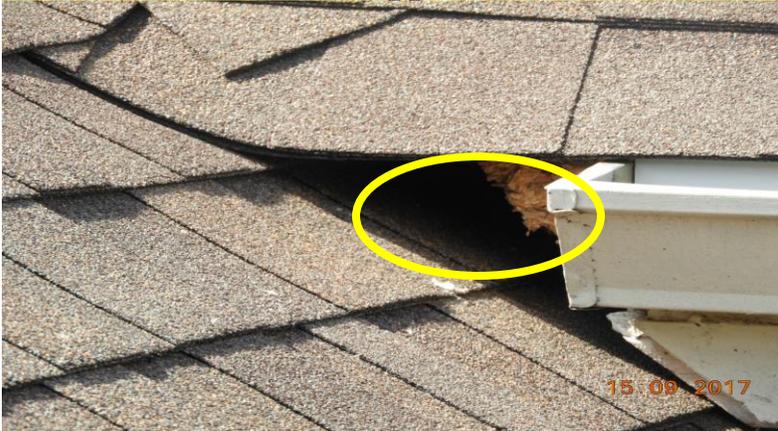
3). The roof flashings appear to be in good condition. Seal all gaps on the roof where past vermin entry had occurred. **It appears that there may be a gap where the soffit of the upper roof intersects with the garage roof.**

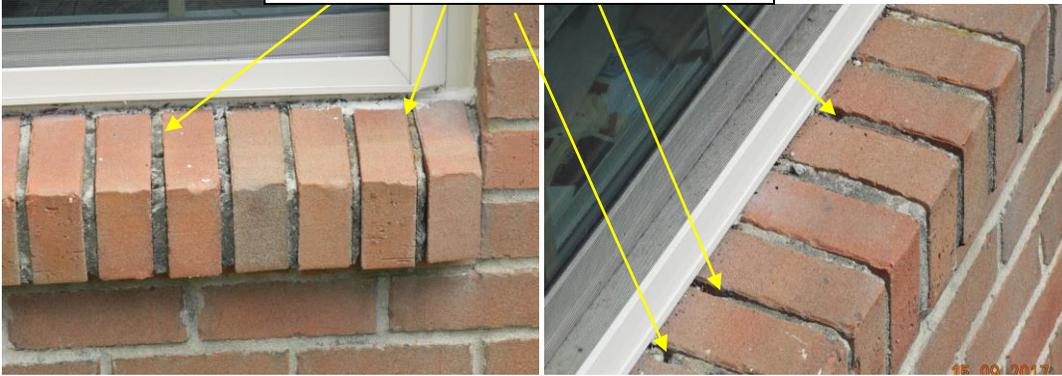
There are some **gaps in the mortar joints noted on the various walls and window sills. Tuck pointing those gaps is recommended** so that water access is not possible. The windows shown in the photos are on the rear walls of the breakfast area.

**Tuck points these and all gaps**

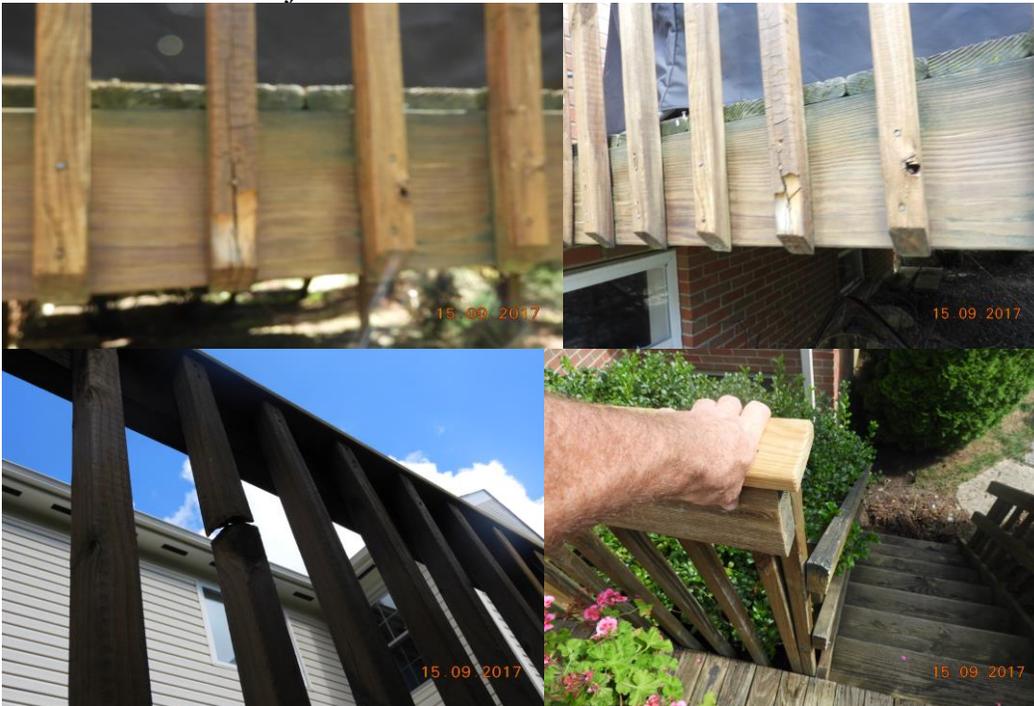
5). On the rear of the home there is a deck. There are several balusters that are loose or cracked. Have all replaced and the securement with deck screws is advised. There is a weak handrail at the top of the deck stairs. A 4" by 4" newel bolted into the deck joists is advised in these locations.

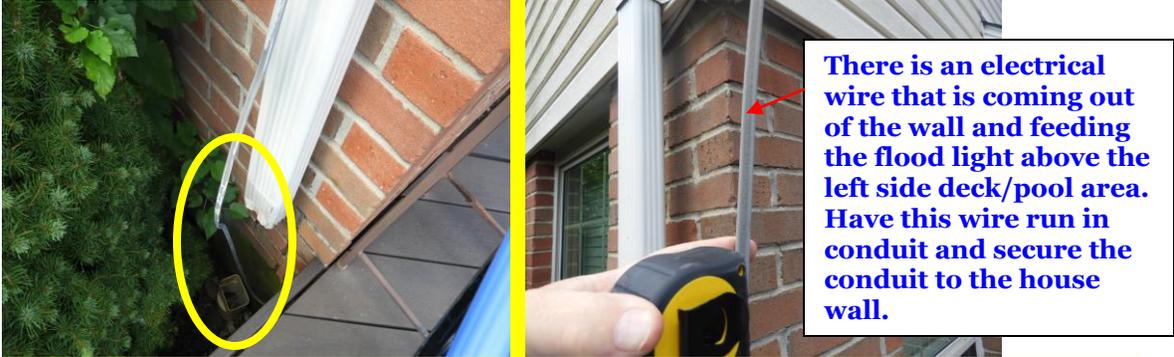
**6). The re-connection of the rear left downspout is needed near the rear deck corner and rear familyroom corner of the house.**

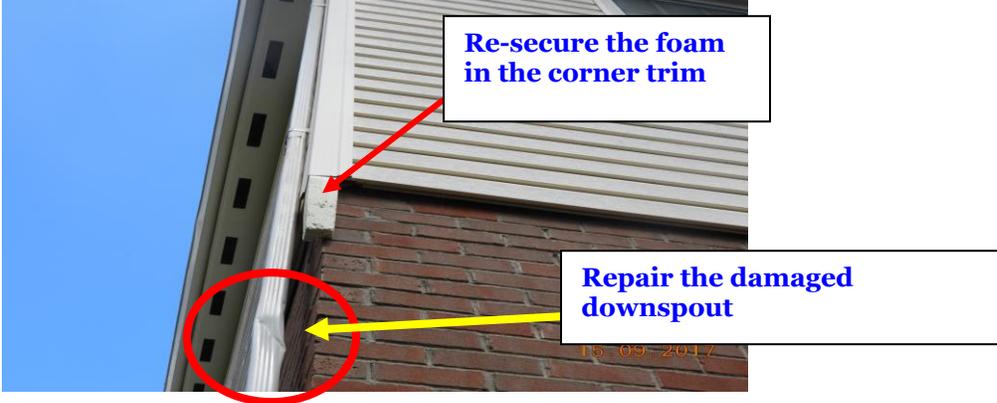
7). At the corner trim of the upper siding, there is some EPS foam that has slipped down out of the corner trim. Have the foam re-secured into the corner trim section. Repair the damaged downspout below the corner trim on the rear right house corner

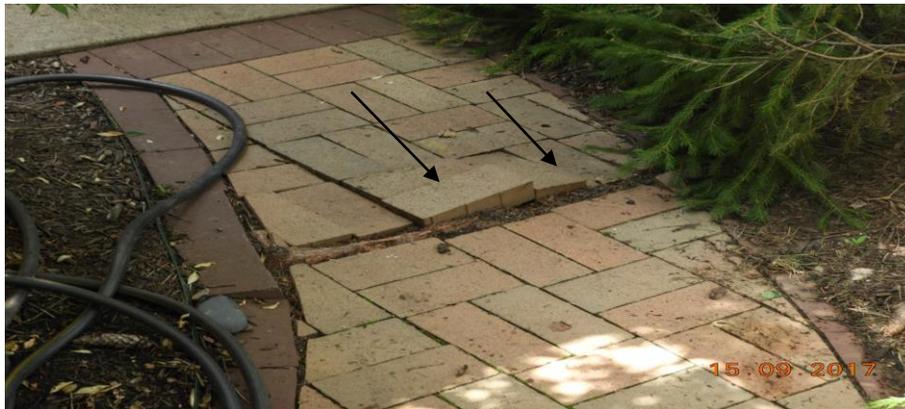
9). At the left walkway the tree root has pushed the brick paver sidewalk upward. This has made the surface uneven and the root should be cut out.

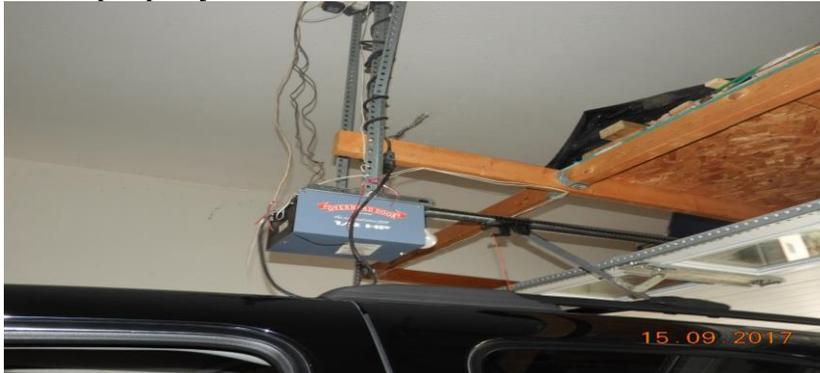
11). The **overhead garage door** was tested and functioned. The door **\*\*automatic reverse did not function properly** and should be adjusted so that it properly functions.

a). There is a **loft constructed using the garage door opener brackets as supports**. Because these brackets are attached to the bottom cords of the truss system and the trusses are not intended to support any additional imposed load other than that of the truss members, the disassembly of the loft is advised.

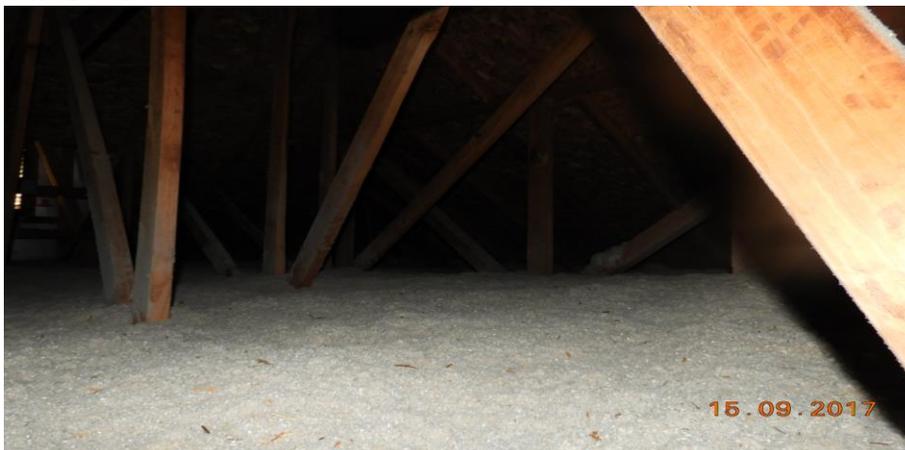
The **upper truss network** shows no issues and the roof deck is in good condition. There were no areas where any re-infestation of the vermin was observed.

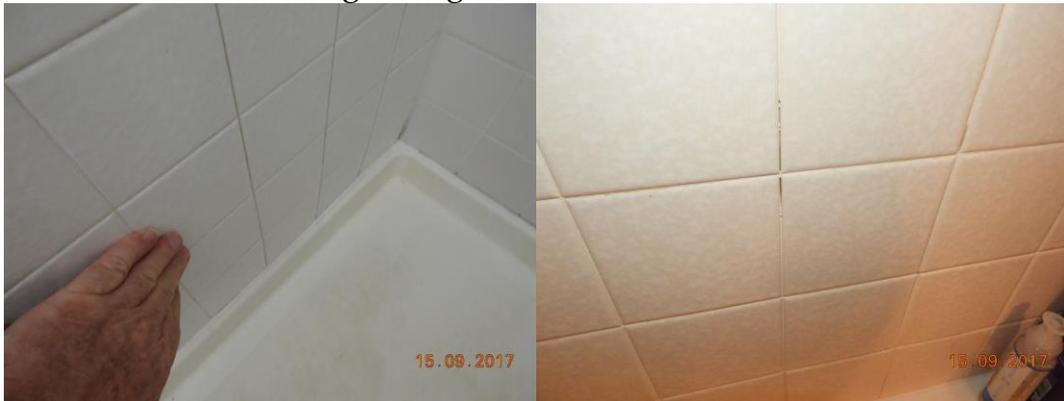
a). There is **movement of the back wall board of the master shower** and missing grouting. The replacement of the bottom 1/3 of the tile and wall board may be considered

b). The **hall bathroom of the second story** also has **missing grouting** in the shower area. The re-grouting of the wall is advised.

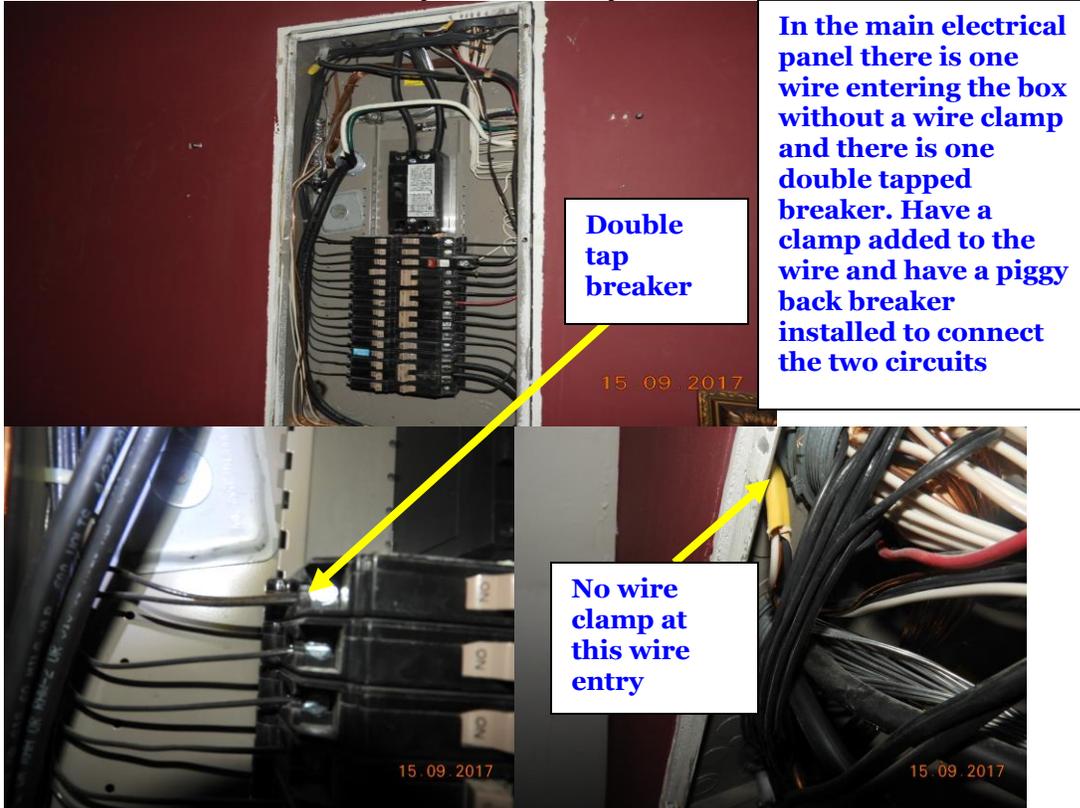
17). The **electrical panel** is inside of the basement. The dead front cover was removed and inside the main panel was inspected.

There were no major observed errors in the wiring technique. No water access was observed and the circuits showed no evidence of overload or overheating.

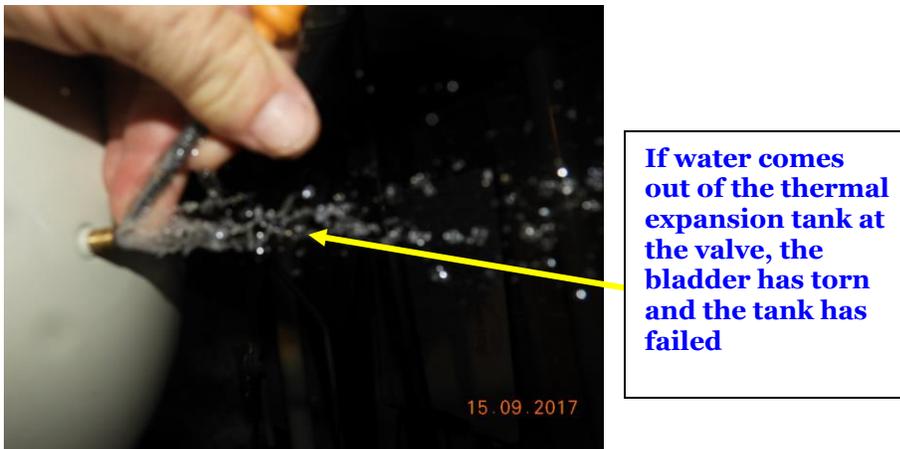
**\*\*18). In the basement** there is a thermal pressure tank installed above the water heater. This tank has failed and needs to be replaced.

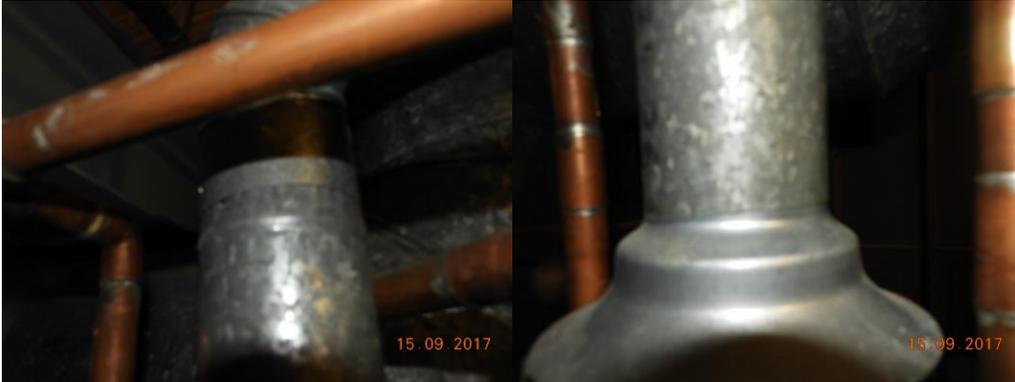
19). The gas water heater needs to have **sheet metal screws added** to each connection point of the vent pipe. There are missing screws on the vent pipe connections at this time.

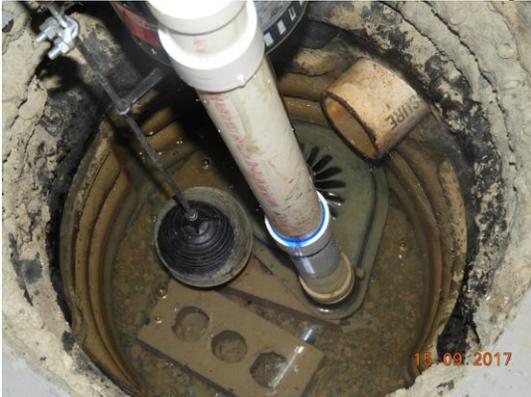
20). Have **the sump pump crotch cleaned out**. All gravel at the bottom of the crotch should be removed with a Shop Vac.

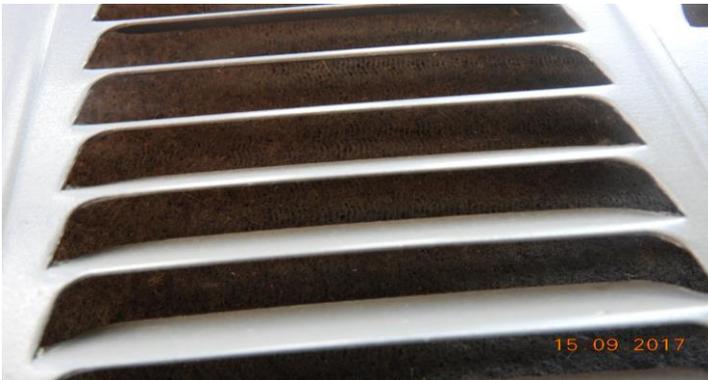
22). There is a **significant volume of debris on the exterior condensing coils** on this air conditioning system. Have the coils cleaned prior to listing the home.
