***FINEGAN INSPECTION SERVICES, INC.  
TERRY FINEGAN  
27 LAURELWOOD DRIVE  
MILFORD, OHIO 45150  
683-0733-PHONE***

This is a specialty report as per the clients' request. The report is designed to discuss the **roof shingle & flashing installation** at the above noted house. **Any items that need to be modified will be written in bold and have a highlight marking.**

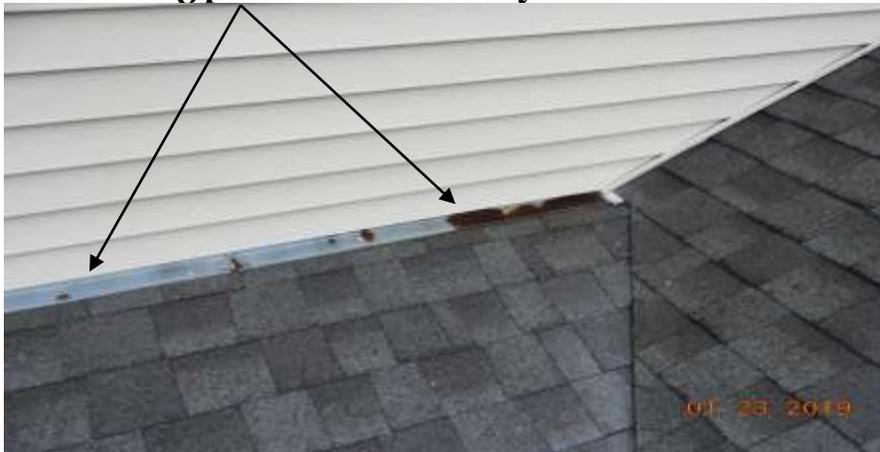
**4). Step flashing-** All step flashing on the roof surface at the wall intersections was **installed properly.**

**\*\*At the apron flashing on the front most gable of the house roof, have the flashing painted in the next year or two.**

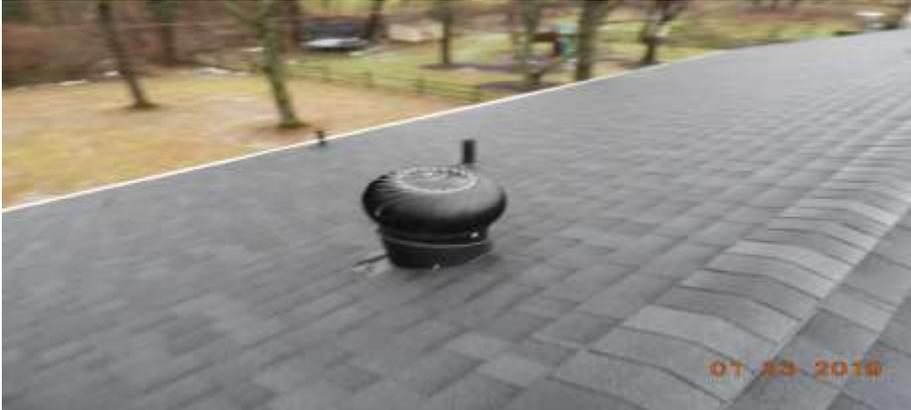
**8). Air vent type and installation-** The type of air vents on this roof were noted to be a spinning “turbine” type. Both appear to be secure and functional. There are also gable vents at the sides of the house. **The dual venting is not recommended. It is recommended that the roof have ridge vents installed and close off the gable vents. The installation of soffit vents is recommended around the perimeter of the home.**

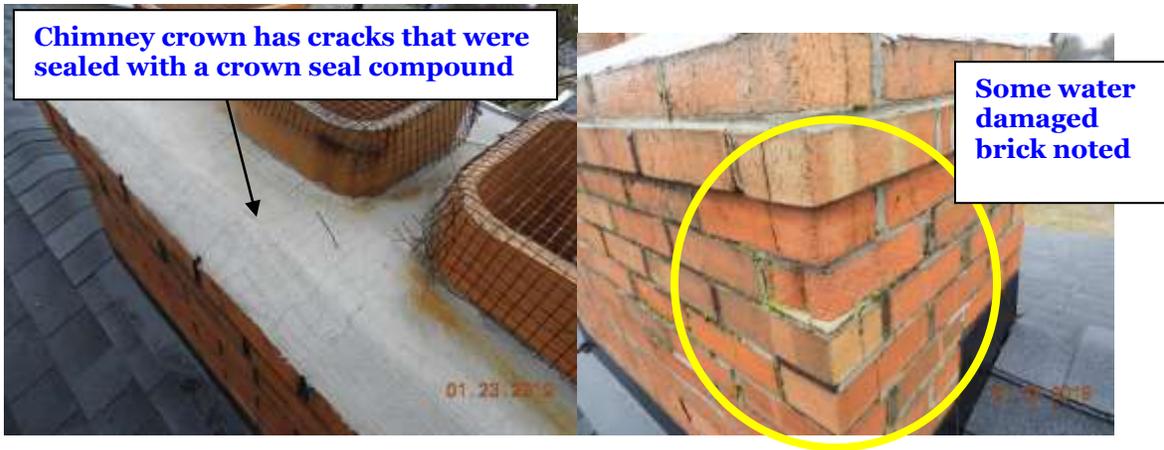
**11). Chimney system-** There was some brick damage issues noted with the fireplace chimney. Some bricks have been water damaged and the front 1/8<sup>th</sup> inch has fallen off. The water had accessed the brick via the chimney crown. That crown has been sealed. Monitor this and if more brick becomes deteriorated, have the chimney crown replaced, then replace the water damaged brick of this house.

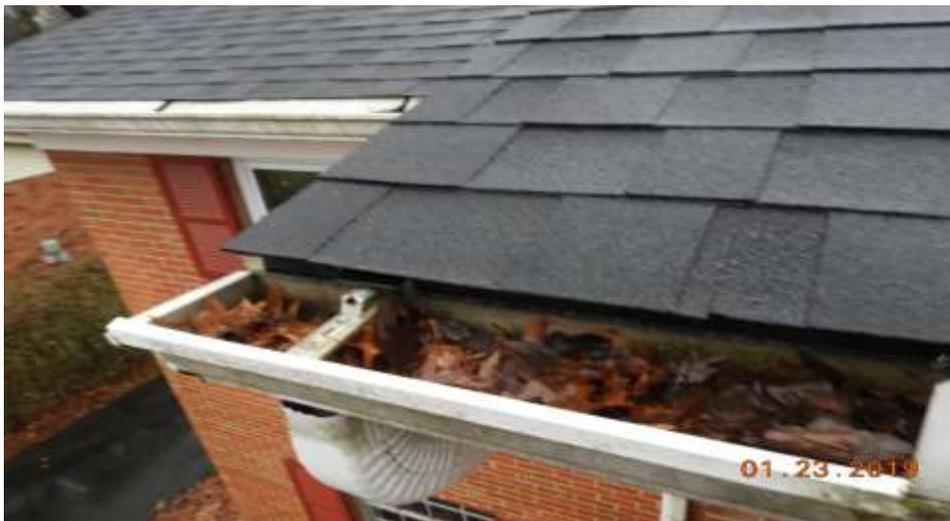
12). Most gutters were noted to be functional and draining without issues. On the front gutter above the front porch area, it is suggested to flush out the leaf debris that has built up in this gutter. There are some missing gutter screens where the leaf debris has collected

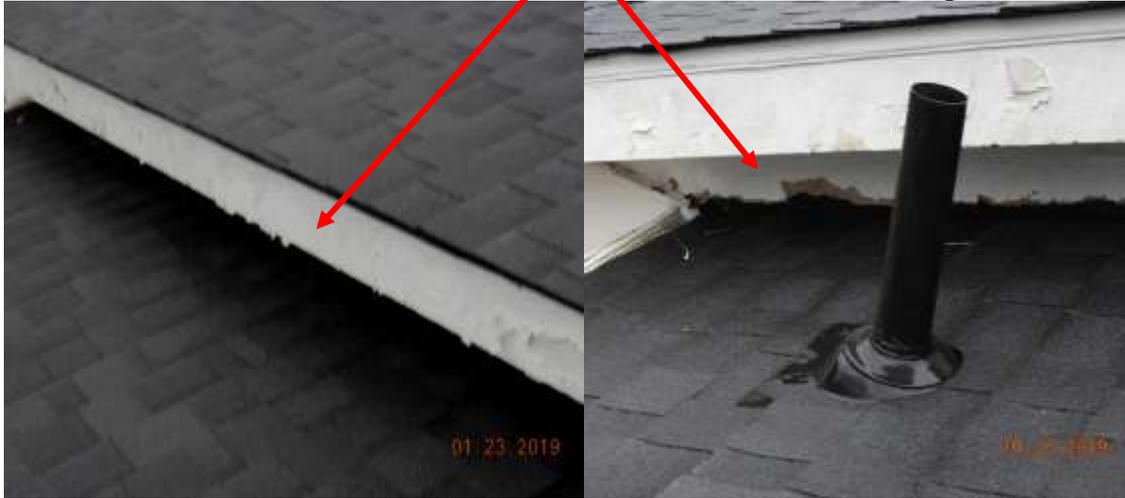
The rake boards at each side of the upper roof are in need of paint. Some lower sections show some deterioration where they intersect with the shingle surfaces. A **fiber-cement type material** is recommended in these areas or aluminum wrap.
