FINEGAN INSPECTION SERVICES, INC.
27 LAURELWOOD DRIVE
MILFORD, OHIO 45150
683-0733-PHONE

NEW HOME INSPECTION REPORT

This is a **punch list report** so as to review the items in the house that are in need of repair or to be finished by the builder as a part of the final walk through process. The inspection was made on _____ p.m.

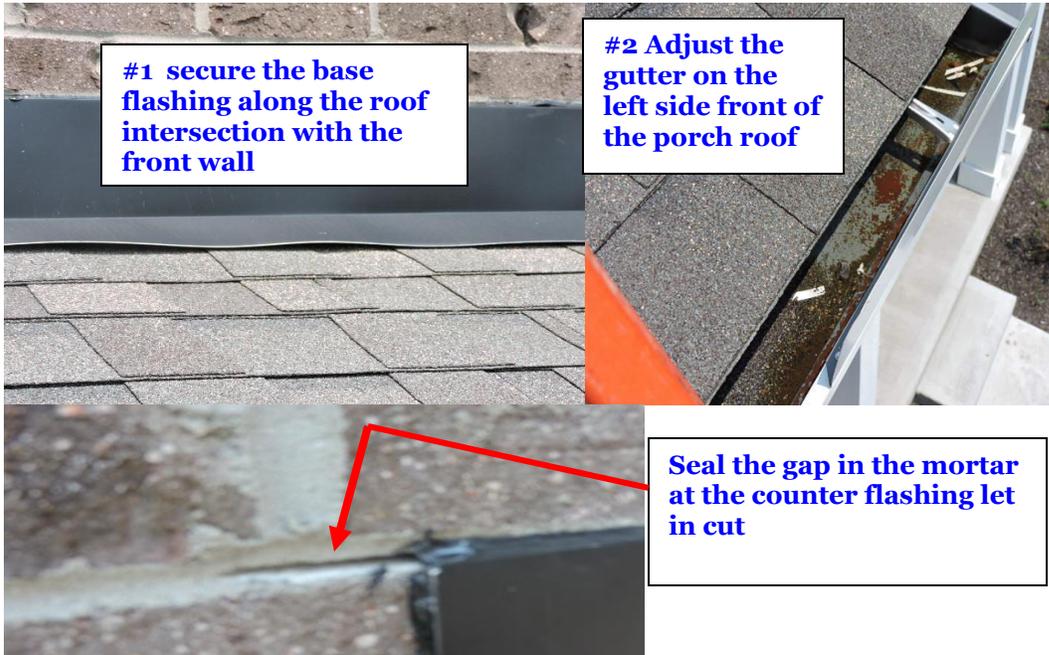
****1).** There is a lifted base flashing on the front porch roof, left surface of the gable area. The metal is not sealed at the shingle surfaces.

****2).** There is a gutter at the left side of the front porch that needs adjustment so that it properly drains. Right now water is pooling in the right 1/2 of the gutter.

****3).** There needs to be mortar seal at the cut lines in the bed mortar where the counter flashings were installed

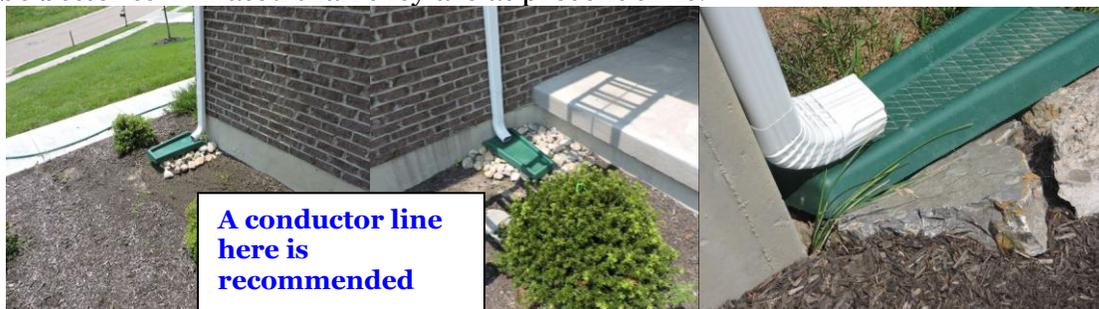
**** 4).** The **downspouts** were secured properly and properly sized for the size of the roof surface that they drain. The termination points of all downspouts should all be established so that the surface water drains away from the foundation. In the left and right and front of the house those downspouts need to be better terminated than they are at present time.

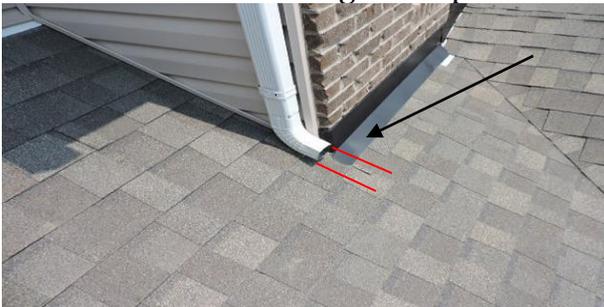
5). It is recommended that the downspout for the front second story roof be extended slightly down the porch roof by a few inches so that it does not terminate on the flashing of the porch roof surface.

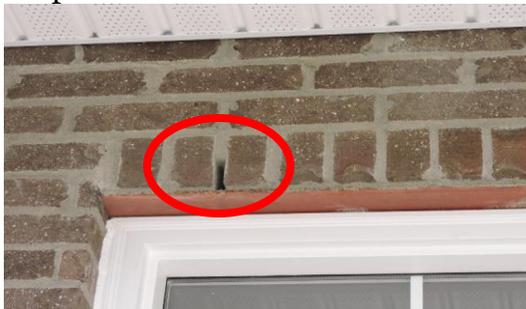
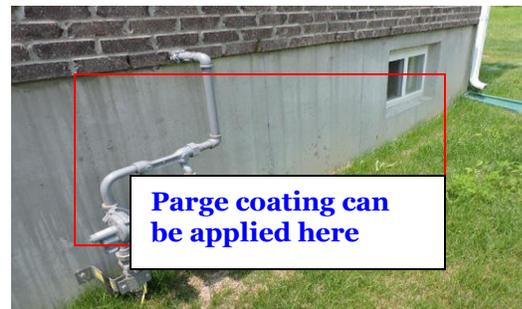
****6).** There were **weep holes** noted at the base of the brick around the entire brick façade. The weep holes were inspected in 4 locations during the inspection and all weep holes were clear of debris and/or blockage. Additional weep hole covers may be installed where some of the existing have fallen out. These will keep out insects in the future.

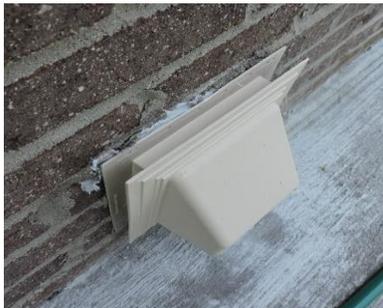
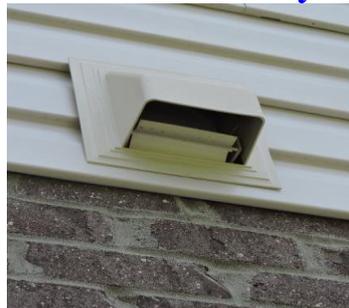
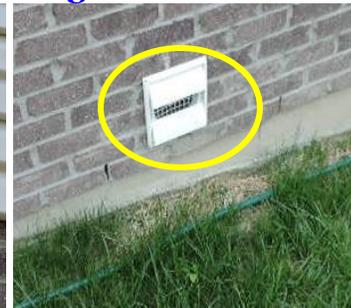
*****8).** The vent openings on the rear house wall all need modifications.

a). The vent cover that is closest to the concrete patio is not intended for brick installation. It is intended for vinyl siding installation.

b). The second story vent has some type of blockage in the vent cover.

c). The air intake vent cover near the familyroom is missing one of the deflector covers.

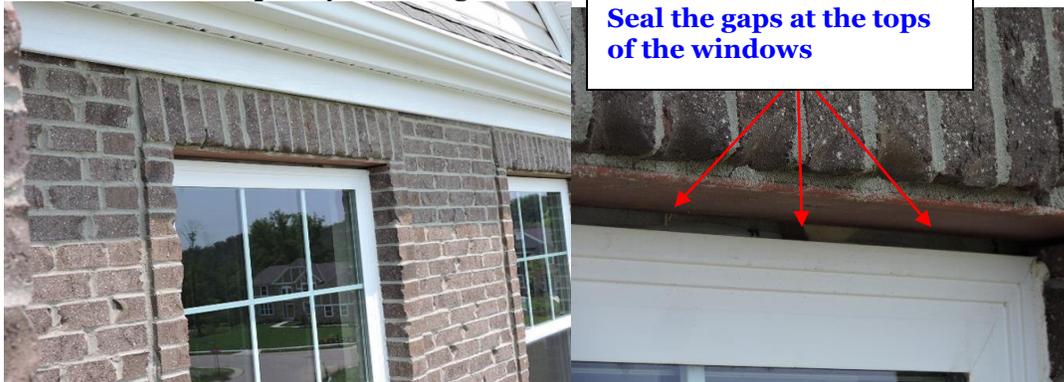
****9).** On several front wall windows that are gaps above the window frame between the frame and the bottom of the steel lintel. Have these gaps sealed with a backer rod and quality caulking.

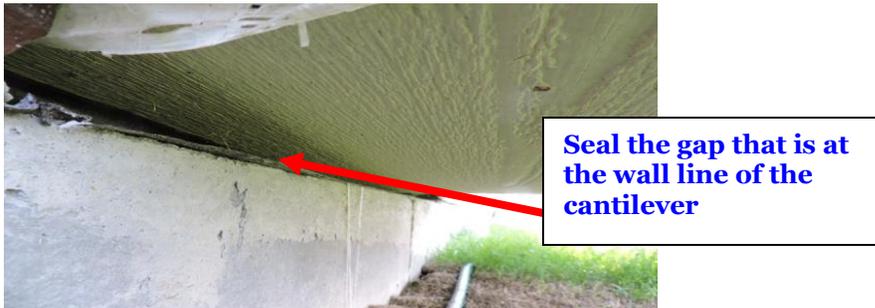
****10).** The fireplace cantilever is noted with a cover on the bottom facing surface. The cover material does not seal all the way to the wall line and this gap is recommended to be sealed with a pressure-treated board so that cold air or field mice cannot find access.

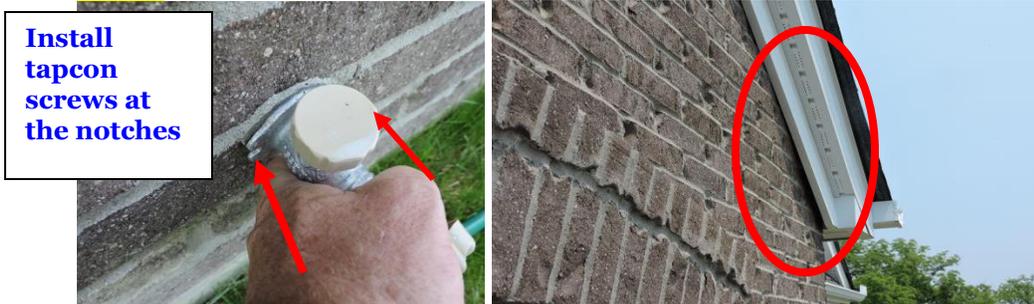
****11).** Secure and seal the faucet on the rear wall of the house.

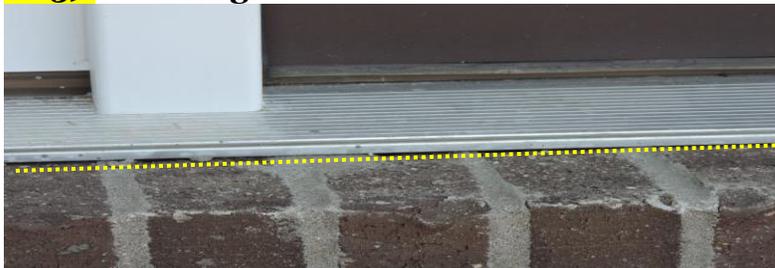
****12).** Better secure the right side rake trim to the wall on the front second story gable.

****13).** Caulking at the front door threshold is needed.

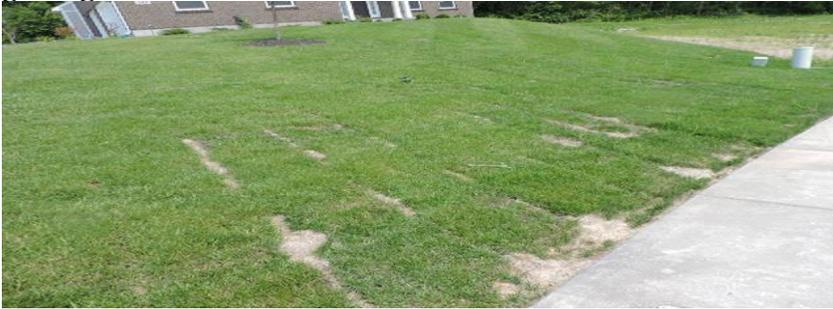
*****a).** There is one area in the front of the house. There is erosion in the yard between the sod areas. This needs new sod or to have seed planted in the fall to grow grass between the sod sections.

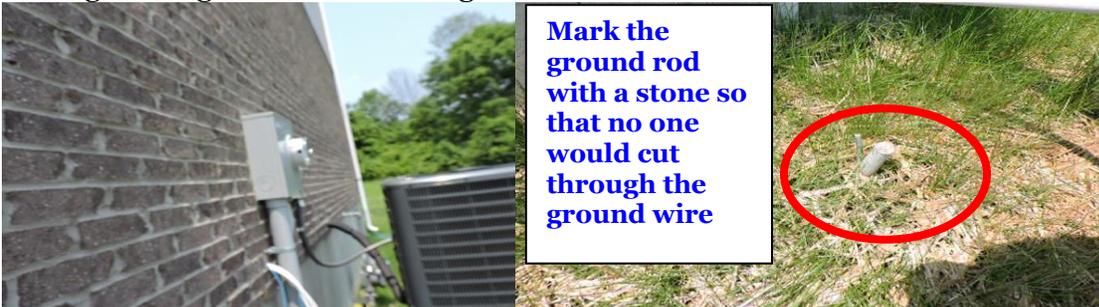
15). The **ground rod electrode** wire was observed at the right wall of this home. The meter is located on the right side of the home. In the future, if any excavation occurs in this area near the electric meter at this area in front of the basement walk-out stairwell, be careful not to cut the ground because accidental cutting of the ground wire is dangerous.

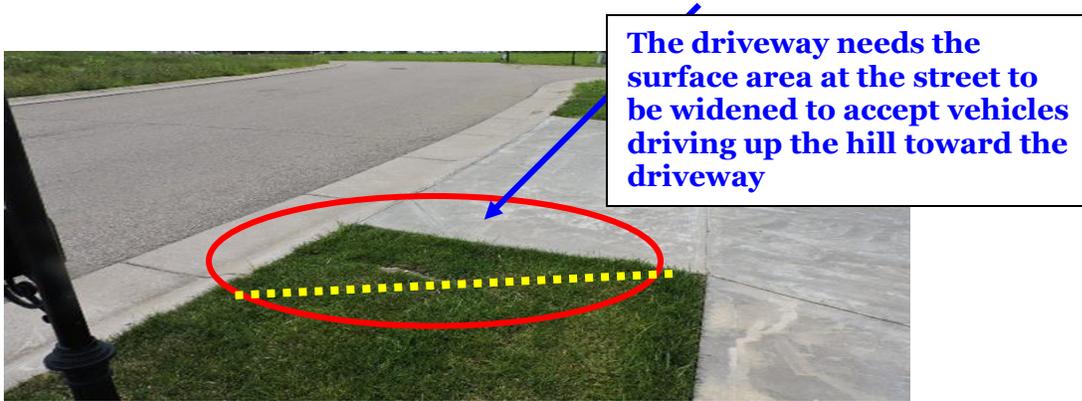
*****16).** Have the driveway apron modified so that a car can easily turn into the driveway without driving on the grass. The apron needs to be extended on the right side of this driveway apron.

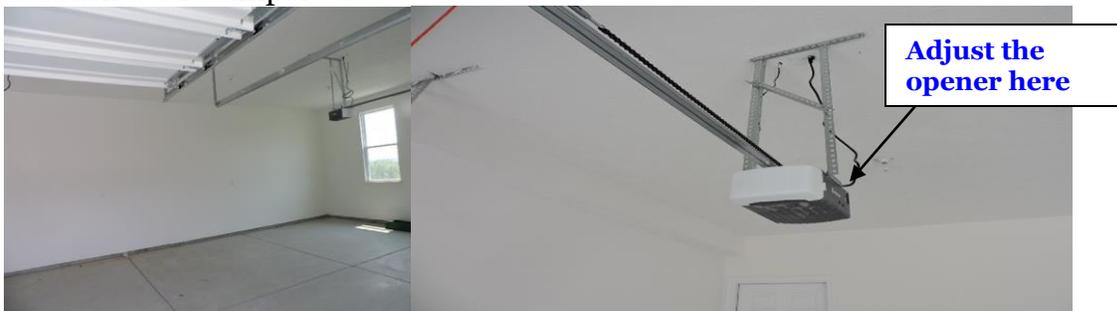
***18). The garage is in good condition. The left most opener,(single door) needs an adjustment of the down force sensitivity so that it will reverse if it were to touch a car bumper

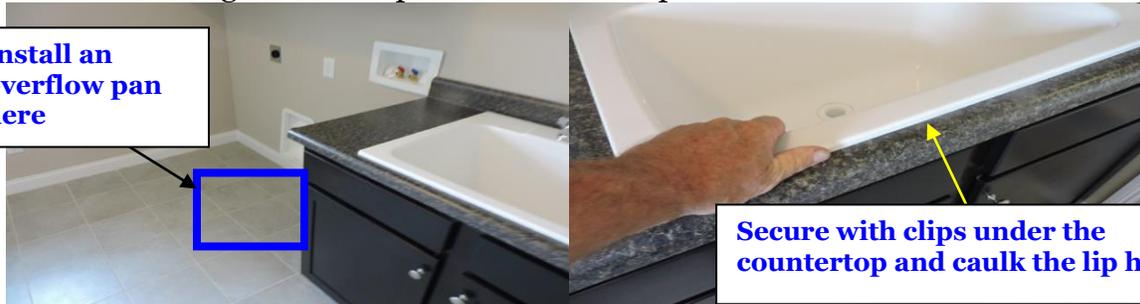
****a).** The **laundry sink** needs to be secured to the countertop so that it is secure. Caulking the sink “lip” at the countertop is also recommended.

Install an overflow pan here

Secure with clips under the countertop and caulk the lip here

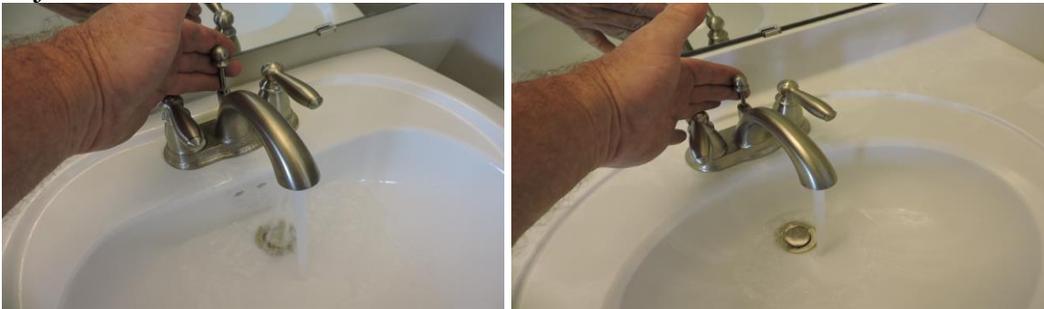
***a). The drain stopper in the 1/2 bathroom needs adjustment so that it will shut off and hold water.

***b). The drain stopper in the hall bathroom sink also needs a stopper adjustment.

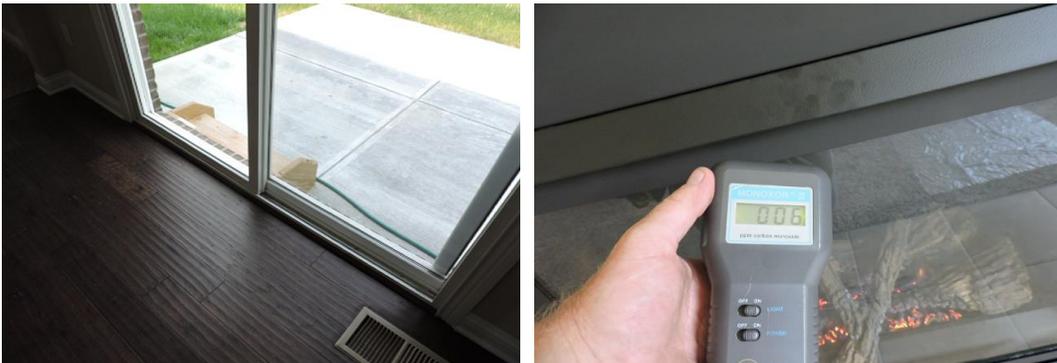
***25). The rear breakfast room door needs adjustment and track cleaning to make it function with less force.

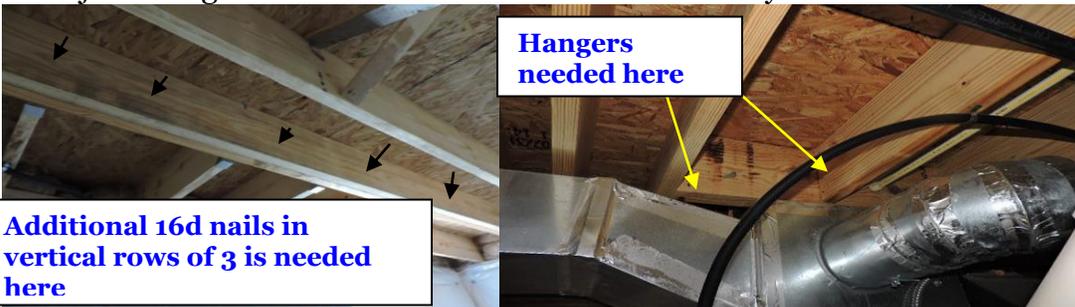
37). The **floor joists** that were observable were noted to be installed without evidence of structural problems. There are two items that are recommended to be modified;

****a).** At the header floor joist that is next to the fireplace, additional nails into the two joists are recommended so that each bears the load equally. Right now there are only a few nails in these double joists.

****b).** At the header and common joists that are above the furnace, a L bracket or a full joist hanger is recommended where there are only face nails at this time.

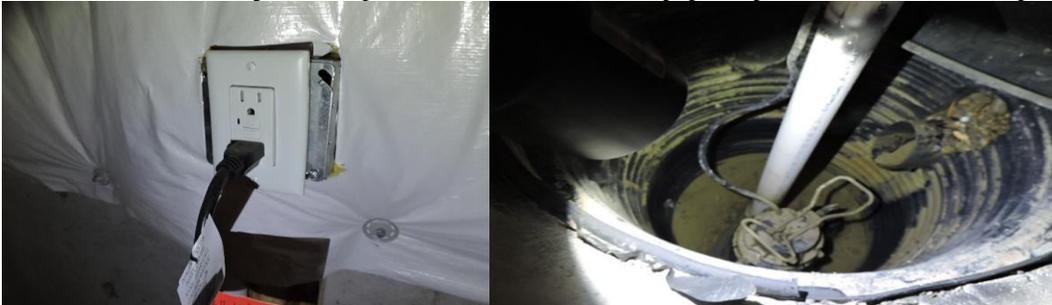
****43).** The **sump pump** needs to have the mud cleaned out of the bottom of the crock and a battery backup is advised. The sump pump is on a GFCI receptacle.
