# Finegan Inspection Services, Inc

## CONFIDENTIAL INSPECTION REPORT

1234 Example Street, Anywhere, Ohio

2/6/2019 10:00 am to 1:00 pm

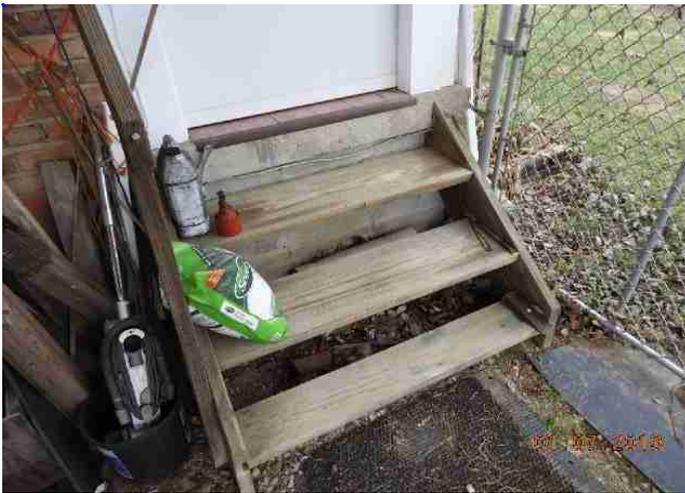
- q There was no observed concrete pad under the bottom of the stair stringers on the rear right stairs to the carport. The soil has compressed in this area near the stringer and caused the steps to twist. It is recommended that a pad be installed under the bottom of the stairs to keep the stair system risers at the proper level.

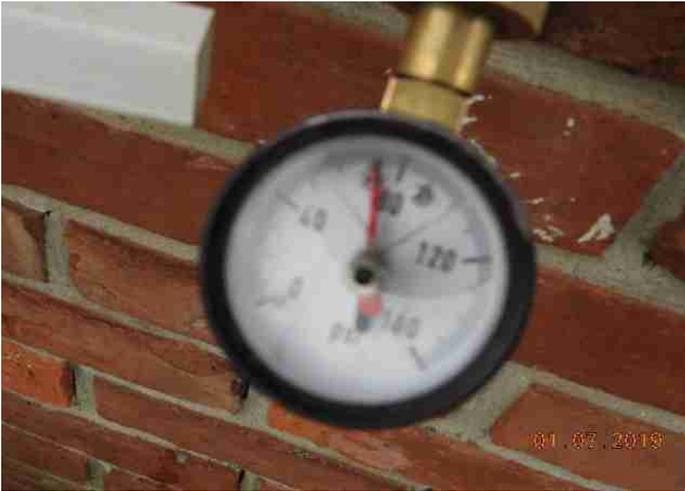
Frost free hose bibs recommended - *Continued*

- q The existing exterior faucets are not a "frost free" types. The installation of a frost free is advised so that water drains out of the line every time the faucet is shut off. That way water can not freeze inside the faucet and burst the line. Remember that the faucet should never be left connected to a hose in cold weather. This will damage even a "frost free" type of faucet.

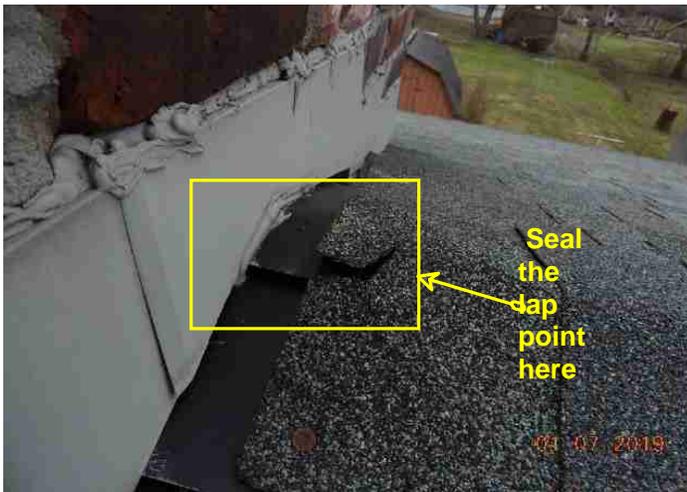
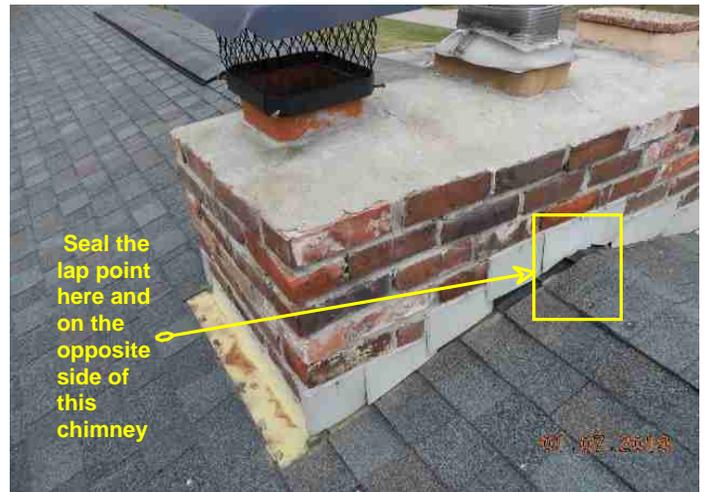
- q On the right and left of the chimney are 2 lap points that need to be re-secured and sealed with roofing sealant.

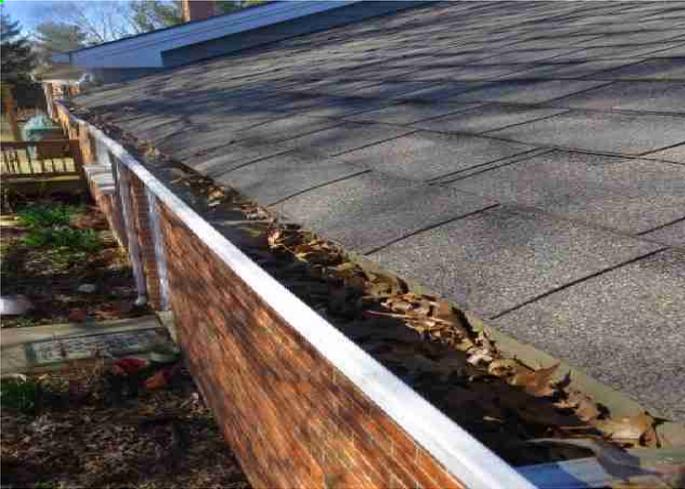
The gutters were noted to have some debris and granulate material - *Continued*

- q The gutter of the front roof of the house there is a significant volume of balls and debris inside the gutter blocking water flow. All of which needs to be flushed out so that water flow is not restricted. Better water drainage in the gutter system toward the downspouts will keep the house walls and foundation less prone to leakage.

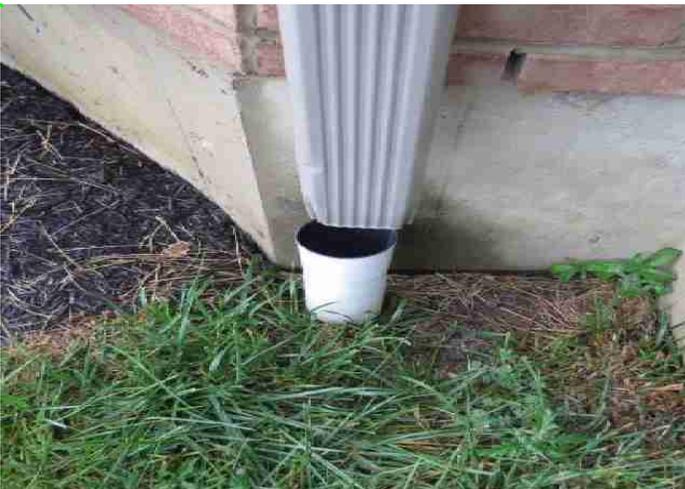
q All downspouts need to properly terminate into the underground drain tile. These are called "conductor lines" and they drain all of the roof water away from the home. The exact termination point was not observed.

In the case of this house there are a few of the downspouts that are not completely connected into the drain tile. This condition will allow water to drain out of the downspout/drain tile intersection and next to the foundation. This condition should be corrected as soon as possible.

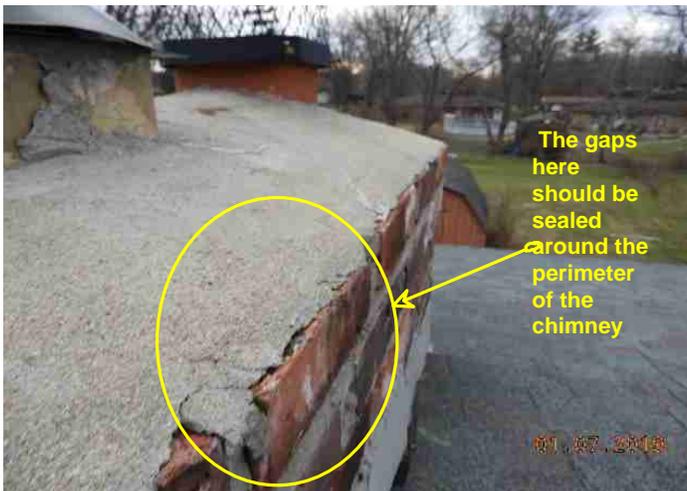
- q There were some small gaps at the intersection point of the concrete crown and the top most brick course at the center fireplace chimney. Have the gaps sealed to keep out future moisture. The replacement of this crown wash is recommended.

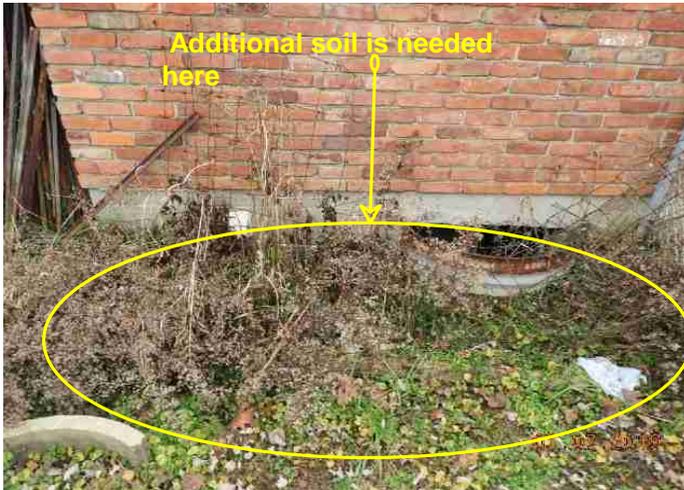
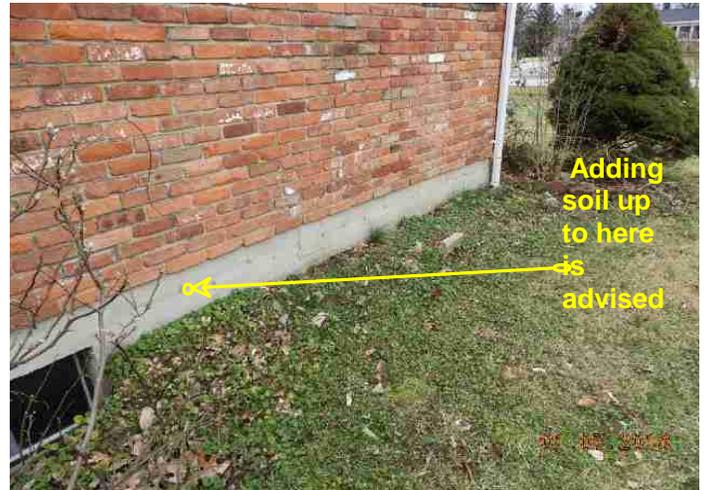
- q There is a low area of the soil grade at the left side of the house close to the foundation of the home. There is surface water that is now draining toward the house foundation given the existing soil conditions. Have the situation modified so that the soil grade will direct the surface water away from the house foundation. The installation of a collection box is advised and then connected to the existing conductor lines for the downspout.

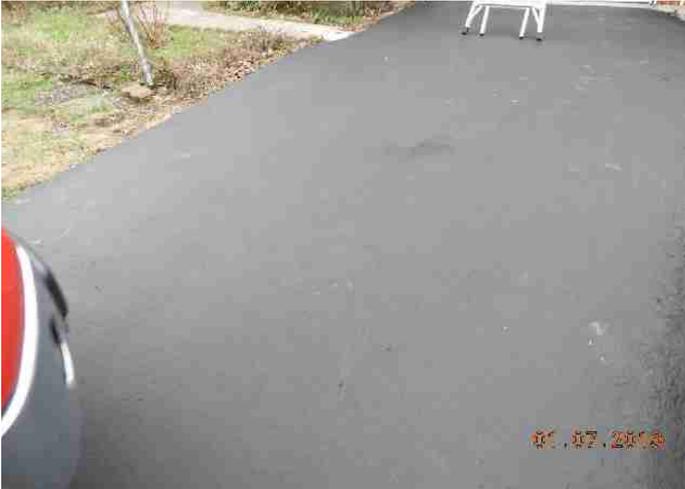
- q Most of the asphalt driveway was noted in good general condition at this time. There were no significant cracks or pot holes noted. There were two surfaces that were sunken slightly at the intersection point with the garage slab. Cut these out and compact the asphalt at these locations. Keep a coat of sealant on the surface in the future.

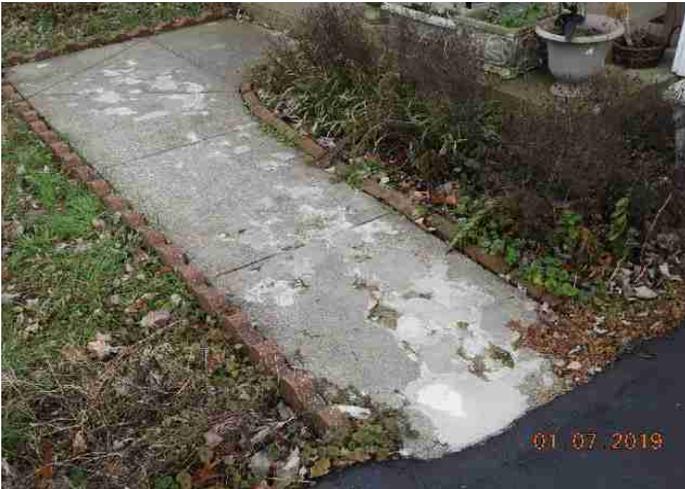
- q There areas of deterioration and uneven surfaces noted on this sidewalk system. Patching the cracks is suggested. The periodic application of a quality water sealant is suggested on the new surfaces. Weather X and Enviro Seal are suggested.

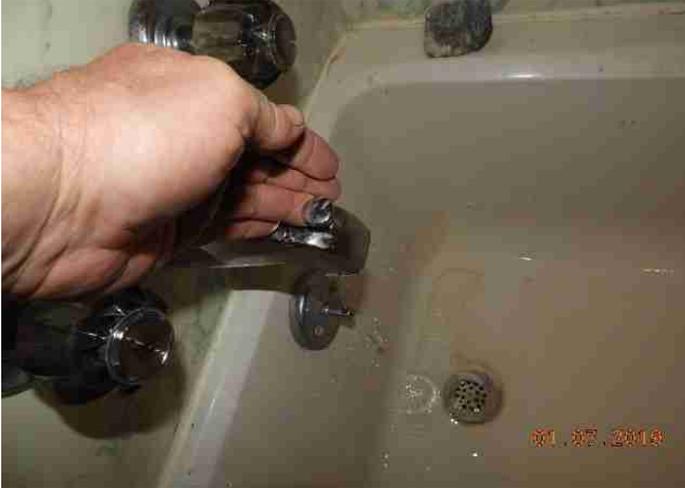
- ✓ The tub drain stopper for the tub was not functional in the hall bathroom. Recommend this be repaired so that it will operate or an alternative stopper system be incorporated.
- ✓ The shower/tub faucet on the first floor bathroom needs repair or replacement. It is not diverting water to the shower head at this time

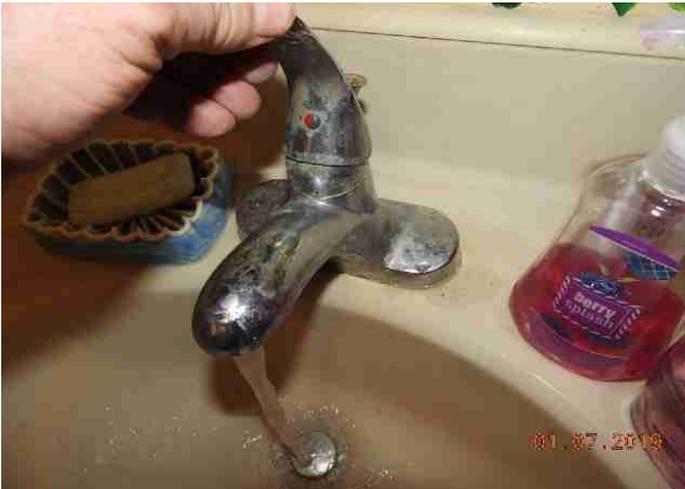
- q There was observed to be a loose faucet handle that leaks at the first floor hall bathroom sink at the connection to the faucet base. Have the faucet replaced.

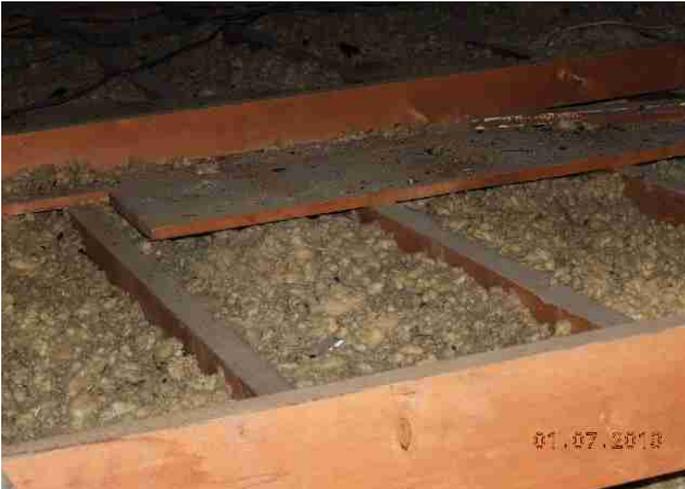
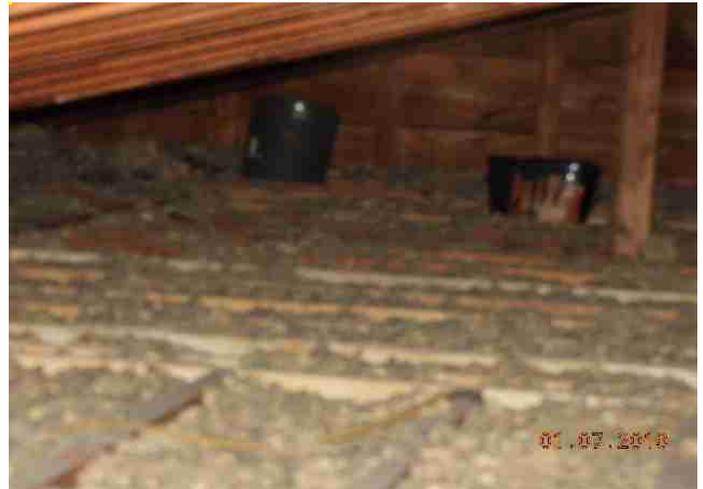
- q The attic insulation in the original house attic area was noted to be about 3" thick which is lower than recommended levels of thickness to provide a proper R value for thermal resistance at today's standards. The attic was noted with compressed loose fiberglass insulation. The addition of 10 " of insulation on top of the existing is recommended at the following locations:
  - 1). Over the entire attic of the house.

The loose fill insulation was noted to be below modern acceptable levels - *Continued*

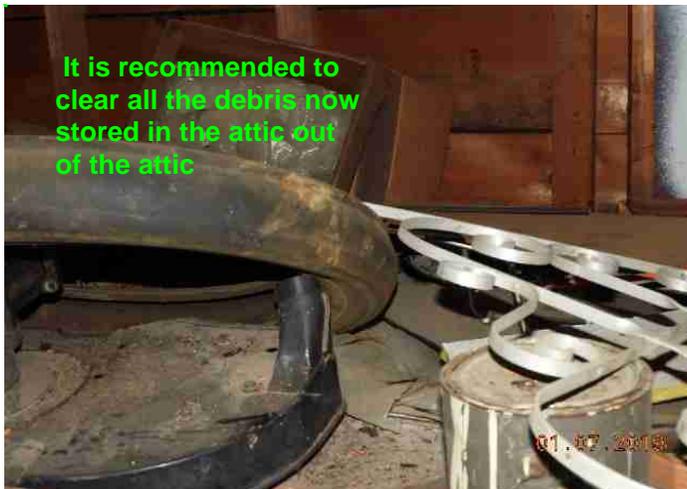
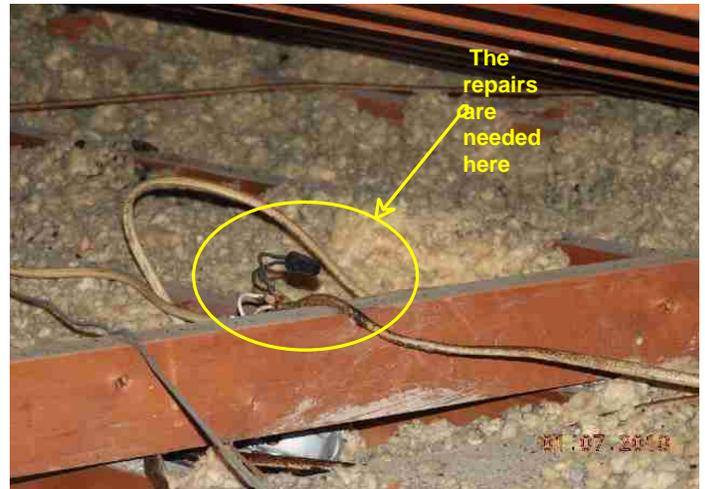
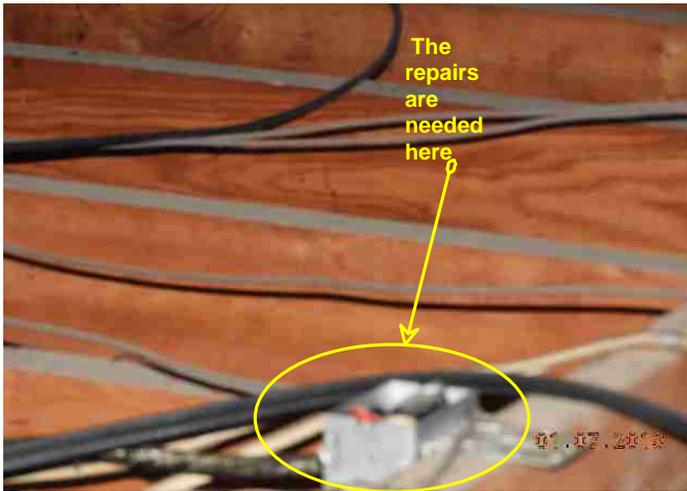
Open splices - *Continued*

- √ Have the electrical wiring that is in the attic above the hallway area properly connected. Have an electrician review the splices and place these in proper junction boxes above the insulation level.

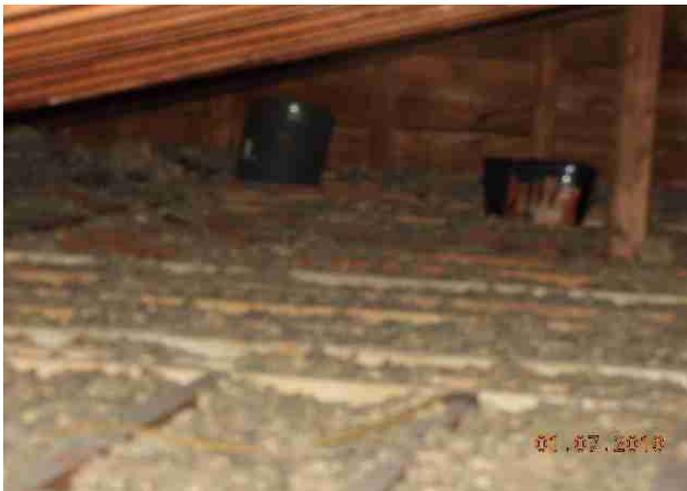
- q There are some buckets inside the attic. There is no water or water stains in this area .Possibly there was a past leak that was corrected by the installation of the new roof

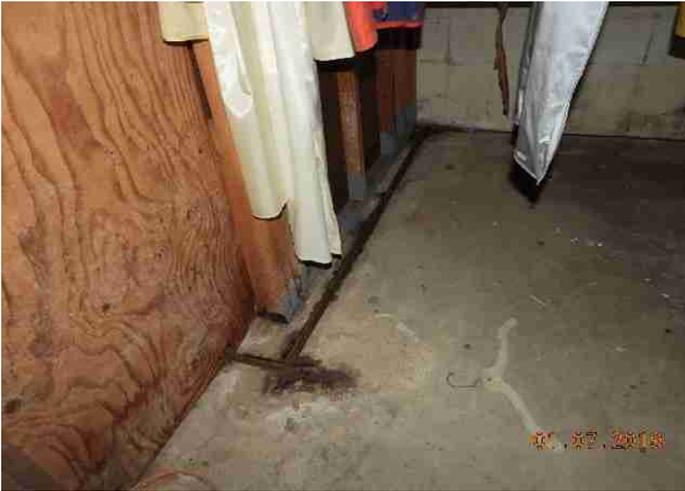
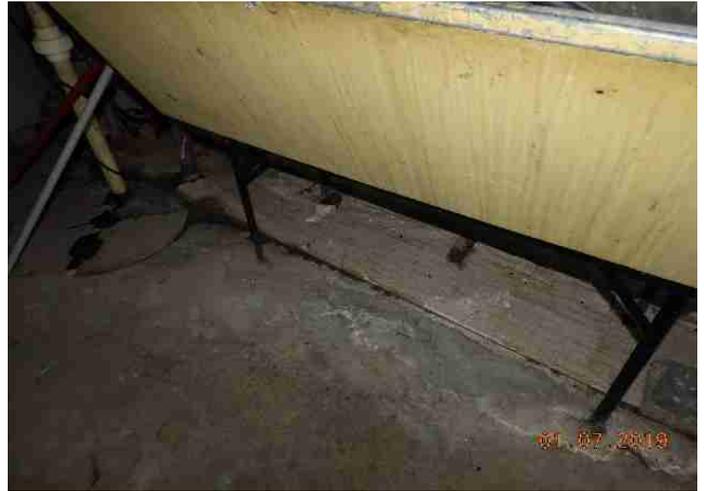
There was noted to be an active leak in the basement - recommend repairs - *Continued*

- ✓ There is a small amount of water noted to be leaking into the basement at the left side wall area and at the front corner near the porch. The drain for the downspout and the negative soil grade on the exterior side of the foundation are contributory. The old foundation has no drain tile around the perimeter like modern foundations so the water that builds up outside . These areas are allowing water to access at the bottom of the foundation near the laundry area.

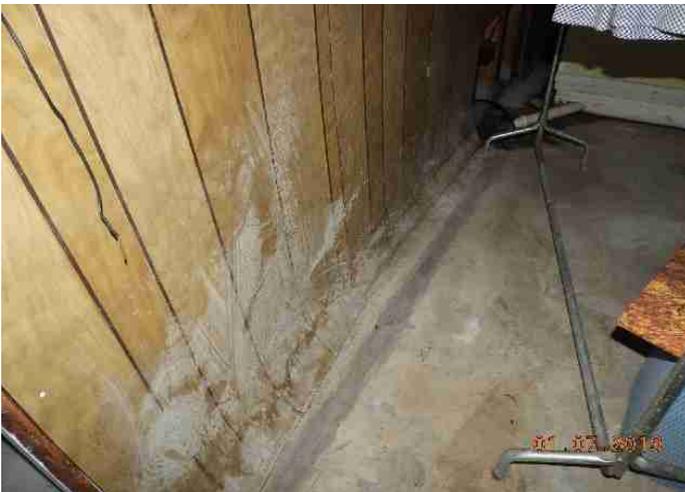
- ✓ There is mold in this basement due to water leaking into the basement on the center wall. The conditions are encouraging mold growth to propagate. Have the wall material removed.

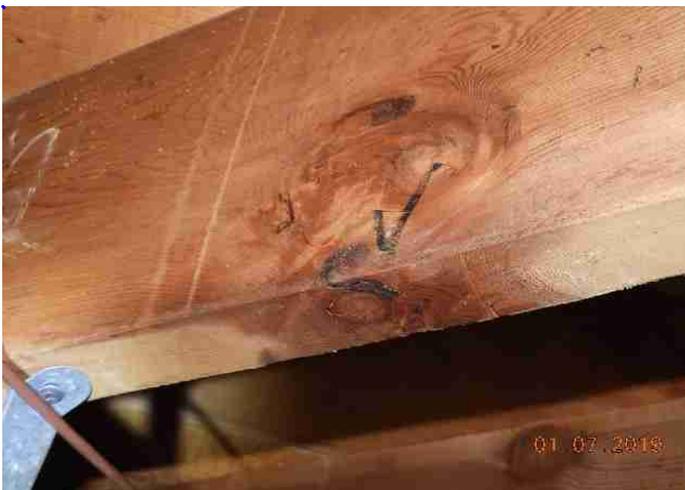
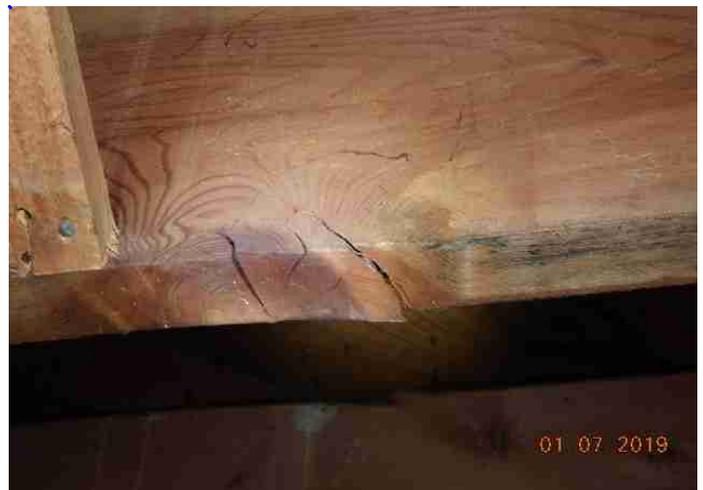
- √ The observable floor joist system in this was noted with a knots and a cracks in 2 of the floor joists below the first floor. When the knots in the joist are at the bottoms of a joist and the location of the knot is near the center point of the span of the floor joist, the joist has a higher propensity to crack in that location. The probability is increased even more if there are electric or plumbing lines or pipes that are cut into the joist in these same locations.  
The repair of these cracked joist is recommended to insure the overall structural integrity of the floor joist system. A 6' to 8' long "sister" added to the side of these joists is necessary. The sister may not be cut or notched. It should be set on one bearing point at minimum. It must be as wide as the dimensional lumber to which it is attached.

The repair of these cracked joist is recommended to insure the overall structural integrity of the floor joist system. A 6' to 8' long "sister" added to the side of these joists is necessary. The sister may not be cut or notched. It should be set on one bearing point at minimum. It must be as wide as the dimensional lumber to which it is attached.

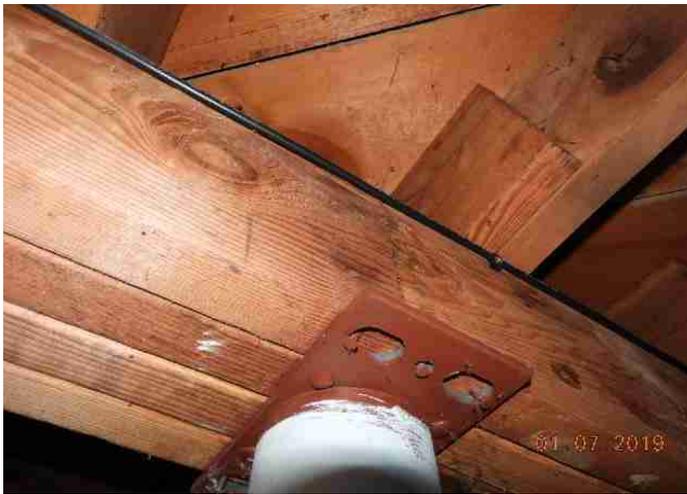
- √ The installation of a steel bolt into the wood beam at the top of the post intersection is needed in the basement area.

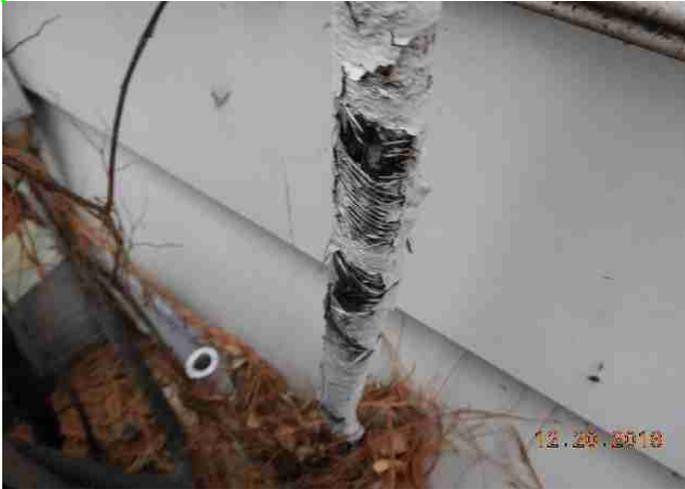
- √ The main cable of the electrical service that is connected to the wall of the home is called the Service Entrance cable. The cable on this home is deteriorated and loose. The cable must be replaced.

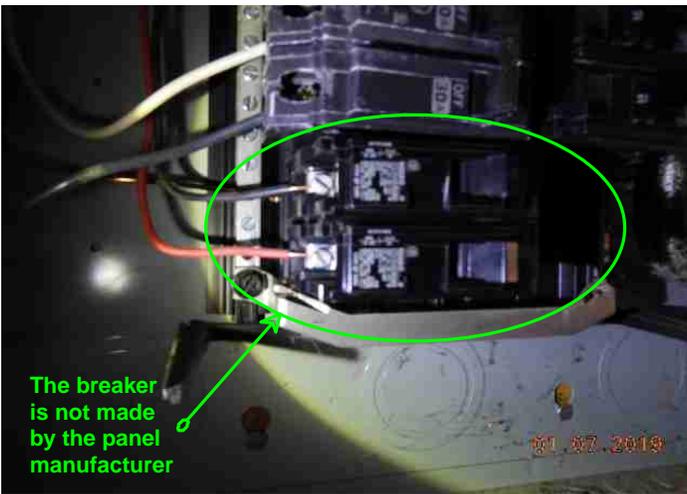
There was noted to be a breaker of a different manufacturer in the garage electrical panel - *Continued*

- √ All electrical panels must have the proper types, sizes and manufacturer of breakers connected to the interior bus bars. The electrical codes require that the manufacturer of the electrical main panel box is the same and only manufacturer of the breakers that is compatible. (Although some breakers do interchange). In the case of this electrical panel there was a 240 volt breaker manufactured by a different manufacturer from the panel box that was noted to be connected to the bus bar. It is recommended that this breaker be removed and a proper breaker be installed.

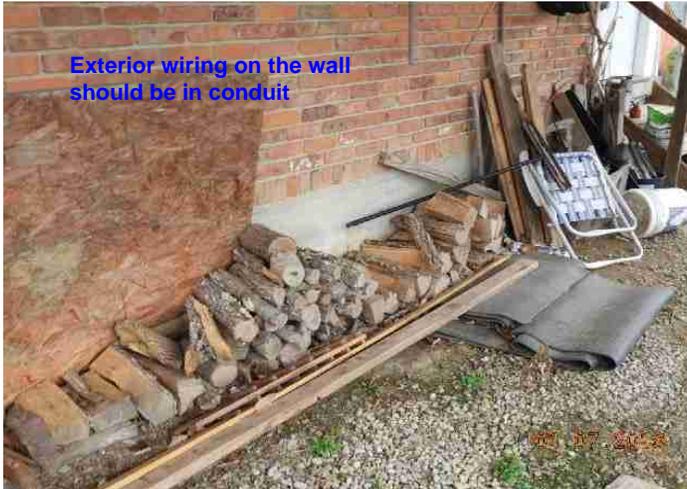
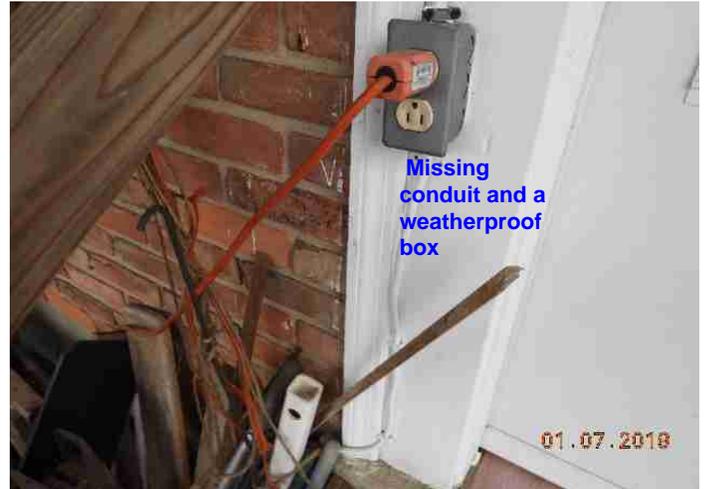
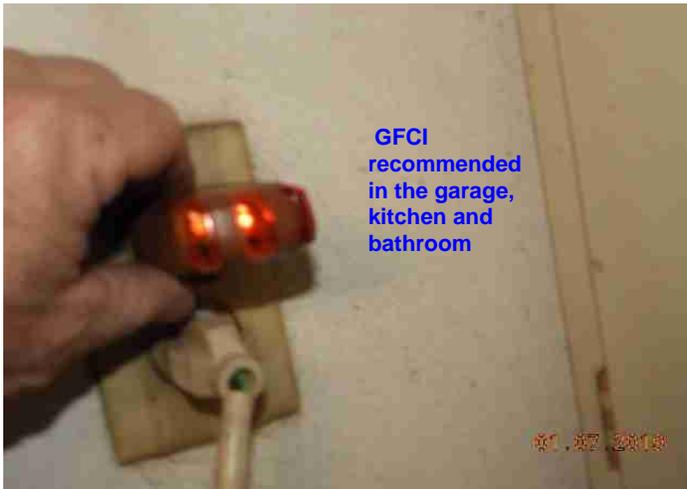
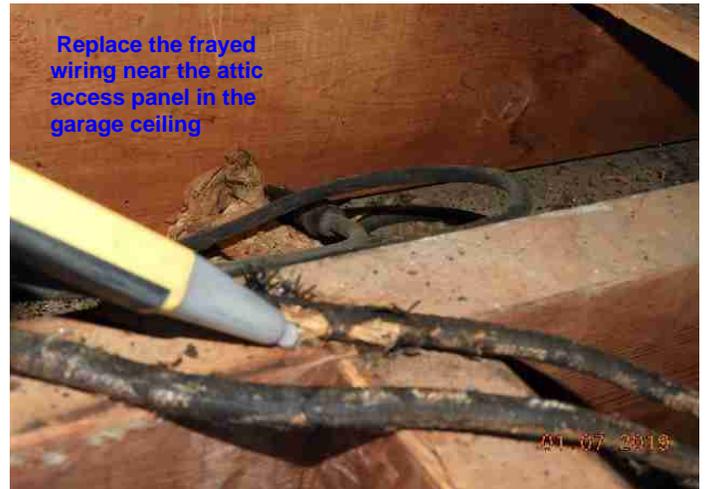
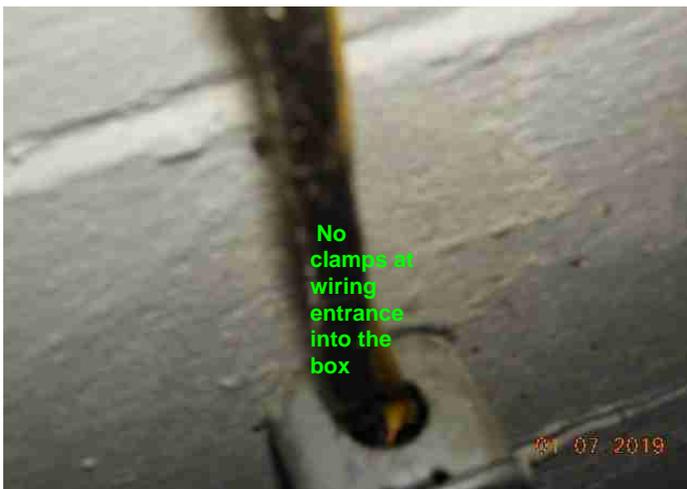
There were some modifications needed in branch circuit wiring in the house - *Continued*

- ✓ There are electrical modification items found in this home. They are as follows:
  - 1). The electrical receptacles in the kitchen nearest the phone is missing grounding. Any circuits that are connected to these receptacles should be connected to GFCI breakers.
  - 2). The kitchen and the bath are recommended to be updated to a GFCI circuit .
  - 3). There are several exterior wiring items that should be modified so that they are within the accepted methods of residential wiring requirements. Things like the wiring in the car port area and in the garage need modifications like adding conduit to the wiring. There are some junction boxes with wires entering without proper clamps
  - 4). In the attic there are wiring modification needed at the splices and some frayed wiring near the access panel.

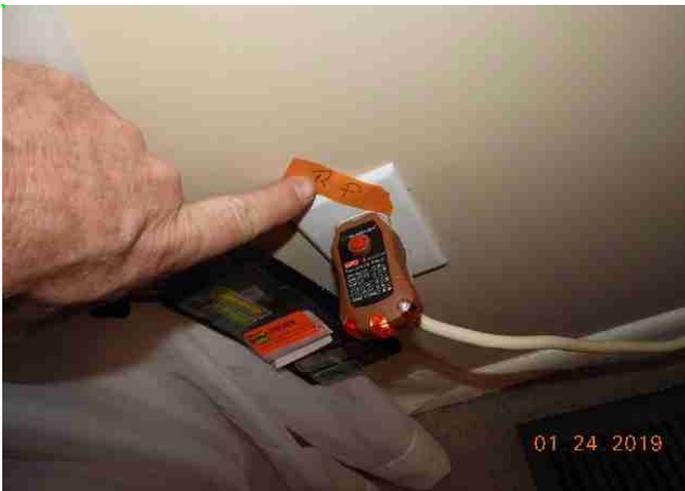
- ✓ As the outlets age, the prongs that are inside the receptacle begin to lose tensile strength and become loose at the connections with the plugs. When the plug becomes loose poor connections are made and resistance develops. This is not a recommended condition.  
There were receptacles noted in this house in several locations such as in the hallway that are not only fatigued but also wired in reverse polarity. This means that the black wire and white wire that connect to the receptacle are in reverse position. This needs to be corrected for safety of the equipment that may be plugged into this outlet. The re-wire of this outlet is necessary at this time.
