FINEGAN INSPECTION SERVICES, INC.
TERRY FINEGAN
27 LAURELWOOD DRIVE
MILFORD, OHIO 45150
683-0733-PHONE

RESIDENCE

This report will review the wall areas in the basement for moisture.

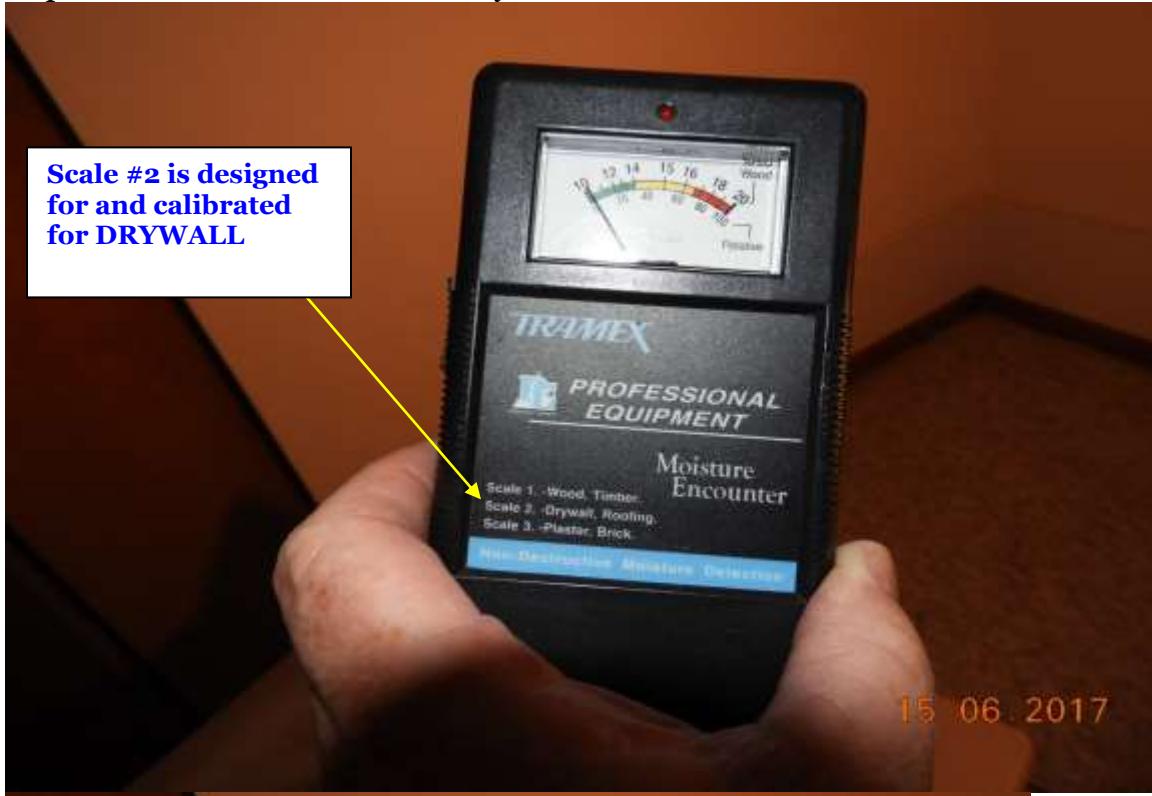
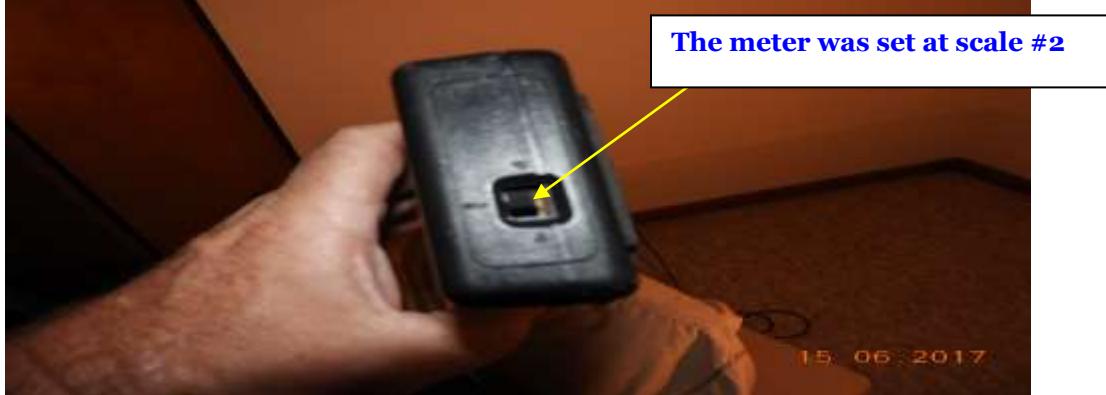
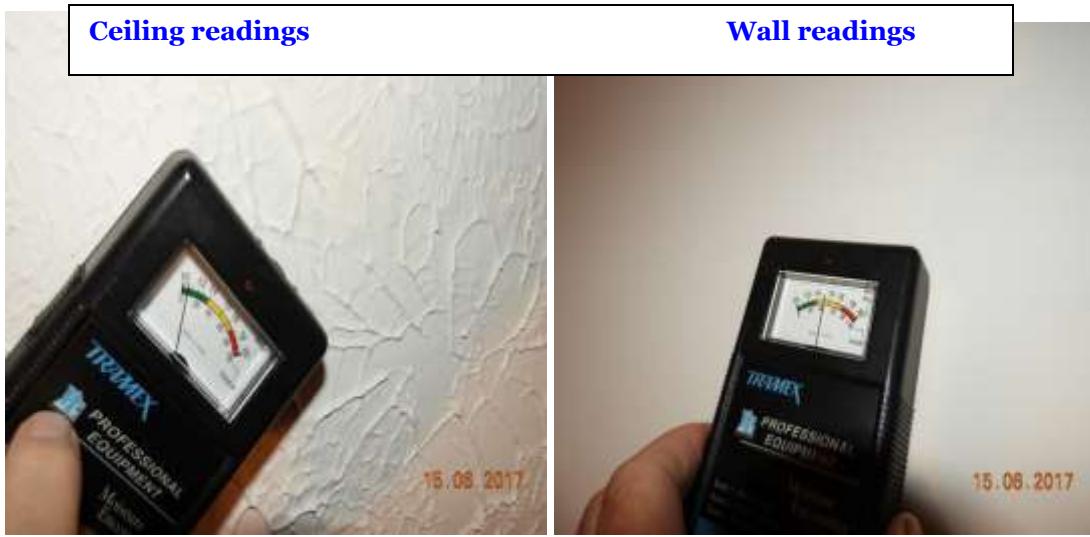
1). Tramex Moisture Encounter meter

In all tested locations with all three meters there were **no elevated moisture readings on any wall surface**. The accessible studs in this same area were also inspected and have normal moisture readings. There is one area on the basement ceiling that has a stain in the front left area of the basement, near the closet. This stain is believed to be from water that had gotten through the floor above from a plant that was located in the area. When the plant was watered, some moisture accessed through the hardwood and OSB and created a small stain on the ceiling. There also is a HVAC supply vent that is in the floor joist cavity in the area above the stain. It is possible that at some point in the past there was slight condensation that could have created the stain. It either scenario, there is no source of a chronic or active moisture intrusion.

Impedance meter calibrated for Drywall

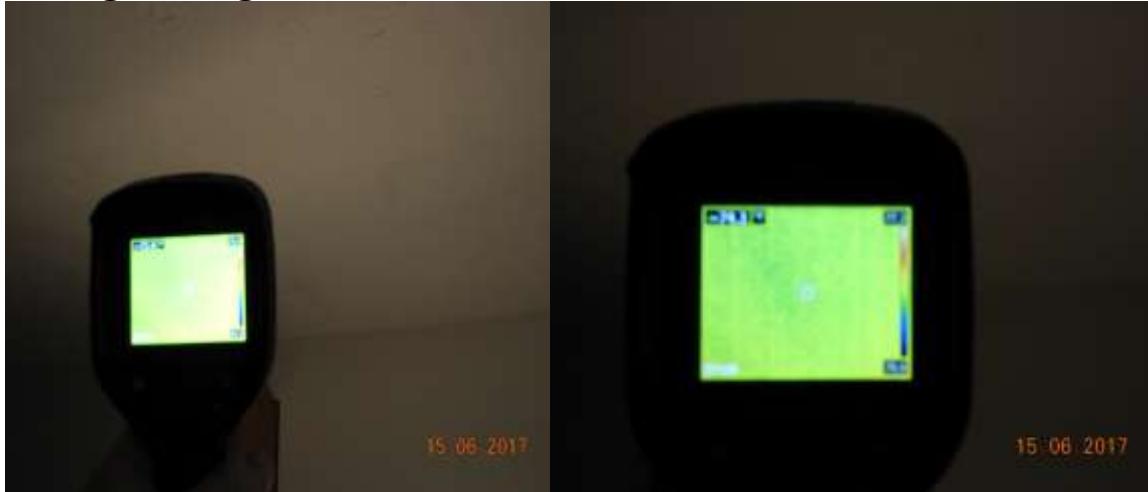
Ceiling readings

The thermal image camera is a survey type that will read the temperature of the surface of the area being tested. An area that is cold will show up as a blue surface in the meter. A cold spot could be wet. The meter shows no blue area on the ceiling area. Only a slight blue area at the floor of the front basement wall and there was no moisture as seen in the photos of the Delmhorst and Tramex meters.

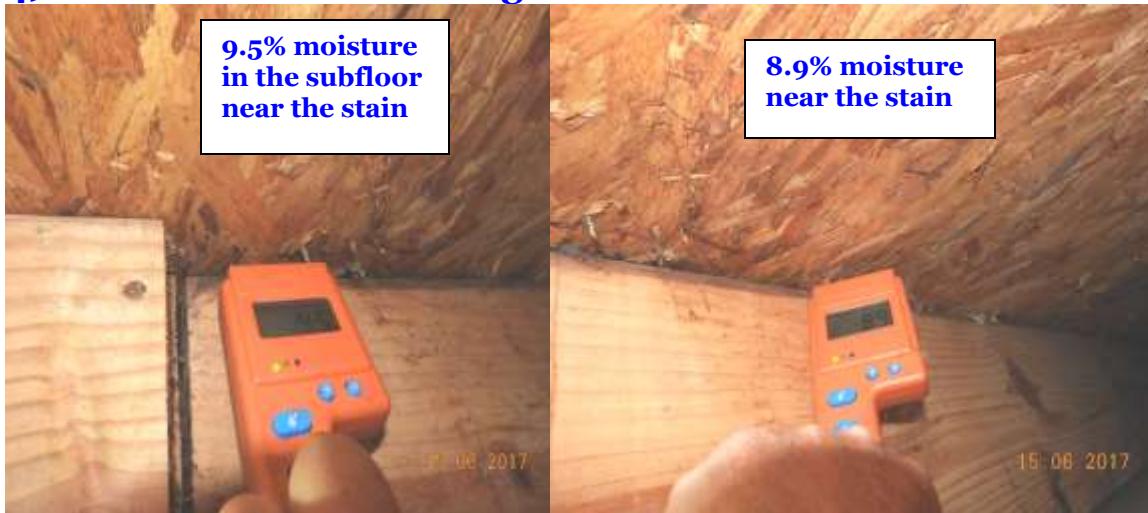
4). Wood sub floor readings above the stained areas

Whatever had caused a stain on the ceiling is no longer active and it appears to be a onetime occurrence or seldom occurrence. The levels of moisture in all drywall and all wood are negligible and well within the ranges of the industry standards. Humidity conditions may have been contributory to the 14% moisture readings discovered by others or a modest calibration variation of the meter used to take the readings.
