FINEGAN INSPECTION SERVICES, INC.
TERRY FINEGAN
27 LAURELWOOD DRIVE
MILFORD, OHIO 45150
683-0733-PHONE

RESIDENCE

EXTERIOR CONDITIONS OF THE MAIN HOUSE

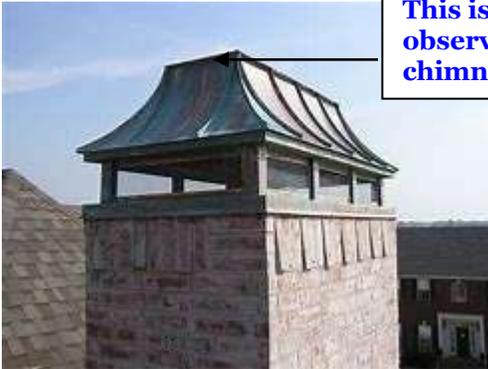
- a) **The far left chimney needs the repair of the flashings and the repair of the crown. Both have allowed water access into the house and that access of water is active at the time of the inspection**

This is the far left chimney (This observation does not pertain to this chimney.)

Three obvious items that were noted on the day of the inspection were the volume of **brick deterioration**, (caused by water access at the top of the chimney) the **lightning rod** was broken, and there is a **lifted flashing** at the back side of this chimney.

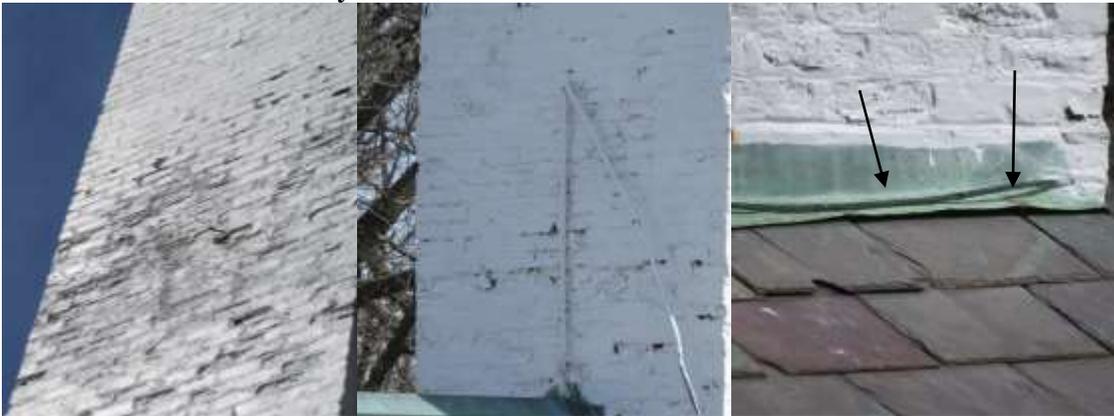
- b). The center chimney needs to have the **base flashing sealed** at the bottom of the chimney surface where it intersects with the slate.

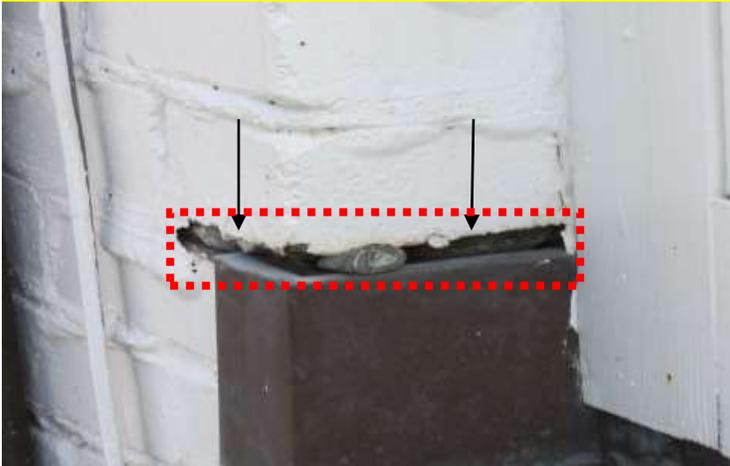
d). On the rear of the home, the left side **gable wall has a counter flashing that needs to be re-secured** into the mortar where it has pulled out at this time.

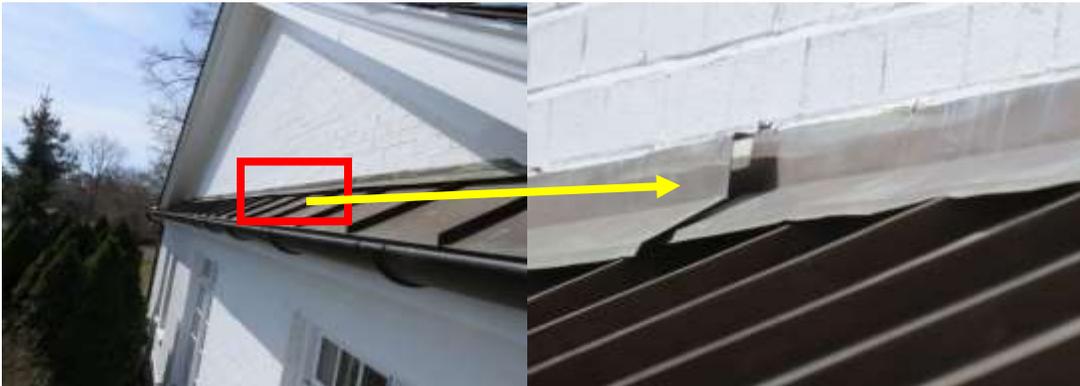
e). The front face of the home, where it connects to the _____ needs to be **re-flashed and the gutter needs to be corrected. There is active water leaking** at the intersection of the left atrium wall and the front wall of the addition

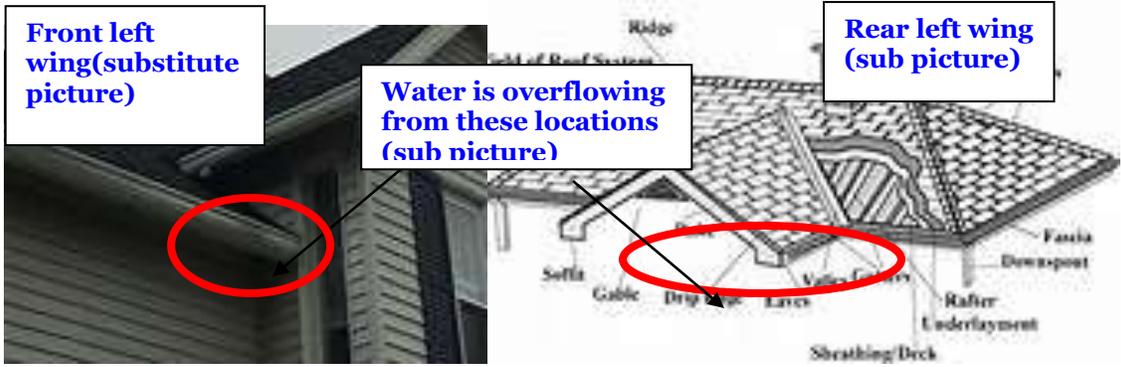
f). Most of the gutters were noted to be installed properly with proper pitch to the downspouts in most locations. There needs to be adjustment of the front left gutter above the center of the left of the home and the rear left gutter on the same, lefthand side of the home. At each location the gutter is bowed downward and is not draining and there is water overflow at that location.

Front left wing(substitute picture)

Water is overflowing from these locations (sub picture)

Rear left wing (sub picture)

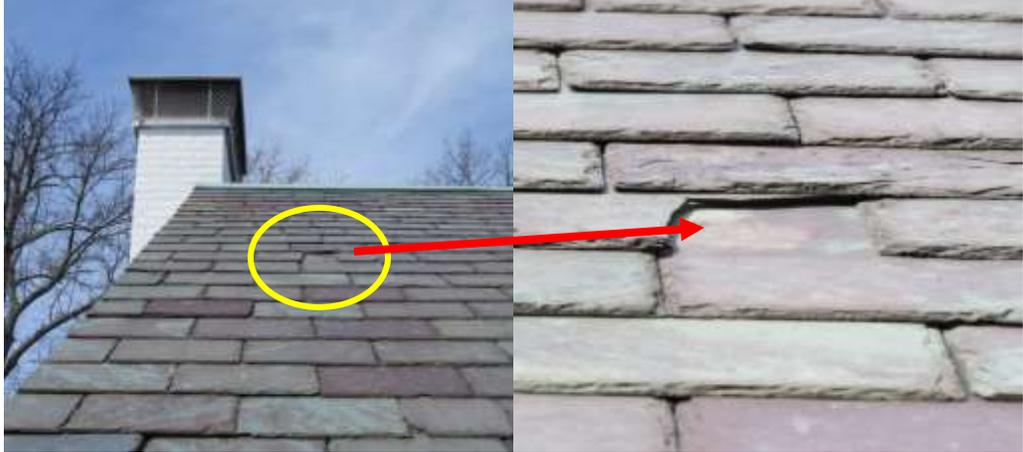
g). At the rear roof, there is one broken slate

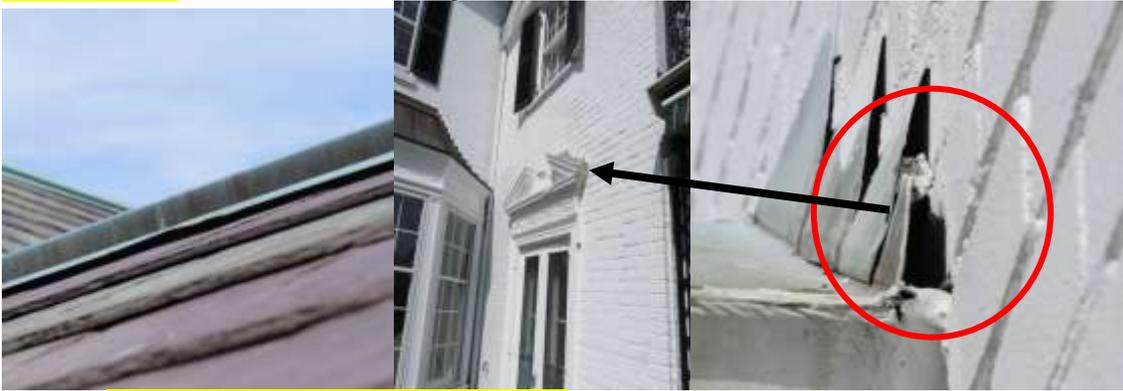
h). The roof ridge that intersects the _____ roof has a **ridge cap that needs to be secured** to the slate at the apex of this roof.
