THE CHINESE TEMPLE
IN CAMBRIA

RESTORATION
OF THE
INTERIOR PAINT

FOR
GREENSPACE
THE CAMBRIA LAND TRUST

ETHOS
CONSERVATION
OF ANCIENT ART

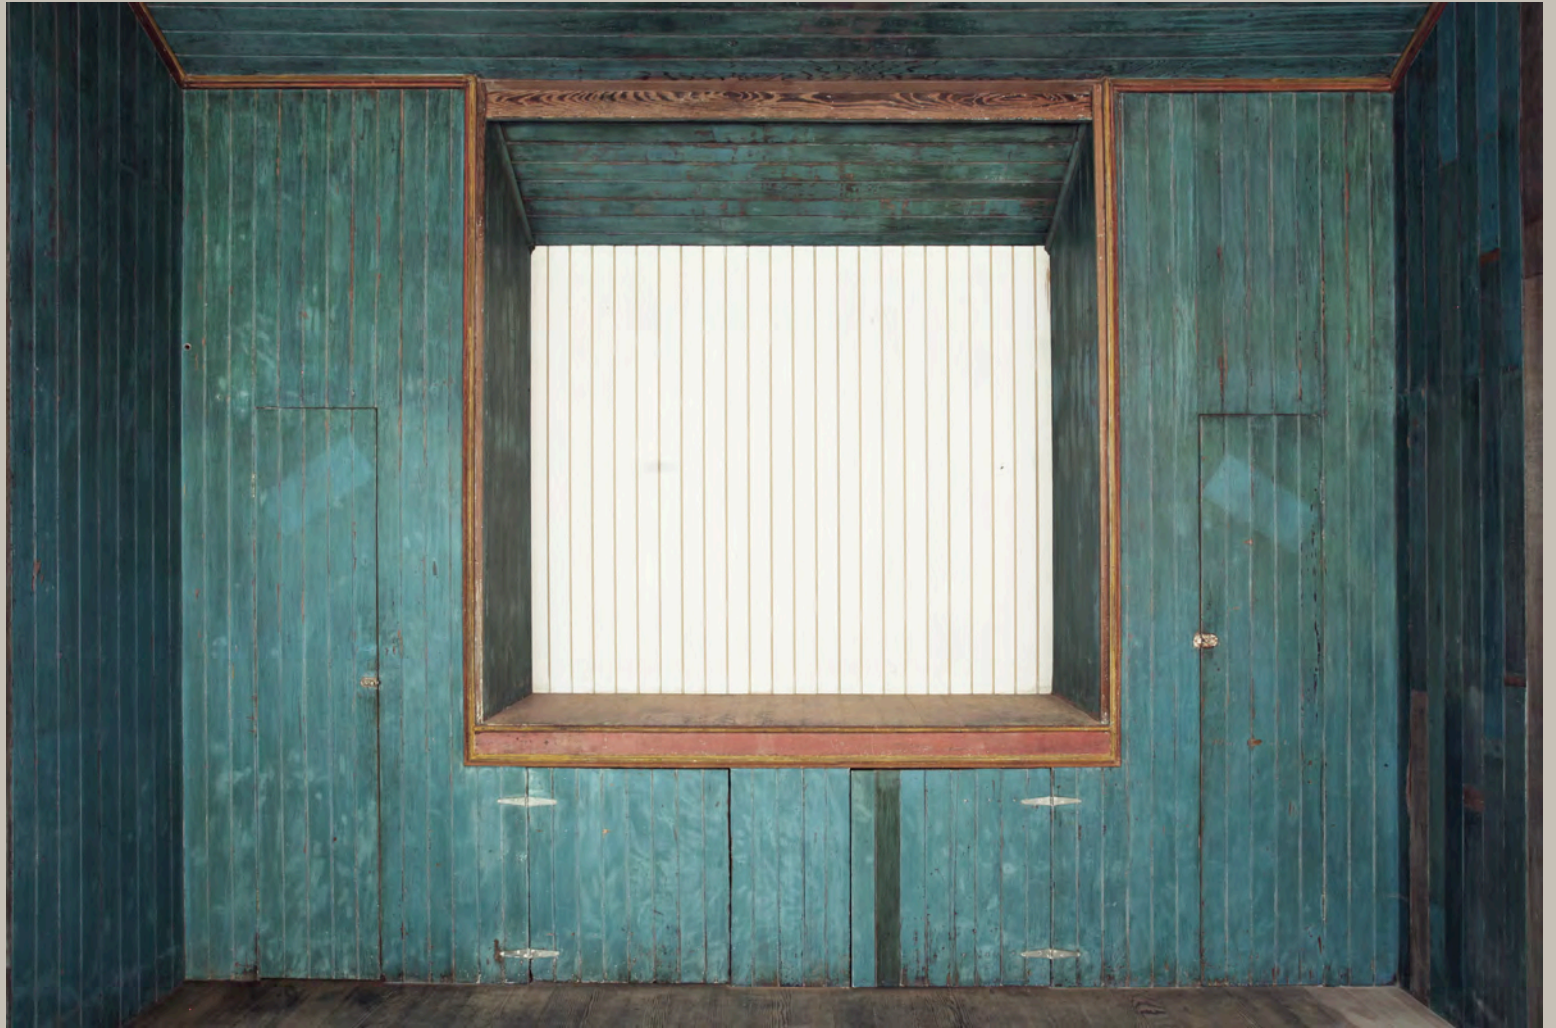
The west wall prior to restoration

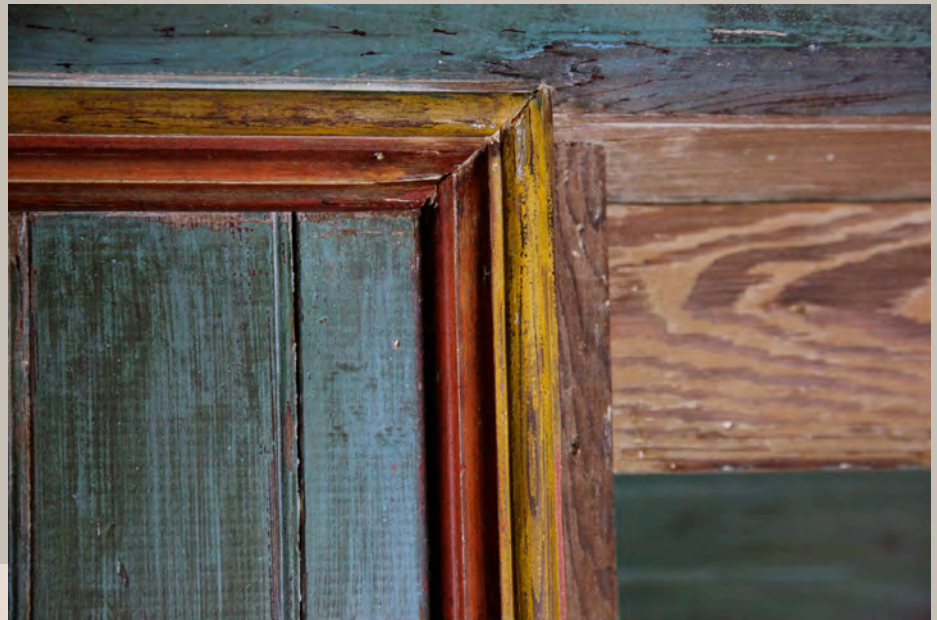
Upper left corner of the altar niche

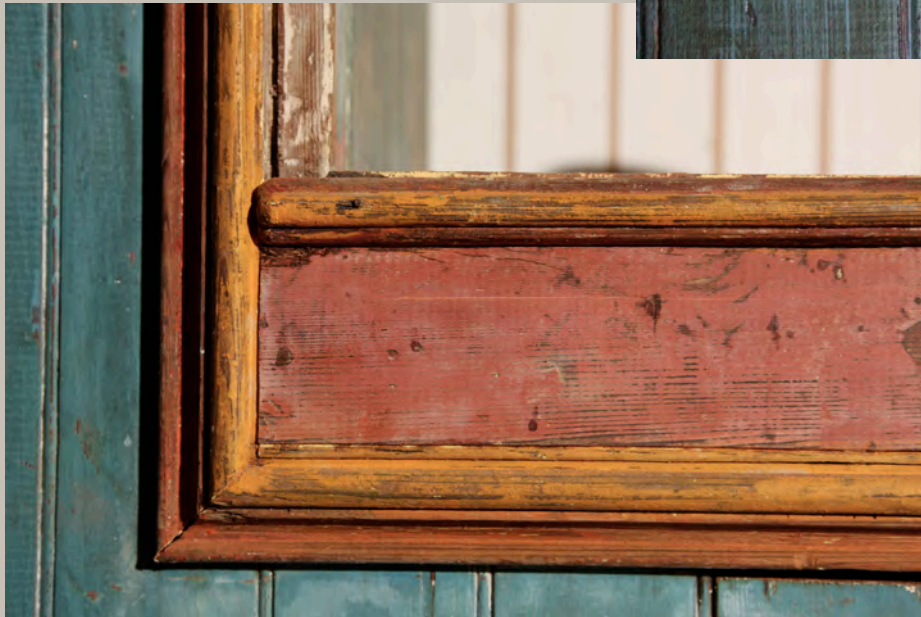
Panel at lower left front of the altar niche

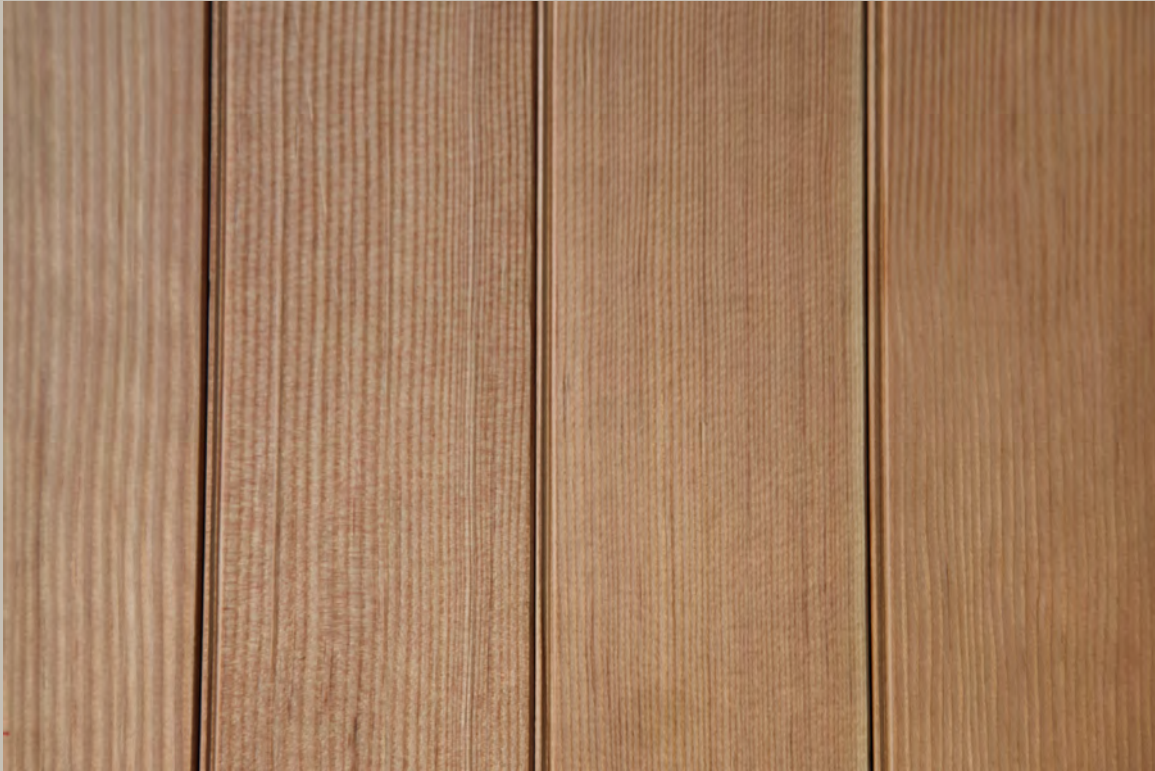
Custom-fabricated new beadboard at back of altar niche prior to painting

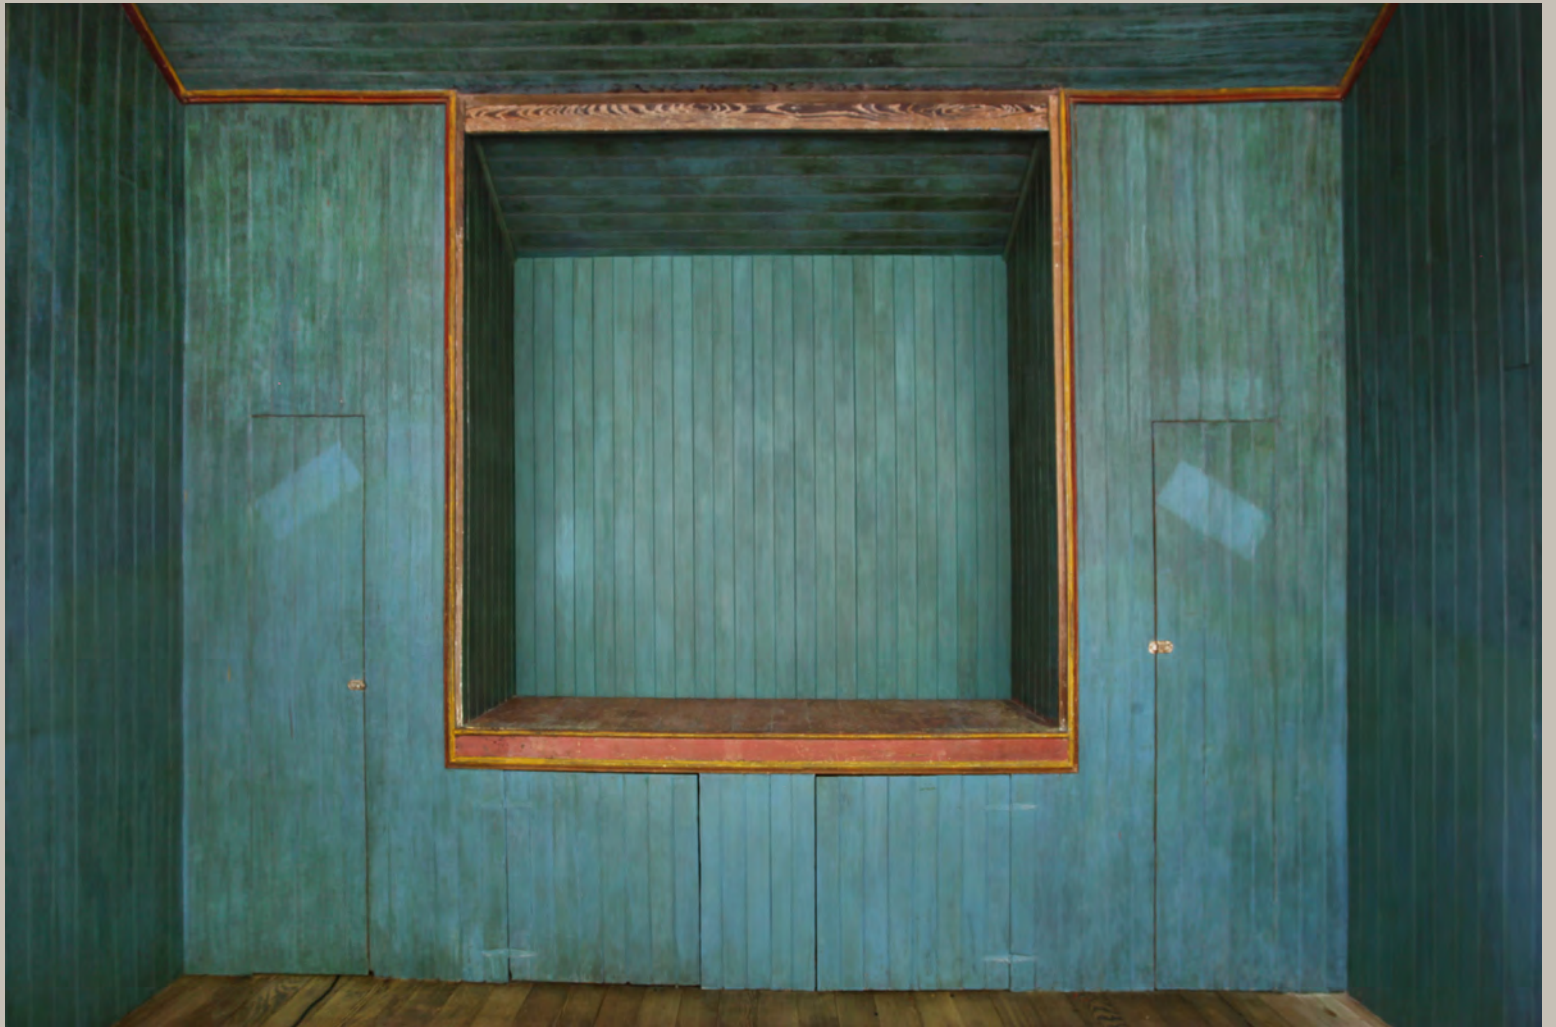
The west wall after restoration

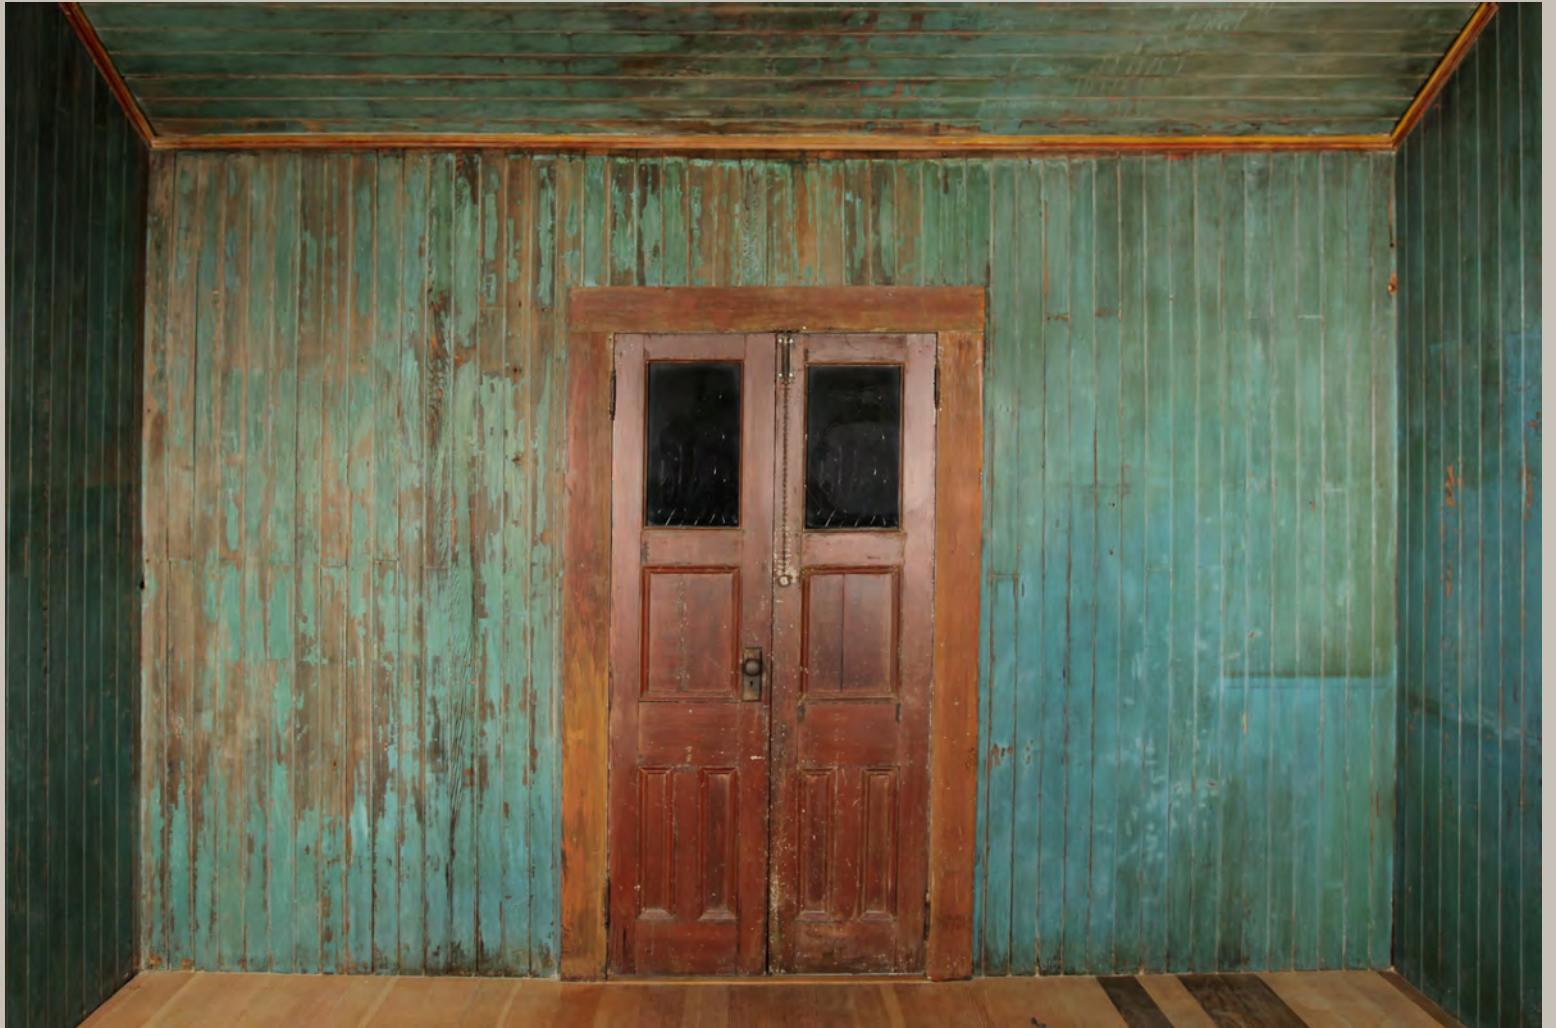
The east wall prior to restoration

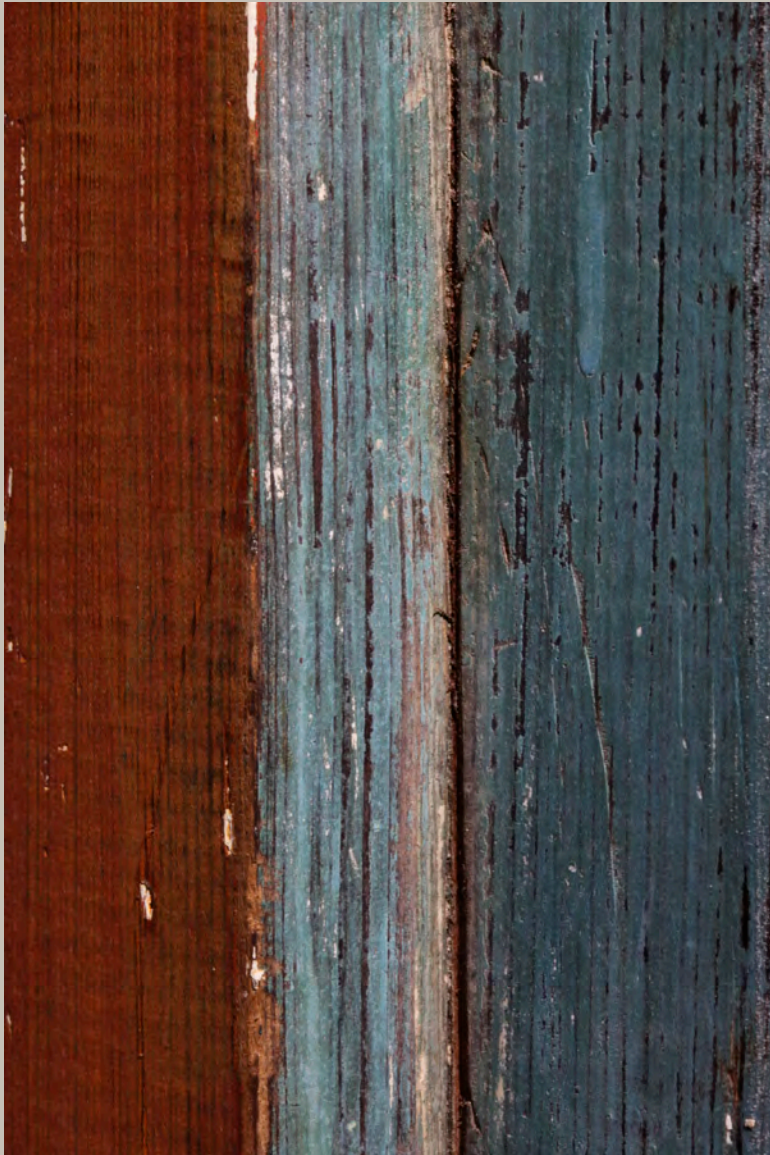
Area above the door before inpainting

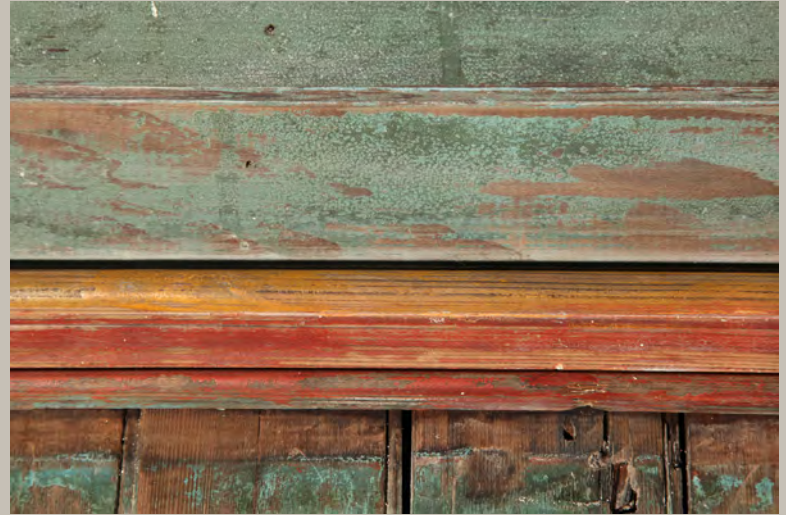
Teal paint was applied to the sides of the casing surrounding the main entrance door (and what appear to be inadvertent traces also can be seen on the face), indicating that the casing is original to the structure. The red paint of the door itself has been covered with a varnish, although the casing was not. The casing face has been heavily washed and it is difficult to tell at this point whether there is original red (matching the door and molding) or whether all remaining paint, including what appears to be mixtures of gold and red, can be attributed to later applications or alterations from cleaning.

Detail of the entrance door showing the original blue paint on the side of the casing

6. The door was left untouched because the varnish cannot be removed without endangering the underlying paint. The casing was also left untreated until analysis determines whether original paint remains on the face.

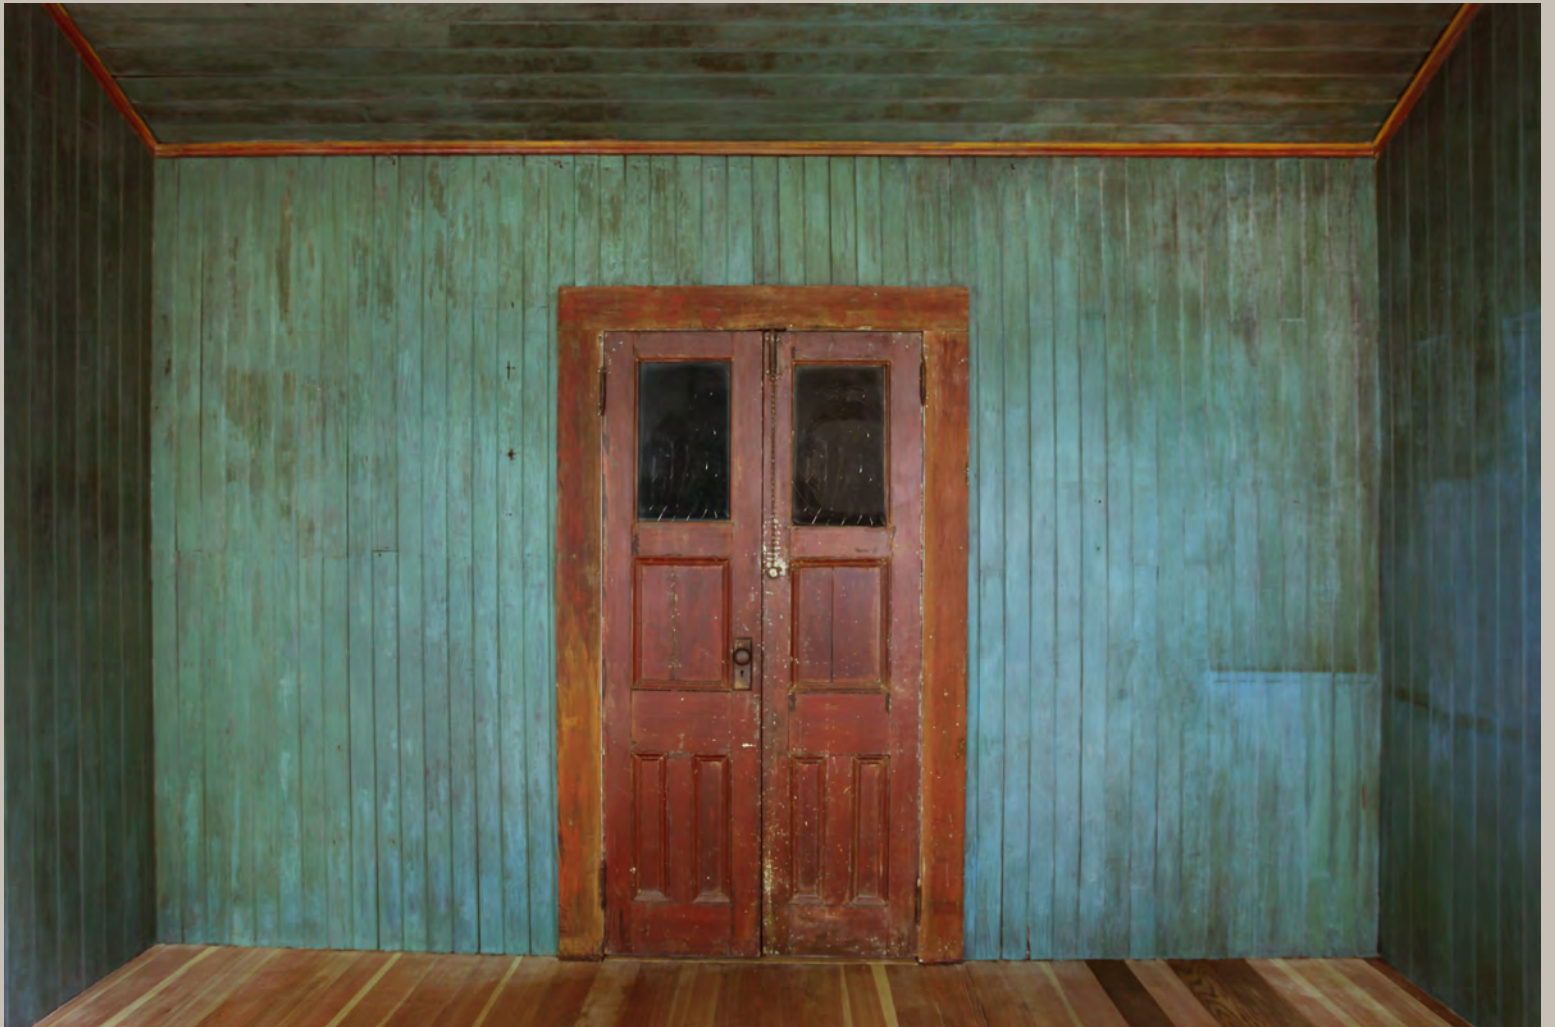
The east wall after restoration

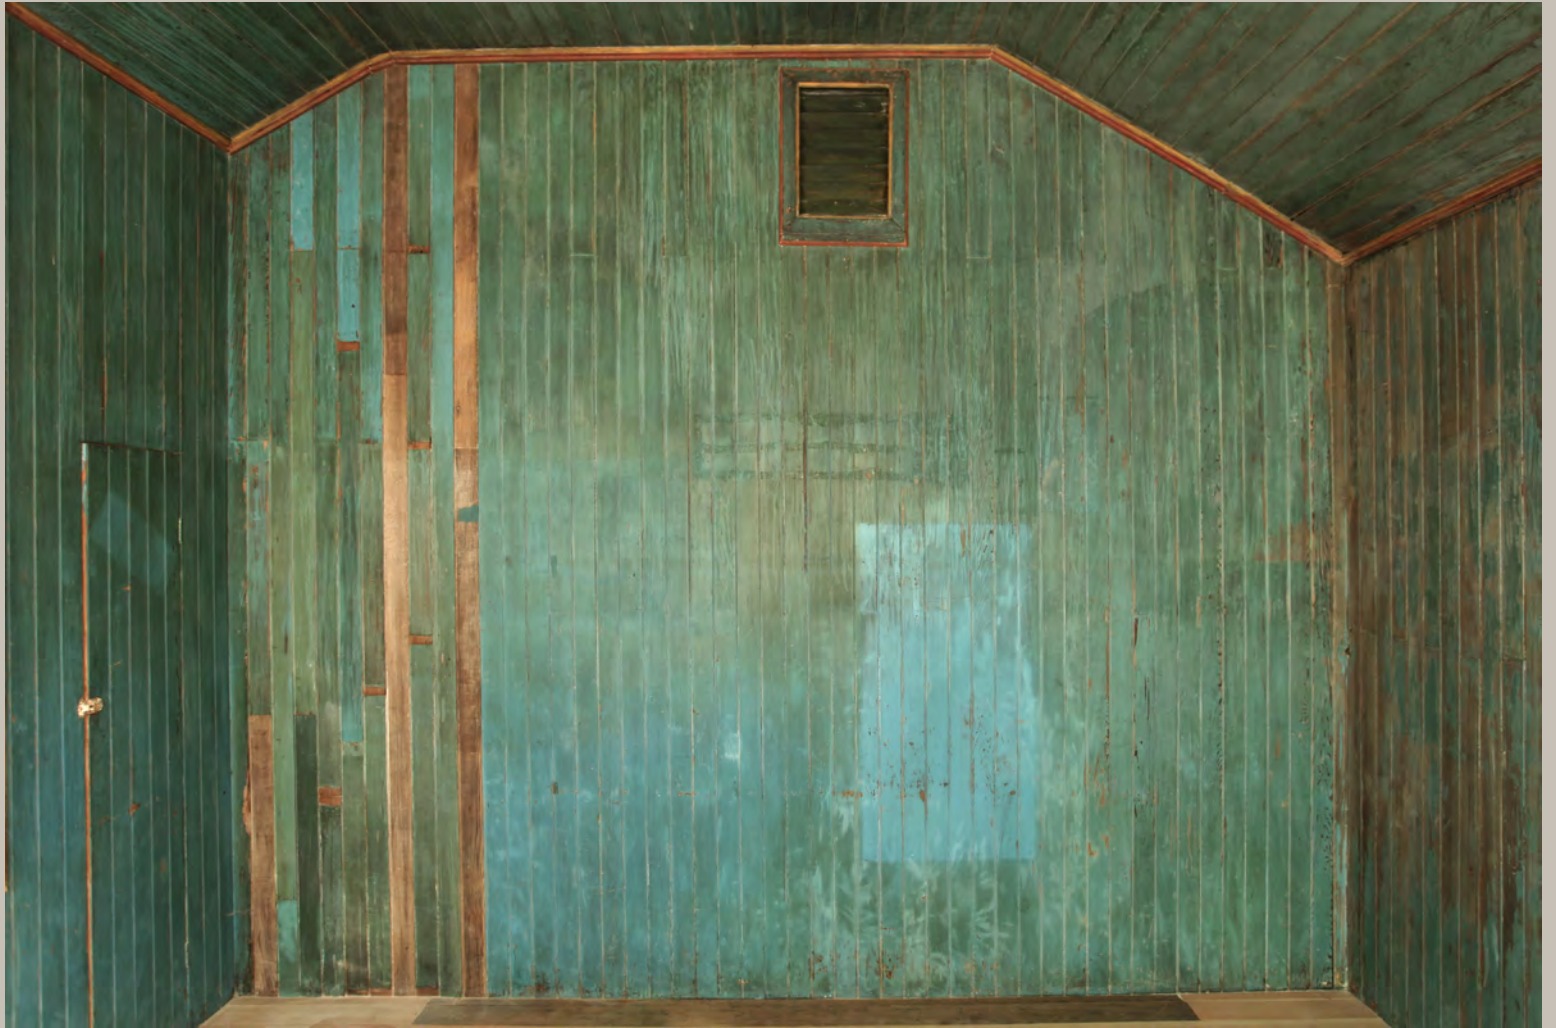
The north wall prior to restoration

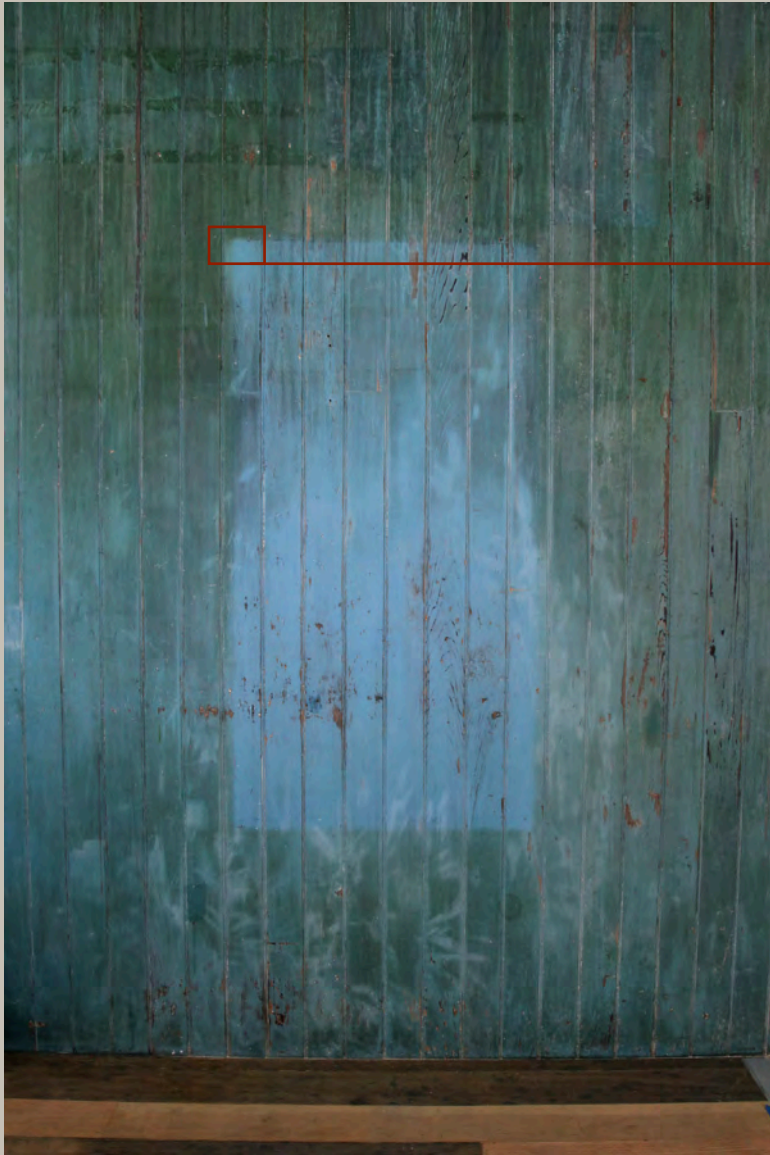
The beaded tongue-and-groove redwood boards are painted with a blue-green color paint (which, for ease of description, may generally be termed “teal”) that exhibits numerous variations in tone and shade. Within the teal areas there are also several distinct, primarily rectangular, patches with clearly defined edges. These patches are markedly lighter and less green than the surrounding paint and are more appropriately classified as light blue in color (“robin’s egg- blue”.)

Area on west wall with patch of 'robin's egg-blue' blue paint surrounded by the more visibly aged 'teal' color.

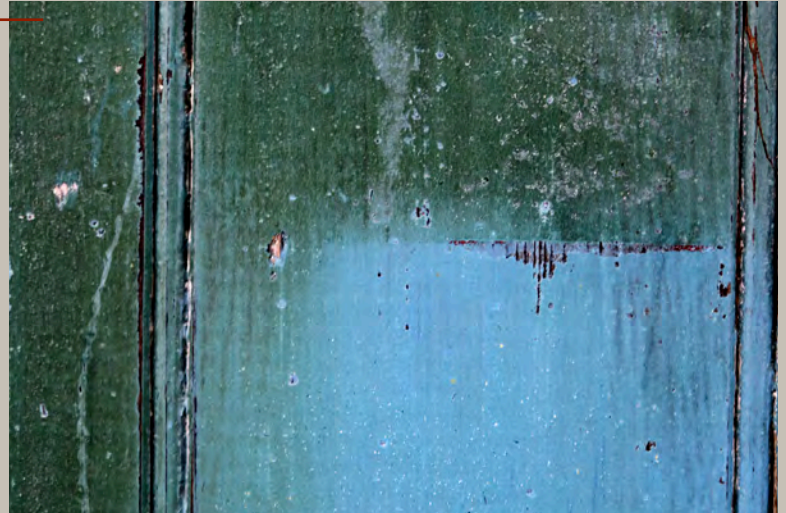
The difference in hue between the teal areas and robin’s-egg blue patches could be explained by either a yellowed coating in the teal areas and/or application of an additional layer(s) of differently colored paint. However, physical examination under magnification and solvent tests of selected sample sites produced no evidence of any varnish, coating or other paint. We have concluded that both the teal and blue areas are actually the same original paint that has simply weathered differently. The shapes and positions of the blue patches indicate that these areas were covered for a long period of time by furniture, signage or hardware and were thus relatively more protected from direct light. The areas of the robin’s egg-blue paint appear to have undergone less change in color than the more exposed teal areas and thus presumably remain closest to the shade as it was originally applied. The color appears to have been applied only in one coat and there is no evidence of repainting or partial repairs.

Detail of the upper left corner of patch of blue paint. This is presumed to be closest to the color as originally applied. As no evidence of an additional coat of paint, varnish or glaze can be observed, it is thought the teal or green variations in tone have occurred as the result of exposure from which the blue areas were protected.

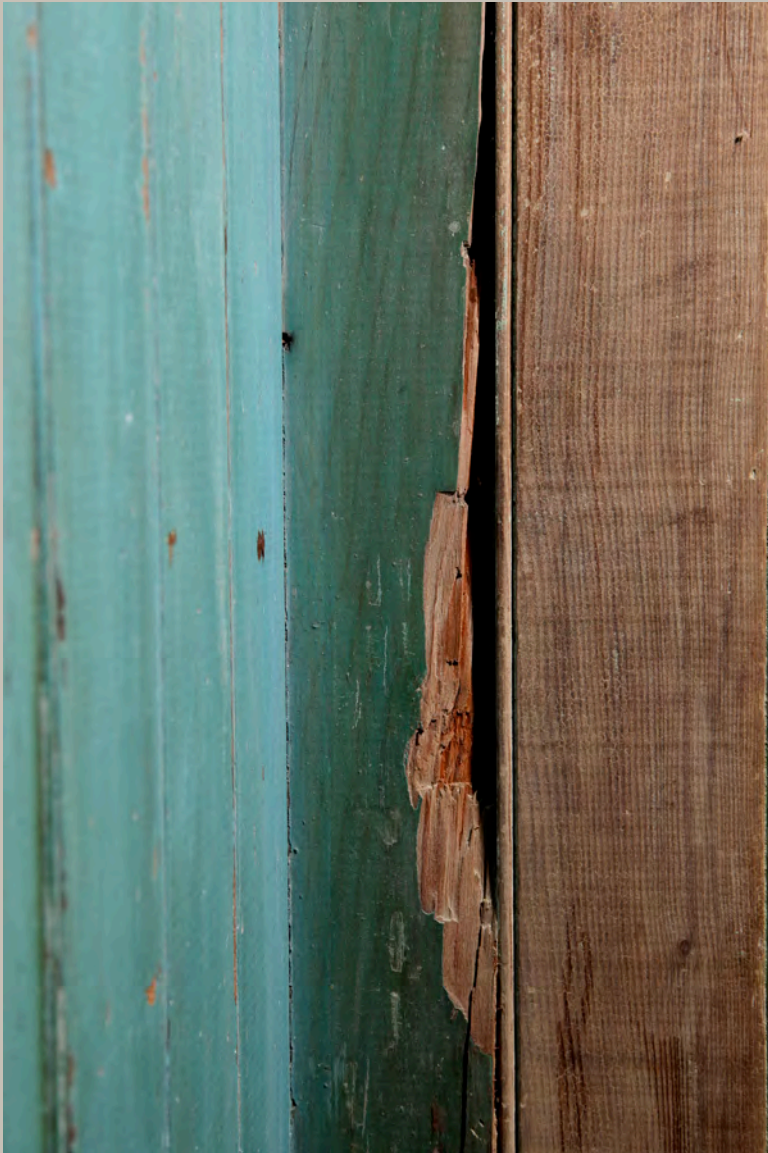
Damaged wooden plank by the NW corner

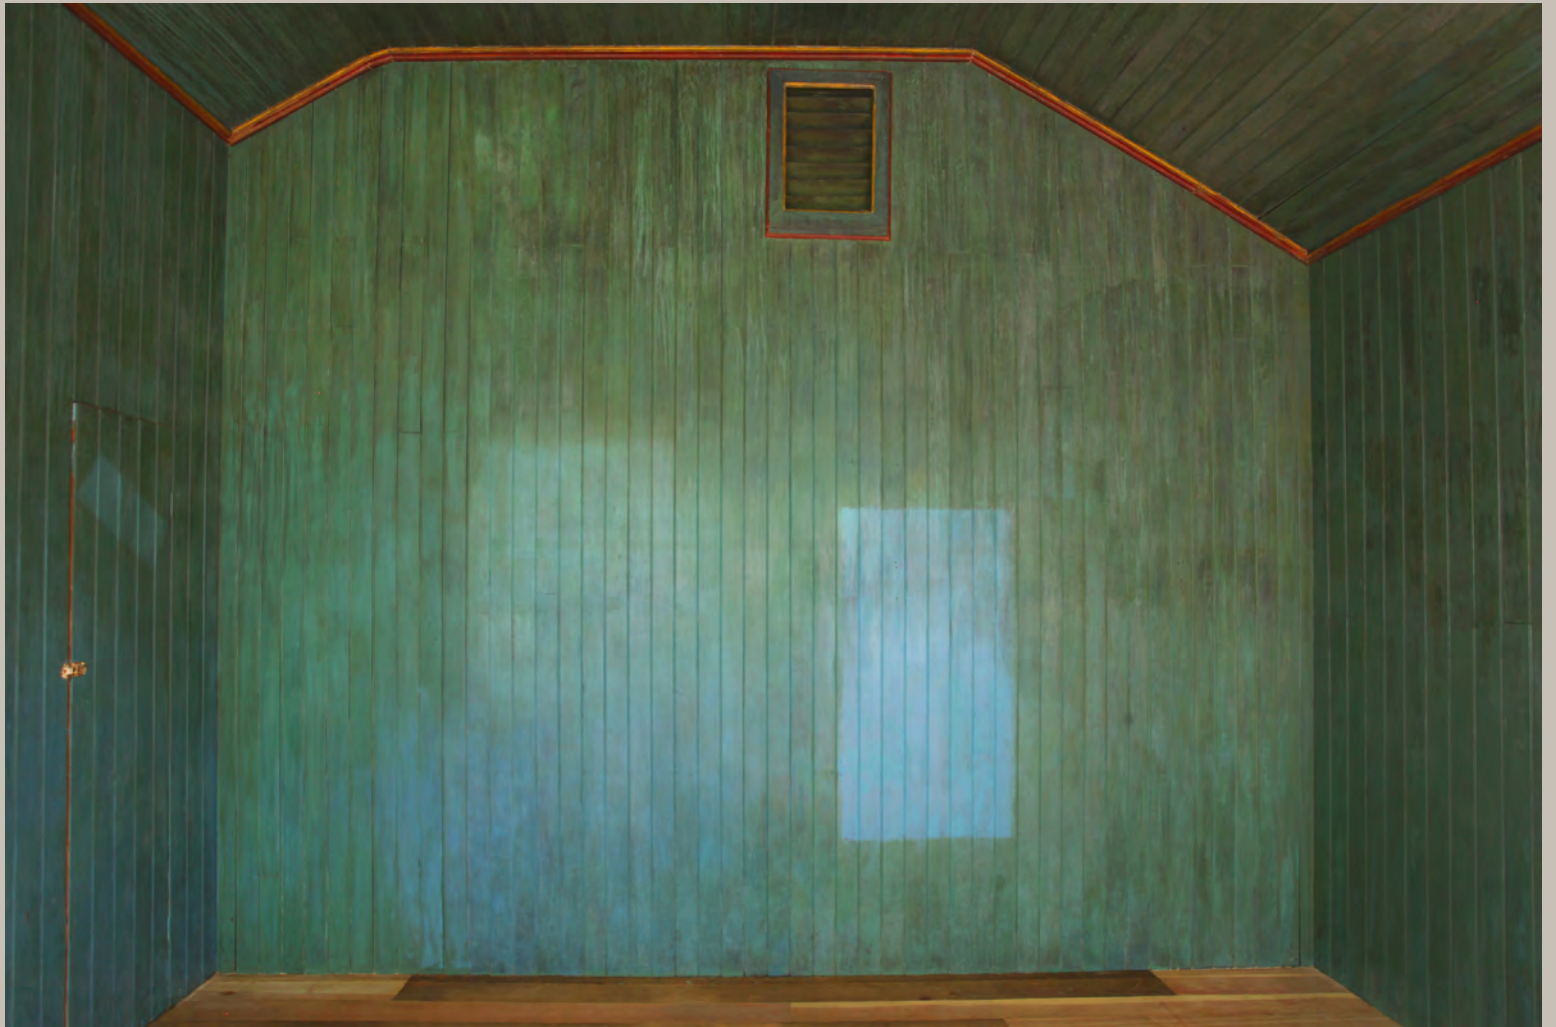
The north wall after restoration

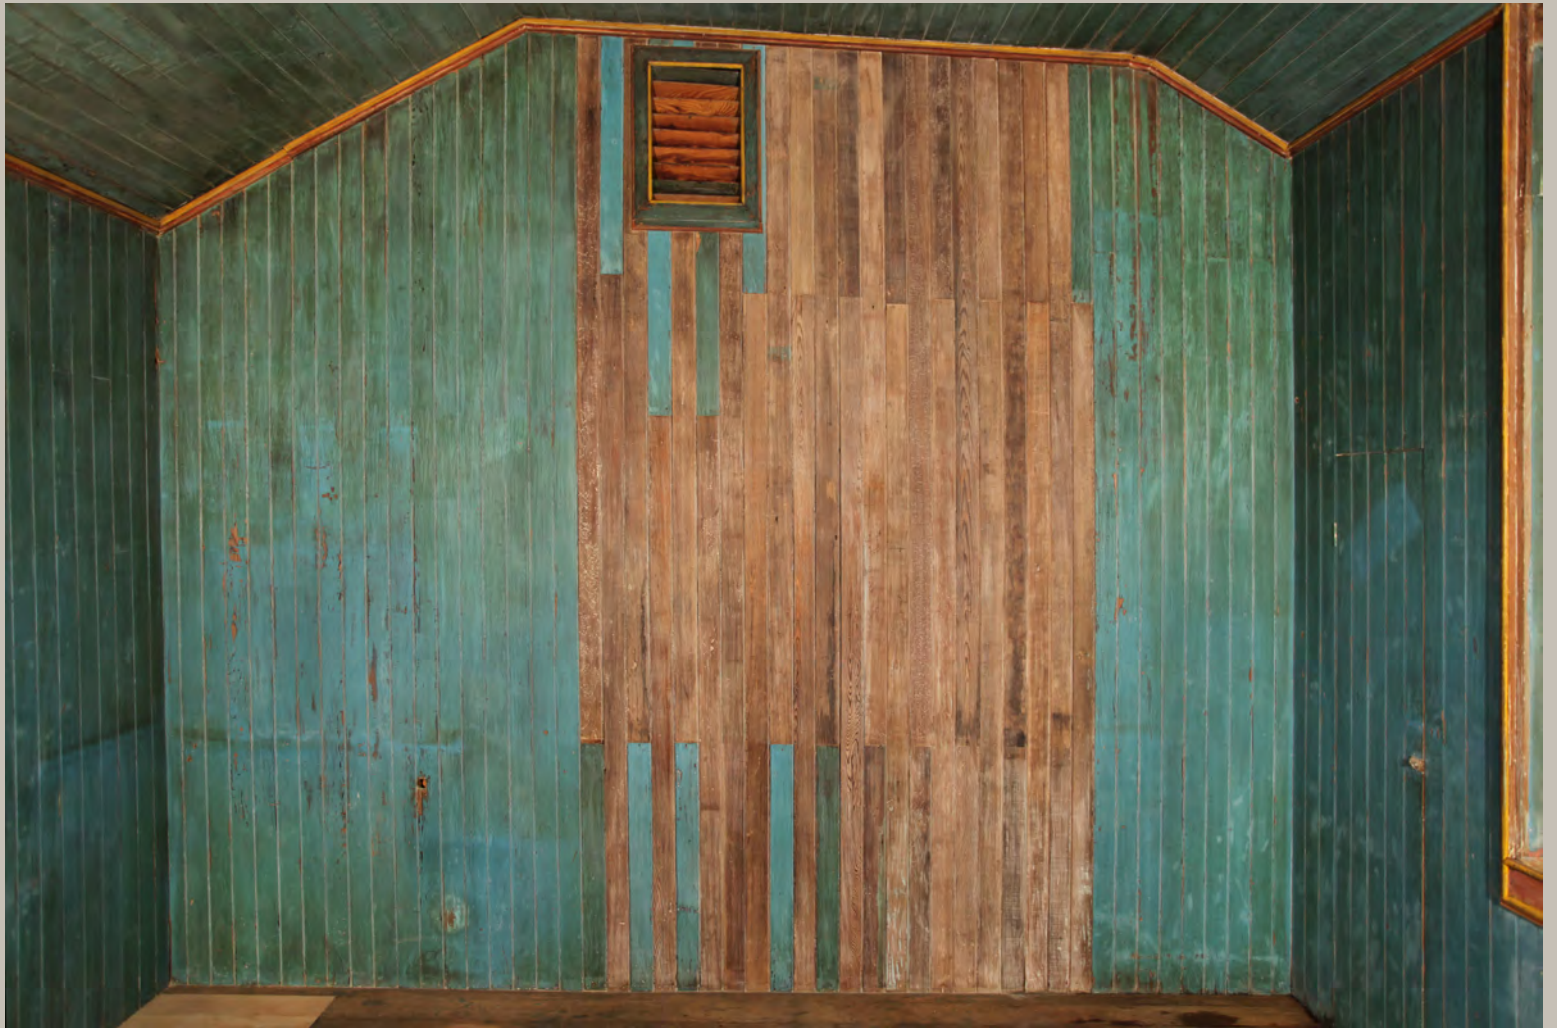
The south wall prior to restoration

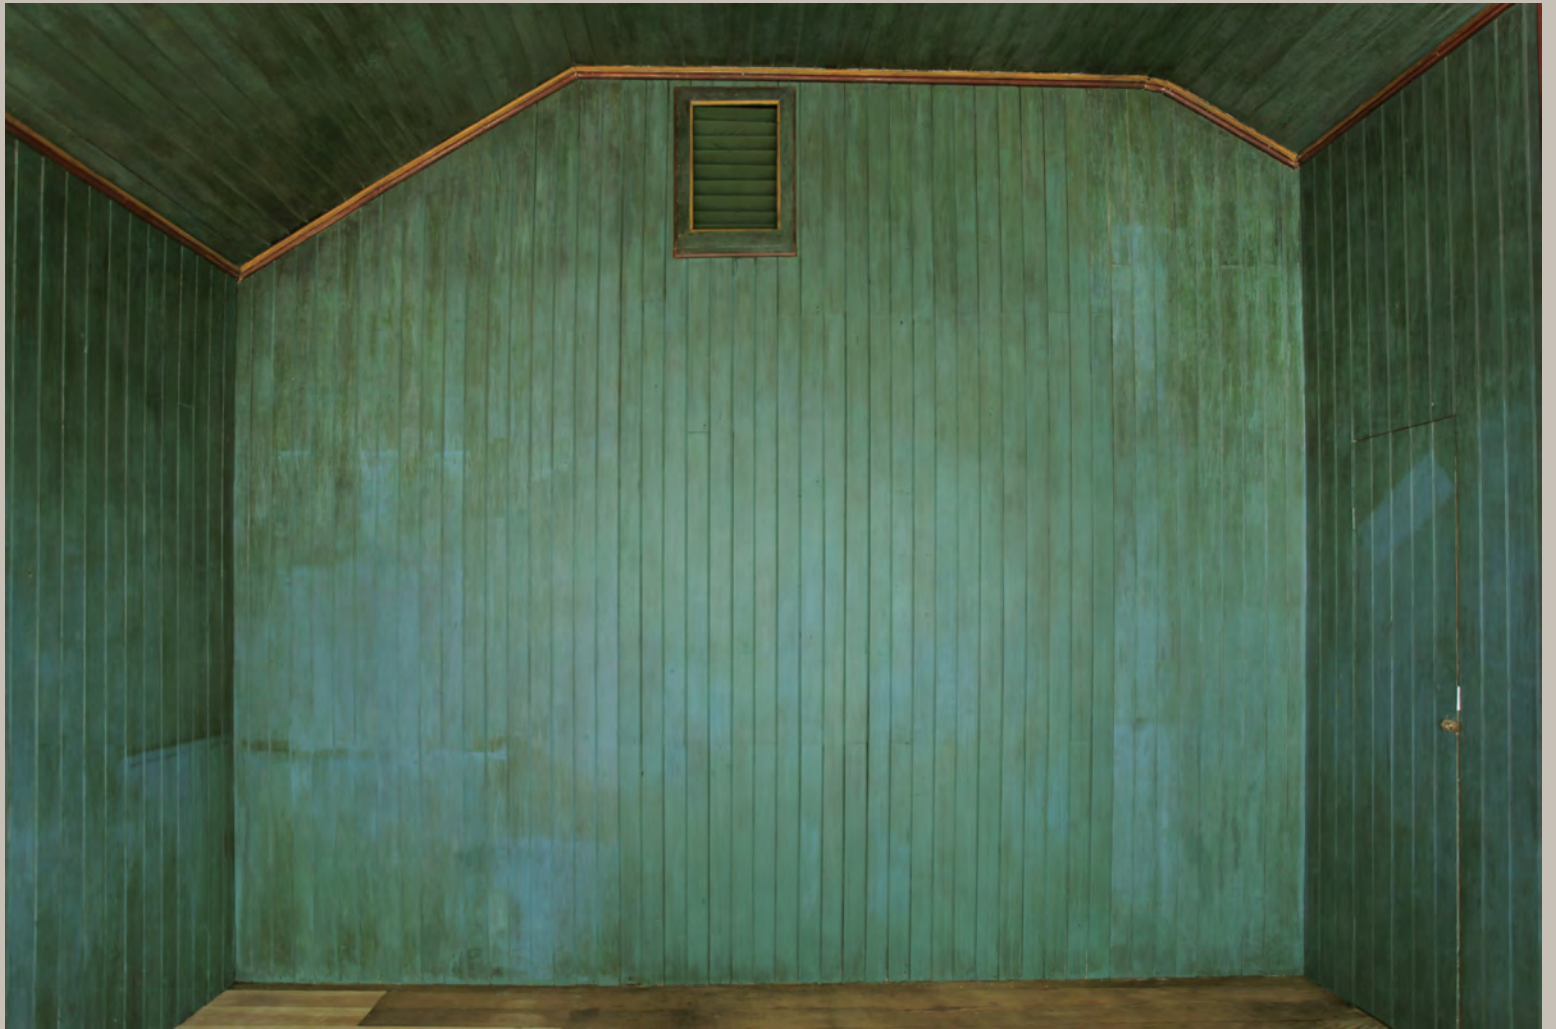
The south wall after restoration

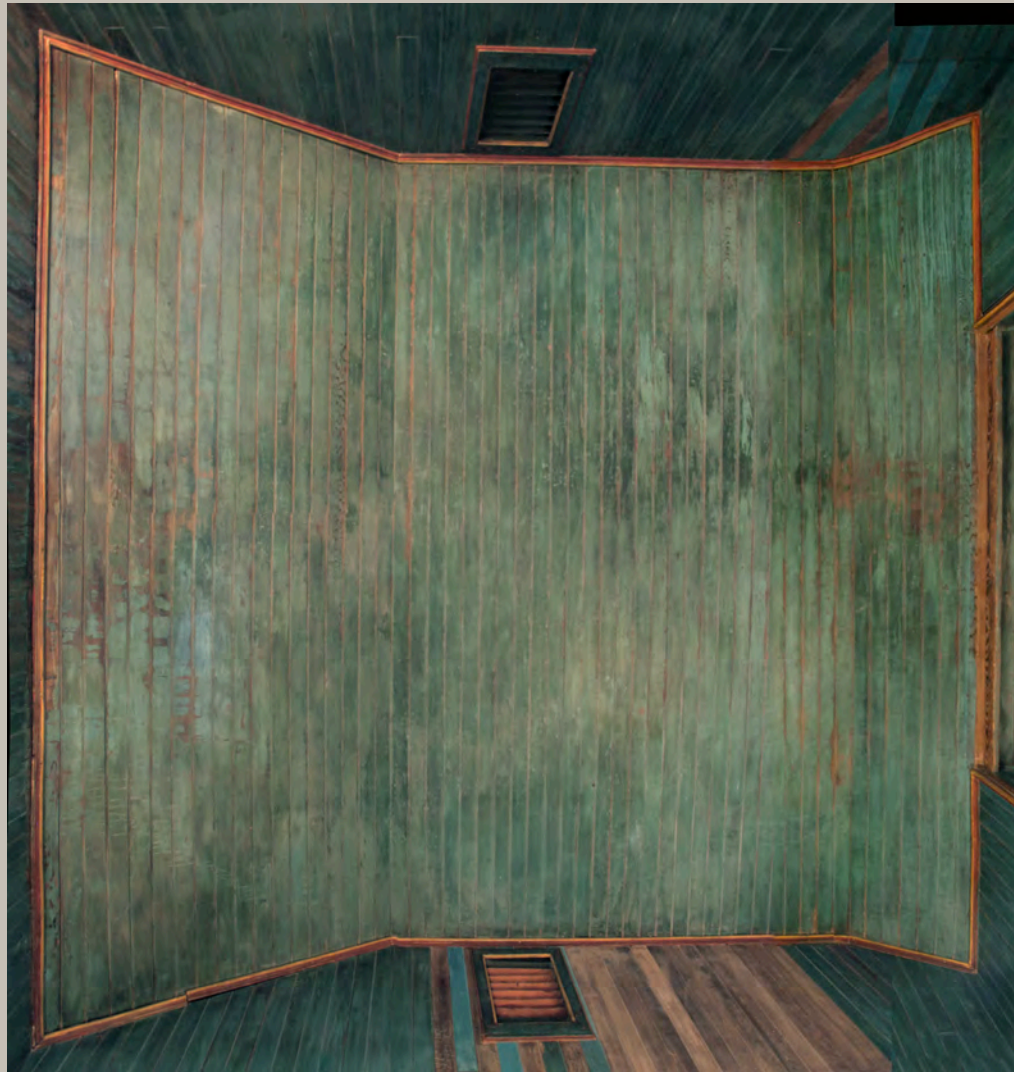
Composite photograph of the ceiling before restoration

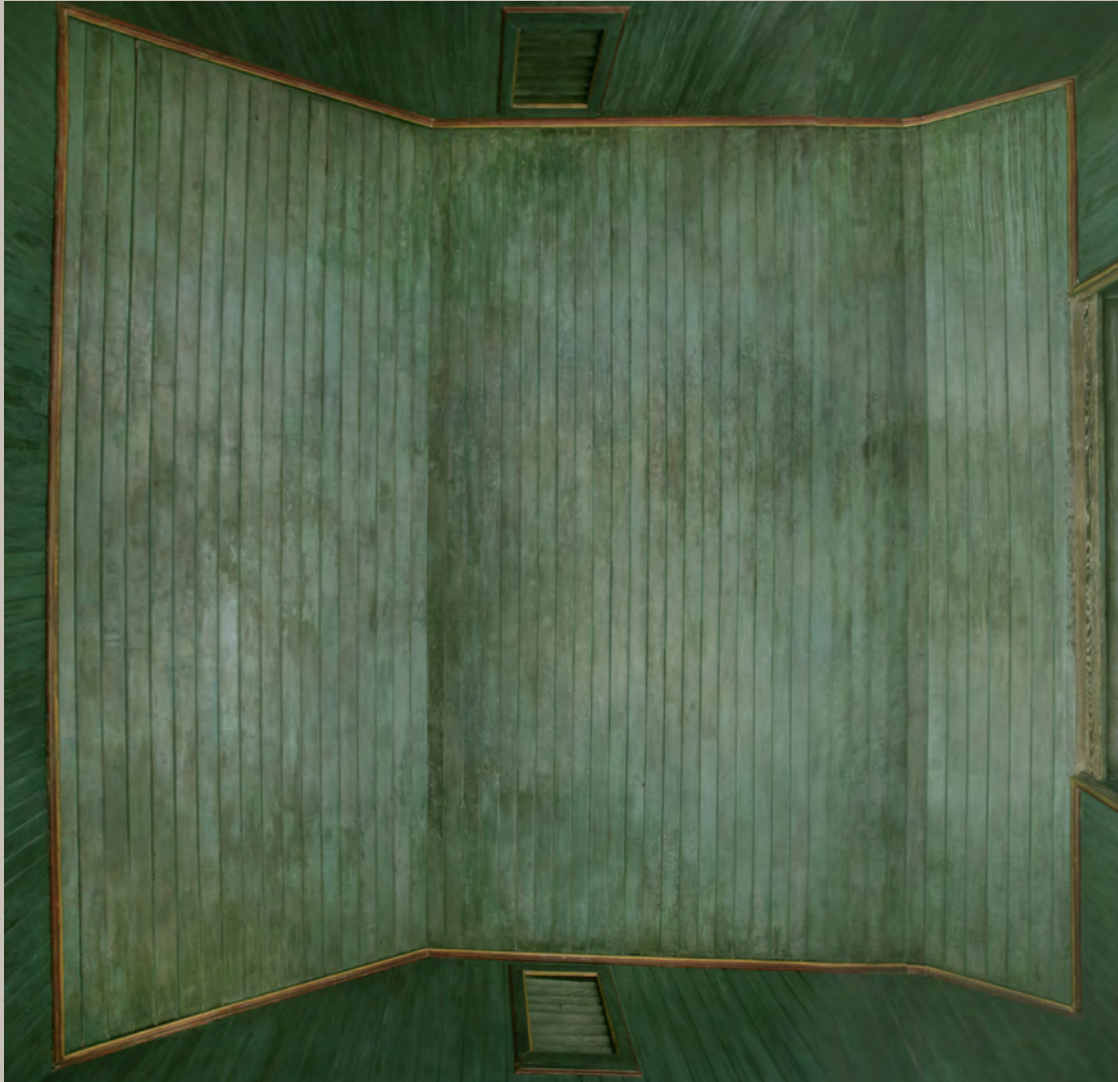
Composite photograph of the ceiling after restoration
