Desert Greens HOA

Level 1 Reserve Study

Report Period - 1/1/2016 to 12/31/2016

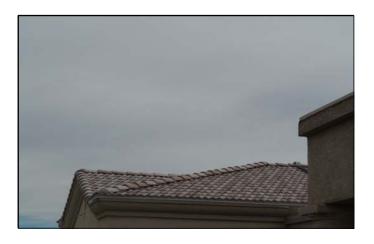
No problems noted or reported. Tile roofs have a typical life expectancy of approximately 25 to 30 years before underlayment deterioration causes significant leaks. Inspect roofs regularly and make repairs as necessary as an operating expense to ensure full life. Remaining life based on current age.

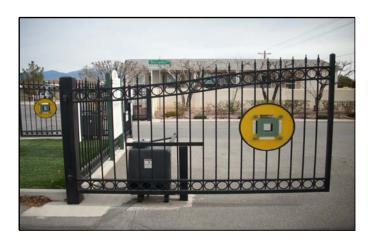
Comp # 504 Vehicle Gates - Replace

Although these gates may reach an extended life we recommend funding to completely replace them approximately every 30 years to ensure appearance and function. We have included funding for the replacement of the adjacent pedestrian gates and fencing at the same time.

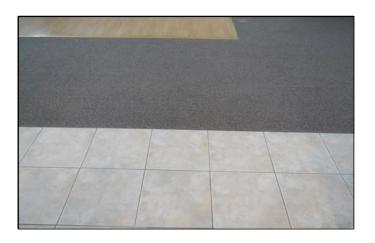
Carpet is in fair condition and is expected to be replaced prior to the beginning of this fiscal year (FY 2016). Some evidence of wear noted but no rips or curling seams observed at the time of inspection. Expect to replace this component approximately every 10 years assuming normal use and wear. Remaining life based on current age and condition.
