Canterbury 2021 Flood Recovery Update 3

Ken Tarboton (Aqueus Consulting)
Shaun McCracken (Environment Canterbury)

31 March 2022

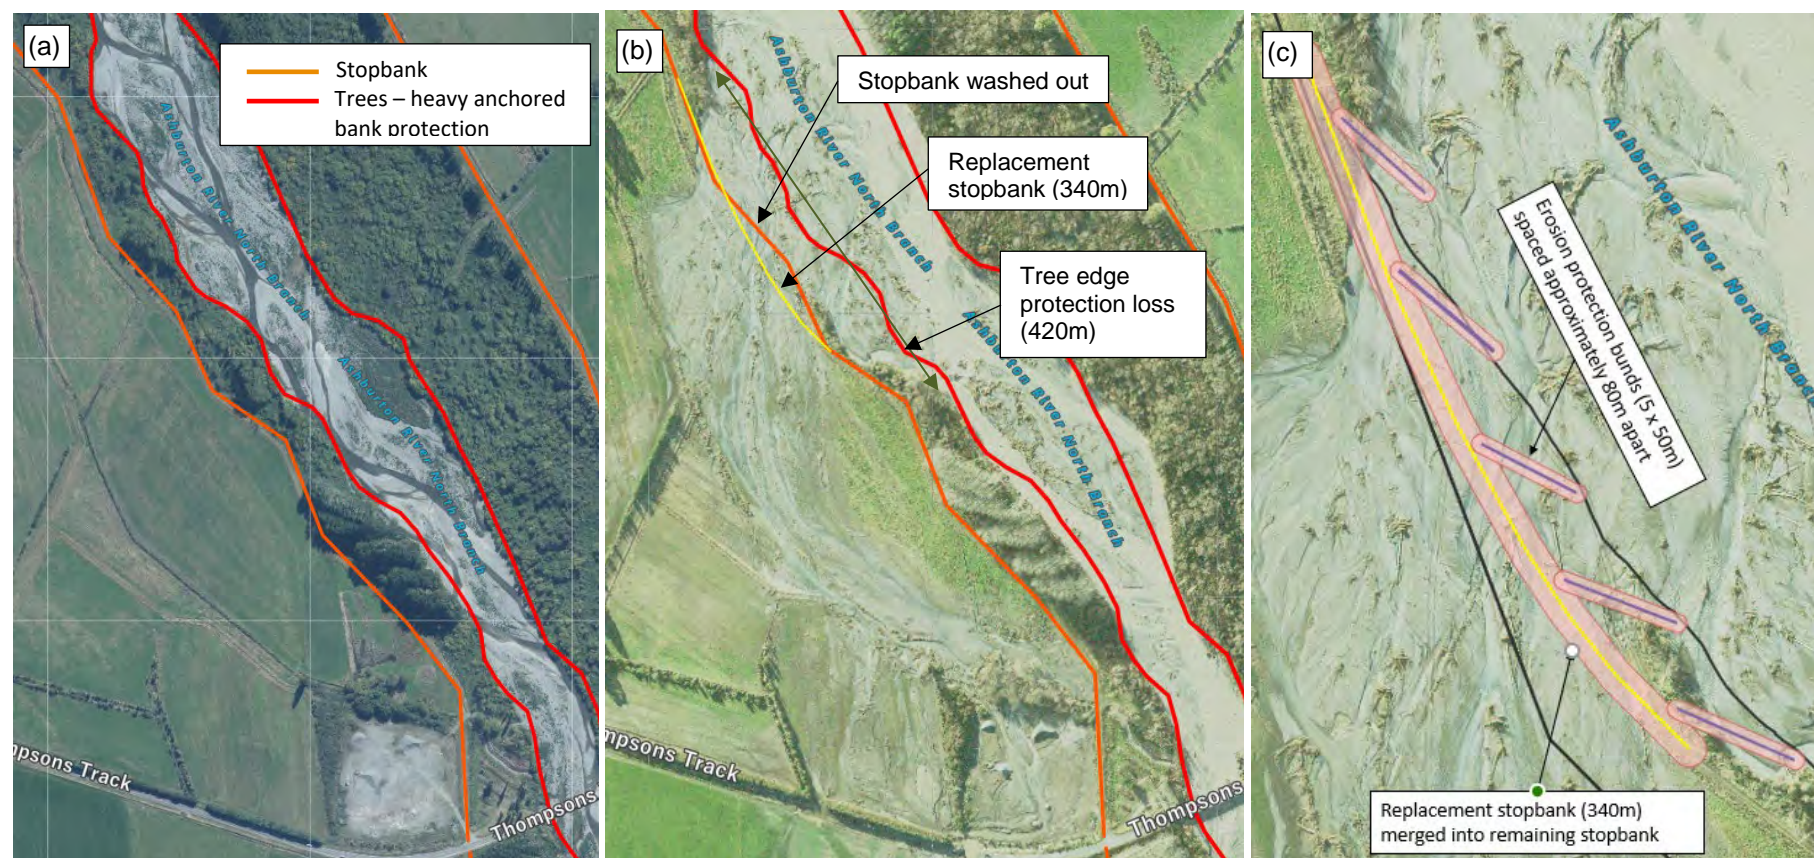
Figure 8-1: North Ashburton at Thompsons Track, approximately 23km northwest of Ashburton. (a) Aerial view prior to flood, (b) post-flood aerial showing extend of stopbank and tree edge protection asset loss, (c) Replacement stopbank and erosion protection bunds.

Like-for like reinstatement of 340m of stopbank has been completed. This work included construction of 250m of erosion protection bunds to provide equivalent edge protection until tree edge protection can be established. Anchored tree edge protection and tree infill planting will follow in the winter of 2022.

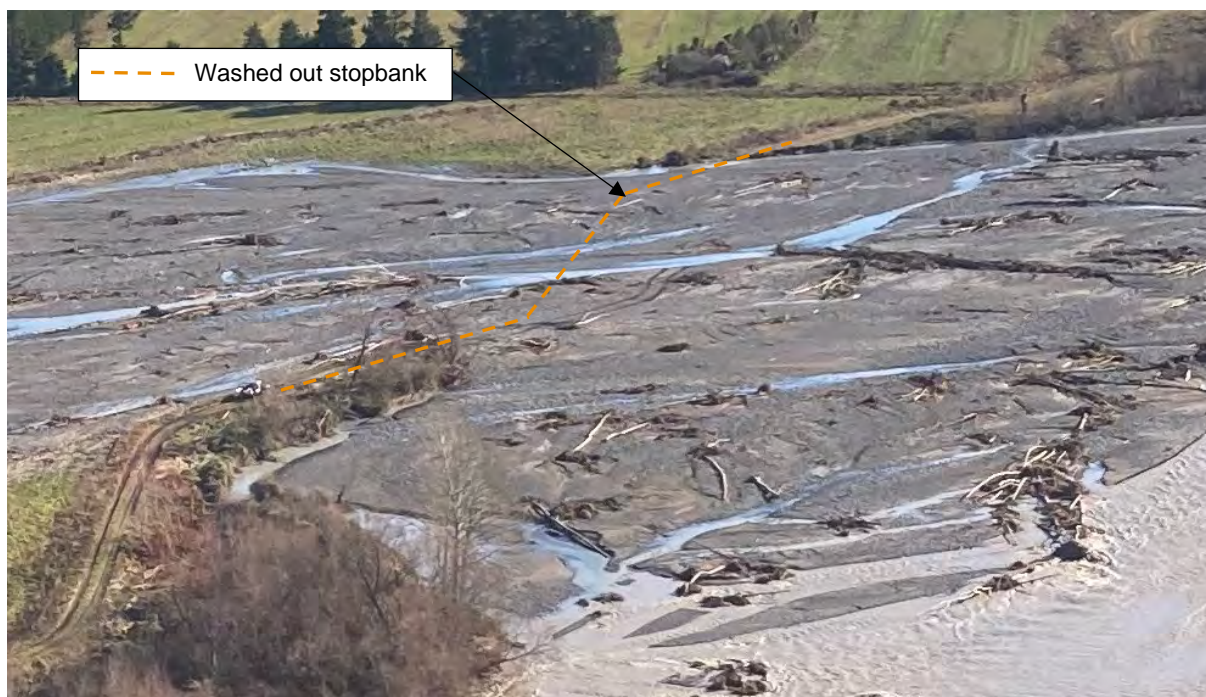
Figure 8-2: North Ashburton at Thompsons Track. Area of stopbank and tree edge protection loss on 3 June 2021.

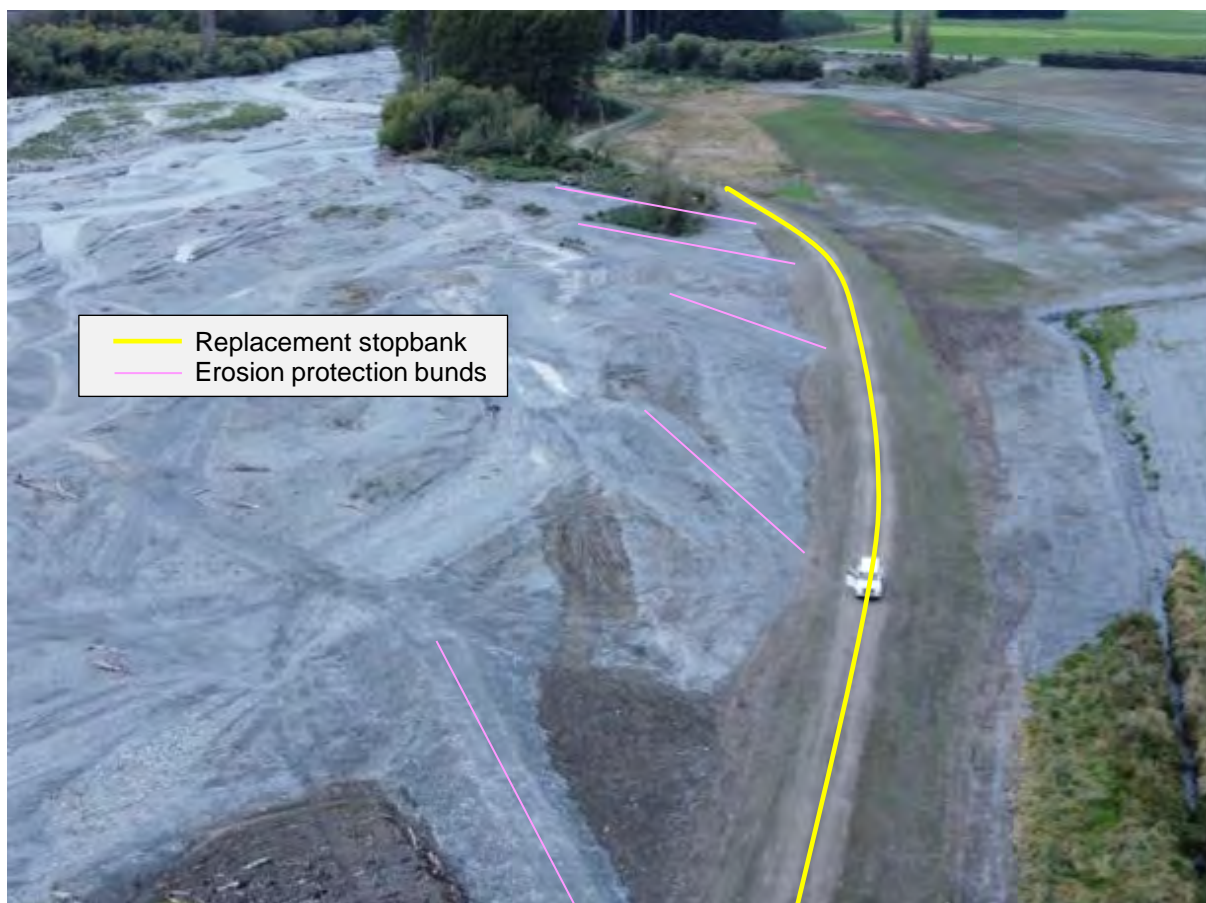
Figure 8-3: North Ashburton at Thompsons Track. Completed stopbank repair on 16 March 2022. Anchored tree protection and infill planting still to be done.

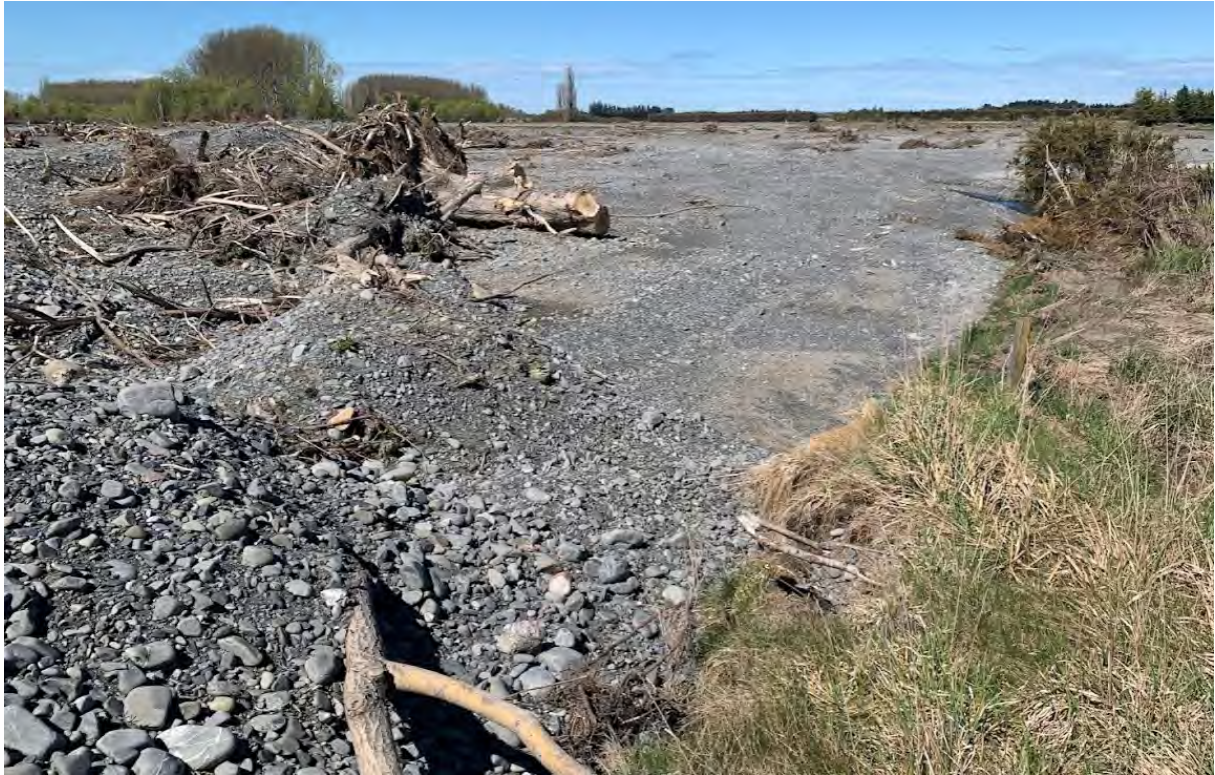
Figure 8-4: North Ashburton at Thompsons Track. Looking downstream from end of remnant stopbank, 29 September 2021.

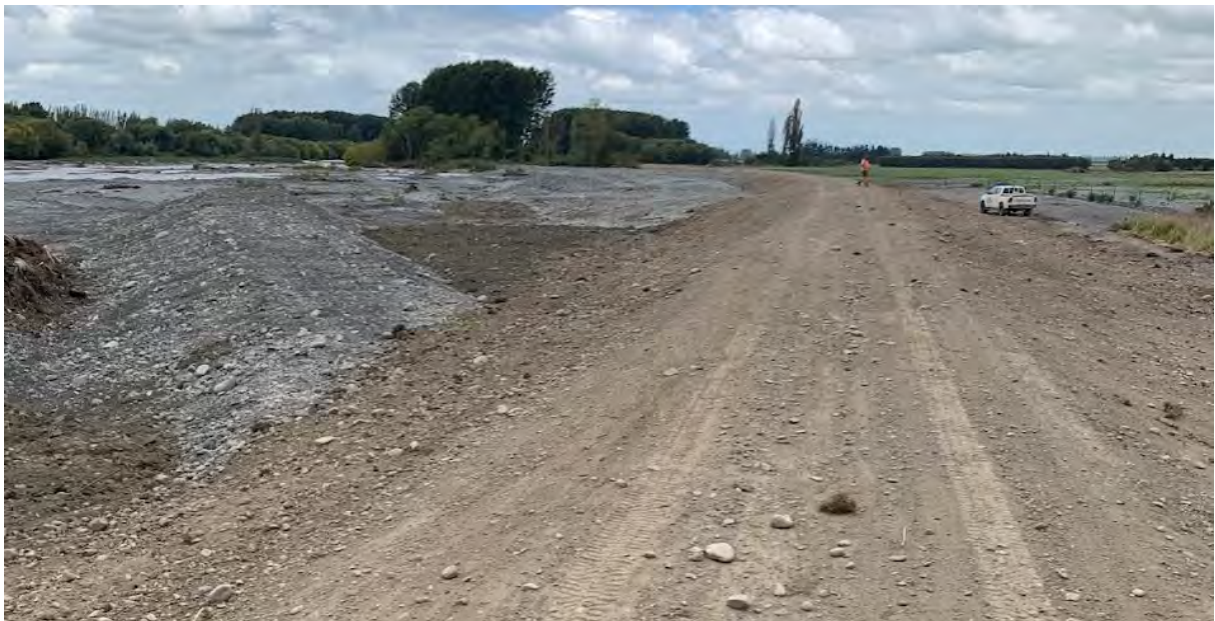
Figure 8-5: North Ashburton at Thompsons Track. Looking downstream from same location as above following completion of stopbank and erosion protection bund repair, 24 February 2022.

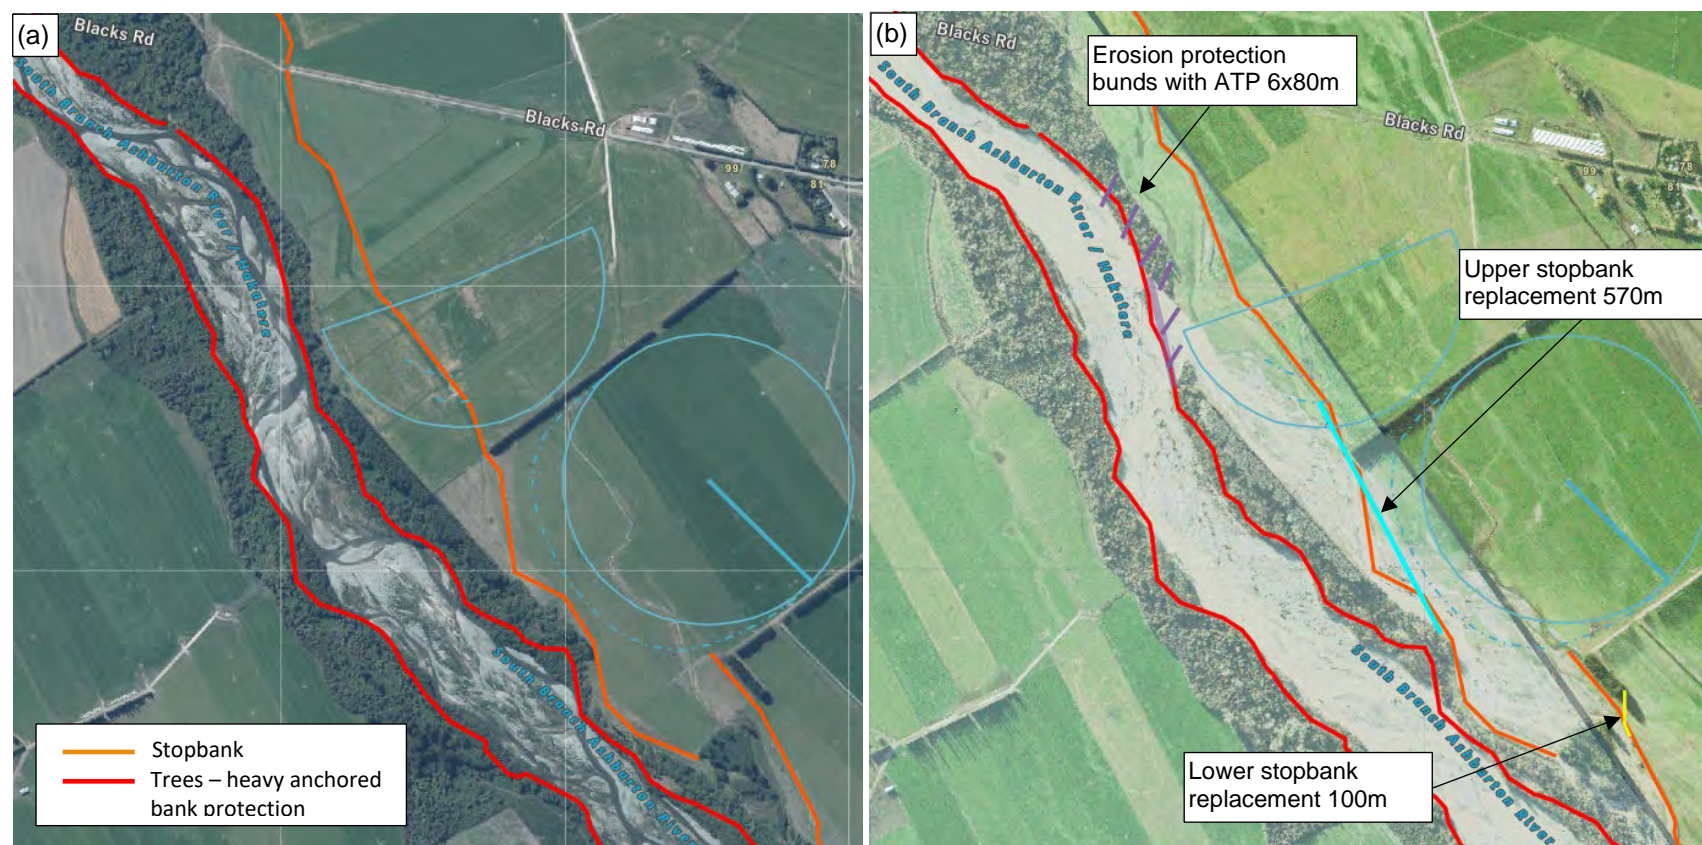
Figure 8-6: South Ashburton at Blacks Road 8km north of Ashburton. (a) Aerial view prior to flood, (b) post-flood aerial showing extent of stopbank and tree edge protection asset loss with proposed replacement stopbanks and erosion protection bunds. Location of centre pivots included for reference.

Betterment at this site included the establishment of erosion protection flanges along the upper stopbank where centre-pivot wheel access was required and tree edge protection is not possible. It also includes establishing new tree edge protection on the lower stopbank (not previously there) and some tree removal to establish a return flow channel back to the river. This work is being coordinated across ECan departments to look for opportunities to combine the return flow pathway with the enhancement of a wetland area.

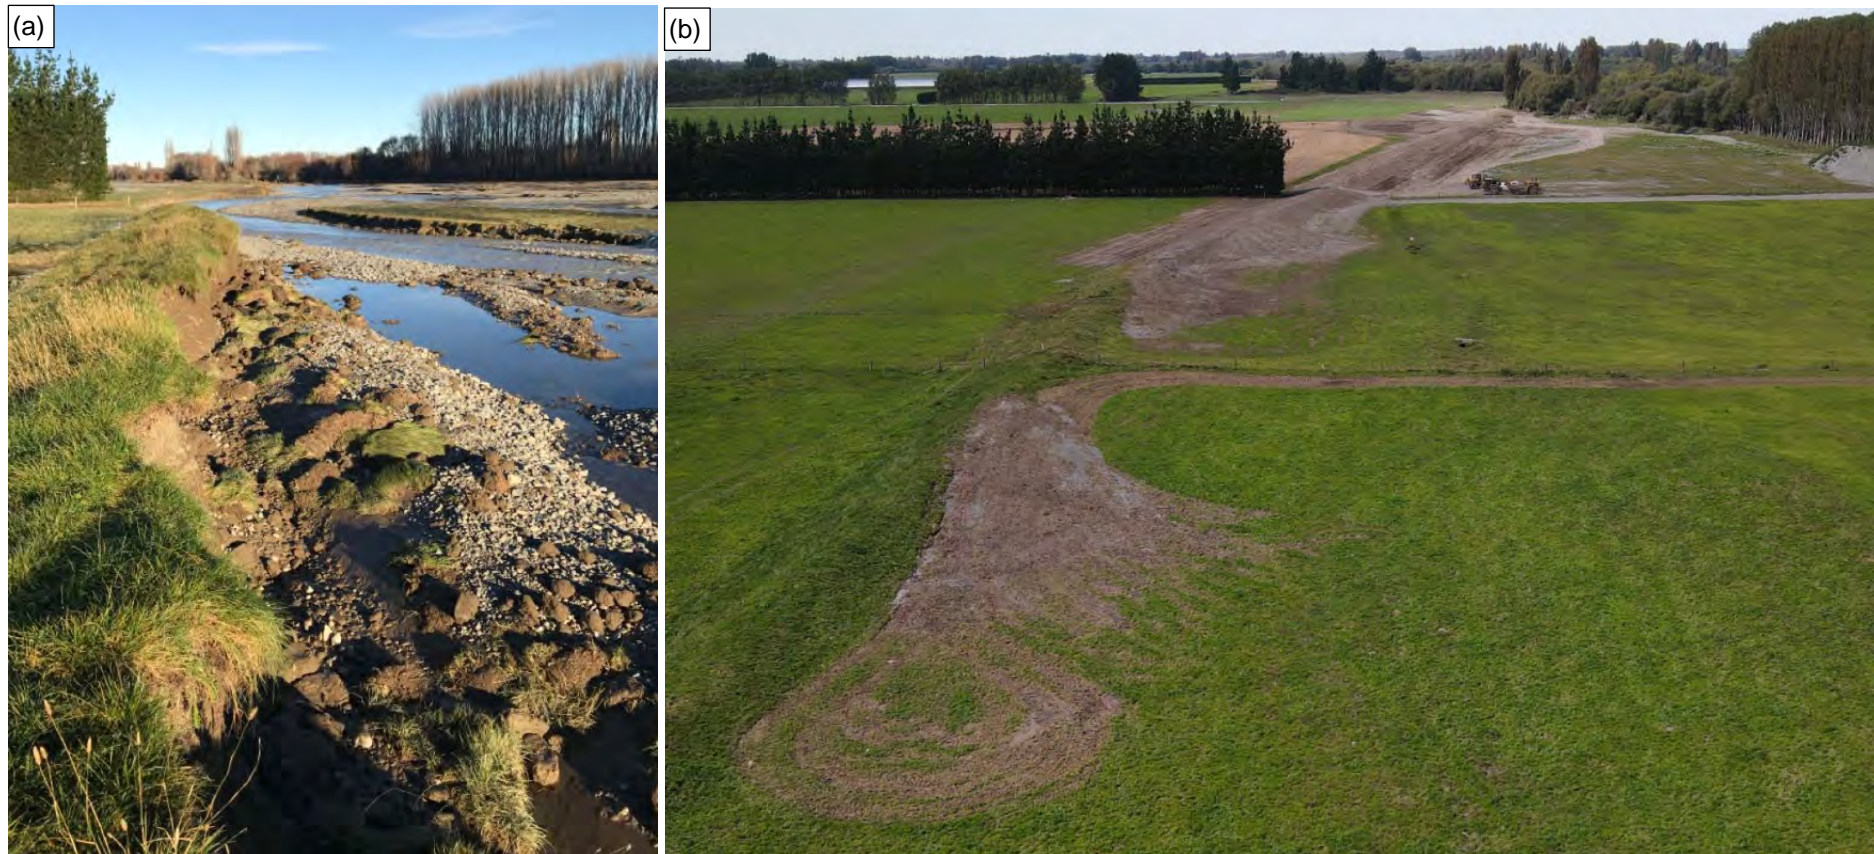
Figure 8-7: South Ashburton at Blacks Road looking downstream (a) from remnant upper stopbank soon after flood, (b) from drone following completion of upper stopbank replacement.

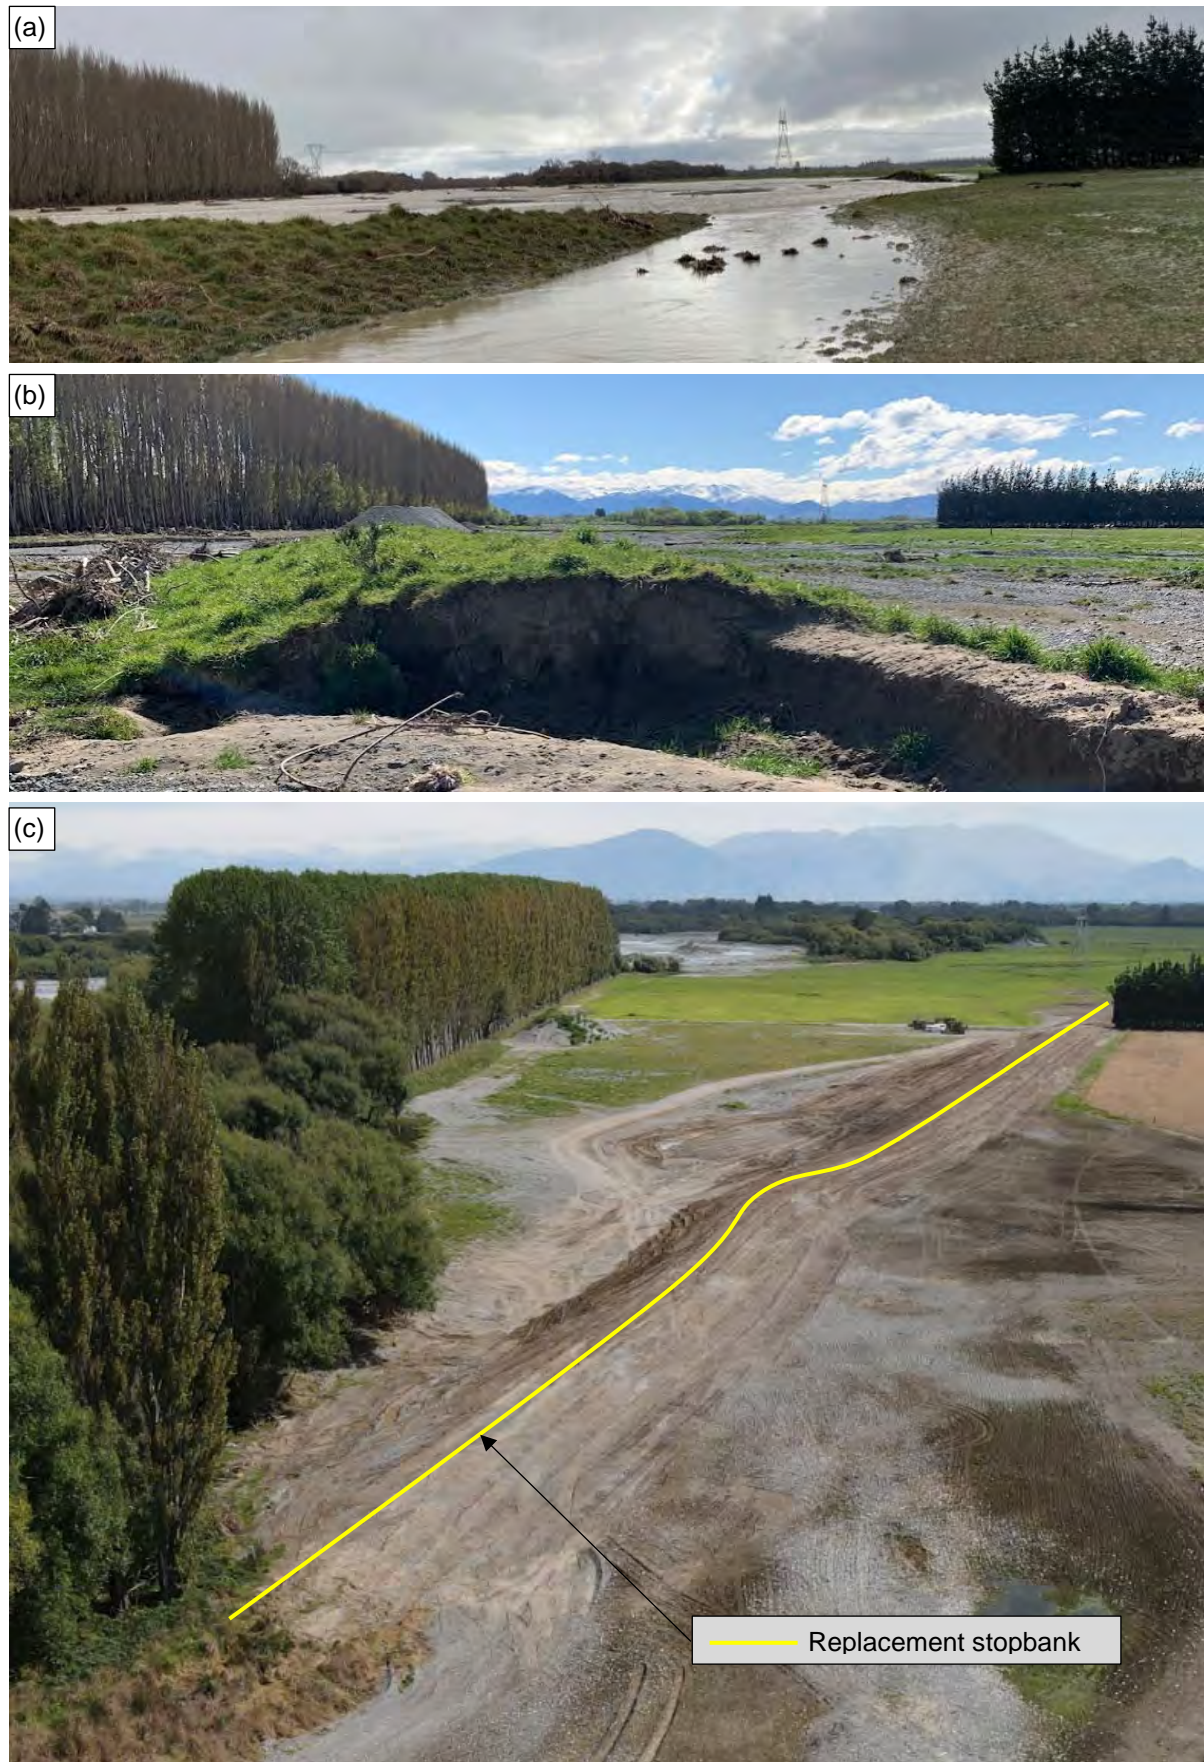
Figure 8-8: South Ashburton at Blacks Road looking upstream from lower end of remnant stopbank (a) early June 2021, (b) September 2021 and (c) on completion of replacement stopbank in February 2022.

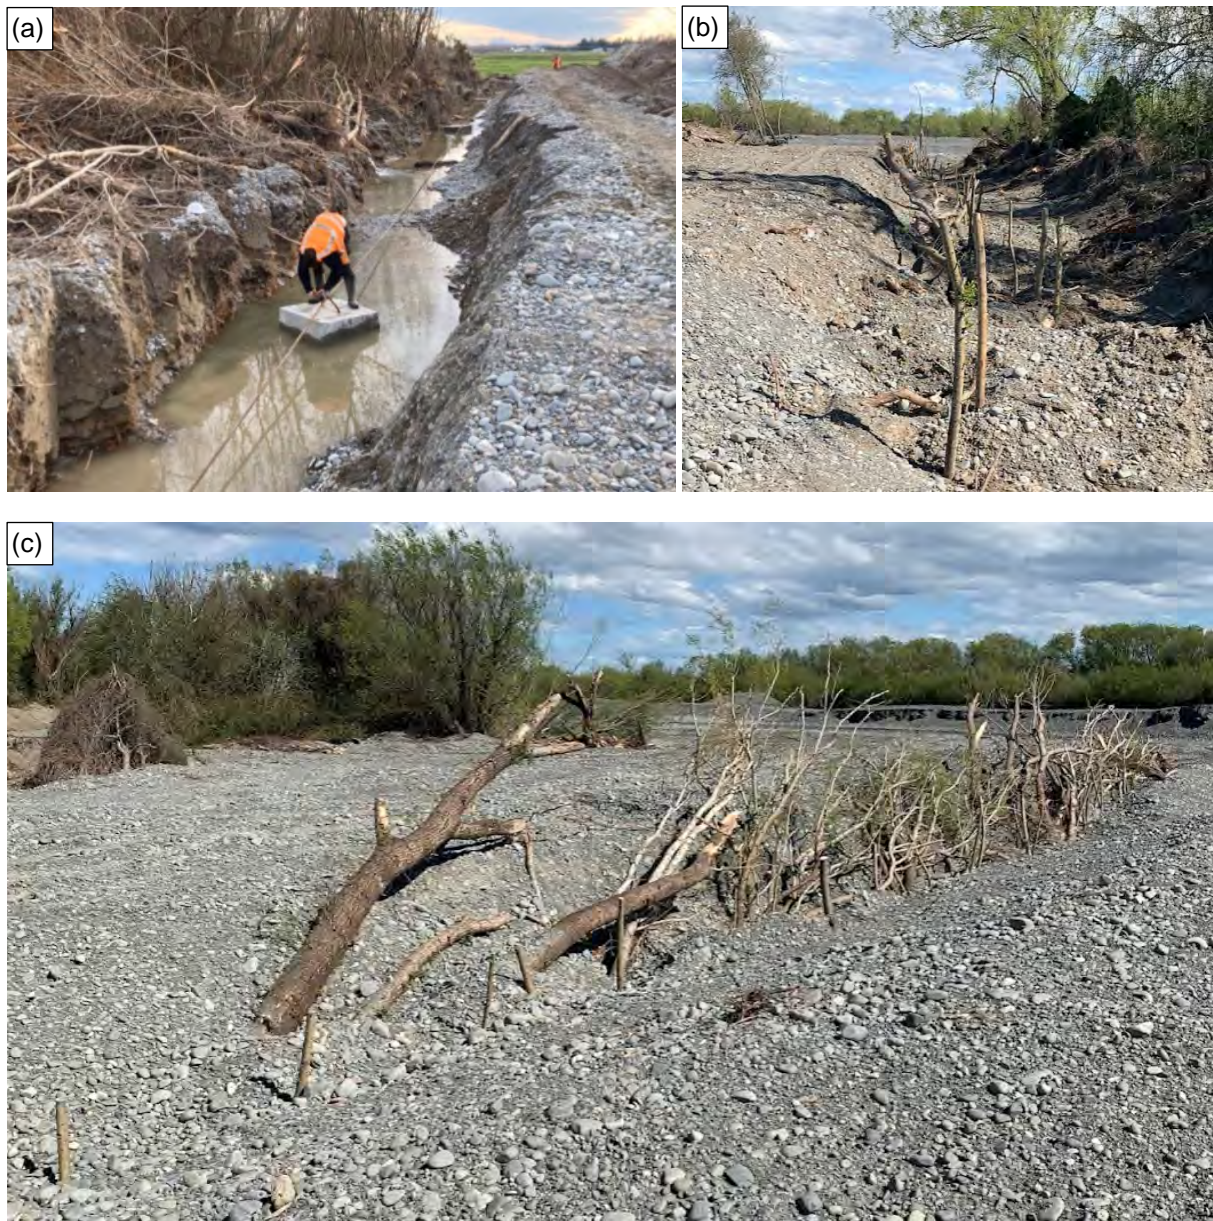
Figure 8-9: South Ashburton at Blacks Road, installation of anchored tree protection at erosion protection bunds: (a) installation of concrete block anchors, (burying willow poles in trench, and (c) completed ATP on upstream edge of erosion protection bund.

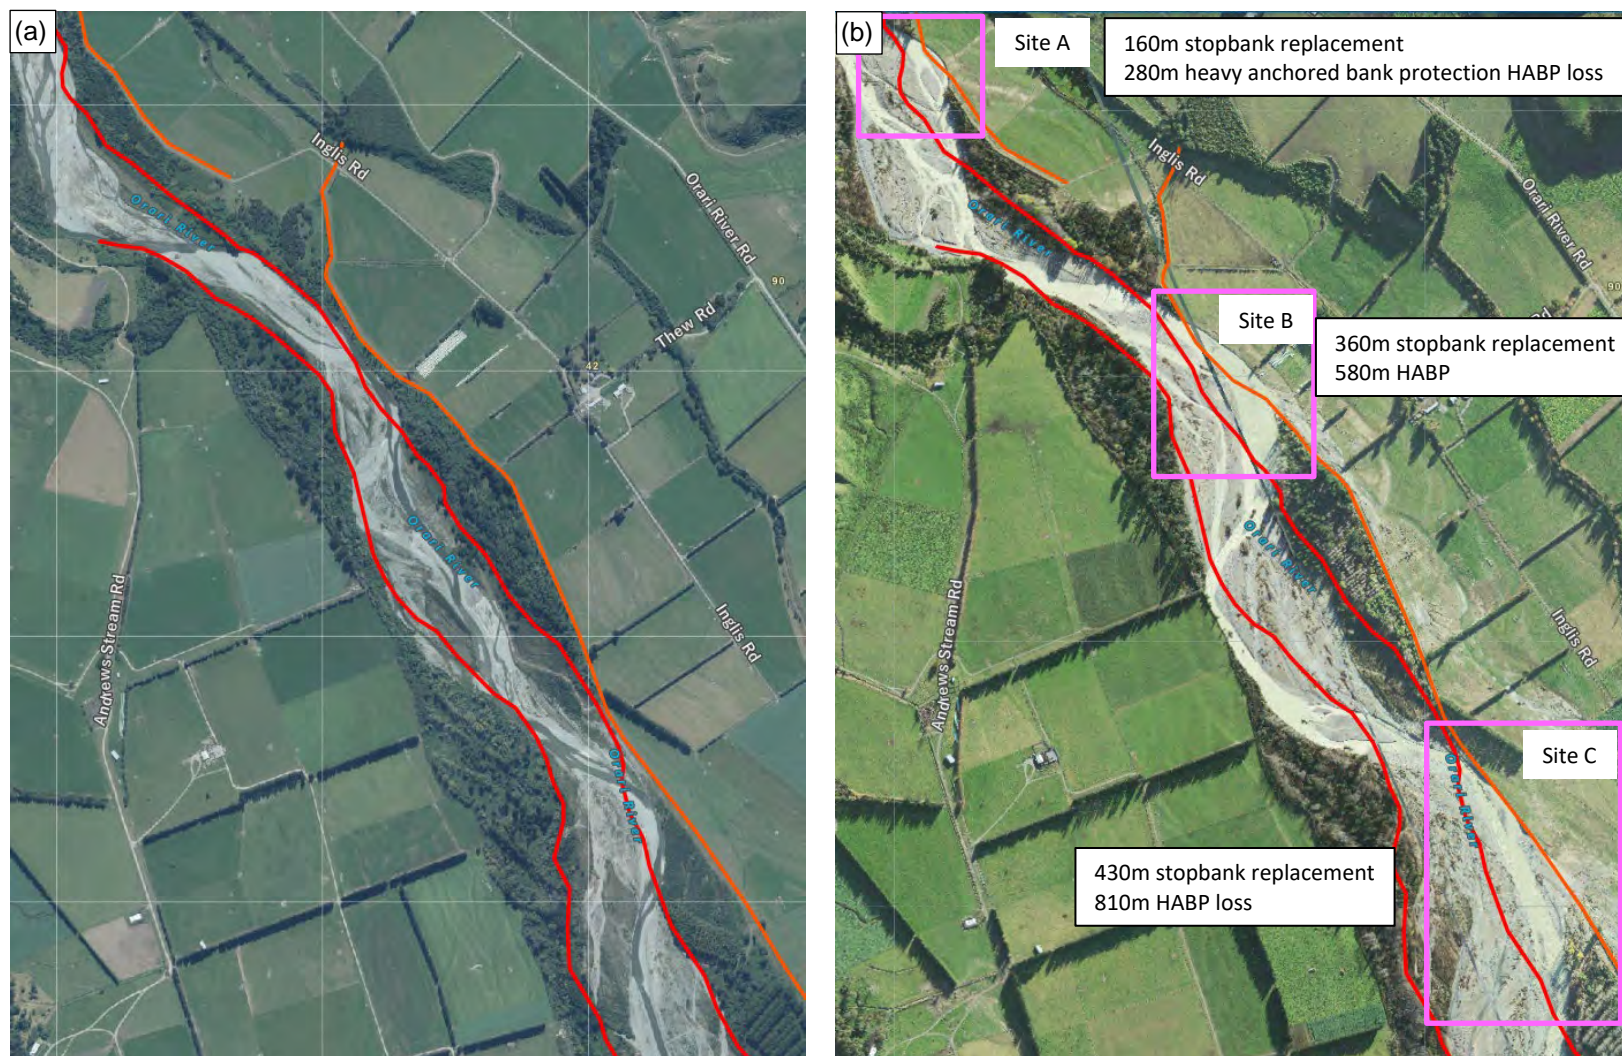
Figure 8-10: Orari at Inglis Road north of Geraldine: (a) Aerial view prior to flood, (b) post-flood aerial showing extent of stopbank and tree edge protection asset loss at three sites.

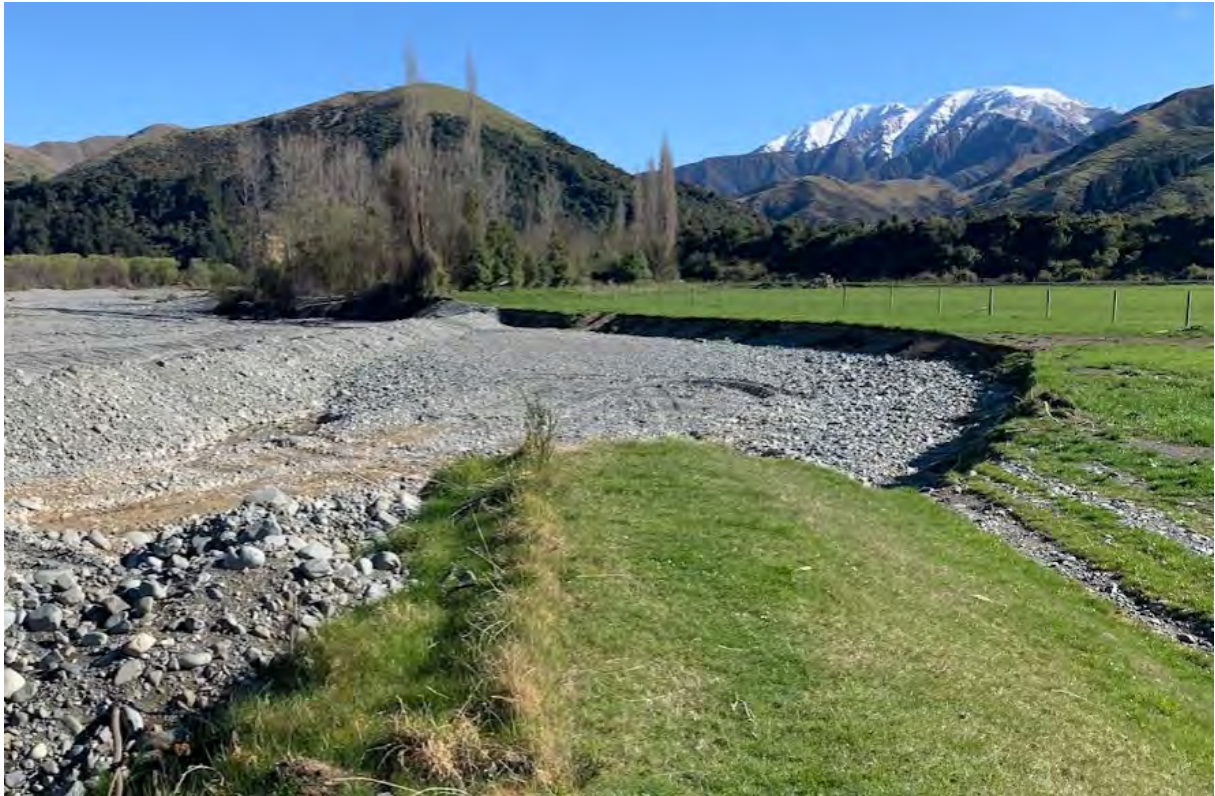
Figure 8-12: Orari at Inglis Rd Site A, Stopbank and edge protection loss - 28/9/2021.

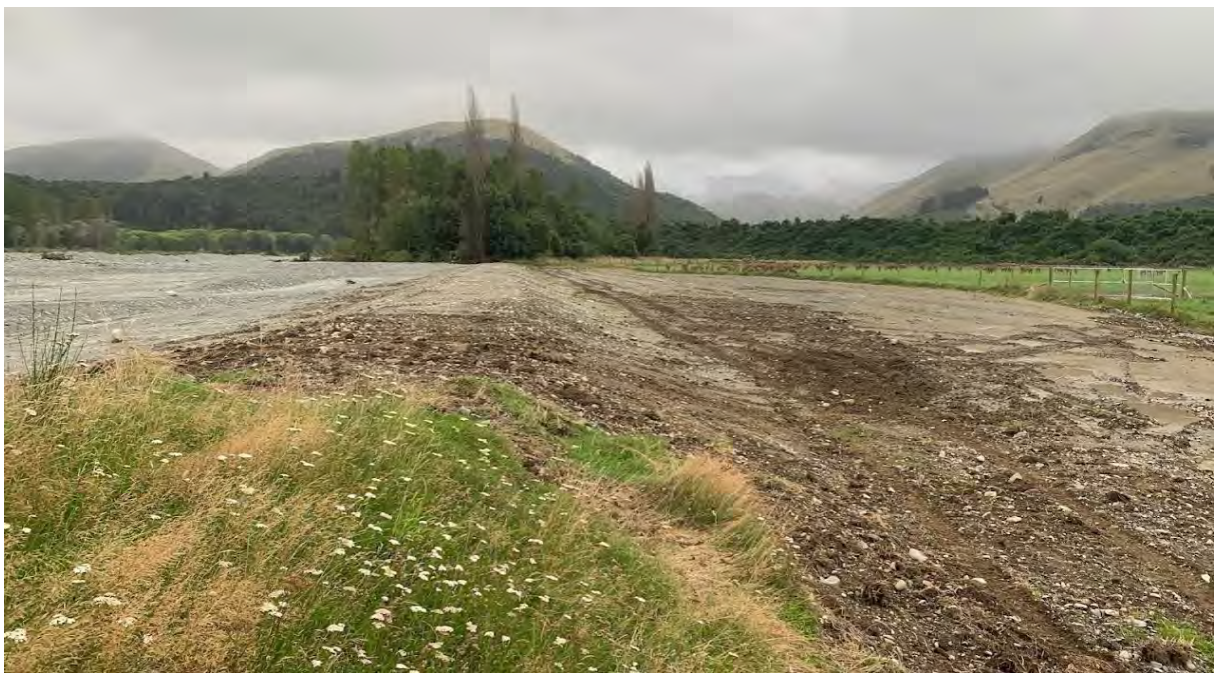
Figure 8-13: Orari at Inglis Rd Site A, Stopbank reinstated - 23/2/2022. Job 23676.

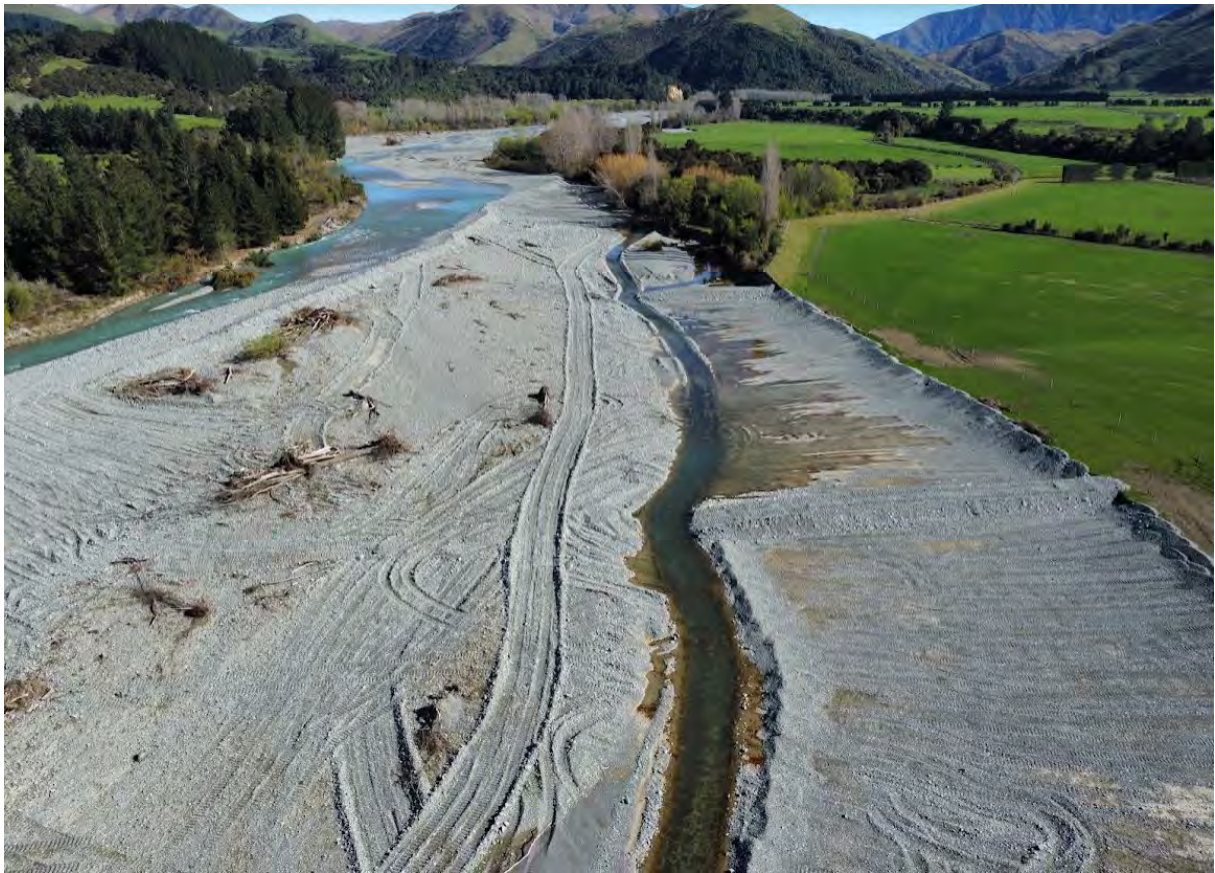
Figure 8-14: Orari at Inglis Rd Site B, Temporary bund work 28/9/2021.

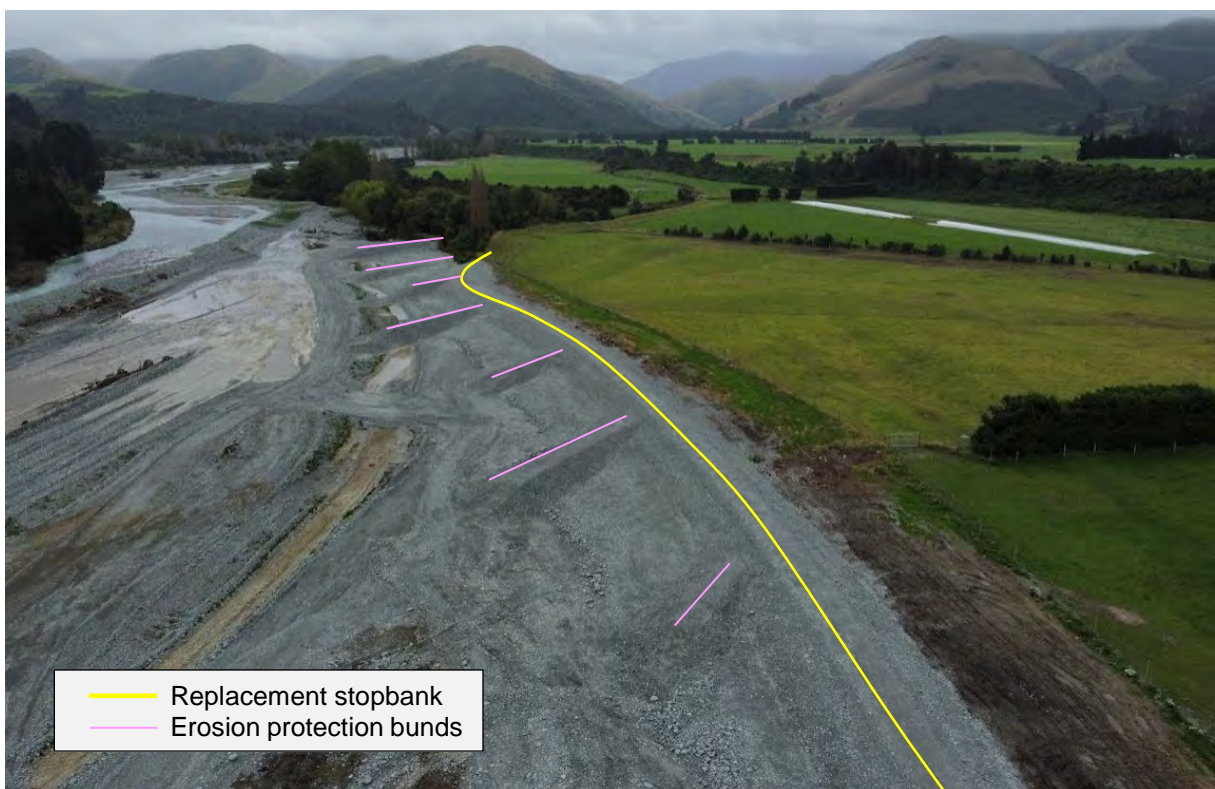
Figure 8-15: Orari at Inglis Rd Site B, Stopbank reinstated with erosion protection bunds. Topsoil to be added. 23/2/2022.

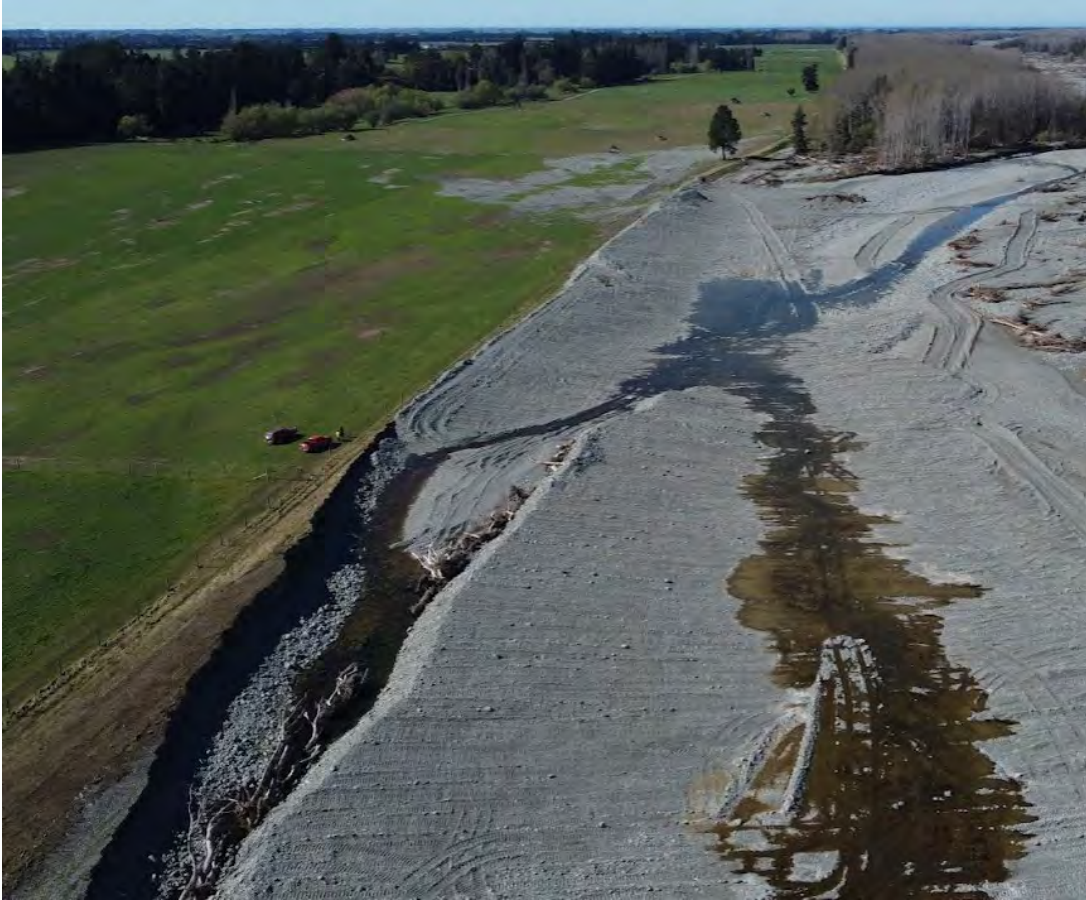
Figure 8-16: Orari at Inglis Rd Site C, looking downstream following temporary work prior to stopbank rebuild, September 2021.

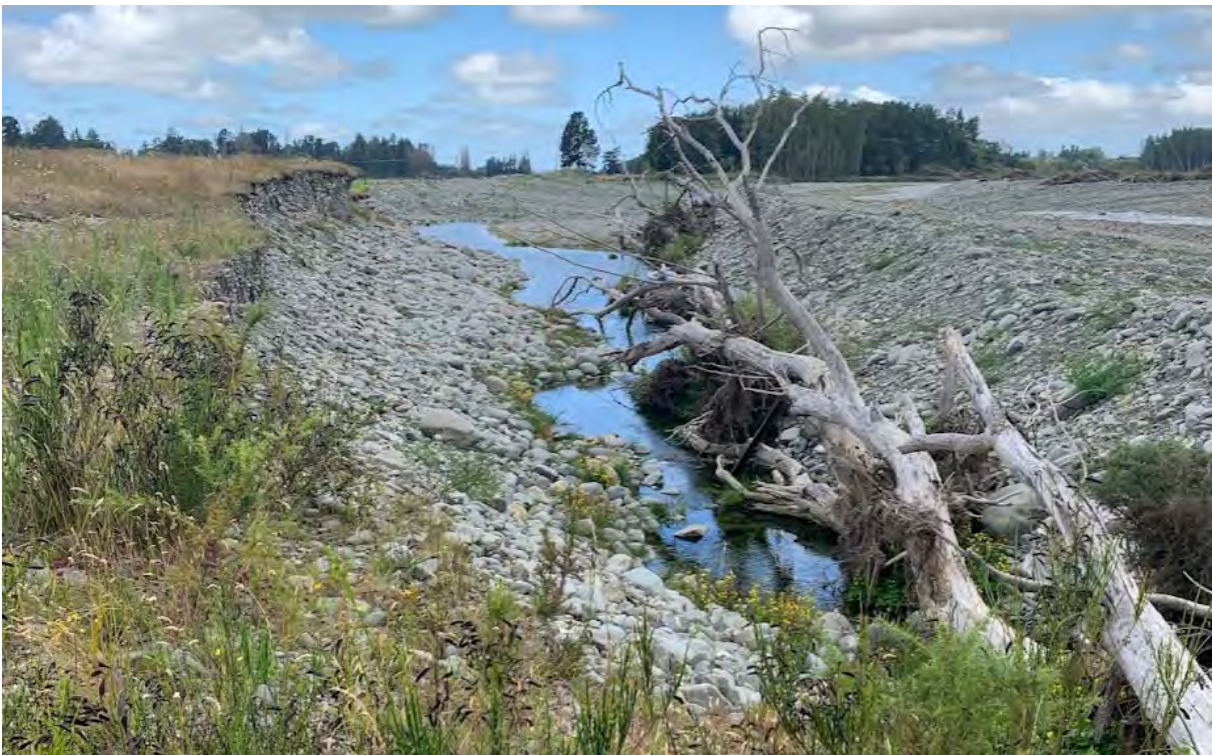
Figure 8-17: Orari at Inglis Rd Site C, looking downstream following temporary work prior to stopbank rebuild, January 2022.

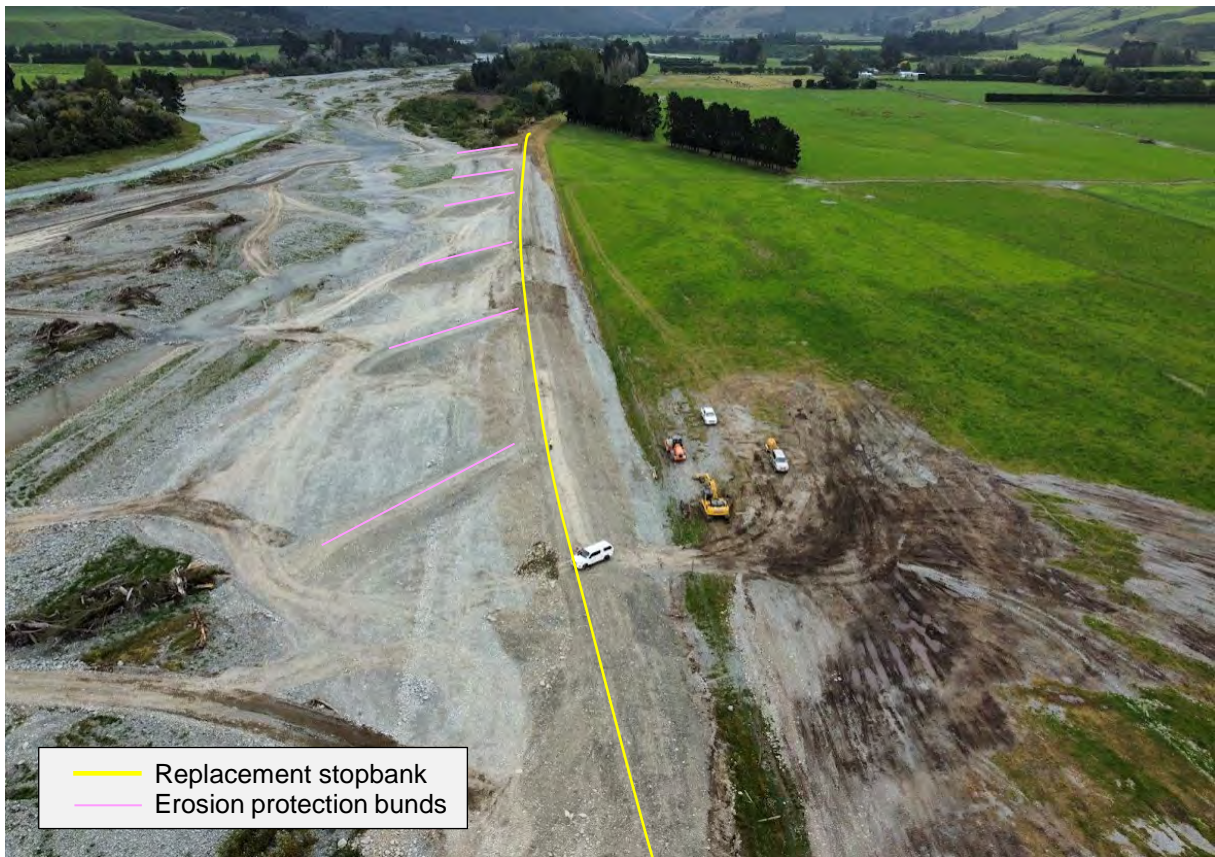
Figure 8-18: Orari at Inglis Rd Site C, looking upstream. Stopbank rebuild nearing completion, January 2022.

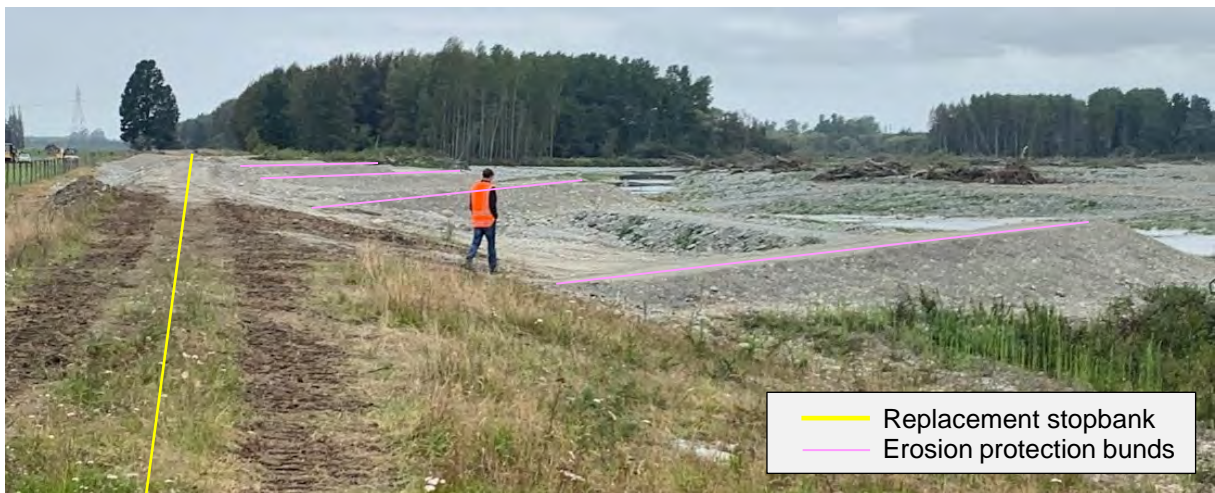
Figure 8-19: Orari at Inglis Rd Site C Stopbank completed to design height 7 of 9 erosion bunds complete, topsoil to follow, 23 February 2022.

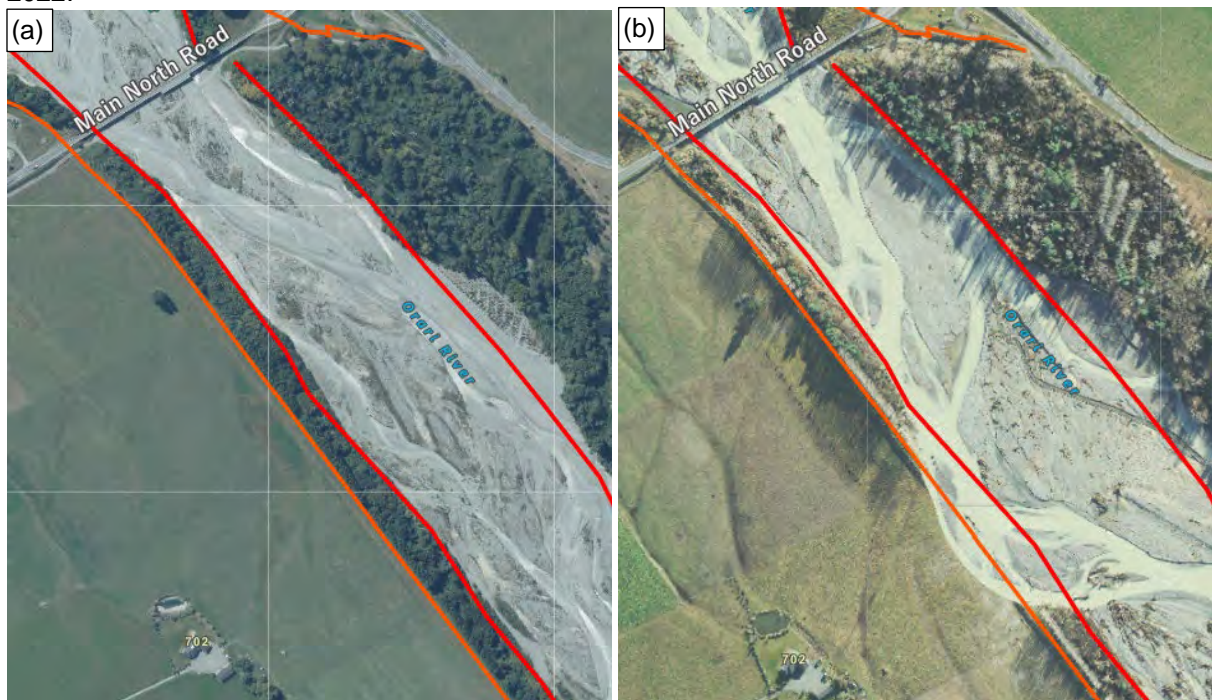
Figure 8-20: Orari at SH79: (a) Aerial view prior to flood, (b) post-flood aerial showing extent of stopbank and tree edge protection asset loss.

Like-for-like reinstatement of 230m of stopbank rebuild; 160m of erosion protection bunds. Anchored tree protection and infill planting still needs to be undertaken in winter of 2022.
